Church of St. Mary
Barnard Castle
1906

The Care of Churches Measure 1991
QUINQUENNIAL REPORT
October 2019

Church of St. Mary, Barnard Castle
Archdeaconry of Auckland

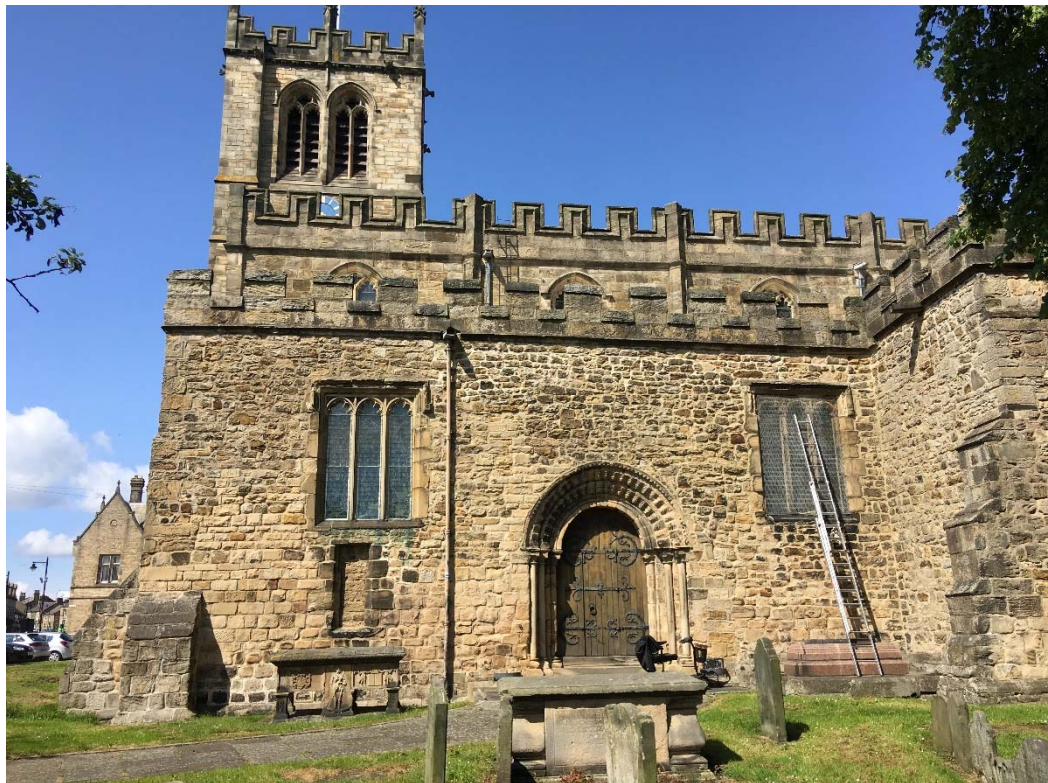
The church stands on the east side of the A67 Darlington-Bowes road immediately south of the Barnard Castle –Whorlton road at a height of 158m AOD (Photo 1).

6. Windows requiring significant work are as follows:
 - sVI requires full restoration and re-leading (Photo 1).
 - nXI requires 3No. panels, re-leading and insitu repairs replaced.

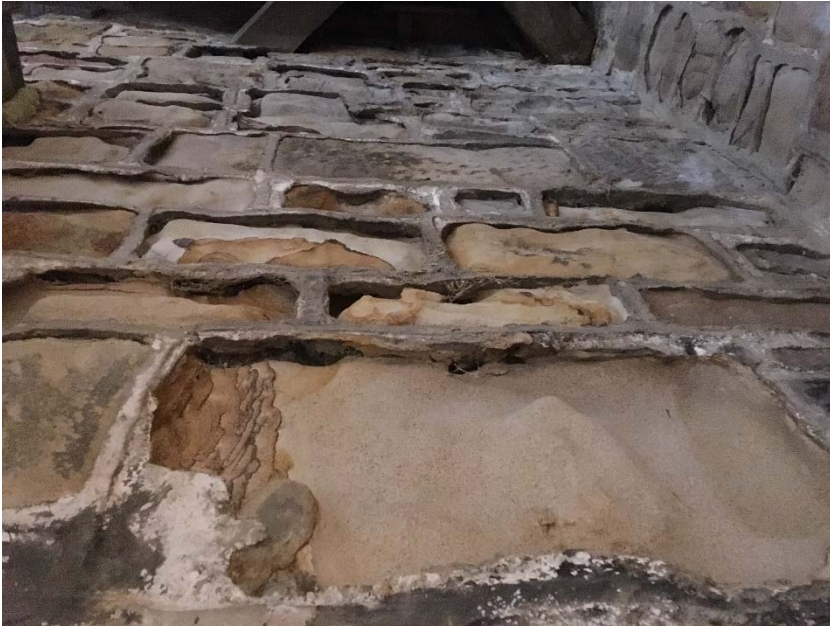
2. Rubble stone walls deteriorating behind cement surface pointing (Photo 5) with large quantities of sand deposited on ceiling below. Also, eroded lime mortar on the east corner, (Photo 4) otherwise in reasonable condition.

Photo 4
Eroded mortar and masonry within Belfry.

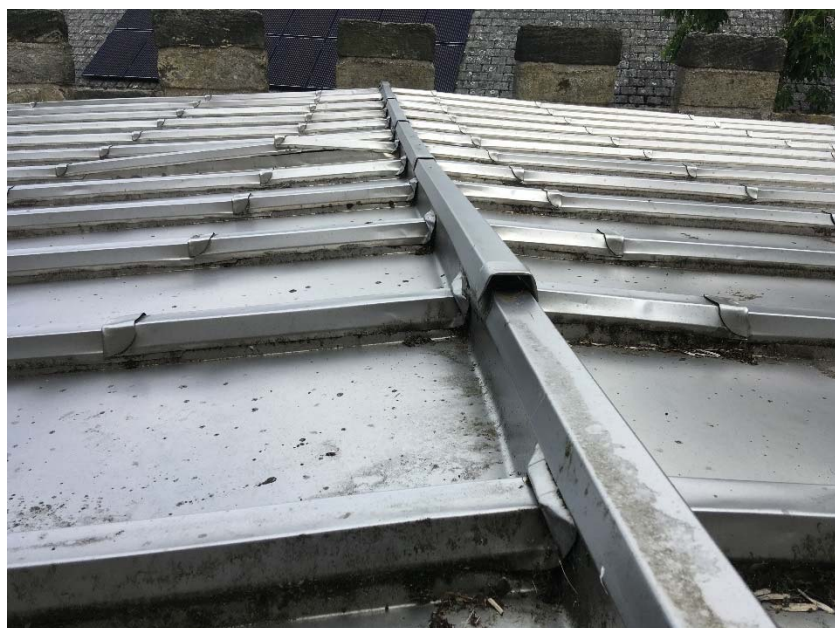
Shallow, double pitch with stainless steel sheets falling to 300mm wide stainless steel parapet gutters to east, north and west. Single outlet to east (Photo 9).

Shallow single pitch with stainless steel sheets falling to 600mm wide stainless steel north parapet gutter with single outlet also receiving discharge from North Transept (Photo 9).

Photo 9
SS roof sheets above North Transept and North Aisle.
