Diocese of Durham

**St JOHN the EVANGELIST
BIRTLEY
(2)**

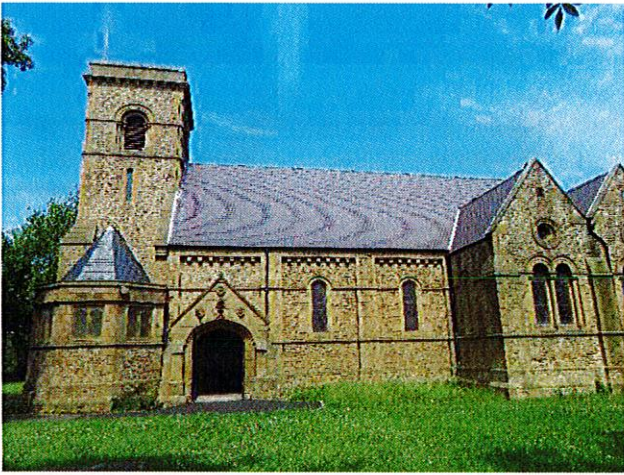
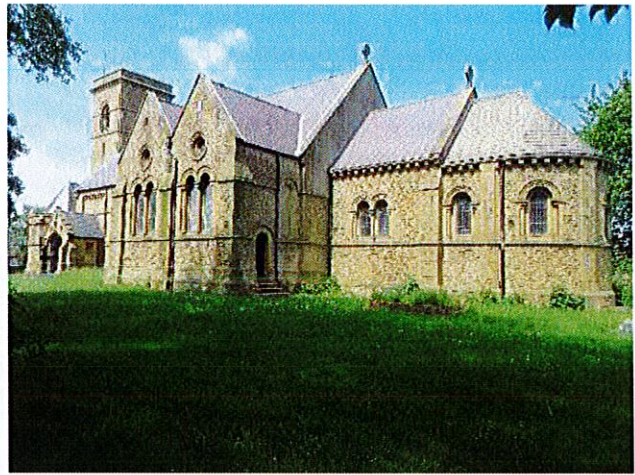
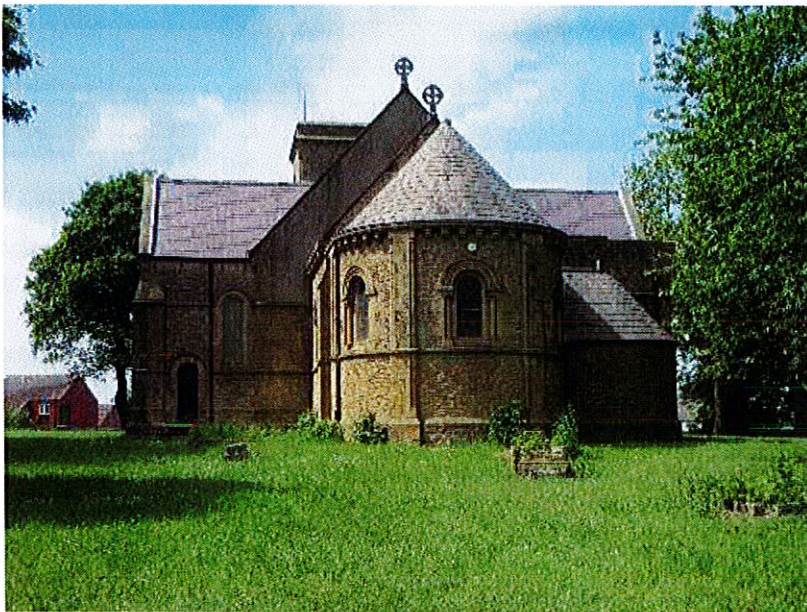
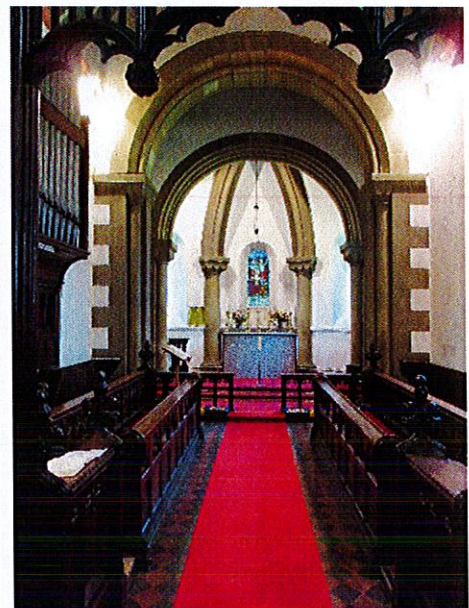
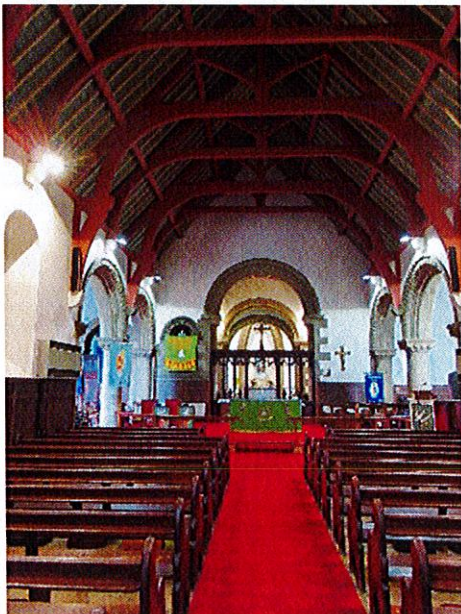
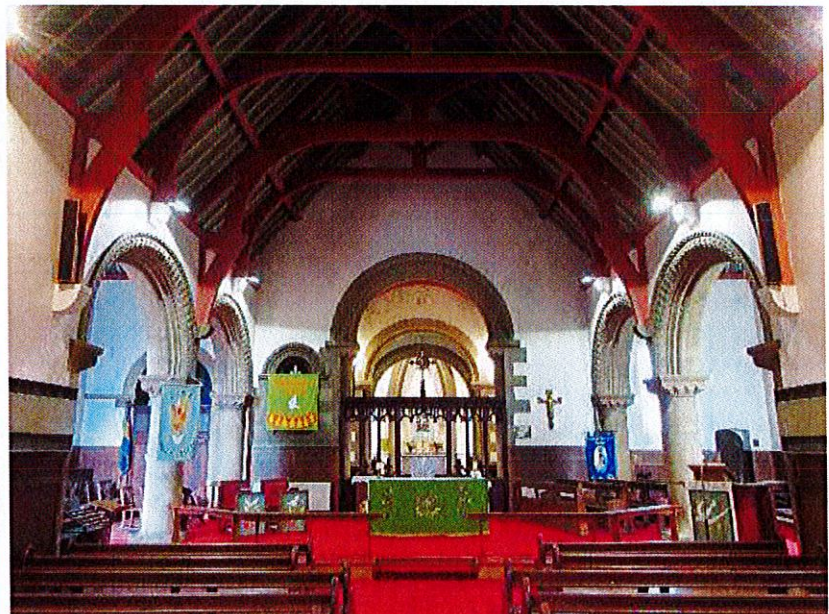
1. I have made a thorough general survey of the condition of the church and grounds. The inspection was such as could readily be made from ground level and ladders. I have not inspected woodwork or other parts of the structure which are covered, unexposed or inaccessible and I am therefore unable to report that any such part is free from defect. The basement chamber under the Chancel was not entered. The flue was not inspected and none of the services were tested. Damp meters were not used.

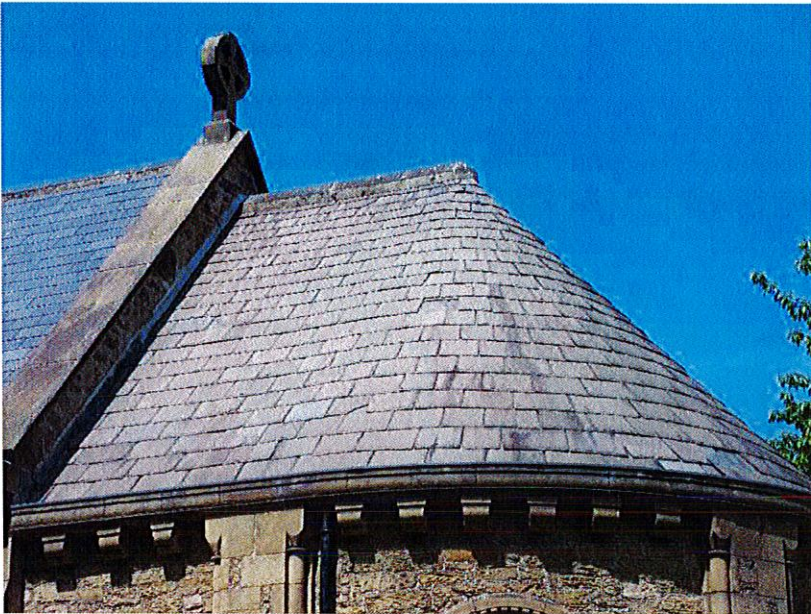
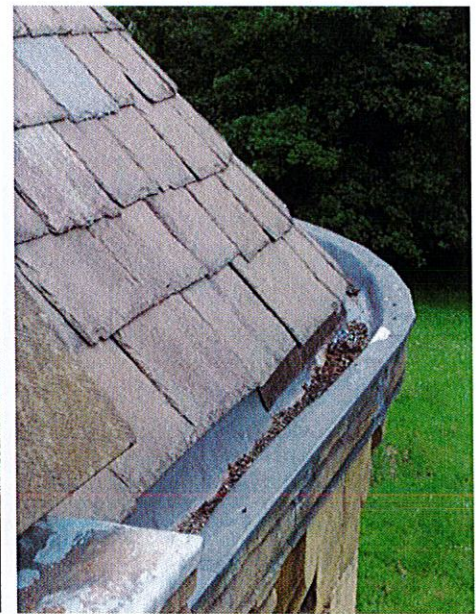
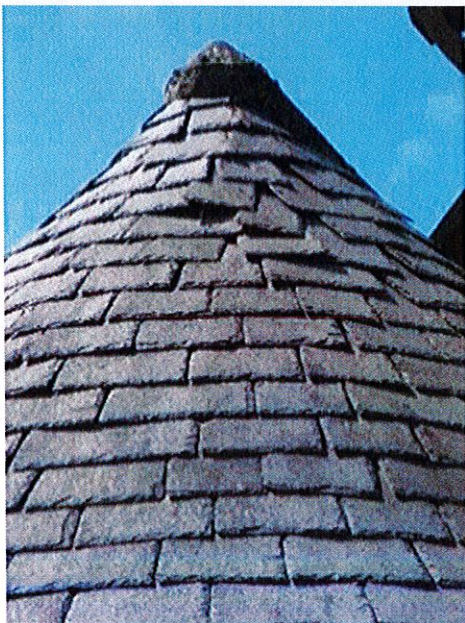
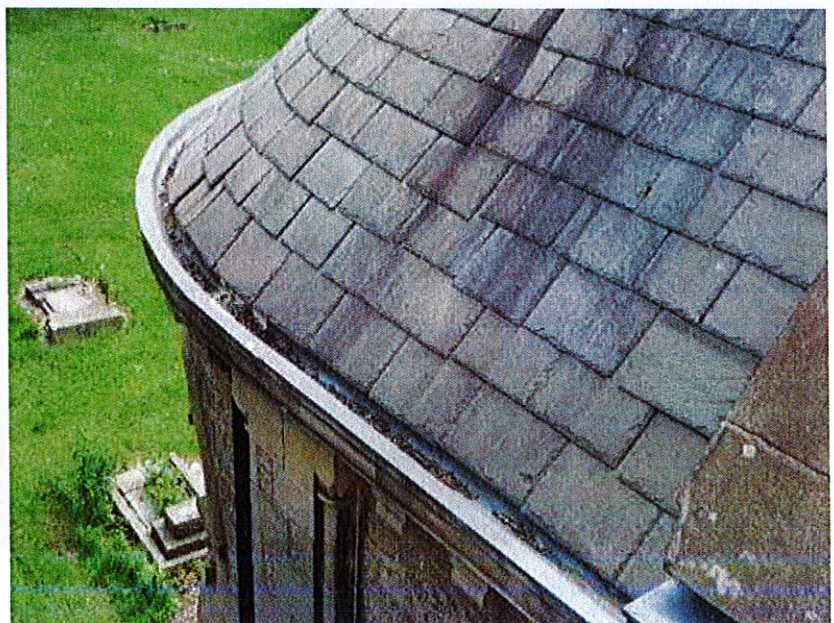
12. Cover flashings over soakers where the slate abuts the low stone Choir E wall. Minor cracks in their cement pointing, which tends to shrink. Lower flashings substitute after theft. Upper flashings remain old lead.

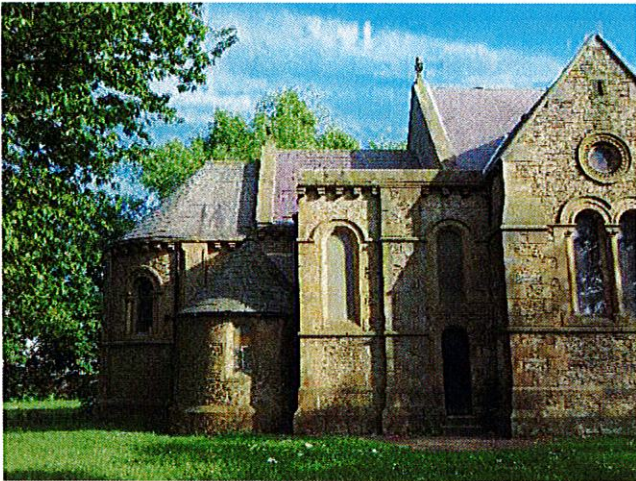
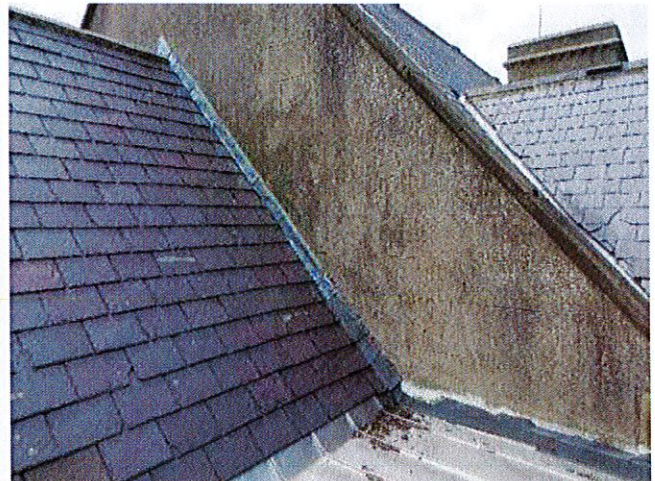
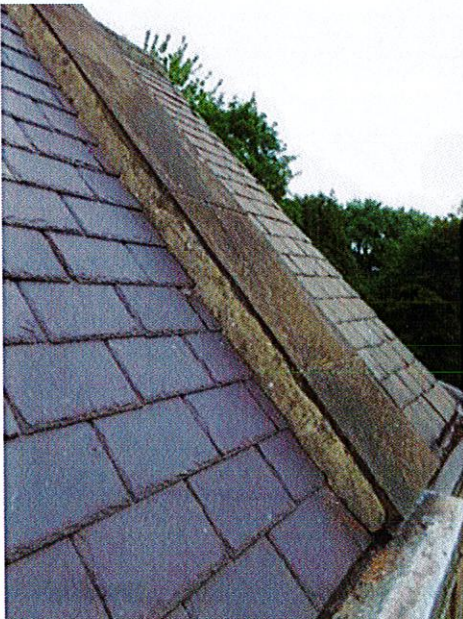
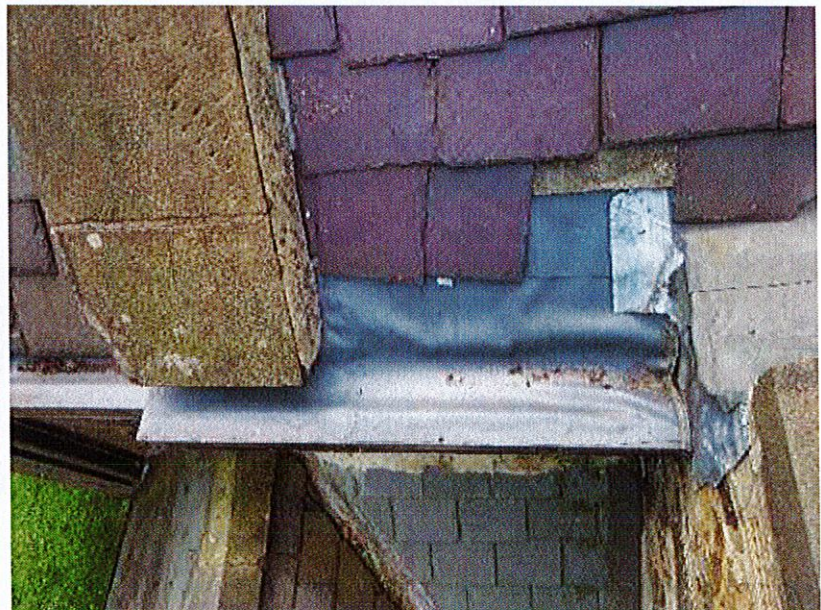
Choir S gutter and mortar fillet against upstand over arch

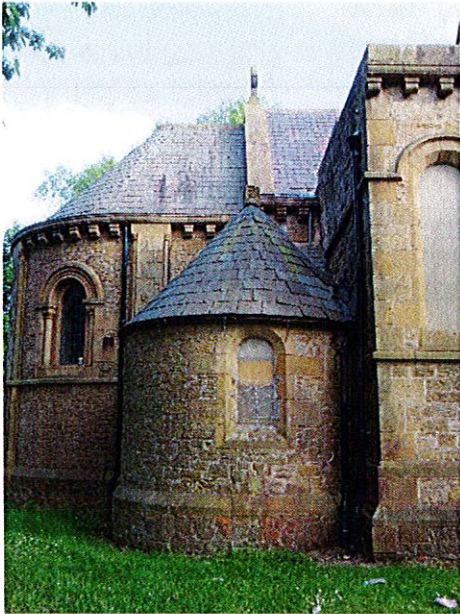
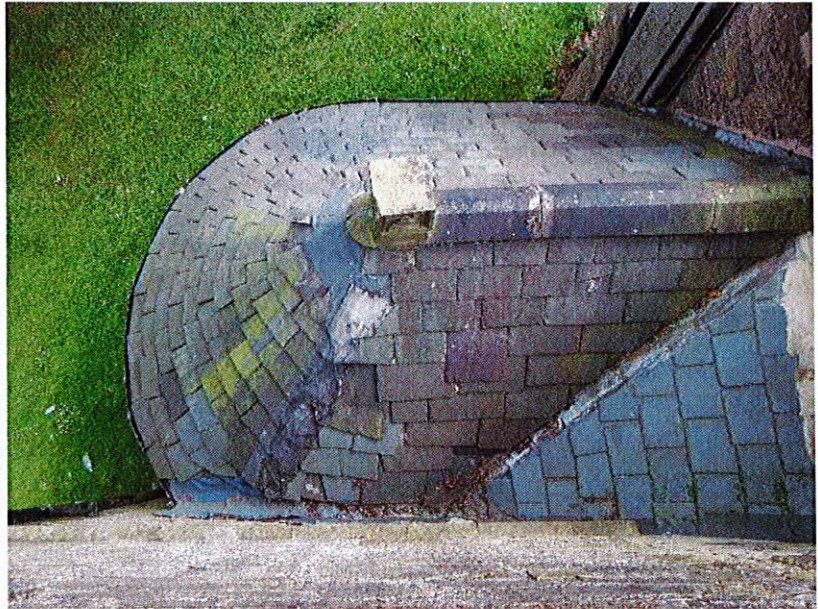
15. Between the **Sacristy** and the much higher later Organ chamber wall a box gutter drains the Sacristy and part of the Choir. It traps leaves and silt and is hard to reach past the Organ downpipe. Previously lead, now substitute. At least one length of substitute flashing is loose from the Organ wall despite several 'pointing' materials being tried. Some water may pass into the timbers below. Box gutter appears recently swept at the inspection and should be kept clear as any blockage may wet the wall below.

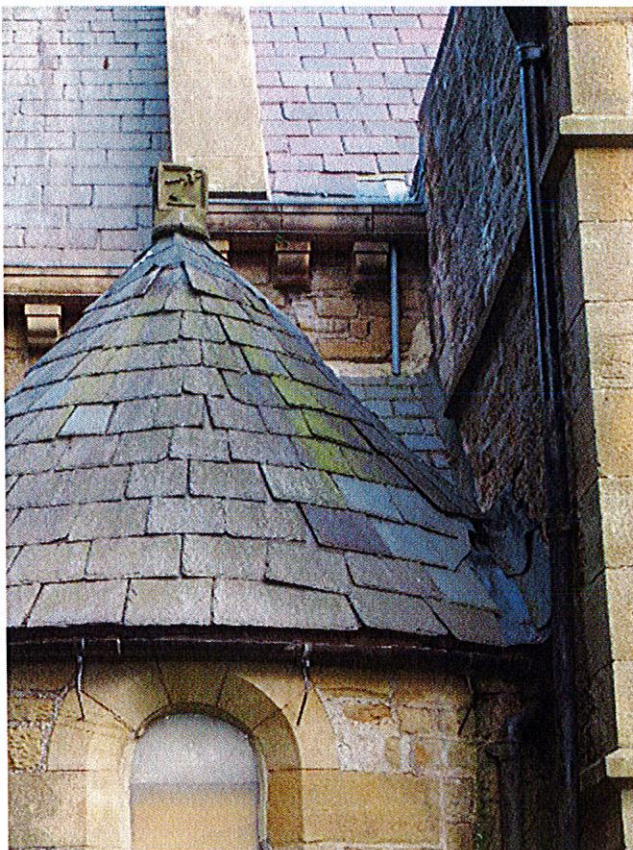
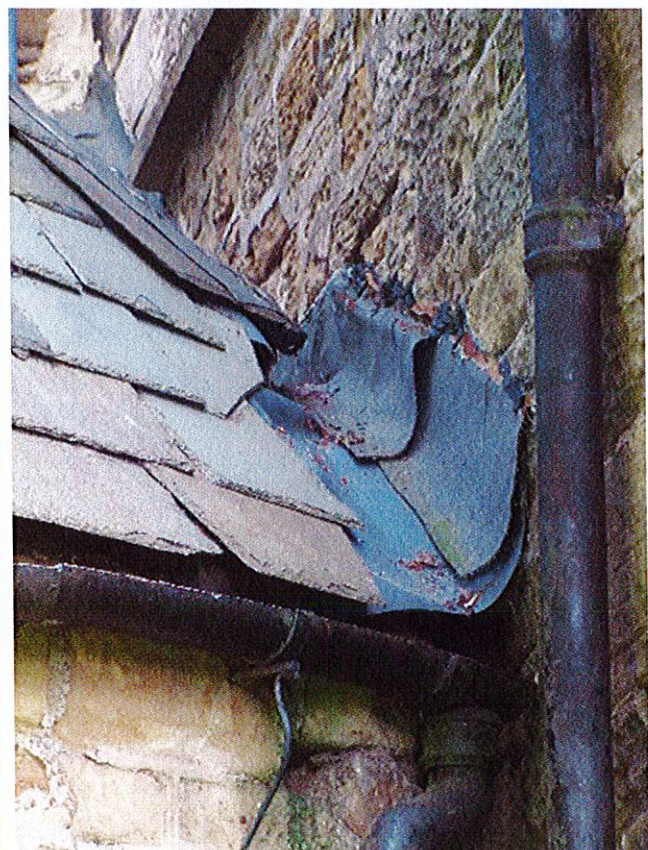
Loose flashing over the outlet from the box gutter

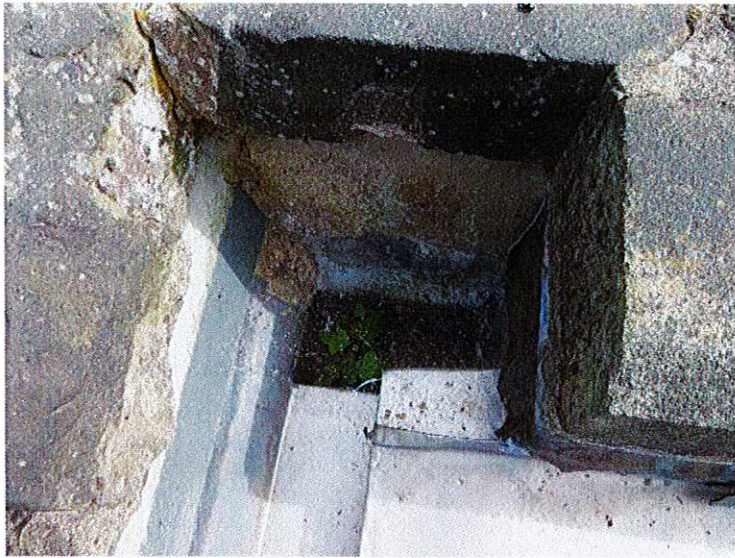
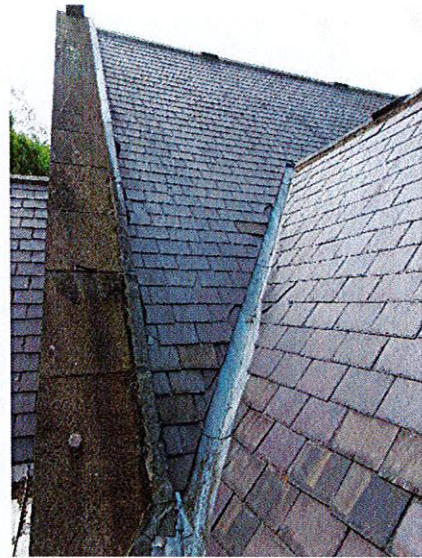
18. **Nave** new slate in 1990's. Ventilating ridge tiles and counterbattens vent between new underlay felt and the roof boarding with limited eave ventilation. One missing slate over the SW Transept ridge and one near the SE Transept ridge begins to slip.

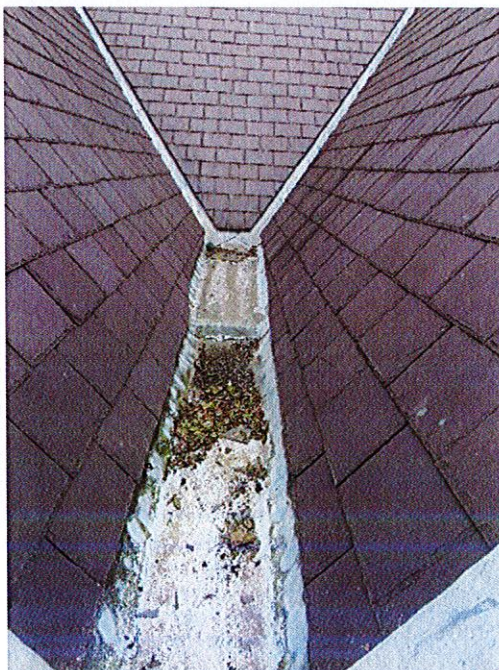
Valley between S Transepts

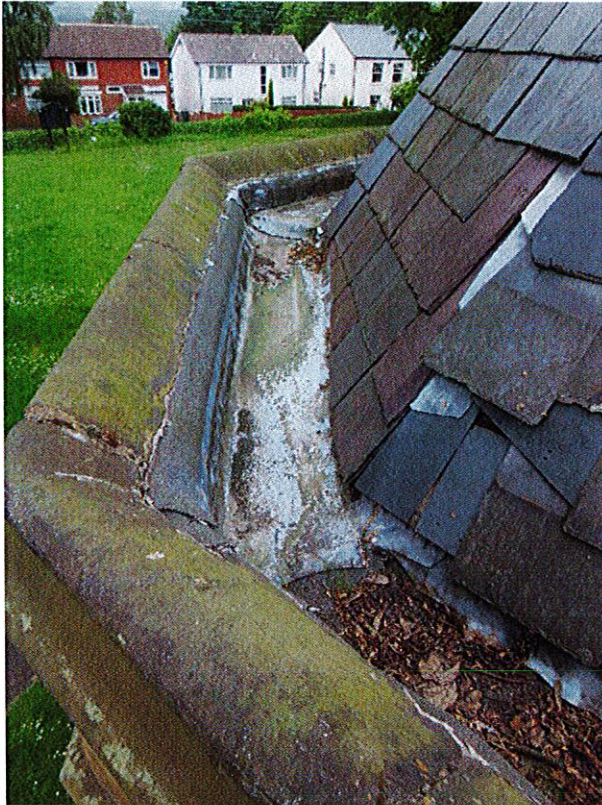
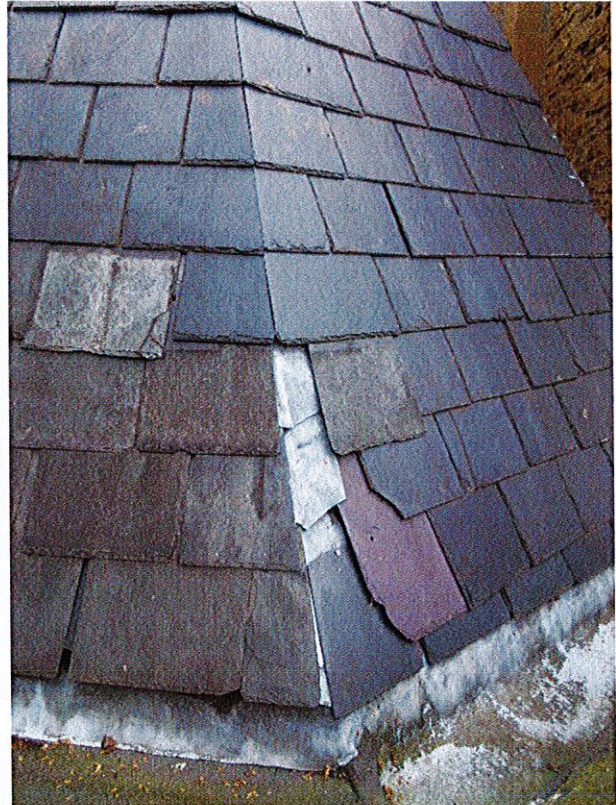
23. Lead gutters behind parapets with falls to single end outlets. Cover flashings with deterrent anti-climb paint. A lead flashing around outlet at E corner of Office is loose from the coping joint and must leak.
 Some flashings substitute after theft. Stone debris building up in the Office gutter.

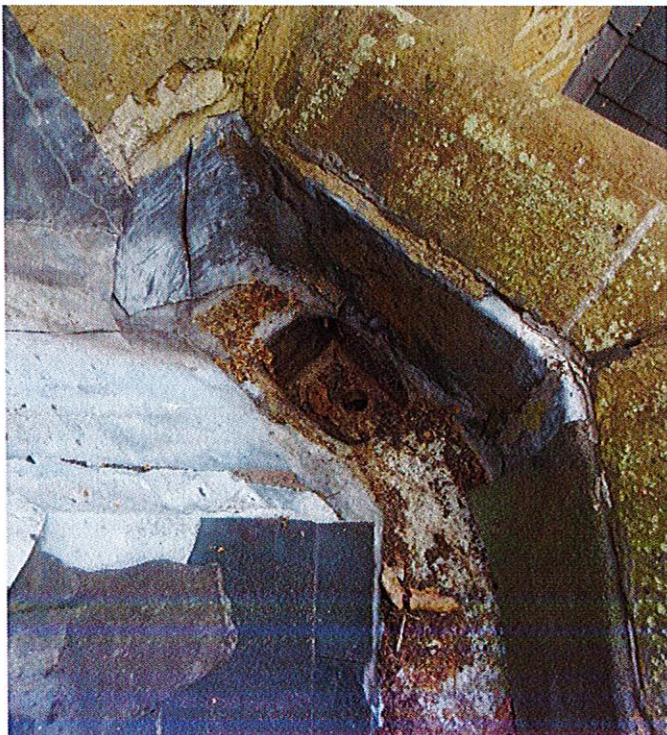
para 23 – loose flashing at E corner of Office

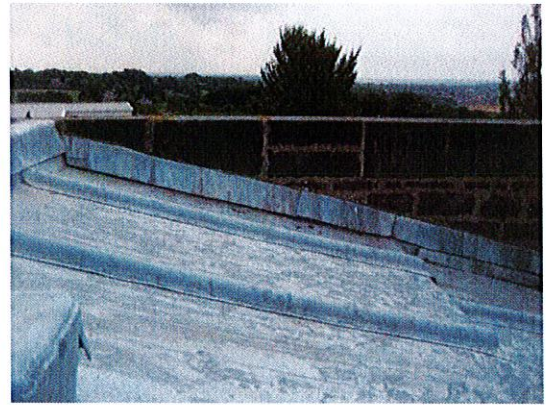
The top cover flashings are wedged into grooves in the top of the E coping but not pointed so may leak slightly, perhaps contributing to the stone erosion seen inside the top of the tower.

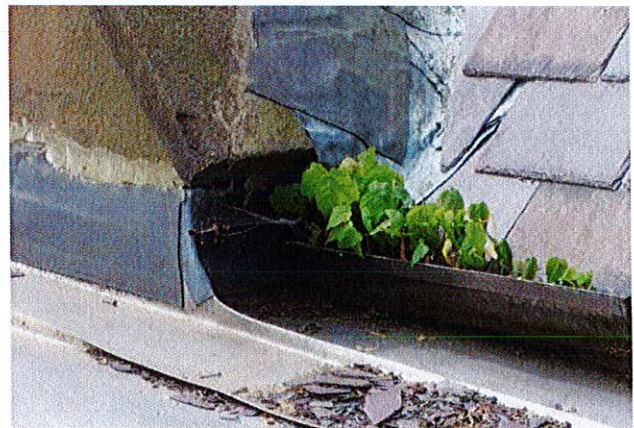
27. **Sanctuary** cornice gutter appears sound but at N debris begins to block the gutter and plants grow in the outlet.

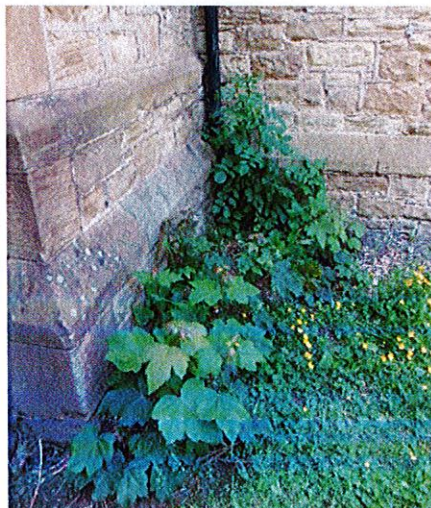
SW Choir – gully cracked and overgrown

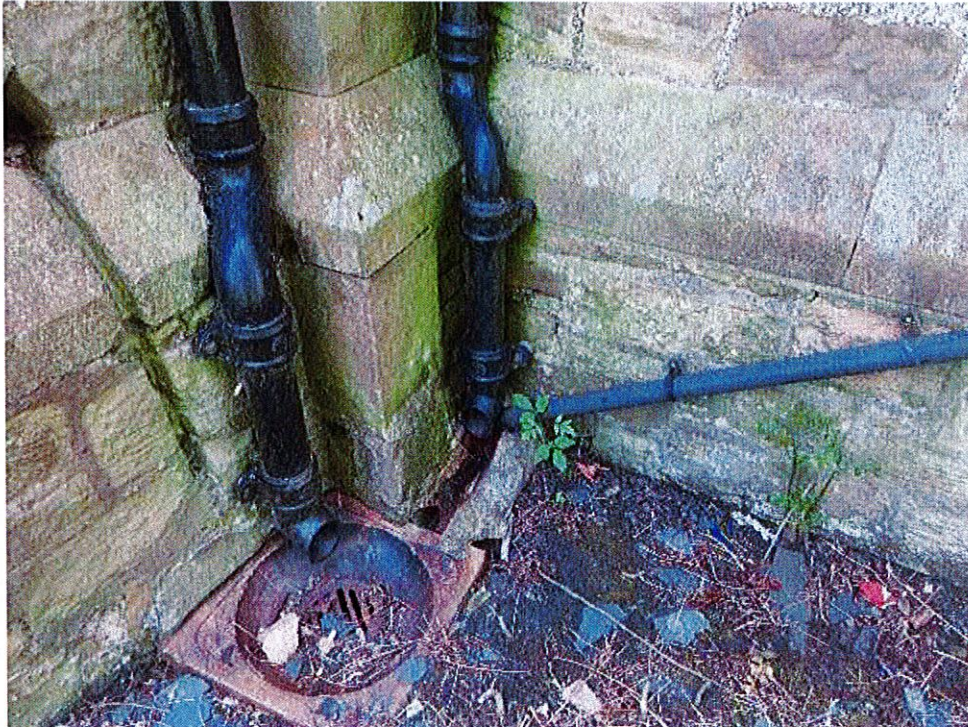
At corner of Sanctuary and Sacristy hole in concrete ground channel wets ground at base of wall

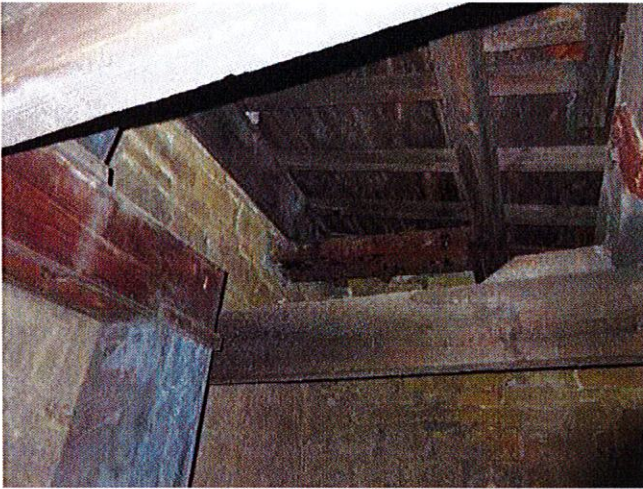
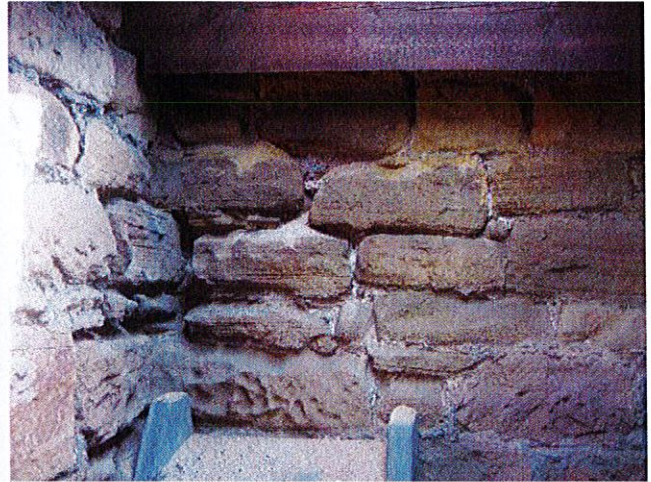
Top stage – under the slipped roof lead and under the roof hatch

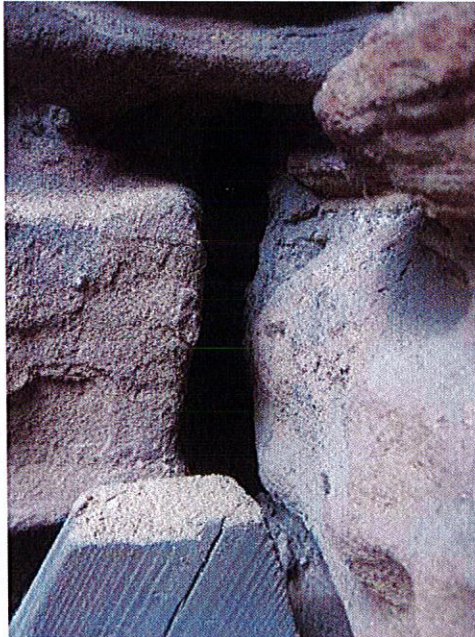
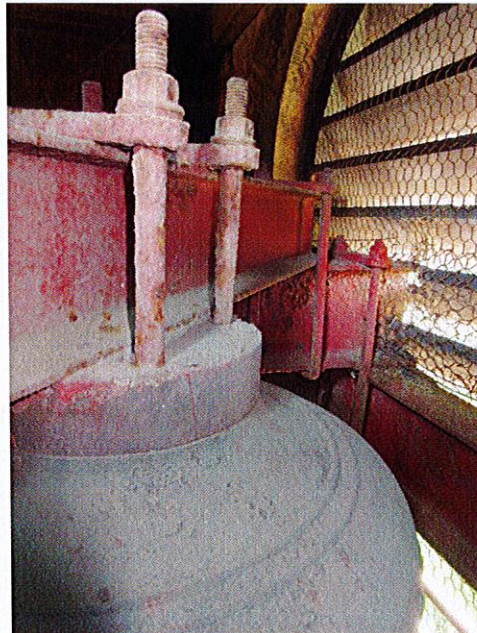
38. Bell stage with six chimed bells by Taylor of Loughborough bolted to three painted steels built into the stone walls. Paint fair but visible past rust at a steel end exposed to the weather at the W louvres. Precautionary repainting at least the most exposed part would be a wise use of money. Three louvred round head openings with wire mesh inside. Timber floors and ladders seem sound but poor access in the narrow space between bells and floor and polypropylene chime pulls. Sample ends of softwood floor beams and flooring examined below appear sound.

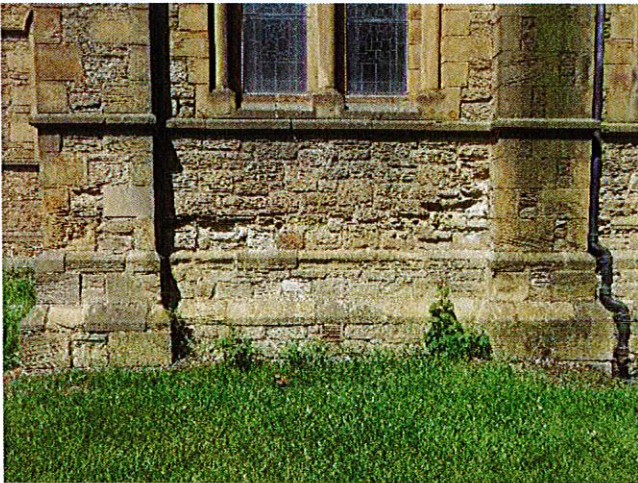
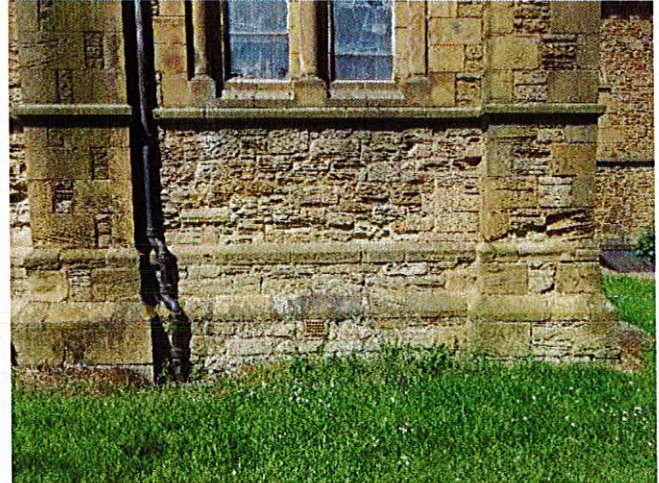
45. **Both Transept gables** have green streaks and minor open stone joints around and below the centre hoppers. At N the narrow joints at the top of the buttress below the hopper are also open. Probably caused by spillage from past or continuing hopper blockage and still causing enough leakage or spillage of rain to flake the paint inside (paras 29, 85).

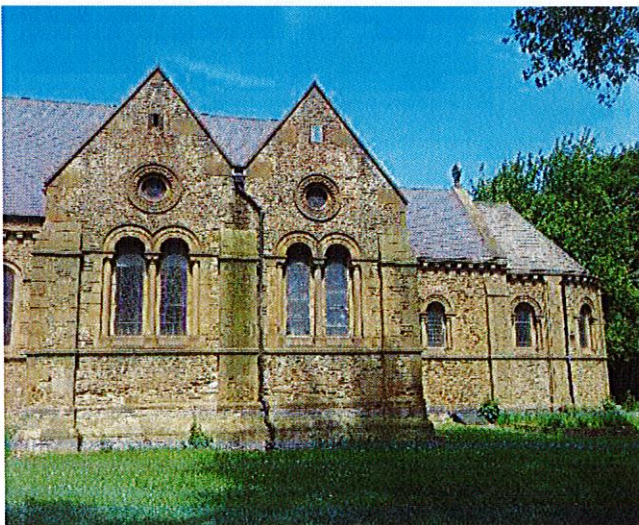
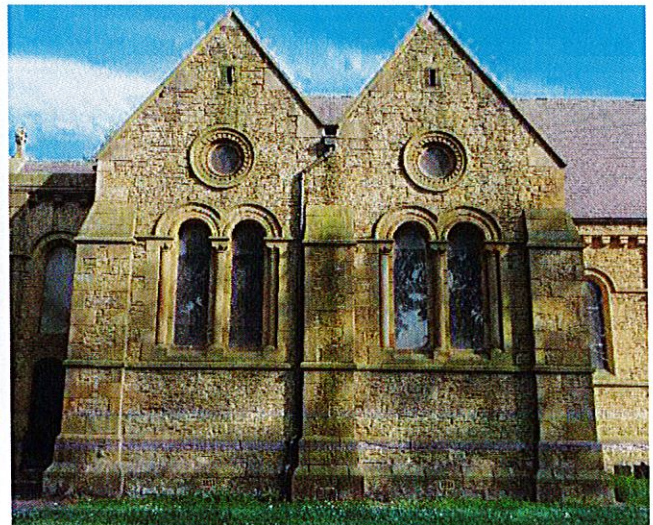
Gables S and N Transepts – note green streaks full height under hoppers at both valley gutters

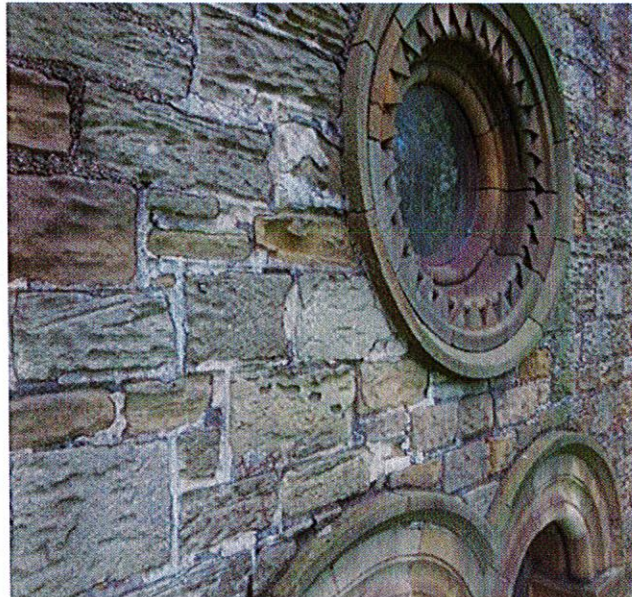
Gradual stone decay below the N Transept roundels

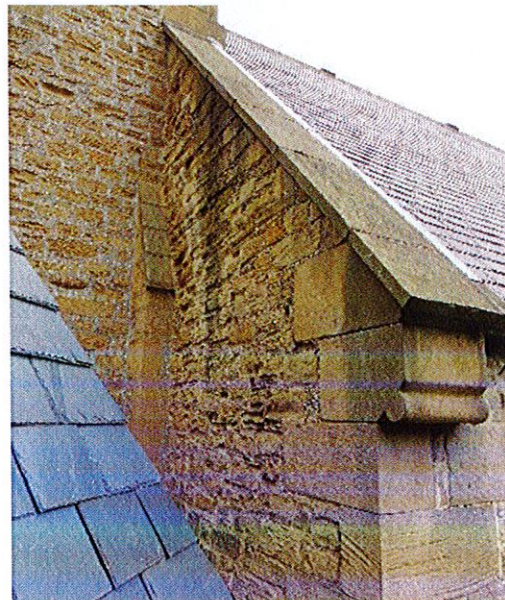
47. At **Porch** some decay in rubble side walls. Good buttressed ashlar gable with carved shields, seems to have little or no bond to the side walls and has moved out. The vertical corner joints have long been open, especially at the SW corner which may have dropped. It is common for porches to have poor foundations. The open vertical joint may be slightly wider than at last inspection. Repointing would show whether movement continues. Other narrow joints in the ashlar are open.

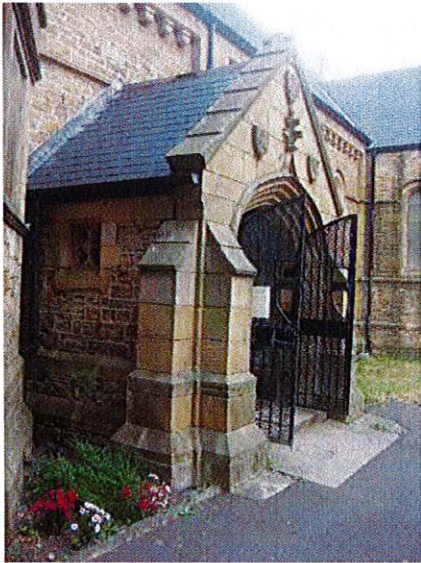
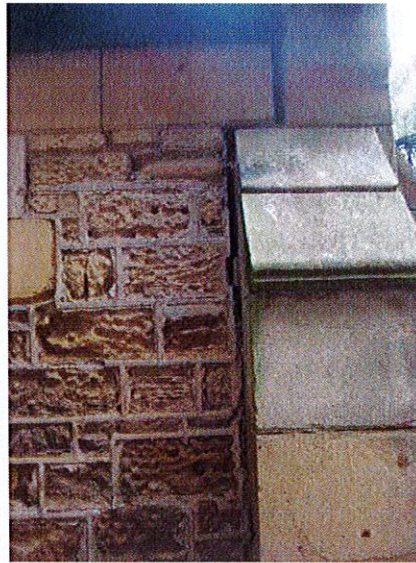
Crack at SW of Porch 2013

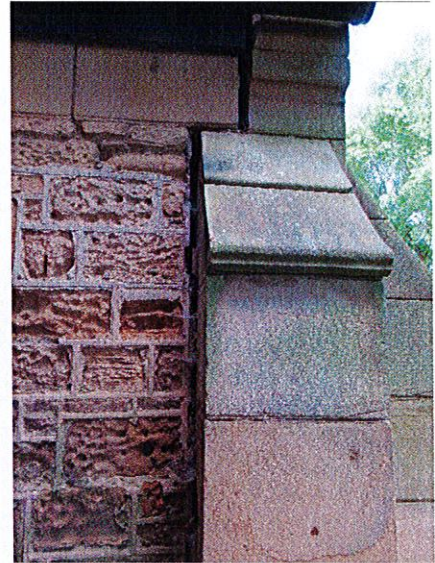
Crack at SW of Porch 2018

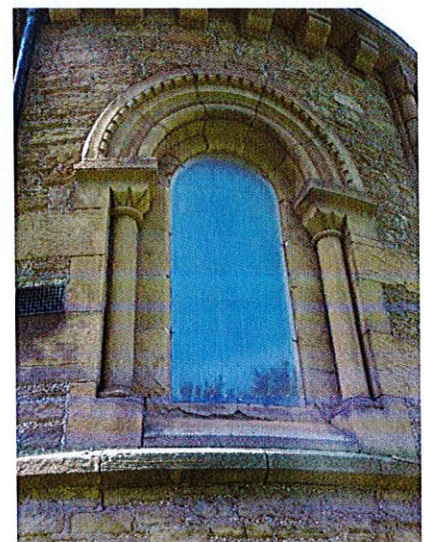
57. **W of S Transept** - plain lancet. Cill fractured. Stone repair should be combined with repair of the poor glass and plaster.
58. **S Nave** - windows good but some pointing missing. Patch pointed where the protection is fixed.
Porch good except eroded cill at W quatrefoil window and minor decay at two jambs and one shaft stones outside the inner Porch doors and at the outer arch in a spring and a reveal below it.

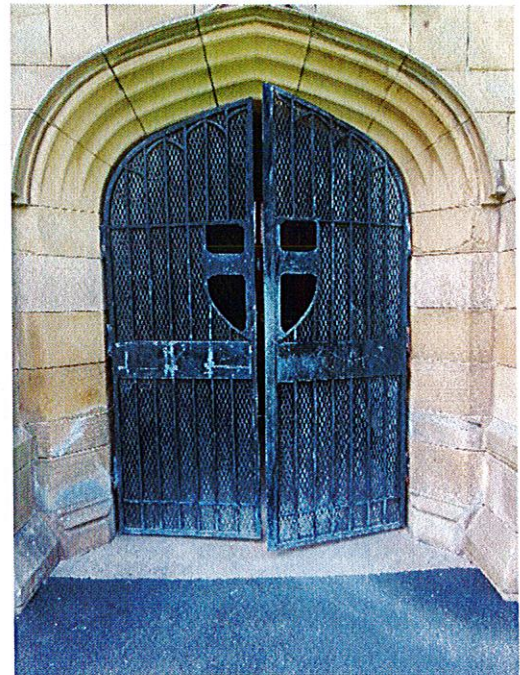
DETAILED DESCRIPTION OF THE INTERIOR

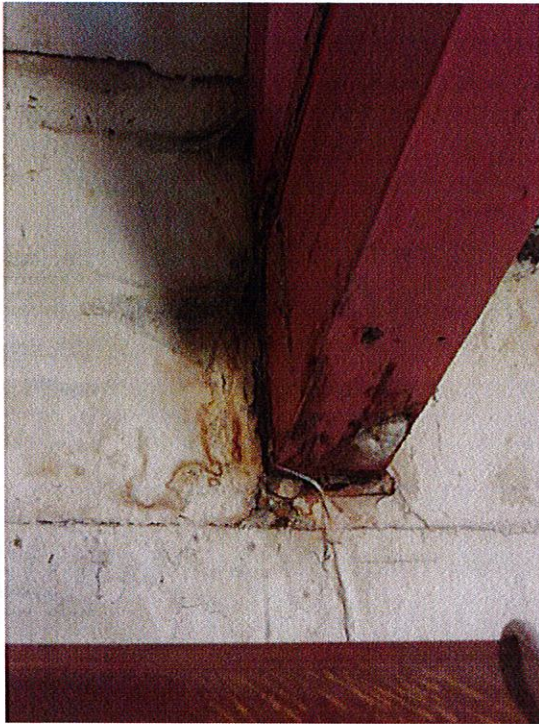
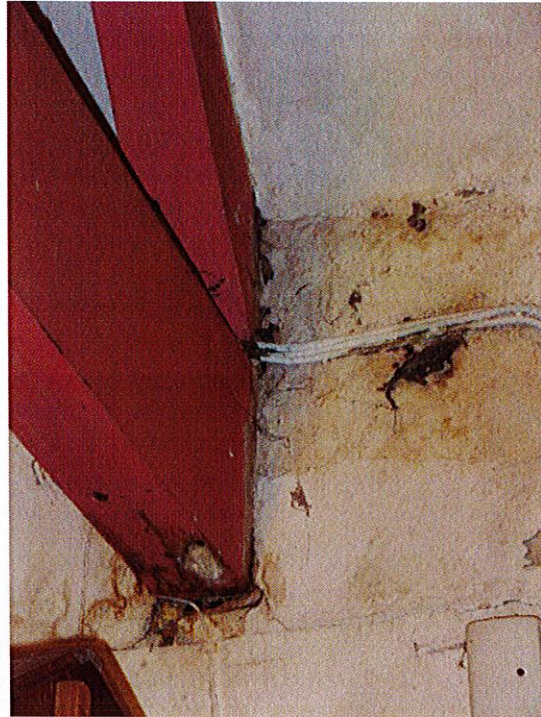
68. The **Organ** roof is simple concealed flat joists, seen in the past to run N-S.

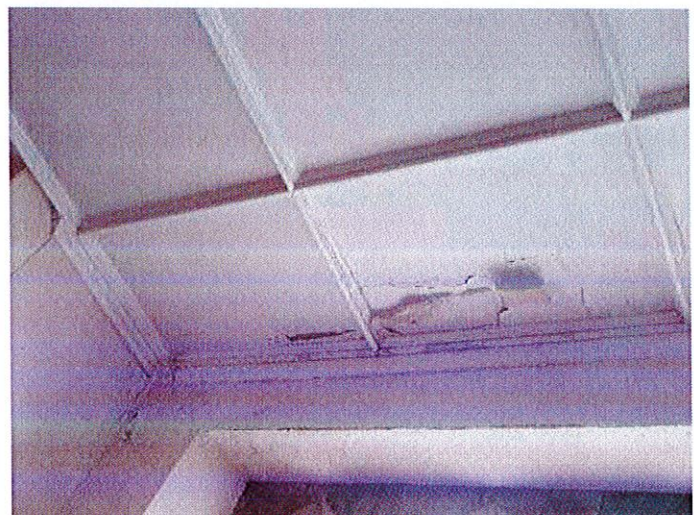
Chancel and Sanctuary Arches, Arcades

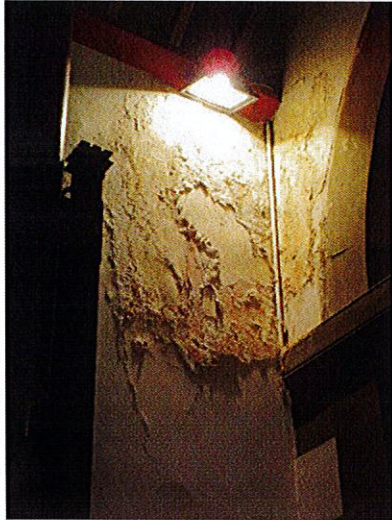
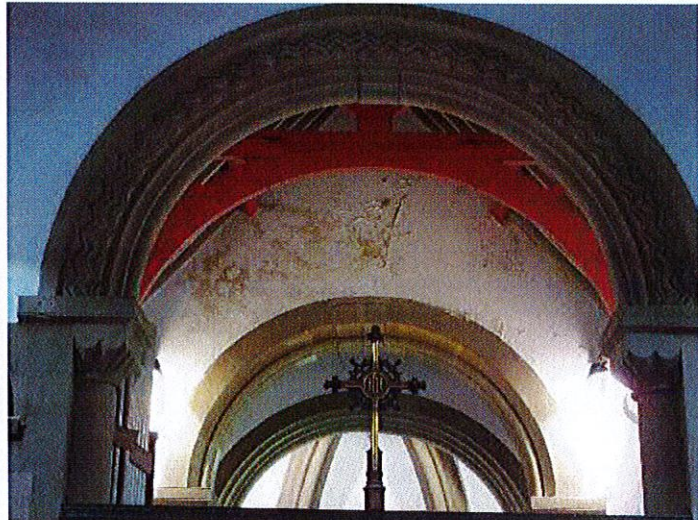
- decay in plinth stones and plaster under the **Sacristy** radiator may simply be rising damp but it is at the reverse of the Choir NE corner so may relate to damage there

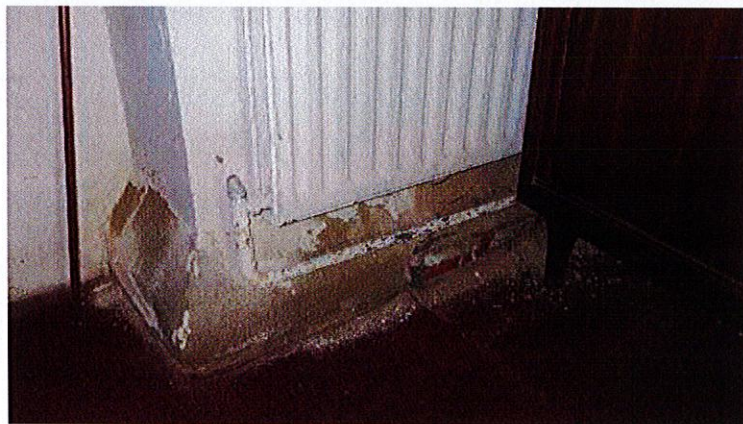
- at **S Transept** W window paint and plaster breaking down

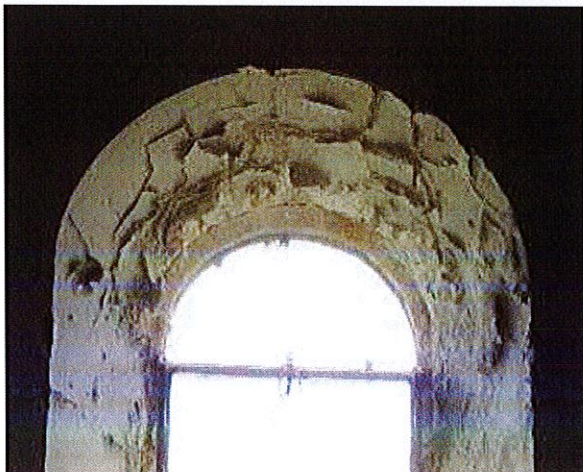
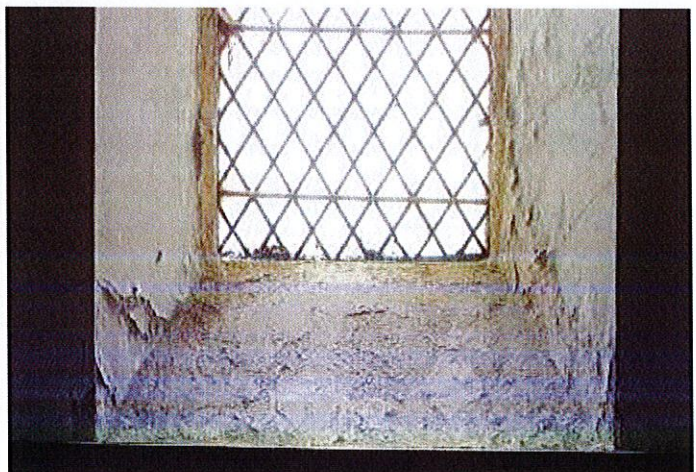
- plaster damage by the S end of the **S Transept** beam and down the wall including corbel decay mid height (paras 29, 45)
- at top of **S Transept** SE corner
- paint poor under the **N Transept** W window
- at **N Transept** N corners some mould on the paint (water vapour condensing in winter on the coldest masonry)
- at top of **Nave** E gable slight paint damage
- over the **Vestry** W window the paint is water marked and the edge bead rusted due to past leaks
- over **Vestry** outer door rusty edge bead, paint lost down E side and some damp in plaster in LH cupboards (rainwater pipe para 32)
- at **Office** under the S cill and slight L of the SE window

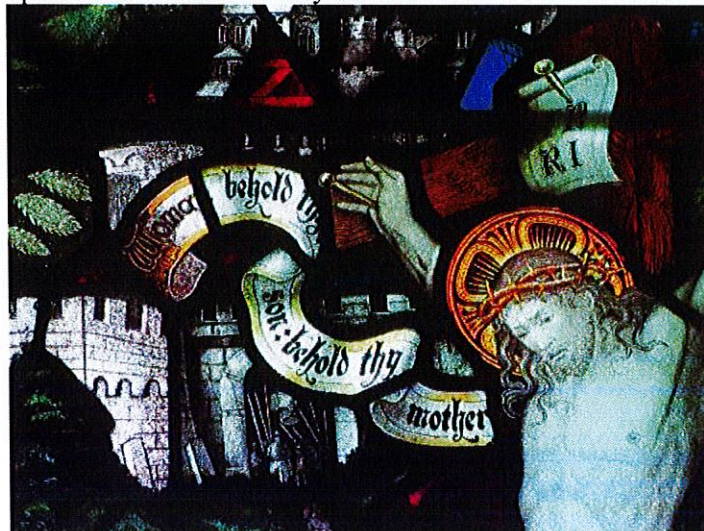
N & S curved lights – white hand made quarries in good condition. A plate records one (both?) is a 1950 substitution for Victorian memorial glass, perhaps to improve light at the altar. Both sound, dirty inside.

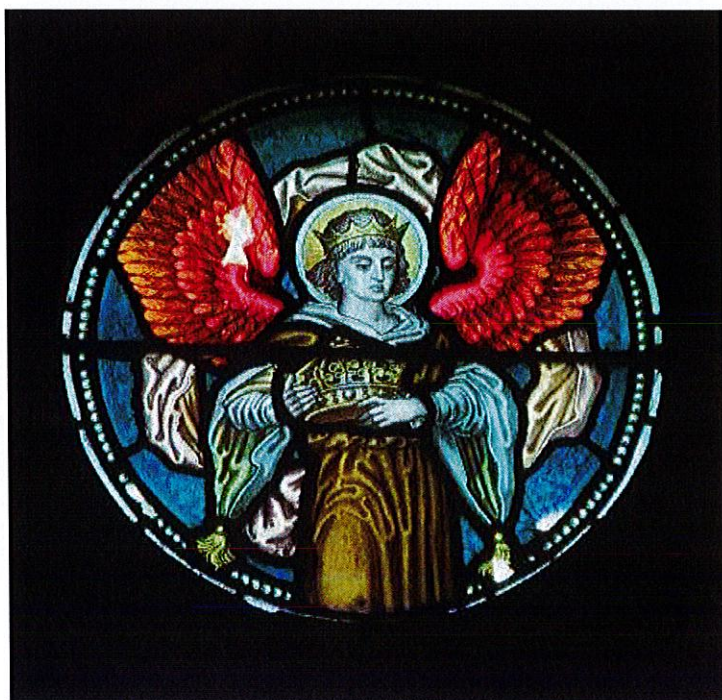
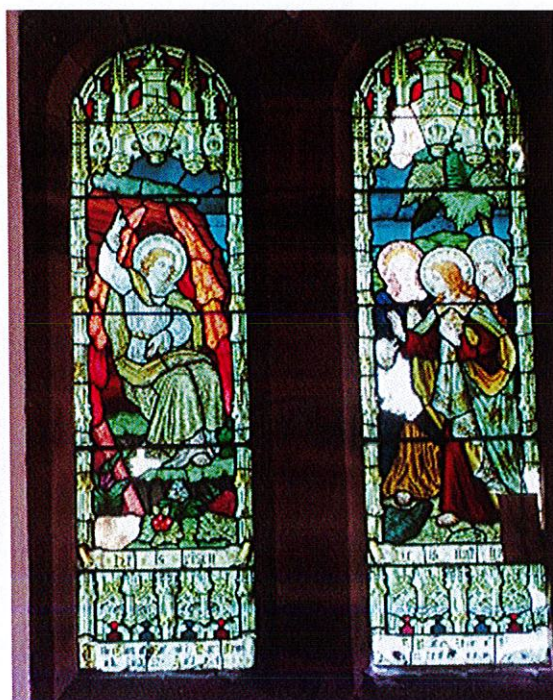
Breakages at S Transept SE lights

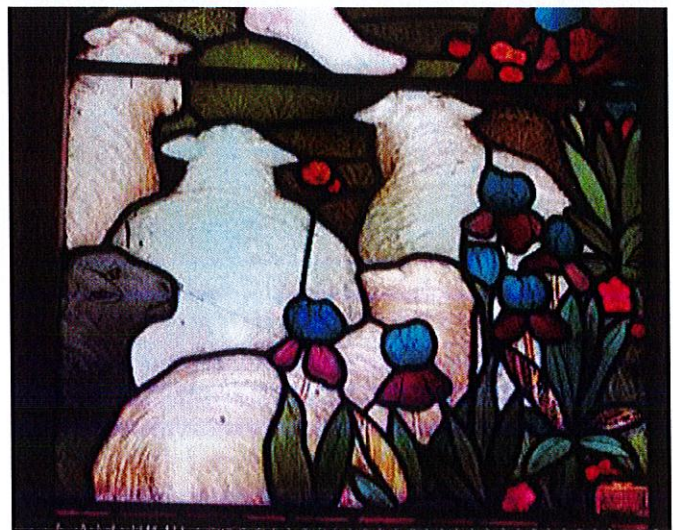
98. Good modern ventilated polycarbonate at all Nave.

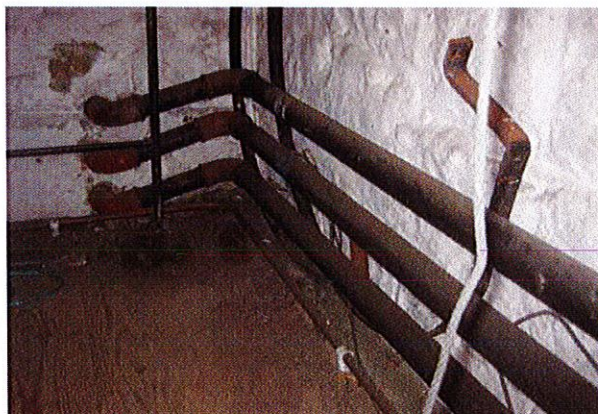
unlagged pipes in Tower

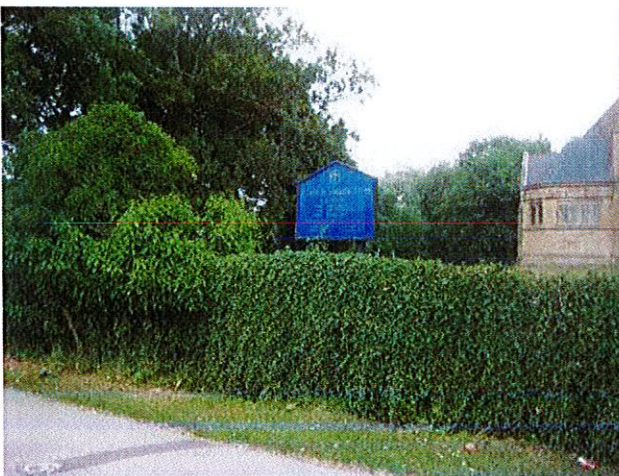
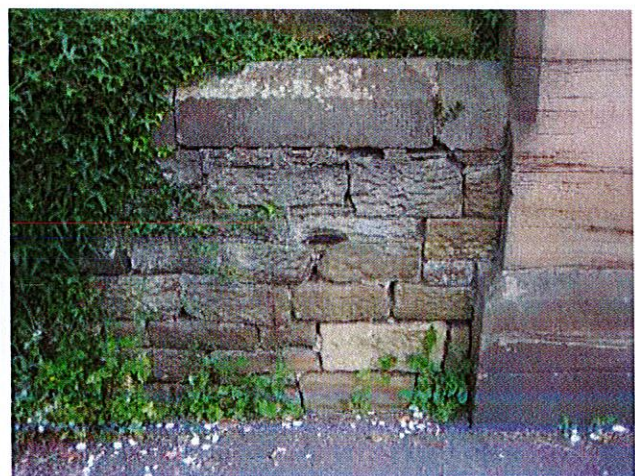
137. Sign at the middle of the W side, fair condition but needs paint.

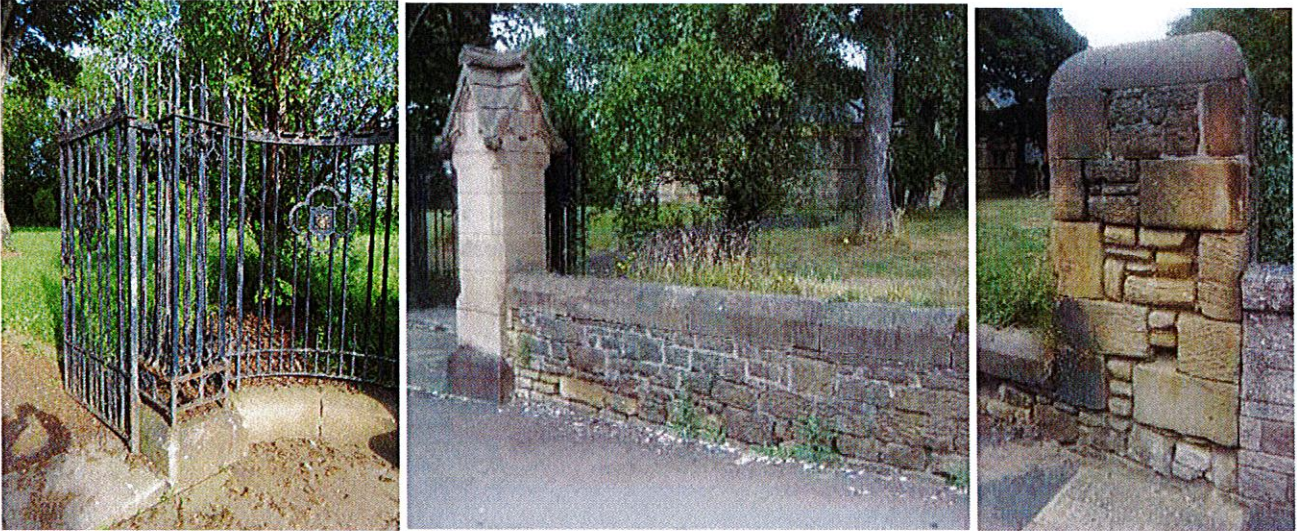
138. A low W wall retains the yard above Birtley Lane. N half covered by ivy. At S including SW pier replacement of missing stones and extensive repointing is needed to prevent decay becoming collapse.
