Church of St. Andrew, Southchurch, Bishop Auckland

DIOCESE OF DURHAM

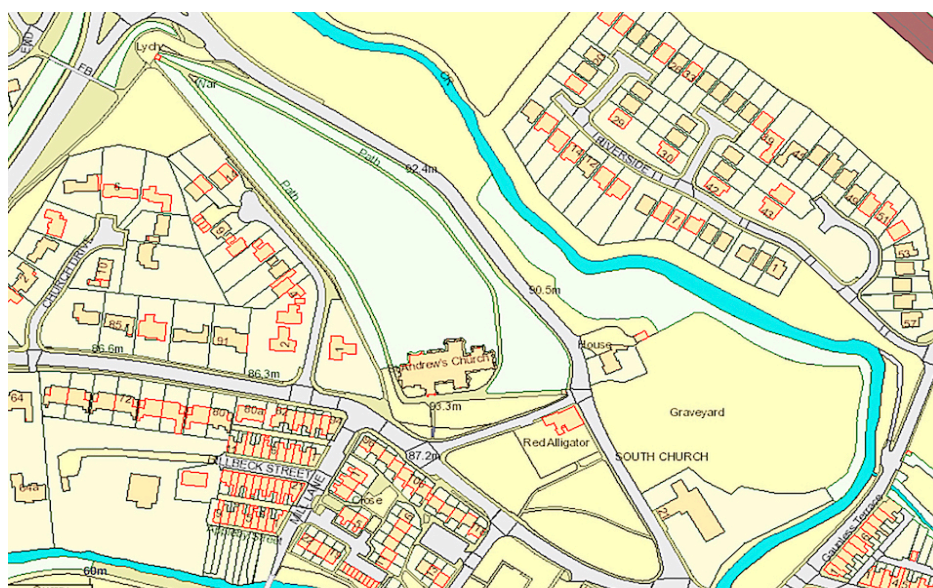
III SUMMARY AND RECOMMENDATIONS

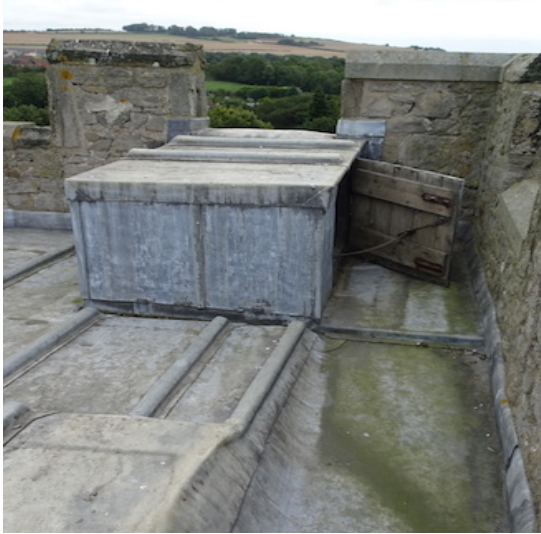
Tower roof – awkward access onto roof defective door.

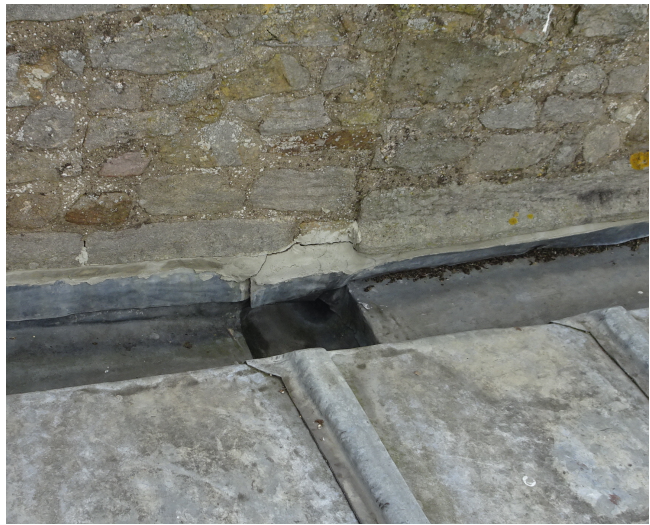
Tower roof – cracked mortar to cover flashing on west parapet wall

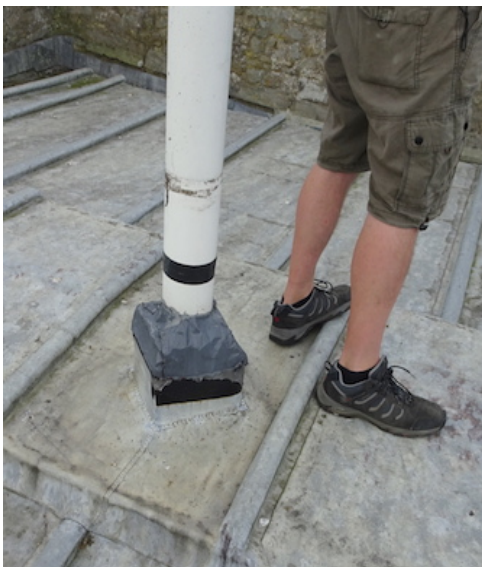
Tower roof – plastic 'sleeve' on flagpole base

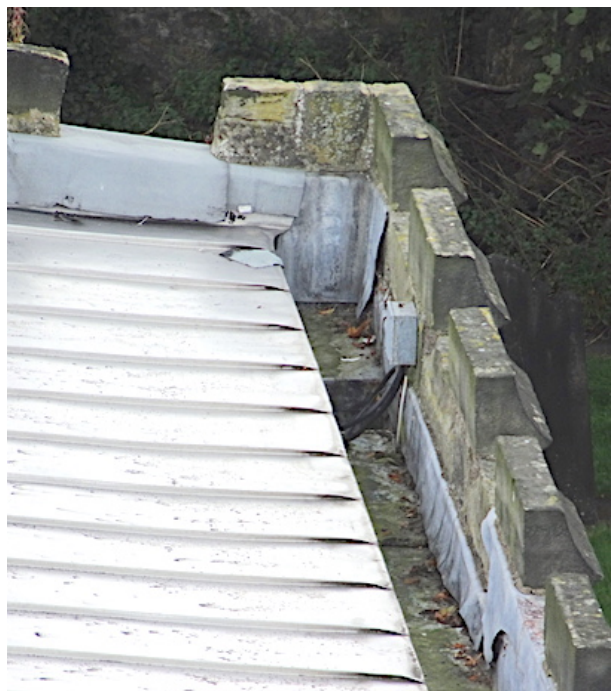
Chancel roof east and south parapet – loose non-lead flashings

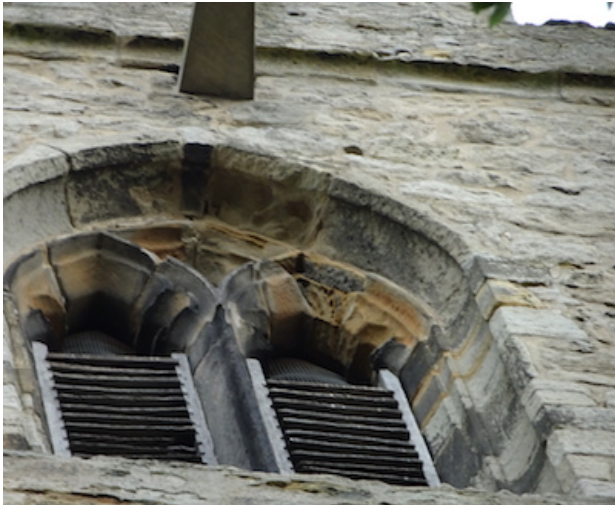
Tower north face - bell chamber eroded window masonry

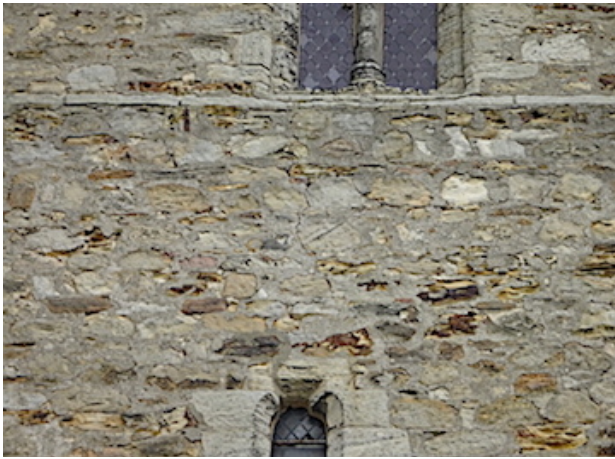
Tower south face - crack in masonry at ringing chamber level

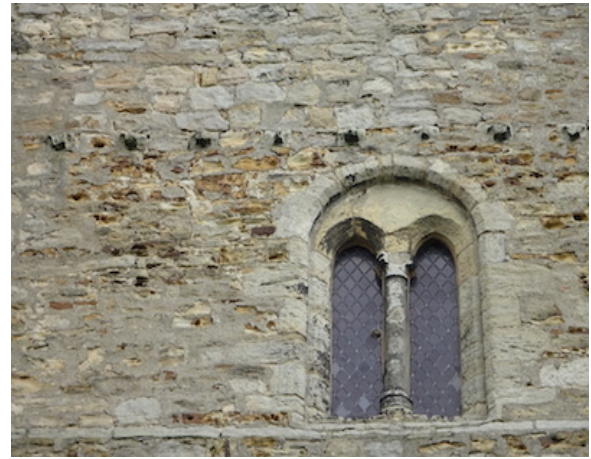
Tower south face - eroded pockets in masonry

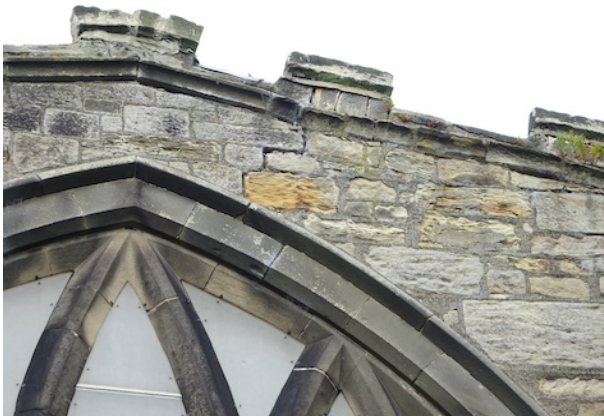
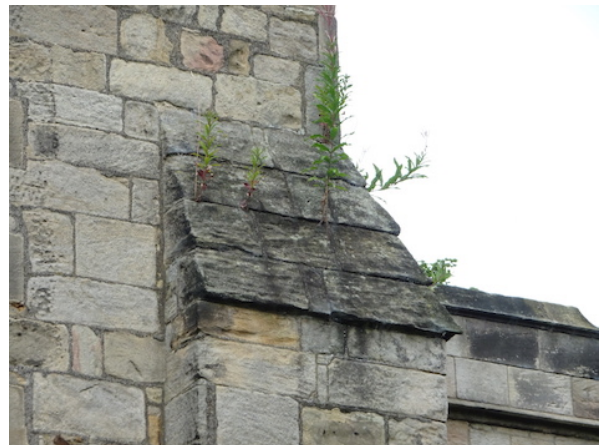
Chancel East gable - fracture in parapet near centre and plant growth at north side

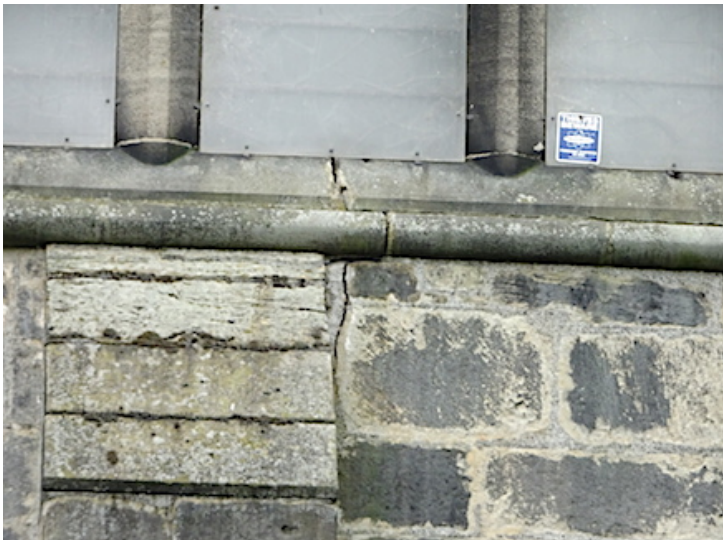
Chancel East gable - fracture in sill level

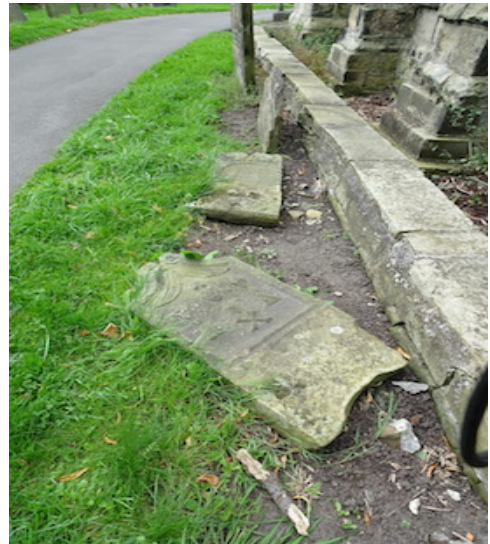
East end - vulnerable fallen gravestones

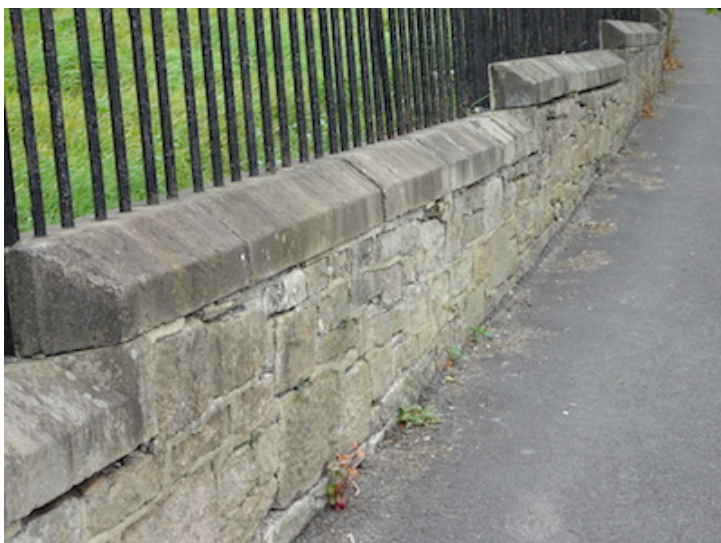
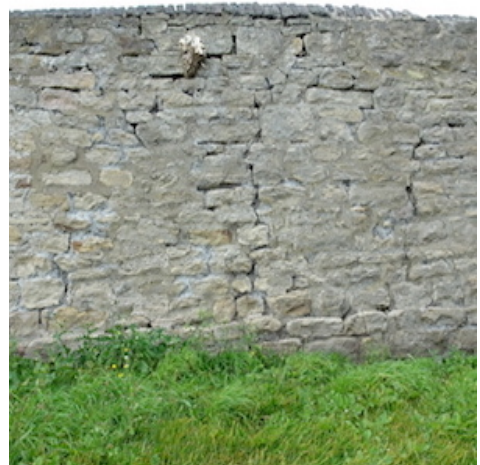
Churchyard wall south side – open joints in railing wall and fractures / open joints in taller section towards the east gate

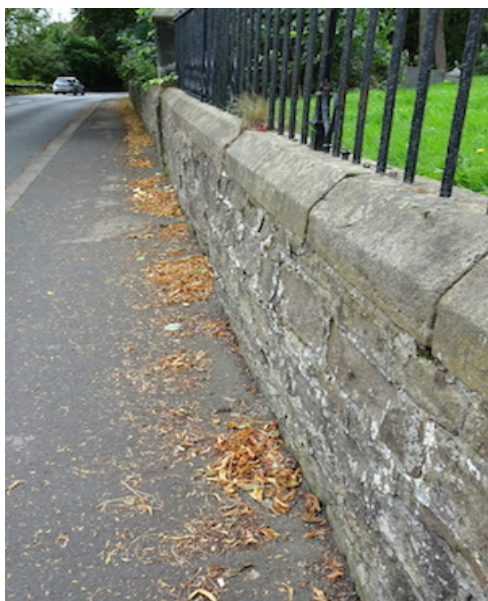
Churchyard wall east side – open joints and bulging.

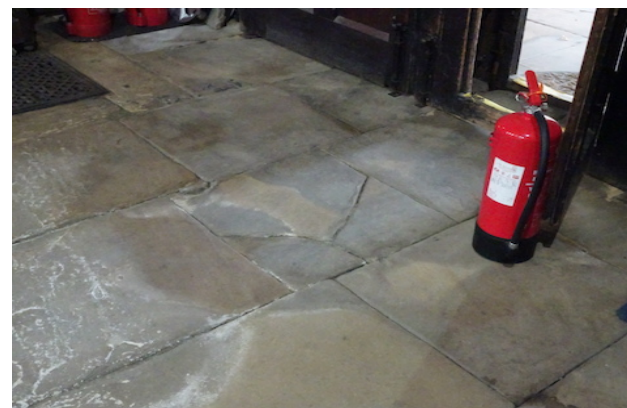
South Aisle – rising damp and cracked flags near south door

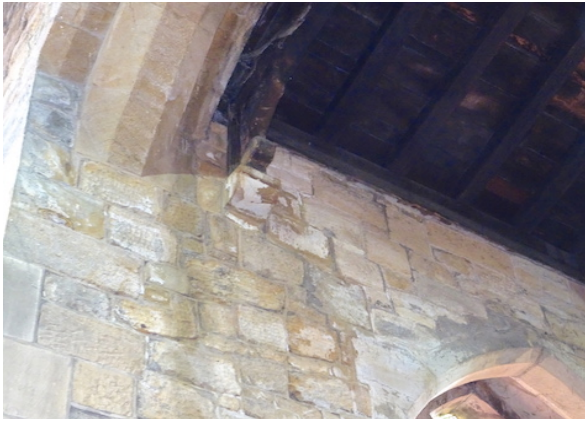
South Aisle – signs of water ingress at ceiling level east end.

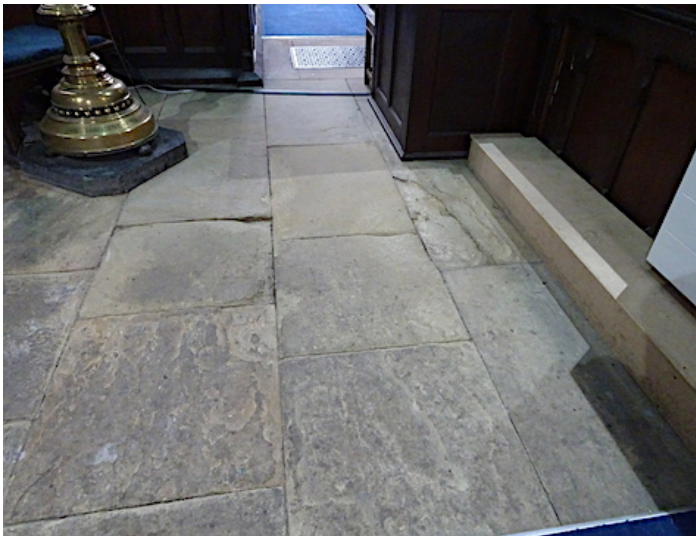
Nave - cracked and worn flags at east end.

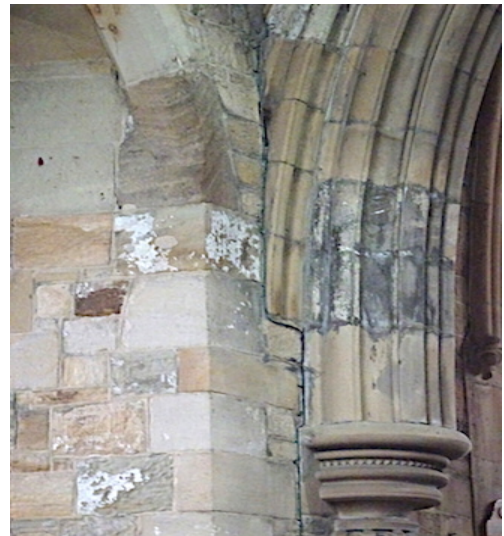
Nave - Chancel arch north side, signs of damp

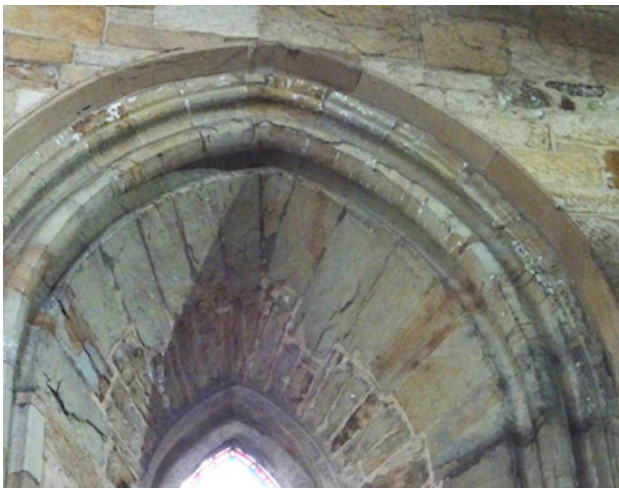
North Transept - cracked and laminating stone to north window.

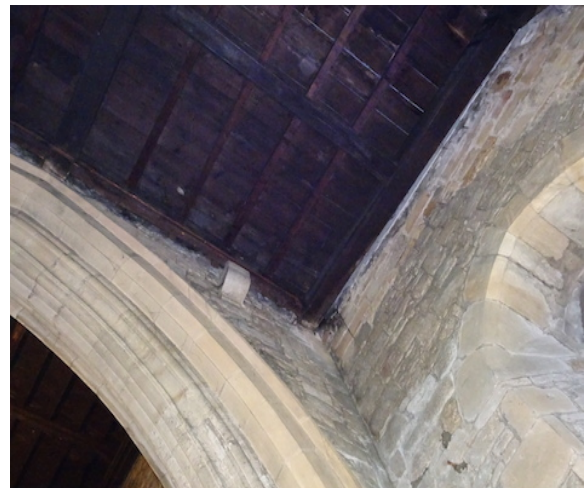
South Aisle – damp penetration at east end at eaves.

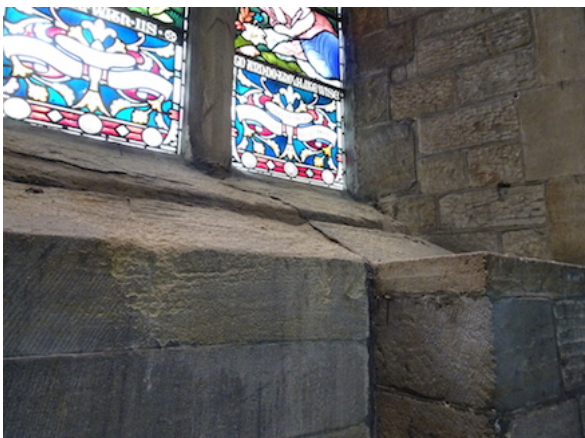
Chancel – south wall lamination and fracture to window sill

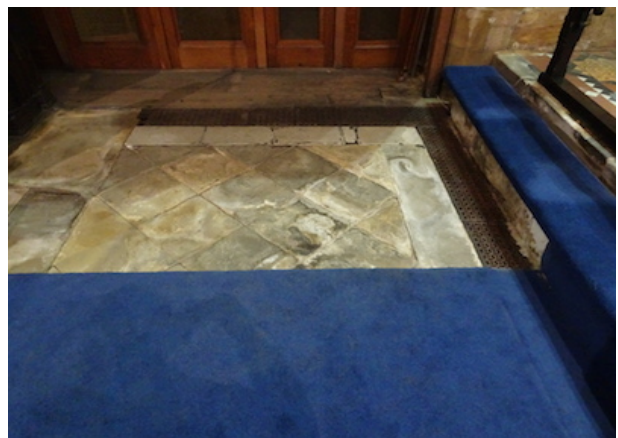
Chancel – rising damp to floor slabs in front of Sanctuary
