CHURCH OF SAINT BRANDON

BRANCEPETH

REPORT ON QUINQUENNIAL INSPECTION May 2018

Knox McConnell Architects Ltd
24 Victoria Road, Saltaire
Bradford BD18 3JR

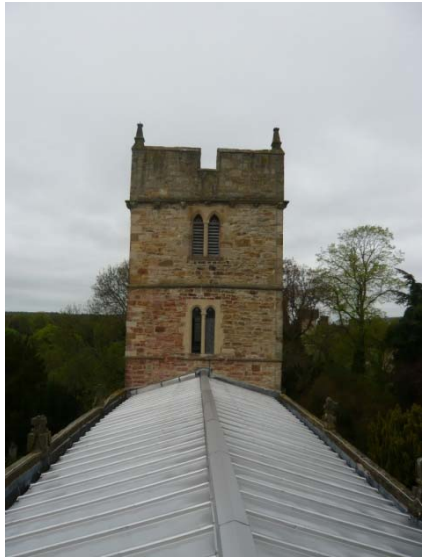
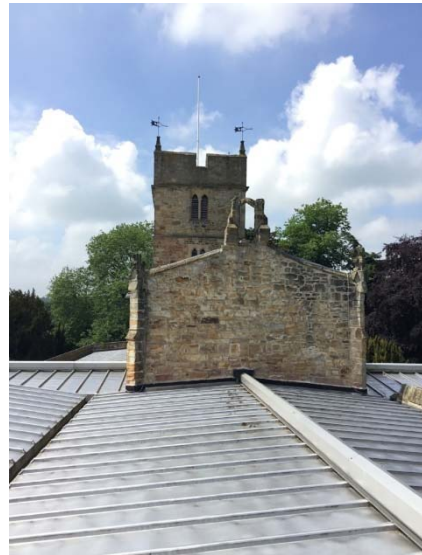
REPORT	
2.	EXTERIOR	
2.1.	ROOFS AND RAINWATER DISPOSAL GENERALLY	
2.1.1.	<p>All of the roofs apart from the roof to the North Porch were rebuilt in 2004 in stainless steel on a steel structure and under clad in timber.</p> <p>The lead flashings have been replaced with black mesh reinforced silicone sheet (Ubiflex or similar) following lead theft, it has been fitted poorly. This should be replaced.</p> <p>The gutters are wide and generally free flowing although some areas of debris require cleaning out.</p>

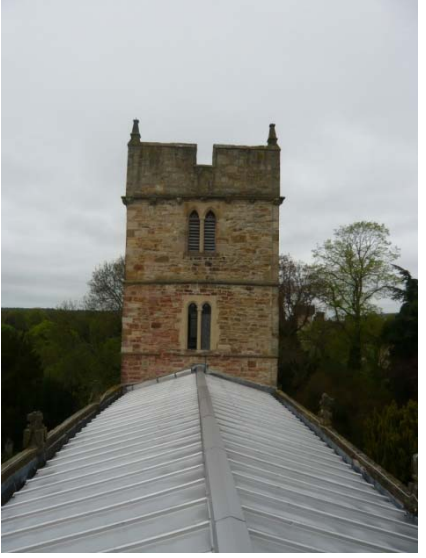
2.1.2.	<p>Nave Roof</p> <p>This is in stainless steel on a steel frame, all rebuilt post fire. The nave originally had lead flashings into stainless steel parapet gutters. It was not clear in 2018 whether these had since been replaced with Ubiflex since access was not possible. The quality of the installation is so poor elsewhere that this should be checked.</p>

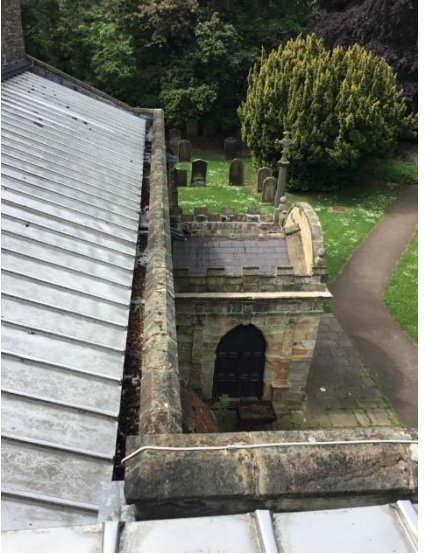
<p>2.1.3.</p>	<p>North Aisle Roof Parapet This appears to be in good order.</p>

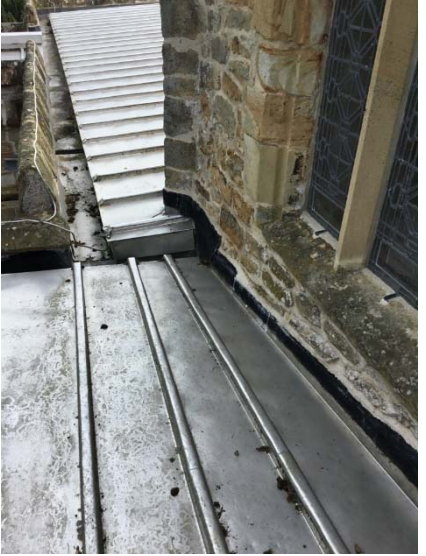
<p>2.1.4.</p>	<p>North Transept Roof The parapet has been reset and is in good order. The roof as elsewhere is stainless steel and the flashings have recently been stolen and very poorly replaced.</p>

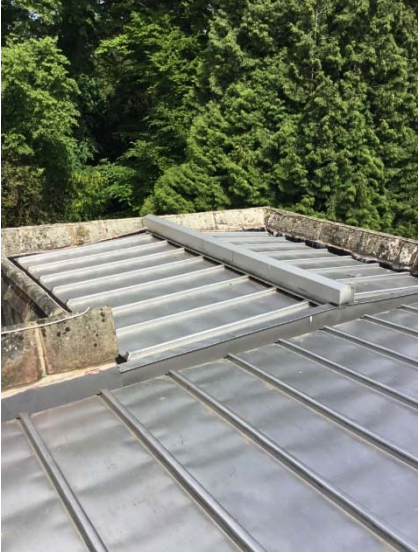
<p>2.1.5.</p>	<p>Vestry Roof The parapet is in good order. The roof as elsewhere is stainless steel and the flashings have recently been stolen and very poorly replaced.</p>

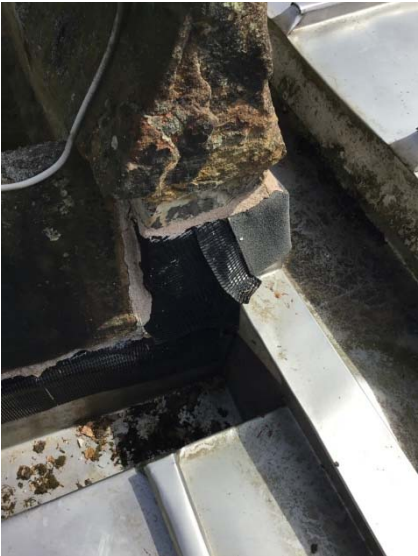
<p>2.1.7.</p>	<p>The Lady Chapel Roof Stainless steel as before and parapet in good order. Lead flashings have been stolen and poorly replaced.</p>

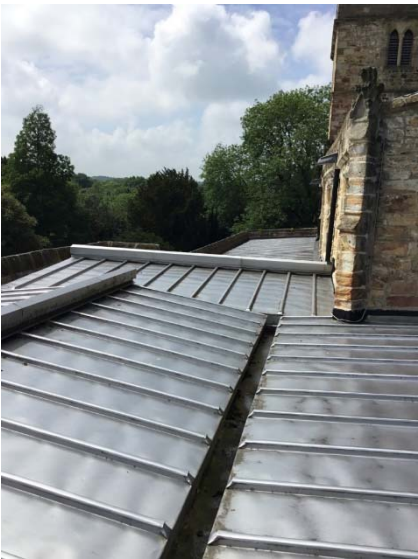
2.1.8.		<p>South Transept Roof Stainless steel as before and parapet in good order. Lead flashings have been stolen and poorly replaced.</p>

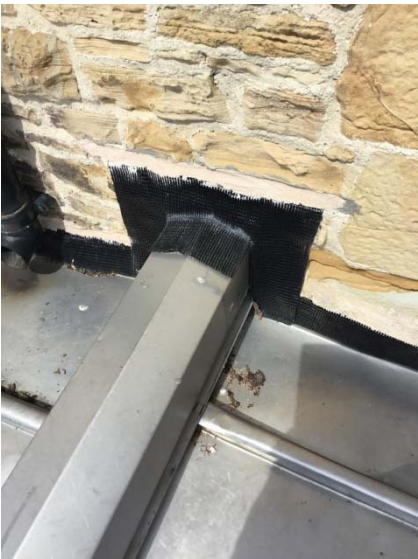
2.1.9.		<p>South Aisle Roof As previously this is stainless steel. The parapets are generally in good order however at the West end there is a coping which requires re-pointing. Lead flashings have been stolen and poorly replaced.</p>

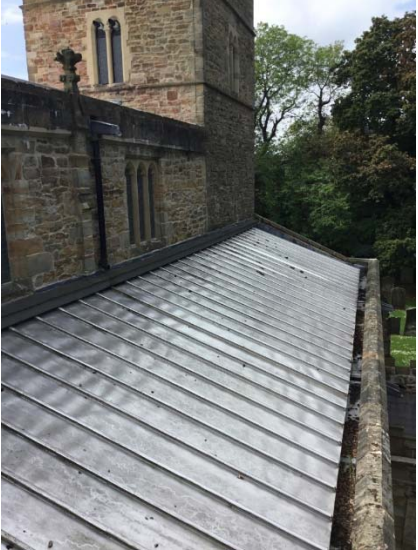
2.2.	<p>ROOF LEVEL STONEMWORK AND ROOFS North Nave Clerestory Level Stonework and Windows - from West to East</p>	
2.2.1.	<p>Windows Generally</p> <p>All of the windows at Clerestory level are in good order having been replaced within the last ten years with lead comes and clear glass.</p> <p>(Note: No close access on north side of roof)</p>

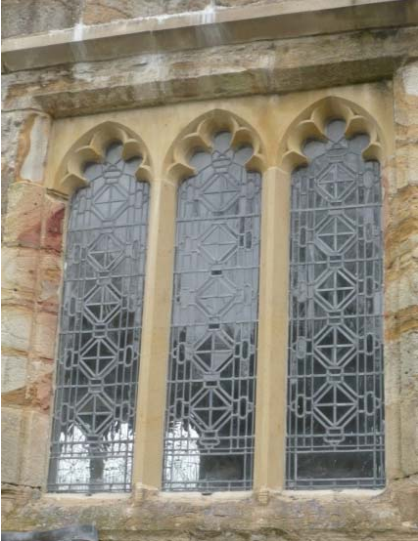
2.2.2.	<p>North Nave Clerestory Bay Two (from west)</p> <p>The heads and two mullions of the window in bay two were replaced following the fire and are in good order. The cill is eroded but in adequate shape at the moment. The western reveal had stones which suffered some fire damage (are quite red) and have some fractures in them. The Eastern reveal is quite friable although in reasonable condition for now.</p>

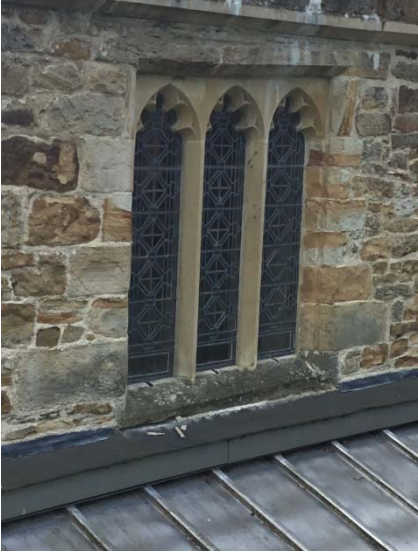
2.2.3.	<p>North Nave Clerestory Bay Three Second window from the West</p> <p>As previously the window head and mullions are replaced and the window reveals and cill are original. Much of the stonework has been re-pointed since the rebuilding in 2004. There is some lime staining where mortar was washed out during construction. The cill and reveals are friable and well weathered. Note that the string course under the parapet is new along the whole of the North elevation.</p>

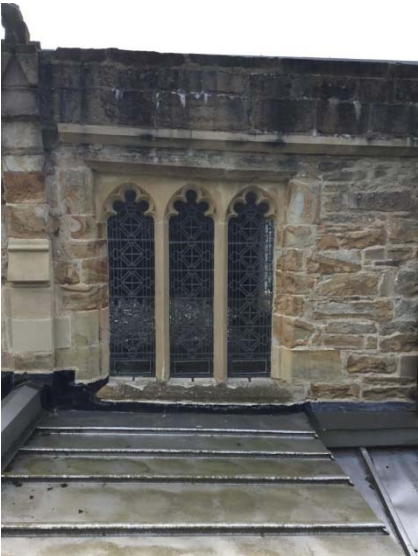
<p>2.2.4.</p>	<p>North Nave Clerestory Bay Four Third window from the West</p> <p>As before the heads and mullions are new as is the glazing and lead work. The reveals and cill although weathered are in reasonable order. The adjacent buttress has had new stone since last QI.</p> <p>To the head, lamination has been pinned back but requires further conservation repair (see photo). Also some failed pointing around central light.</p>

<p>2.2.8.</p>	<p>Recommendations:</p> <ul style="list-style-type: none"> B • To the east elevation of the nave at roof level: Repair friable stones and regularly check for blockages and damage caused by falling stone debris. B • North Nave Clerestory Bay Three – Second window from the West: Replace the cill pointing below the cill which has failed B • North Nave Clerestory Bay Four Third window from the West Carry out conservation repair to head and reveal. B • To Bay 5 north clerestory, fourth window from west: repair failed pointing.

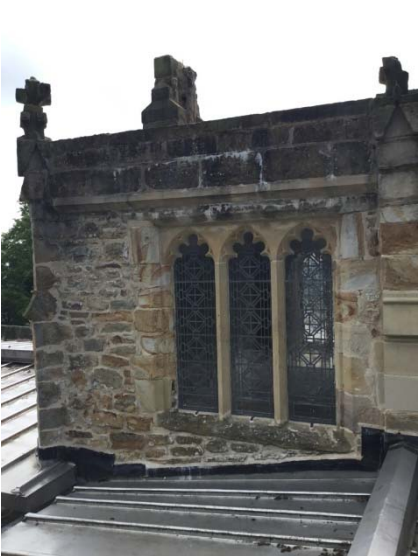
<p>2.2.5.</p>	<p>North Nave Clerestory Bay Five Fourth window from the West</p> <p>This also has new heads and mullions. The reveals and cills although weathered are in reasonable condition. Above the windows there are lime stains. On the East reveal of this window there is a stone which has got its face blown and another with a crack in it. This stone is particularly friable and some pointing may be necessary around the stones.</p>

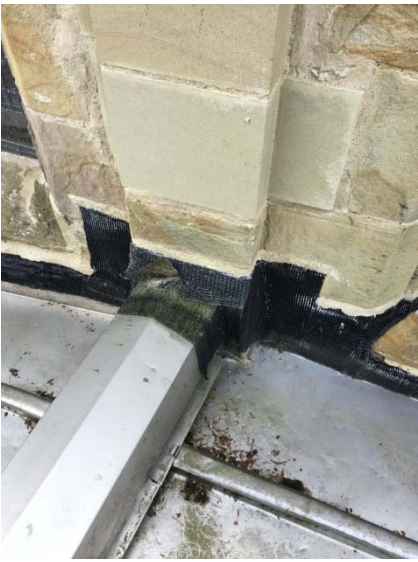
<p>2.2.6.</p>	<p>North Nave Clerestory Wall Generally</p> <p>The small buttresses between the window bays have pinnacles with crockets and poppy heads. One pinnacle has lost its top. These appear to be well bedded and secure but were not physically tested. A number of stones on the small buttresses between the windows require replacement.</p> <p>The flashing is universally of poor quality and should be replaced.</p>

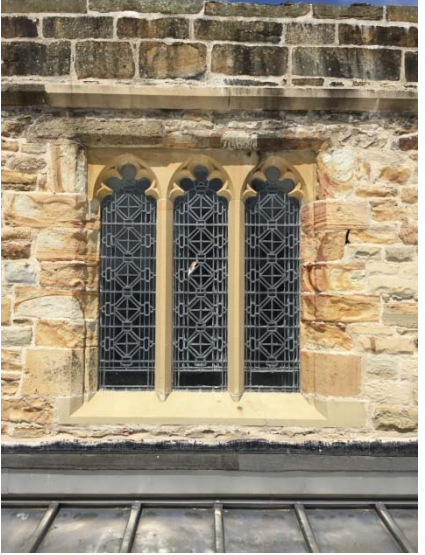
<p>2.5.2.</p>	<p>Bay Three 2nd window from the West As previously the heads and mullions of the window and glazing have all been replaced post fire. The cill has been replaced. Some mortar has also cracked and has failed. A small area of stone has fallen out of the wall entirely to the east of the window reveal.</p>

2.5.5.	<p>Recommendations:</p> <ul style="list-style-type: none"> B • Bay two, 1st window to south clerestory: Replace failed mortar to glass line B • Bay three, 2nd window to south clerestory: <ul style="list-style-type: none"> ○ Renew failed mortar ○ Replace stone to East of reveal B • Bay four, 3rd window to south clerestory: Replace failed mortar B • Bay five, 4th window to south clerestory: Replace failed repair

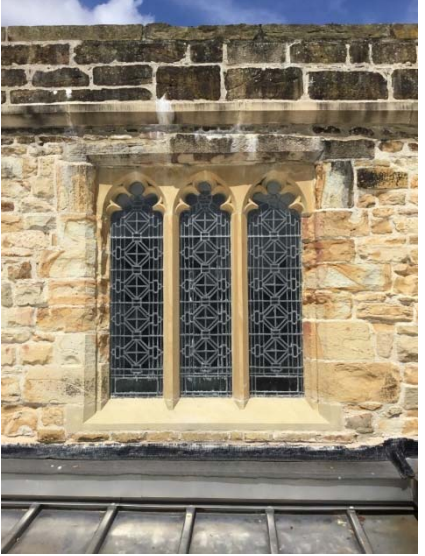
<p>2.5.3.</p>	<p>Bay Four 3rd window from the West As previously, post fire heads and mullions and glazing. The cill has been replaced since the last QI. The reveals are eroded but have undergone repair. Some pointing has failed. Buttress between 3 & 4 has been recently replaced. As before the string course is almost all replaced although there is one original stone. The parapet looks sturdy.</p>

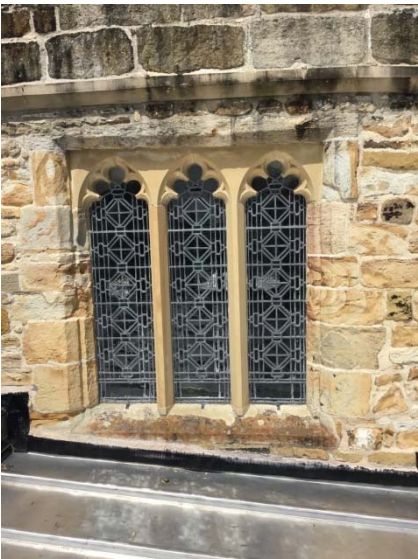
2.5.4.	<p>Bay Five 4th window from the West</p> <p>Some conservation repairs are failing where they have been used to fill cavities in the stone.</p> <p>As before, post fire heads and mullions however the cill is older. The mortar fillet at the base of the window has failed in a couple of places. Repairs have been undertaken since the last QI.</p>

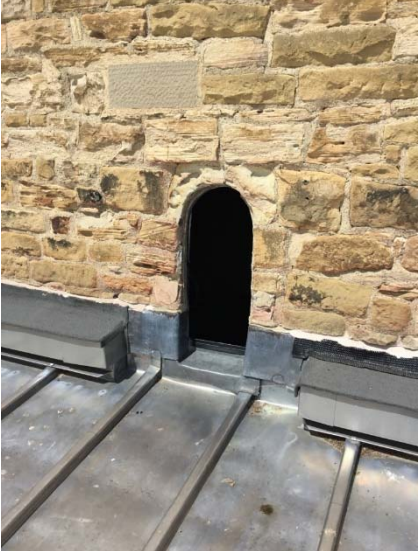
2.6.		TOWER STONEMWORK
2.6.1.	<p>Base of Tower South Side – From Roof Level A small round headed window provides access onto the roof. This is adequate if a little narrow. The South face of the Tower has been repaired and re-pointed within the last seven years. Some of the stones are severely eroded however the worst ones have been replaced.</p>

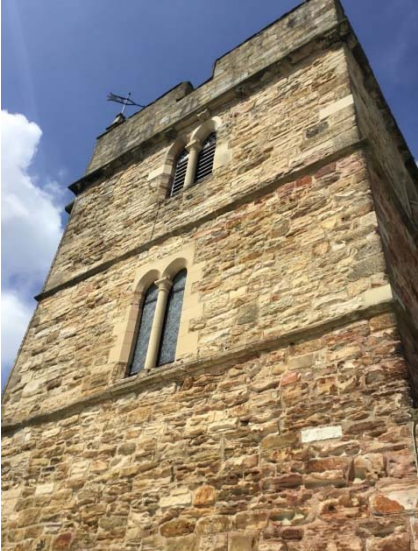
2.6.2.	<p>Middle Section of Tower South Side - Stonework New window with new stone heads and eastern most reveal. Central column is also new. The string course below the window is original if a little eroded. Some pointing to the string course is required.</p>

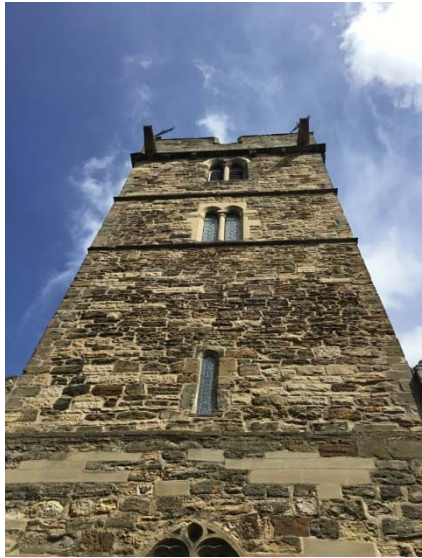
2.6.9.		<p>Upper Middle Section of Tower West Side This has double lancet windows in Venetian style with a central column. The majority of the stonework around these windows has been replaced and the stonework on this section is well pointed and in good order.</p>

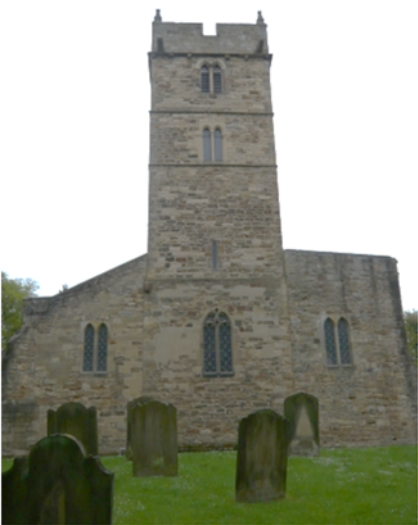
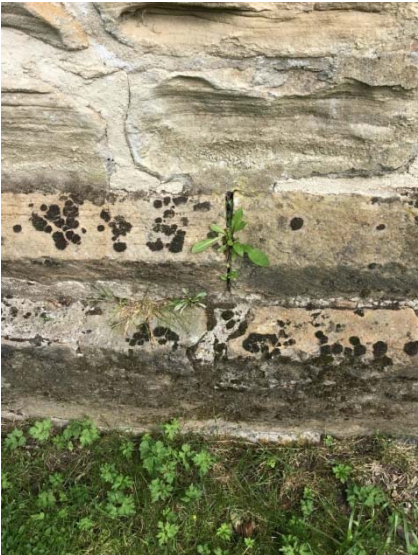
2.7.	WEST ELEVATION	
2.7.1.	<p>West End Gable to North Aisle</p> <p>This gable has a lean-to roof with a parapet and a buttress set at 45°. There is a two lancet window opening and this has been re-glazed and re-leaded as have all of the windows following the fire.</p> <p>The pointing around the head of the South light of this window needs redoing. There are a number of replaced stones which were carried out about twenty years ago and the faces of these stones have been tooled. They do however have an ashlar appearance and unlike the rest of the stonework which is coursed and random coursed rubble. The face of some of these replacement stones is also spalling. Some of the stonework is severely eroded. And there will need to be a steady programme of stone replacement over the next few years. Some small amounts of pointing are required at lower level but this wall is fairly typical of all of the stonework around the building. At the base just above plinth level there is the incoming gas pipe.</p> <p>It is noted that the ground level slopes down towards the plinth and this may cause the base of the walls to get damper than they should however there is no obvious indication of that.</p>

2.7.3.	<p>Recommendations:</p> <p>B</p> <ul style="list-style-type: none"> • West elevation, north aisle: repoint head of south window.

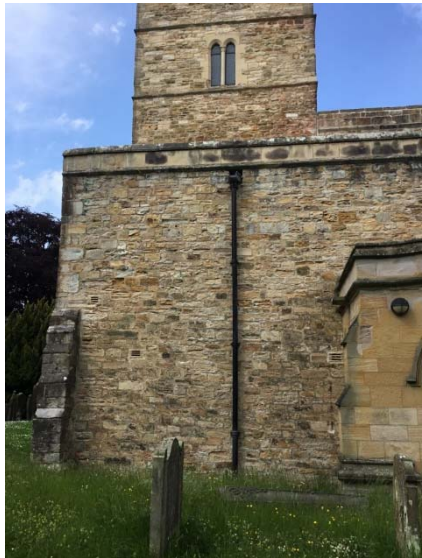
2.8.1.		<p>South Elevation: Bay One To the West of the South Porch</p> <p>A couple of the coping stones in this section require re-pointing. Some stones are shaling fairly badly though the erosion isn't quite as bad as the West elevation. There is some hard pointing at lower level which is affecting the stone to a certain degree, however, removing it would probably cause more damage. There are two ventilation holes which have been constructed in stone and are very neat. At the base of the wall there is no plinth but there is a stone path. The grassed area slopes down towards it. The gully was blocked with vegetation. Note that there is an overflow outlet at low level from the WCs beyond.</p>

2.8.11.	<p>Recommendations:</p> <ul style="list-style-type: none"> B • South elevation copings at west end: repoint. C • Bay Two - To the East of the South Porch; eroded stones require replacement below the window. Remove fixings. M • South Elevation - Bay Three from the West; The buttress between Bay Two and Three Note shaling stones C • South Elevation - Bay Three from the West; repair crack to cill. C • South Porch: secure cables at high level. B • South Porch: replace rusted gulley grate. D • South Porch: refinish door. B • To all elevations – replace eroded stone. A • Clear blocked gullies throughout. C • Lady Chapel: South Elevation Bay One from the West, fix air vent grate and replace stones. C • Lady Chapel: East Elevation Gable, replace string course and repoint below. Refix power cable. A • Lady Chapel: South Elevation Bay Two from the West – clear gulley and down pipe. C • Lady Chapel: South Elevation Bay Two from the West – replace decayed stones. B • Lady Chapel: East Elevation Gable, remove old boiler enclosure and oil tank store. B • Investigate defunct pipe routes possibly leading to a culvert and install underground pipes for rainwater disposal. C • Lady Chapel: East Elevation Gable, replace stones to mullion, cill and reveal. C • Lady Chapel: East Elevation Replace stones to buttress base. C • Lady Chapel: South Elevation Bay Two from the West: Elevation Replace stones to buttress base.

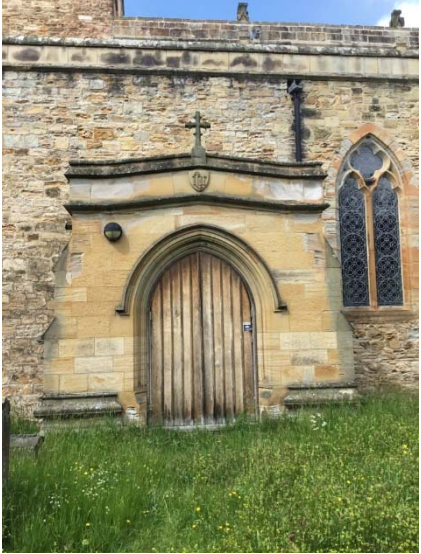
2.8.2.		<p>South Elevation South Porch</p> <p>This is a Victorian addition and is of ashlar. Some of the narrow joints require re-pointing on the South elevation at plinth level and around the hood mould of the doorway. The string course below the parapet also requires some re-pointing. The new timber door had been varnished and it is now flaking off. It may be worth considering removing the coating and assessing the state of the door and refinishing. Note that there is an orange wire hanging loosely from the roof of the porch.</p>

<p>Adjacent is a downpipe from the aisle roof and the grating in the gully is rusted and requires replacing.</p>

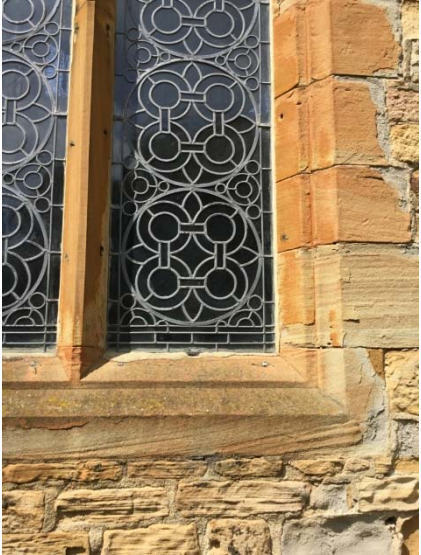
<p>2.8.3.</p>	<p>South Elevation Wall above South Porch There are areas of severe erosion at this level and some replacement and pointing should be considered.</p>	
<p>2.8.4.</p>	<p>South Elevation: Bay Two To the East of the South Porch This bay has a two lancet window with a quatrefoil light above. The stonework around the window reveal and cill appears to be of some age and a pinkish colour which is shaling off to reveal a greyish stone behind. This may be due to the fire damage. A two or three millimetre thick shale appears to be coming off most of the stones although they do not appear to be structurally compromised due to it. Some of the narrow joints require re-pointing. There are a number of ferrous fixings and copper wires still in the stonework. These ought to be removed if possible and repaired. There are areas of eroded stone which require replacement below the window in due course.</p>

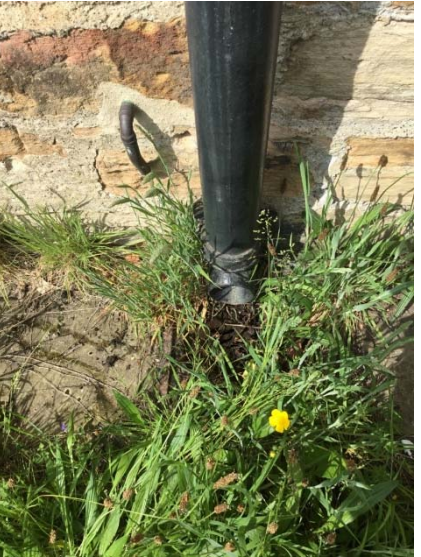
<p>2.8.5.</p>	<p>South Elevation: Bay Three From the West The buttress between Bay Two and Three is in reasonable condition however some of the coping stones are shaling somewhat. This should be noted. Bay 3 has a two lancet window as before with a quatrefoil above. The reveals and cill are original as previously apart from the West reveal which may have been inserted post fire. The cill directly below the mullion has shaled and the flaunching at the base of the windows has cracked somewhat. A repair should be incorporated. There are areas of severe erosion on this elevation and replacements should be considered. The downpipe in this bay feeds into a gully blocked with vegetation.</p>

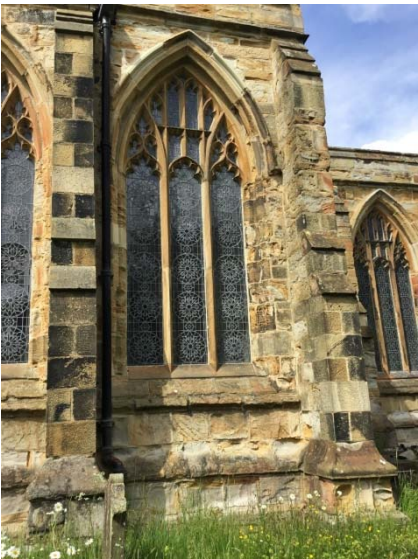
<p>2.8.9.</p>	<p>Lady Chapel: South Elevation Bay Two from the West This has a similar window to the one adjacent. The West reveal is very eroded and some replacement should be anticipated. The pointing above the window is in good order. And so is the buttress between the two bays. The downpipe and gully appear to be blocked. The base of the buttress to the East has two severely weathered stones which should be replaced.</p>

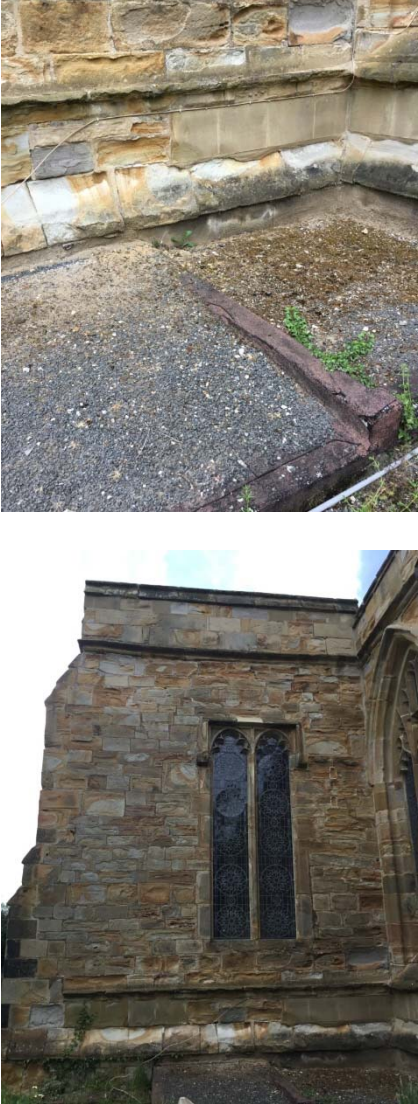
<p>2.8.10.</p>	<p>Lady Chapel: East Elevation Gable This has a two lancet window with a perpendicular head and a square hood mould above. There are a number of longitudinal cracks down the lower part of the mullion and also to the North reveal. The cill also has fractures in it. Replacement should be considered. The string course requires some re-pointing and occasional areas of pointing have fallen out and require replacement.</p> <p>The plinth is suffering from splash back from the roof of the old boiler house.</p> <p>There is a loose power cable pulled off the wall – requires re-fixing.</p> <p>One stone is particularly severely eroded in the wall and also the string course. Replacements required to string course.</p> <p>At the base of this elevation is a raised flat area which is the roof to what was the boiler room. There are stone steps leading down into the ex- boiler room which have been protected with a horizontal grille to stop people falling down into the steps. This area would benefit from being cleared away and the area used for the oil storage tank also removed since it is now redundant and poses a hazard. The structure is causing dampness within the Lady Chapel.</p> <p>The underground drainage for rainwater has been investigated and the soakaways found to be lacking.</p>

Further investigation and potential introduction of water pipes leading to an existing culvert should be considered as a long term solution to alleviate damp.

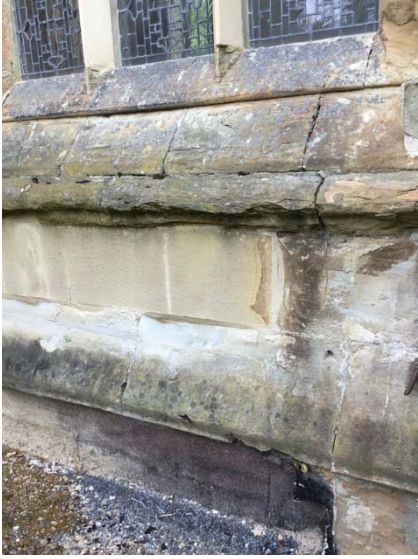
2.9.	CHANCEL AND VESTRY	
2.9.1.	<p>Chancel: South Elevation Bay One from the West</p> <p>This has a three light window with perpendicular tracery above. There has been some recent stone replacement although these probably predate the fire. Above the window there is severe erosion of the stones and stonework is falling off onto the floor. Replacement should be considered. There is a ferrous fixing at low level which should be removed to prevent blowing of the stonework. The string course under the cill requires re-pointing. The buttress between this bay and the adjacent bay is in reasonable condition although some pointing is required at lower levels.</p>

2.9.11.	<p>Recommendations:</p> <ul style="list-style-type: none"> B • Chancel: South Elevation, Bay One from the West, above the window replace stone. Remove ferrous fixing at low level, repoint. B • Chancel: South Elevation, Bay Two from the West, replace severely eroded stones. B • Chancel: South Elevation, Bay Two from the West, at the Eastern most end the bedding for the moulded string course above is undermined due to erosion. This should be replaced. B • Chancel: East Elevation, replace eroded stones B • Chancel: East Elevation, repoint string course above window. B • Chancel: North Elevation, replace eroded stones. B • Vestry: East, repoint movement cracks and monitor. C • Vestry: West Elevation, fix handrail to steps. C • Chancel: North Elevation, first bay from east: remove fixings from reveals. Repair stonework above overflow. Open joints at the head require pointing

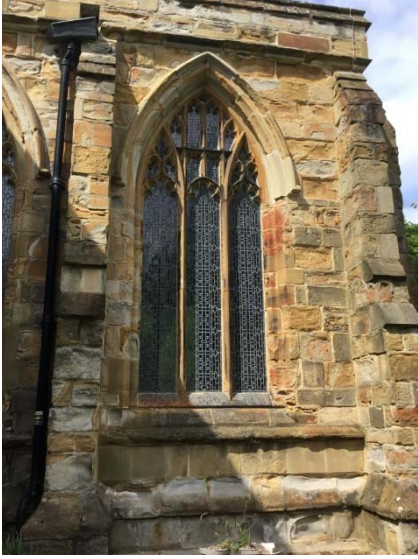
2.9.2.	<p>Chancel: South Elevation Bay Two from the West</p> <p>As adjacent this has a three light window with decorated tracery above. The Eastern reveal is well weathered at lower levels. The cill however appears sound. The area at plinth is again eroded. At higher level above the window the stones are suffering severe erosion and at the Eastern most end the bedding for the moulded string course above is undermined due to erosion. This should be replaced. Note that there is an outlet from the roof over the first bay of the East End of the elevation and the overflow is working effectively though it is evident that water is splashing up from the flat roof of the boiler house onto the plinth courses.</p>

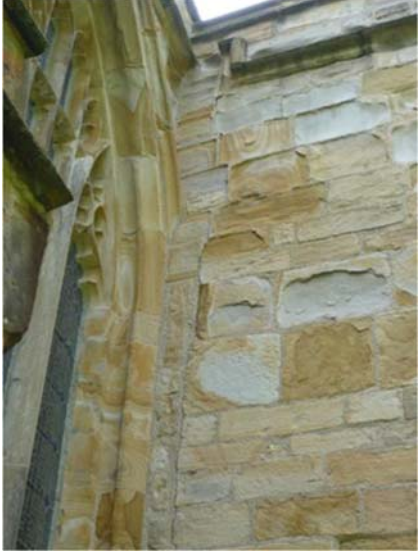
<p>2.9.6.</p>	<p>Vestry: East Elevation This contains a small two light window with diamond leading and a square head. The pointing on this elevation is generally good. Whilst there is quite a large amount of erosion this wall isn't as bad as some of the others. There appears to be a movement crack along the junction between the East wall of the Vestry and the North wall of the Chancel and this should be re-pointed and monitored.</p>

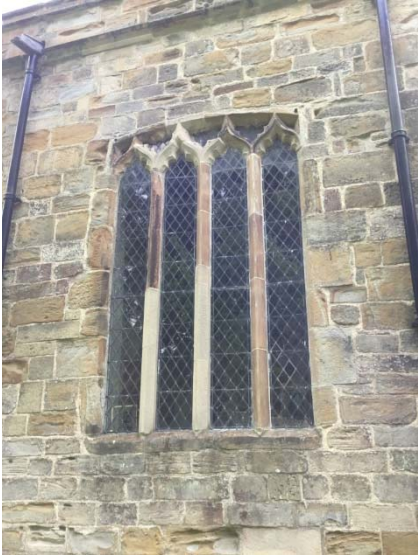
<p>2.9.7.</p>	<p>Vestry: North Elevation This contains a four lancet window with small lights above and a shallow three centred arch. The wall is well pointed and although suffering from erosion as elsewhere is not as bad as in other areas. The cill in some areas is beginning to shale although this can be repaired. There are two down pipes on this elevation and the overflows appear to working and the gully is clear.</p>

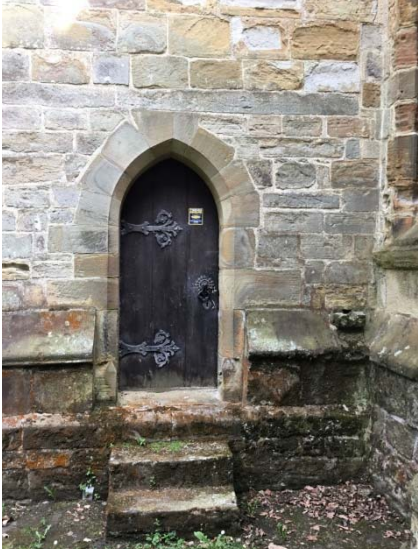
<p>2.9.8.</p>	<p>Vestry: West Elevation This elevation contains three risers up to the Vestry door. This is a good old oak door in large planks with decorated ironmongery. The door reveals and head appear to be in good order. There are no hand rails around the stone steps and the incorporation of one should be considered. The pointing appears to be sound on this elevation. A vertical crack running from the Southernmost side of the parapet was pointed up and has not re-cracked. Whilst there is severe erosion of the stone this is not as bad as in some areas. At lower level above the upper plinth there is a moulded carved stone with a drainage outlet which would have been from the lavabo inside the vestry. There is some orange algae at plinth level.</p>

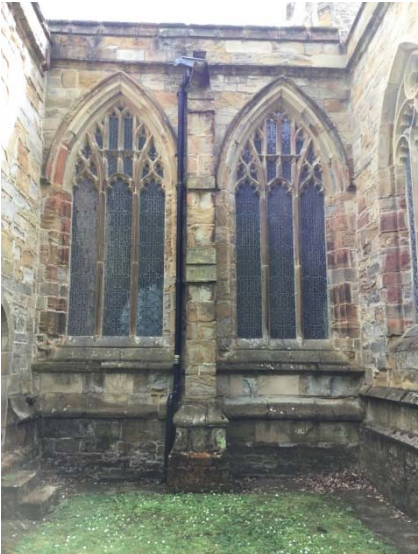
2.9.9.	<p>Chancel: North Elevation This short elevation is split into two bays.</p> <p>Bay one from the East The Easternmost bay has a three lancet window with decorated tracery above. Mullions and tracery appear to be in good order. The reveals are well eroded and there are some fixings which need removing from them. Open joints at the head require pointing. The elevation is well pointed however there is a small amount of stonework just above the overflow which requires repair. The new lead overflow does not follow the line of the original stone overflow.</p>

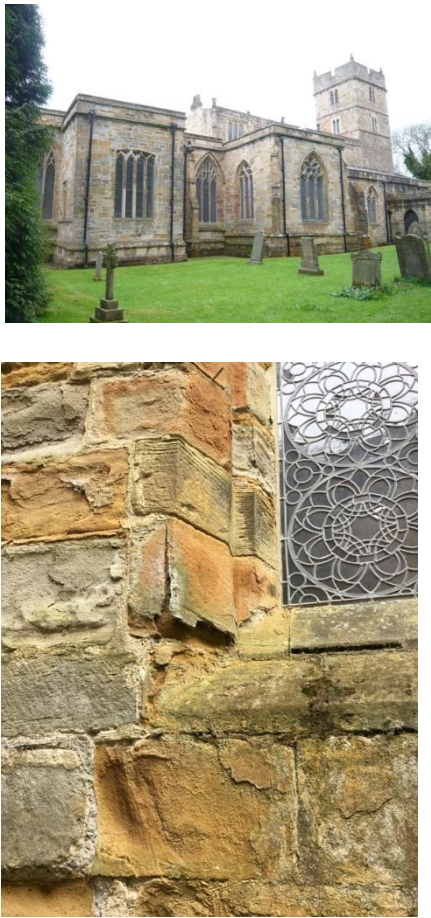
2.10.	NORTH TRANSEPT	
2.10.1.	<p>North Transept: East Elevation</p> <p>This has a three-light window with tracery above. The tracery and mullions appear to be in reasonable order. There is some shaling to the reveals. At the base of the Southern reveal the stone has a vertical fracture which looks like the face of the stone is about to fall away. This requires repair. There are some stones which are severely eroded. But the pointing appears generally sound. The buttress to the North is in reasonable order.</p>

2.10.4.	B B	<p>Recommendations:</p> <ul style="list-style-type: none"> • North transept: East elevation, repair stone at the base of the Southern reveal. • North transept: North elevation, repoint lower string course. Small fixings around the window stonework require removal.

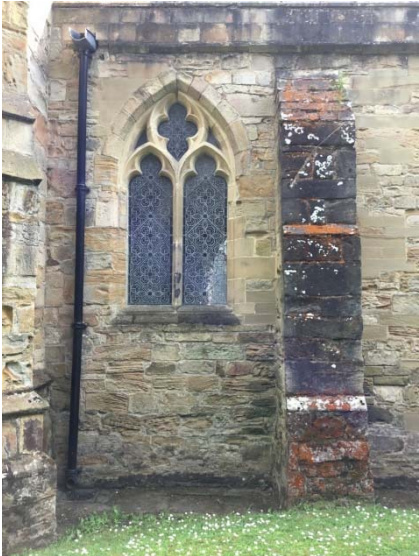
2.11.		<p>NORTH AISLE ELEVATION</p>	
2.11.1.		<p>This elevation is split into four bays from the East.</p> <p>North Aisle: North Elevation, Bay One from the East</p> <p>This bay has a two light window with tracery above. The tracery and mullions appear to be in reasonable condition. Some of the voussoirs require some re-pointing. There is a crack in the cill which requires repair. Other than these the pointing is in reasonable order. The stone is suffering from erosion as elsewhere.</p> <p>The buttress between bay one and two appears to be in reasonable order. Vegetation requires removal.</p>

2.11.5.		<p>Recommendations:</p> <ul style="list-style-type: none"> C • North Aisle: North Elevation, Bay One, remove vegetation. Repoint voussoirs and repair cill. C • North Aisle: North Elevation, Bay two. Repoint voussoirs and around base of downpipe. B • Remove vegetation above North porch.

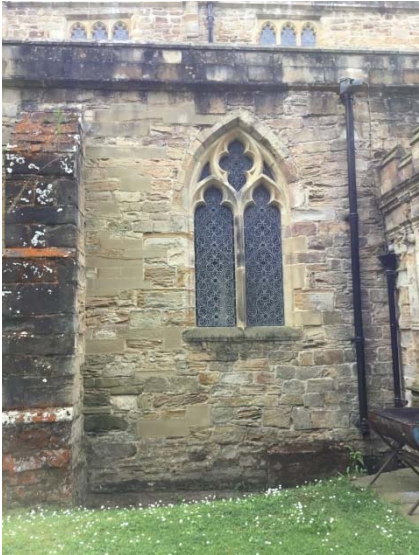
2.11.2.		<p>North Aisle: North Elevation, Bay Two from the East</p> <p>This bay has a two light window with tracery above. The mullion and tracery appear to be in reasonable order. The voussoirs require some re-pointing. The pointing appears to be sound except for at the base of the plinth where the downpipe discharges into a stone gulley and the plinth is damp.</p>

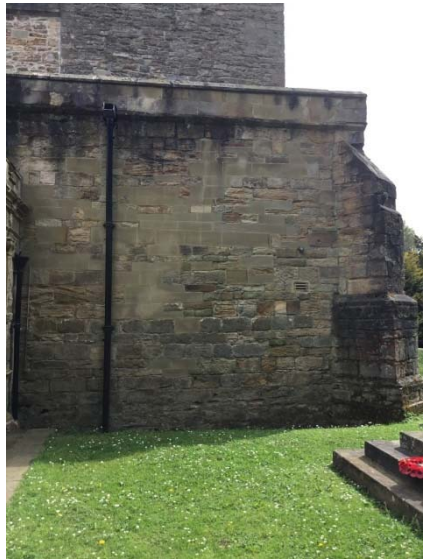
indicates dampness – no obvious defects in the gutter though.	
2.11.4.		<p>North Aisle: North Elevation, Bay Four</p> <p>This is a blind bay with a considerable amount of replaced stone which is in dressed and tooled ashlar which appears rather unsympathetic. The pointing appears to be in reasonable condition. This elevation also has a vent constructed in stone as on the South side.</p>

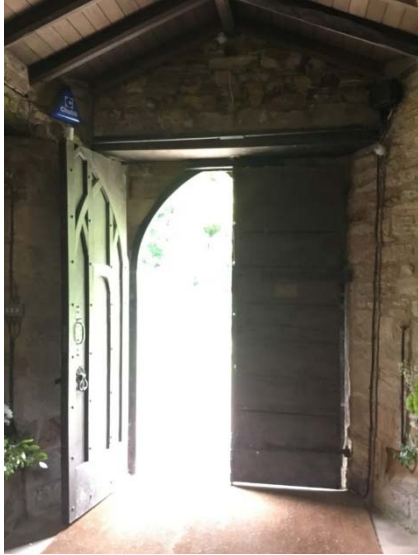
3.1.2.	<p>North Porch: West wall The blocked up doorway has a seat built into it. Below that the stonework is in poor order and should be re-pointed and a couple should be replaced. Within this space there is an ADT fire and security panel and some fairly unsightly wiring on timber which should be improved if possible.</p>
