Church of St John the Evangelist, Castleside

**QUINQUENNIAL INSPECTION REPORT 2022**

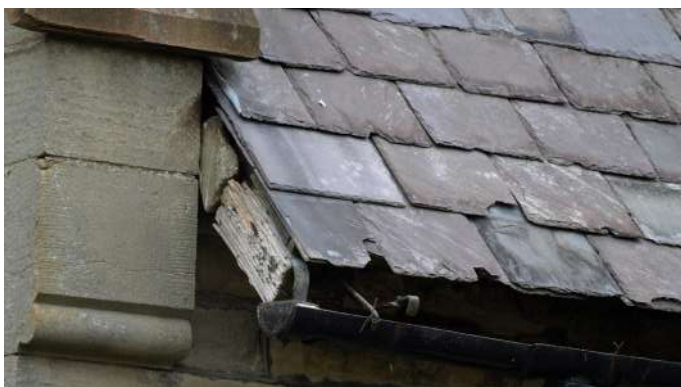
Decayed rafter end to Nave roof above Porch, and damaged slates

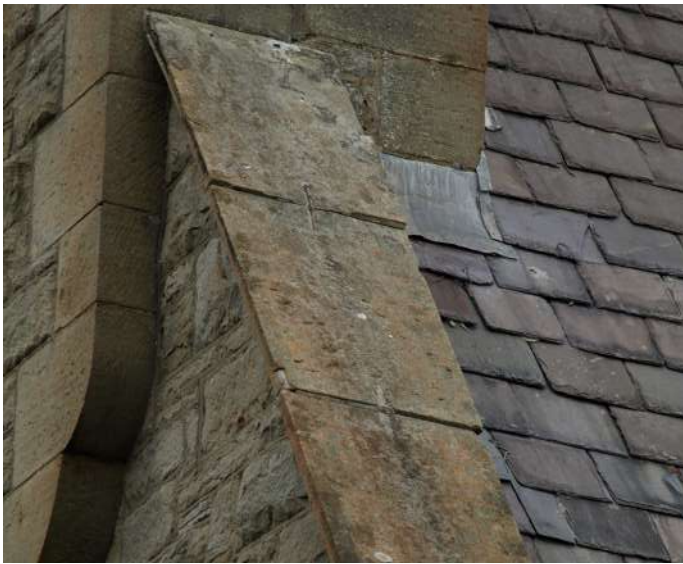
Displaced water-tabling to Nave verge, and loss of pointing from joints

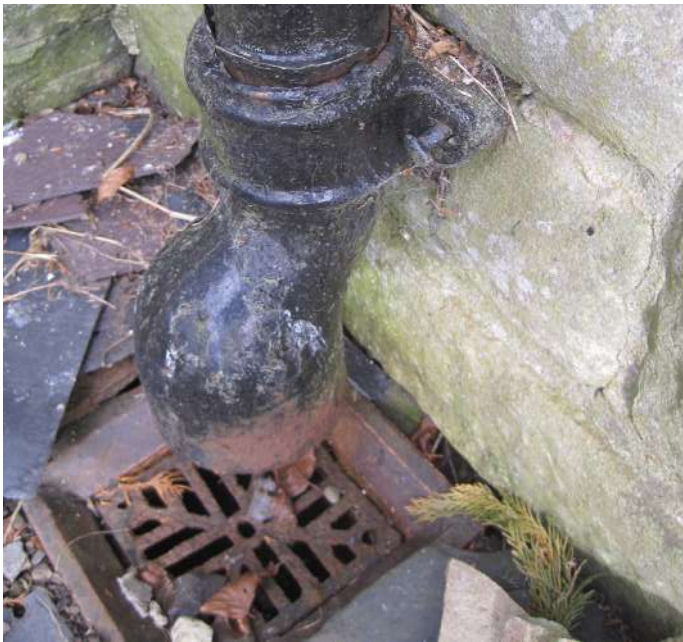
Some rainwater goods are rusting, and fixings are working loose

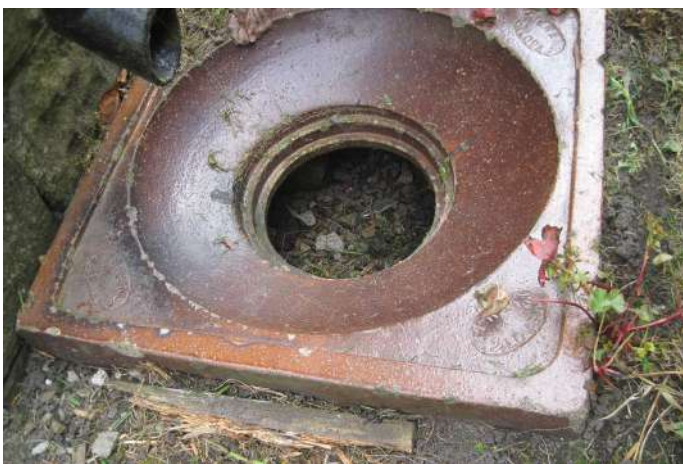
Rainwater gullies need to be kept clear of debris, and should have grilles fitted

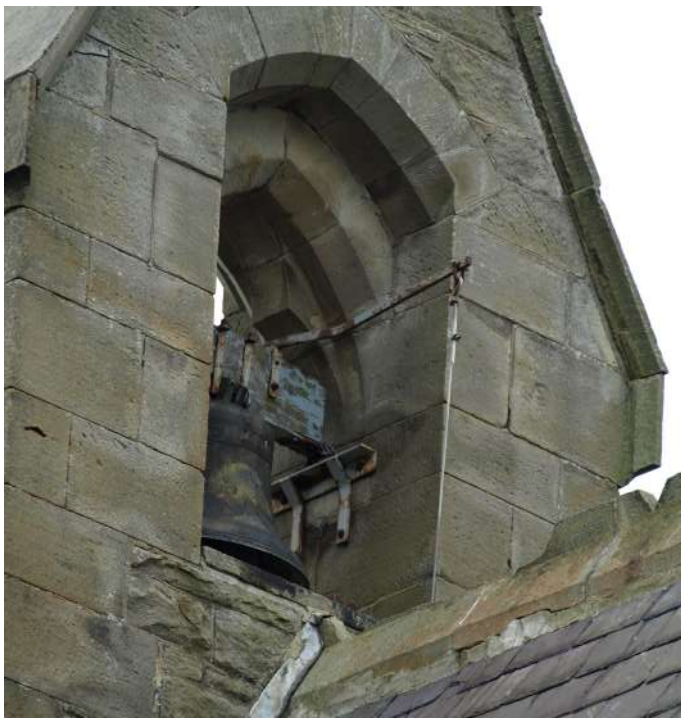
Bell headstock is decayed. The whole mechanism requires overhaul

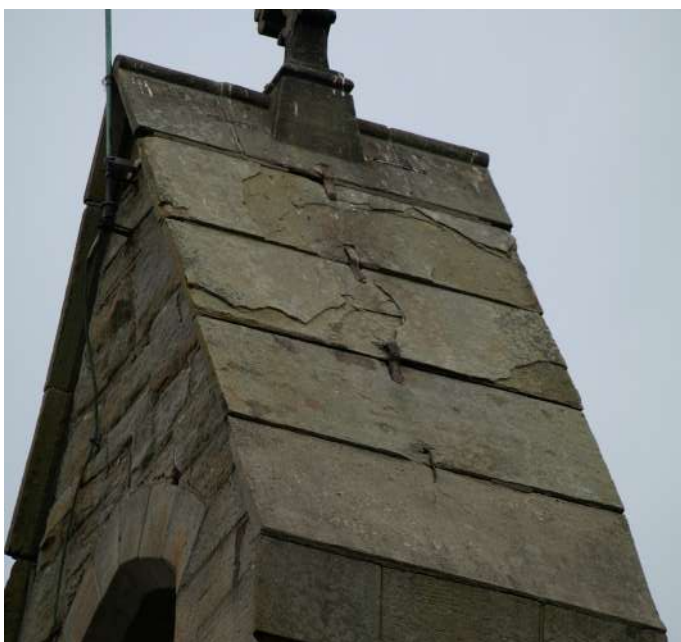
The masonry of the bellcote in reasonable condition, apart from shaling and opening of joints in the water-tabling

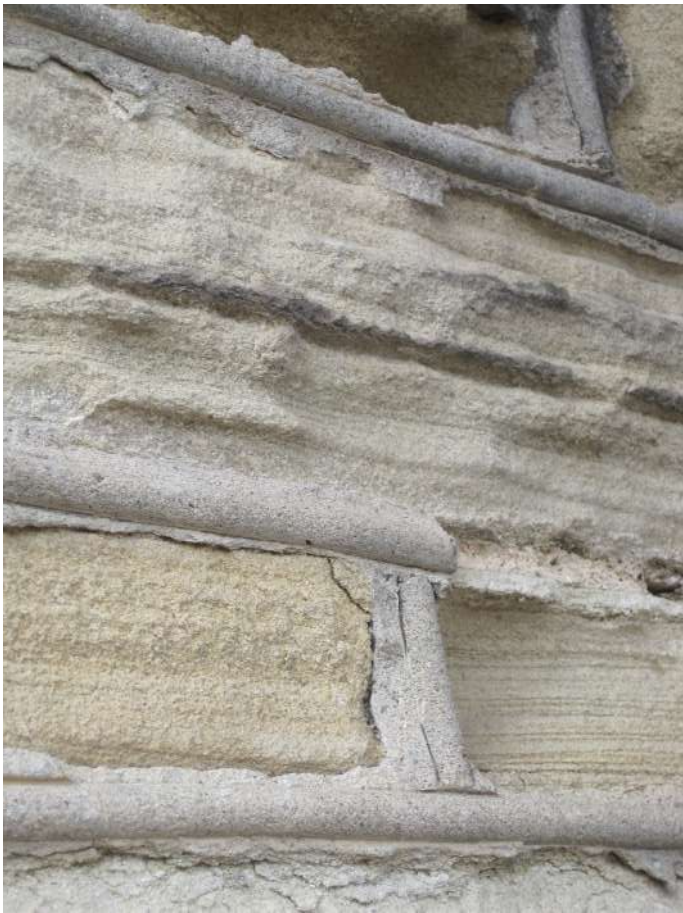
Walling stone suffering from differential erosion due to hard cement mortar. Where a danger to public, loose masonry should be brushed down and any larger pieces gently pulled away using fingers

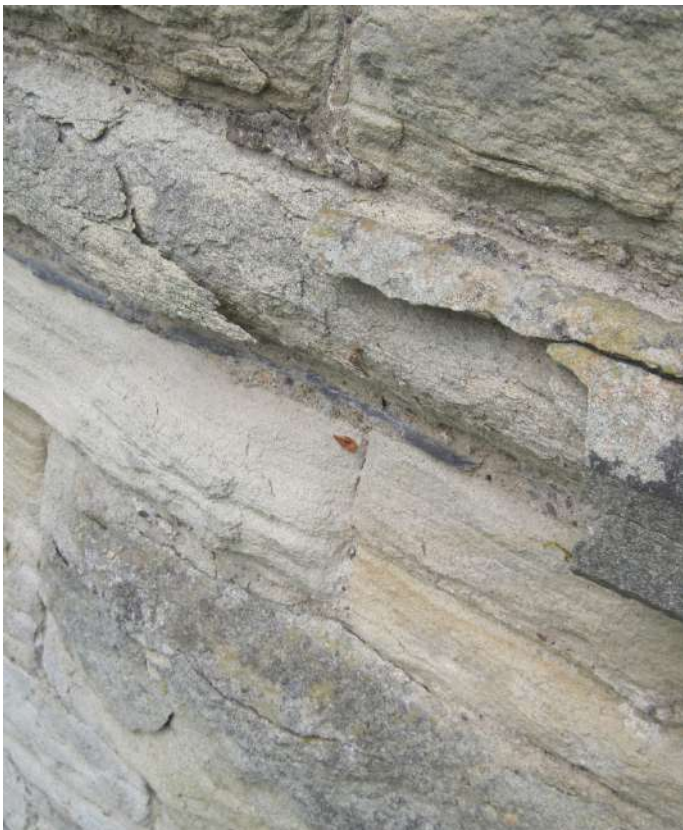
Cementitious pointing will accelerate the natural decay processes which break down the soft sandstone.

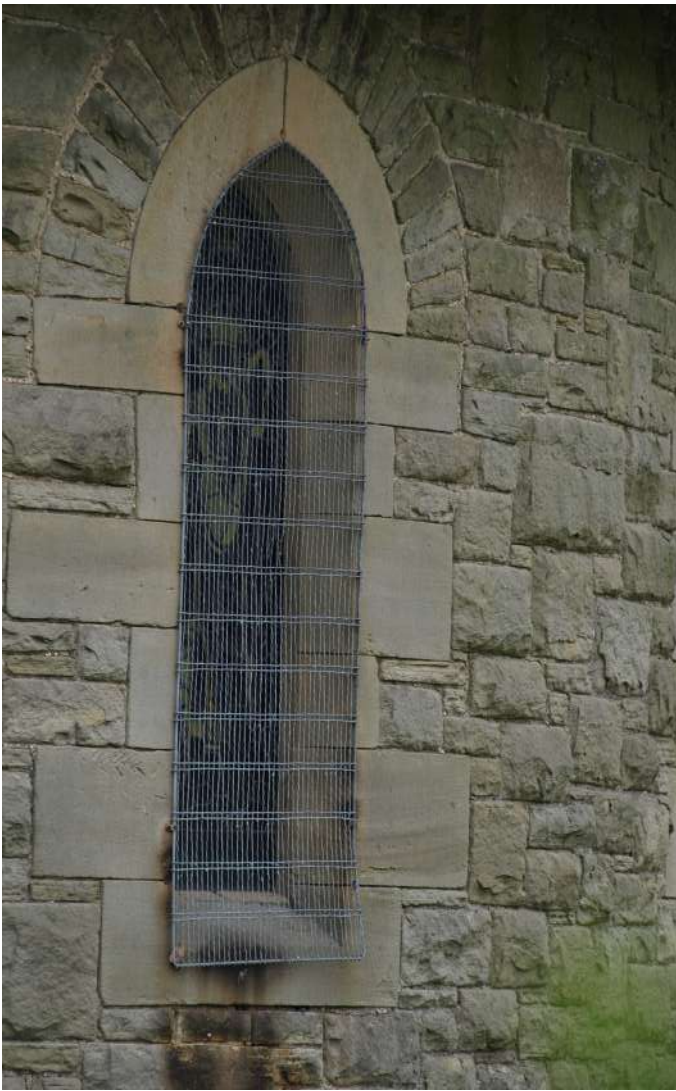
Some window grilles are ill-fitting and would benefit from being re-made. Grilles should be fitted with non-ferrous fittings to avoid rust staining of the masonry.

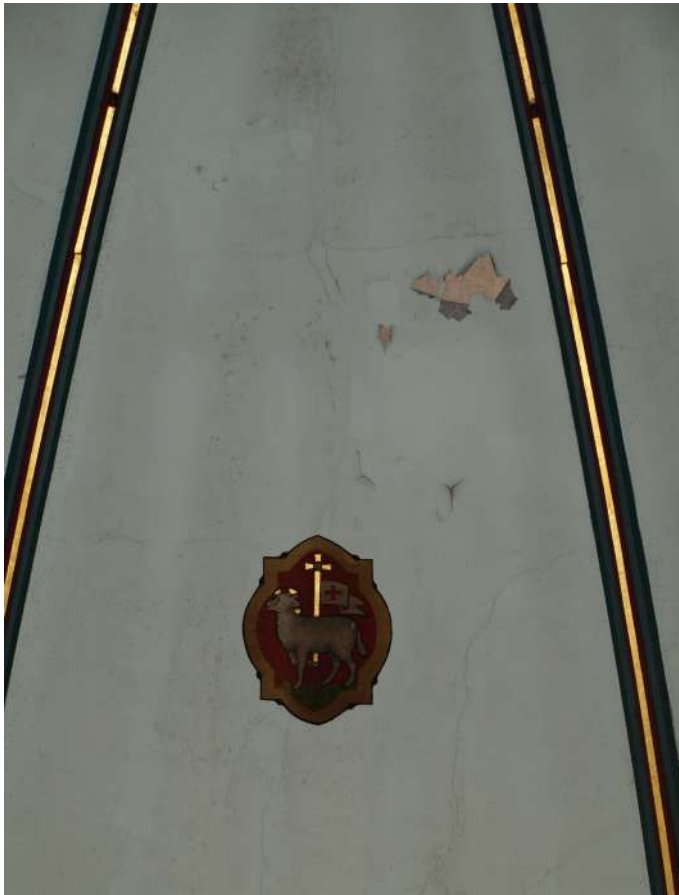
Cracking and loss of paint from Apse ceiling

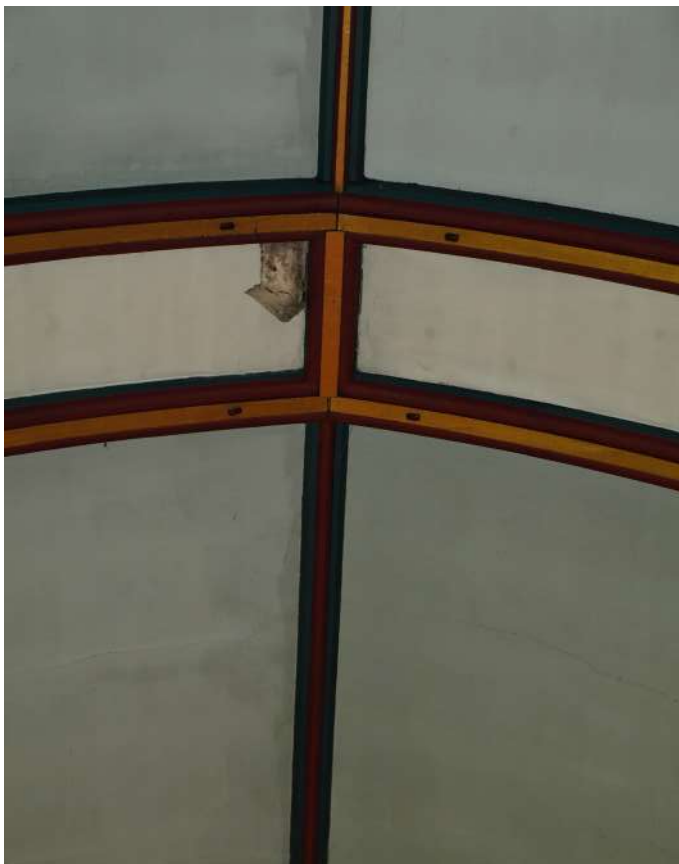
Minor loss of plaster at the junction of Nave and Apse

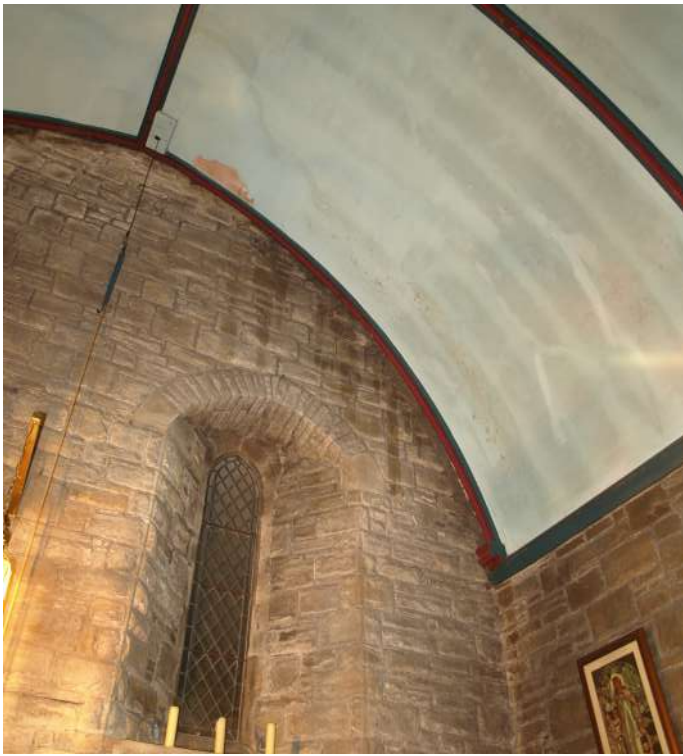
Loss of paint and water staining to the west end of the Nave

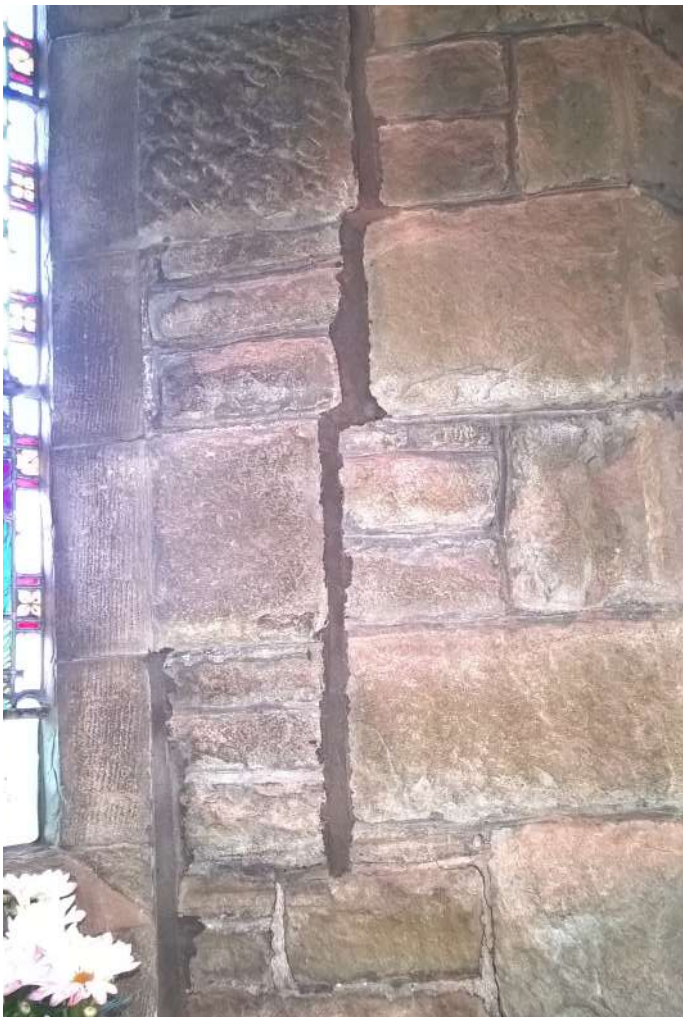
Historical cracking, repointed, to Nave window.

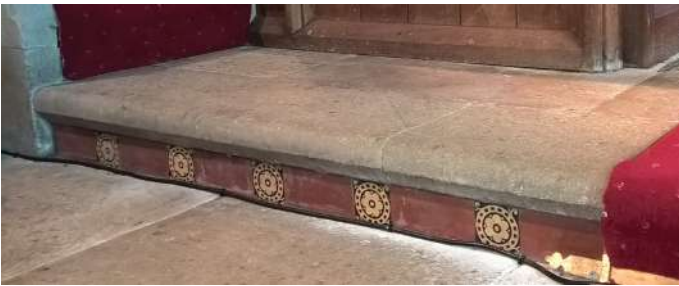
Encaustic tiles in riser of chancel step in good condition

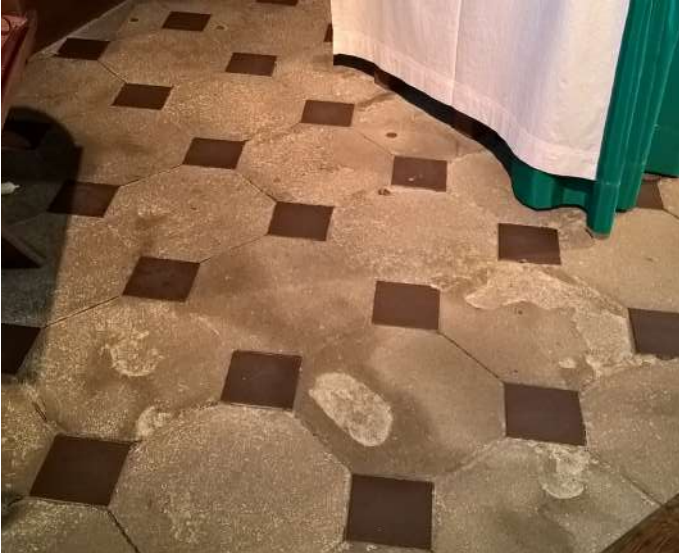
Stone damage to floor in sanctuary, as well as damp showing through - investigate construction of floor build-up

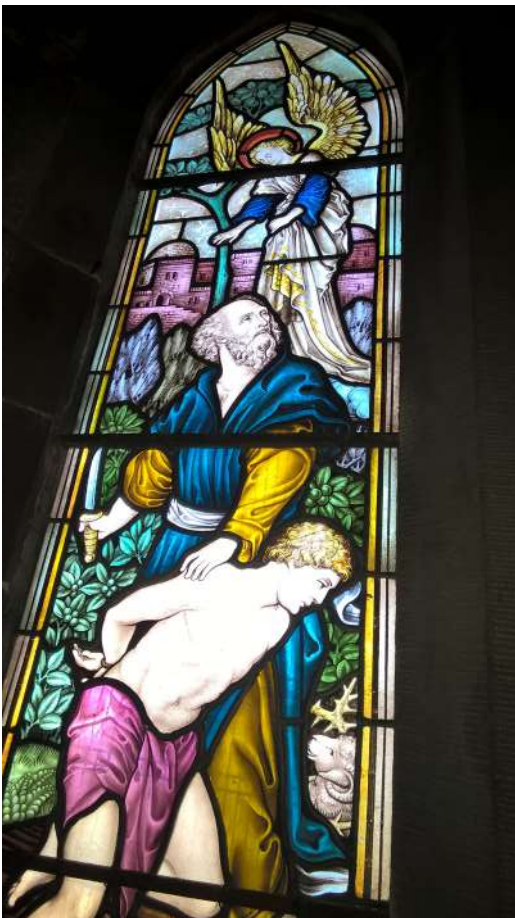
Exceptional quality pair of windows, dedicated to the Rev'd Wesley Farrar, positioned at the east end of the north nave

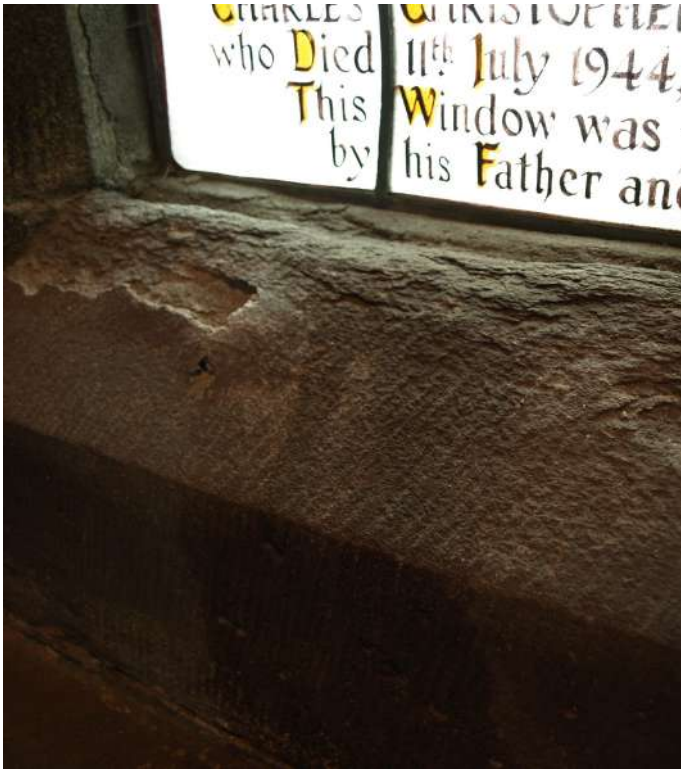
Spalling masonry to window cill

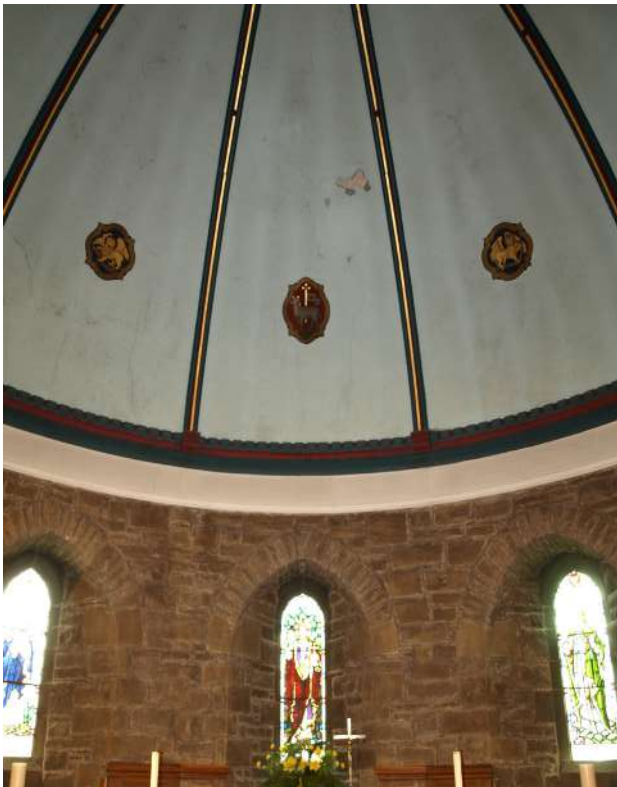
Internal scheme of colours and motifs will need careful consideration at redecoration

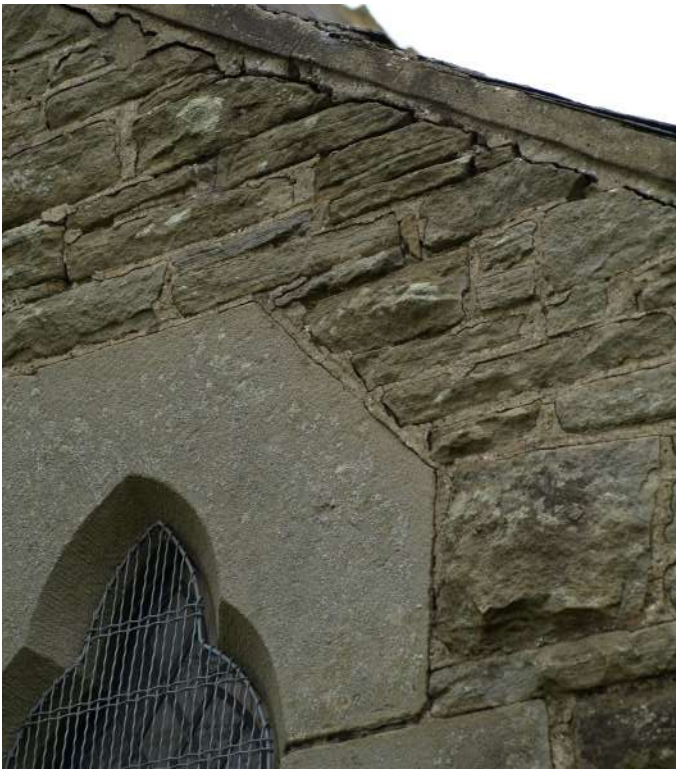
Cracked pointing and open joints will be contributing to the damp walls in the Vestry

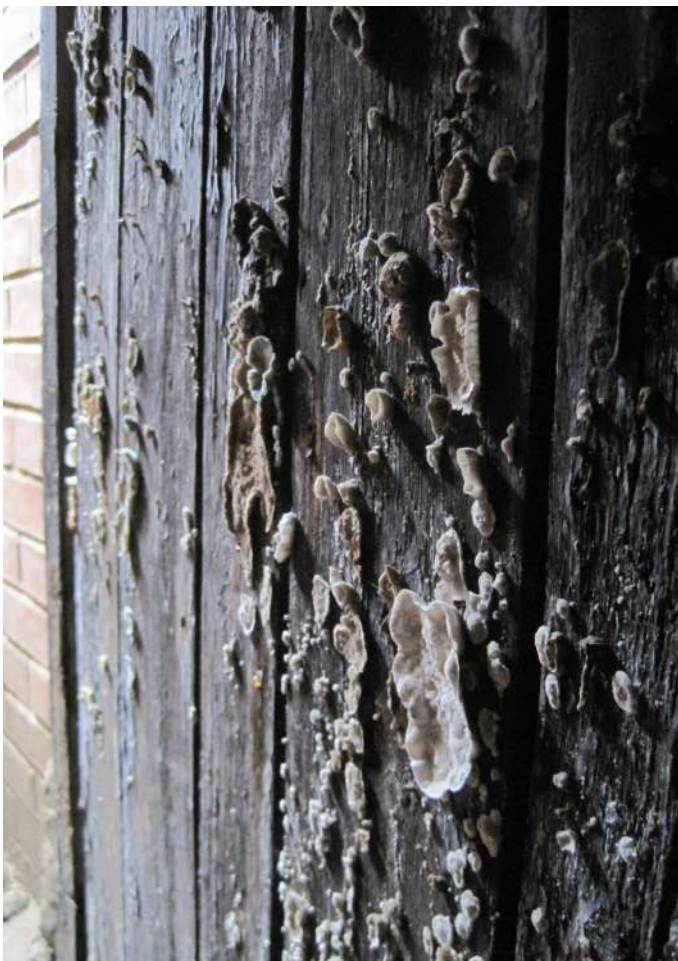
Original boiler room under south porch - door is decaying due to damp. Improve the ventilation

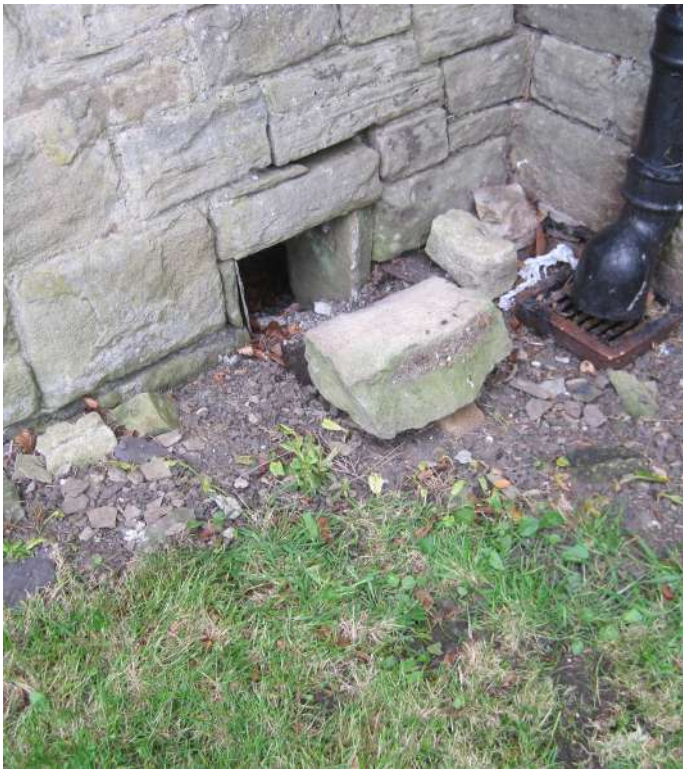
Vent to the former boiler room - needs to be kept clear. Fit a cast iron grille, and keep vegetation clear.

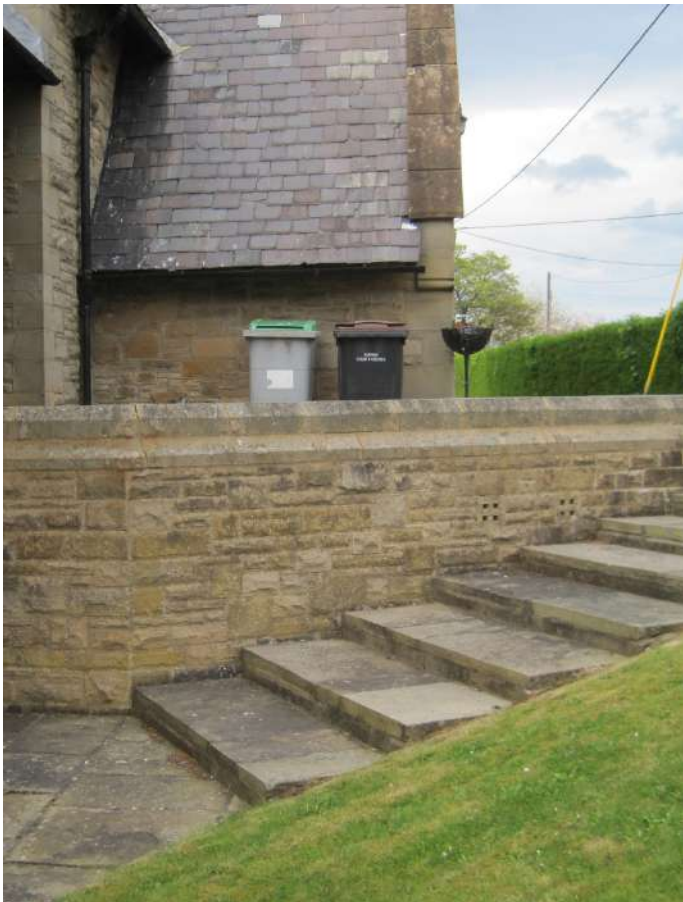
Vent to the former boiler room in wall adjacent to the steps - keep clear

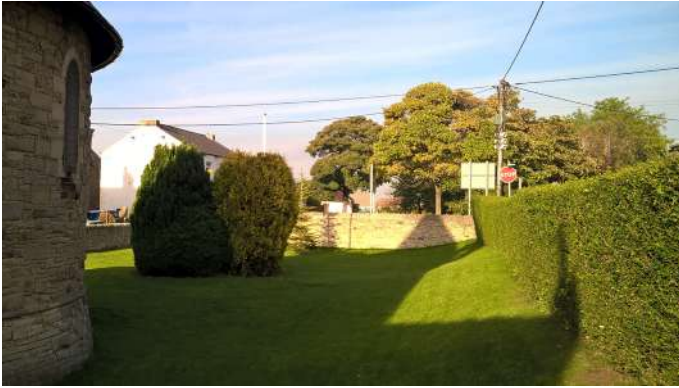
Grounds kept in very good condition

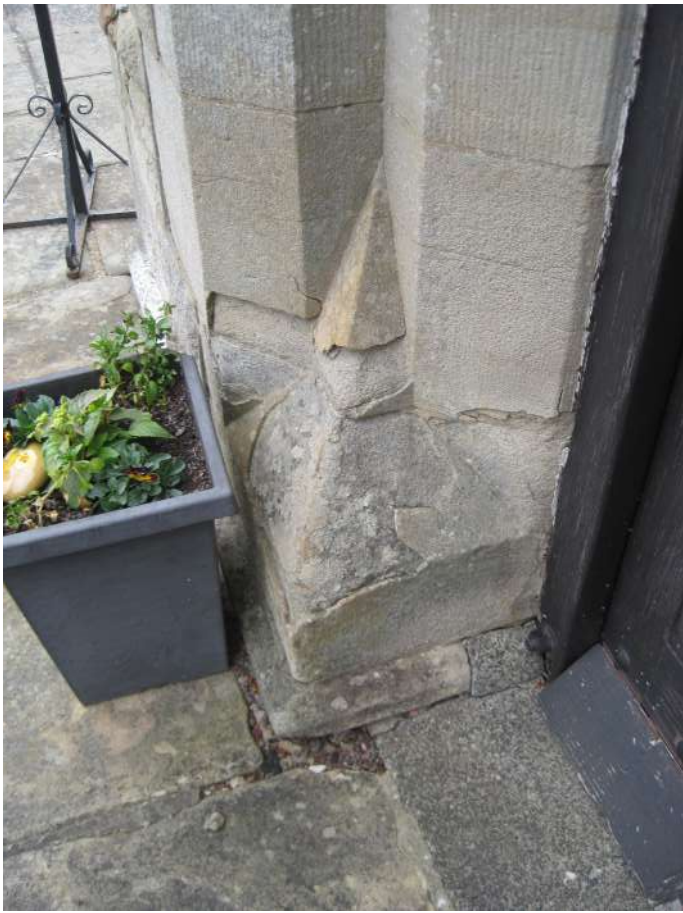
Delamination of soft sandstone jambs to the main church doorway
