# Quinquennial Inspection Report

**Church of St John the Evangelist**

**Chopwell**

**Date of inspection:** 6 October 2020; weather conditions - dry and sunny

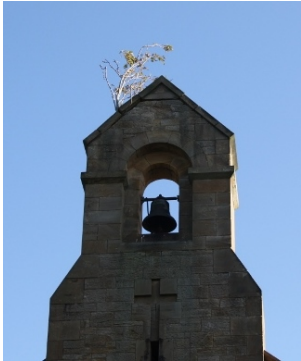
<b>1.3 Bellcote</b>		
Condition	<p>The branch growing from the water-tabling reported at the last inspection has not only grown but has lifted the water-tabling and apex stone further making them in more danger of falling off in high winds and causing injury or death to passers-by.</p> <p>Close up photos of indicate that there may be some rusting of the bell headstock.</p>	
Repair needs

<p>As a matter of urgency the water-tabling and apex stone should be lifted, the branch removed, a herbicide applied to prevent re-occurrence, followed by re-bedding and re-pointing of the water-tabling to prevent danger to the public.</p> <p>While the bellcote is scaffolded for the water-tabling repairs it is recommended that the bell headstock is rubbed down to remove any rust followed by re-decoration. The bearings should also be lubricated at this time.</p> <p>Internally the bell rope has become detached from the lever arm and needs to be replaced/re-fixed.</p>	A         B

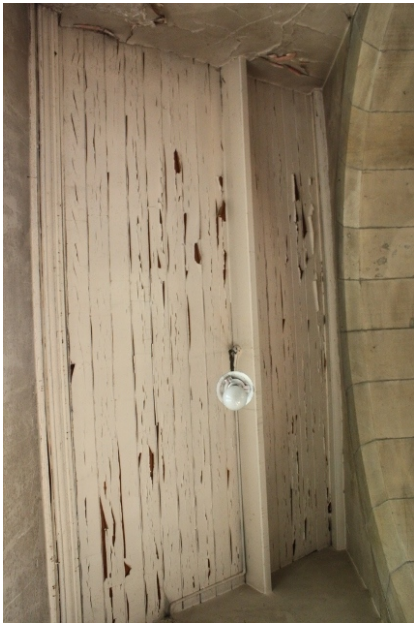
<p>Ceiling over Lady Chapel</p>	<p><u>Roof void:</u> As access was not gained to the roof voids over the Chancel and Nave. The inspector cannot state that this area is free from defect. It is recommended that these voids are inspected periodically and any concerns should be raised with the architect.</p> <p><u>Nave:</u> The timber boarded panelled ceiling and exposed part of the trusses appear to be in fair condition.</p> <p><u>Chancel:</u> The decoration to the segmental timber boarded ceiling is in poor condition. Redecoration is recommended funds permitting.</p> <p><u>Lady Chapel and Organ Chamber:</u> The decoration to the boarded ceilings is peeling due to damp from leaks. The cause of the damp ingress should be investigated and solved and any rotten timbers replaced before redecoration is attempted.</p> <p><u>Kitchen and Vestry:</u> The varnished timber boarded ceiling is in reasonable condition from a purely visual inspection.</p>	<p>E</p> <p>C</p>

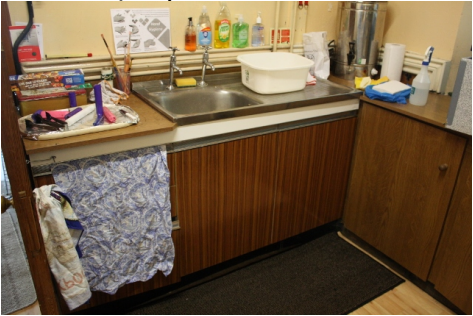
<p>Vestry - the plaster is very uneven and the paintwork in poor condition. Redecoration is recommended.</p> <p>Kitchen – has a range of base and wall units together with a sink and drainer and is functional. The lipping to the edges of the veneered blockboard doors is coming away in places. Re-fixing the lipping is needed.</p> <p>There is no toilet on the premises and the PCC should give consideration to installing a wheelchair accessible one, funds permitting.</p>	<p>E</p> <p>C</p> <p>E</p>

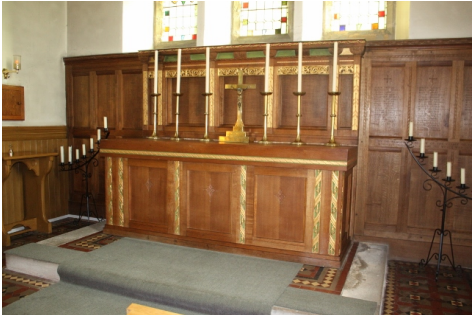
<p><u>Font:</u> Octagonal stone bowl and pedestal with carved oak cover. The outer edges of the stone bowl are chipped in places.</p> <p><u>Pulpit:</u> Semi octagonal stone base and finely carved oak sides. Carpeted steps and floor. All in good condition.</p> <p><u>Rood screen:</u> Finely carved oak – in good condition.</p> <p><u>Nave altar, lectern and chairs:</u> Oak framed altar; finely carved oak lectern and chairs – all in good condition.</p> <p><u>Chancel altar:</u> (see photo) Oak framed with some painted and gilded detail in good condition.</p> <p><u>Reredos and war memorial:</u> (see photo) In carved oak, some gilding to the reredos. All in good condition.</p>

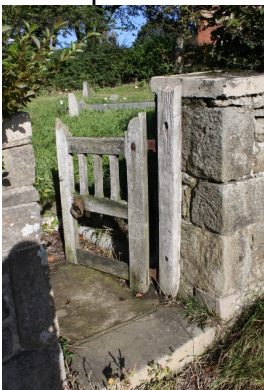
<p>The oak pedestrian gate by the main entrance has a loose frame and the gate is catching on the ground. Re-fixing and adjustment are needed. The gate would also benefit from cleaning and re-oiling.</p> <p>The secondary entrance gate on the SE boundary has missing battens and the gate posts are showing signs of rot. (see photo). The repairs to the gate followed by cleaning and re-oiling of the gate and gate posts are needed.</p> <p>The open boarded fence on the north boundary near the entrance drive has many missing boards. Fitting new boards is recommended.</p>	C  C  C
