Quinquennial Inspection 2021

St Matthew and St Luke's Church
Darlington DL3 6DX

Quinquennial Survey Report

Church of St Matthew and St Luke

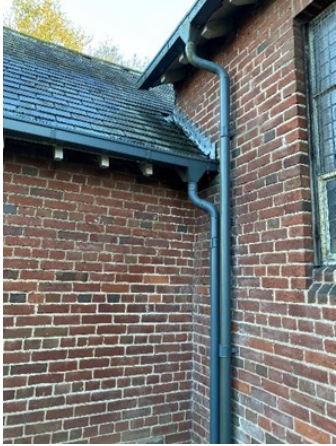
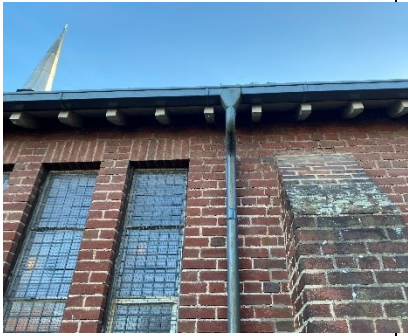
2.4	Rainwater Goods	<p>All rainwater goods are a replacement pre-finished aluminium, which were recommended in the 2007 inspection.</p> <p>Downpipes discharge to a below ground drainage system.</p>	<p>Some vegetation build up in gutters.</p> <p>Leaking gutter joint identified above the boiler room.</p> <p>Water seepage noted from 2No. downpipes on North elevation – potential blockage.</p>	<p>High level inspection and clear out of gutters and hoppers/downpipes. Seal defective gutter joints</p>	<p>North and East</p>	<p>1</p>
-----	------------------------	---	---	---	-----------------------	----------

Category	Ref No	Works Recommended
1 Unavoidable, immediate	2.4	Repairs to leaking gutter joints (e.g. east side of boiler house and North aisle)
	2.5	Replace damaged door threshold strip (main north-west entrance)

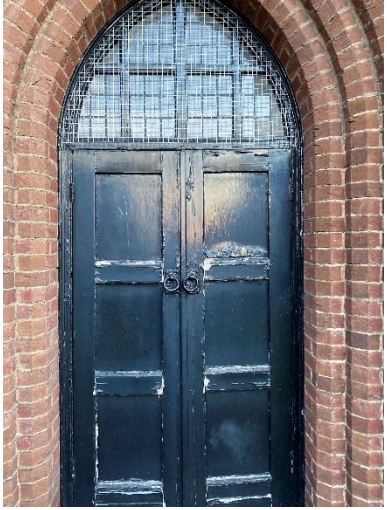
2.5	External Doors & Windows

<p>External doors are of painted timber.</p> <p>Joinery is generally in good order although in need of decoration.</p> <p>The locking mechanism to the West door was discussed as this is a fire escape, however relies on being unlocked when the building is in use as internal ironmongery does not incorporate a thumb turn.</p> <p>There is minor timber decay to the base of the boiler room door, which has been subject to a previous repair.</p>	<p>Consideration to be given to changing the door ironmongery.</p> <p>Joinery repair/installation of weather bar to base of boiler room door.</p> <p>Decoration of external timber work.</p>			1

2.5	Repairs/installation of weather bar to boiler room door.
	2.1	Lead wedge and localised repoint to defective joint on lead flashings to south aisle abutment.
3 Essential, within 18 – 24 months	2.5	Decoration of external door.

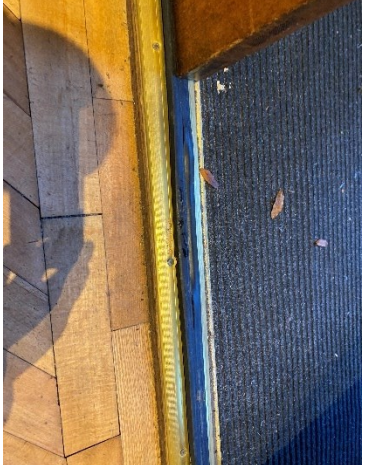
<p>The rubber seal on the threshold strip to the North door is damaged and presents a trip hazard.</p>	<p>Replace north door threshold/rubber seal.</p>	North	1

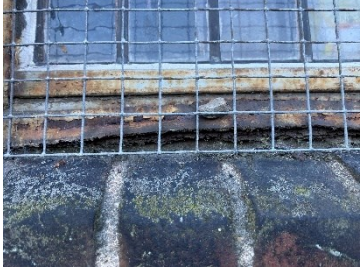
<p>The external windows are metal framed with leaded glazing and internal saddle bars. There are a number of bottom hung openers. Externally the windows are protected with wire mesh.</p>	<p>Adequate, but opening windows are largely unused and inoperable. Significant corrosion apparent in frames which in some instances has caused distortion. A number of the leaded glazing panels are also distorted of particular note to the triple lancet window in the west gable.</p> <p>Some leaking apparent though quarries.</p> <p>Corrosion generally to protective grills.</p>	<p>Phased refurbishment by specialist including lead cement to glazing (rebuilding/forming leaded glazing), treatment of frames and recoating, renewal of glazing putties, easing and adjusting of opening mechanisms. Specialist cleaning would also be considered beneficial.</p>	<p>All</p>	<p>5</p>
--	---	--	---	---	------------	----------

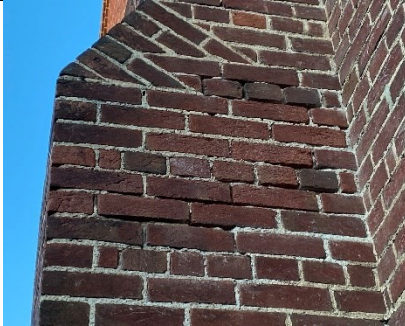
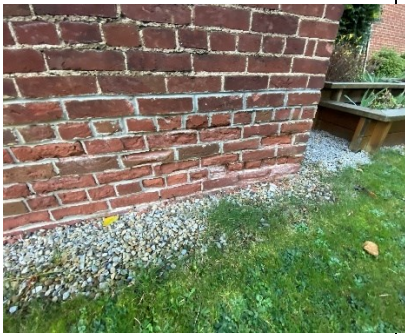
2.6	Walls / External Fabric including Damp Proof Courses

<p>Walls are formed with clay brickwork laid in English bond and incorporating brick buttresses, plinth course to each gable and with stepped recessed arches to entrance openings and some windows and brick decorative details.</p> <p>A bitumen damp proof course is visible in areas at the base of the wall.</p>	<p>Overall the brickwork and pointing of the external walls is predominantly in good order. There is a longstanding issue with frost damaged brickwork below DPC which continues to deteriorate. It is apparent and was reported in previous QI's that a cement rich mortar has been used previously to repoint the brickwork at low level. This is likely to be exacerbating/accelerating the issue making the brickwork sacrificial to the pointing rather than the other way around.</p> <p>There are some small localised areas of defective/missing pointing for example to the brick buttresses on the West elevation and bell tower.</p>	<p>Repointing with a traditional hydraulic lime mortar and some selective brick replacement to worst affected areas/bricks.</p>	<p>Predominantly South East and West.</p>	<p>4</p>

2.1	Missing pointing to ridge over vestry
	5.2	Decoration of external railings
4 Required, prior to next QI	2.6	Frost damaged brickwork below DPC – Remove cement over-pointing and re-point with hydraulic lime mortar. Cut and replace isolated most severely damaged bricks.

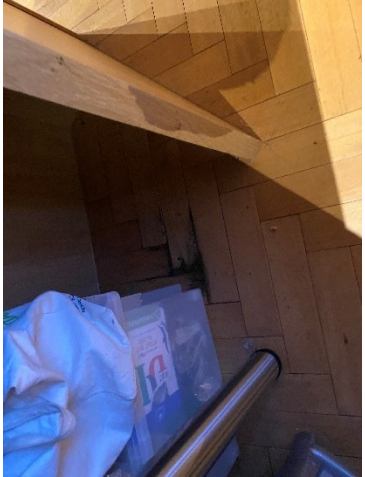
3.3	Floor Structures and Finishes

<p>Assumed ground bearing concrete with parquet floor laid over and bonded with bitumen adhesive.</p> <p>Carpet laid to chancel and central aisles between timber box pews and to Lady chapel.</p> <p>Carpet tiles and barrier matting in the vestry and corridor. (possible parquet flooring below)</p> <p>Small area of black and white quarry tiles adjacent organ.</p> <p>Vinyl laid in the accessible WC.</p> <p>Exposed concrete to South west entrance vestibule.</p>	<p>General unevenness in the floor finish particularly over removable boarded covers to heating ducts, and particularly to the North Aisle. Issues with the subfloor conditions cannot be ruled out but appears to be historic issue.</p> <p>Darkening of some timbers associated with soft spots indicating localised failure of the DPC. Historic issues have occurred with wood beetle damage (Weevil). Refer to previous Specialist report provided by Peter Cox. Remedial works including sectional replacements of the floor have been carried out previously (centre rear).</p> <p>Vinyl floor to accessible WC is marked and stained, however is a relatively recent replacement in 2018 together with new flooring in the office and vestry.</p>	<p>No immediate repairs considered necessary, however issue is likely to be progressive over a long period of time until all areas have been subject to remedial works.</p> <p>Continue to monitor and plan for phased removal of parquet, damp treatment of concrete and reinstatement of wood flooring.</p> <p>Remedial works to the flooring will facilitate a more thorough inspection of the underlying concrete floor.</p>	6

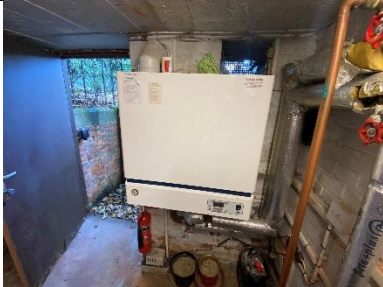
4.1	<p>Heating (incl Radiators and Pipes and Plant Control)</p>

<p>Gas boiler located in cellar/boiler room below the North East corner of the church.</p> <p>Combination of column, some pressed steel and fan coil radiators supplied by cast iron piping laid in purpose made floor ducts.</p> <p>Electric fan heater in choir vestry.</p> <p>Room stat located on west gable.</p>	<p>Not tested but operational during inspection and working adequately.</p> <p>Annual services and gas safety check carried out. Last service 02/09/2.</p> <p>New probe installed on boiler November 21</p> <p>New 100L expansion vessel, microfine & PRU installed, and leak on condo sump repaired 2018</p>	<p>None noted. Continue annual service and gas safety inspection by qualified engineer.</p> <p>See also comment on flue at 2.2</p>

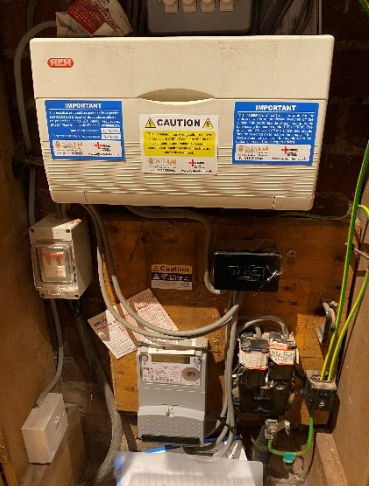
4.2	Electrical

<p>Smart meter (installed 2018) and 'modern' DB installed on incoming supply on West gable near North West entrance. Second DB located in choir vestry.</p> <p>Log book notes new installation of some sockets to nave and chancel 2019.</p> <p>Copper Lightning conductor installed.</p>	<p>Last electrical test carried out August 2020. Next electrical test is due 6/8/25</p> <p>Lightning conductor test informed to be due 2022</p>	<p>None noted within limits of inspection – Continue with periodic electrical tests.</p> <p>Arrange lightning conductor test in accordance with inspection regime.</p>		<p>2 – Lightning conductor</p> <p>4 – Electrical testing</p>
4.3	Water Supply, Drainage, Foul Waste and Septic Tank	<p>Assumed mains water and drainage.</p>	<p>No noted issues.</p> <p>Cracked salt glazed drainage gullies to perimeter replaced since last inspection.</p>	<p>N/A</p>

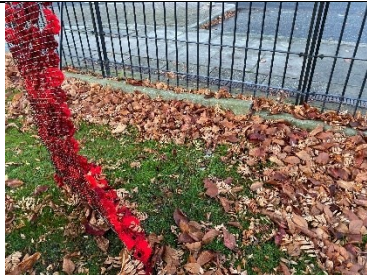
5.0	GROUNDS AND OUTBUILDINGS					
5.1	External Areas

<p>Majority of the grounds are laid to lawn with some flower beds, shrubs and trees. Gravel margins are formed against the church to the south and east elevation.</p> <p>Memorial garden created prior to 2012 inspection including pergola, stepped planters, seating, 'bug hotel' and footpaths.</p>	<p>Well maintained and good condition.</p> <p>Some slight lifting of the concrete kerbing on the north boundary fence line caused by the roots of a nearby Rowan tree.</p>	<p>As this will be a progressive issue with potential further damage over time consideration could be given to removal of the tree.</p>		5

2.6	Selective re-pointing to defective pointing on brick buttresses.
	2.2	High level inspection of Bell Tower – Check for corrosion to bell fixings.
	4.2	Electrical testing.
5 Desirable	5.1	Rowan Tree damaging kerbing/paving – Take down.

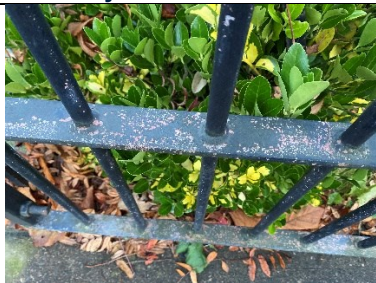
5.2	Boundary Walls / Fences

<p>Iron railings to North and West boundary. Timber fencing to the South and East boundaries.</p>	<p>Overall good order although paint finish to railings has deteriorated and is in need of decoration.</p>	<p>Painting of railings.</p>	North & West	3

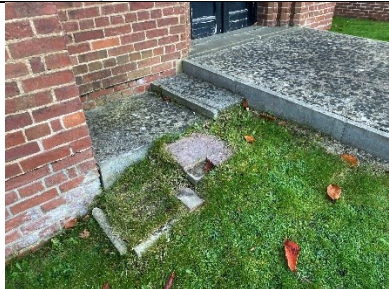
5.3	Driveways / Paths

<p>Ramped concrete paths are formed to each of the three entrances to the church.</p> <p>There is no onsite parking.</p>	<p>Overall good condition</p> <p>Inadequate/loose damaged steps.</p>	<p>Secure/replace paving to steps onto garden or consider removal in favour of alternative access– Fall hazard</p>	West	2

2.2	Enquire with boiler/heating engineer with regards to adequacy of existing flue.
2 Urgent, within 12 months	5.3	Secure/replace paving to steps onto garden or consider removal in favour of alternative access– Fall hazard.
