## QUINQUENNIAL INSPECTION REPORT

**CHURCH OF ST. CUTHBERT**  
NORTH ROAD, DURHAM, DH1 4NQ

JUNE 2022

Diocese of Durham

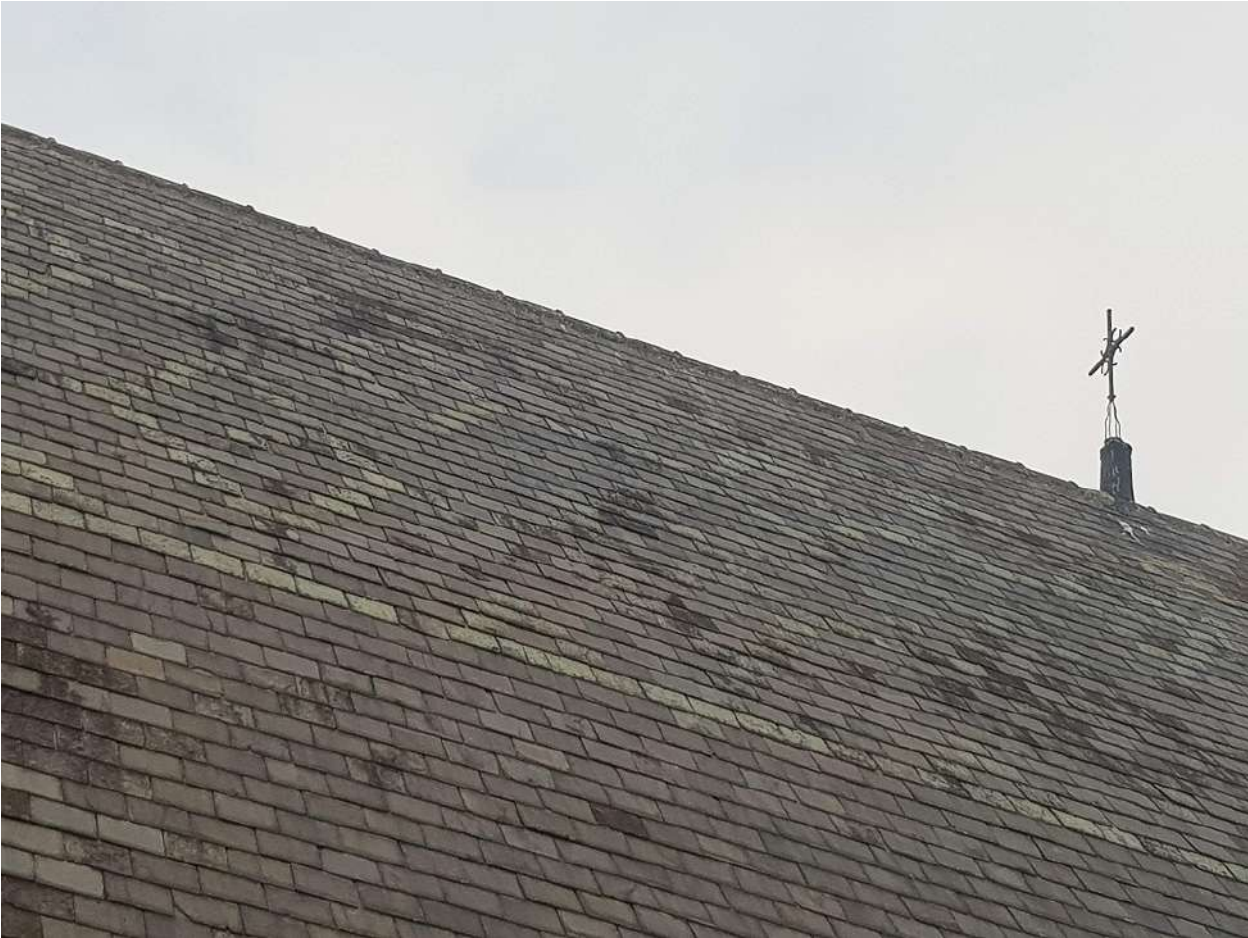
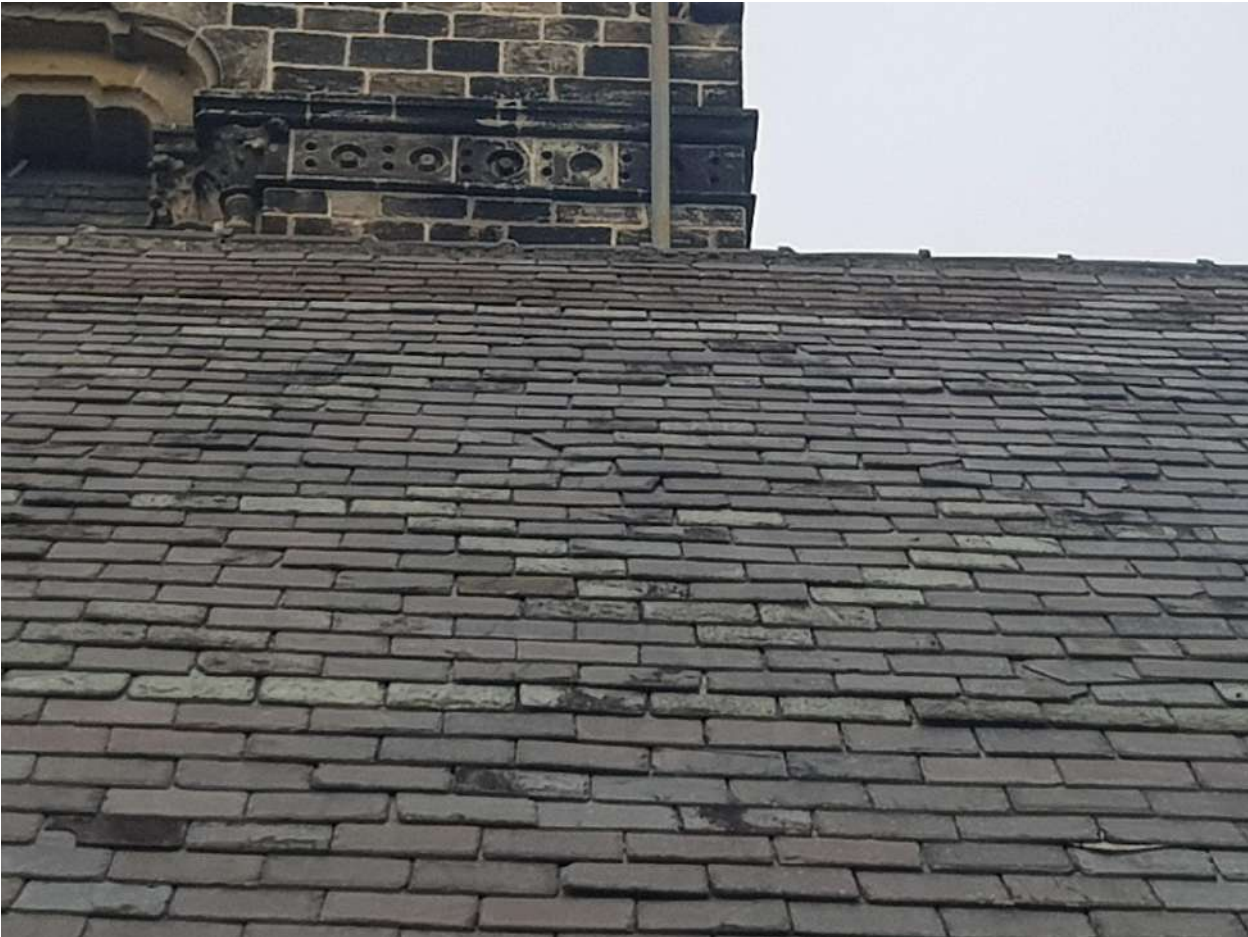
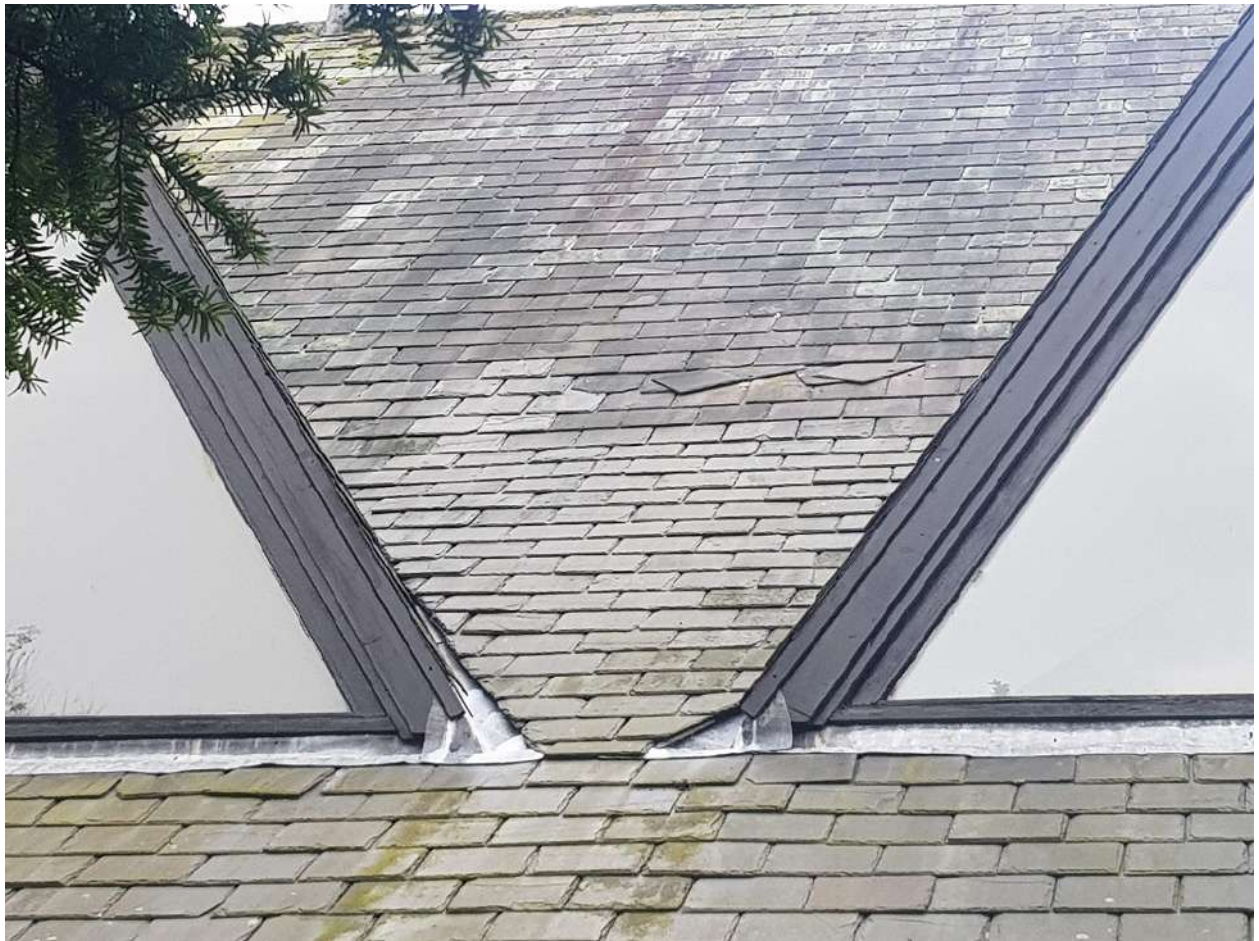
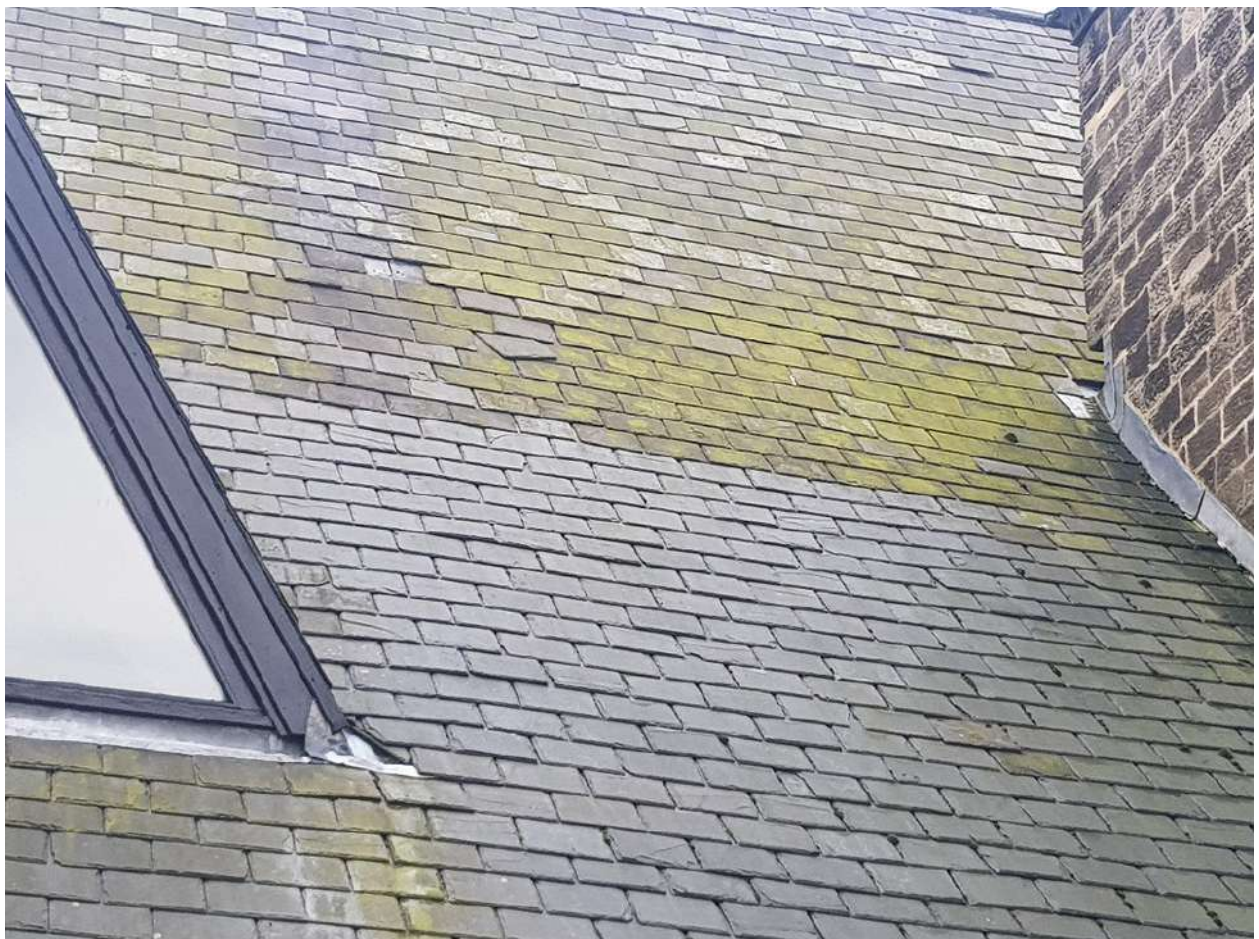
However, loose, slipped and/or missing slates are noted at the junction between the 1990 North Aisle extension and the nave roof above. These are not causing any water ingress issues but need to be addressed promptly within the course of the forthcoming quinquennial period. This area of the roof appears vulnerable to slate defects, perhaps the shape and form of the triangular dormers are channelling wind directionally up the roof slope. This combined with an aging roof covering leaves the slates here susceptible.

**R1**

Carry out slate repairs by a competent and experienced roofing contractor.

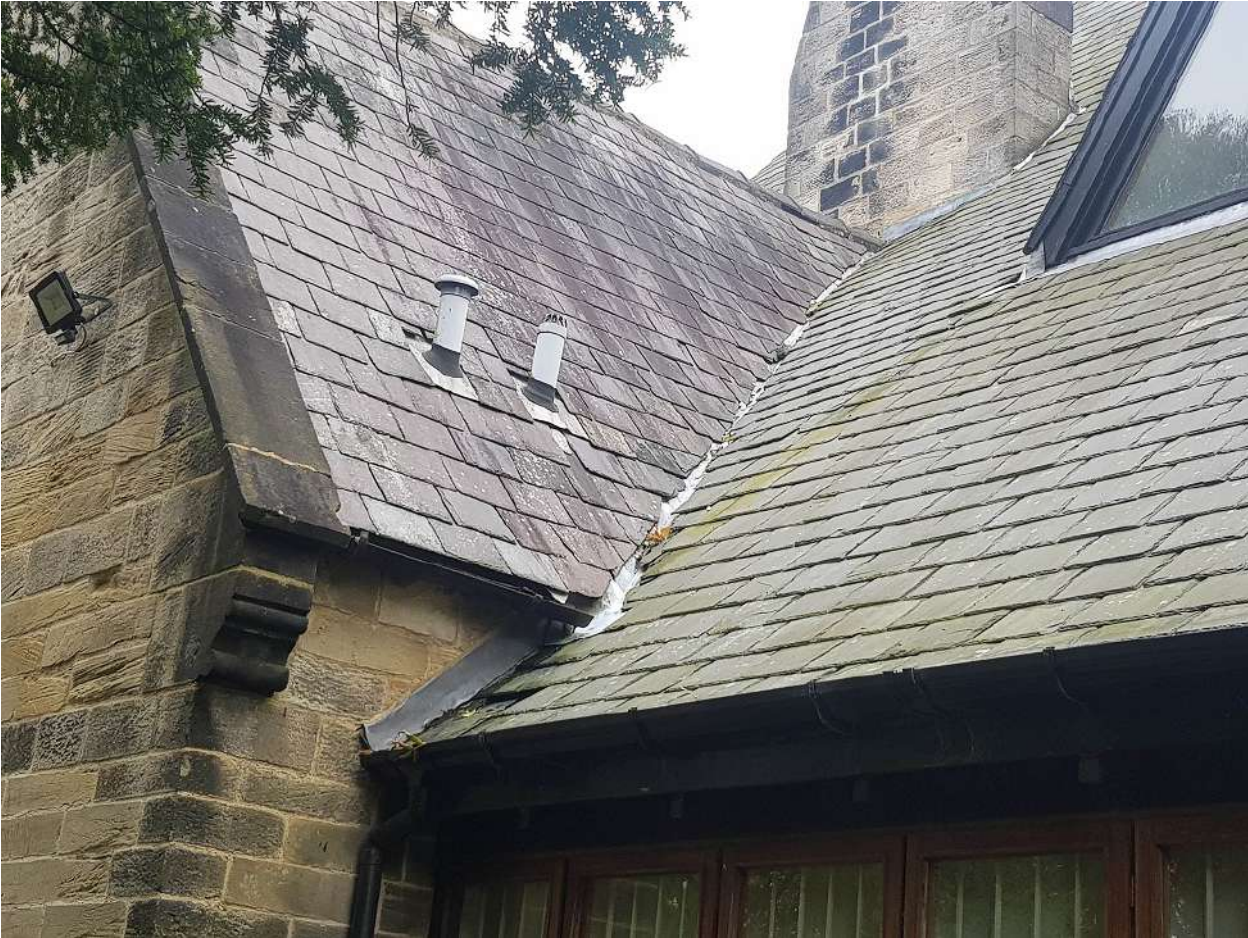
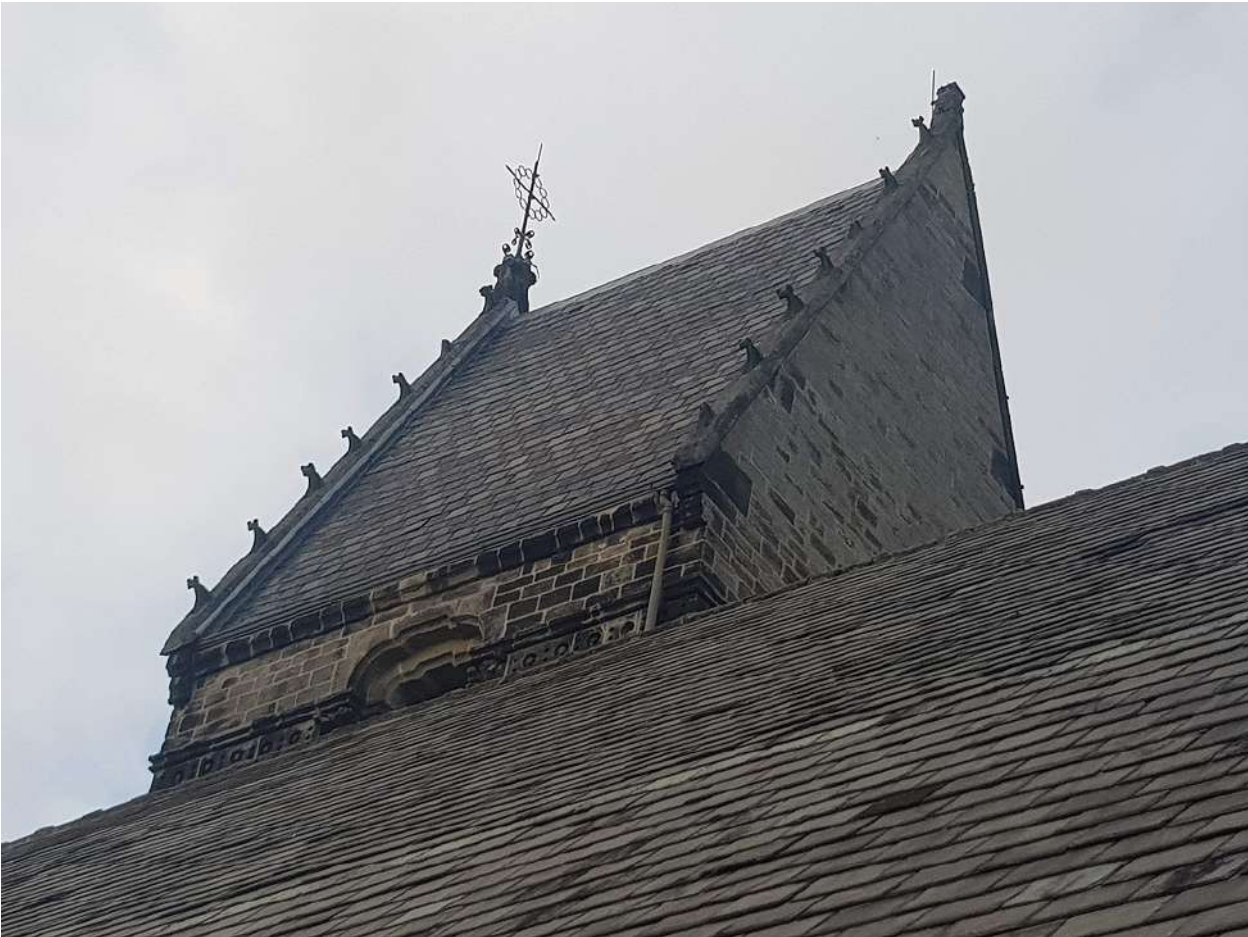
- 4.1.1 The rainwater goods appear to be in a sound, serviceable condition.

Previous QIR's raised the issue of water staining and algae growth to the buttressing to the North elevation, suggesting that issues of heavy downpours surcharging the gutters is an issue. The repair works to the Community Room dormers (item 3.1.2) also included for raising slightly the eaves line of the roof so that this would help break the speed of rainwater. It is understood that this has reduced the issue of overflow of the gutter.

The abutment valley gutter between the tower and north roofing slope was not able to be examined as part of this inspection. There is no internal evidence of water ingress that would suggest failure of this gutter lining.

<b>R3</b>	It is recommended that refurbishment of the CI rainwater goods is carried out.
-----------	--

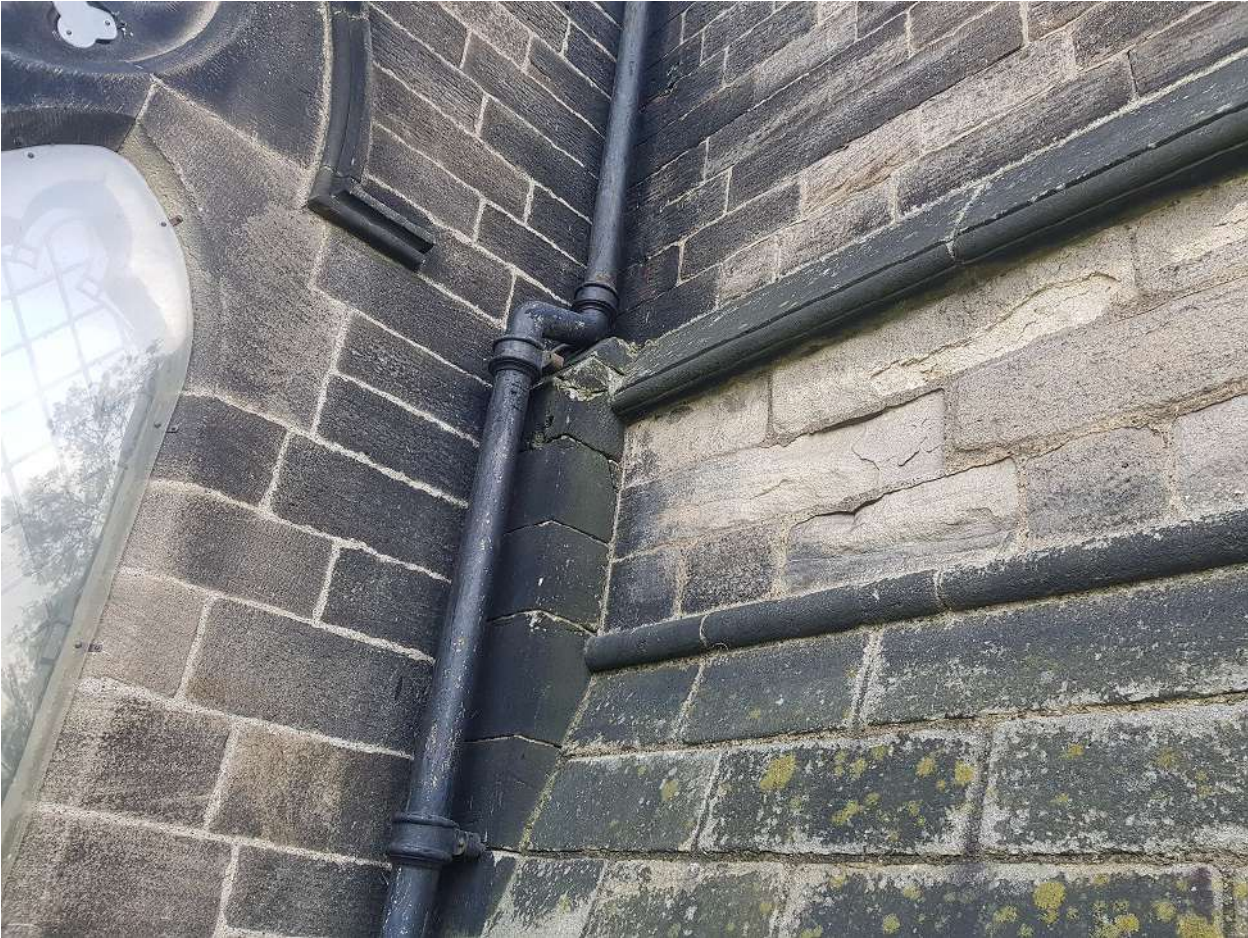
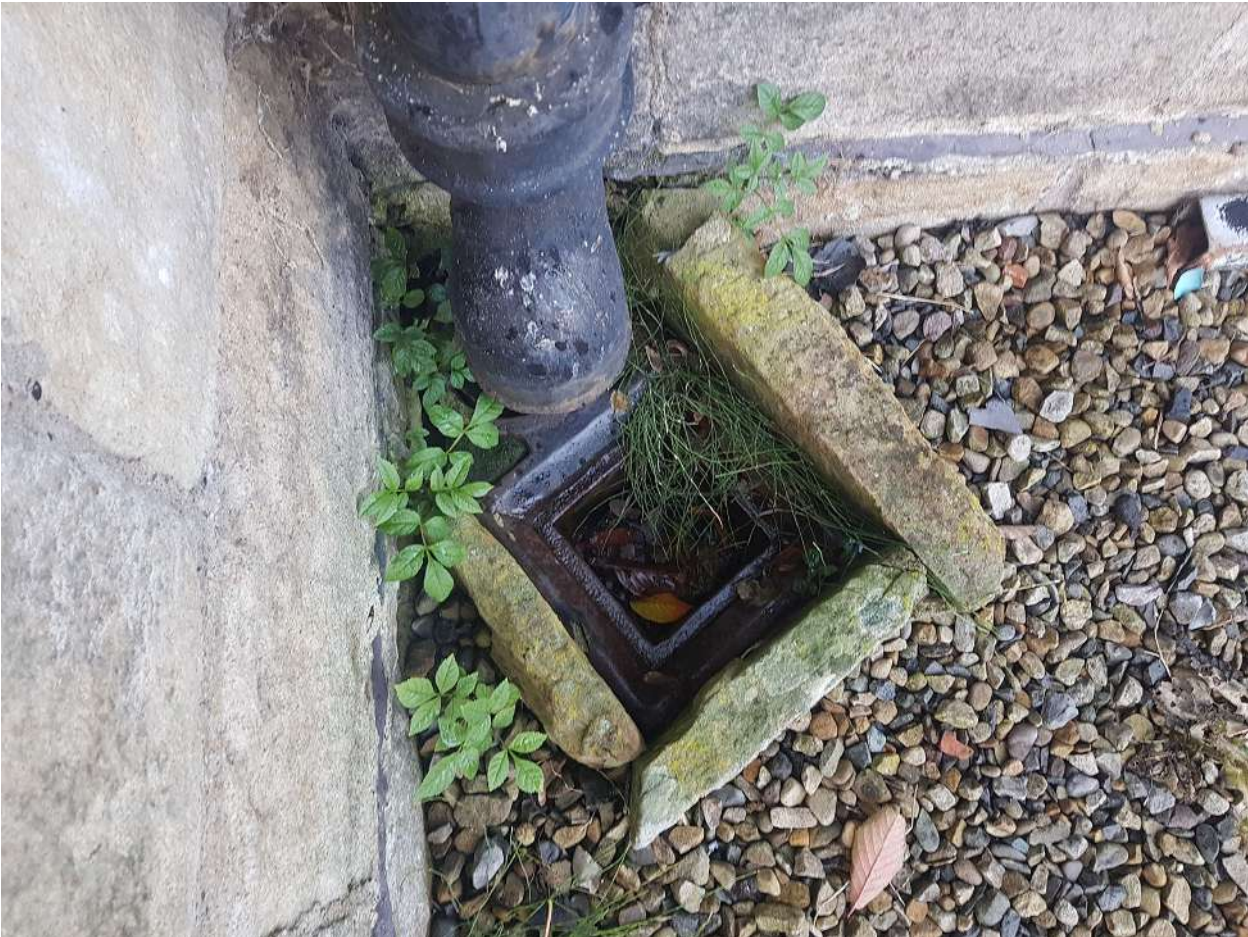
4.3.1 The rainwater goods appear to be in a sound, serviceable condition.

**M** As a routine item of maintenance, the rainwater goods (gutters, downpipes and gullies) should be checked and cleared on a twice yearly basis.

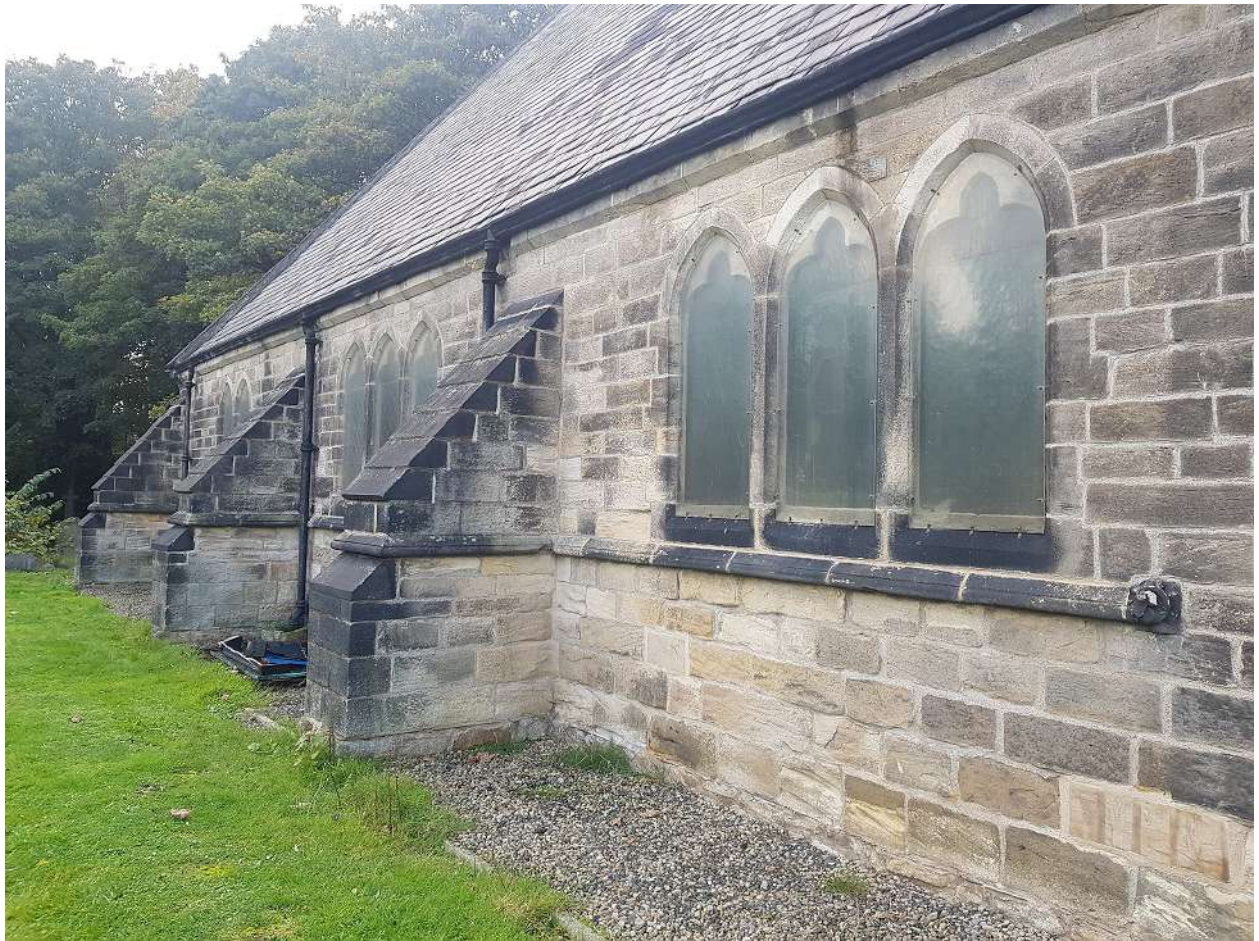
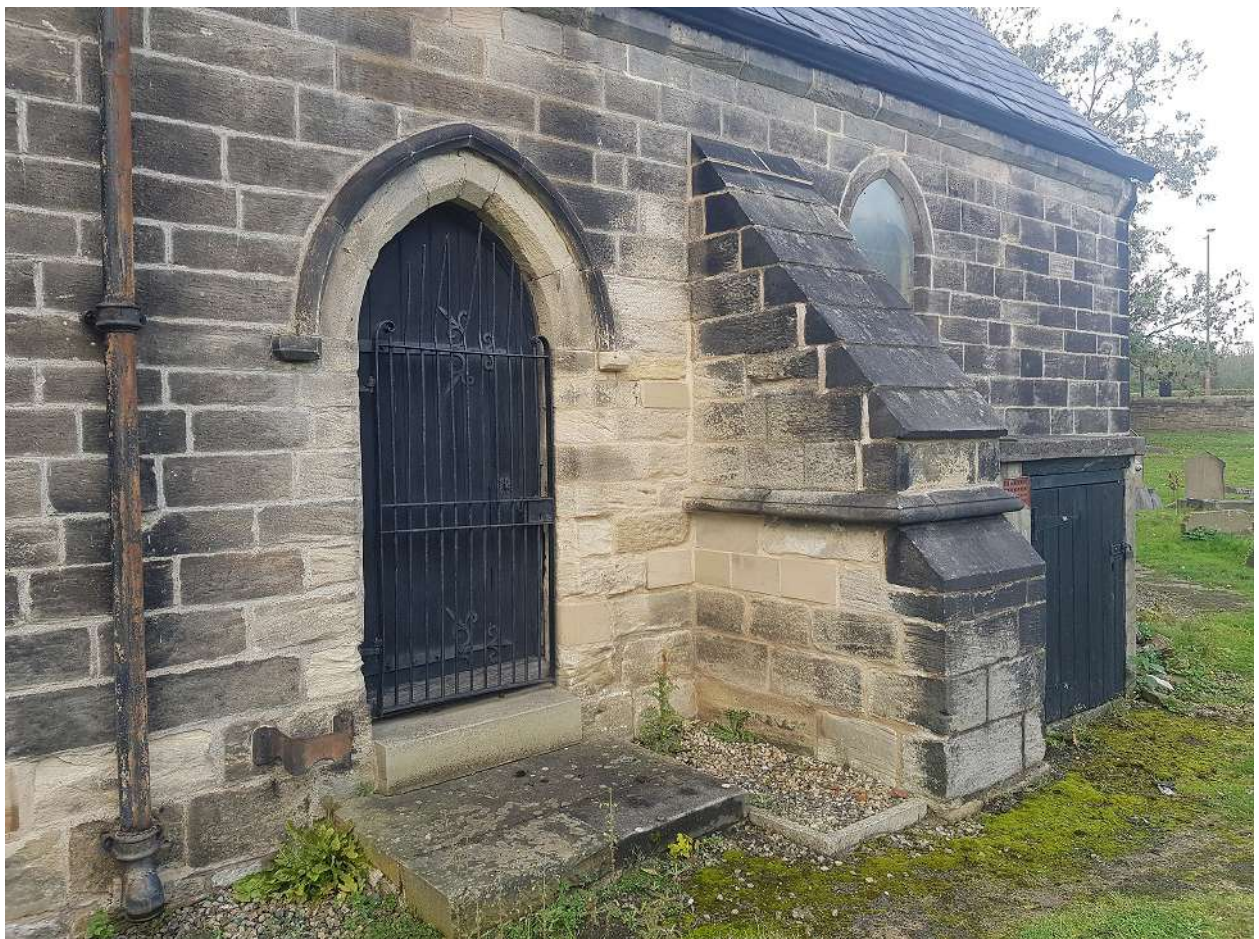
The walling fabric to this elevation is in a sound, good condition. There is some eroded stonework, face only below the cill string level.

Two previous areas of slight structural cracking have been repointed as part of the above repair work; locations are as follows:

- Head of the westernmost light within the third bay from the west end.
- Head of the single light in the easternmost bay.

**M** As a matter of routine maintenance these movement cracks should be visually checked annually over the course of the quinquennium.

Any change and/or signs of further movement should be reported immediately to the church architect.

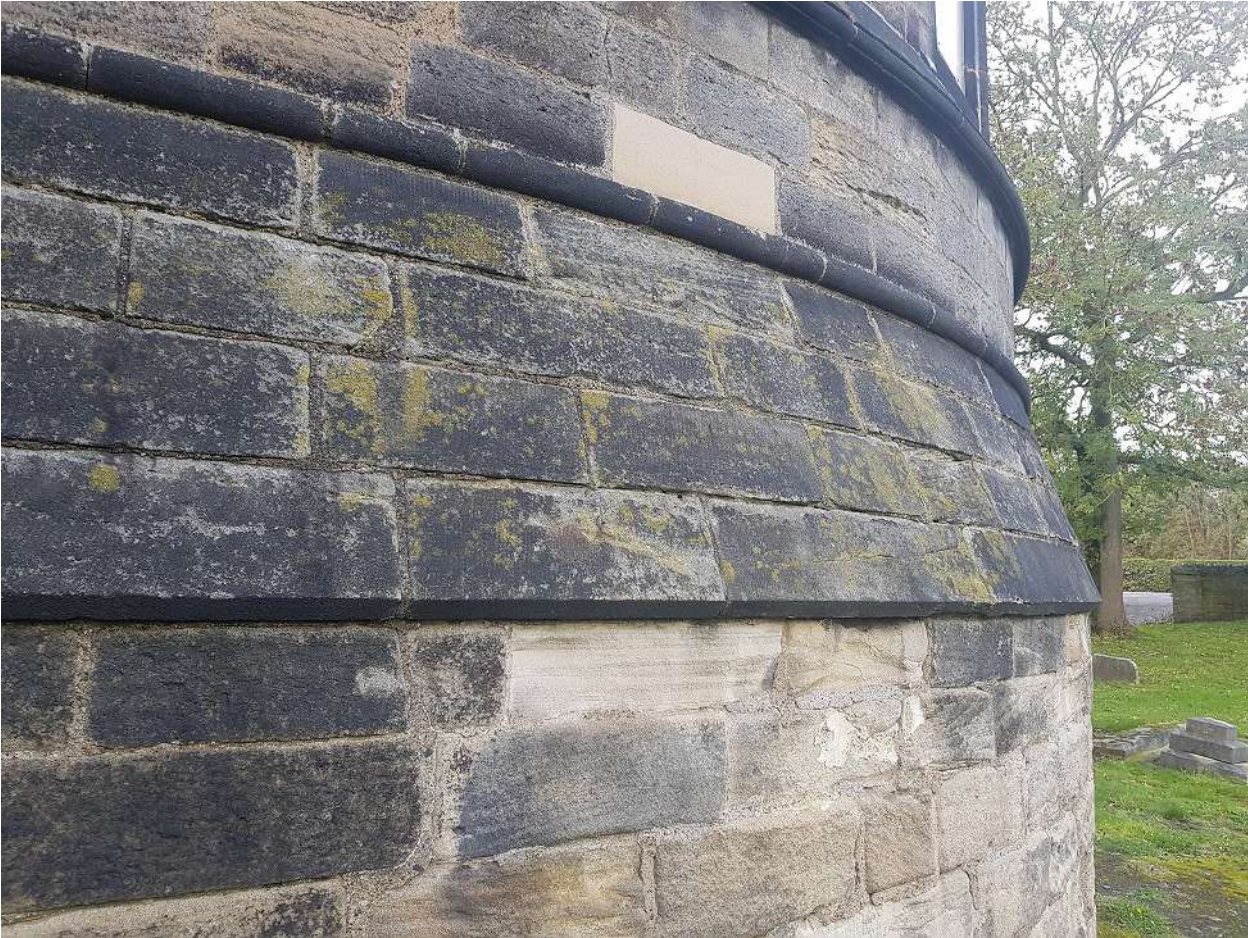
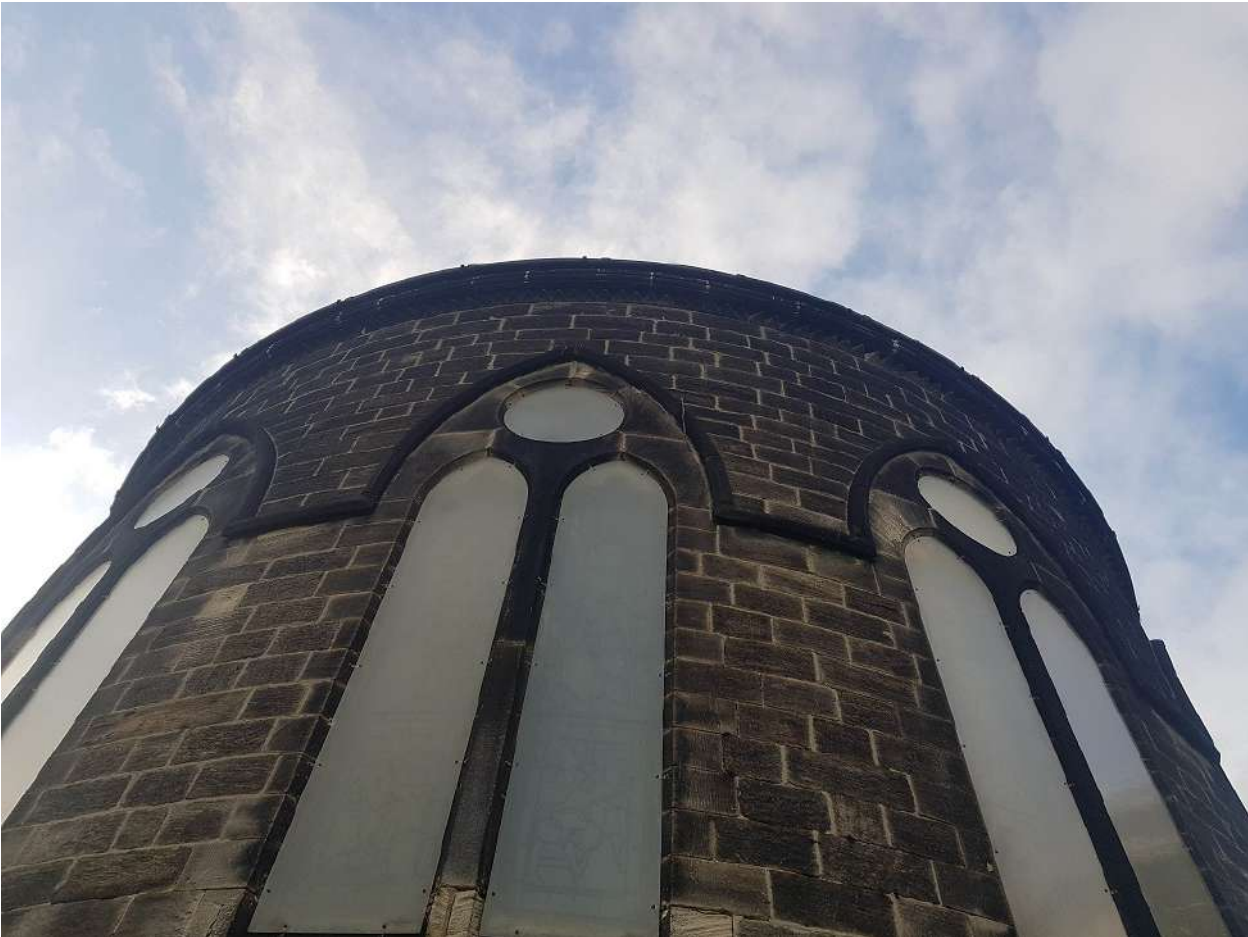
There is some material loss to the stone surface at high level but only to isolated pieces of stonework, most predominantly to the cill level of the five lancet windows which surround the sanctuary. These are concentrated to the first lancet on the north side and the junction of the apse wall with the south aisle east gable. The projecting cornice could do with repointing.

Repointing elsewhere across the upper levels appears in a sound satisfactory condition with only selective minor loss of material.

**R2** It is recommended that a schedule of work and specification in connection with selective stone replacement and repointing in a lime : sand mortar is prepared concerning this elevation.

**R3** 7.1.2.4 It is recommended that a phased schedule of stone replacement is actioned over the course of the quinquennium, highlighting the most severely eroded stones (decay > 50mm) where a shelf has been created which will retain water and accelerate further decay.

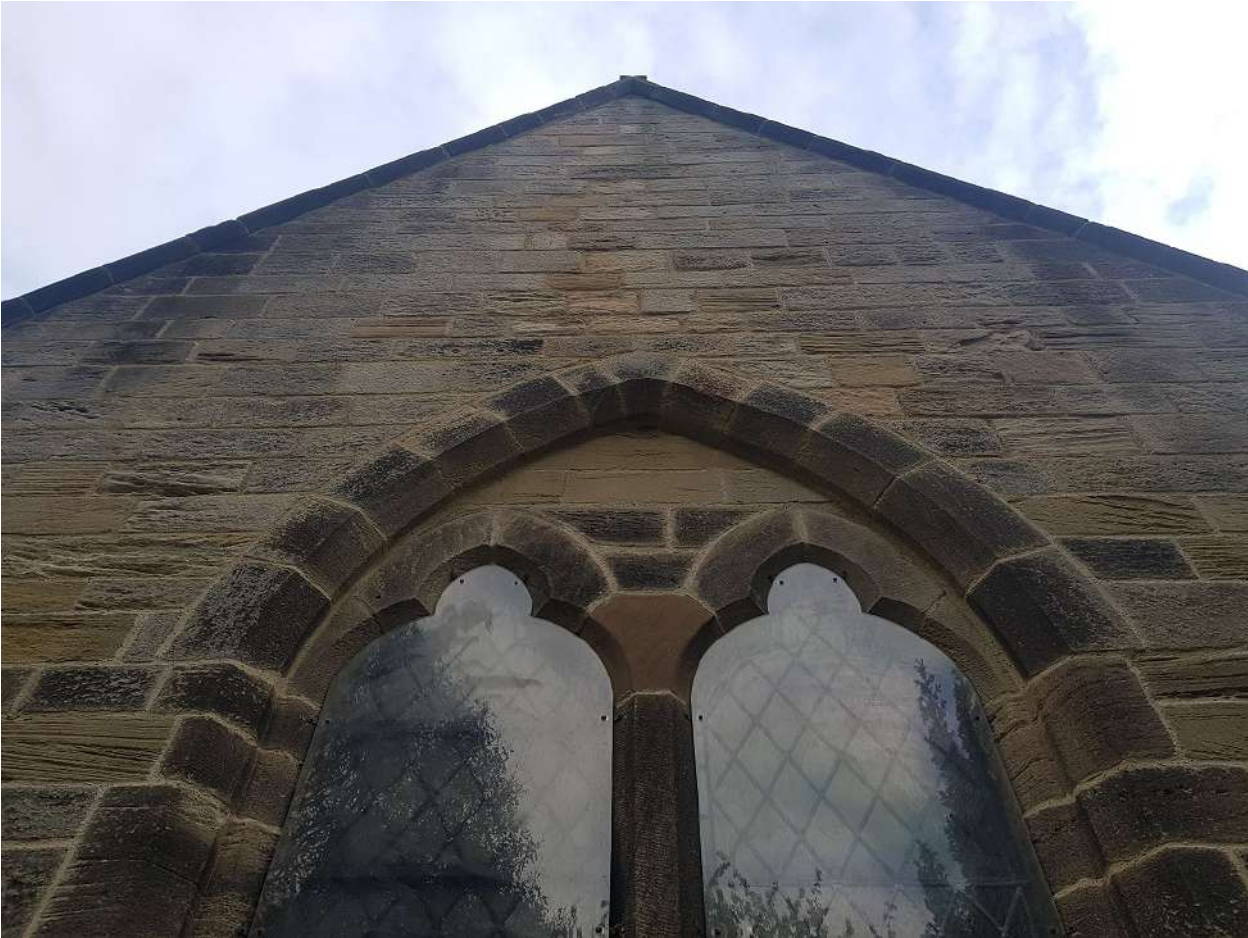
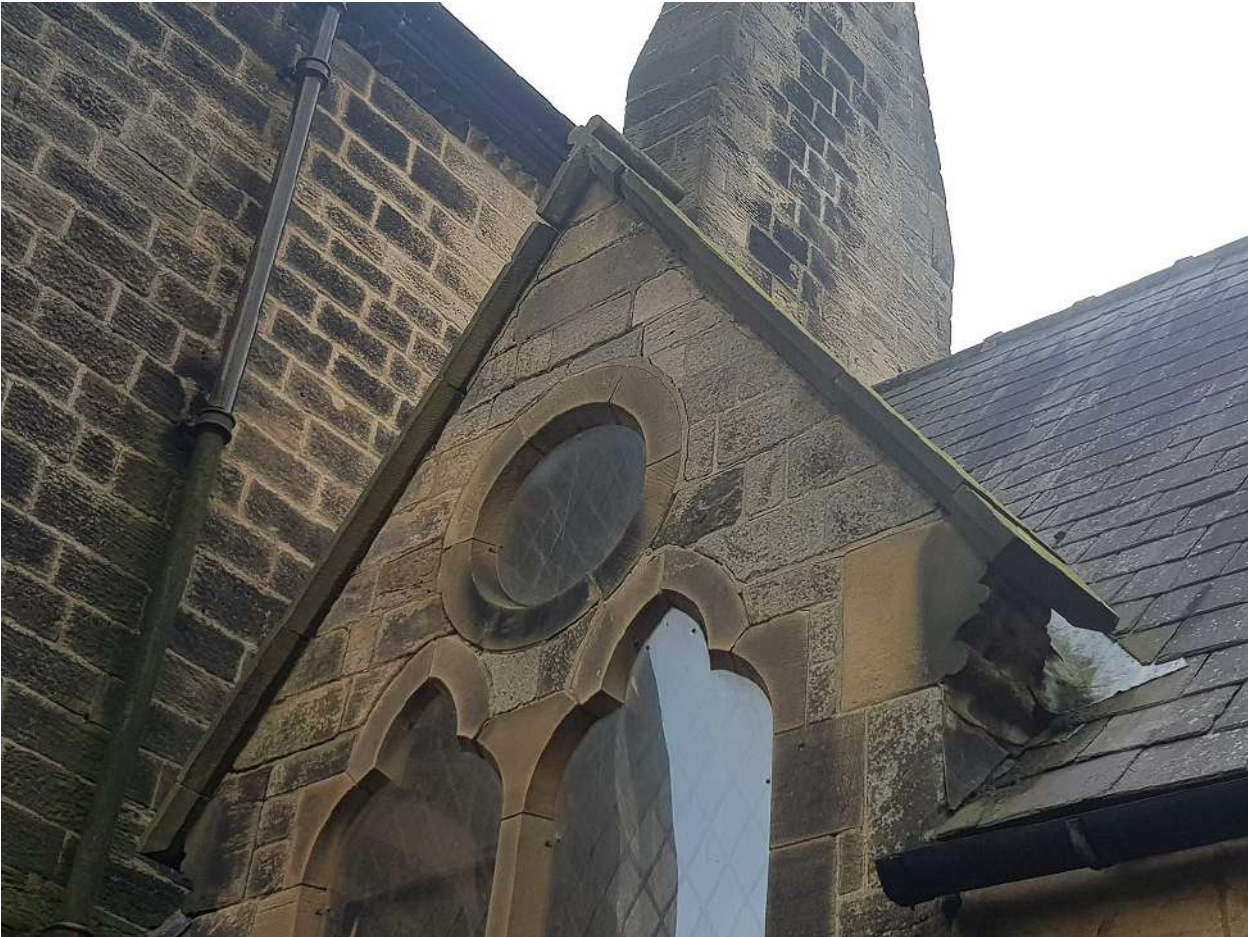
8.1.1 The door and frame are generally in a sound, satisfactory condition, albeit with some damage and wear at low level.

<b>R3</b>	It is recommended that the door is redecorated over the course of the quinquennium and hinges refurbished, finished with a rust inhibiting paint.
-----------	---

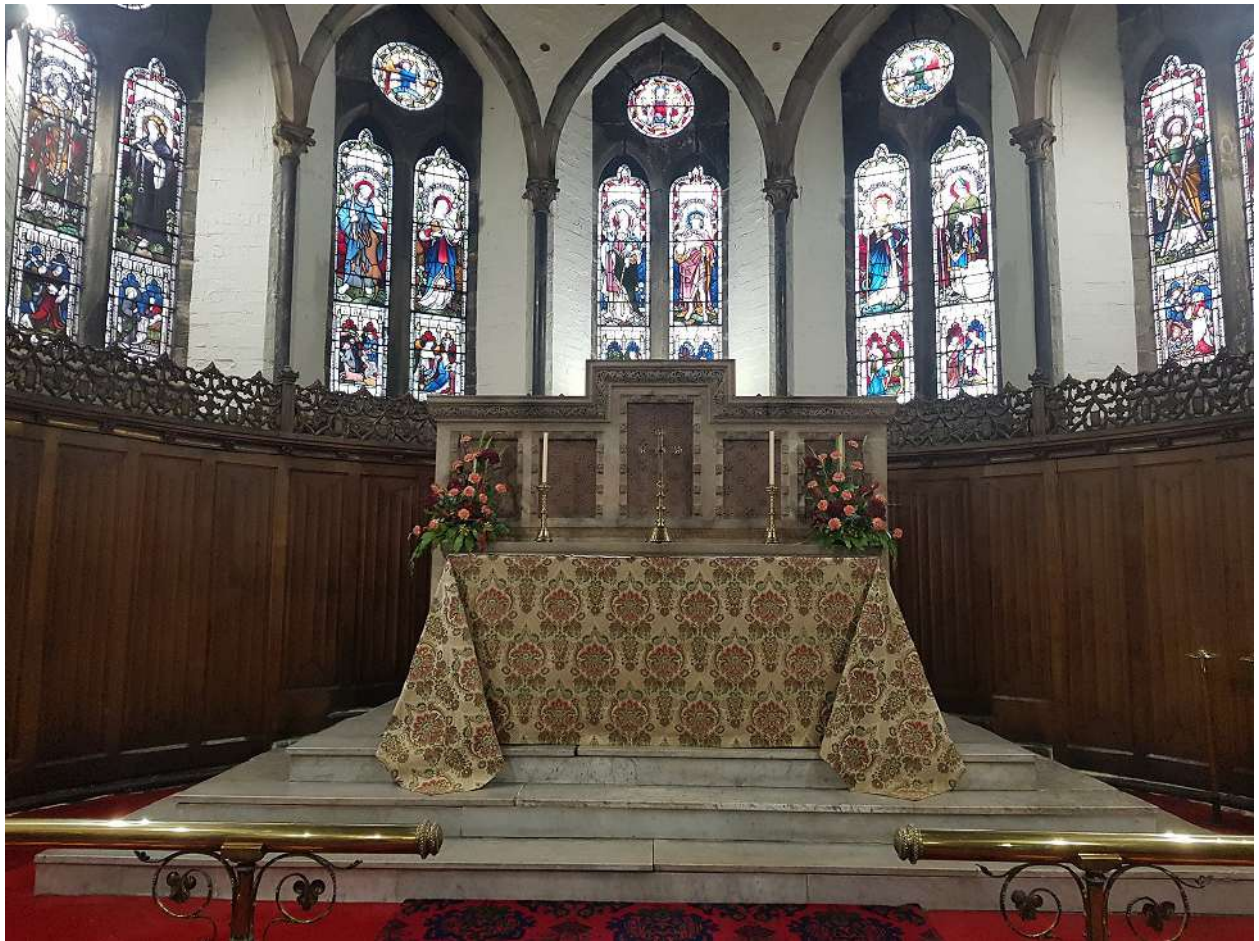
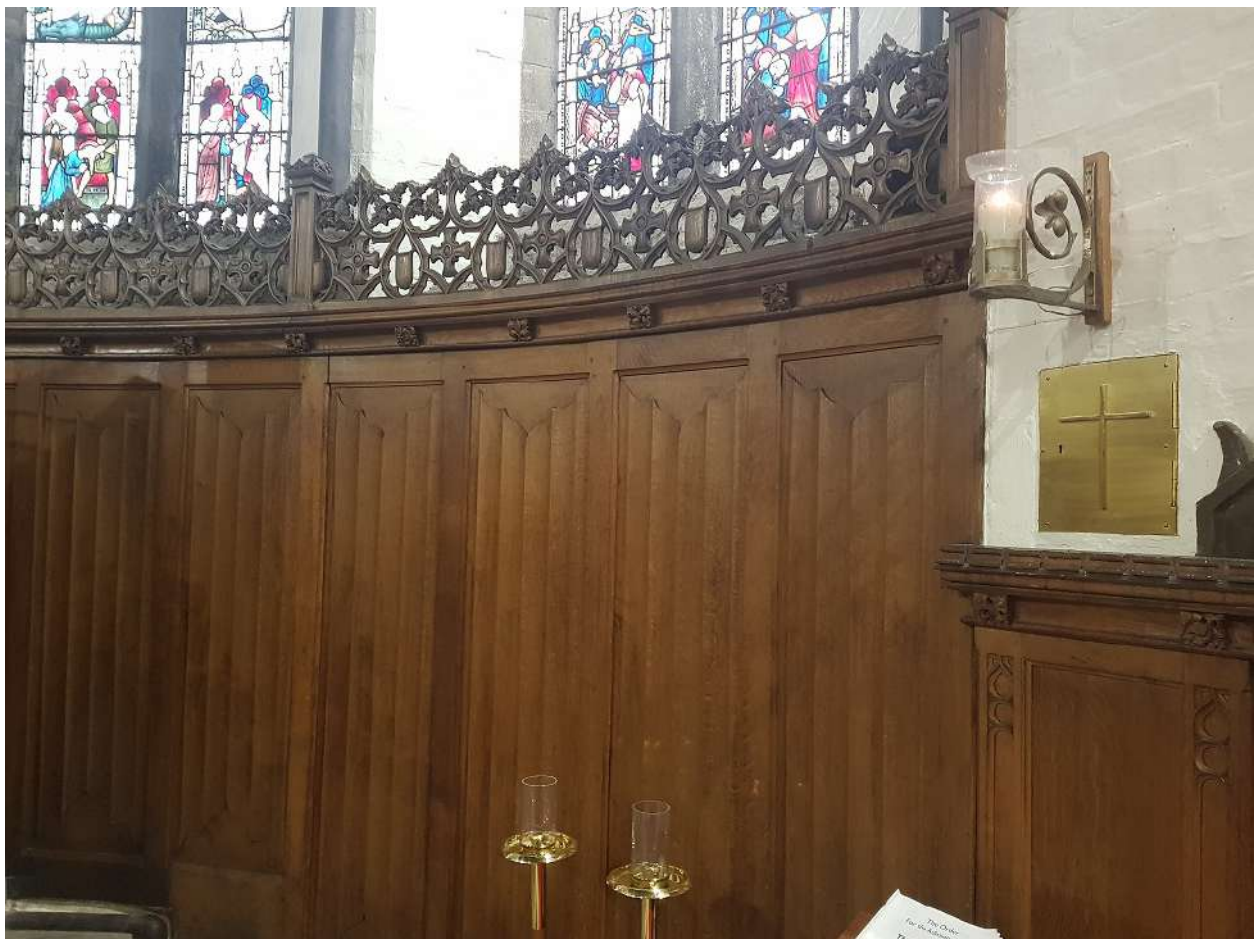
## 15.3 ALTAR REREDOS

The reredos is generally in an excellent condition however issues with its dead load and position on top of the marble high altar steps are causing issues with movement. Variable ground conditions and poor workmanship in the screeded floor are also contributory factors.

**M** As a routine item of maintenance visual checks are made twice yearly to assess any deterioration of the floor covering immediately below the reredos.

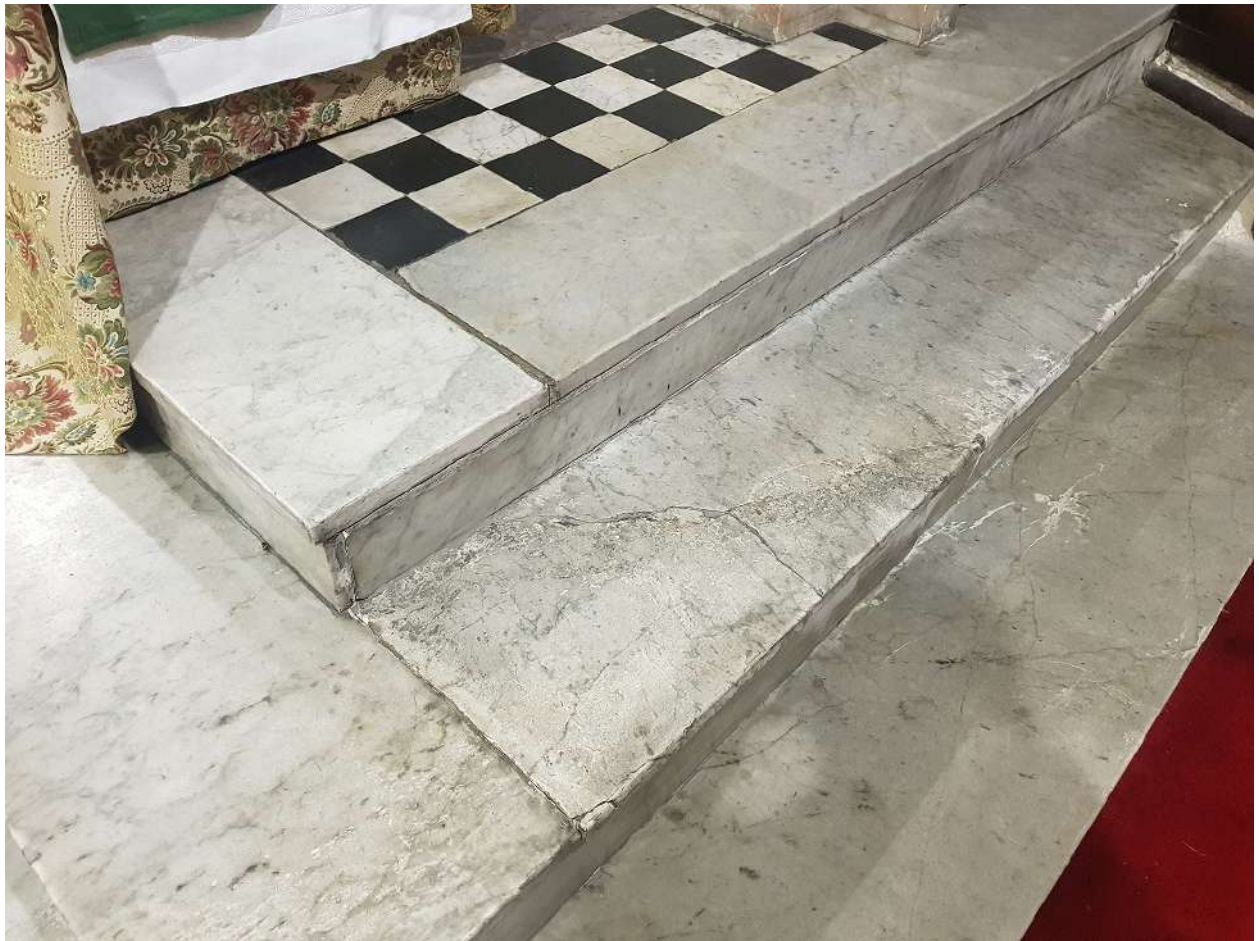
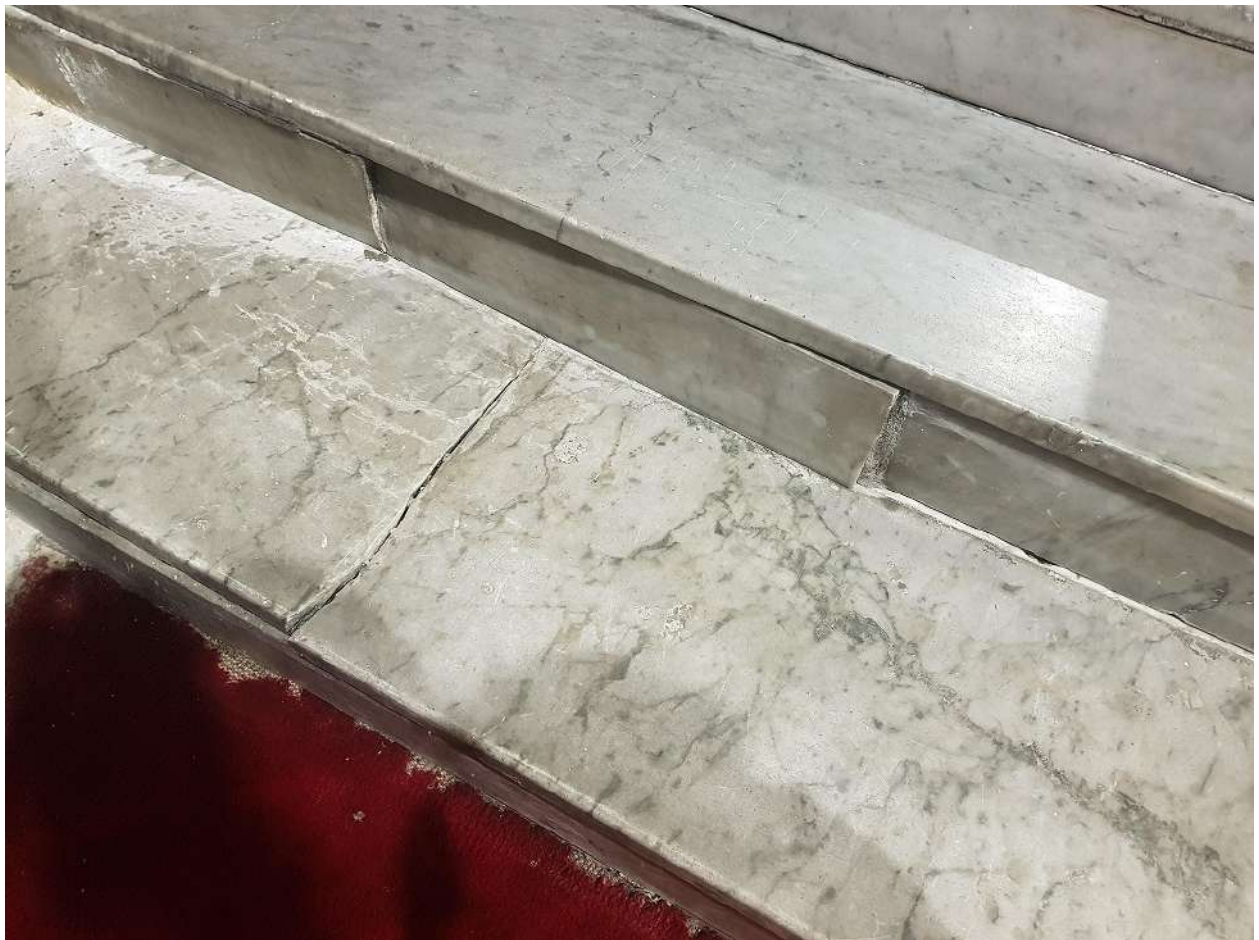
16.1.1 Previous QIR's have made comment of a generally even flooring surface, some movement in the subfloor and large gaps between blocks being a hindrance to cleanliness and appearance only. In many ways this supports a positive statement on the condition of the floor structure and covering.

However, the previous QIR raised serious concerns with sections of the flooring, predominantly the following areas: adjacent to the northwest entrance door, junction between nave and south aisle at west end, adjacent to the chancel steps and adjacent to the south door at the east end of the south aisle.

Since then, in 2017 a comprehensive programme of flooring repairs has been carried out to address the structural issues to both floor structure and covering by Kennek Construction Ltd. of Sunderland.
