## QUINQUENNIAL INSPECTION REPORT

**CHURCH OF ST. CUTHBERT**  
NORTH ROAD, DURHAM, DH1 4NQ

JUNE 2022

Diocese of Durham

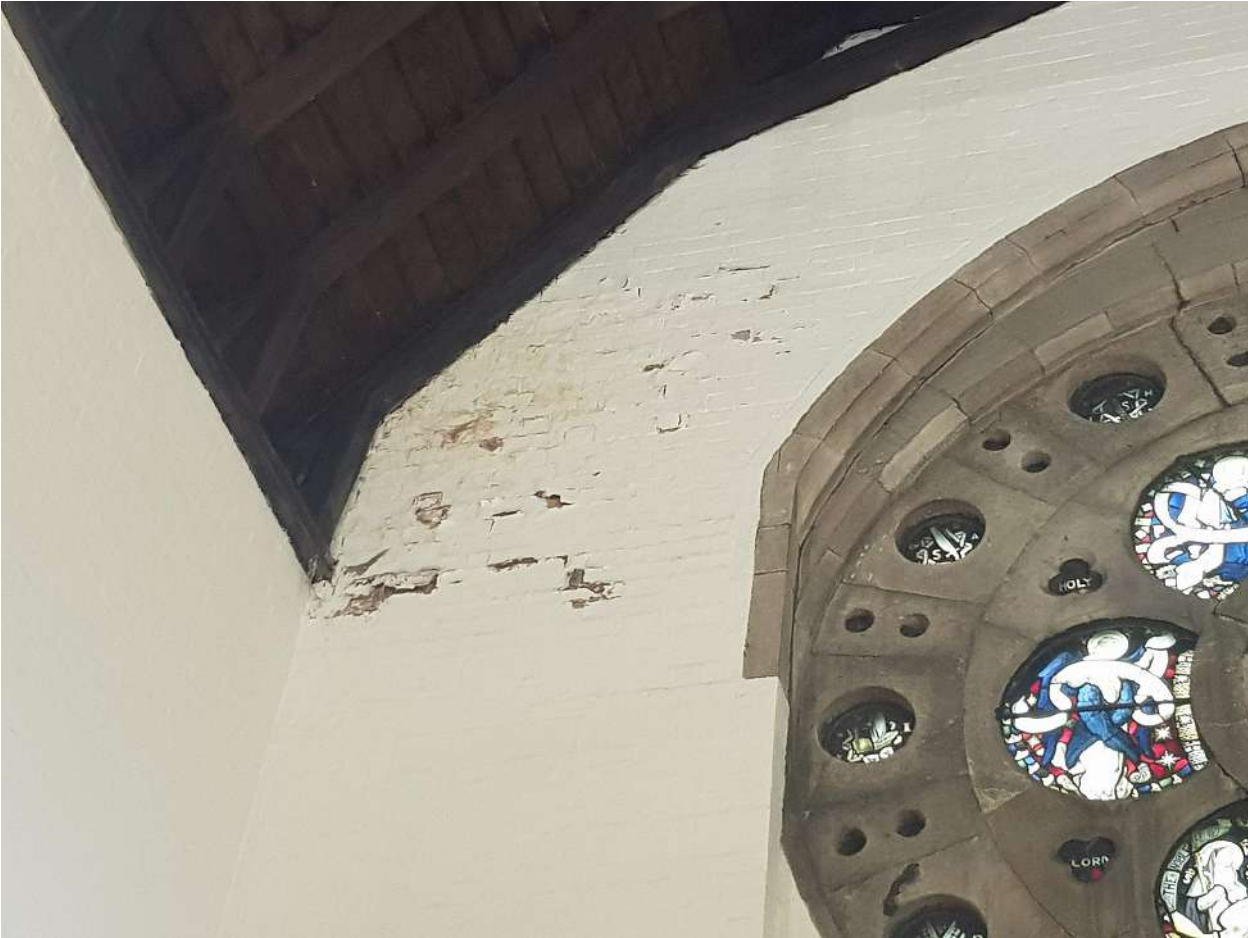
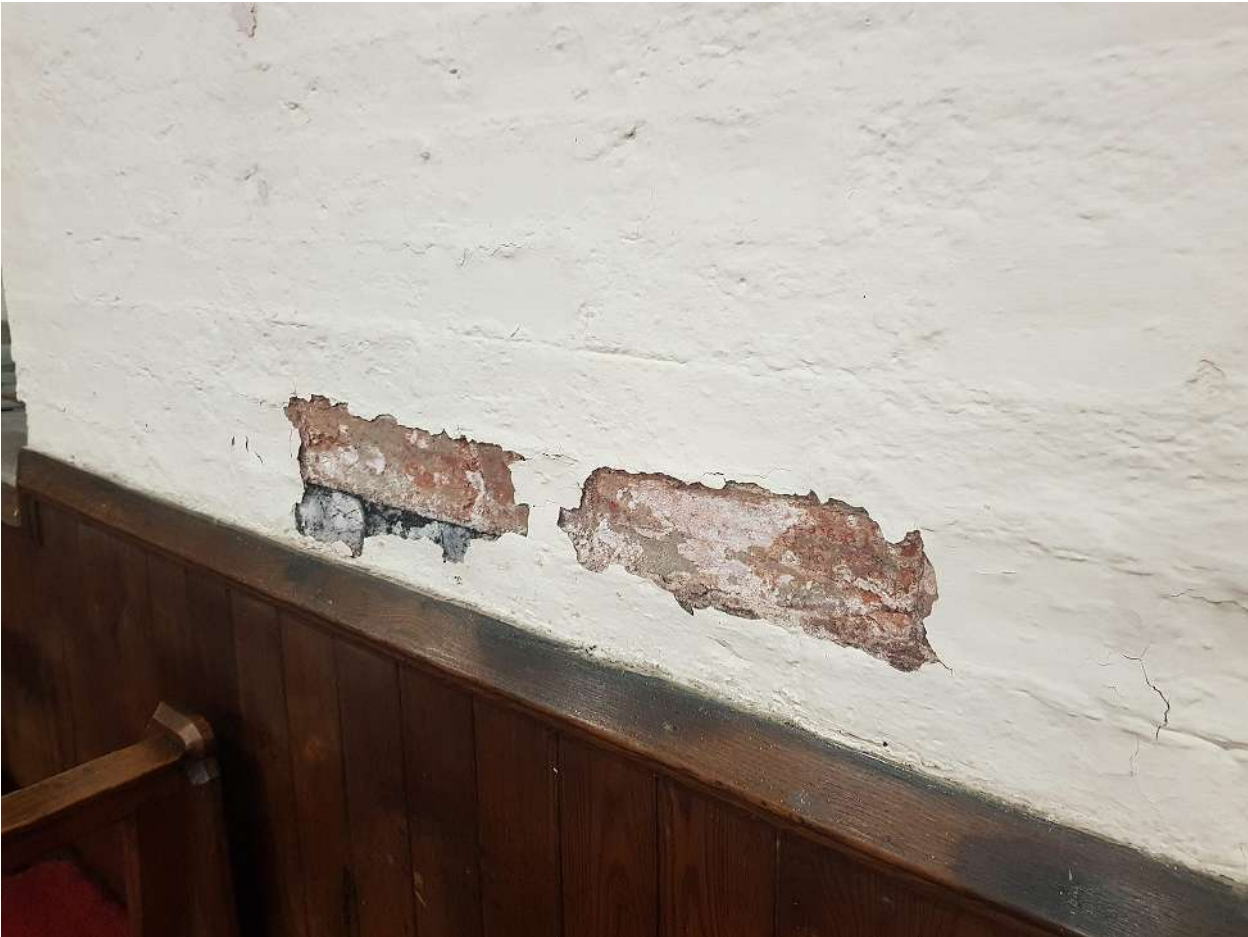
There are however two localised areas which will need some attention.

1. Mid-way between each three light window opening and just above the dado panelling a small section of paintwork has completely 'blown' off the surface of the brickwork due to a build-up of efflorescence salts that became trapped between the paintwork film and walling masonry. This has been triggered by dampness or water ingress within the masonry.
2. The wall decoration between the single light window opening to the organ chamber and south door has been subject to damage by an excessive build-up of efflorescence salts that have become trapped between the paintwork film and walling masonry. This has been triggered by dampness or water ingress within the masonry.

**R2**

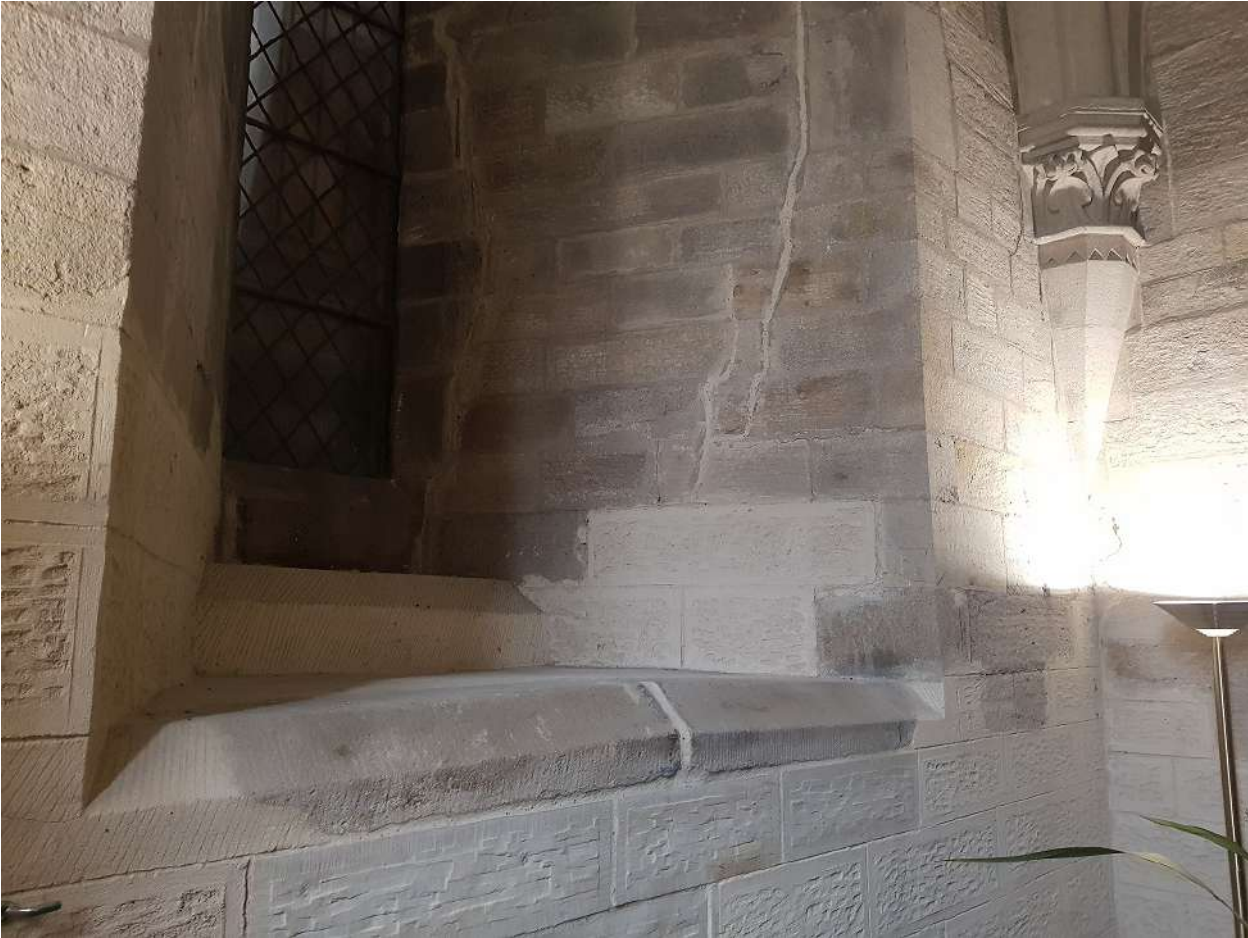
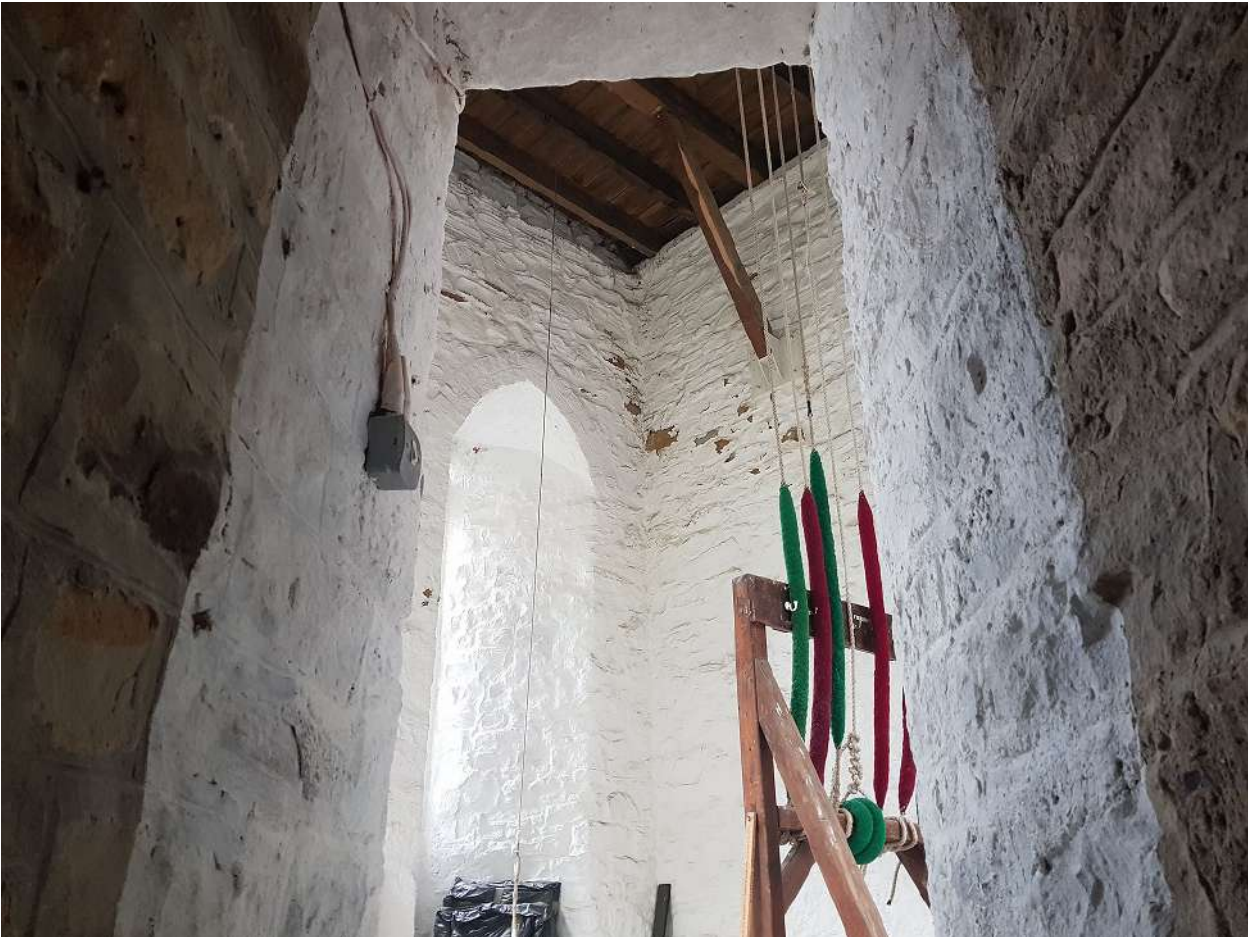
The wall decoration is generally in a good, sound condition, albeit with localised failure of the limewash coating due to a build-up of efflorescence salts in the stonework.

<b>M</b>	As a routine item of maintenance lying dust particles should be regularly cleaned up and removed.
----------	---

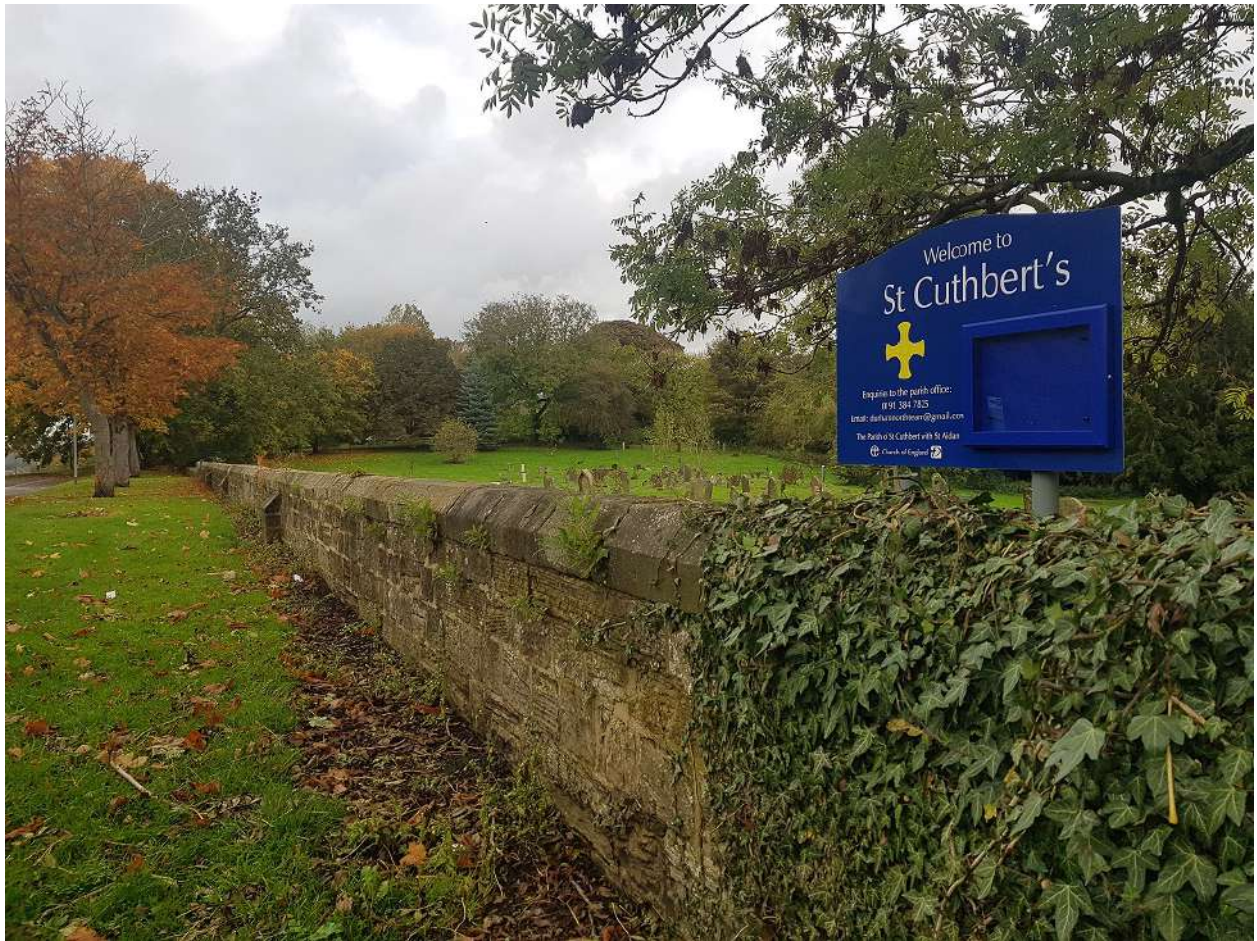
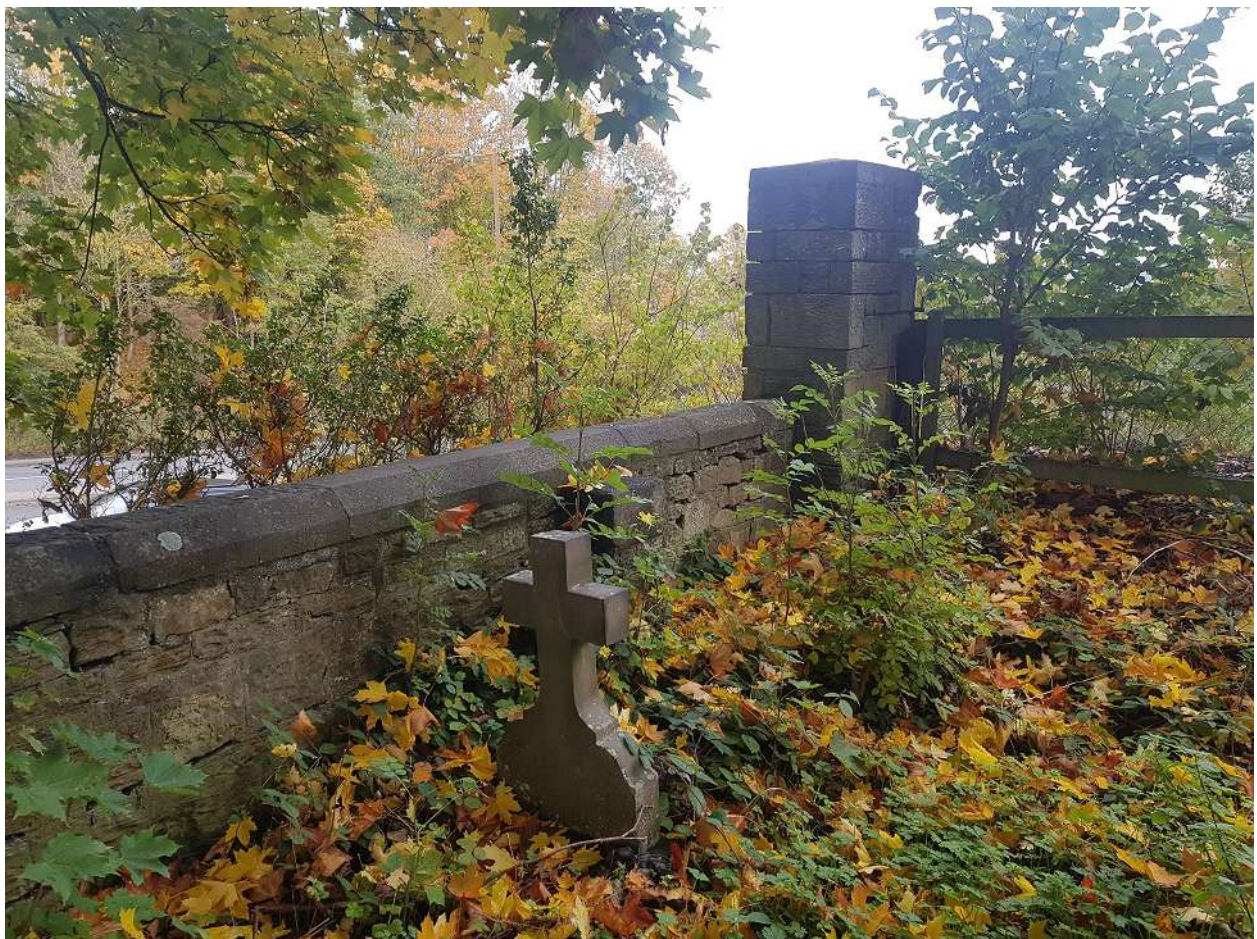
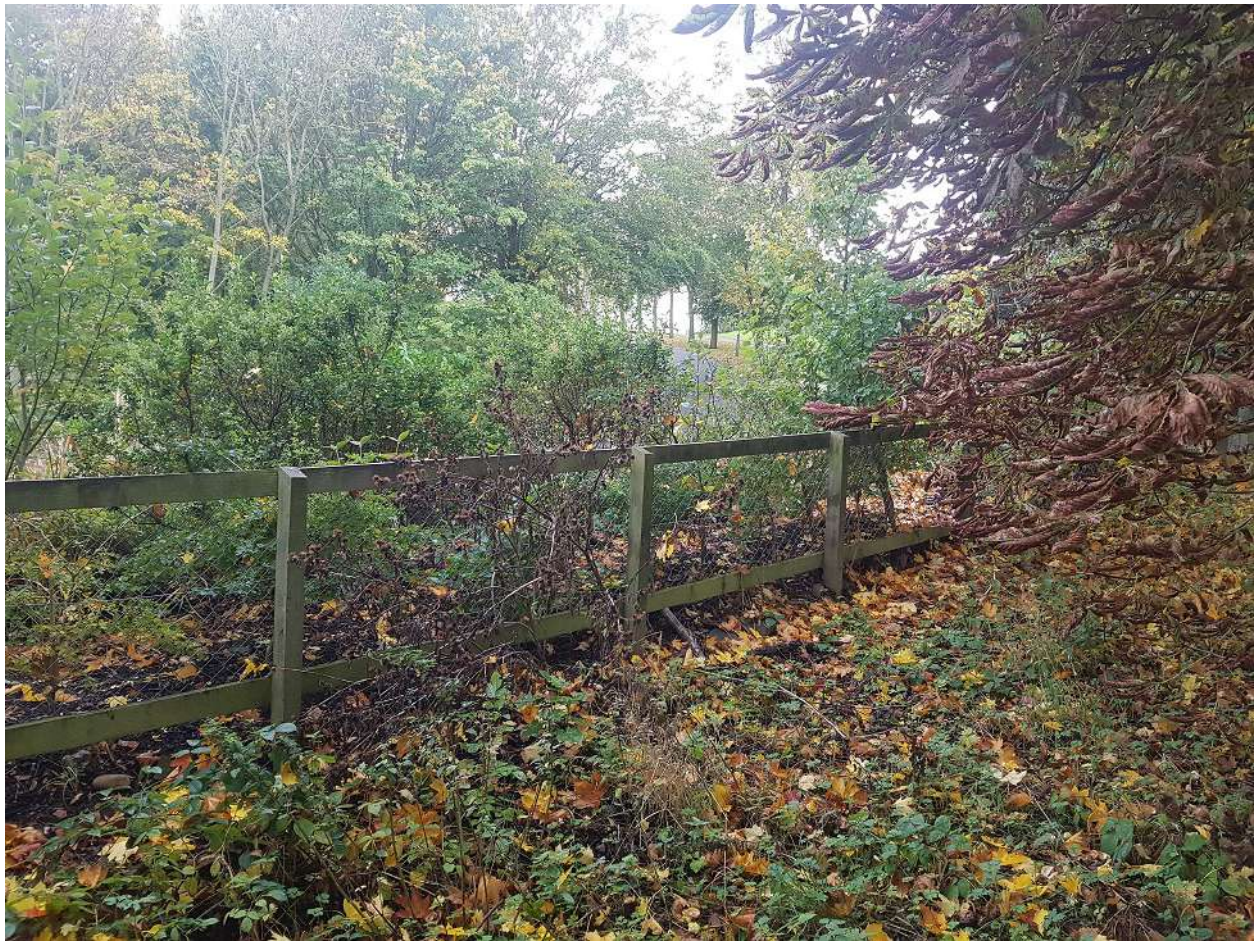
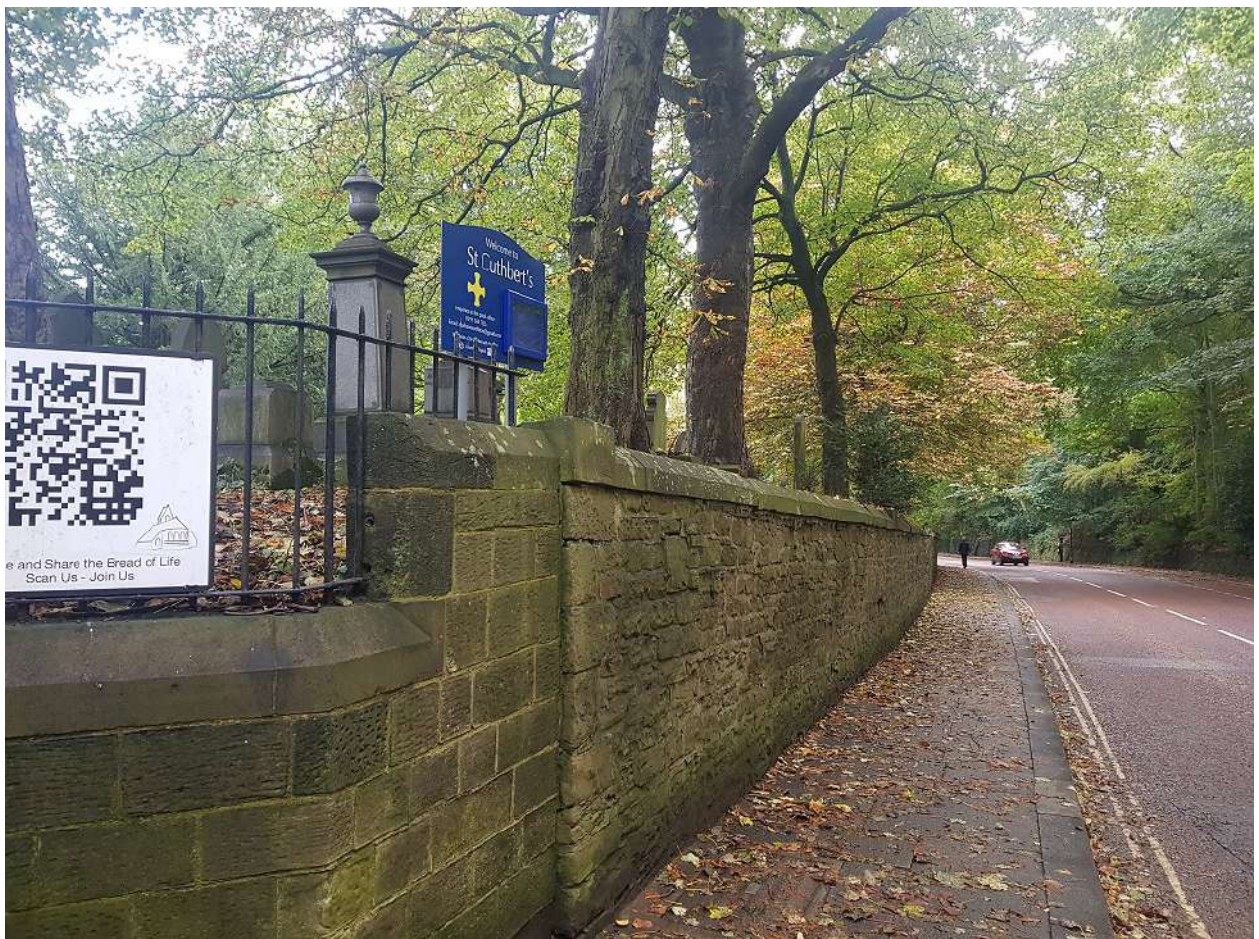
### 37.4 WEST BOUNDARY

37.4.1 The western boundary to North Road is formed by a substantial stone retaining wall at approximately 2m in height and adjacent to the public highway. There are also substantial mature trees along the length of this boundary near the rear of the retaining wall. Previous QI reports have commented on the poor condition of the wall and this continues to be the case.

This is most evident in the condition of the pointing material where there are several differing attempts at repointing either in cementitious mortar, pointing of sub-standard workmanship and missing sections of pointing resulting in deep voids between stones. The close location of tree roots is also having an effect on the alignment of the wall several ripples are evident on its western face and there is a pronounced bulge at approximately ten metres south of the lychgate. Coping stones are out of alignment in several locations.

<b>R2</b>	It is recommended that prior to any repair works carried out to the boundary wall a structural assessment is made concerning its ongoing condition.
<b>R3</b>	37.4.2 It is recommended that a masonry repair specification (including lime:sand repointing) is drawn up and repairs carried out over the quinquennium period.
<b>M</b>	37.4.3 As a routine item of maintenance shrub clearance and vegetation within the boundary wall is to be removed periodically over the course of the quinquennium.

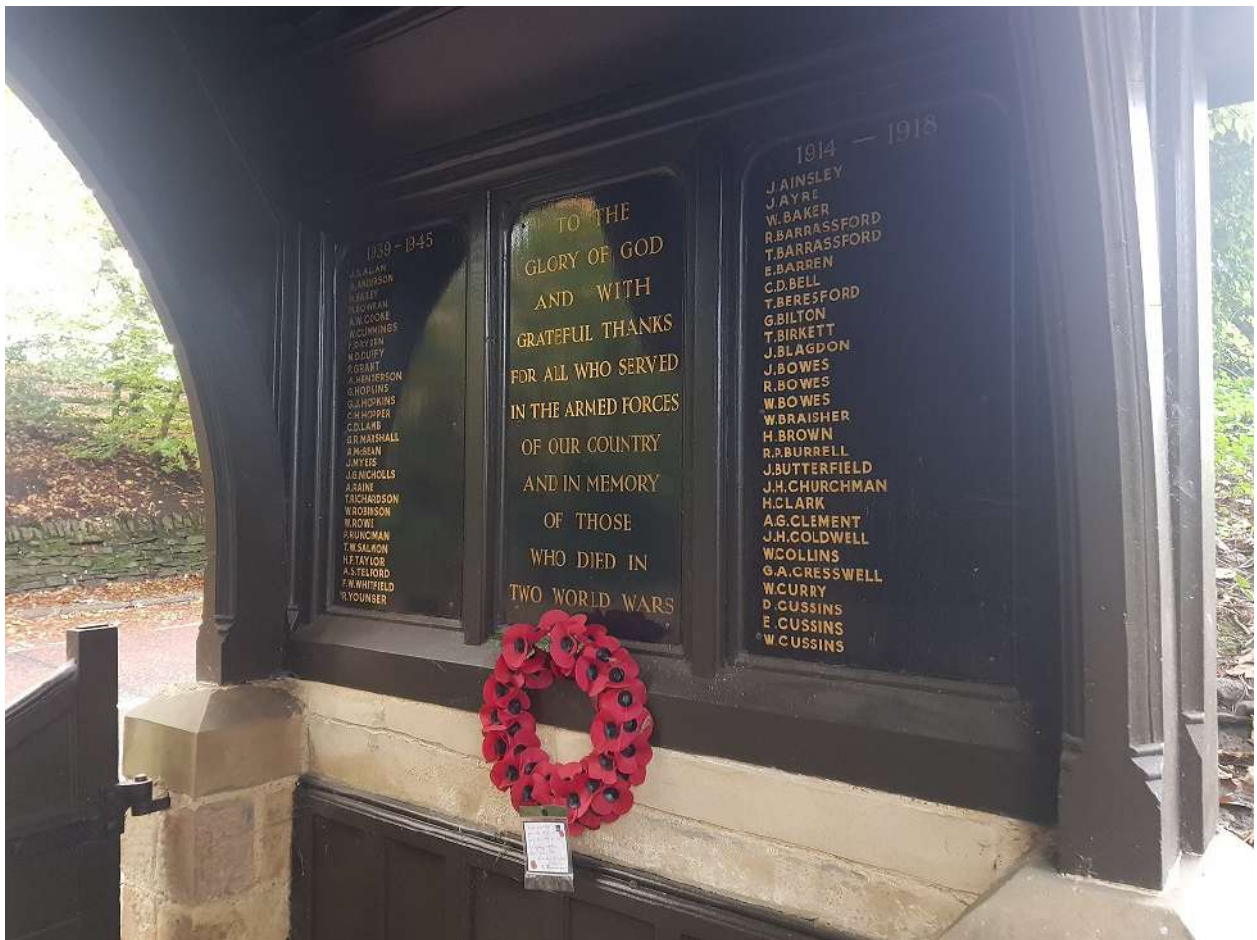
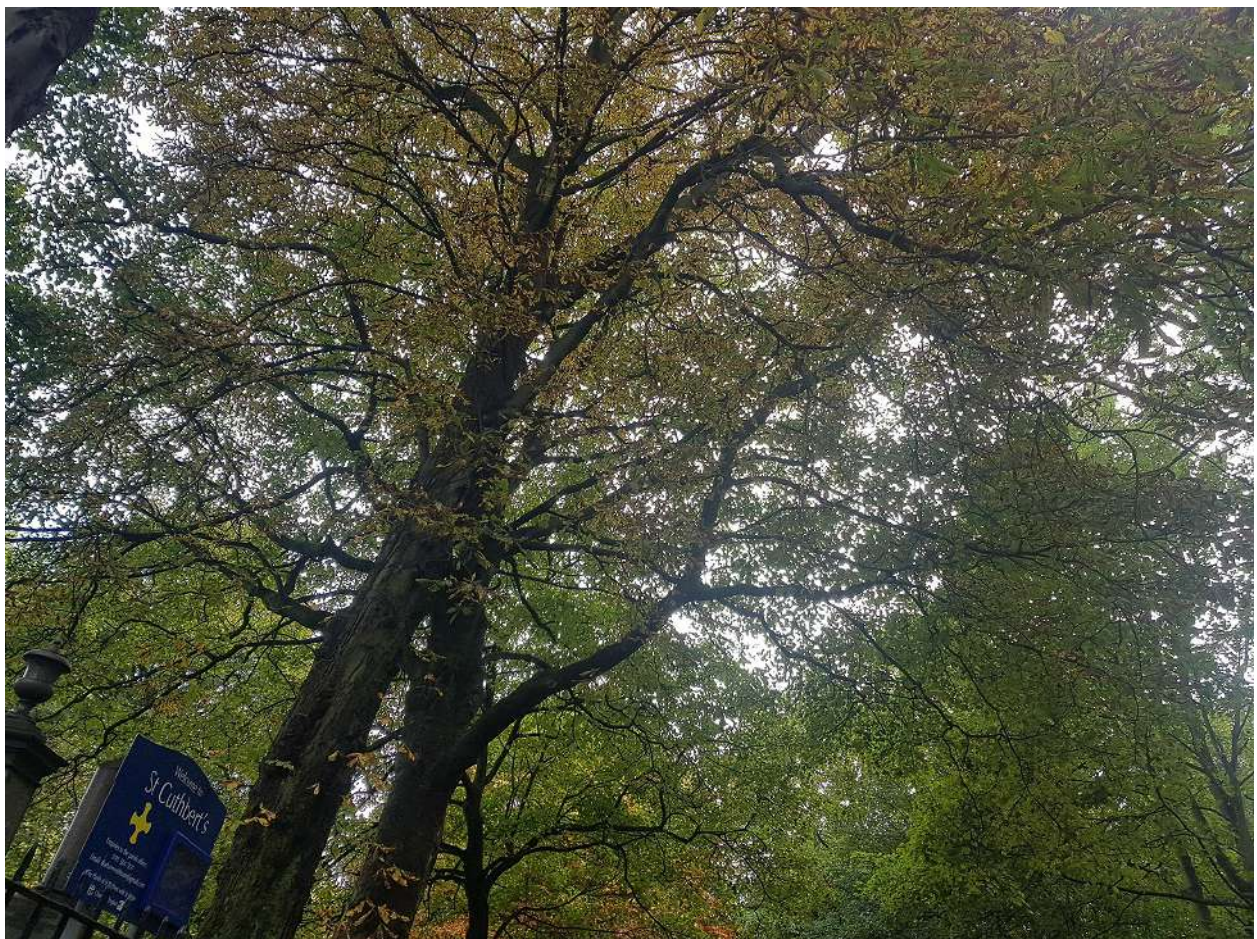
All trees within the church grounds will require permission from the Local Authority to carry out tree work being located within a conservation area.

<b>R1</b>	38.1.1 It is recommended that enquiries are made with the Local Authority regarding the last known inspection date of the trees.
<b>R2</b>	38.1.2 Should there have been no inspection during the last quinquennium then it is recommended that a tree condition report is carried out by an arborist.

| <b>M</b> | 38.1.3 It is recommended as a routine item of maintenance that the existing shrubbery and hedging across the churchyard is regularly monitored and maintained over the course of the quinquennium. |
