**QUINQUENNIAL INSPECTION REPORT  
OF  
ELWICK HALL, ST. PETER**

**DIOCESE OF DURHAM  
ARCHDEACONRY OF HARTLEPOOL  
DEANERY OF HARTLEPOOL**

**QUINQUENNIAL INSPECTION AND REPORT**

**DATE DECEMBER 2022**

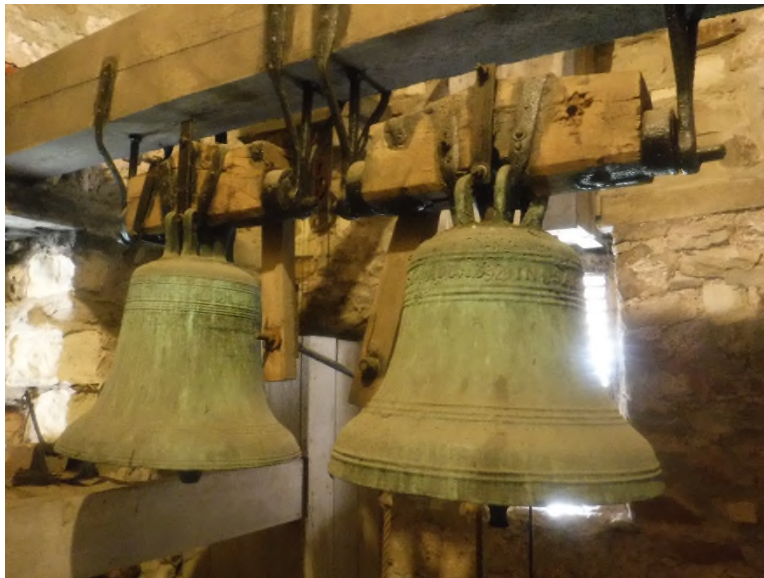
Two bells in the tower, dated 1664- 'Sol Deo Gloria' (Glory to God alone) and 1694- 'Deo Gloria', these bells are tolled. They are hung from timber headstocks with painted metalwork suspended from a large E to W beam. Bells are chimed by rope and leavers stapled to the headstocks and there is also a hand chimed hammer. The clappers are eroding the sound bow and it might be wise to have these turned if funds allowed, or checked over by the DAC bells advisor.

**Recommendation:** review with Bell advisor

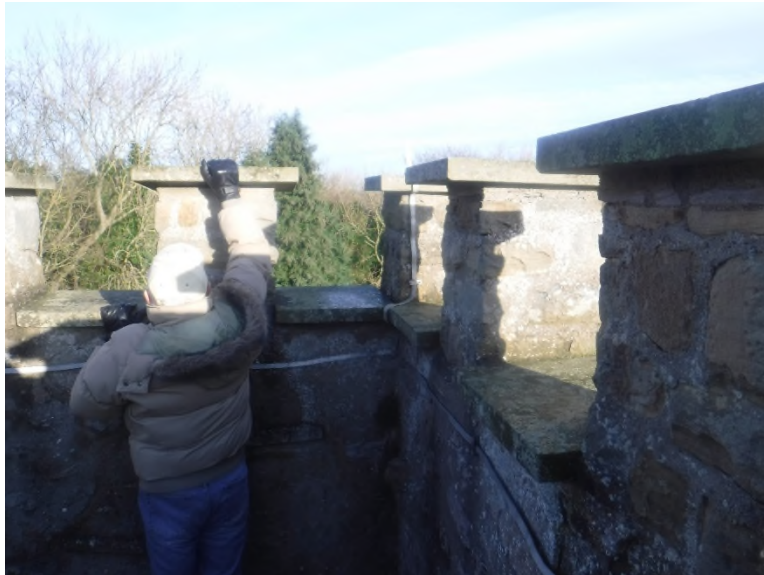
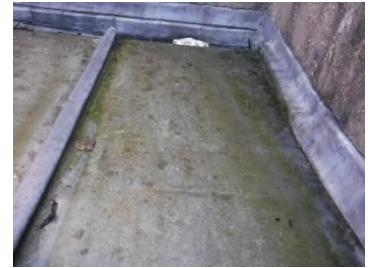
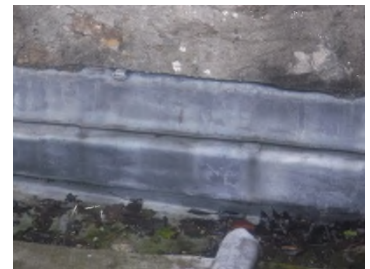
#### **Roof:**

Loose slab tops to the murlons. Pointing to the flashing out in places but it is firm, hatch could do with a hinge on it, better grabrailing, another two in fact as you exit is required. Lightning conductor has four terminals just made of the straps and one downtape. Render inside on the masonry is all sound, dirt in the top of the parapet gutter.

**Recommendation:** refix merlon slabs, sweep up parapet gutter, add grab rails, add hinge to hatch.

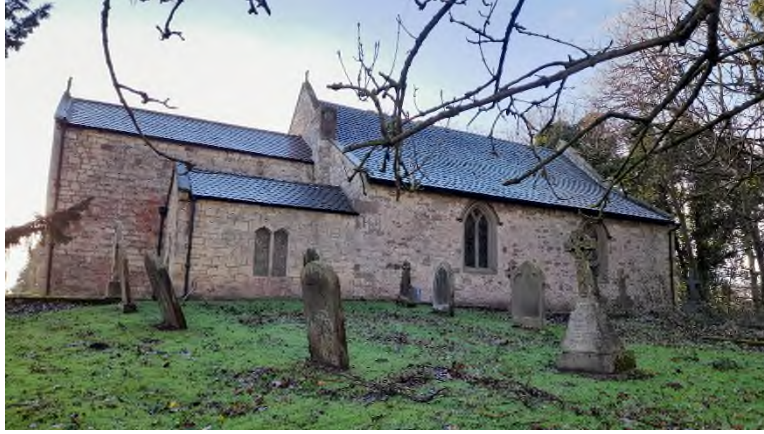
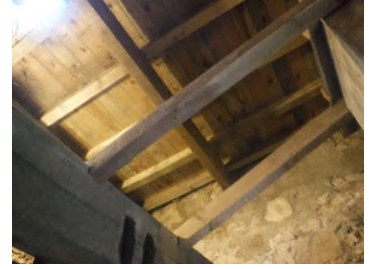
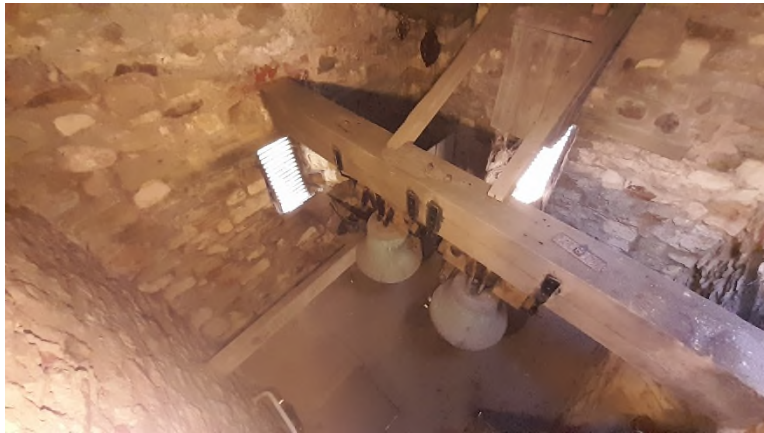
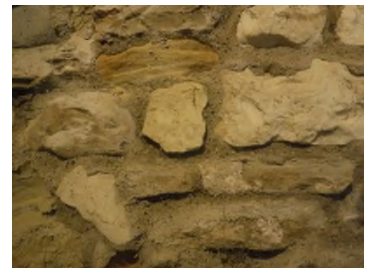
## Belfry:

- **Roof** - Is all dry ok. I might argue that the head of the parapet shows a touch of damp I'm not sure really but that is why that needs to be cleaned out a bit more regularly.
- **Walls** – Plastered over, fair faced walls a bit eroded but ok. Walls are not particularly thick, possibly 300-400mm and there are some erosion to the mixture of sandstone and limestone walling. Timber lintels over the openings support the bell beam, the window to the E is slightly eroded but it is sound.
- **Floors** – Boarded timber, bit dirty with dust and sand from stone they are slightly uneven but I think they are sound enough.
- **Miscellaneous** – Two bells old on headstocks, painted, reasonably sound, they are tolled, the sound bow to both of them are wearing rather and it might be wise to turn these sometime in the future and the striking hammer is making a bit of a dent on the E one.

**Recommendation:** see recommendations on bells above

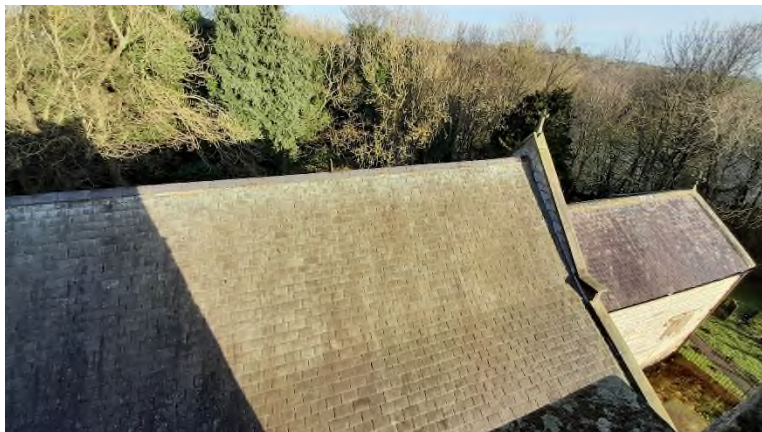
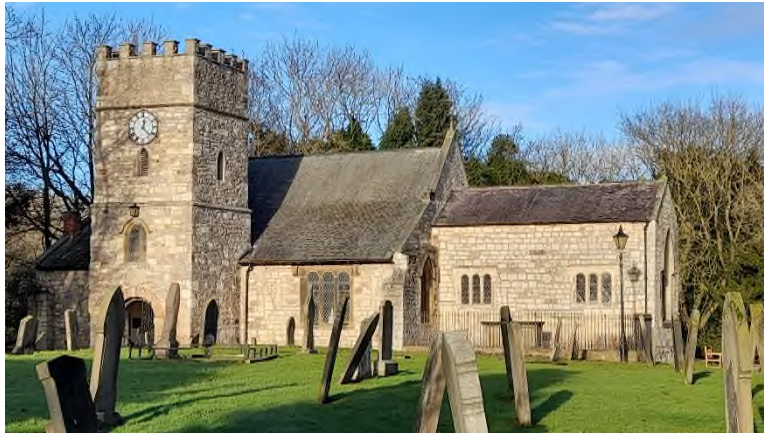
**E Nave and South Aisle:**

**South side** – Angled clay ridges. Bedding has been patched and broken over years. Slating generally looks sound I think it is Westmoreland, maybe the odd missing one.

**West Abutment** – Rebated watertable has lead flashings and soakers they look to be in place.

**East Abutment** – Same as the W with cross at apex which is broken, the aisle watertable at the E doesn't have a kneeler but doesn't seem to be sliding.

The watertable over the aisle at the W end is slightly undulating at the brick flue and this is now redundant, the brickwork itself is in pretty poor condition and I think frankly this should come down now and then reset the watertable, bits of bedding lying on the slating surface, actually looking at the watertable from the W that is also over the nave is wriggling a bit.

**Recommendation:** remove chimney

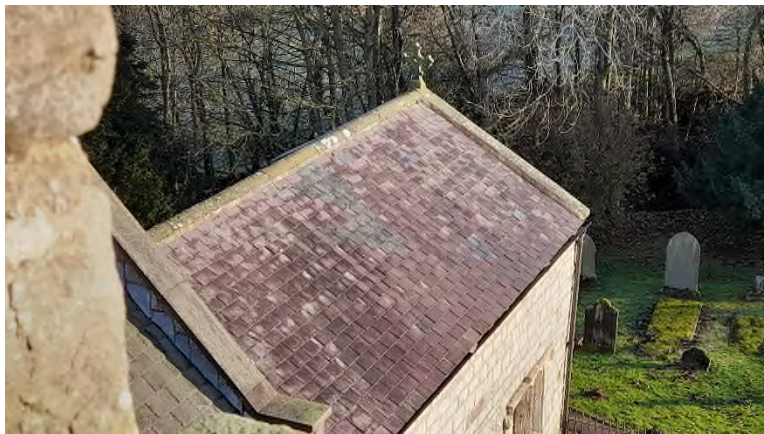
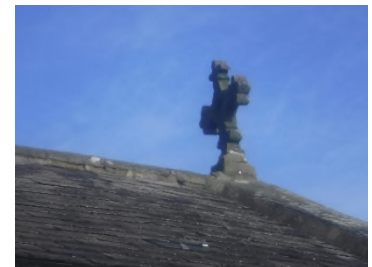
- **Chancel:**

**South side** – Stone angled ridges laminating in places, ridge bedding looks just about ok, it might need a bit of a patch towards the E end. Welsh slate has been patched quite a bit in the past, it is fair condition.

**West Abutment** – Is lead flashing and in a different colour at the apex and I don't quite know why.

**East Abutment** – To the watertable not much chance of an upstand here, has a mortar flaunching, is there lead behind that? Watertable is sound, the cross looks to have a crack in the base, it is quite gnarled and it is leaning in a bit.

**Recommendation:** check chancel cross fixing,

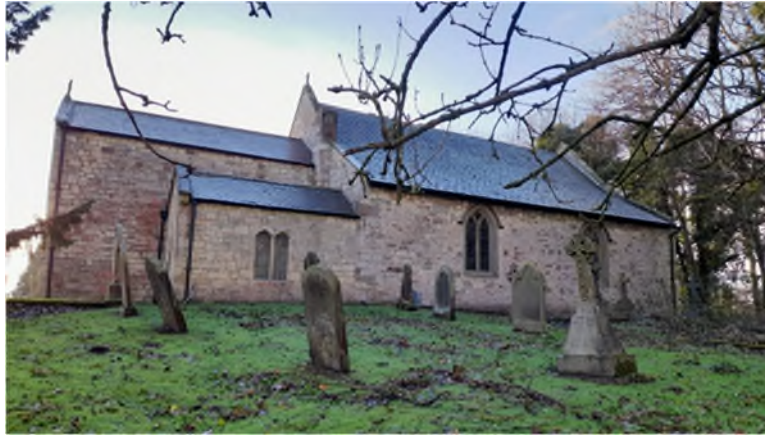
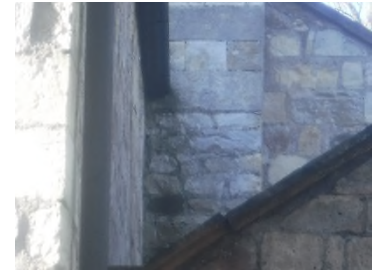
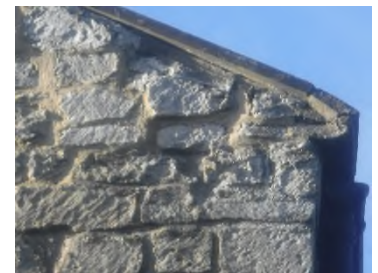
**Nave and Aisle North Side** – Ridge as S.

**East Abutment** – leadwork looks ok although it does come onto a back box gutter of a former chimney to the vestry, is that ok?

**West Abutment** – Watertable flaunched as S side but noticeably not parallel and it widens out at the foot. Watertable is just about alright, it has not got a proper kneeler at the foot but it has been repaired since the last QI, it doesn't look well repaired either because the watertable isn't parallel to the wall.

**Recommendation:** check vestry walling around chimney,

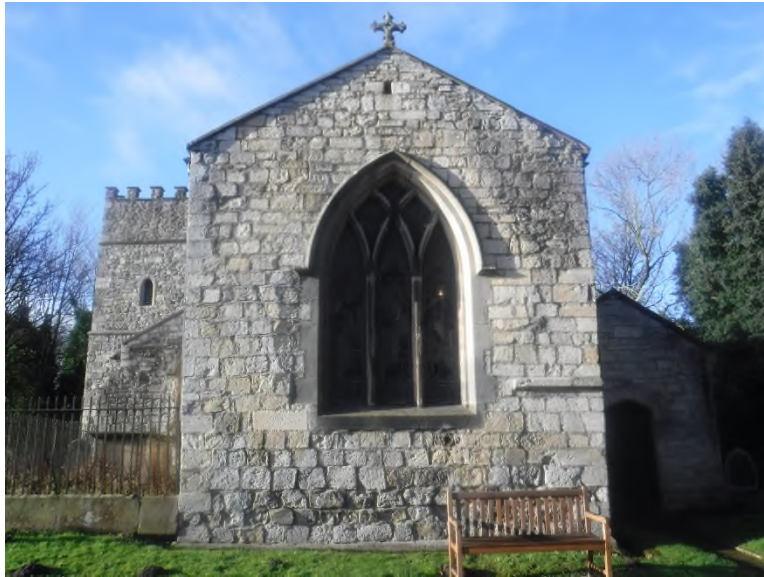
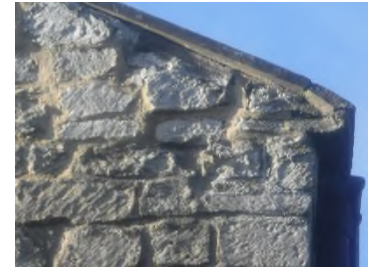
**East side** – Walling is ok apart from a few open joints at the bottom. Large three light tracery window, pictorial glass, historic crack at the apex and slight open joint which should be filled and mullions are generally ok. Above that is a small square hole in the gable apex, is that a perch has it got protection behind?

**North side** – A bit more random type walling here particularly at high level over the vestry there looks to be some open joints, not possible to see all of it inside, stonework is a bit red perhaps there has been a fire here in the past or is that lichen?

**Recommendation:** point up east lancet apex open joint

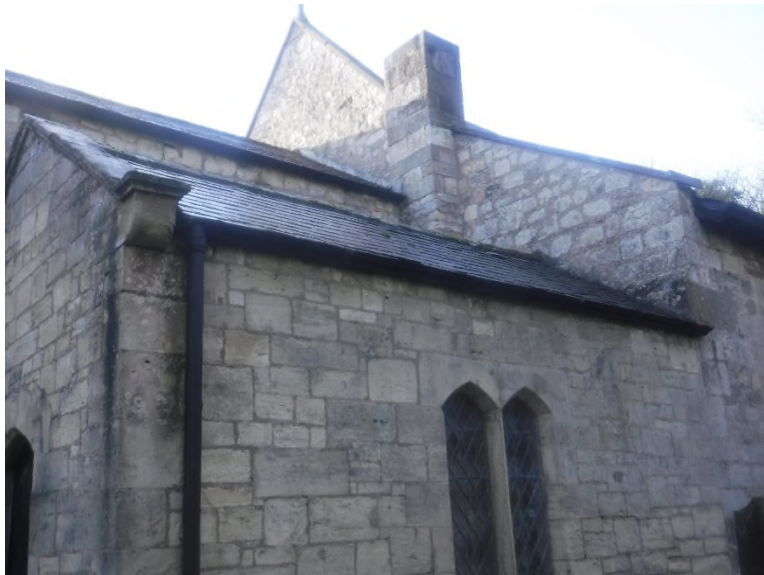
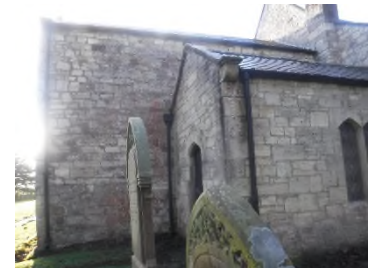
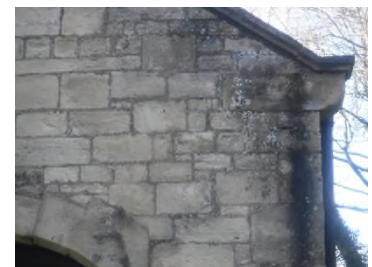
- **Vestry:**

**East side** – Watertable looks ok (but note the last QI asked for them to be repointed- were they?), walling is generally sound but

there is a crack running from the N kneeler down to the door head probably dropping in the corner, historical differential settlement, nothing too troublesome, a slight open joint at the bottom by the gulley and the arch has dropped fractionally in the past but is ok. Door within it is timber boarded locked shut not in use and the decoration is ok.

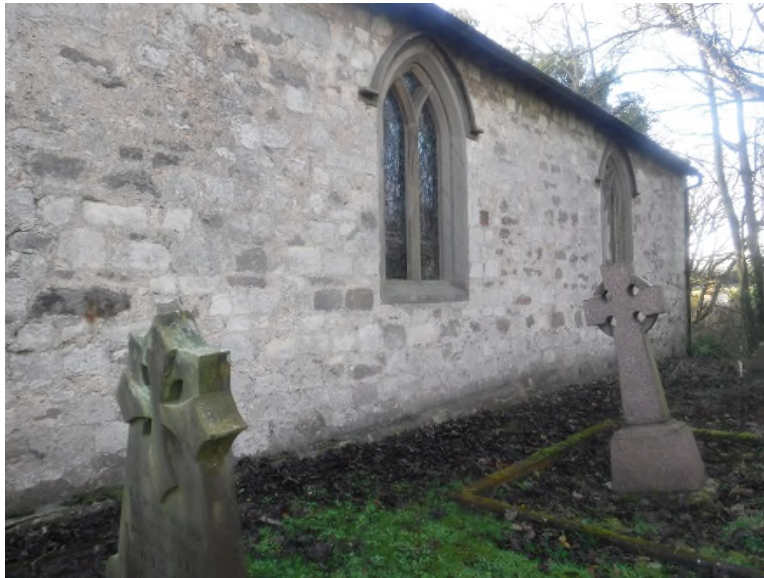
**North Aisle:**

Random rubble brought to course, it is all tight apart from two or three small areas but they just don't need doing at the moment. Wall has two windows in it, both the same pattern twin light lancets with pictorial glass in good condition. The W most mullion has been patched in cement in the past, this is the modern glasswork, and it has been done in lime so that is to its credit. There is damp at low level inside. Perhaps the external ground level should be lowered or perimeter drain be installed?

**Recommendation:** look at reducing external level/ improve ground drainage

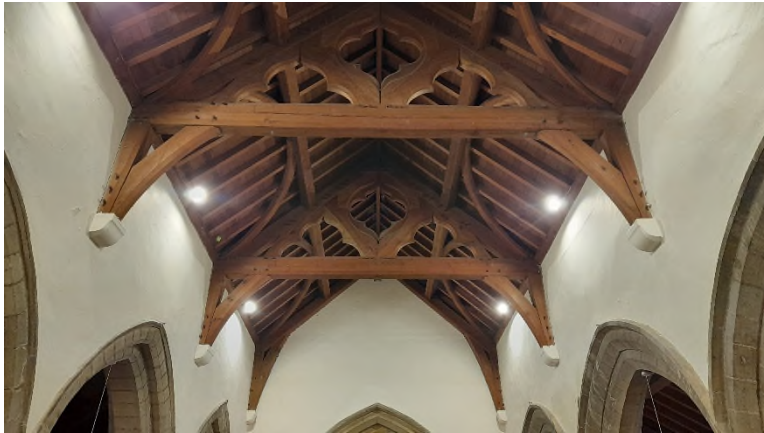
#### **Nave:**

Three large sized decorative softwood trusses with cusping to struts, curved wind braces to purlins, rafters and horizontal sarking boards. All exposed and attractive but hard to see details against the downlights. No obvious defects.

At aisles similar purlins on massive principal rafters on corbels. No visible defect.

There is no evidence of any movement to the structure, all the joints seem to be quite solid and there is no staining to the timbers either.

**Recommendation:** none

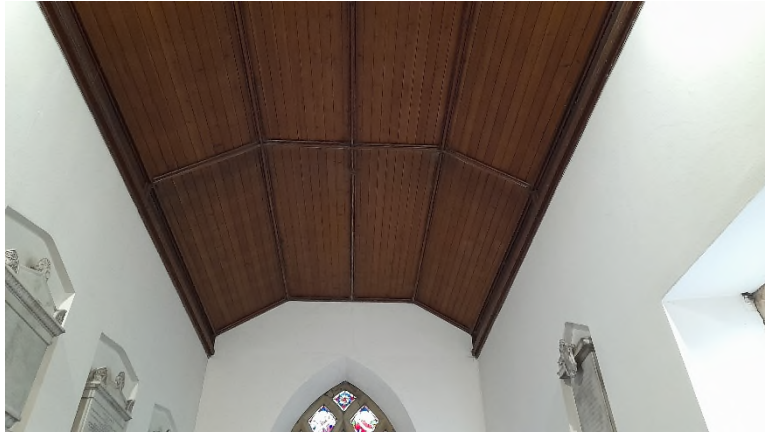
### **Chancel:**

Flat and sloping varnished boards, good condition- no staining.  
Vestry flat plaster good.

**Organ:** there is no protection above the organ so if there is a failure in the vestry slating that could affect the inside of the organ.

**Recommendation:** put up organ protection

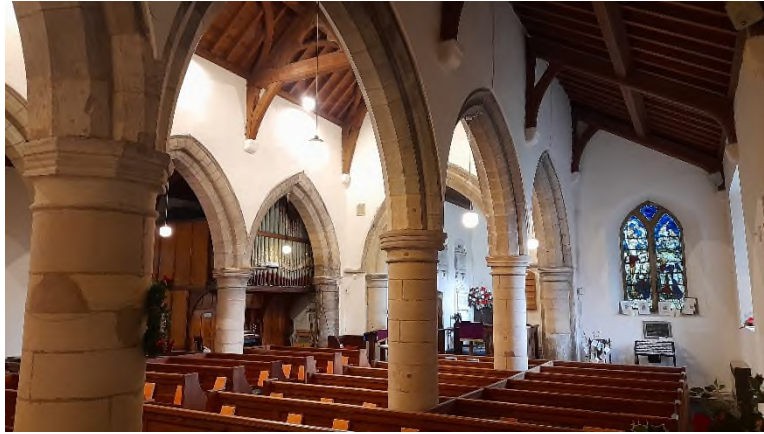
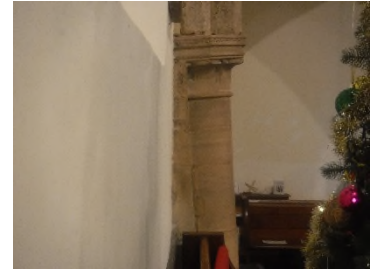
**Arcades:**

Four bay arcades similar design except waterleaf capitals at NE and NW responds. Good condition.

The only evidence of cracking is at the W end on the N side, last arch where there is a diagonal shear crack and you could argue that is possibly noticeable outside, the land is falling away at that point and perhaps that is as a consequence of the location, also the arcade column is going over slightly and I think the whole of the W gable is not quite right, it is leaning out and that is actually repeated on the S side as well, so on reflection I'd say the old W end had moved but then when there was a Victorian re-build they kept the leaning and re-built around it.

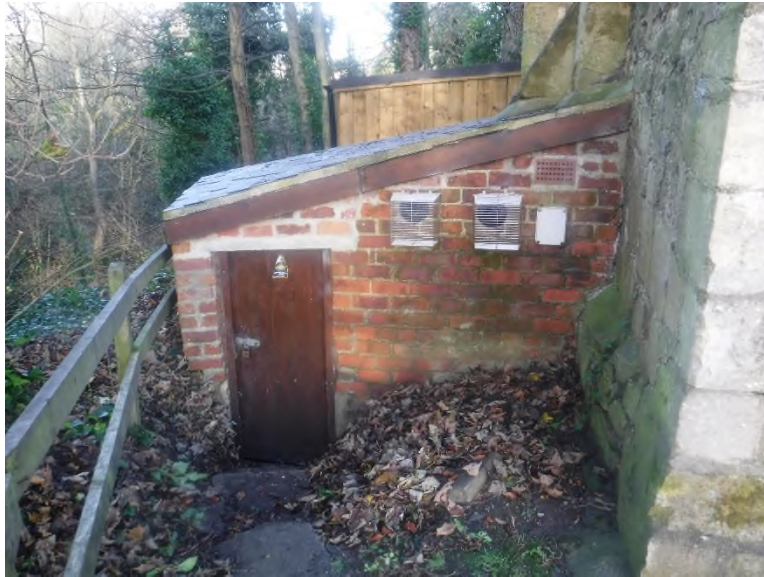
**D Boiler Room:**

Elementary lean to brick structure to provide a boiler room. The steps down are coming apart and need repair.

**Recommendation:** repair steps

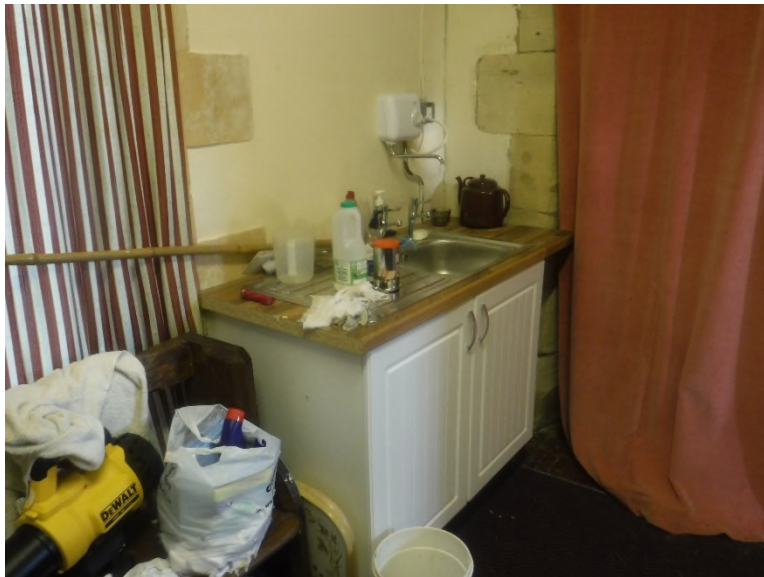
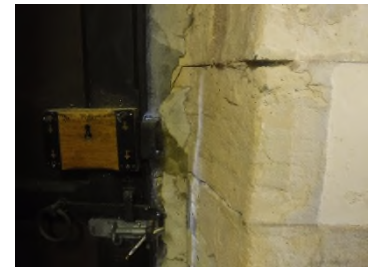
**Vestry:**

Poorly heated and rather forgotten area with not much in the way of appropriate shelving and fittings. It has a basic sink and hot water supply, electric heater and is carpeted over timber board with a bit of a floor vent showing. The bottom of the walls by the E end doorway salting rather, the E door is rather forgotten it is behind curtains and not used, it is draughty and it could do with improving if it means squeezing something into the gaps.

**Recommendation:** update vestry

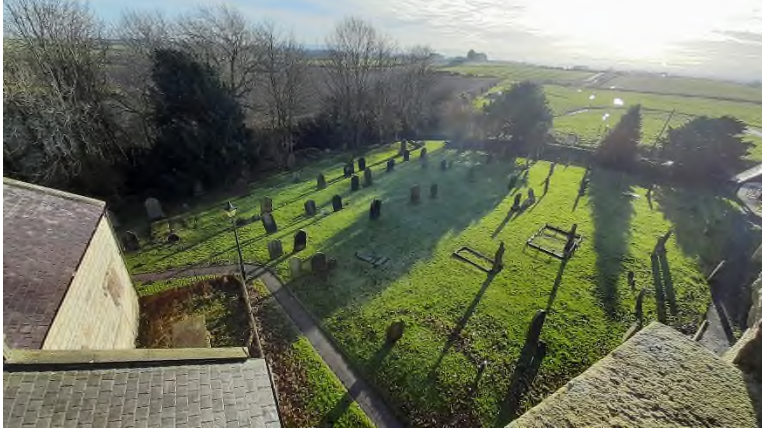
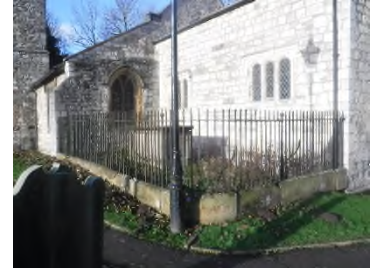
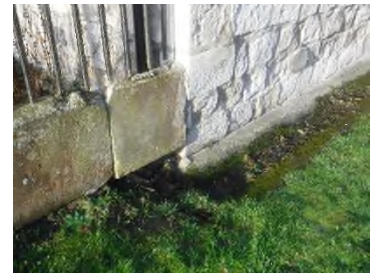
The churchyard is closed, it is mostly to grass with circulation areas in tarmac which are ok. Couple of notable things: large bed memorial to Jane Bell, the metal work is rather broken up and that there is a chest tomb at the chancel which is enclosed by ironwork which itself is also broken up and busting the stonework.

**Recommendation:** repair railings and stone kerbs, repair bed tomb.

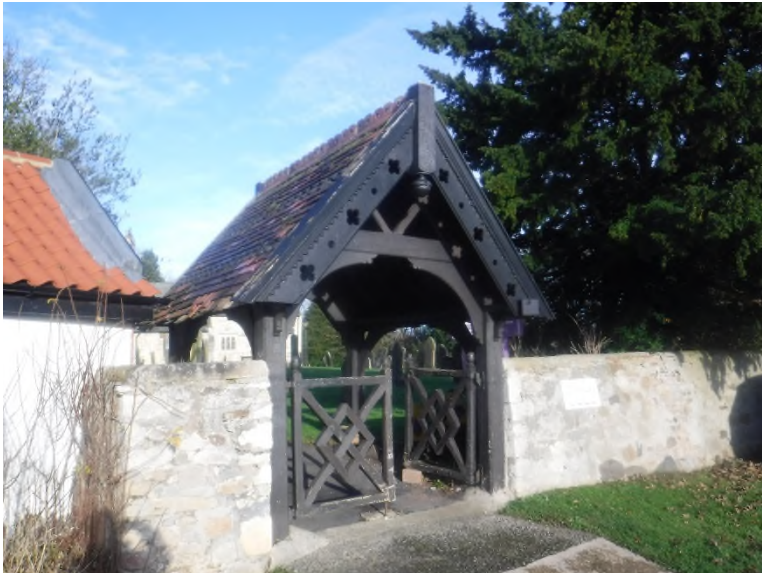
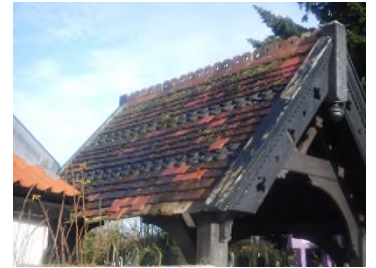
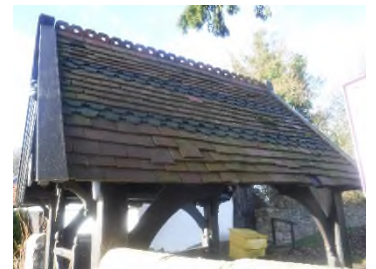
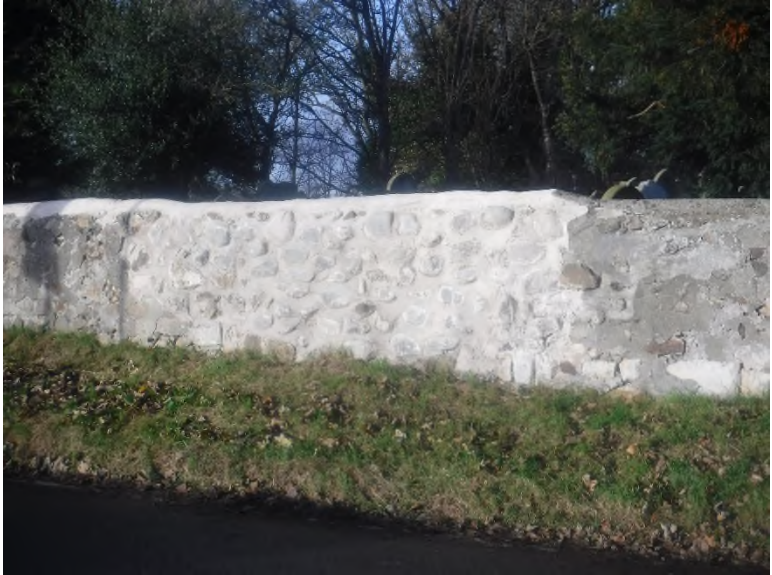
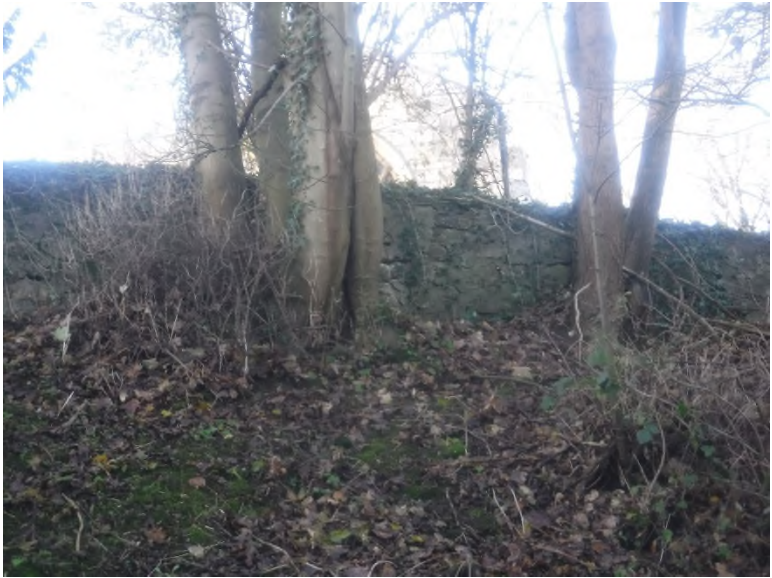
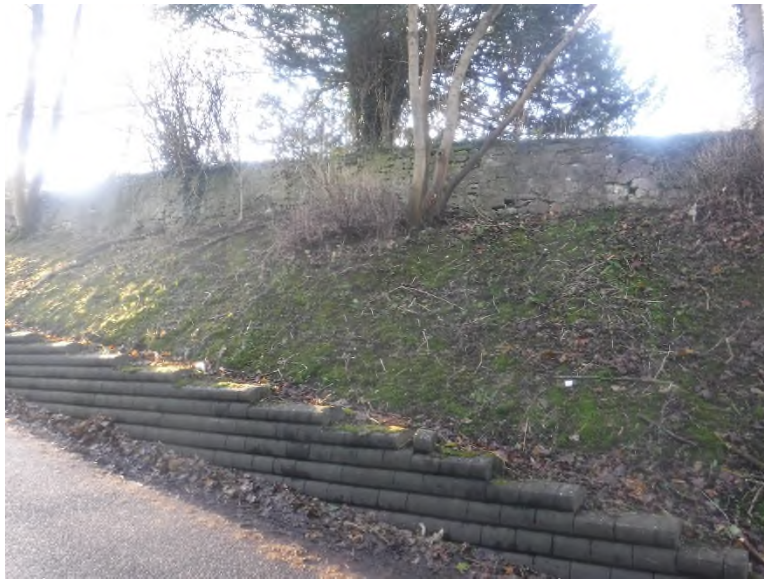
### South side

Timber lych gate which is in fairly good condition though there are some slipped slates.

The graveyard is higher than the road and this banks down to the highway and is protected by some quite significant retaining material.

Boundary wall formed of random stonework which has seen some recent repairs and hard capping.

Conifer and Yew trees on the boundary, the one on the bend looks as though it could potentially be pushing the wall.

**Recommendation:** replace slipped slates on lych gate, remove trees threatening boundary wall.

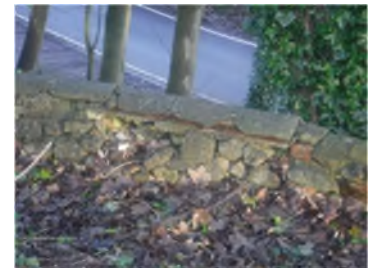
- D East side** – Original walling has been lost around the bend because it has just broken down over time and the wall is steep I think, the trees have no doubt knocked it out as well and they look like Sycamores. As it goes down the hill there is a masonry wall but it is in pretty poor condition with lots of trees growing out of it. Halfway down the W side there is a break in the wall and there is a footpath that leads down to a simple carpark area set aside off the highway. The stairs are all concrete and covered in leaves, and the churchyard retaining wall is covered in moss and not possible to see.

**Recommendation:** reduce encroaching growth, repair walls

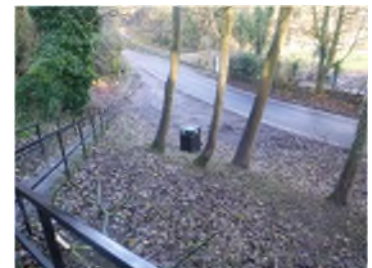
- D North side:**

This I think has had a wall in the past but it is now so heavily overgrown that any trace of it is pretty much lost, there's certainly nothing above ground and this leads to a very steep bank down to the small beck that runs in the valley below, Actually there has been a retaining wall, in fact the base parts of it are there and it's pretty much like that as it comes round to the W side.

Not able to be seen on the outside it is all scrub. The timber gates to the top of the steps is a bit rotten on the top rail, the gate posts have been rebuilt in modern brickwork, recovered perhaps, cap concrete perhaps I can't tell but it has got a big crack in it.

**Recommendation:** clear undergrowth

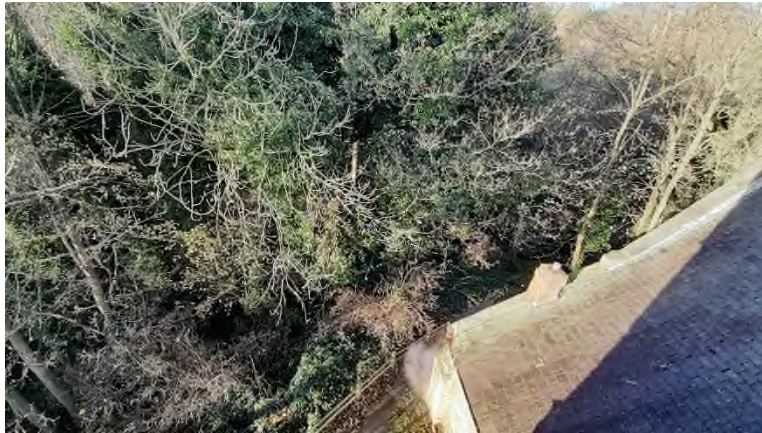
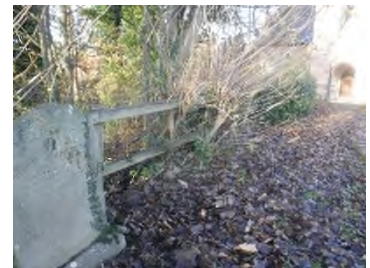
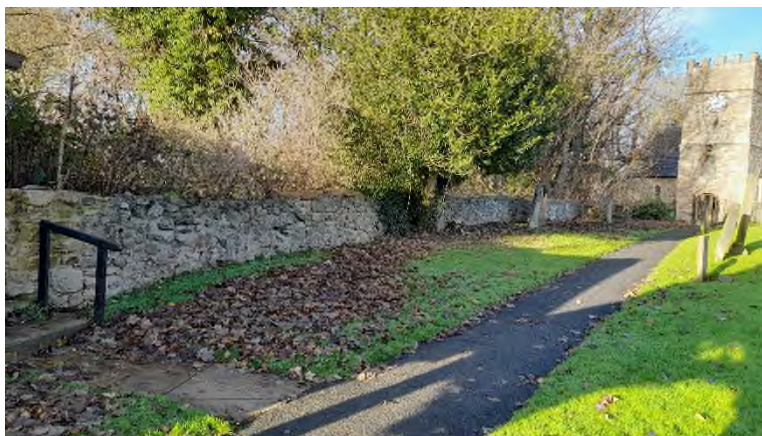
**D West boundary – This is in two halves-**

- **Northern end** – This looks down to the beck that curves around and runs along the W of the boundary, there is a brick retaining wall here that is holding back the bank but it is breaking up and is pretty poor condition, there are a lot of trees just outside of the church boundary that really are beginning to threaten the W end, they certainly could do damage to it, there is some trees particularly at the NW corner whos branches are over the roof and those that are on the W side are beginning to do the same.

- **Southern end** – Some rudimentary timber fencing leading down to the boiler room and as we head S it is beginning to go over where there is some older and close to the cottage wall which is made up of random

stonework with terracotta round coping that has all been patched up in cement in the past, not brilliant condition. Is this the cottages or the churches responsibility? This then terminates by the cottage where there is a small timber w.c. which doesn't have a light inside it.
