QUINQUENNIAL INSPECTION REPORT - APRIL 2021

THE PARISH CHURCH OF
SAINT MICHAEL AND ALL ANGELS

FRONT STREET, ESH, CO. DURHAM, DH7 9QY

Report prepared by

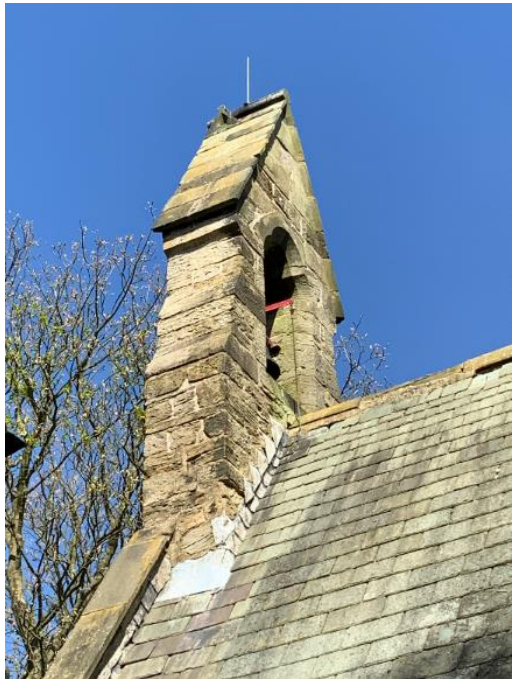
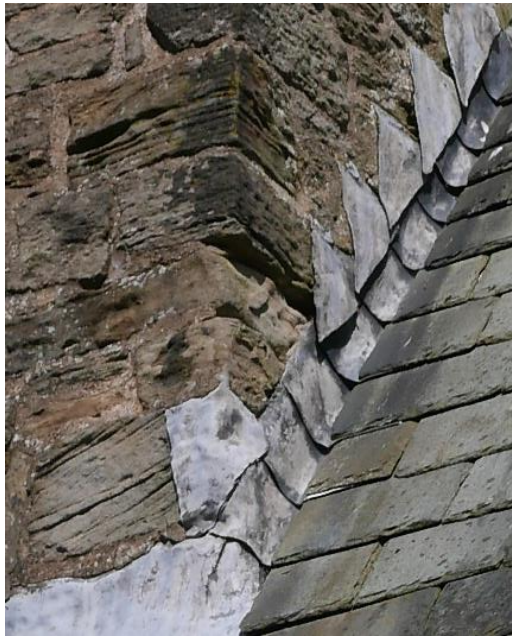
<p>Condition</p> <ul style="list-style-type: none"> • The 2009 report notes that the bell-cote was completely repointed between the 1994 and 2000 inspections, and the bell being remounted with new fittings, bearings, etc. • Pointing remains in a sound condition. • There are some large chips of stone missing from the projecting edge of the water tabling. • Lightning conductor tape appears to be secure. • Two of the lower lead step cover flashings on the South East side of the bell-cote have come away, probably due to natural weathering opening up the stone joints they were bedded into. In fact one of these remains in the gutter below. Although the lead soakers remain in place, these cover flashings do need to be replaced as soon as possible. The work will require the repointing of the stone joints in this area. • There is a missing stepped cover flashing on the North East side of the bell-cote, but this has been replaced with a mortar fillet at some point in the past, and this remains stable.

<p>Repair Needs</p> <ul style="list-style-type: none"> • Re-fix lead cover flashings to prevent water ingress, and repoint stonework joints in the same location. 	<p>B</p>
---	---	-----------------

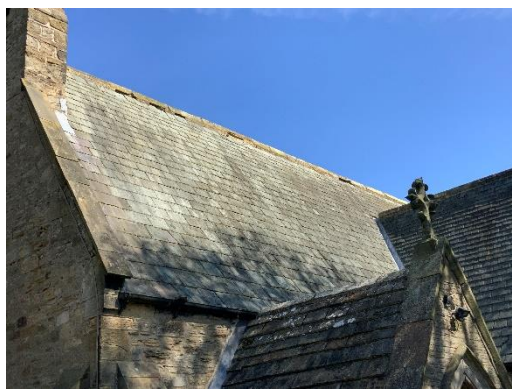
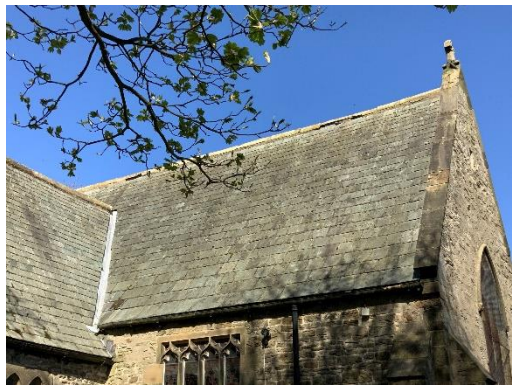
Southern Pitch of the Nave / Chancel Roof

<p>Condition</p> <ul style="list-style-type: none"> • Some minor delamination of slates, but generally in sound condition. Some moss growth. • A few slates missing from the ridge line which need replacing, and one or two cut slates at the valleys have slipped. • Flashings in sound condition. • Ridge tiles are delaminating and the bedding has completely come away in several locations. In the near term, this bedding can be replaced without moving the ridge tiles, although this is a temporary solution. In the medium term, more significant repairs are needed which will require all ridge tiles to be removed and re-bedded, and some replacement of tiles is to be expected.

<p>Repair Needs</p> <ul style="list-style-type: none"> • Repair pointing / bedding to ridge tiles. • Replace the missing slates at the ridge line. • In the medium term, the stone ridge tiles should be removed and re-bedded. It is expected that some ridge pieces will need to be replaced, and this should be on a like for like basis, rather than resorting to clay products. 	<p>B B D</p>
---	--	----------------------

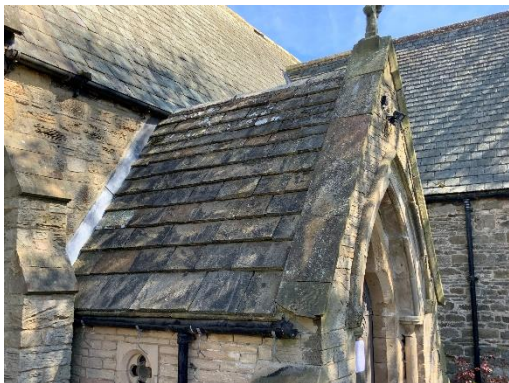
Porch Roof

<p>Condition</p> <ul style="list-style-type: none"> • The previous report indicates this was stripped and recovered in 2005, and the roof remains in good condition. • As noted in the last report, the mortar fillet is pulling away from the South gable creating a route for water ingress. However, the fillet itself remains generally sound. 	
	<p>Repair Needs</p> <ul style="list-style-type: none"> • Seal the gap between the mortar fillet and the South gable to prevent water ingress. 	<p>C</p>

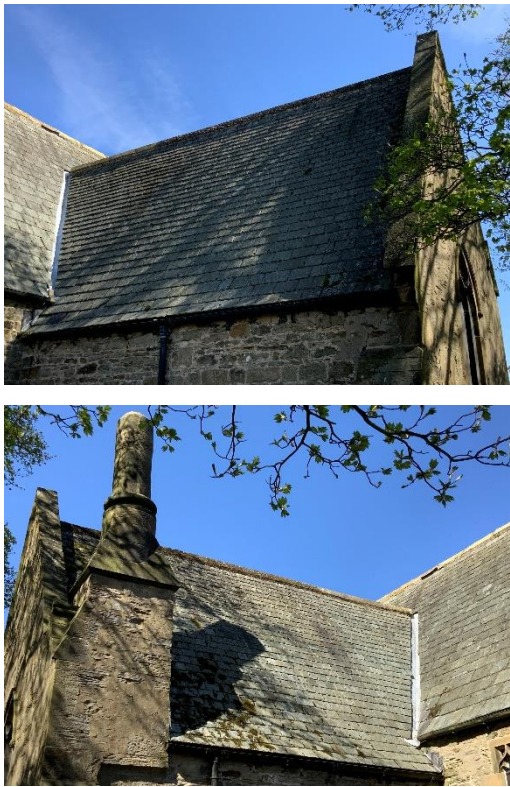
<p>Condition</p> <ul style="list-style-type: none"> • Some minor delamination of slates, but generally in sound condition. Some moss growth. • One broken slate on the West slope. • Flashings in sound condition • Flashings behind the chimney are not visible from the ground, but appear to extend an appropriate height. • Ridge tiles are soundly bedded and pointing is complete. • Moss growth, particularly in the region of the chimney, is becoming excessive. 	
	<p>Repair Needs</p> <ul style="list-style-type: none"> • Replace broken slate. • Remove moss growth. 	<p>C</p> <p>D</p>

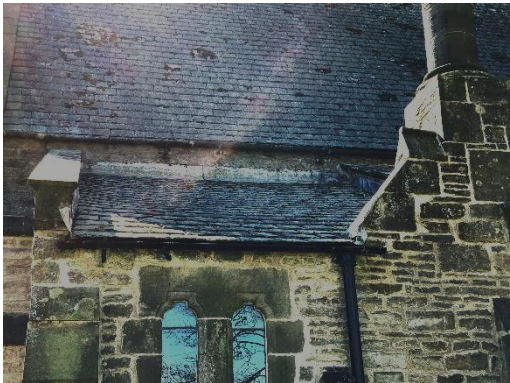
Vestry Roof

<p>Description</p> <ul style="list-style-type: none"> • Graduated green Lakeland slates, with stone copings at the ridge. Lead soakers and flashings. • Roof pitch is on the low side for slate roofing. 	
	<p>Condition</p> <ul style="list-style-type: none"> • Slates generally in sound condition. One broken slate visible. • There is the start of some vegetation growth at the lower part of the roof, and behind the chimney. This should be removed before it takes hold. 	
	<p>Repair Needs</p> <ul style="list-style-type: none"> • Replace broken slate. • Remove vegetation from roof slope. 	<p>C</p> <p>C</p>

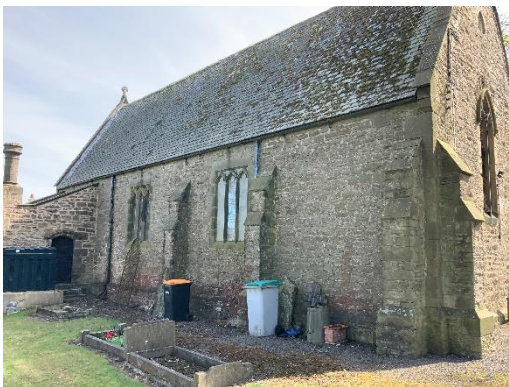
North Pitch of the Nave / Chancel Roof

<p>Description</p> <ul style="list-style-type: none"> • Graduated green Lakeland slates, with stone copings at the ridge. Lead soakers and flashings. 	
	<p>Condition</p> <ul style="list-style-type: none"> • Some minor delamination of slates, but generally in sound condition. • Some moss growth, becoming excessive towards the West end. • Flashings in sound condition. • Ridge tiles are delaminating, as noted above. Pointing has been carried out in recent years, although some bedding has fallen out in some locations, particularly towards the West end. 	
	<p>Repair Needs</p> <ul style="list-style-type: none"> • Remove excessive moss growth. 	D

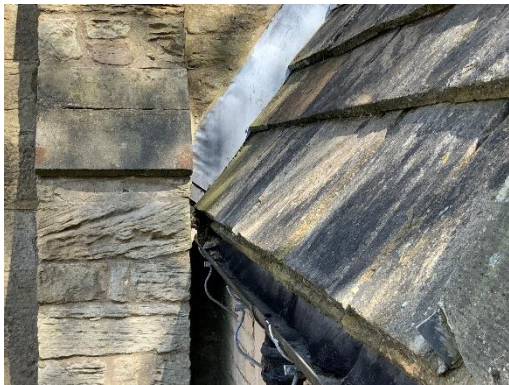
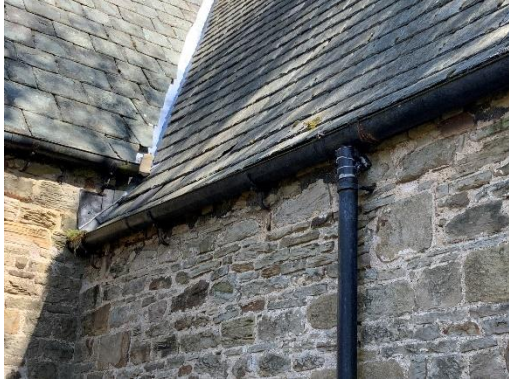
<ul style="list-style-type: none"> • There is some debris backed up in the gutter between the Porch roof and the western buttress. There is vegetation growing in the gutter at the junction of the Nave and Transept roofs to the right of the Porch. Just above this is a piece of mortar that has fallen from the ridge and is blocking the lead valley. All this should be easily cleared. • The gutter outlet on the West face of the Transept has been repaired poorly with impregnated tape. Whilst not visually sympathetic, the repair appears to be functional. • The gully on the South side of the Chancel has broken. It appears to be discharging normally. • The gutter on the South side of the Chancel has been repaired, possibly a weld/solder. The repair is functioning. • The downpipe on the North side of the Chancel offsets at the plinth. Previously I reported standing water at the joint above the plinth, suggesting that the offset was blocked. Due to a long spell of dry weather, it has not been possible to say if this is still an issue.

<p>Repair Needs</p> <ul style="list-style-type: none"> • Clear debris from Porch and Transept gutters. • Clear the blockage in the base of the downpipe on the North side of the Chancel. Install a wire basket leaf-guard at the gutter outlet above to reduce the likelihood of a reoccurrence. 	<p>M</p> <p>M</p>

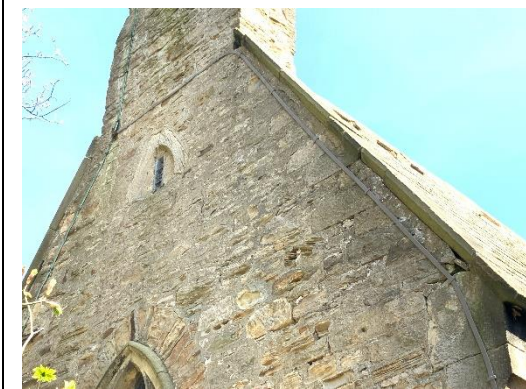
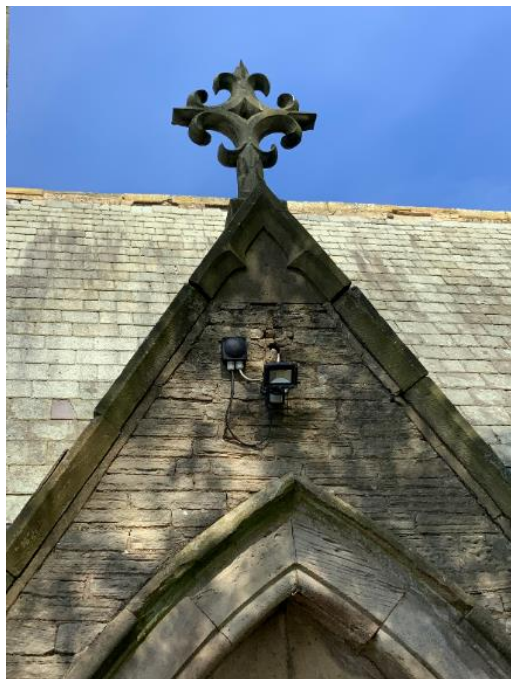
- The mortar pointing between the copings to the Porch gable has weathered out, allowing the copings to slip down. It is not clear whether there are metal cramps holding the stones in place. At best, the water ingress through the copings will continue to damage the stonework of the Porch front wall. At worst, the lowest coping retaining stones will shear, allowing the whole coping to slip down.

- The lowest coping stone on the West side of the Porch has broken corners at its lowest point. Although unsightly, this is probably not resulting in water ingress.

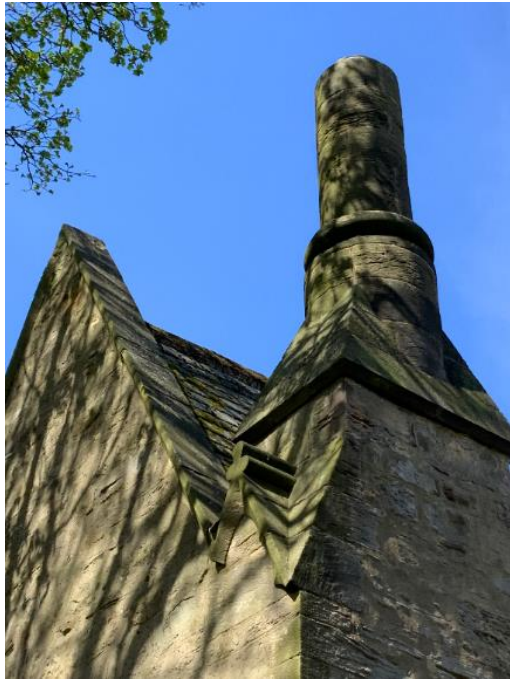
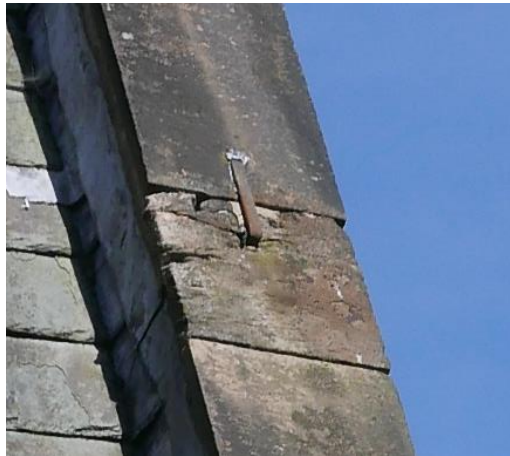
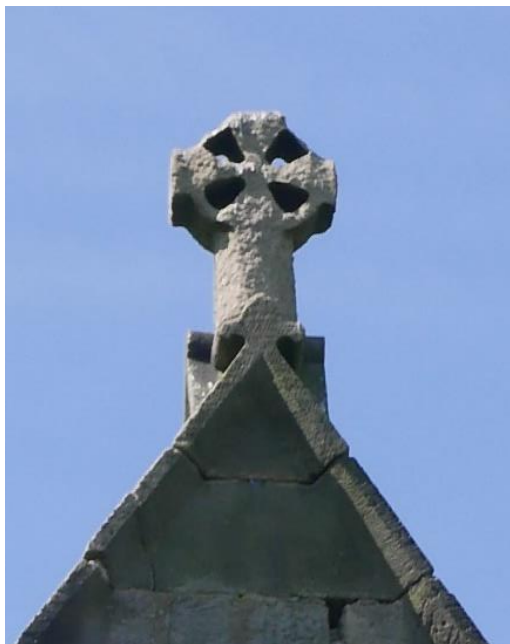
- The apex stone at the Transept gable is weathering far faster than the adjacent coping stones because its stone 'bed' is exposed on one side. This weathering will continue slowly.

- The chimney stack at the Transept gable is sound and remains in reasonable condition. It appears to have been haunched with mortar on its top surface. This haunching was out of sight and couldn't be inspected.

- The coping stones at the Chancel gable have been displaced in the past, and some iron cramps have been installed in the South slope to address this. There is displacement in the North slope too. The pointing is weathering out in a number of locations, and the cramps have caused some copings to crack.

- The coping stones on the Transept gable should be repointed.
- The apex stone on the Transept gable will benefit from replacement in the longer term.
- The coping stones on the Chancel gable should be repointed. At the same time, check whether they remain securely bedded and if not, they should be reset. Similarly, at the same time, check the bedding of the cruciform finial.

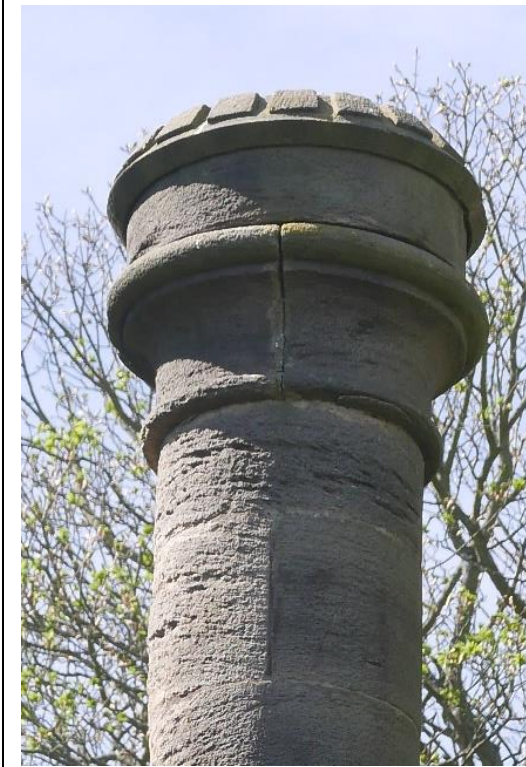
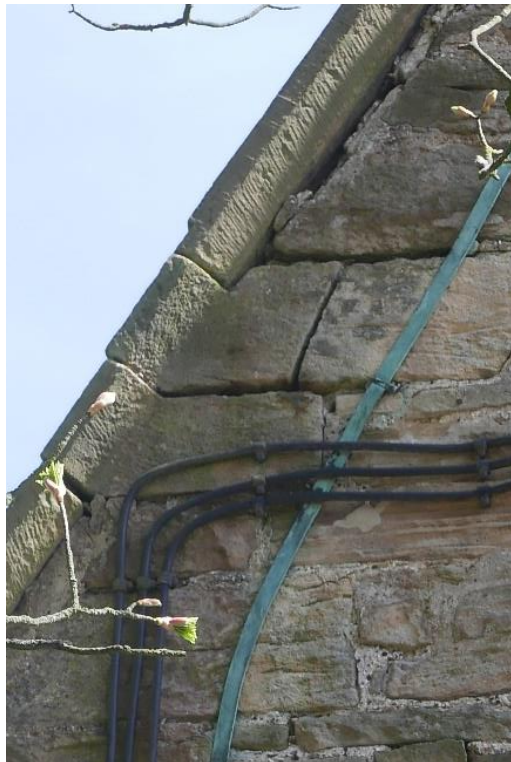
- The coping stones at the West Gable are themselves sound. However, the pointing has weathered out resulting in some slippage of the coping stones which aren't integral to the walling. This displacement has opened up some joints further, leaving the coping unable to perform its water shedding role properly. As the stones have slipped, they have debonded from their bedding. The bedding of the copings has weathered out in some locations, leaving gaps at the top of the wall.

- The chimney stack at the Vestry will benefit from some localised repointing at the very top, although it appears stable
- The copings to each side of the West Gable should be repointed, and reset if needed, and the pointing beneath these stones repaired at the same time.

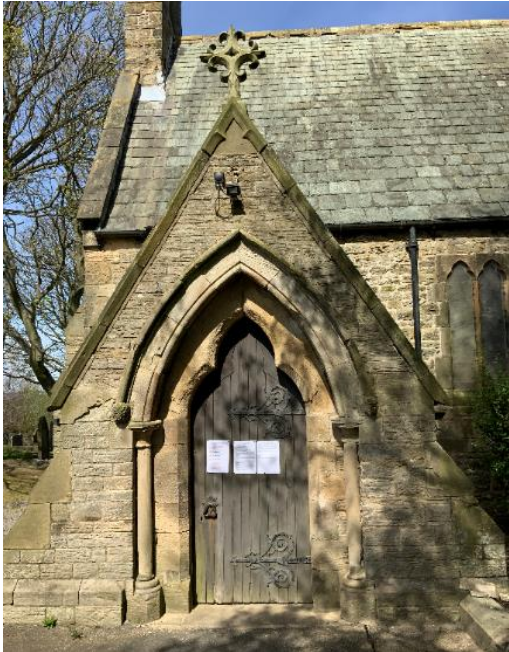
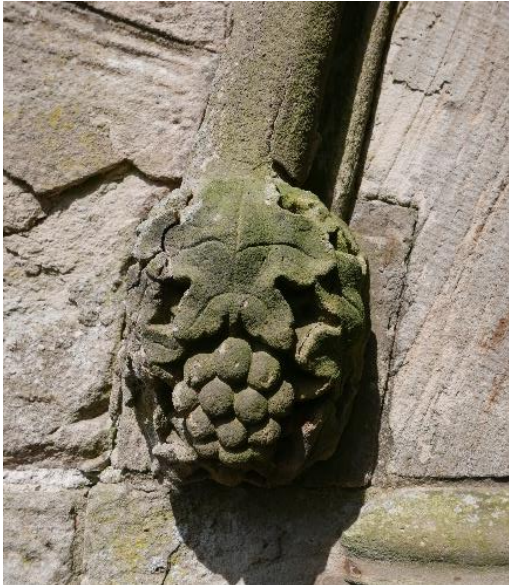
<p>Condition</p> <ul style="list-style-type: none"> The pointing has weathered out of the stonework at low level in a number of locations, probably exacerbated by dampness in the stone. Repointing with a lime mortar will aid stone drying. The pronounced weathering of the front gable wall has continued since the last inspection. Further delamination has occurred, including the loss of edges and features. There is delamination of the ashlar stone which is integral with the lowest coping stone, on the left hand side. There is pronounced weathering of the roll-mould above the arch including chips and cracks, and also a loss of clarity in the features of the leaf-stops at each side, probably caused by excessive dampness in the wall. There is pronounced weathering to the right hand pilaster at its head and base.

<p>Repair Needs</p> <ul style="list-style-type: none"> There are some areas of stonework at low level which should be repointed using lime mortar. The gable will continue to weather slowly, and at some point some replacement stonework will be required. Weathering will certainly be reduced by dealing with water ingress from the copings noted in the previous section. 	<p>D</p> <p>E</p>

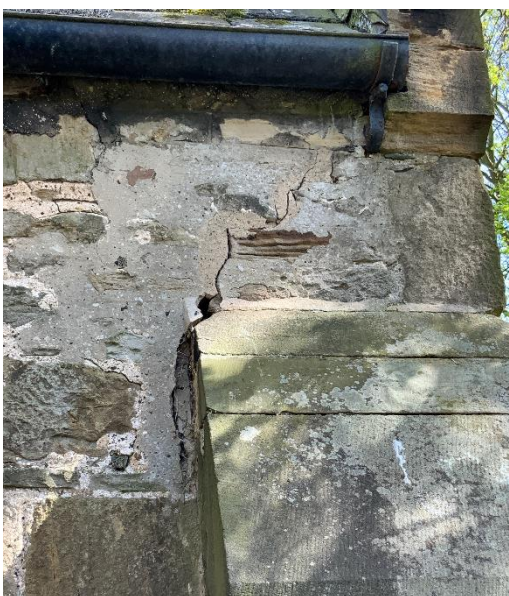
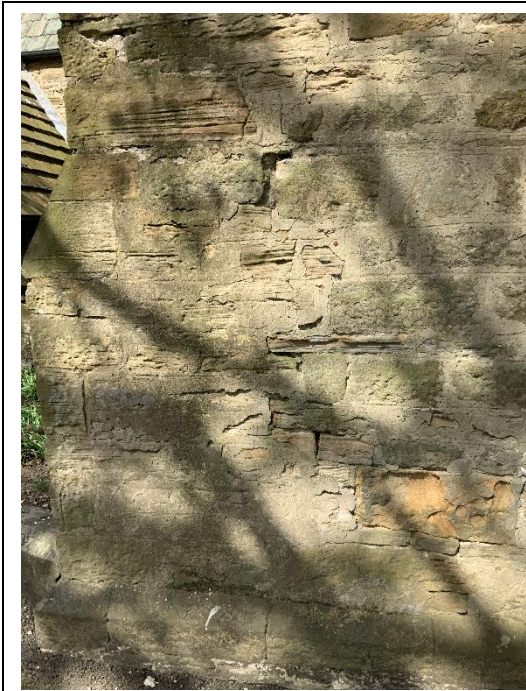
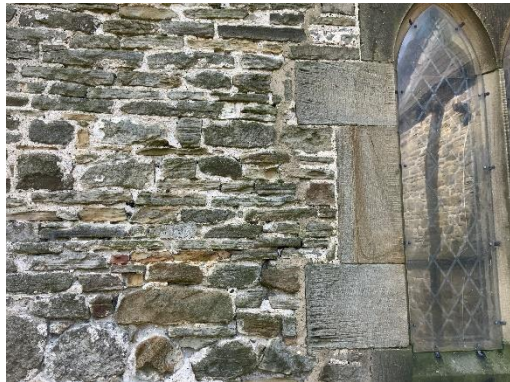
Transept Walls

- Some areas have been repointing poorly with cement-based mortar and this is exacerbating the stone degradation.
- The cracking in the wall at the head of the Western buttress, noted in the last report, and which has been patched with cement mortar, appears to be worsening. This should be repointed to limit any water ingress.
- The area of stonework to the Western side of the gable window still needs repointing. The stonework continues to weather badly here, exacerbated by previous use of cement mortar.
- The remains of an inset sundial can be seen to the left of the gable window, although it is badly eroded.
- An area of stonework to the left of the window on the side of the Transept is in need of repointing.

- Repoint the crack at the head of the buttress on the left-hand side of the gable.
- Carry out localised repointing to areas identified.

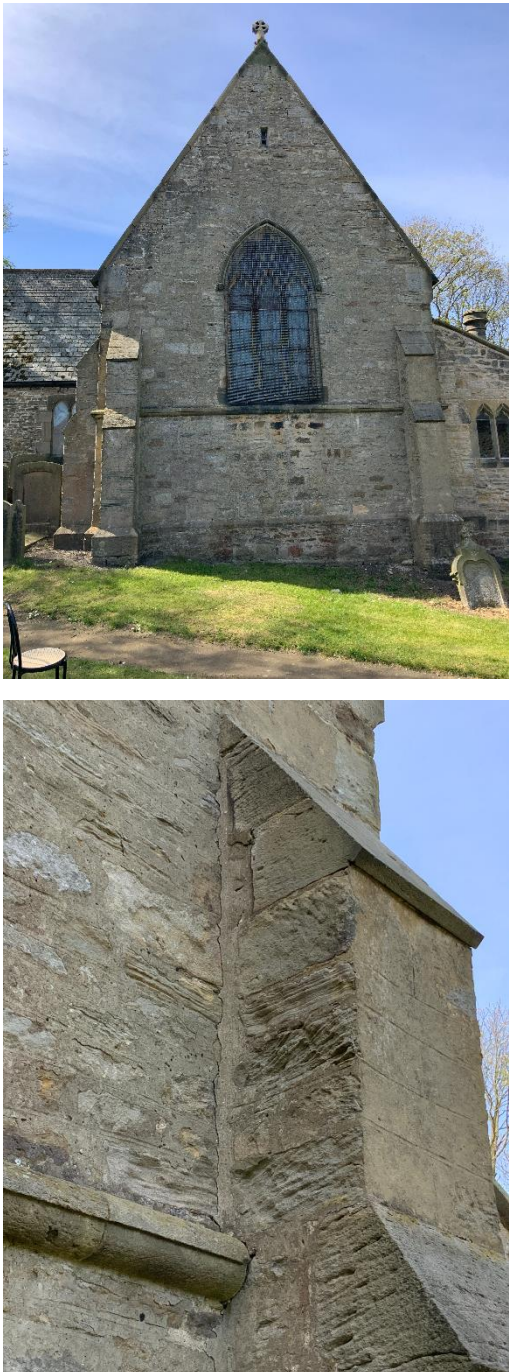
East Gable of the Chancel

<p>Description</p> <ul style="list-style-type: none"> Walls are of sandstone rubble with ashlar dressings, and plinth. The gable has buttresses at each side. The wall has a large window (described later). Ashlar water tabling at sill level There is a roof ventilator at high level with a wire bird guard. 	
	<p>Condition</p> <ul style="list-style-type: none"> Walling is generally sound, although with some pronounced weathering to isolated stones, as elsewhere. Some areas have been repointed poorly with cement-based mortar and this is exacerbating the stone degradation. Stonework at high level beneath the copings would benefit from repointing. Some of the lower parts of the wall around the plinth are in need of repointing. There is some staining beneath the window caused by runoff from the window grille. There is some cracking in the mortar fillets where the buttresses at the North East corner meet the main wall, perhaps indicative of some movement.

<p>Repair Needs</p> <ul style="list-style-type: none"> Carry out localised repointing to areas identified. 	D

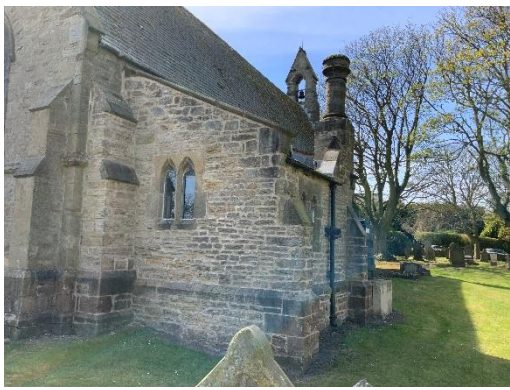
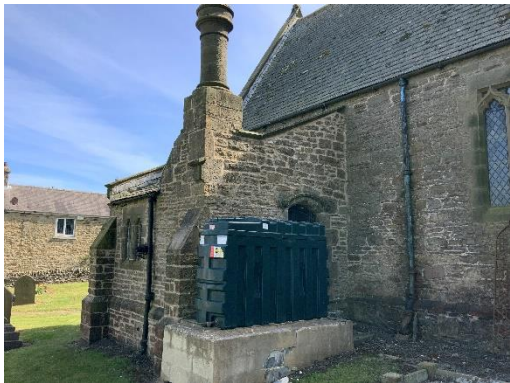
Vestry Walls

<p>Condition</p> <ul style="list-style-type: none"> • Walling is generally sound, although with some pronounced weathering to isolated stones, as elsewhere. • The walls have been repointed recently. It does look to have been well executed, although it is not known whether cement or lime mortar was used. The pointing does seem very hard. Given the softness of the stone, a feeble lime mortar mix should be used, with appropriate aggregates. • The oil tank plinth is unsympathetic to the church and would benefit from being faced with stone or screened from view. 	
	<p>Repair Needs</p> <ul style="list-style-type: none"> • Carry out localised repointing to areas identified. • Face the oil tank plinth with stone, or screen it. 	<p>D E</p>

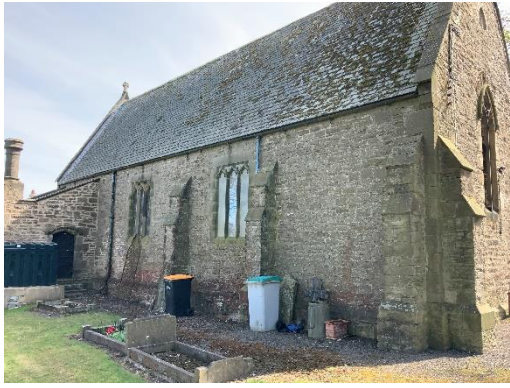
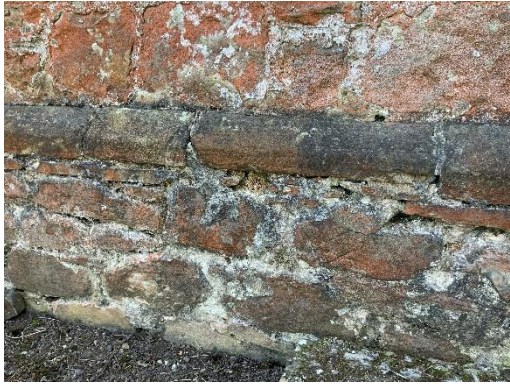
<p>Condition</p> <ul style="list-style-type: none"> • Walling is generally sound, although with some pronounced weathering to isolated stones, as elsewhere. • Some areas have been repointing poorly with cement-based mortar and this is exacerbating the stone degradation. • Stonework at plinth high level would benefit from repointing.

<p>Repair Needs</p> <ul style="list-style-type: none"> • Carry out localised repointing to areas identified. 	D

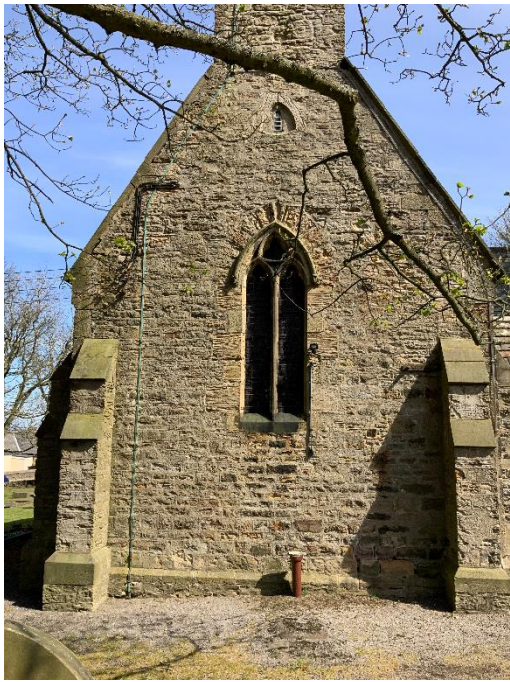
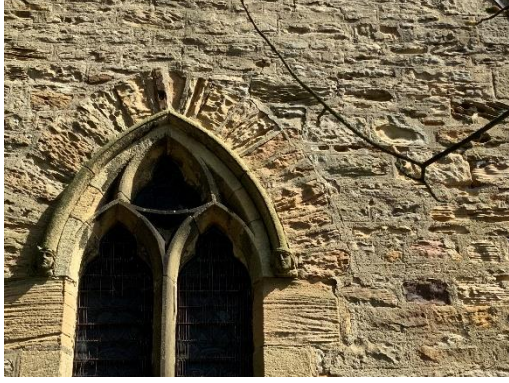
West Gable of the Nave

<p>There are a couple of stones at knee level which are also weathering poorly. See photo.</p> <ul style="list-style-type: none"> This is being exacerbated by the hard cement pointing which has been applied at some point in the past. Removal of the pointing will cause further damage to the stone face so it should be left to weather away. Isolated stone replacements will be required at some point in the future. There are some isolated areas of walling, particularly below the copings and on the buttresses that would benefit from repointing. The long crack in the walling running from the window head upwards for about six feet does not appear to have propagated further since the last report. However this should continue to be monitored. The cables and lightning cable attached the elevation appear soundly fixed.

<p>Repair Needs</p> <ul style="list-style-type: none"> Carry out isolated areas of repointing, using lime mortar. Monitor the cracking in the wall above the window head. 	<p>D</p> <p>M</p>

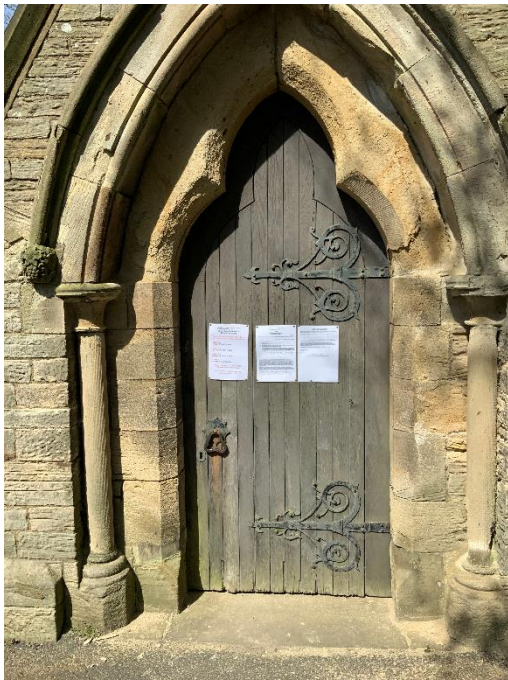
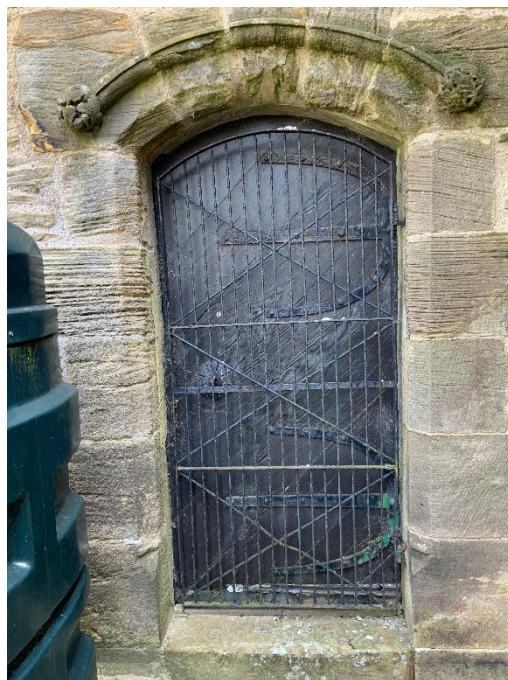
D1 (above) D2 (below)

<p>Description</p> <ul style="list-style-type: none"> Doors are framed and boarded doors with decorative iron hinges, with a woodstain finish. 	
	<p>Condition</p> <ul style="list-style-type: none"> The front entrance door (D1) is in good condition. The latch and the lock are both in working order. The iron hinges are secure, but for some reason there are three studs missing from the uppermost

- The front door has a crack, noted in the last report, which seems to be getting bigger. This is manifesting itself as a large splinter which should be secured to expel water.
- The front door would benefit from a new coat of preservative woodstain, particularly in the splash zone at the base where it is degrading.
- The exterior door to the vestry (D2) is in sound condition. There is pronounced weathering to the stone arch, particularly around the keystone, although no remedial action is needed now. There is an outer iron security gate which doesn't latch to the stonework and so moves freely. The timber door has preservative woodstain which is failing at the base of the door and it would benefit from replacement. The weatherbar at the base of the door has completely come away and needs to be replaced.

- Glue the large splinter at the top of the front door with a suitable exterior grade wood glue.
- Repaint the front door with preservative woodstain.
- Repaint the rear vestry door with preservative woodstain, and replace the weatherbar at the base.

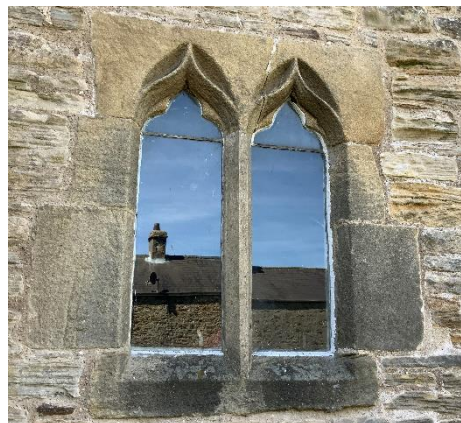
W7

- The east window (W7) into the Vestry is reasonable condition. A two-part plain-glazed window, the stone lintel has a pronounced crack at the head. The crack has been pointed in the past, suggesting it's not recent. There is a sizeably pit on the right hand side of the stone mullion, and a hairline fracture running up its centre. This lintel and mullion should be monitored for further cracking and/or movement. The putty around the glazing is cracking and will need replacing, but not imminently.

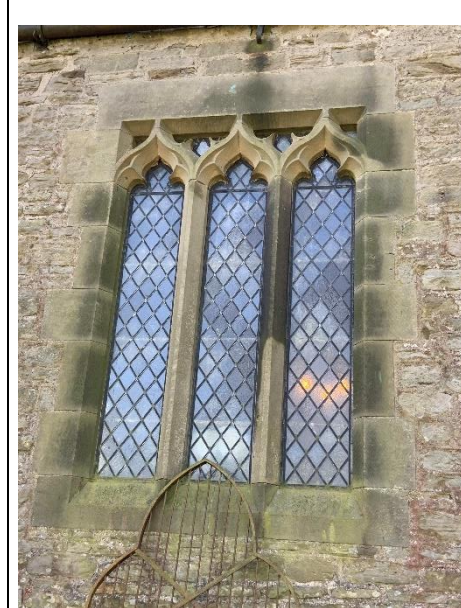
- The westernmost window (W10) to the north wall of the Nave is in sound condition. A three part window

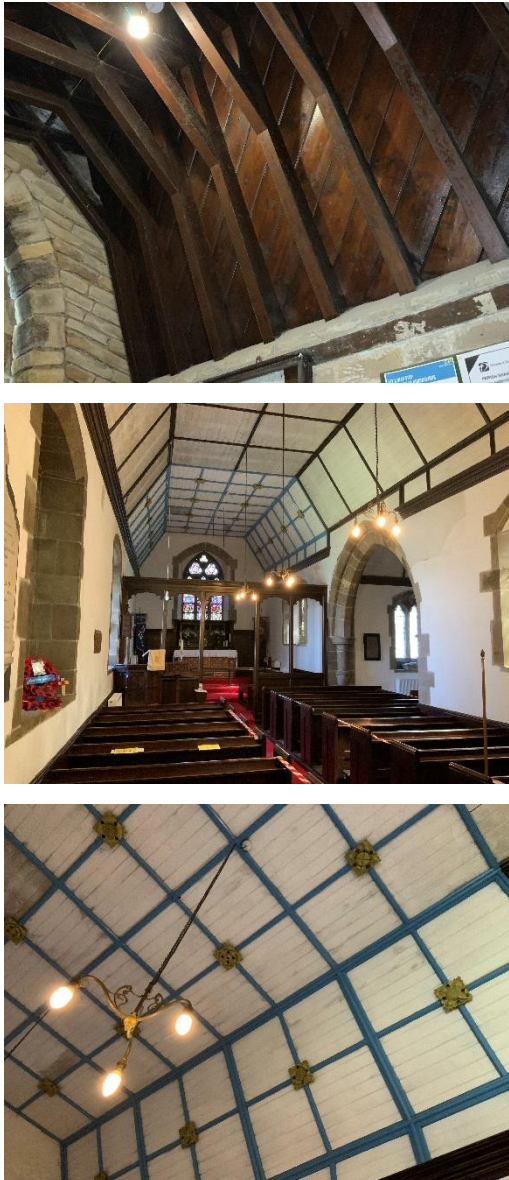
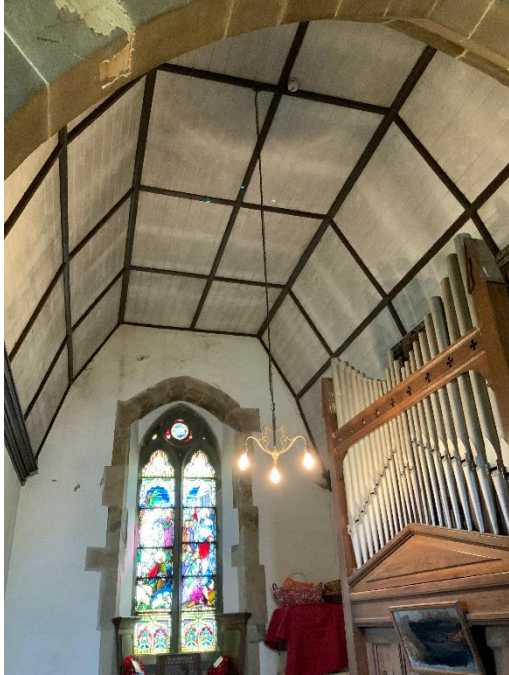
<p>not be ascertained. There are some areas of pronounced colour variation which are unsightly.</p> <ul style="list-style-type: none"> • The ceiling in the Transept is discoloured and is showing some mould growth too. • The roof structure above the Vestry is sound, although the painted timberwork is discolouring as elsewhere. 	
	<p>Repair Needs</p> <ul style="list-style-type: none"> • The ceilings in the Nave, Chancel and Transept need to be repainted. Care should be taken when specifying appropriate paints. • Take note that <u>historic paintwork may contain lead</u>, and thus any work carried out should be done by experienced tradespeople using appropriate methods. 	<p>E</p>

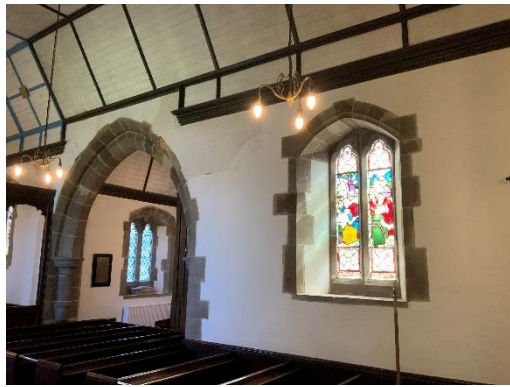
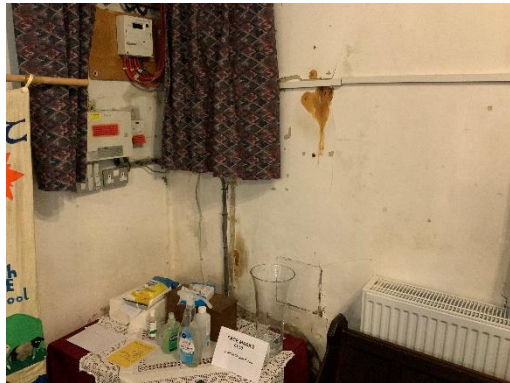
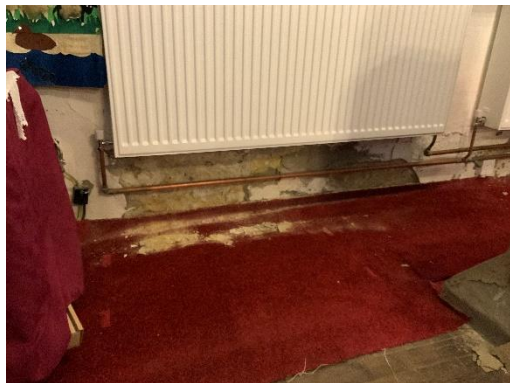
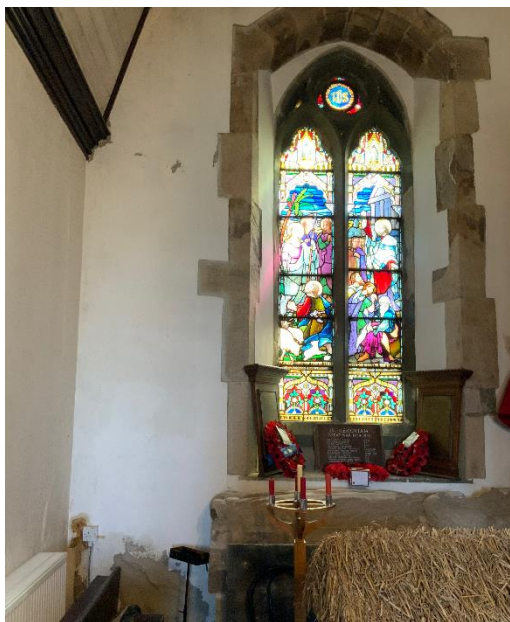
<p>Description</p> <ul style="list-style-type: none"> • The walls in the porch are pointed coursed rubble stonework. • The walls in the Nave, Chancel and Transept are painted plaster with expressed stone detailing around windows and doors. • There is an expressed stone arch at the entrance to the Transept. • The walls in the Vestry are exposed stonework, with some areas plastered. 	
	<p>Condition</p> <ul style="list-style-type: none"> • There has been little change to the internal walls since the last inspection. Rev.Peers believes the new heating system is reducing the general level of humidity. There is a need for redecoration generally. • The porch walls are in sound condition, although they have been repointed at some time in the past

with cement-based mortar which is not recommended for solid masonry walling.

<p>Repair Needs</p> <ul style="list-style-type: none"> • The Chancel, Nave, Transept and Vestry would benefit from being repainted, with some minor plaster repairs in advance of this. • Monitor the vertical crack in the SW corner of the Transept • Any plaster repairs should be carried out with lime-based plasters rather than those containing cement or gypsum. Lime plaster will permit the masonry to breathe fully. 	<p>E</p> <p>M</p>

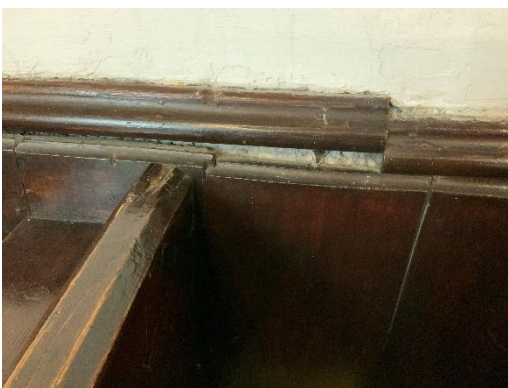
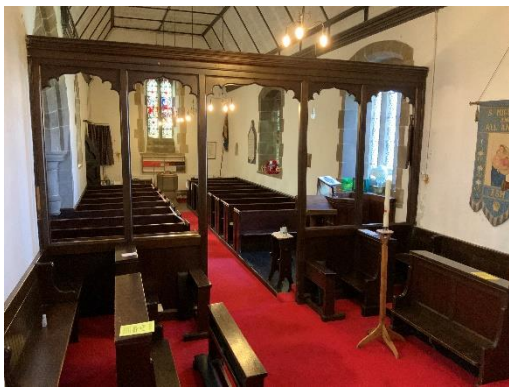
<p>Condition</p> <ul style="list-style-type: none"> • There is some distortion of the paneling, perhaps due to structural movement in the church, or the result of dampness in the supporting timberwork. This should be monitored. • The Chancel screen is secure and stable. • The reredos paneling in the Chancel is sound, and the communion rail is stable. 	
	<p>Repair Needs</p> <ul style="list-style-type: none"> • Monitor the distortion / cracks in the paneling in the Nave 	M
