# St Paul's, Evenwood

DIOCESE OF DURHAM

Quinquennial Inspection

## CONDITION SURVEY 2021

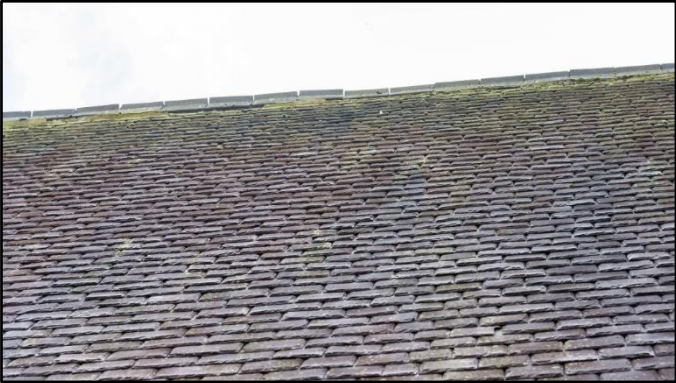
<p>All in acceptable condition apart of the nave ridge which has many open joints and is dislodged in places. If work to re-lay the ridge is to be carried out it would be good to incorporate removing the existing stub chimney which is redundant and will allow water into the redundant flue built into the core of the chancel arch wall.</p>

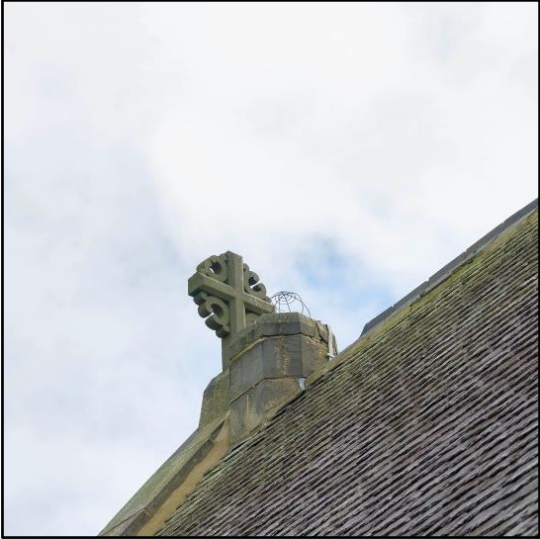
<p>Redundant stub chimney over chancel arch.</p> <p><b>Chancel</b></p> <p>As nave but with mitred hips which should incorporate code 3 lead soakers. The slate appears to be laid in courses of reducing slate width to suit the pyramid geometry. The clay ridge terminates in a steel cross sitting on a lead finial. The chancel ridge appears to be in better condition than that of the nave.</p> <p><b>Vestry</b></p> <p>A flat roof. Reported previously to be bitumen. I was not able to access it myself. I believe it is regularly checked and cleaned, as necessary. There were no signs of internal leaks.</p>

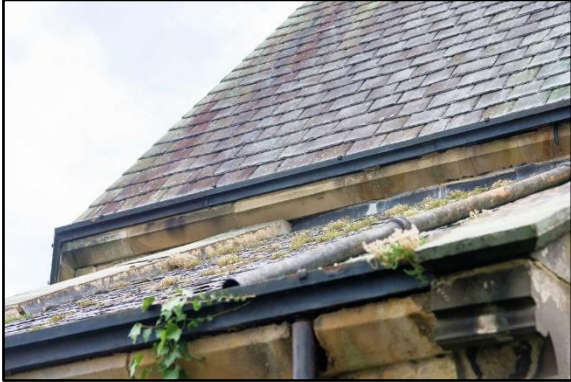
<p><b>Organ Chamber Roof</b></p> <p>This has a very shallow pitch and does not get much sun. Therefore, moss is growing on the roof and the condition of the perimeter flashings are more likely to allow water ingress.</p>

<p>This roof needs regular cleaning to remove moss growth and the perimeter flashings need to be checked regularly for cracking the mortar or movement in the lead flashings.</p>
3.02	Rainwater goods and disposal systems	<p><b>Gutters</b></p> <p>Ogee profile cast iron sitting on a stone corbel string.</p> <p><b>Rainwater Pipes</b></p> <p>Standard round cast iron.</p>

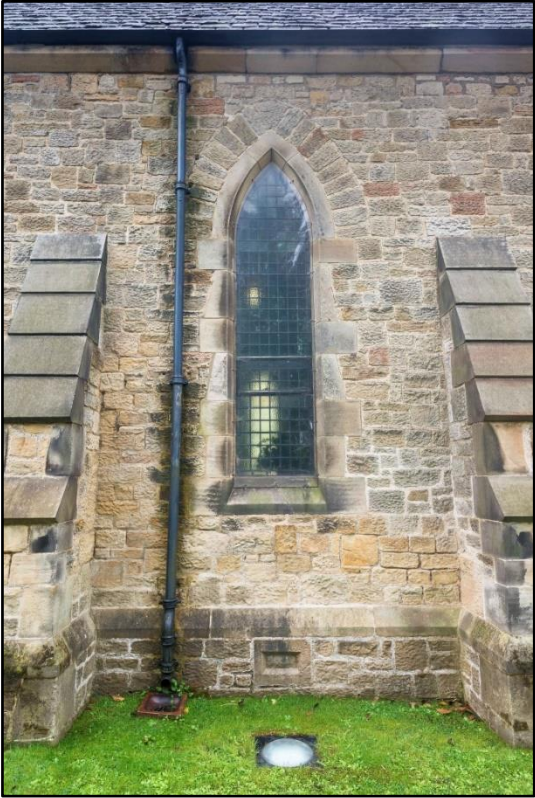
<p>All recently cleaned out and overhauled with one seriously leaking gutter joint being resealed.</p>

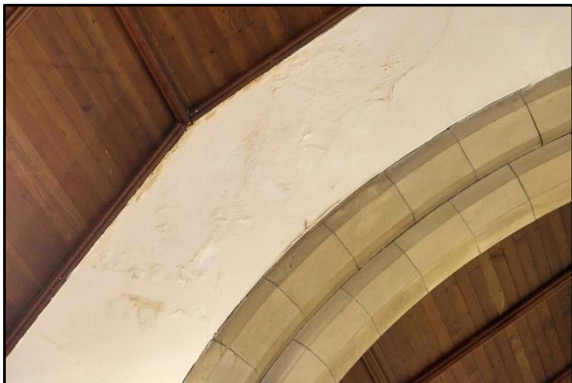
4.05	Internal structures, arcades, upper floors, balconies, access stairways	<p><b>Chancel Arch</b> Plaster over masonry walling. The wall contains a redundant flue which is open to the elements. Dampness and products of combustion are leaching through the stone and damaging the plaster.</p> <div style="text-align: center;">

</div> <p>The recent decoration has concealed this quite well but there are already signs of deterioration. When viewing the east end of the nave ridge, from the outside, the flue can be seen at the east end. It has a wire basket which should prevent birds accessing the flue. Please refer to the roof section for the remedials proposed.</p>

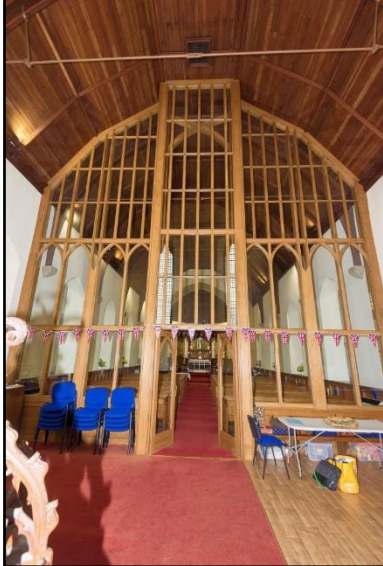
<p>The only concern is that the base of the door leaves scrape on the carpet and they are difficult to open. The doors need adjusting. This work needs to be done by a joinery firm familiar with the unusual, high-quality pivots on which the door leaves swing. Is there a record of the company that made and installed the screen?</p>

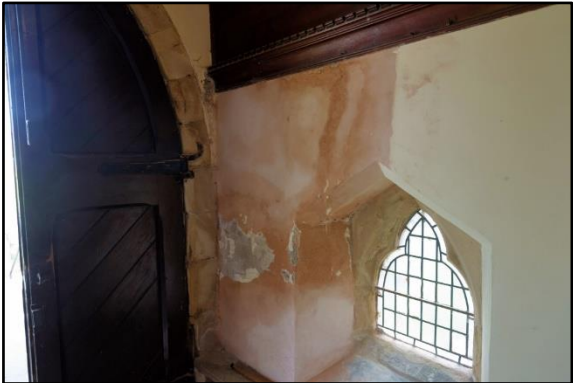
<p><b>Porch</b></p> <p>Painted plaster on masonry. The plastering in the northeast corner of the porch seems to have been affected by a gutter leak and many well have been repaired in gypsum plaster (hence the pink colour).</p>

<p>This needs to be investigated and possibly be replaced with lime-based plaster prior to redecoration.</p>

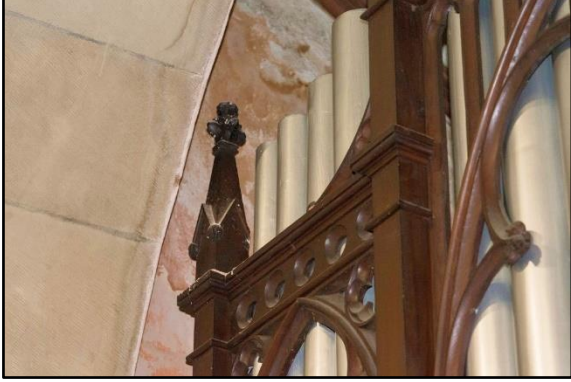
<p>The ceiling and walls are dusting, and dust is falling on to the organ.</p>

<p>In the short-term a thorough clean is required. The condition of the plaster needs to be carefully monitored over a few months and repair and redecoration of the plaster considered.</p>
4.12	Monuments, tombs, plaques etc	<p><b>Collis Memorial Plaque</b>                  At the south side of the chancel arch. Marble and slate.</p> <p><b>World War One Plaque</b>                  At the northwest corner of the nave. Bronze on an oak pattress.                  For full details see this link to Northeast War Memorials Project.  <a href="http://www.newmp.org.uk/detail.php?contentId=7184">http://www.newmp.org.uk/detail.php?contentId=7184</a></p> <p>Both items in acceptable condition.</p>

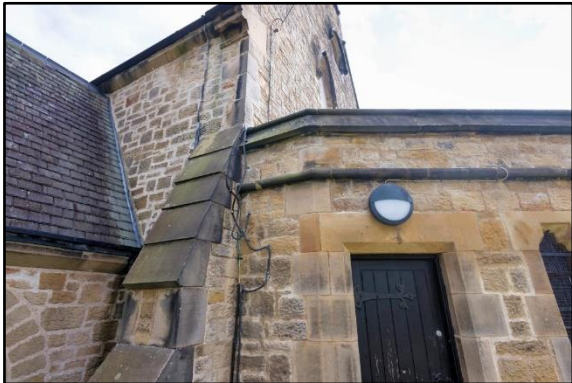
<p>The supply cables are untidily clipped to the building.</p>
