Parish Church of St. John
Gateshead Fell

Diocese of Durham
Archdeaconry of Sunderland
Deanery of Gateshead

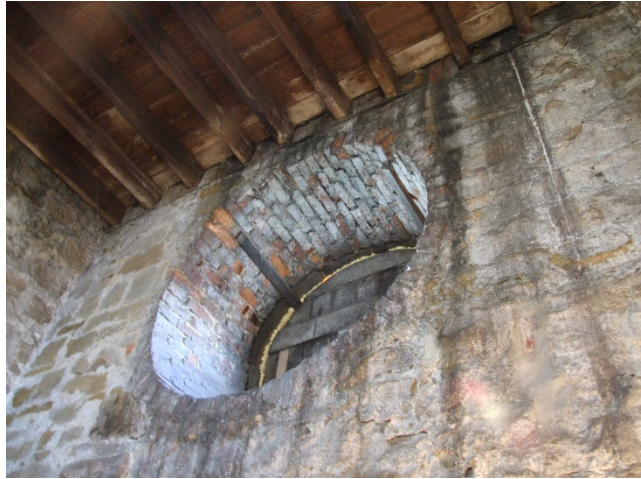
Narrow gap between parapet
and tower spire

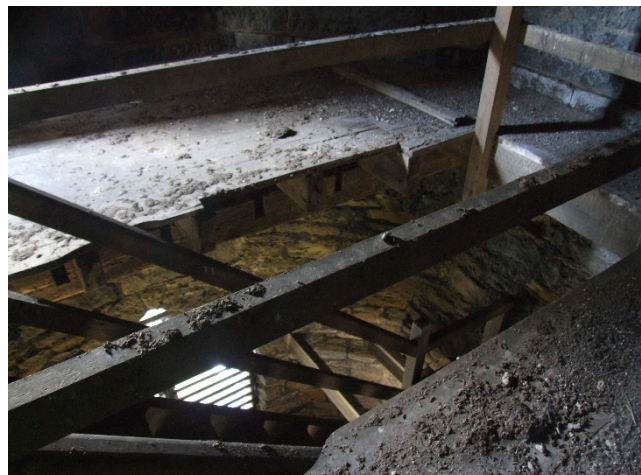
Disused/damaged access ladder within tower spire

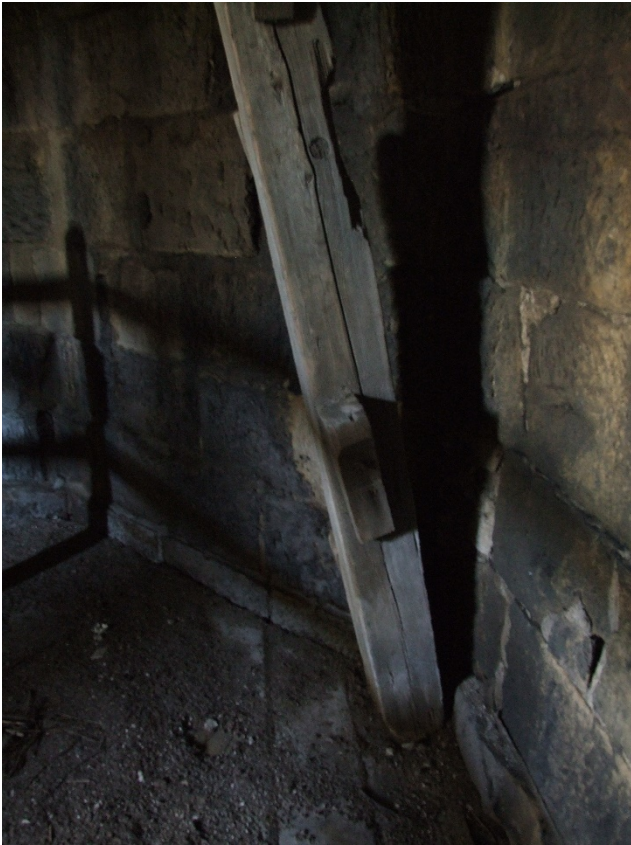
Tower parapet floor joists; damp to joist ends

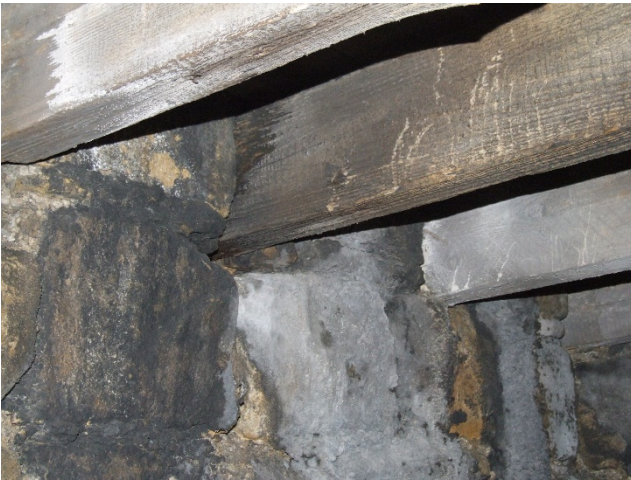
Tower parapet floor; principal beams showing advanced end decay

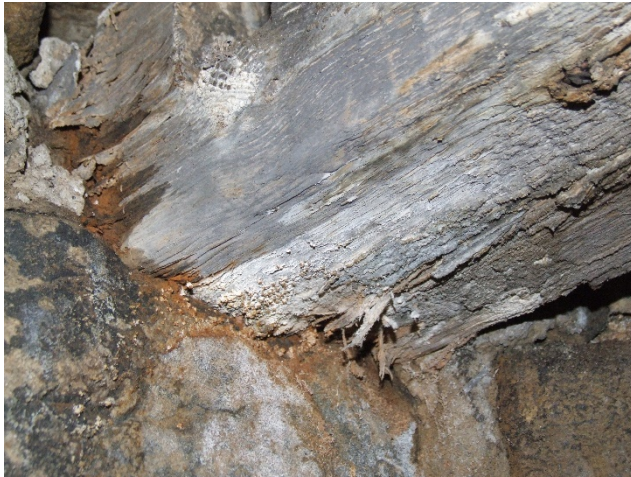
Insulated ceiling above nave

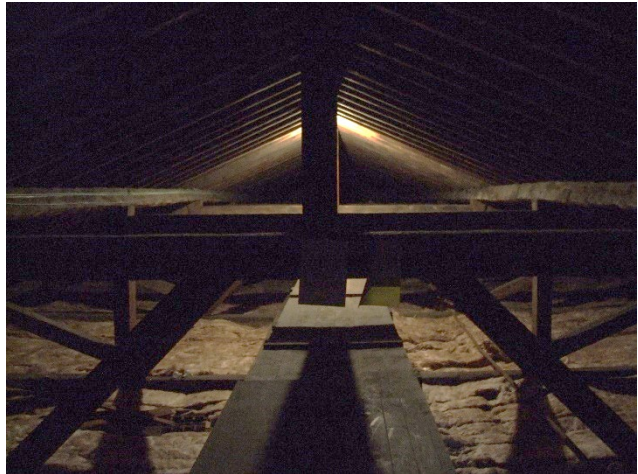
Meeting room;
spalling plasterwork

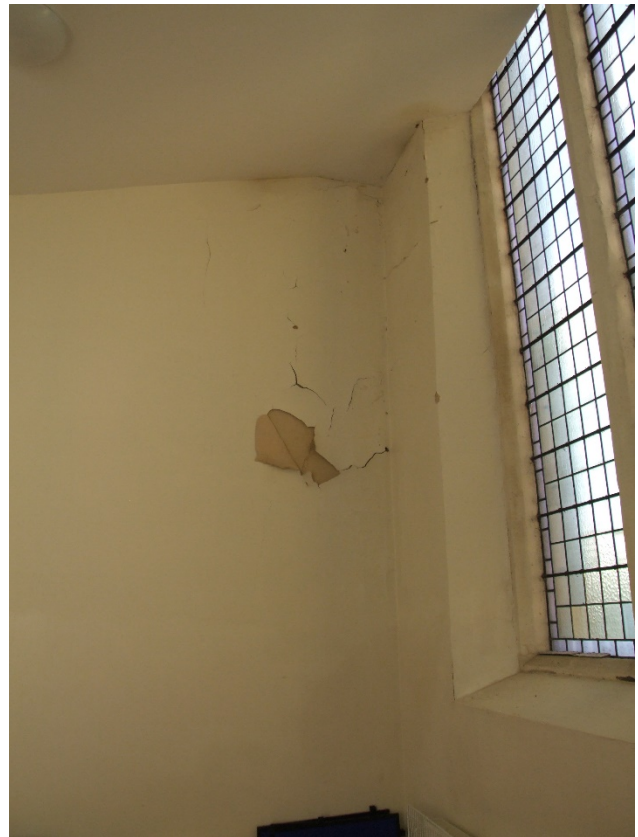
Meeting room;
Missing pointing to glazing

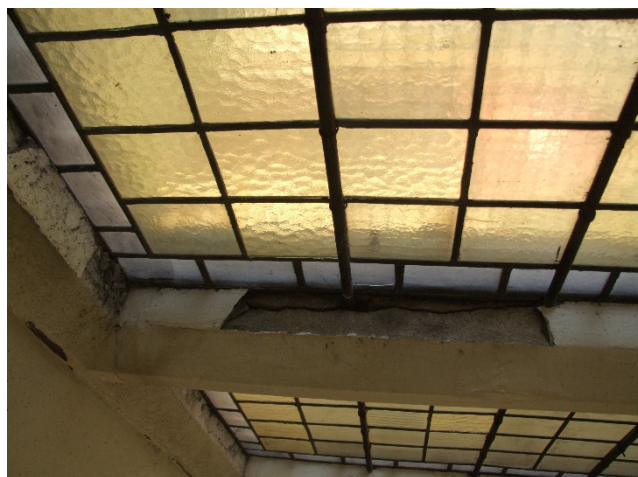
Tower;
south elevation

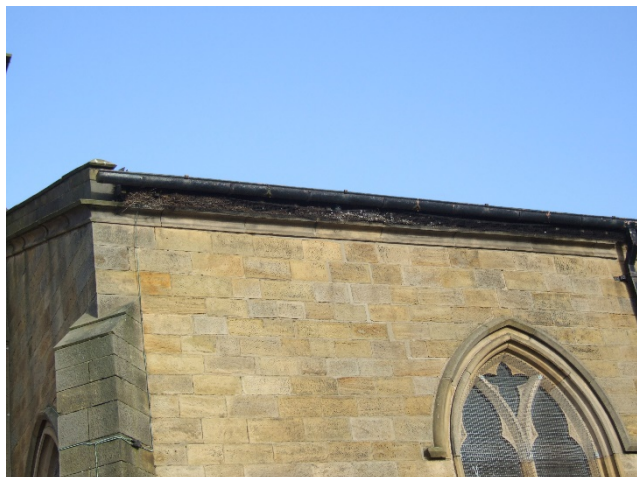
Tower, west elevation;
historic crack pointing

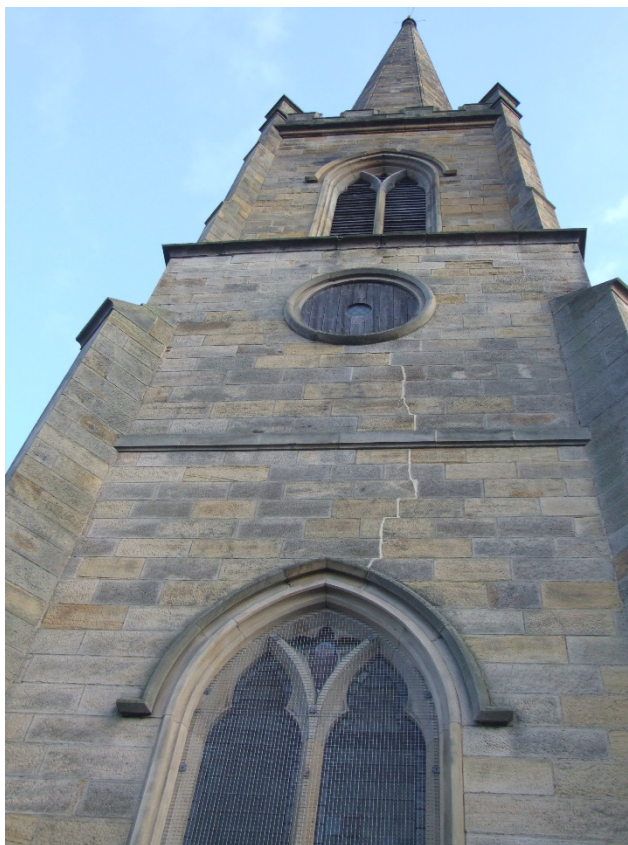
Nave;
north elevation

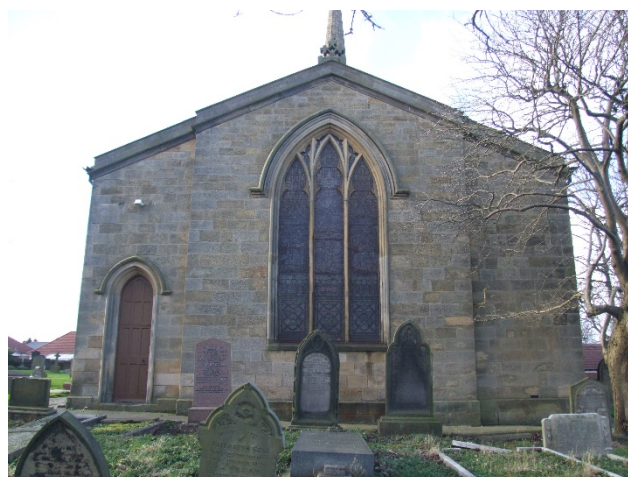
East end pathway;
trip hazards

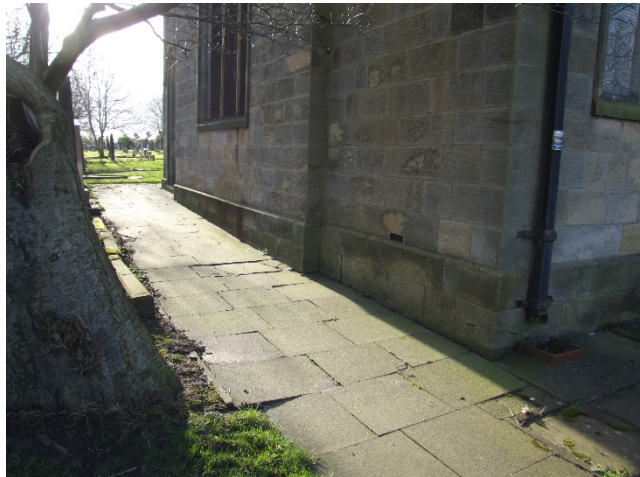
North end pathway;
moss hazard (note proximity of trees)

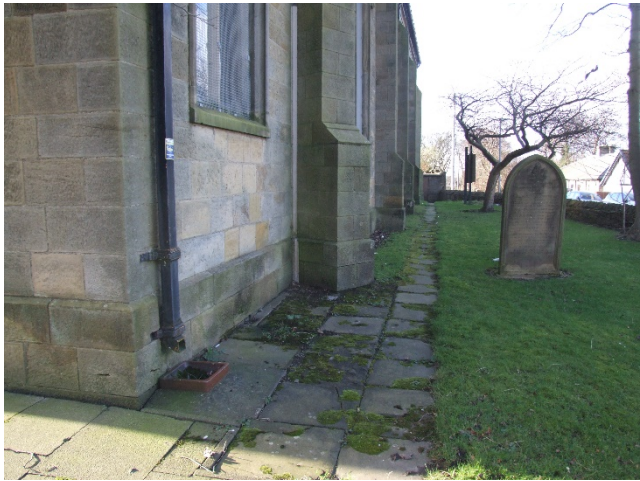
Northern chancel elevation;
faulty gully

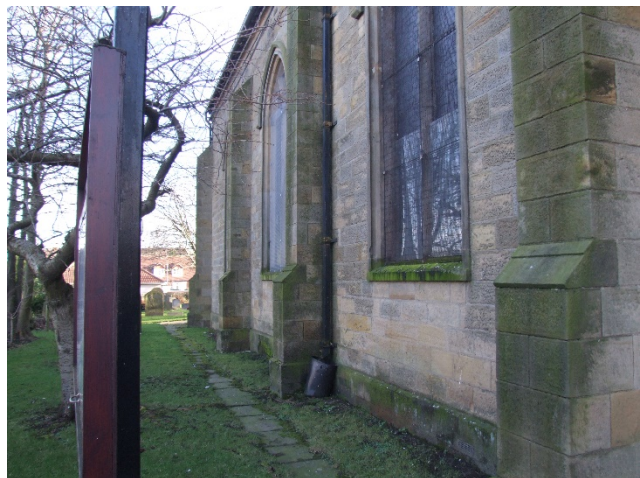
North elevation;
historic movement cracking

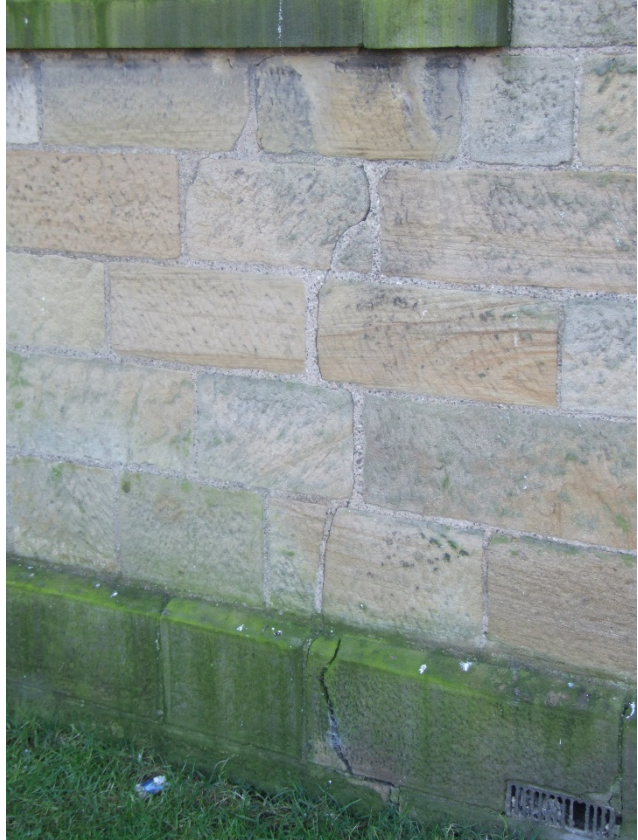
Tower parapet rainwater outlet;
previous issues with blockage

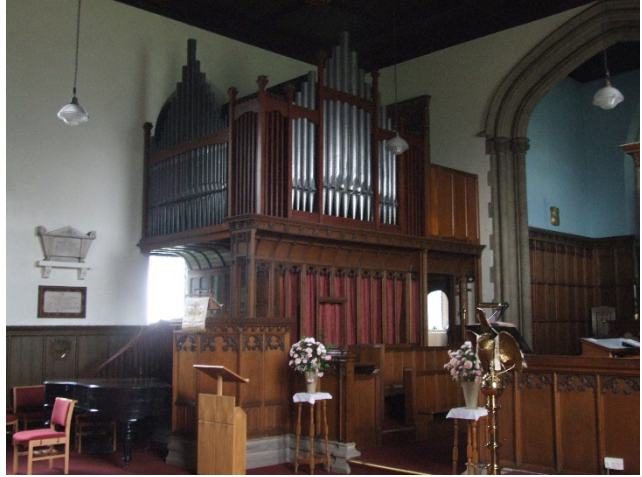
Cracking to west wall of vestry

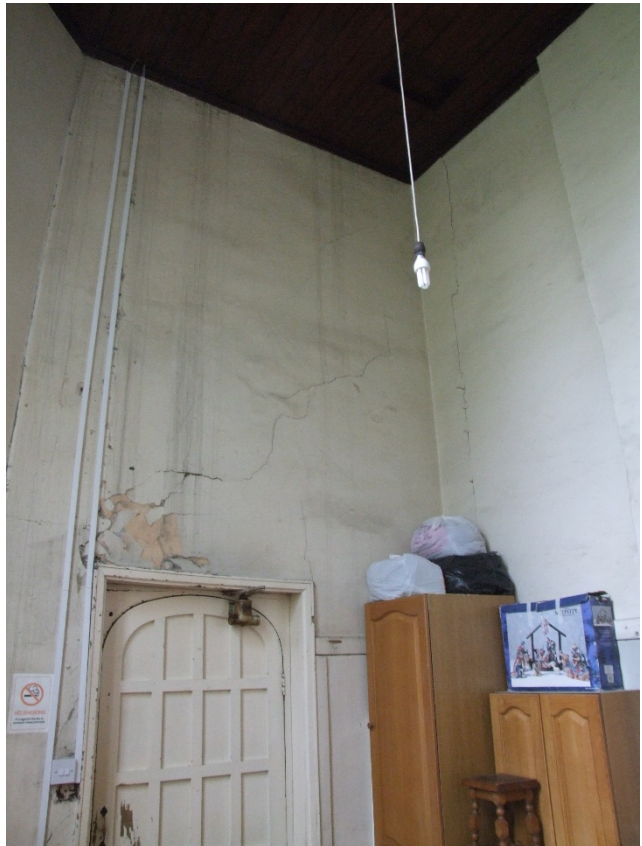
Vestry south wall window sill showing water staining

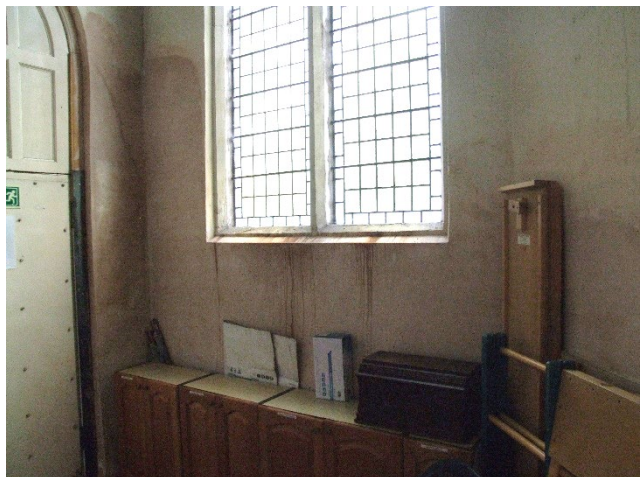
North vestry wall showing water staining

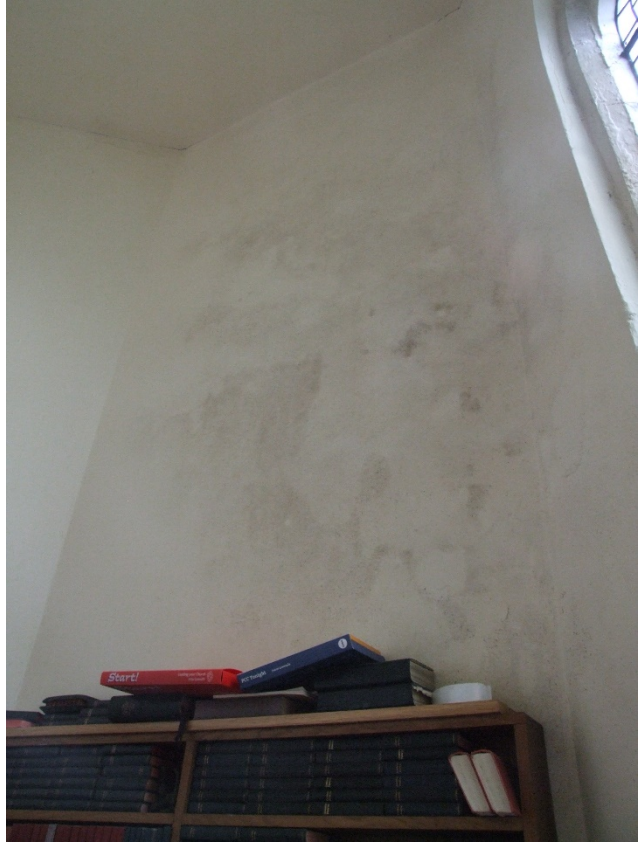
Meeting room;
moisture indication to plaster

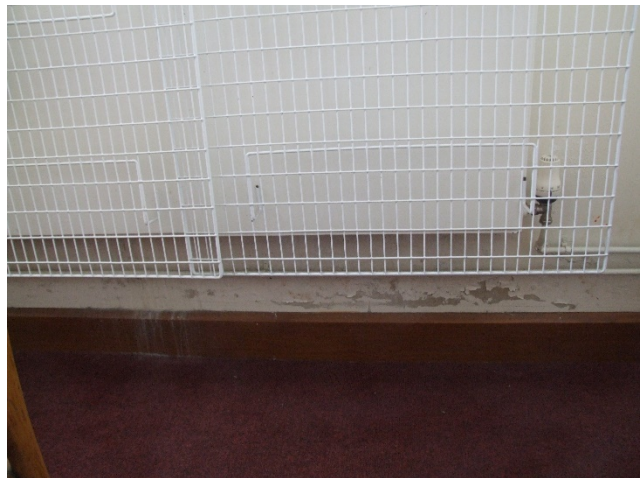
View from south side of galley

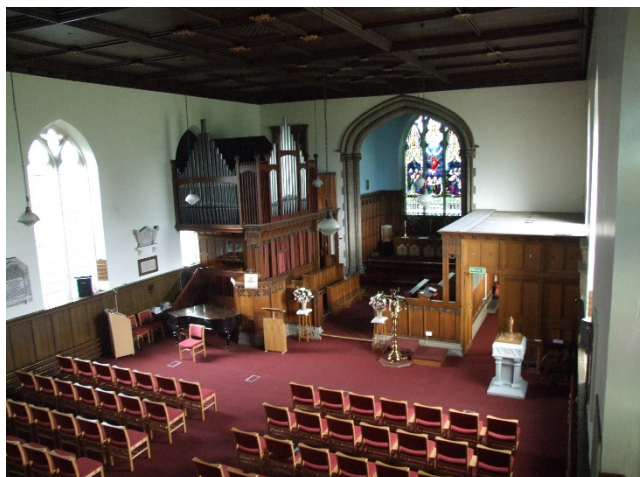
Inadequate guarding to tower stair

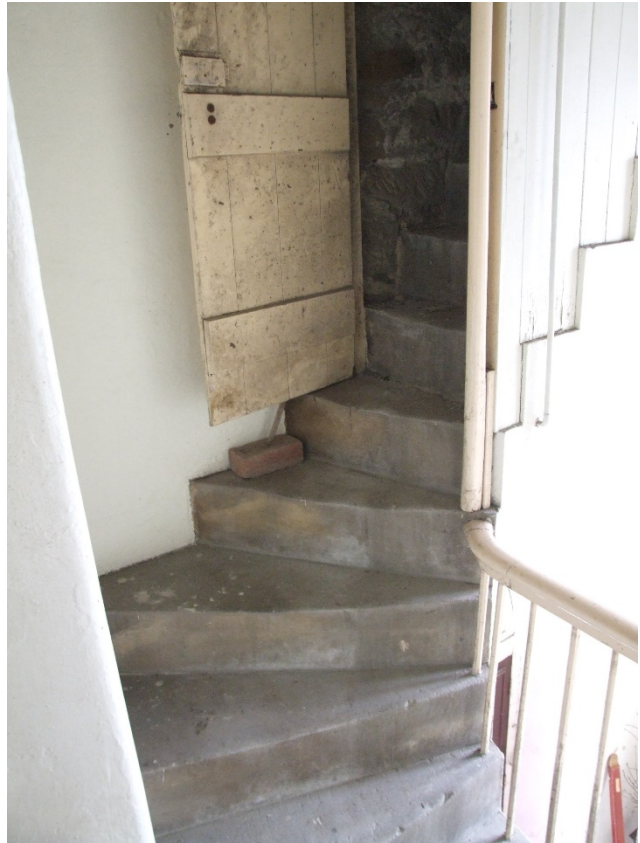
Damaged gulley, south elevation

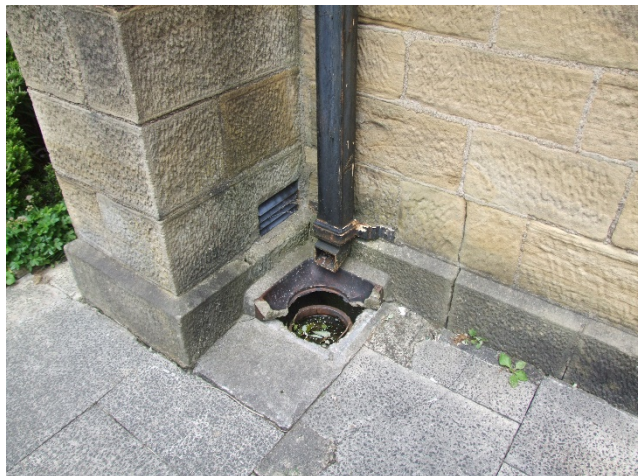
Self-sown trees disrupting grave sites

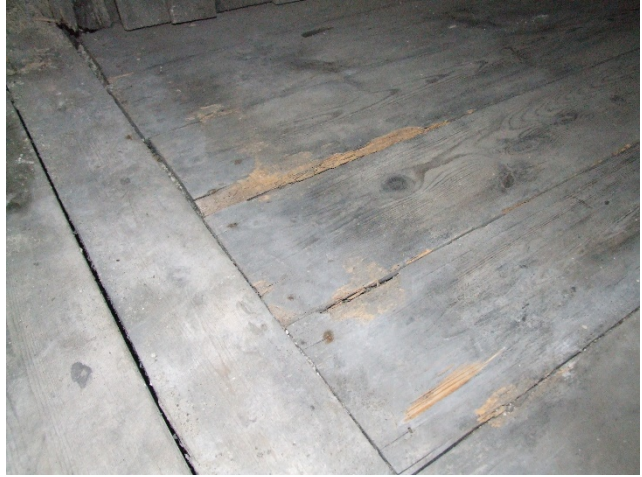
North elevation nave window;
moulding cracking

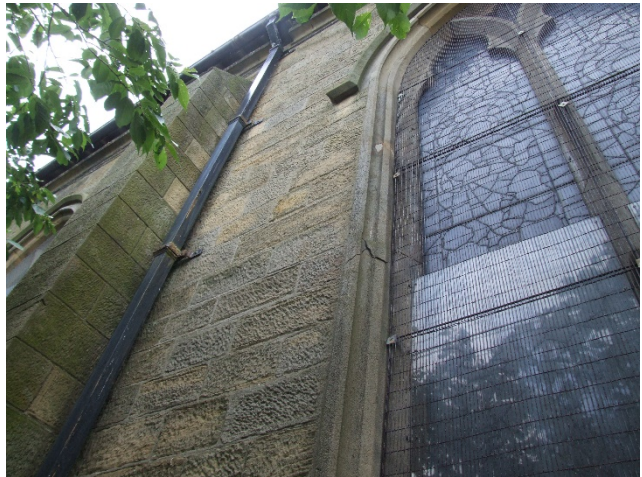
Damage to left hand side pintle position

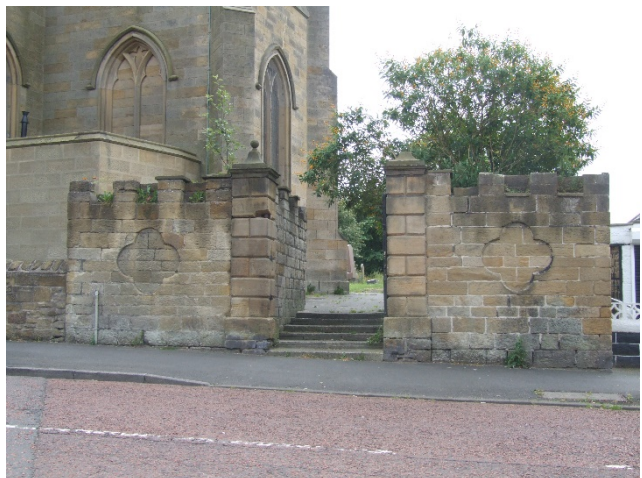
Ivy growth ultimately damaging to stone walling

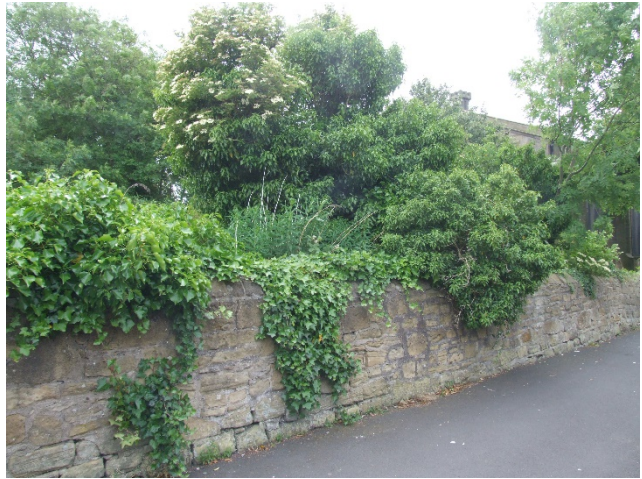
Graveyard in poor maintenance condition

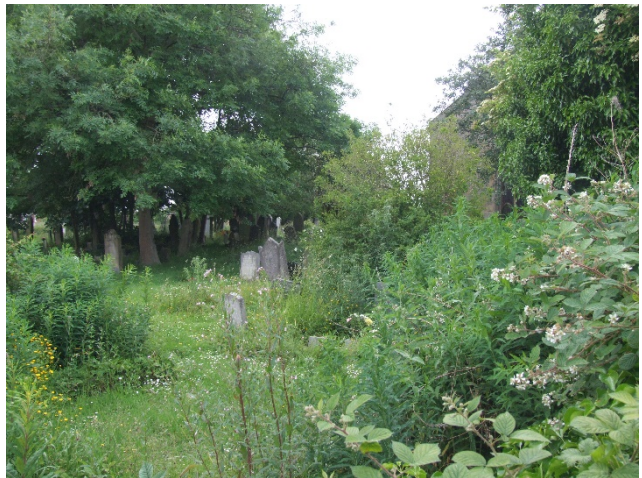
Appendix C – Listing Document:

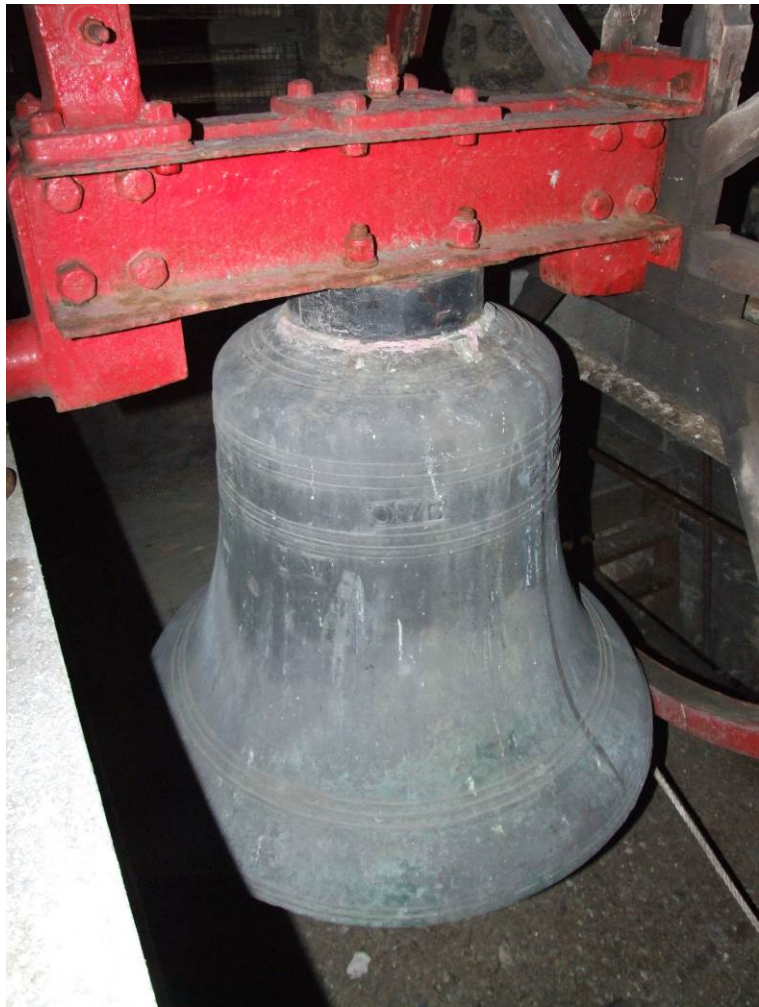
Surface corrosion to
bell headstock

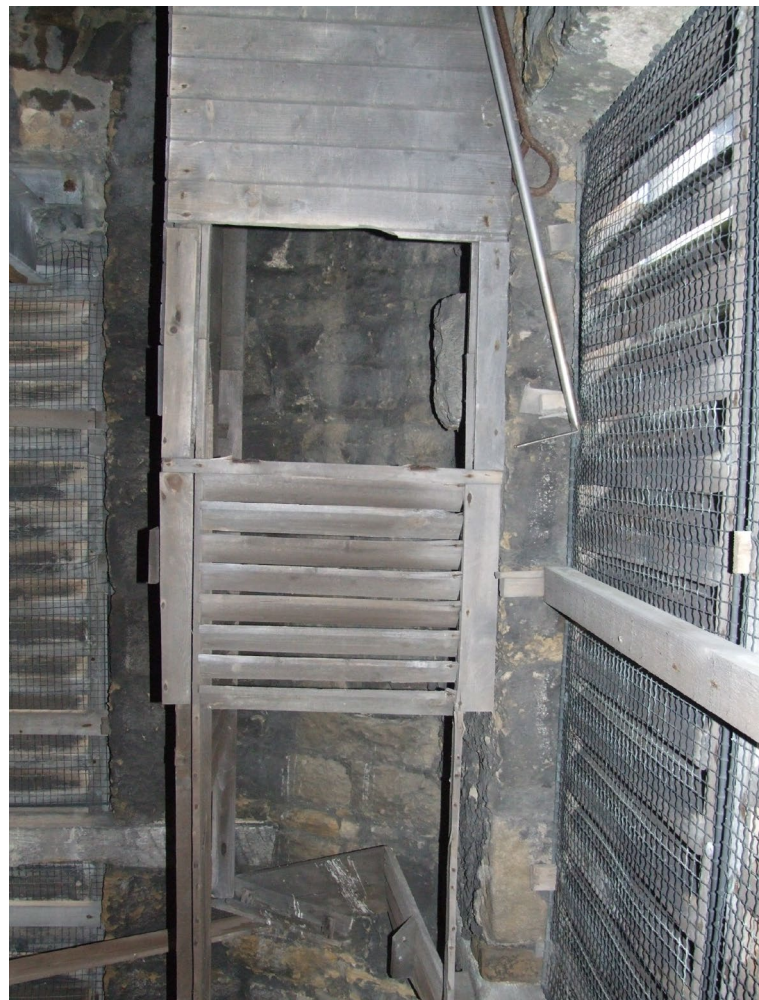
Redundant ventilation system

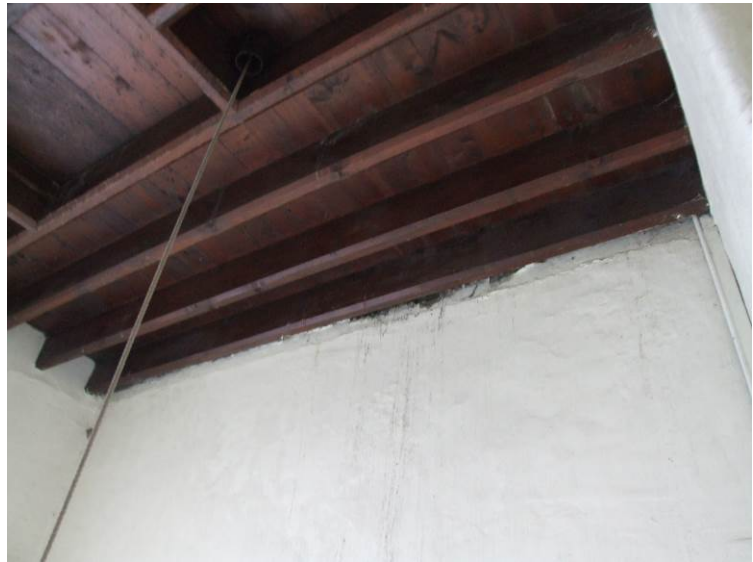
External view of tower levels
