# Quinquennial Inspection Report

Church of St Andrew  
Aycliffe Village, County Durham

Diocese – Durham  
Archdeaconry – Auckland  
Deanery – Auckland

**Date of report:** 2<sup>nd</sup> August 2023

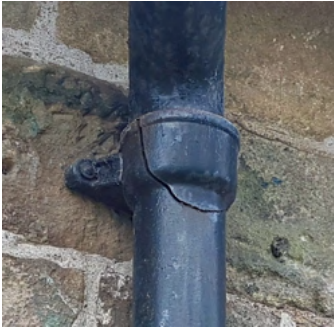
<p>Vestry - cracked collar</p>

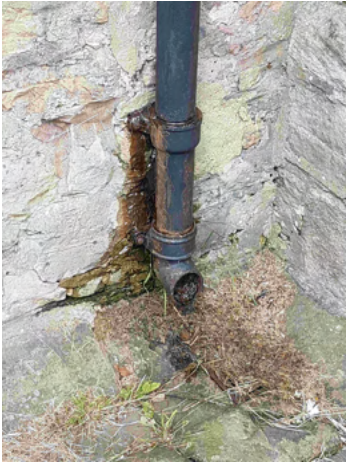
<p>N. Aisle - blocked outlet</p> </div>	<p><u>Drainage system</u> The external walls are suffering from rising damp. (See 3.3). This is thought to be resulting from the surface water drainage system.</p> <p>The stone drainage channels are porous and permit moisture to track to the earth and the sub structure walls beneath. The channels will also prevent evaporation of the moisture beneath, effectively trapping it. Not all of the rainwater pipes have a gully beneath so some of the rainwater will migrate through the channel and joints before entering the gully and drain.</p> <p><u>Tower</u> The parapet gutters discharge into lead spitters on the east facing wall of the Tower onto the Nave roofs beneath. There are no downpipes. The spitters are in good condition and doing their job effectively.</p> <p><u>Porch</u> The Porch has no gutters or downpipes. Rainwater run-off from the roof is collected by the drainage channel.</p> <p><u>Nave</u> There are no gutters to the Nave as rainwater run-off discharges directly onto the Aisle roofs beneath.</p> <p><u>North Aisle</u> The gutters are a shallow half-round cast iron type discharging into circular cast iron downpipes with eared sockets.</p> <p><u>South Aisle</u> Rainwater from the parapet gutter discharges through a chute and hopper into a circular cast iron downpipe with eared sockets. The parapet gutter has debris.</p>

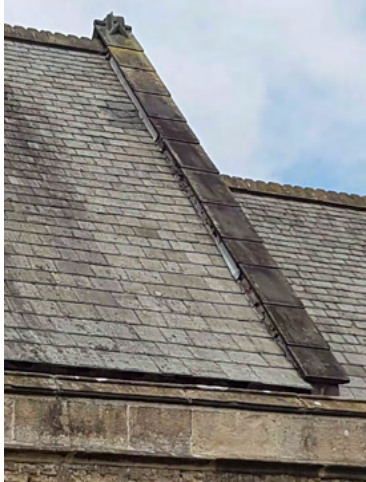
<p>Nave E gable flashings removed</p>

<p>Repair needs</p>	<p>The stolen sections of flashings need urgent replacement to prevent water ingress. It is recommended that non-lead flashings (e.g. Masterform) are used to deter future theft.</p> <p>Consideration should be given to replacing all remaining lead flashings with a non-lead alternative.</p> <p>The PCC are advised to consider the installation of a roof alarm to deter thieves from stealing the lead from the tower roof.</p> <p>Repointing of open and receding joints required.</p> <p>Repointing of water tabling to N Aisle west gable needed.</p>	<p>A</p> <p>B</p> <p>E</p> <p>C</p> <p>C</p>
<p><b>2.4 External walling</b></p>	<p>See 1.6 for door masonry.  See 1.7 for window masonry.</p>	
<p>Condition</p>	<p>Generally, the masonry and pointing are in fair condition throughout. However, attention is needed in the following areas.</p> <p><u>Chancel</u>  East gable  – apex stone out of alignment with north slope water tabling.</p> <ul style="list-style-type: none"> <li>- open joints window arches.</li> <li>- open perpend joints between cills.</li> <li>- 300mm long crack below string course.</li> </ul>

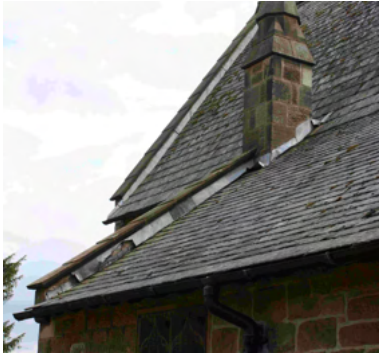
<p>Vestry E gable flashings removed</p>	<p><u>Nave – north slope</u>  Water tabling – in fair condition  A 1m long section of the lead abutment flashing to the west abutment to the Tower and a 1m section of lead flashing to the east gable upstand has been removed by thieves.</p> <p><u>South Aisle</u>  The apron flashing to the east gable upstand wall has been removed by thieves. The apron flashing to the west gable appears to be intact. The stainless-steel top abutment flashing to the south face of the Tower and the Nave are in good condition.  Open joints on east face of upstand wall.  Parapet and copings on south wall in satisfactory condition but there are open joints on the east facing upstand gable.</p> <p><u>North Aisle</u>  70% of the top abutment lead flashing to the roof has been removed by thieves. The remaining flashing has been disturbed. Receding bed joints to kneeler and quoins on NE corner. Open joints in water tabling.</p> <p><u>Vestry/Organ Chamber</u>  The flashing to the east gable upstand has been removed by lead thieves.</p> <p><u>Vestry chimney</u>  The masonry and pointing are in fair condition. However, the apron flashing has been partly uplifted during the lead theft of the Vestry east gable abutment flashings.</p>

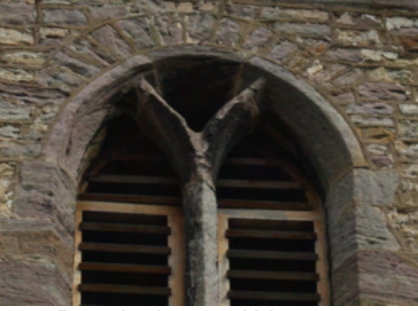
<p>Deeply decayed Y tracery</p>	<p><u>Vestry</u> East wall - crack below central stone to water tabling. North wall - open pointing below eaves by NE corner.</p> <p><u>North Aisle</u></p> <ul style="list-style-type: none"> <li>- open pointing below eaves by NE corner.</li> <li>- open perpend joints to corbelled eaves course.</li> <li>- some cracking between window n(x) and NW corner.</li> </ul> <p><u>Tower</u> East face – some vegetation growing at second stage. North face – ditto. West face – some deeply decayed stones at 1<sup>st</sup> and 2<sup>nd</sup> level; deeply decayed Y tracery to louvred opening.</p> <p><u>South Aisle</u> West gable - receding bed joints to window jambs to s(x). South wall - heavily pointed, open bed joints to buttresses.</p> <p><u>Porch</u></p> <ul style="list-style-type: none"> <li>- open joint to apex joint of water tabling</li> <li>- some receding joints</li> <li>- surface decay to upper RH jamb of arched opening.</li> </ul>

<p>Repair needs</p>	<p>Repointing of cracks and open and receding joints. Consider replacing Y tracery to Tower west face. Remove vegetation from Tower walls.</p>	<p>D D D</p>

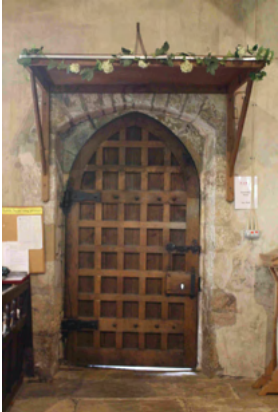
<p><u>Porch:</u> The framed, latticed and boarded oak door is in fair condition. The door catches on the stone paving when opened fully though adjustment is likely to be difficult. The door would benefit from re-oiling.</p> <p><u>Chancel (priest's door):</u> The framed, latticed and boarded oak door - in good condition.</p> <p><u>Oil storage enclosure:</u> Framed and boarded softwood double door – in fair condition but in need of protective wood stain.</p> <p>Hardware to the doors is appropriate for use and security.</p>	<p>D D</p>

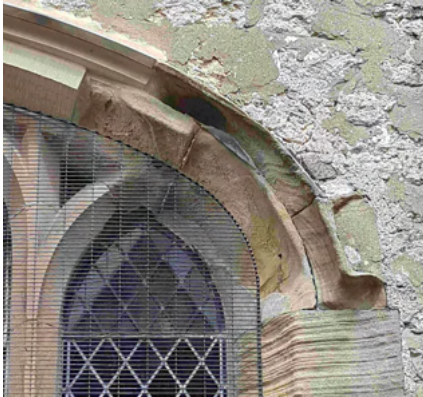
Deep decay to hood mould and arch to window s(viii)

- Masonry – deep decay to RHS of hood mould and arch stone below; surface decay to RH mullion; deep decay to RHS of cill. Masonry repairs recommended.
- Glazing – vent sash is bowed and not sliding – repair needed.
- Protection – ferrous mesh – in fair condition.

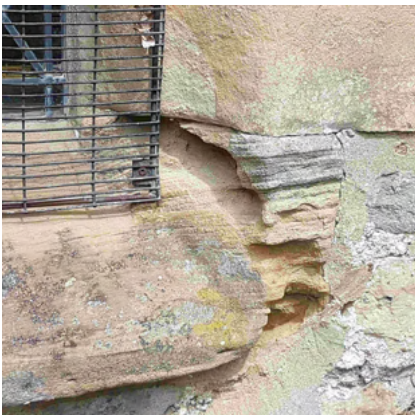
Deep decay to cill to window s(viii)

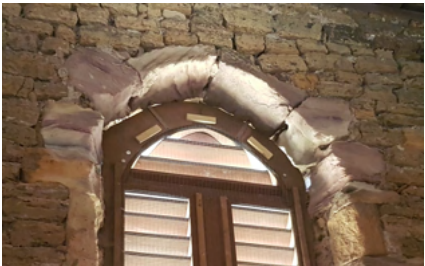
<p>Deeply decayed jambs and voids</p>

<p>Repair needs</p>	<p>Interior generally in good condition. However, the condition of the walls to stage 3 gives cause for concern. The jambs and arched stone to the louvred openings are deeply decayed and have many voids. The worst decayed jambs require replacement.</p> <p>All other jambs require raking out and repointing. The rest of the walls at this stage have many open and receding joints. Repointing of all the walls is recommended.</p> <p>The steel beams and bell frames have mild rust. It is recommended that this is removed and the steelwork repainted.</p>	<p>C</p> <p>C</p> <p>C</p>
<h4>3.2 Roof structures, ceilings</h4>		
<p>Condition / repair needs</p>

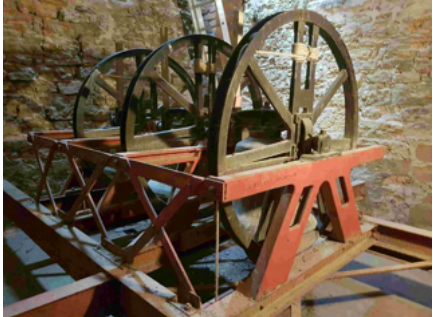
<p>Bell frame and steel beams rusty</p>	<p><u>Stage 1</u></p> <ul style="list-style-type: none"> <li>• Floor – boarded floor; concealed joists, deep beams.</li> <li>• Walls – random rubble with lime pointing.</li> <li>• Ceiling – timber boarded, stained and varnished.</li> </ul> <p><u>Stage 2</u></p> <ul style="list-style-type: none"> <li>• Floor - boarded floor; concealed joists, steel beams.</li> <li>• Walls – rubble stonework and lime pointing in satisfactory condition.</li> <li>• Ceiling – boarding in fair condition.</li> </ul> <p><u>Stage 3</u></p> <ul style="list-style-type: none"> <li>• Floor – boarded timber with dust from mortar and stonework walls etc. Steel beams with light rust.</li> <li>• Bell frame – light rust to steelwork; bell wheels and headstock is fair condition. Bell ropes satisfactory.</li> <li>• Walls – deep decay to jambs of louvred opening especially on south and north sides; many voids in rubble stonework generally.</li> <li>• Louvres – timber and mesh in good condition.</li> <li>• Ceiling – chunky rafters and beams supporting boarded sarking to lead covered low-pitched roof over.</li> </ul>

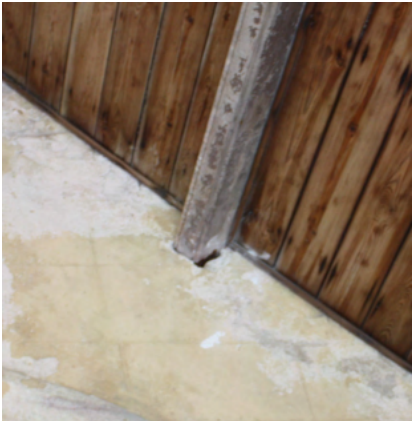
<p><u>Porch</u> Concealed rafters, exposed purlin and boarded sarking. The easternmost purlin appears decayed where it enters the Nave (see photo opposite). This needs investigation. Some staining of the boarding from past leaks. The boarding would benefit from a light-coloured stain preservative treatment.</p> <p><u>Chancel</u> Scissor trusses with exposed boarded sarking all with light stained finish. In good condition.</p> <p><u>Nave</u> Same construction as Chancel. Again, in good condition.</p>	<p>B</p> <p>D</p>

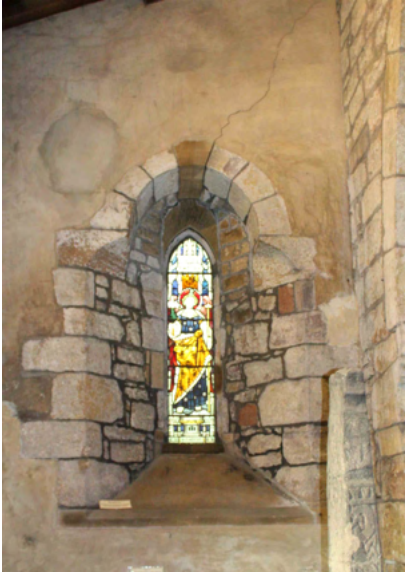
<p>Diagonal crack above Window s(x)</p>	<p><u>Porch:</u> Side walls - with render finish marked with stone joint pattern. In fair condition apart from some slight pitting. Inner face of gable wall – some surface decay to arched stones on LHS. This should be monitored.</p> <p><u>Nave:</u> Stonework and pointing above arcade, generally in fair condition. Arches and columns in good condition.</p> <p><u>Base of Tower (west wall)</u> The stonework is in fair condition. The lower part of the wall was obscured by the warm air blower unit. The inspector cannot comment on the condition of the wall behind.</p> <p><u>South Aisle</u> Wall westwards from the Porch door was re-plastered in 1981 and is in fair condition apart from some localised pitting. Elsewhere the wall is suffering badly from rising damp thought to be resulting from the external drainage system (see 2.2 for actions). There is a diagonal crack above the arch to window s(x). This will not be recent but needs investigation.</p> <p><u>North Aisle</u> The rendered walls has numerous horizontal cracks and has no decorative finish. The wall is damp at low level due to rising damp again due to the external drainage system. Once the rising damp problem has been resolved and the walls are dry the PCC should consider removing the render and applying lime plaster with a limewash finish.</p>	C

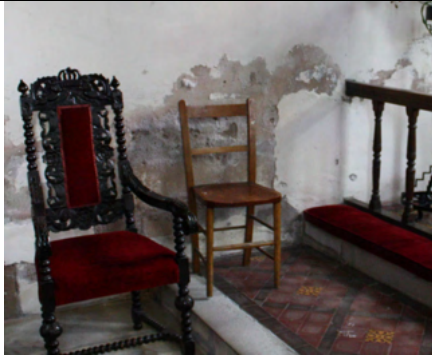
Blistering paint to Chancel

The plastered and painted walls are generally in fair condition apart from blistering paint at low level on the north wall (east of the Vestry door). Again, this is thought to be caused by rising damp from the drainage system. There has been water ingress on the east facing wall above the Chancel arch resulting from past leaks at the roof/wall junction.

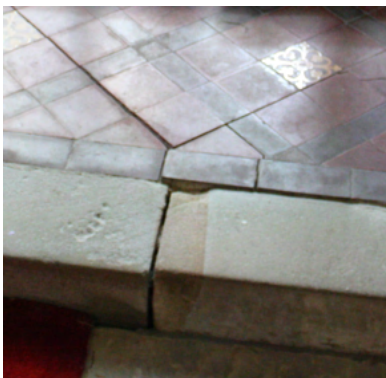
The Minton tiling in the Sanctuary is generally in fair condition but some of the tiles have become unbonded. The loose tiles should be re-bedded.

Sanctuary  
open joints to steps  
and unbonded tiling

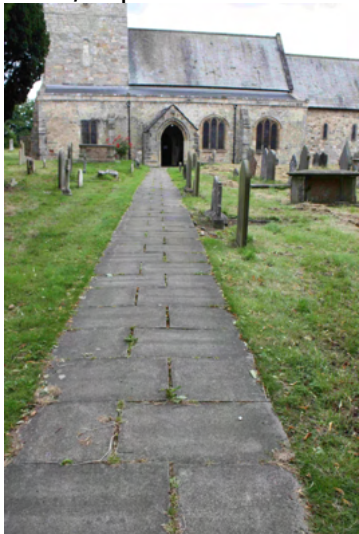
<p><u>Paths</u> The main path from the car park to the Porch comprises stone flags. These have been laid to fall to the outer edges but this has resulted in raised edges along the centre of the path causing a tripping hazard. It is recommended that the flags are levelled for safety reasons.</p> <p><u>Drives</u> The gravel car park and access road are in a serviceable condition.</p> <p><u>Access</u> Level access is afforded from the car park into the Porch and South Aisle.</p>	C

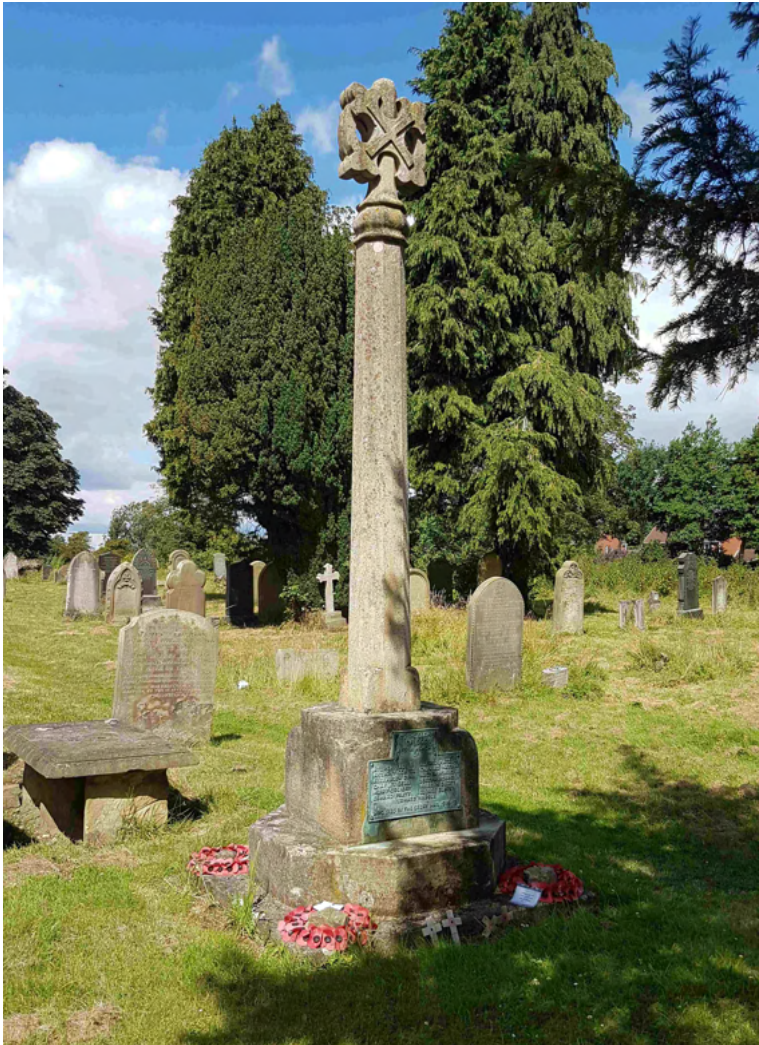
Photo

Stonework and bronze plaques in good condition.  
No actions required.

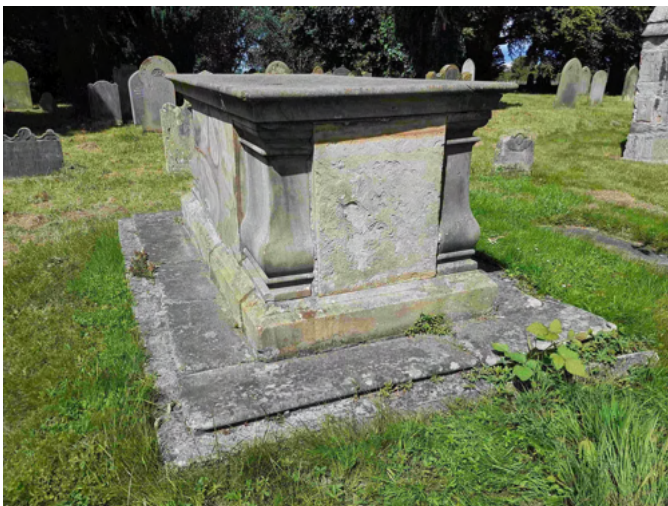
## Photo

Crack in table top; surface decay to end panels.  
Otherwise in sound and stable condition.  
No actions required.

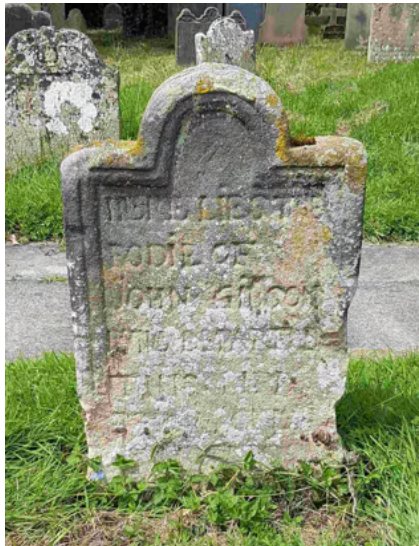
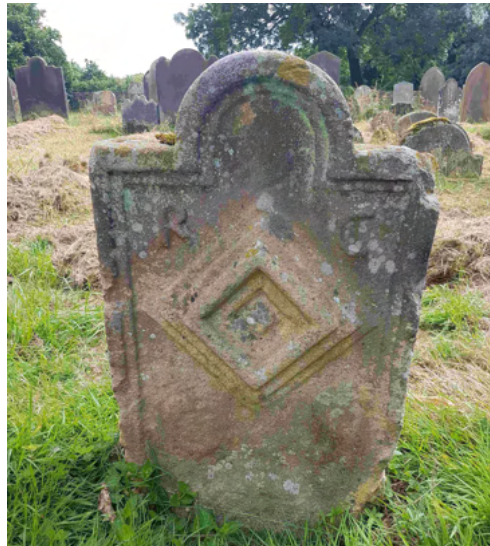
Damage to northern edge at low level. Loss of detail to inscription. Otherwise in sound and stable condition. No actions required.
