Job No. 21 54
Quinquennial
Church of St. James
Hamsterley

CHURCH OF ST JAMES

HAMSTERLEY

QUINQUENNIAL REPORT AUGUST 2021

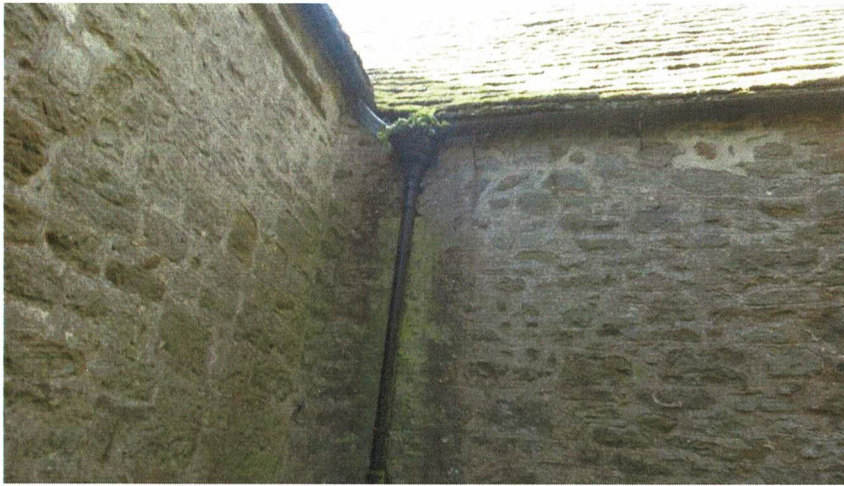
Photograph 1

Stonework walling is generally sound, with some evidence of local staining, caused due to roof water overflow. This has been caused by the hopper head being blocked (P1), which requires cleaning.

Clear out all rainwater goods and lead valleys to roof.

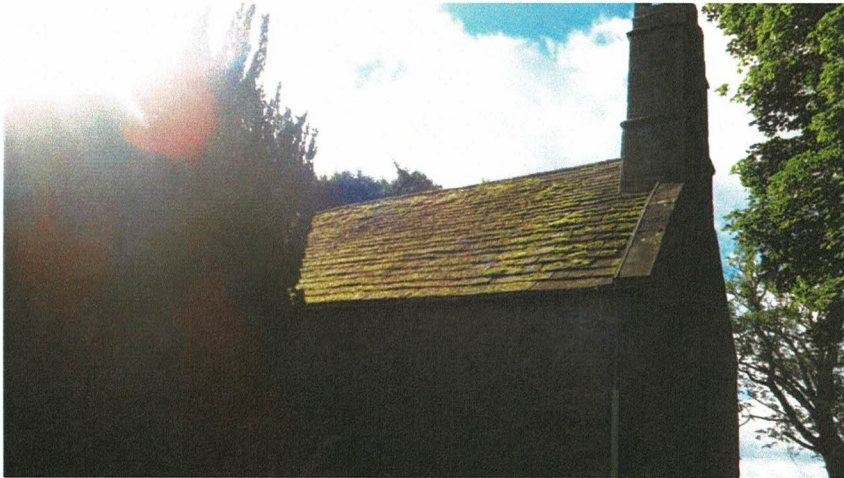
Photograph 2

Roof stone slabs were noted to be uneven, but generally sound. Some areas have heavy moss growth on the surface (P2). All mortar and lead flashings appear sound.

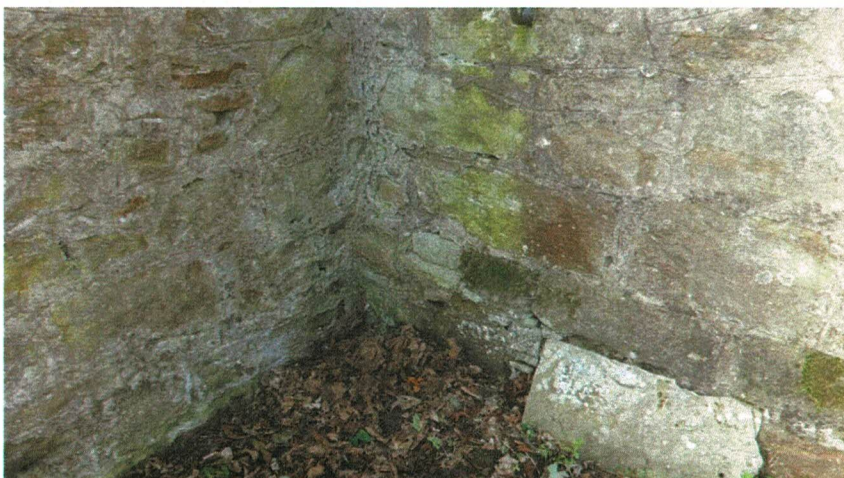
Photograph 3

Rainwater goods discharge into gully and into water butt (P3).

Ensure water butt rainwater collection point discharge is operational

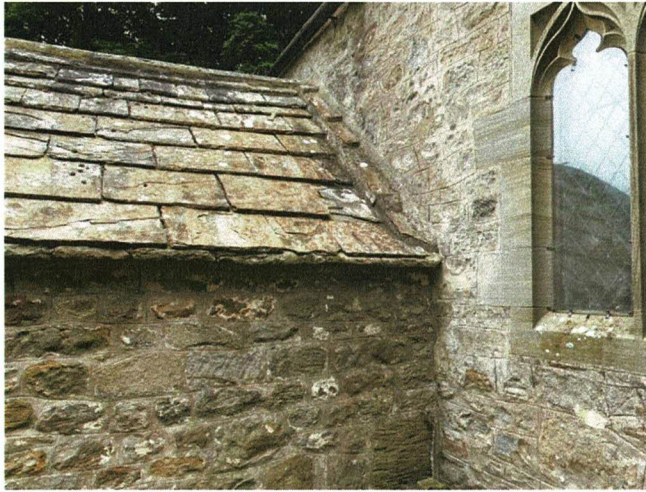
Photograph 4

The east side of the porch roof one stone roof slab has substantially delaminated and requires replacing (P4).

Replace missing stone roofing slab.

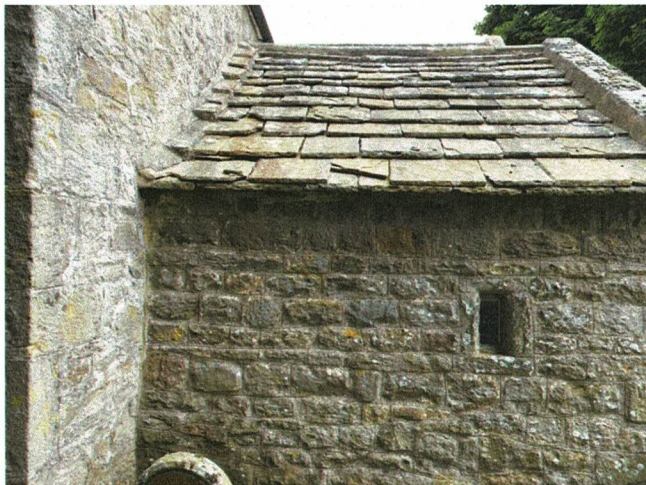
Photograph 5

The west side of the porch roof several stone slabs have fractured and require replacement (P5).

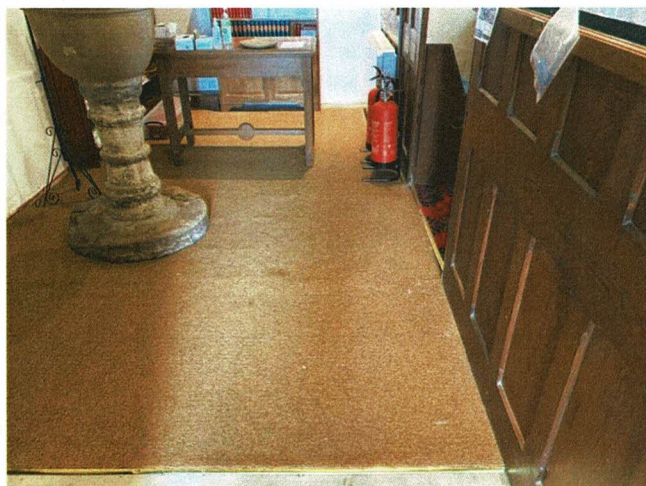
Photograph 6

The floor has an inlaid inscribed headstone (noted from last quinquennial) which is now covered by carpeting (P6).

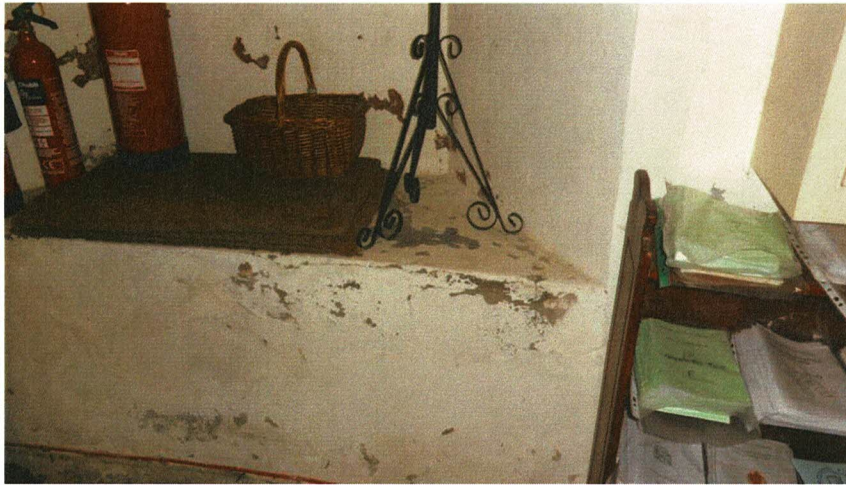
Photograph 7

The West gable has evidence of damp, which has subsequently caused the internal finish to crack and blister in places (P7).

Remove areas of loose/flaking paintwork and repaint with a breathable product

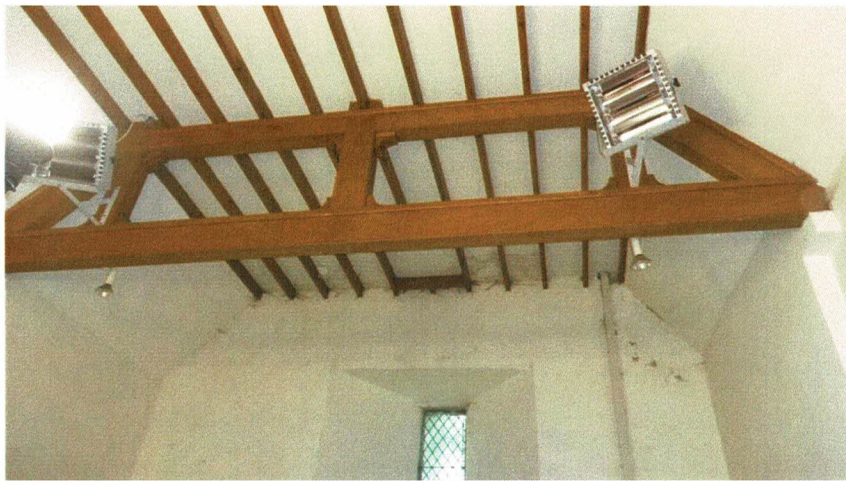
Photograph 8

The roof/ ceiling is subdivided by the lower parts of three trusses, which are clad in heavy decorative pine mouldings. There are joists spanning between the trusses with painted plaster panels between them. There was noted to be evidence of water ingress, with staining to some plaster panels (this may be historical as noted in the previous report), prior to maintenance works being carried out on the water tabling to the West gable (P8).

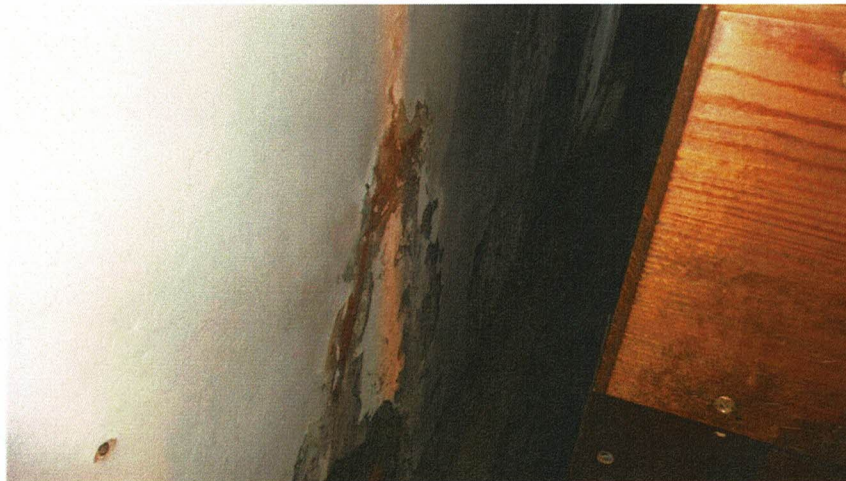
Photograph 9

The west wall is rendered and painted (incorporating a carved grave cover), the wall is indicating evidence of damp at low level, with some cracking, blistering and peeling. The organ is located adjacent to this wall (P9).

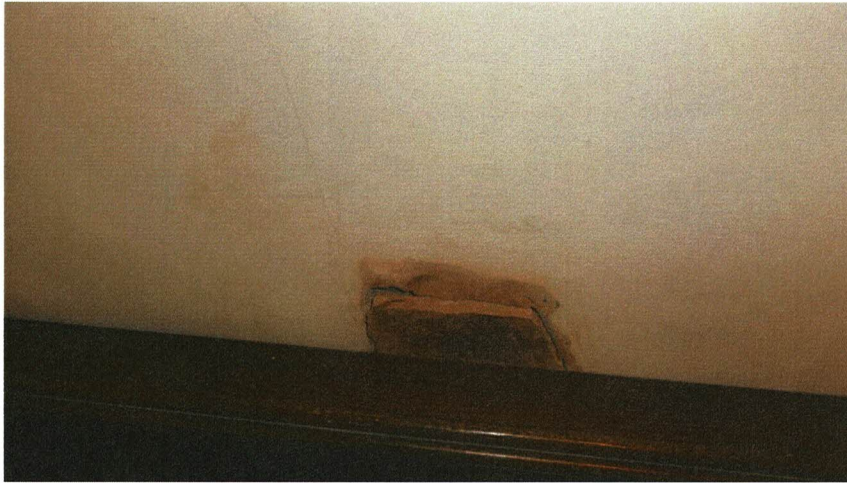
Photograph 10

The West wall incorporates a memorial stone and grave cover. There are two recesses, crudely cut into the wall, approximately 150mm x 150mm of unknown depth, 1.0m above floor level (P10).

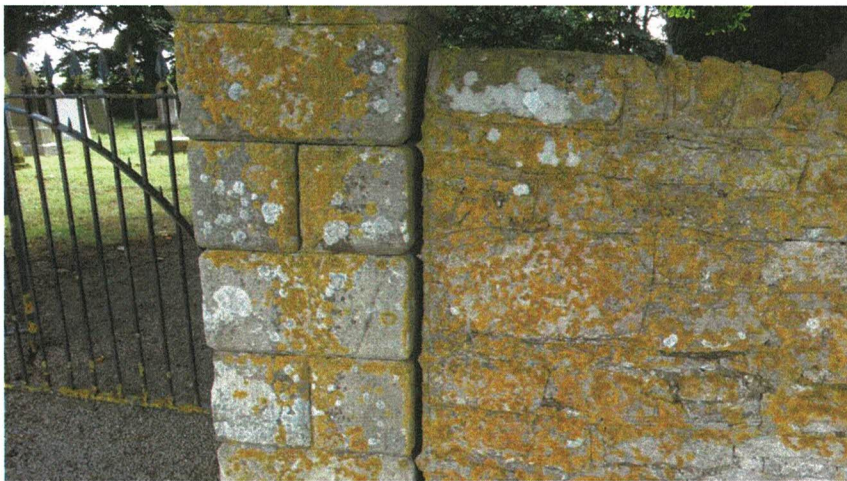
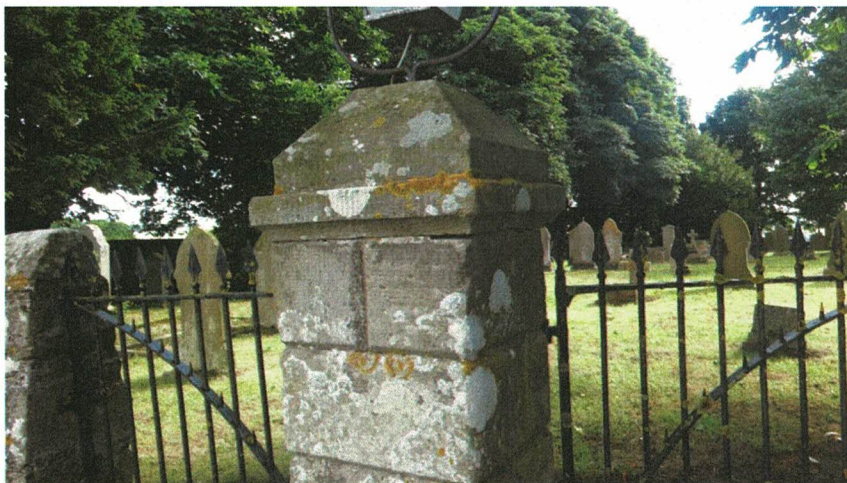
To the South of the gates the mortared stone becomes a dry stone wall. There is a gap between the RH pillar and the wall indicating movement and the pointing under the coping was noted to be spalling (P11 & P12). There was noted generally to be vegetation growing between the stones.

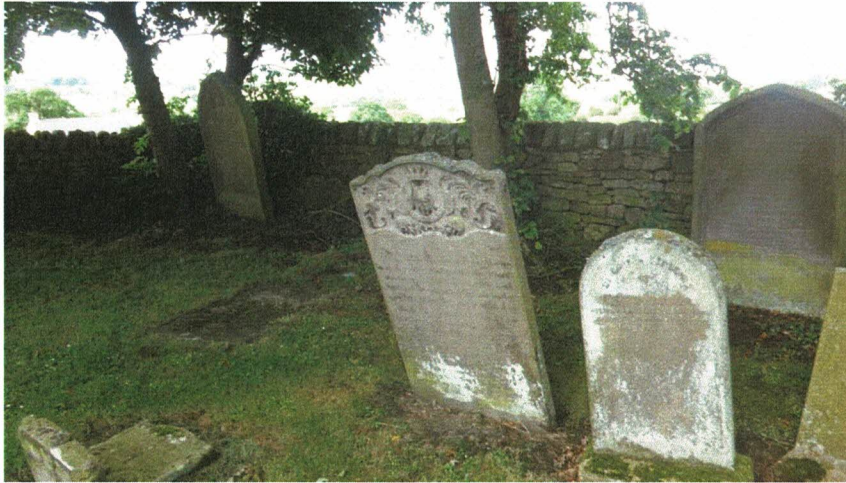
Photograph 13

Some headstones have been laid horizontally, presumably having become unstable (P13).

A watching brief should be maintained on the stability of all headstones.

Monitor stability of headstones within the Churchyard

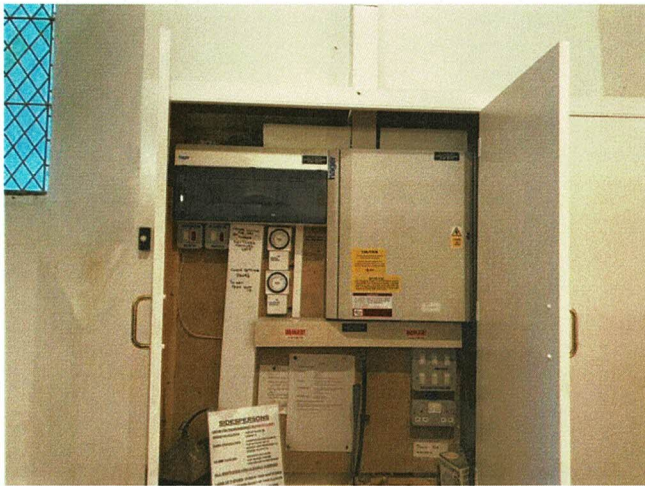
Photograph 14

Installed in 1988, operates the heating, lighting and power installations (P14).

The mains supply is 415V and all circuits are wired in MICC cable and circuits are protected by MCB's and earth leakage switch.

No test Certificate has been seen.

It is recommended that the heating and electrical systems be tested and certified by an appropriately qualified person. This report is based solely on a visual inspection of visible components and no instruments have been used or internals or switches/ sockets etc.

Obtain certification for electrical installation

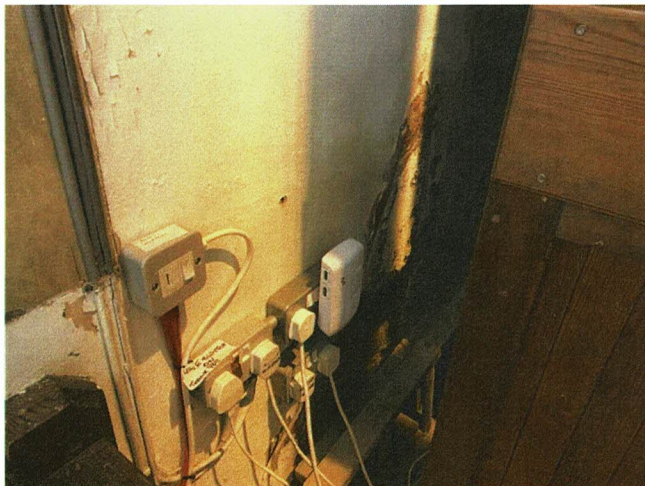
Photograph 15

Exposed cable runs are generally untidy (P15).
