CHURCH OF ST. OSWALD, HARTLEPOOL

REPORT ON QUINQUENNIAL INSPECTION NOVEMBER 2023

Inspection No: Three
Date of Inspection: 24th October 2023
Previous Inspection: 16th October 2018

Geoffrey Holland Dip Arch, Dip Conservation Studies, RIBA AABC ACA FRSA

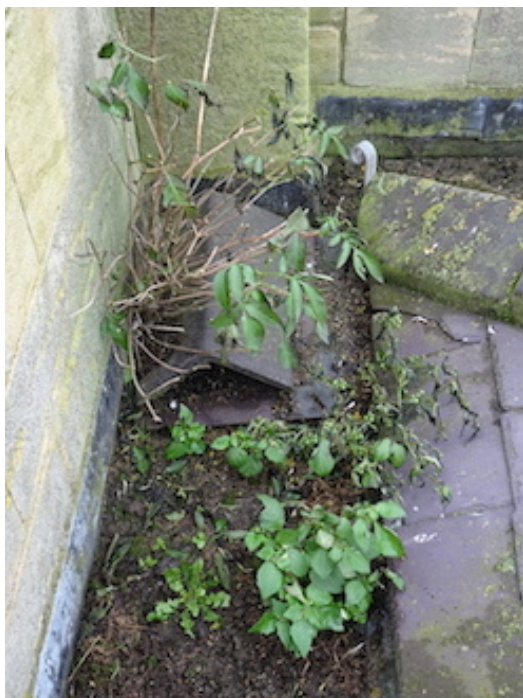
2.2.1.5 Where visible the sumps are approximately 100mm deep and lined in lead, and in fair condition. Normally they would cope admirably with the small volume of water from the Tower, but it appears that they have not been inspected and maintained regularly, and both the sumps are badly blocked with soil, leaves and tress and should be cleared immediately.

01 Tower Roof south side - blocked gutter and sump

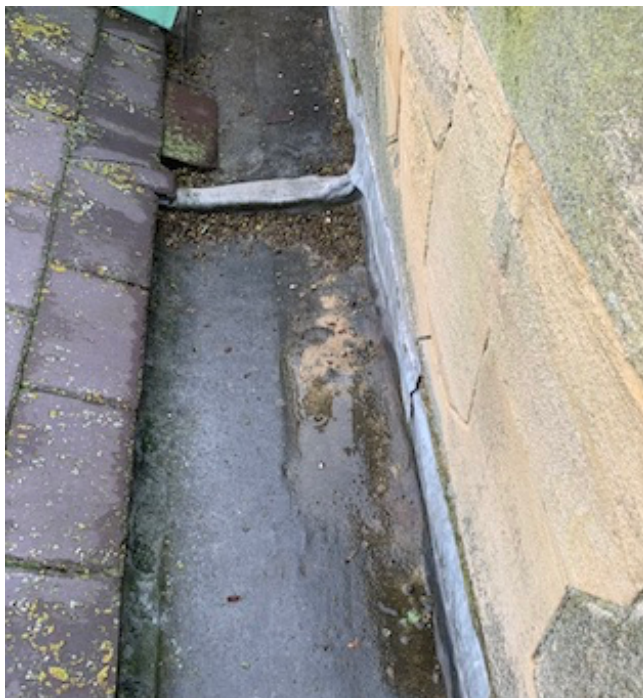
2.2.1.2 The leadwork to the gutters is in fair to poor condition where visible and the bays lengths seem a little too long. Two sections of gutter near the roof access hatch on the north side depress when stood upon.

2.2.1.4 The decking beneath the lead to the north parapet gutter has sunk slightly just north of the centre point in two places and any affected boarding or support timbers should be replaced at the same time as 2.2.1.2 above.

02 Tower Roof north side – sinking substrate in gutter below leadwork

Although some of the leadwork was patch repaired in 2017 these problems still exist and ideally the whole of the north gutter leadwork should be renewed – see also 2.2.1.4 below.

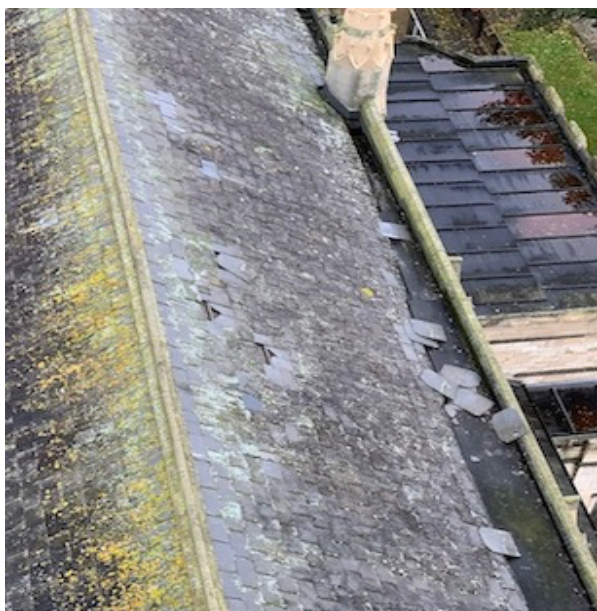
- 2.1.7 There are slates missing on the south slope of the Nave roof and if not attended to soon, water penetration could start to potentially affect the timber rafters below. Attention to roof coverings should be a primary concern to avoid any potential future structural deterioration.

03 Nave Roof south slope – missing, broken or slipped slates.

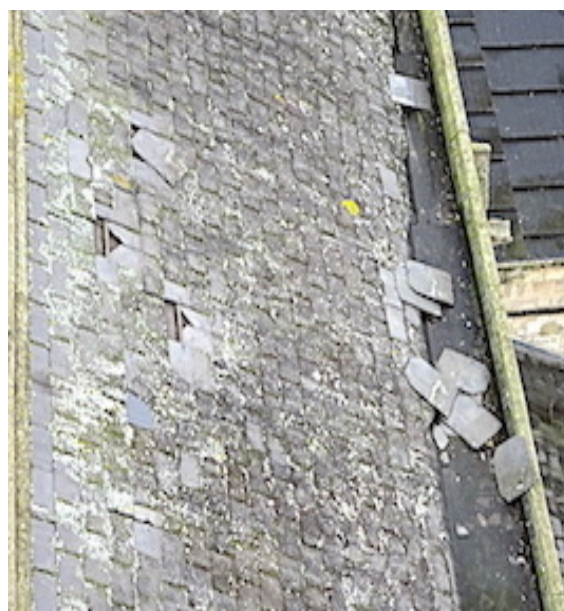
04 Nave Roof south slope – close up of slate defects.

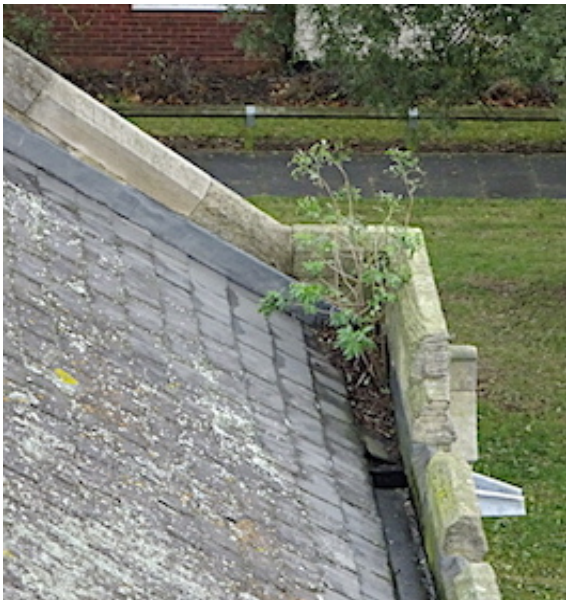
2.2.2.2 The parapet gutters are lined with 'Masterform' (lead substitute) and in generally good condition; so too are the sumps, copings between the parapet crenellations and cover flashings. There is, however, a build up of soil at the far east end of the southern parapet gutter in which an elder bush is growing, and this and the other detritus should be removed as soon as possible.

05 Nave roof south slope – tree growing at east end gutter!

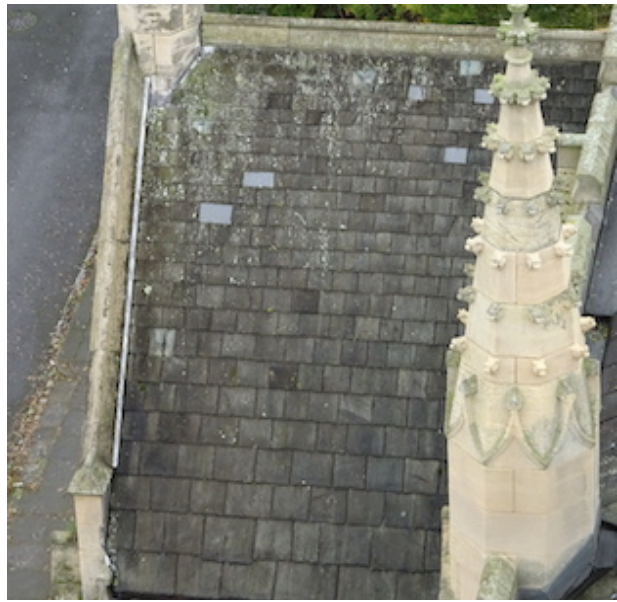
- 2.2.7.5 The west roof slope is likewise covered with Burlington/Westmoreland slate laid in diminishing courses and random widths. They are also generally in fair condition but at least 6no. slates are cracked, slipped or missing. They should be replaced whenever possible. M

06 Organ Chamber roof west slope – slipped slates at ridge

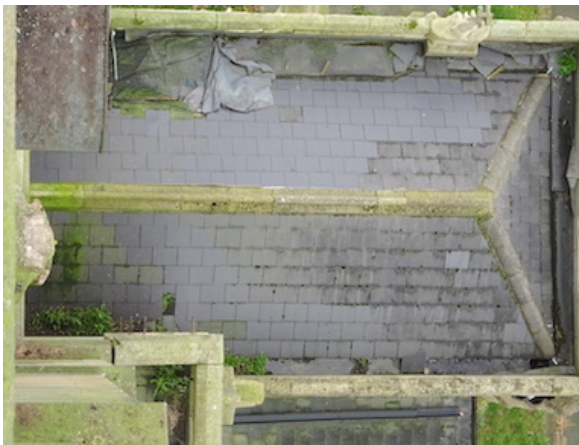
2.2.10.1 Hipped roof at north end and all three slopes covered with relatively recent fibre cement 'slates', all of which are in good condition. Many slipped slates are still lying in the gutters.

2.2.10.3 The parapet gutters appear are apparently lined in 'Masterform' but their condition is impossible to assess due to the accumulations of slates, and temporary coverings.

07 North Porch roof - slipped slates and temporary covers etc.

** It is understood that repairs to the roof and gutters on the North Porch are to be carried out soon.*

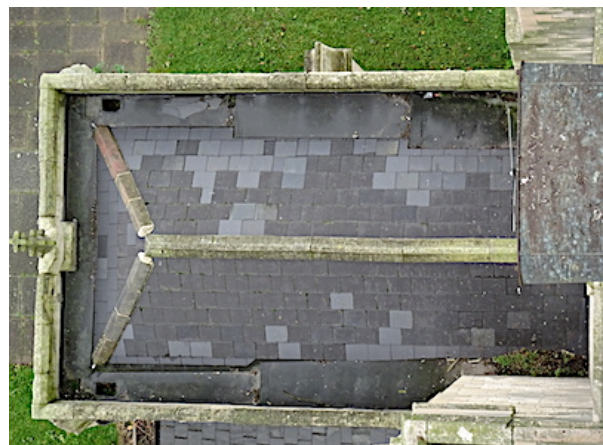
2.2.11.3 The parapet gutters are lined in 'Masterform' and appear to be in good condition. However, there is a build-up of soil and plant life in the east gutter at the north end where the gutter adjoins the Tower.

08 South Porch roof – grass build up at northeast corner gutter.

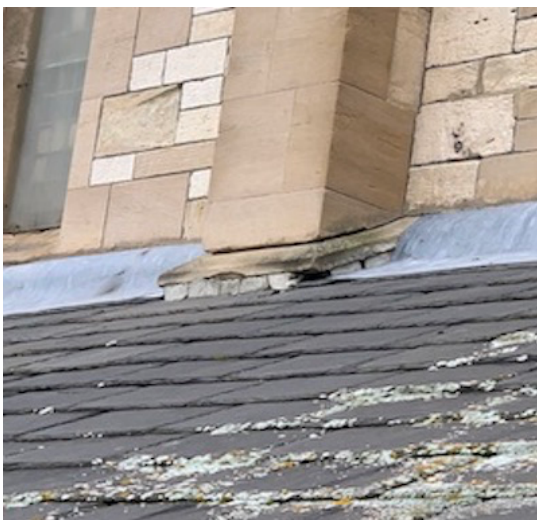
2.2.9.2	The roof junctions at the south Nave clerestory walls and window sills are covered in lead and in good condition. There are amounts of defective and missing mortar at the junction of the roof with the south clerestory buttresses. These defects should be repaired within the quinquennium.	C

09 South Aisle roof junction with buttress – defective mortar.

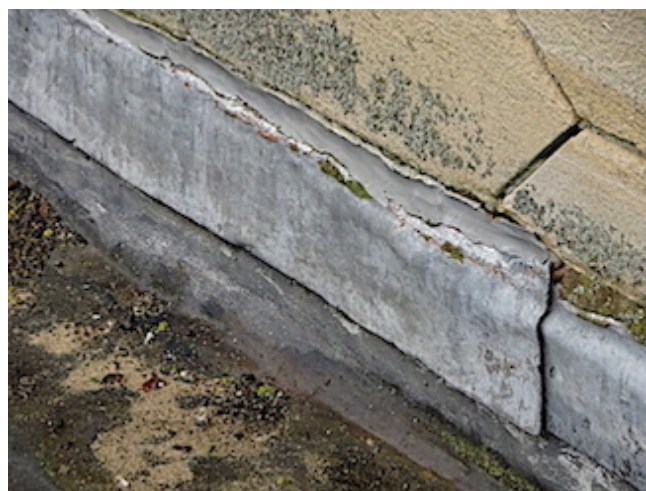
10 Tower roof north parapet – defective pointing

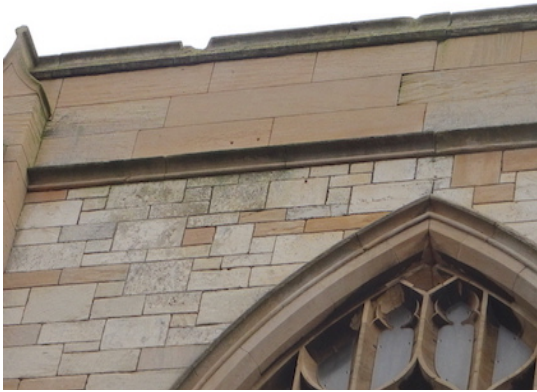
11. Nave north parapet – defective stones at coping

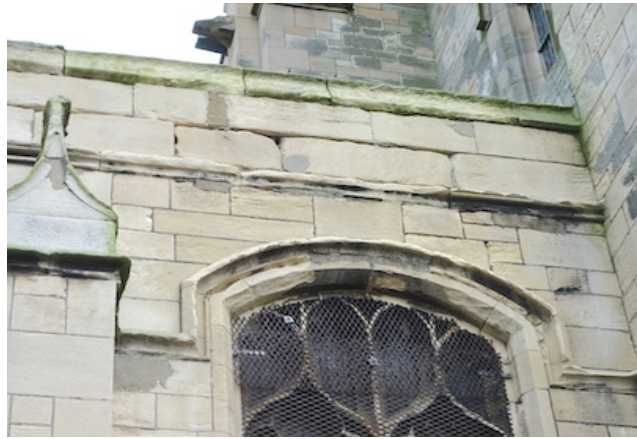
12. North Porch west face – defective and eroded stones and open joints

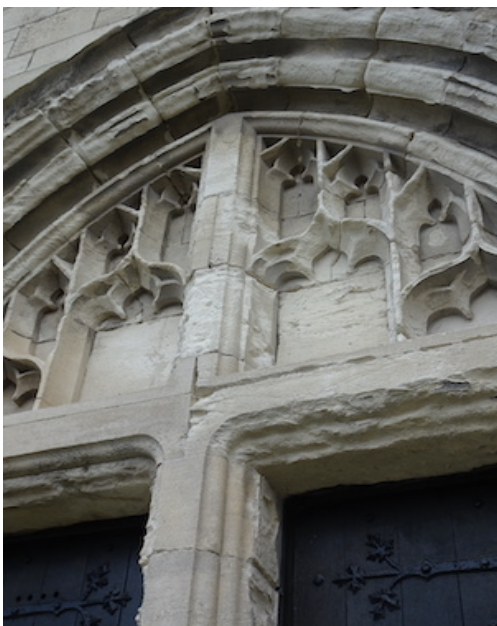
13. North Porch west face – eroded doorway stonework.

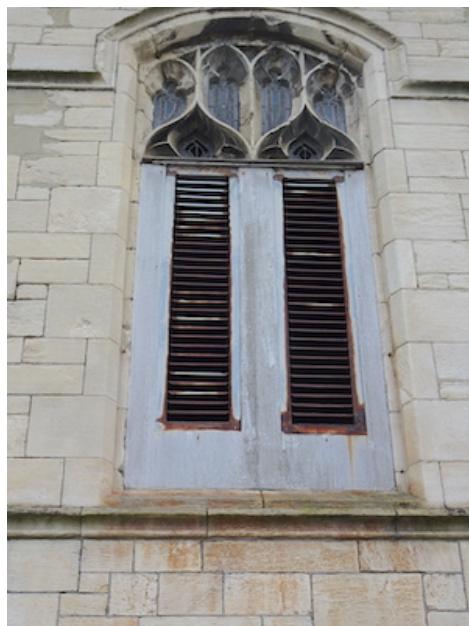
14. North Porch north face – blocked window opening.

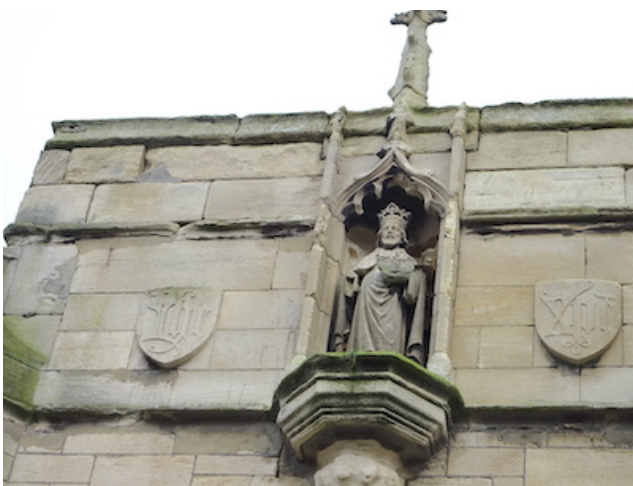
15. North Porch west face – eroded niche, label and pinnacle stonework.

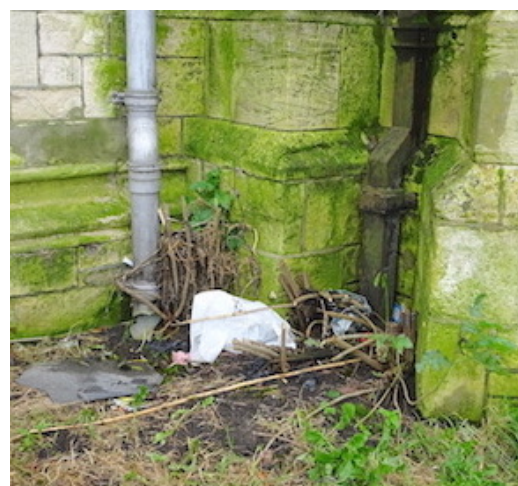
16. North Porch east face – growths at downpipe gully level

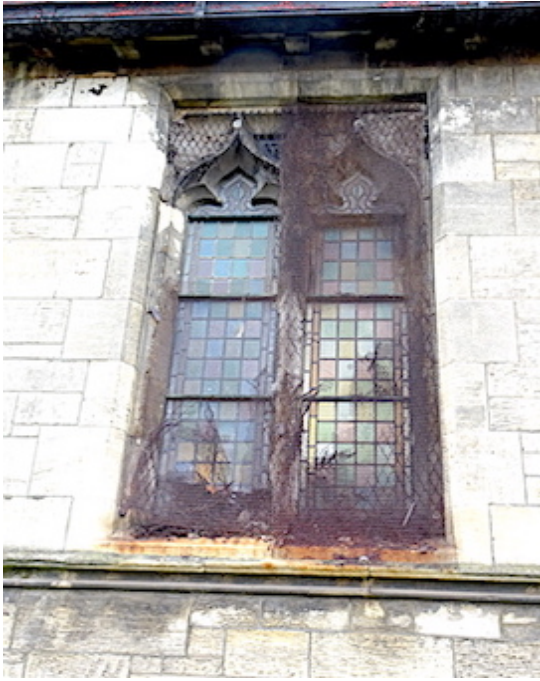
17. North Aisle window – damaged window guards

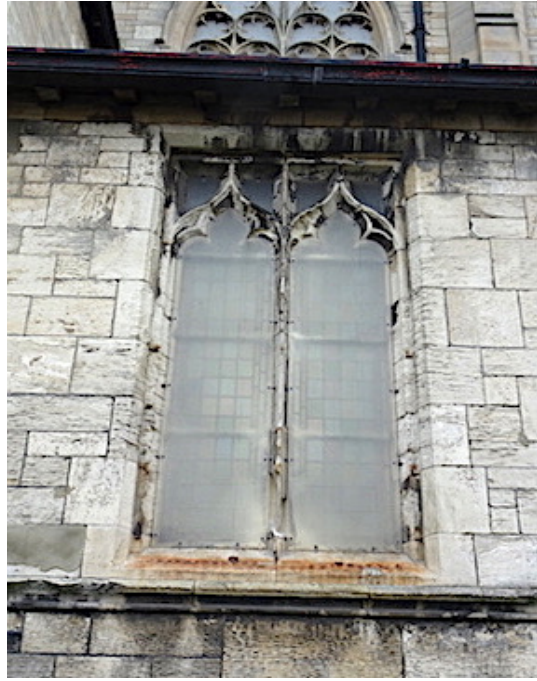
18. North Aisle window – damaged window mullion stonework

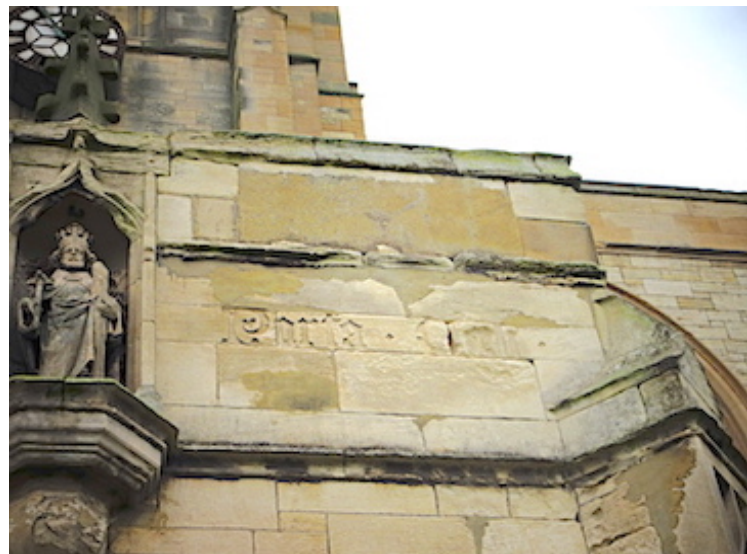
20. South Porch – defective stonework on south front

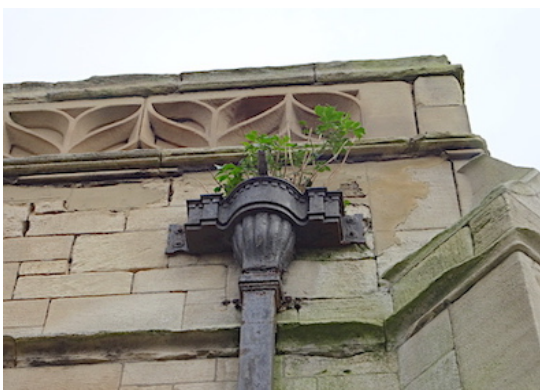
21. South Porch – blocked rainwater hopper on west face

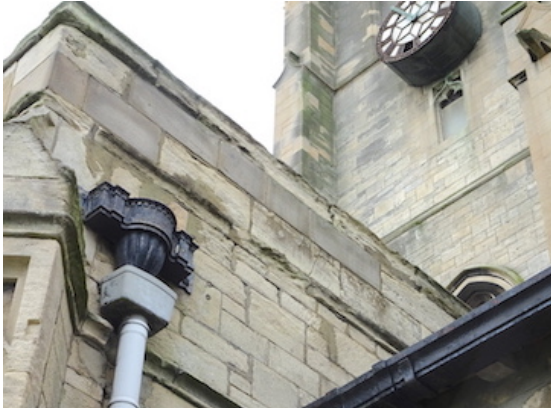
22. South Porch – east wall high level, eroding stonework

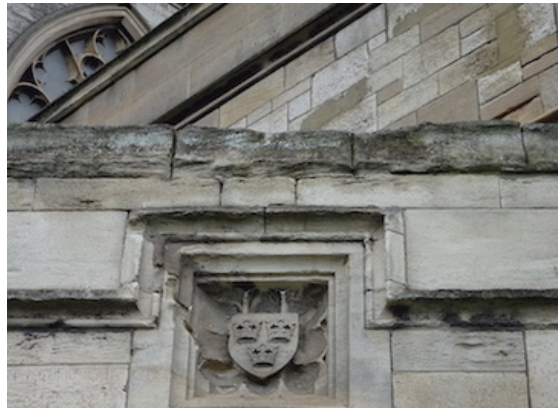
23. Lady Chapel Porch – eroding stonework above doorway

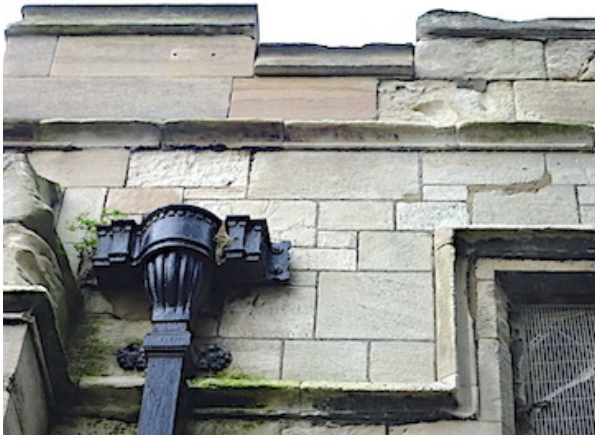
24. Lady Chapel south wall –eroding stonework & blocked hopper.

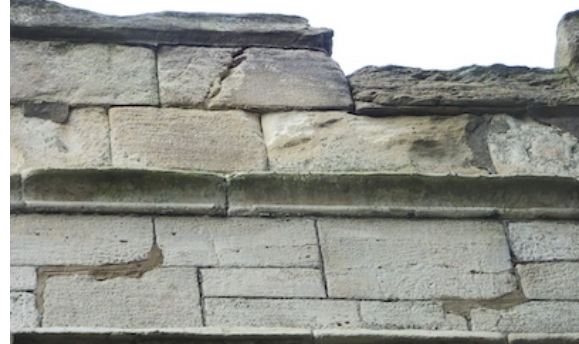
- 2.1.4 There is some significant fracturing visible at the centre of the south wall of the Lady Chapel but otherwise there are no signs of serious or significant movement, settlement or fracturing.

25. Lady Chapel south wall –eroding stonework

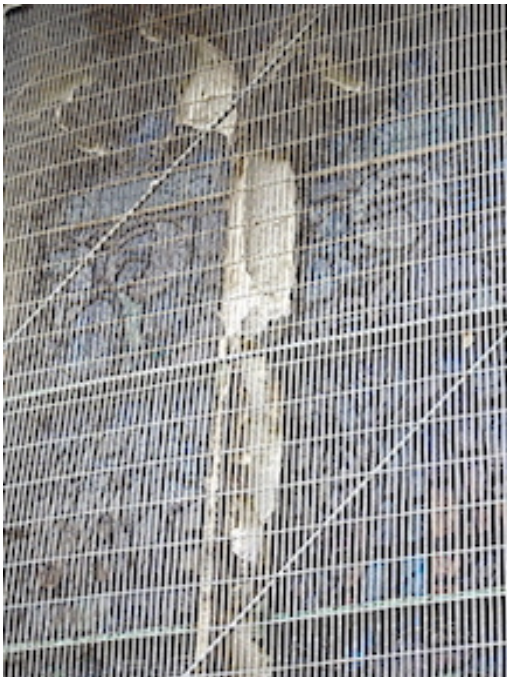
26. Lady Chapel south side–eroding window mullion.

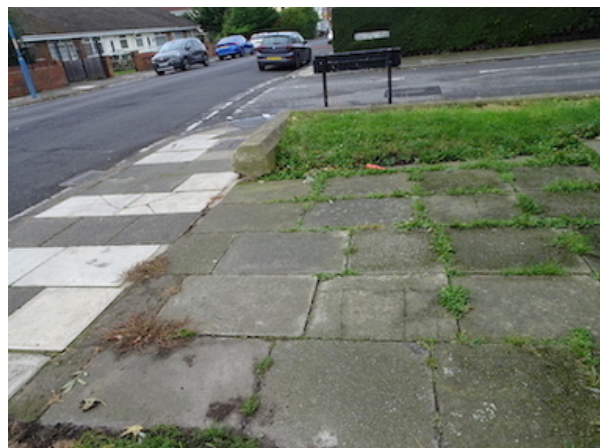
27. South entrance path – open joints and weeds.

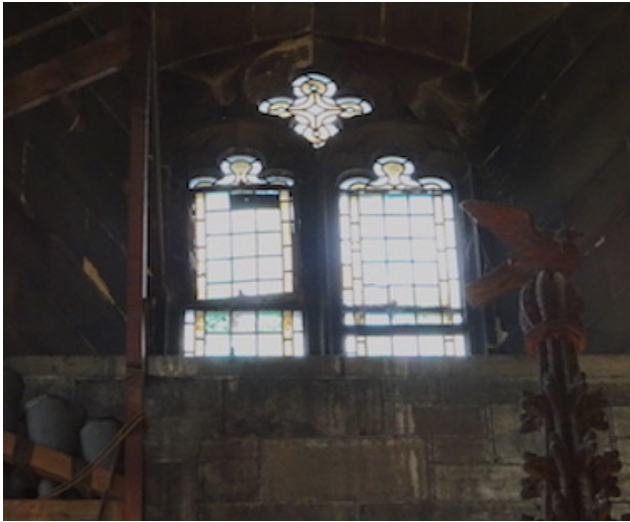
28. Tower upper part of base stage – window glazing defects.

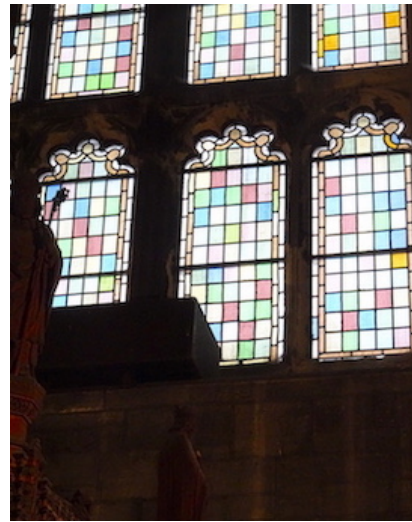
29. Tower west window – buckled glazing panels

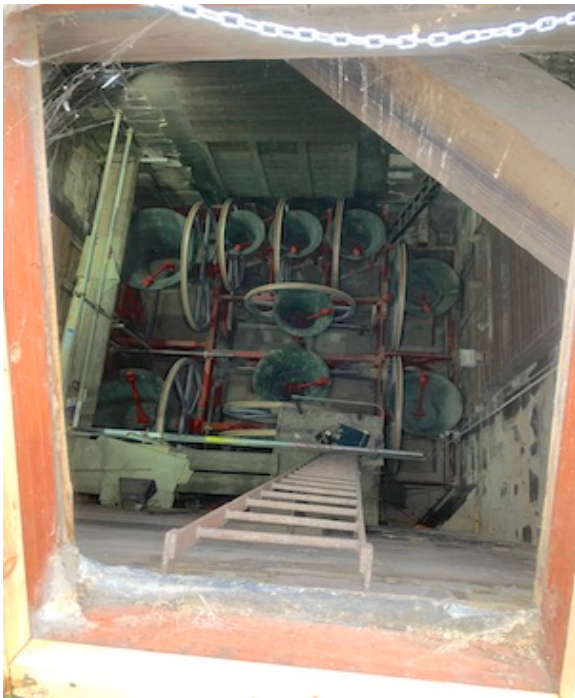
30. Tower Belfry – looking down to bells from unguarded ladder.

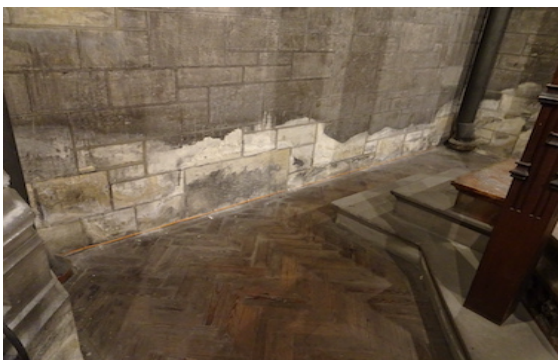
< 32. Tower Base west wall – rising damp

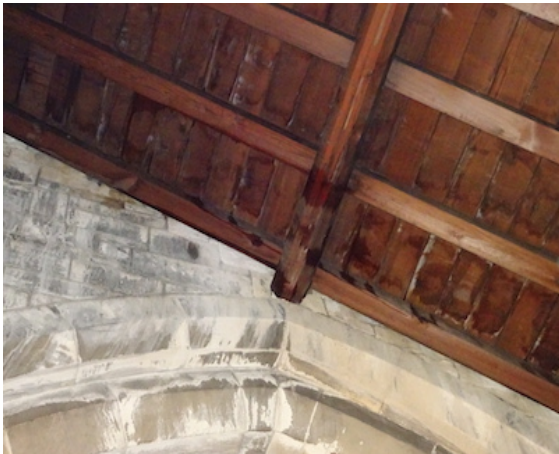
35. North Aisle west end – leaks from roof junction.

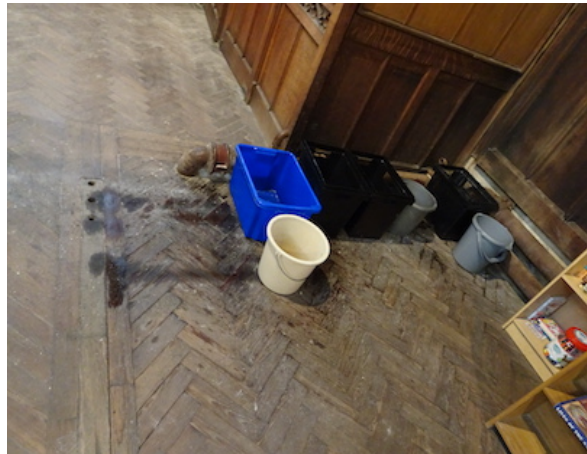
36. North Aisle west end – buckets catching the leaks from above

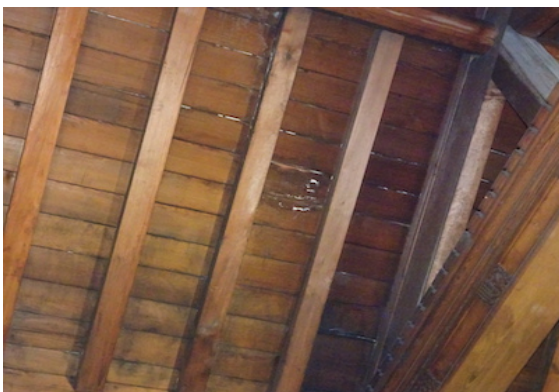
37. North Aisle roof – white marks/stains on boarding to note

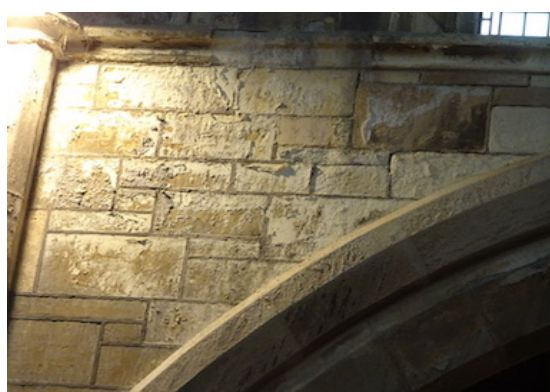
38. Nave north clerestory wall – eroding stonework

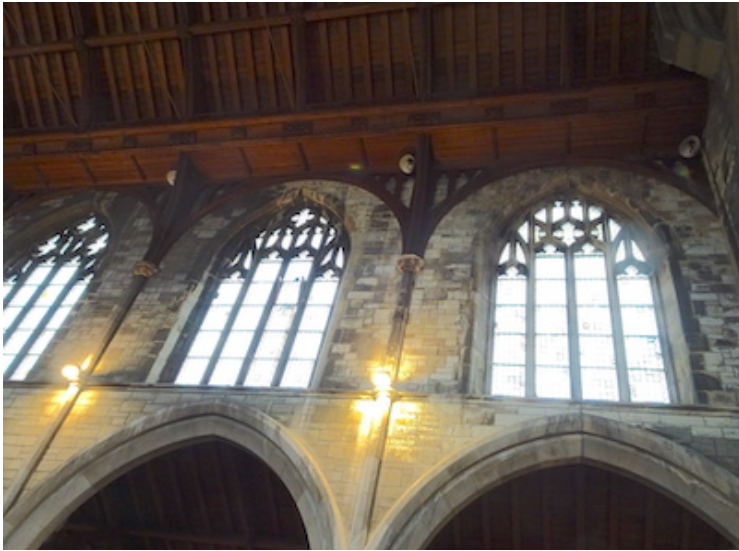
39. Nave north clerestory wall – stained stonework at high levels

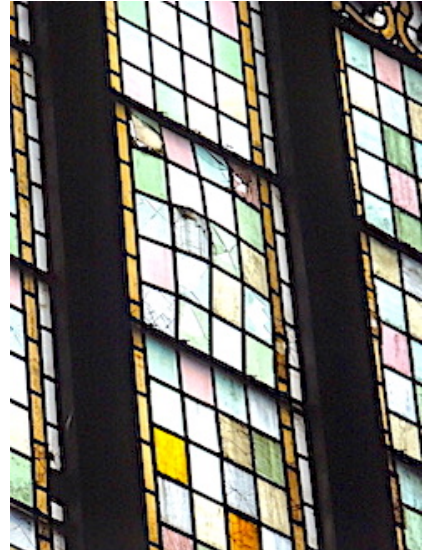
40. Nave north clerestory wall – glazing defects

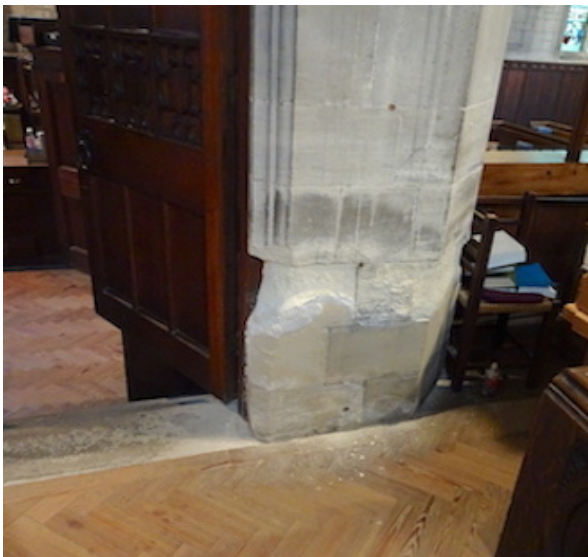
41. Chancel - north side doorway stonework decay down to Vestry

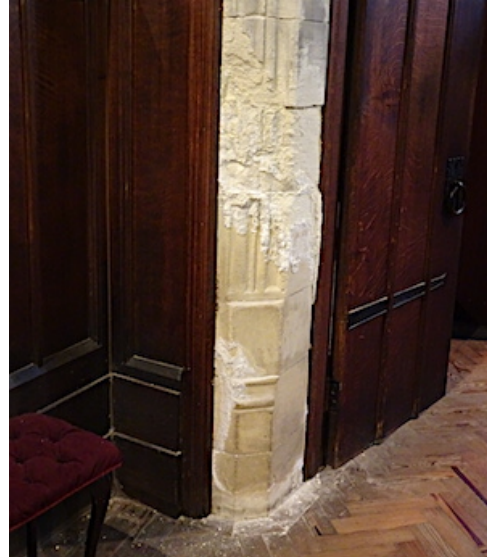
42. Lady Chapel – eroded stonework to east doorway

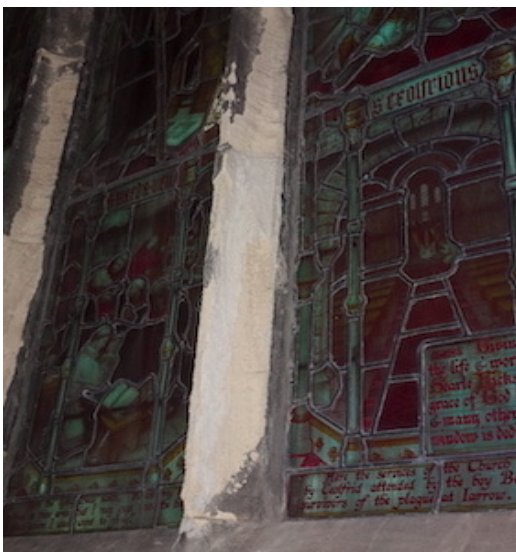
43. Lady Chapel – eroded mullions on south windows

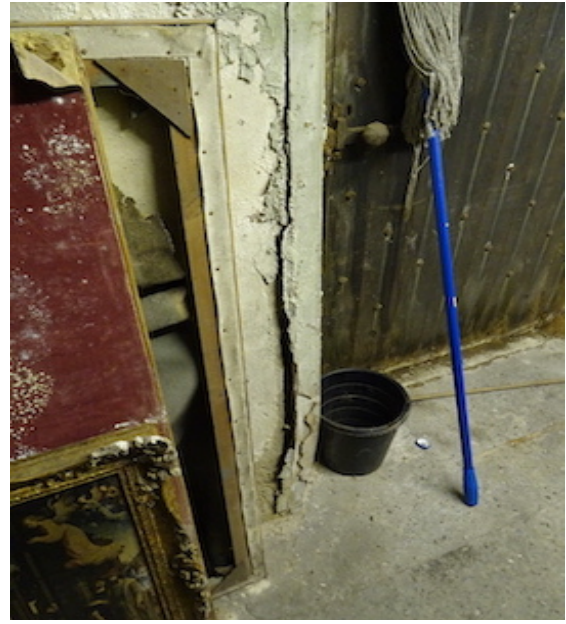
46. Passage below Chancel – defective reveal to east dooway
