**QUINQUENNIAL INSPECTION REPORT  
OF  
ST. IGNATIUS, HENDON, SUNDERLAND**

**QUINQUENNIAL INSPECTION AND REPORT**

**February 2020**

**David Beaumont BA (Hons) Grad Dip, RIBA, AABC**

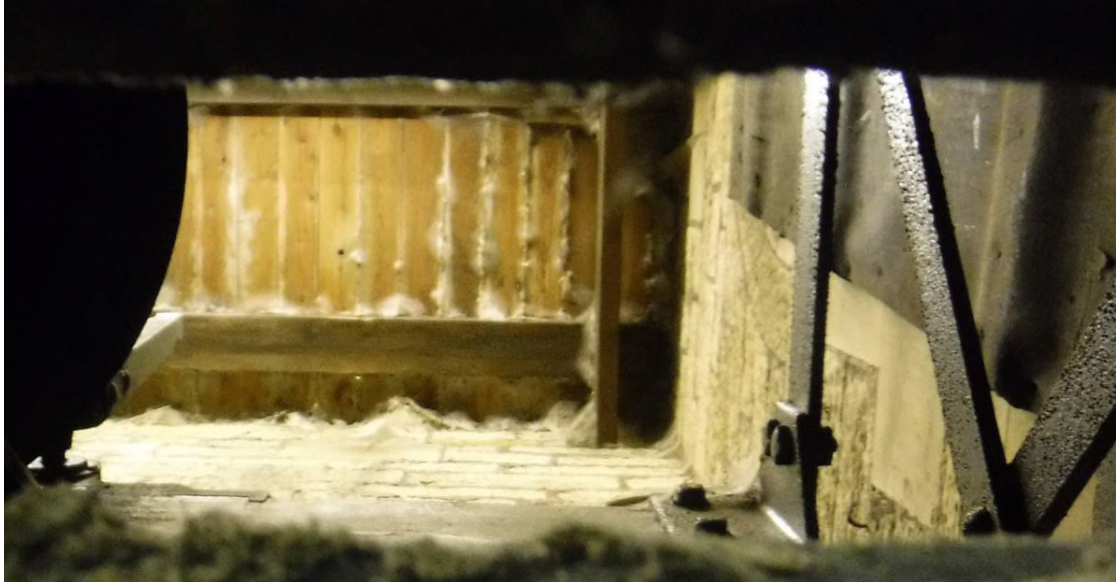
*Belfry ceiling showing white marking suggesting guano build up and possible timber decay*

Pigeons are entering the spire lucarnes (the ventilating openings) and I have a concern that there may well be a high amount of guano at the base of the spire- the belfry ceiling- because it is badly stained- that might be causing some damp problems and that might affect the spire though there is no obvious external sign of problems seen from the ground via binoculars. The interior of the spire hasn't been seen for many years and it is vital that it should be also inspected.

The interior of the belfry and spire were not inspected due to poor access and the church should arrange adequate inspection facilities to enable this to happen urgently.

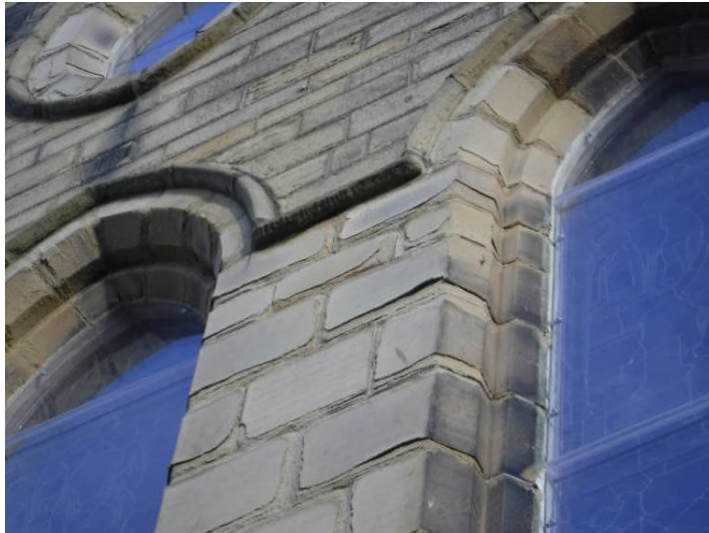
The surface erosion to the masonry continues. It is most noticeable on the ashlar work at the west tower and south side.

The work is of a high standard with narrow joints but it is losing its crust. It does make me wonder about the quality of the mortar in the joint and whether this has caused the problem.

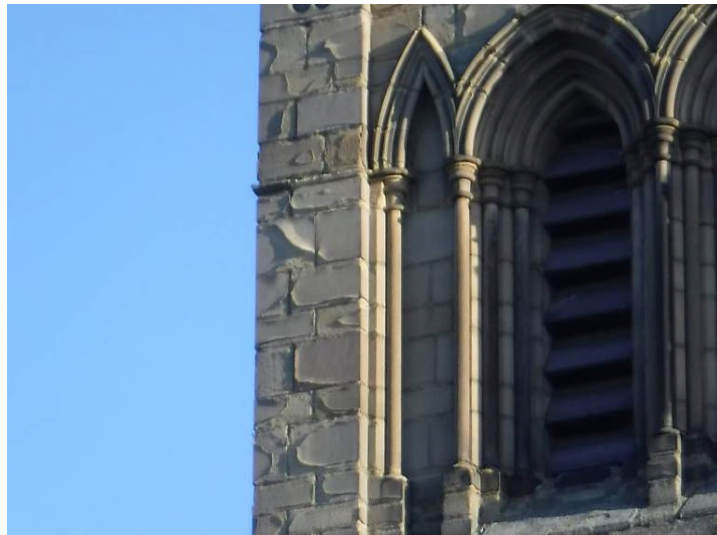
There are some high level items that may well come down and they are close to the footpath and the south west corner of the building, but as to their likelihood of injuring a passer-by it doesn't seem to be high because these are just flakes and at high level they may well get blown away from the footpath below it. There are small pieces of stone at the bases of the walls and they don't appear to be a hazard. The dilemma is that the cost to remove a small amount of this material is so high relevant related to the risk. The church will no doubt in the future need to go round and de-shale again but we are not at that tipping point yet it may well be another 5 – 10 years before that occurs.

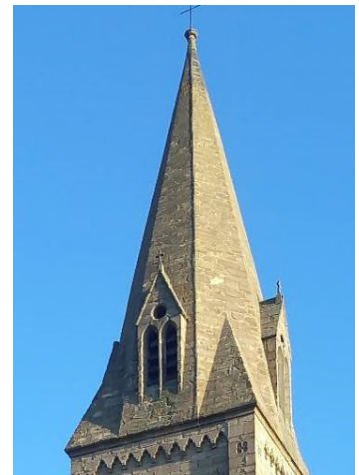
**B** **Belfry:** Unable to access. This room contains the bells but could just get a look at it through the trapdoor and the following observations are:

- Ceiling – Beamed floor showing white marking at board joints and perimeter suggesting guano build up and possible decay. It looks to be quite damp, there is a lot of cobweb on it and I wonder if that's as a consequence of guano build-up that it is wet. Perhaps the lancets are letting in water.
- Walls – Unable to see.
- Floor – Unable to see. The floor is lead-covered because I guess that is because of rainwater coming through the

The ladder to the belfry is timber and has got a broken rung. It is not fixed properly and should be replaced with an aluminium raking ladder, fixed at the head and foot. The hatch is too heavy to lift and the bells are in the way and that is why I couldn't inspect any further. There is a secondary aluminium ladder leading to a secondary access. Two accesses into the belfry? Why?

**Recommendation:** replace ladder, lighten hatch, and provide grab rails. Reconnoitre the belfry and establish what is needed to access the spire. Beware of possible major biohazard when accessing the spire.

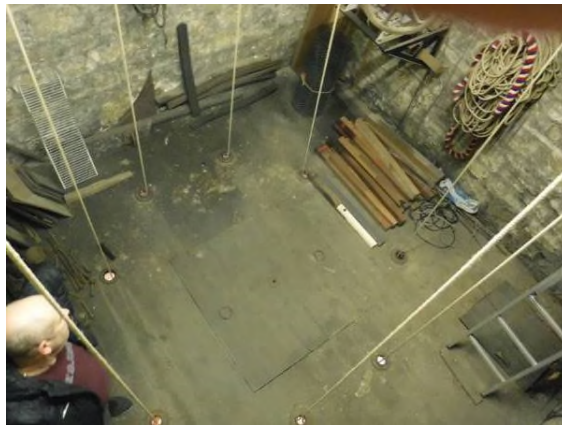
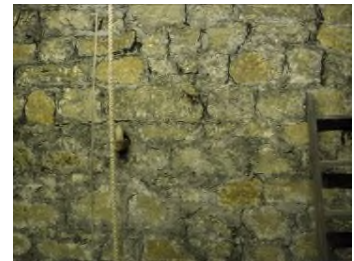
#### D Deafening Chamber:

- Ceiling – Heavily beamed and joisted boards which look sound. Some rusting bolts to it.
- Walls – Exposed stonework pointed up with hard cementitious pointing. Signs of old industrial pollution in the cracking where it is black, slightly sooty but all sound.
- Floor – Boarded floor all reasonably sound and dips a bit into the middle where there is a bell hatch. The floor is a little bit dusty.
- General – Room has various bits of lumber that need removing. The room contains the electric motor which chimes the tolling bell. Difficult to exit ringing room ladder.

**Recommendation:** sweep up room. Provide grab handles

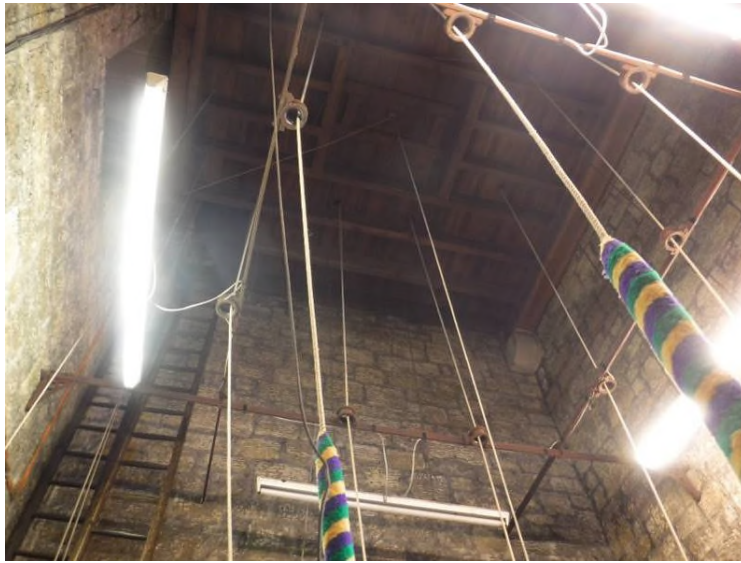
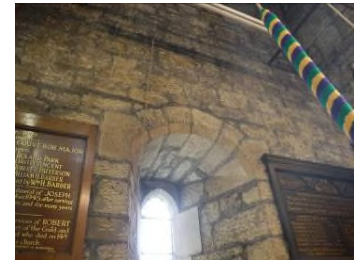
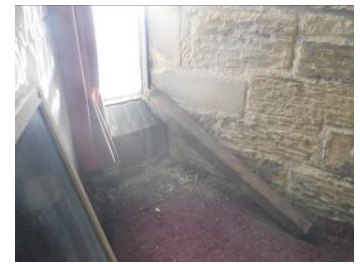
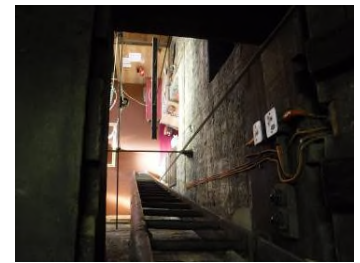
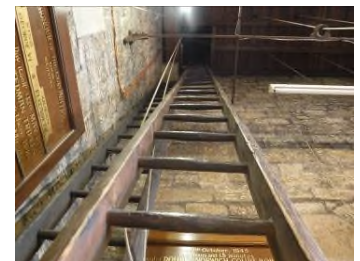
**Ringin Room:**

- Ceiling – Timber beams and joisted floor, looks ok, they are set on stone corbels that look sound.
- Walls – Exposed stonework, cement pointed, some minor easing's at the arches of windows but there is no structural cracking.
- Floor – Carpeted reasonably sound, central bell trapdoor.
- General – Room has simple fitting out of some dado panelling in modern materials with some low seating all generally sound.
- Glass is cracked in places does have metal guarding but I guess this is possibly come from air rifles. Access door into the west end looks ok.
- The timber ladder bounces and is not conducive to a safe inspection and you have to negotiate the rope frame at the upper part. It needs replacing with an aluminium ladder at a less steep pitch.

**Recommendation:** replace ladder promptly to enable safer access to inspect the belfry and spire.

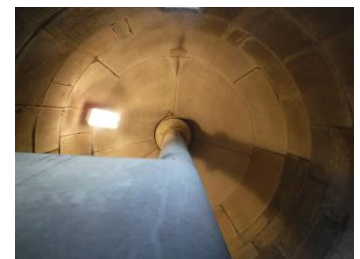
**C**      **Base of Tower:** This forms the entrance in the south west corner and it is split into two, with a draught lobby of elementary timber partition.

The secondary space is the principal lobby. Ceiling decoration is breaking down a bit and there is some damp showing at the walls bottoms but of no consequence. The door looks like it might be catching on the floor and that itself is partially decorated.

**Recommendation:** ease door, update decoration

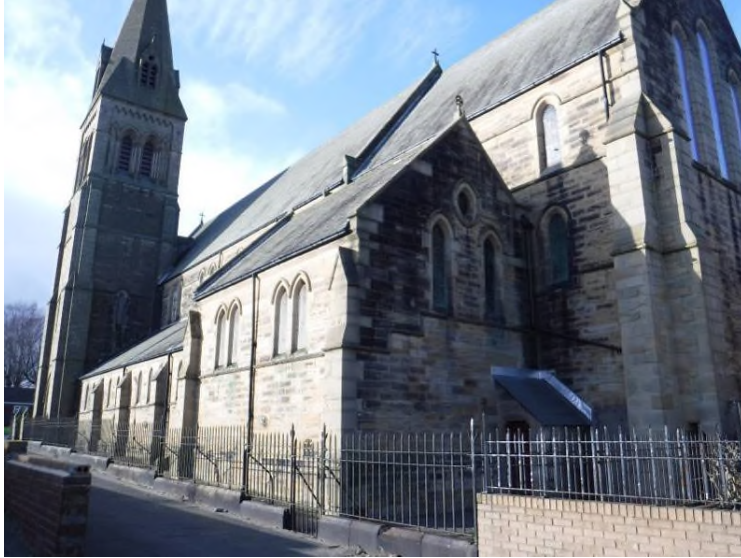
**M** **Chancel:** Broken ridge bedding coming away, couple of slipped slates some missing, some replacements in Welsh. Abutment flashings to nave OK, water tables look alright.

**Recommendation:** monitor ridge bedding

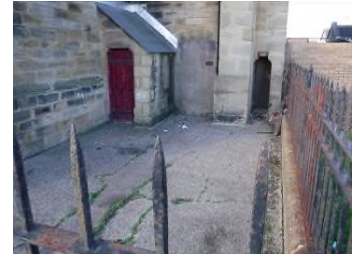
**B North Aisle:**

Flashing coming away at the clerestory. The water trays over the aisle are all ok but have rust marks to them. Slating is a bit patched some aren't the right size and others are chipped but looks serviceable, the abutment flashing look ok.

**Recommendation:** fix back flashing

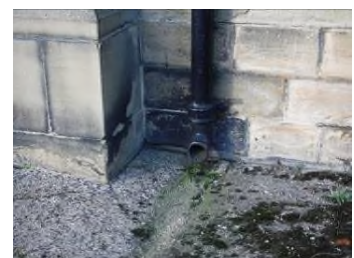
- B** Grass growing in the south aisle roof gutter.

**Recommendation:** clear gutter grass

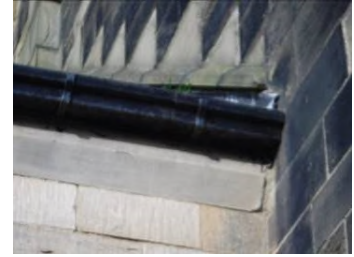
- B** **Nave East end:** Looks like there is a blockage in the hopper and the pipe discharges to the ground. The hopper from the box gutter of the Lady Chapel could have been blocked in the past as the walls quite green but I believe that it has been repaired recently.

**Recommendation:** check hopper

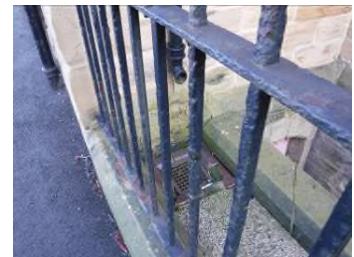
- E** **Lower Vestry Roof:** Half-round gutter rusting. The upper part of the downpipe has got anti-climb that is worn away.

**Recommendation:** renew decoration and anti climb

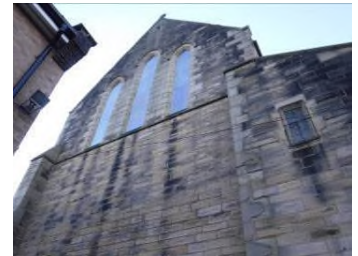
- M Lower Vestry East Side:** Mullion beginning to break away at the lower window, guarding has been lifted in the corner.

**Recommendation:** monitor mullion, refix guarding

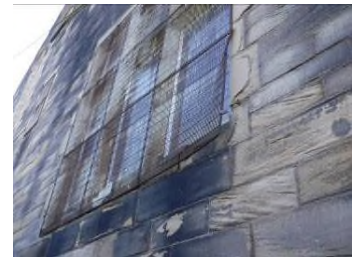
- D Chancel:** One of the clerestory window glazing is broken. This is the next area of planned window repairs

**Recommendation:** carry out window repairs

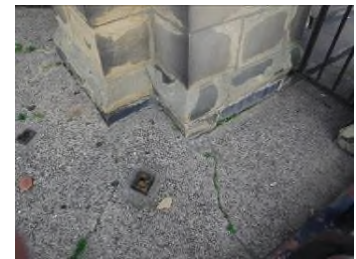
The area within the railings is a concrete margin and this is broken up in places and has various bits of masonry and rubbish within it some of which will be ammunition for vandals.

**Recommendation:** sweep up the margin, look to restore the railings and stonework kerbs

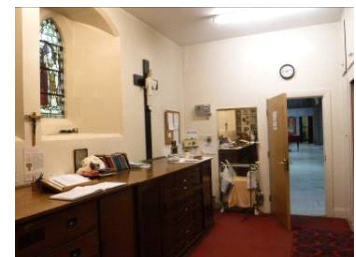
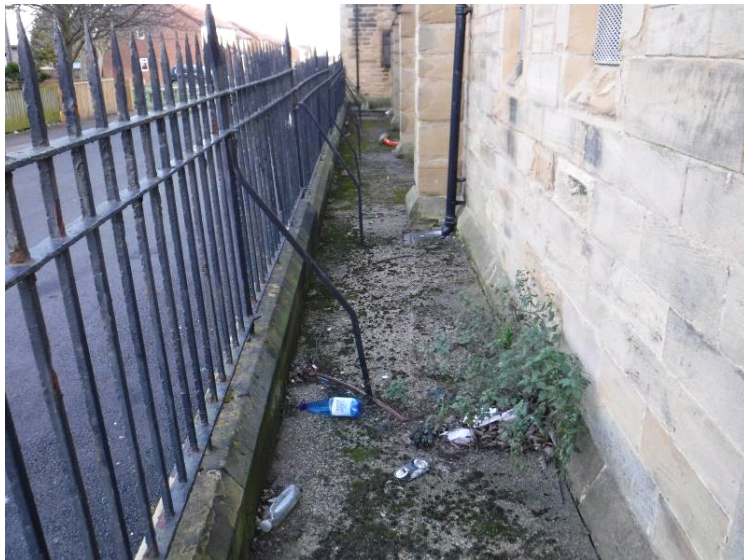
- C** **Sacristy:** Basic fitted out room at the west end of the north aisle. Providing cpding for robes and chests for frontals etc. Has a heavy door to the west that is curtained off that is not used. Room contains a sink but drainage not obvious externally.

Perhaps under planting here?

**Recommendation:** clear planting outside sacristy

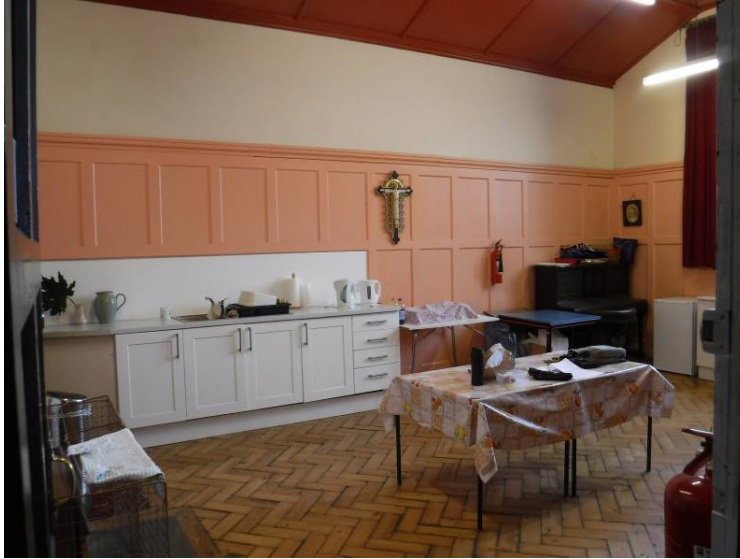
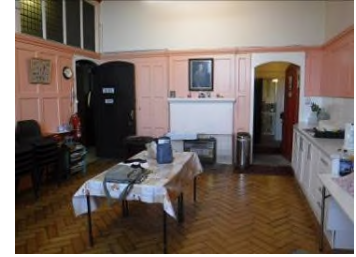
E Vestry:

- Ceiling – Plain boarded in reasonable condition.
- Walls – Plastered at high level with some secondary glazing which looks a little grey could do with being cleaned. Walls have dado panelling some of which was renewed when the roofing works were carried out.
- Floor – Large format timber herringbone pitch pine.
- General – Room is fitted out for a modest tea kitchen with sink and power and some servery spaces. A basic gas fire within the room.

**Recommendation:** clean glazing
