Diocese of Durham

St LAWRENCE the Martyr
Horsley Hill
(304)

QUINQUENNIAL REPORT
on the architect's inspection on

9 June 2022

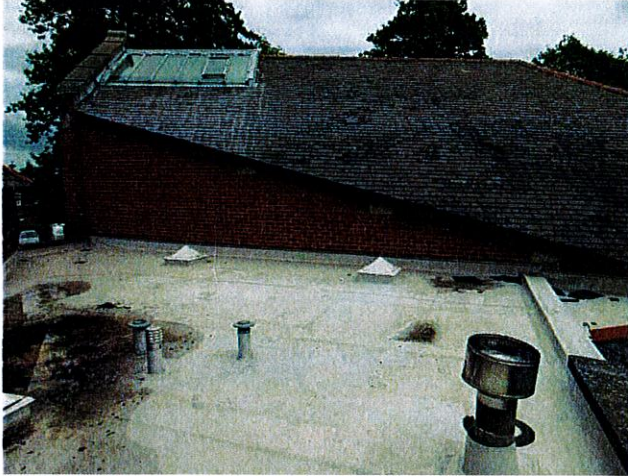
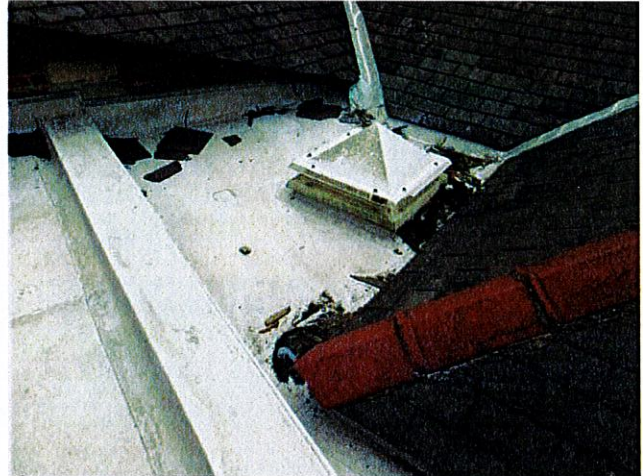
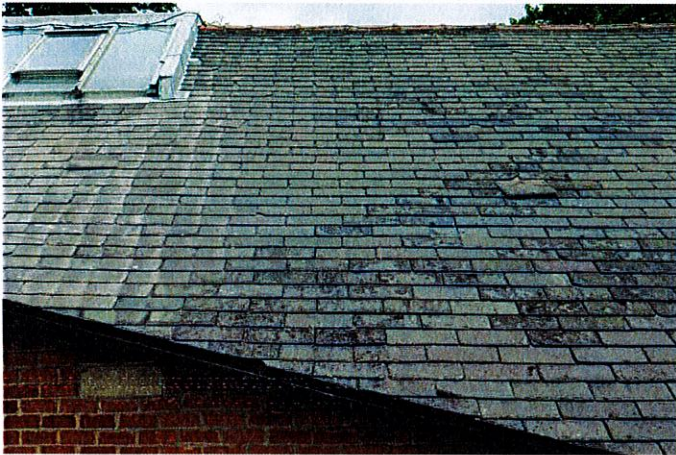
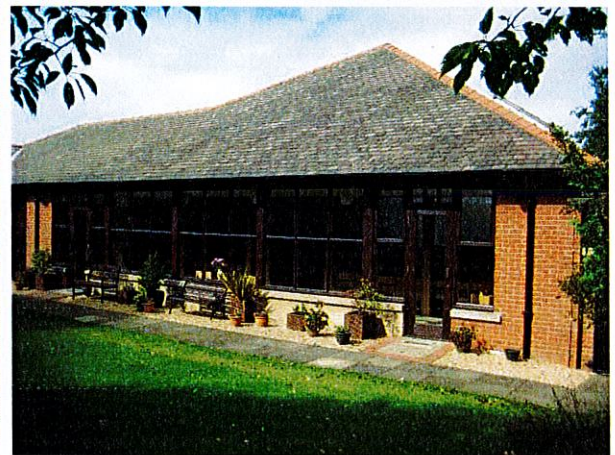
para 12

11. Welsh slates at Church and Chapel with red clay ridges and hips with lead valleys, abutment flashings and lead capped upstands at the patent glazing. The lead valleys appear sound. One slate begins to slip by top of Church valley. Some slates lie on the flat roof after repairs. Some ridge pointing is missing.
12. The garden and E side slates good. Three Church slates facing the flat roof are slipping. Two slates slipped at the west Church/Chapel valley.

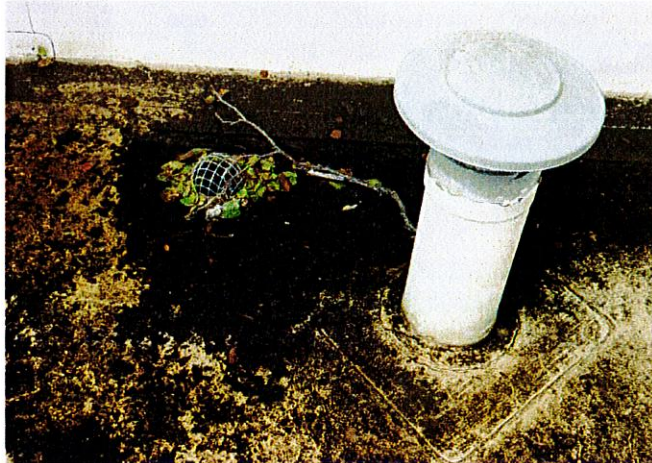
Debris around caged roof outlet before clearance and draining of the pond at inspection

15. Note the Sarnafil is beyond its design life, though it may serve for many years to come. It would be sensible to build a small fund set aside for its replacement when necessary.
16. A small patch, luckily near the top of the roof slope over the Entrance lobby, is NOT Sarnafil but the short life material 'Flashband' which has split open exposing the foam insulation. The only patch material which bonds properly to the membrane and is durable enough is Sarnafil itself. A new Sarnafil patch must be fixed (this summer) by one of the properly trained specialists in the region.

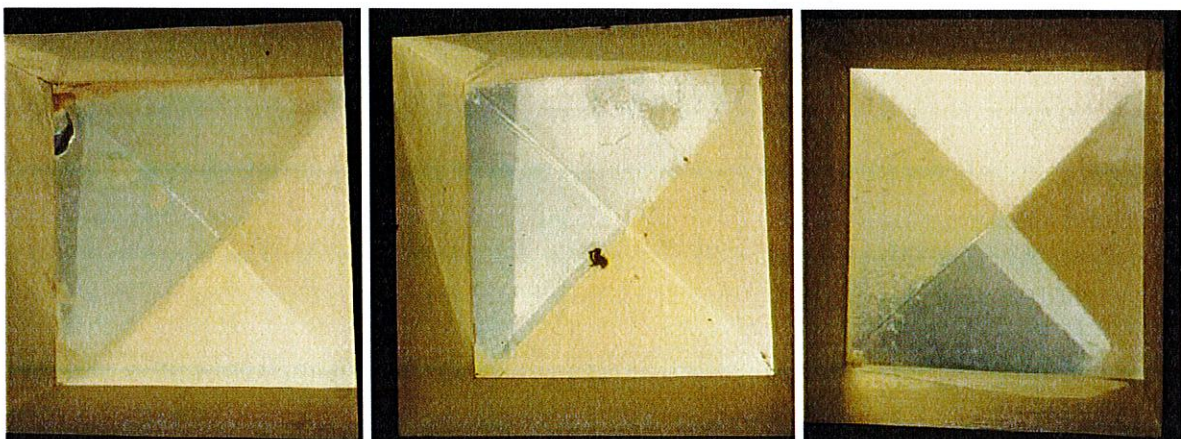
17. Five polycarbonate rooflights, all become brittle and clouded by sunlight. The double skin Kitchen rooflight is now concealed below by a continuous ceiling. Others single skin. The large passage rooflight has broken edges. Breaks in two others. The Kitchen rooflight could be left or roofed over in Sarnafil if preferred but it is time to replace the other four for better light. Using UV resisting polycarbonate will prolong improved light levels inside.

Renew four rooflights (UV resisting)	17
--------------------------------------	----

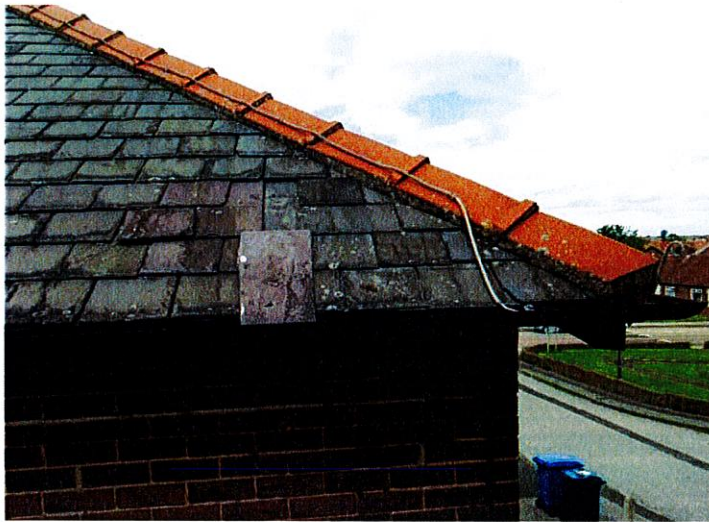
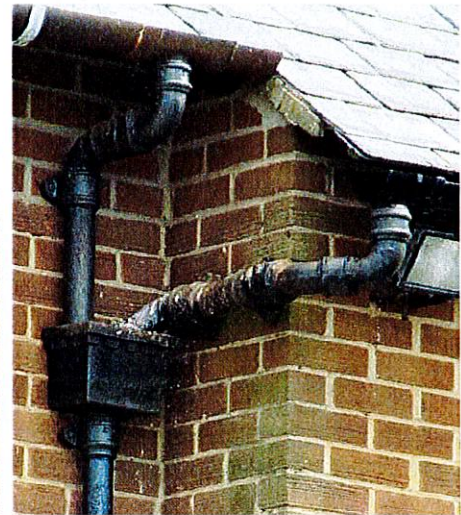
18. Hall has welsh slates, red clay ridges and hips with a fully glazed store roof. Sound but one slate at the SE corner of the Hall facing the flat roof found slipped out into the gutter was temporarily pushed back into place at the inspection. Another at the same long side facing the Church is beginning to slip out.

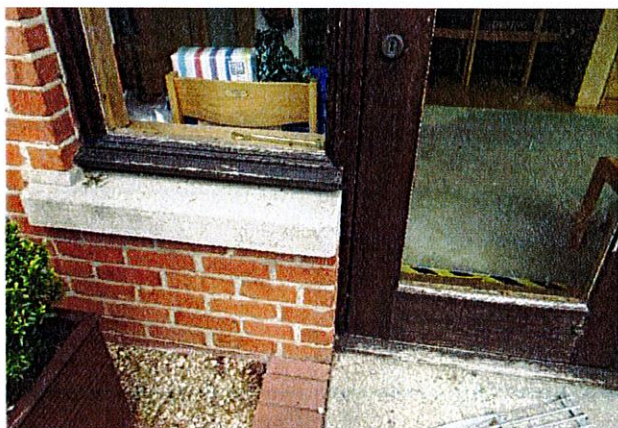
para 24

24. The pair of stained doors from passage to garden are sound. The doors, their glazed frame and the Church windows are good but stain at the more exposed outer transoms, beads and cills is beginning to perish and restaining is needed.

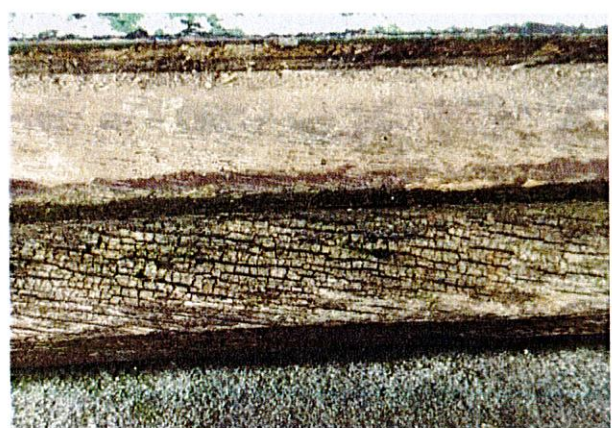
para 25

25. Both doors from Church to garden sound. The E door needs a very slight lift to close so minor adjustment of the lock keep may be needed.

Both exposed oak door cills begin to craze and need to be either oiled to feed the timber or perhaps covered in non-slip metal to prevent weathering.

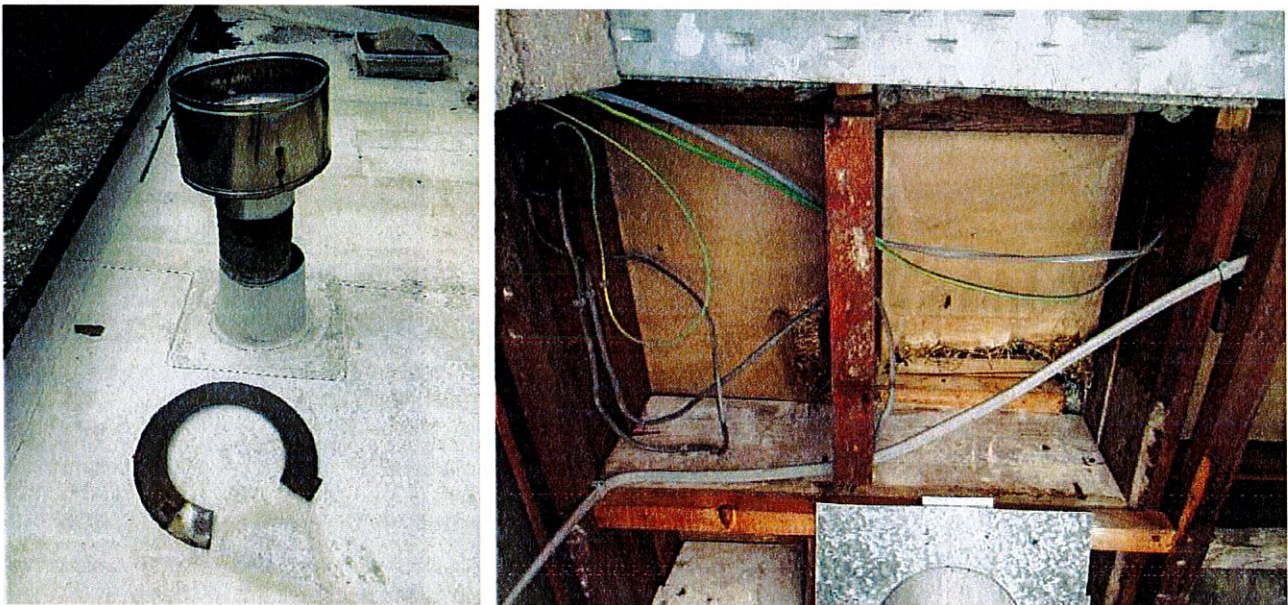
9. The loss of the collar around the boiler flue is letting weather into the boiler space, causing deterioration of the roof and perhaps damage to the boiler.

31. Concealed timber rafters and steel trusses in Church. Trussed rafters on the Hall.
32. Concealed timber joists and deck at the flat roof over the passage, wcs, Kitchen and boiler room. Some sign of deterioration of the deck over the boiler room where it is pierced by the flue, now open to the weather because its collar has failed.

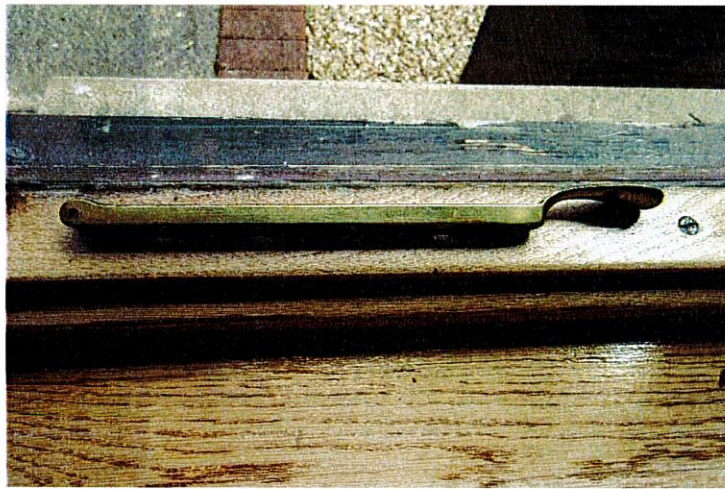
At the Church W corner the pin at the window stay is broken.

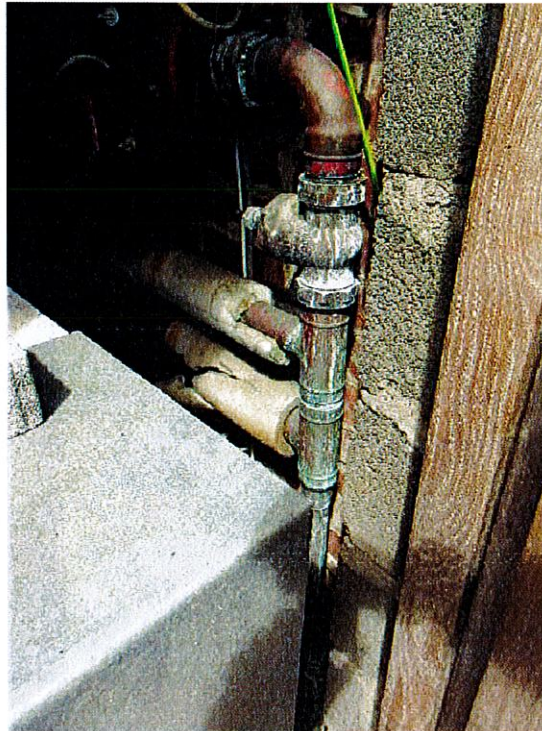
53. The Church and Hall are heated by separately controlled circuits (fan convectors in the Hall and radiators and fan convectors in the Church and passage) from a single gas boiler with stainless steel flue through the flat roof. The boiler front is now covered by added metal sheet. Thermostatic valves at most radiators.
54. A metal collar around the flue which should keep rain out of the roof structure and boiler space lies loose on the flat roof due to a fixing rusting through. Refixing is urgent to protect the roof and boiler.
55. The Hall roof and the Church and Chapel are insulated and the system is said to be effective when the controls work.
56. Some large bore copper circuit pipes in boiler room are lagged but others are not, wasting heat.

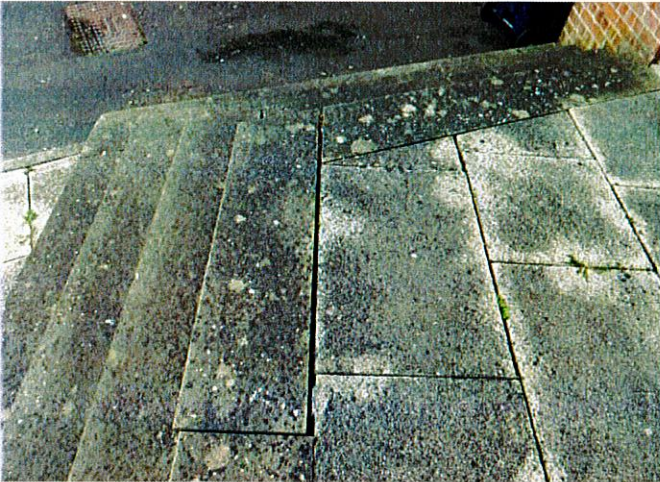
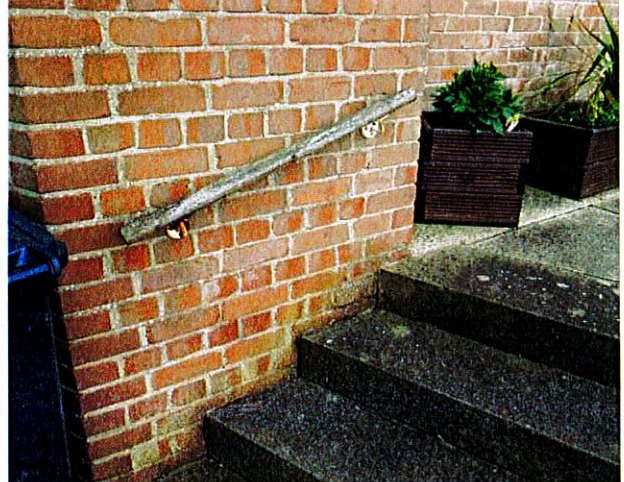
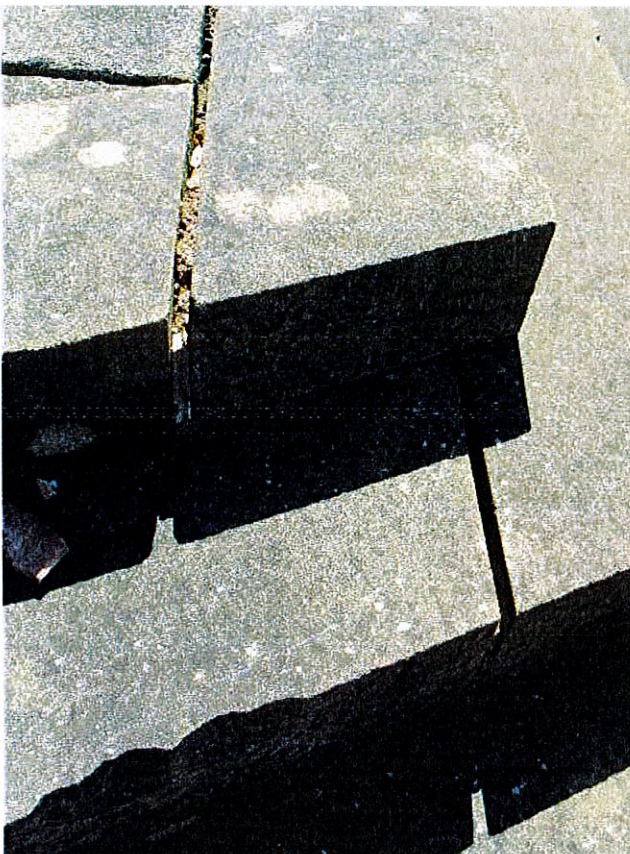
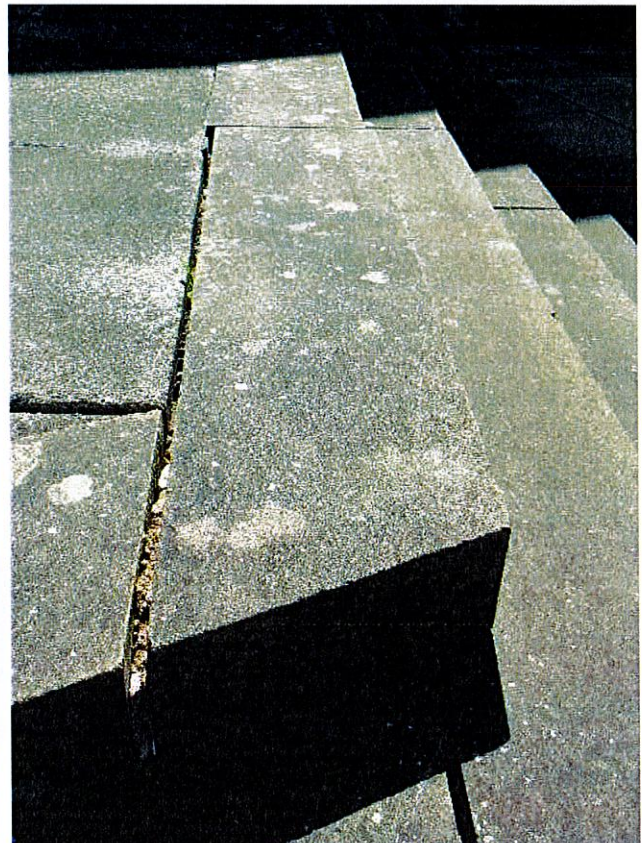
72. The front steps, ramp and stainless rail are mostly sound but the corner steps have moved outward slightly. If their back joints can be raked out and the steps eased back the joints can be filled with adhesive grout to hold them in place.
73. Joints between the other stones (and the copings at the ramp) are mostly open and should be raked out and pointed carefully to avoid marking the stone.
74. Some bricks under the ramp appear to stay damp and are deteriorating.

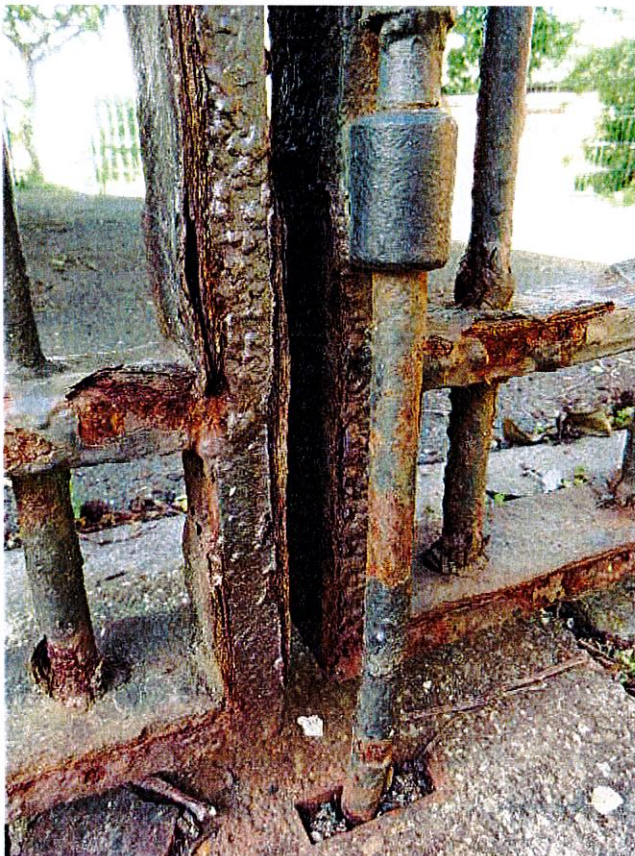
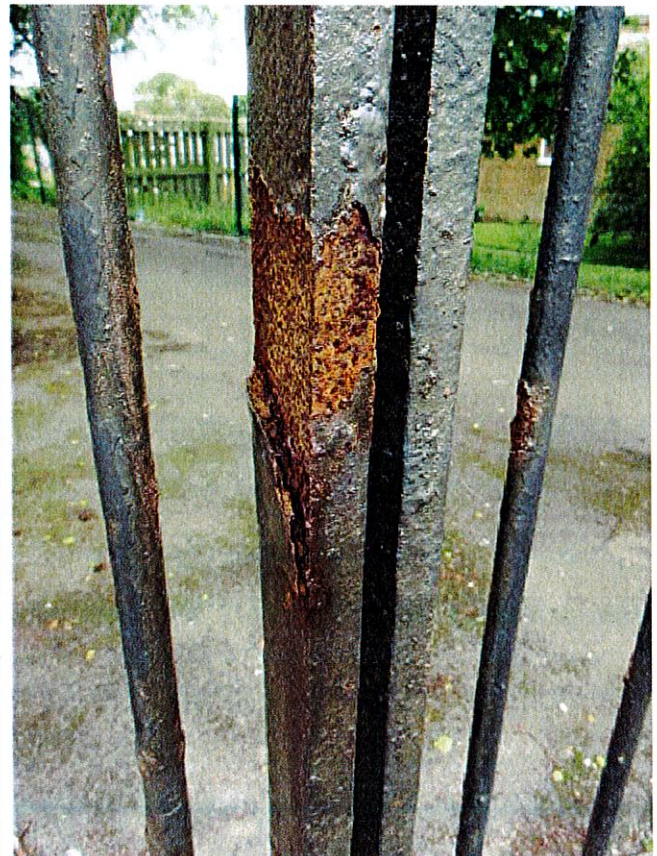
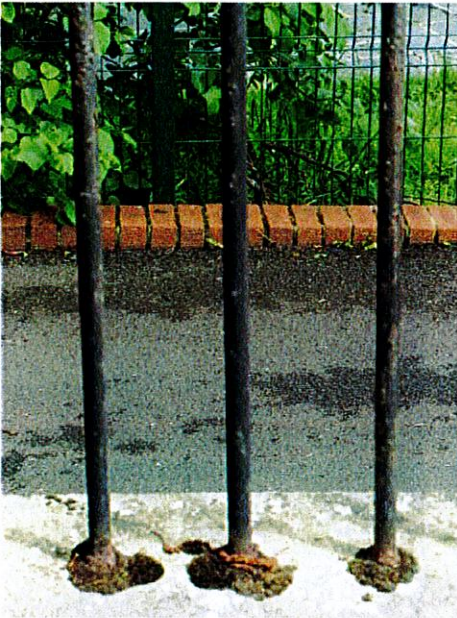
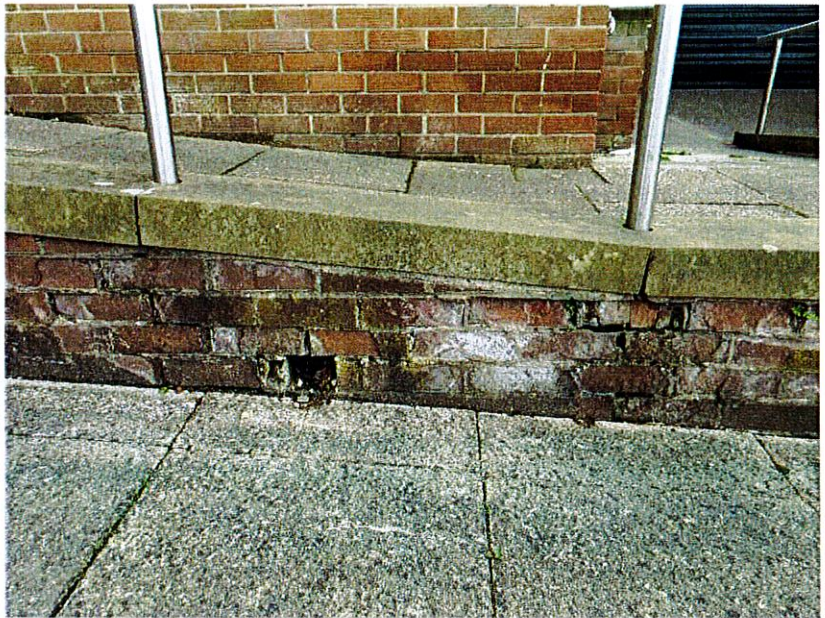
78. Garden enclosed by brick walls with cast stone copings in good condition except:
- the overgrown surface of ridged copings at part of W side are starting to deteriorate.
 - by the Garden of Remembrance some coping joints are open and some copings show some deterioration.
79. Steel railing panels in the walls and the matching gates are for security by making the garden visible. Recorded that the gates have been painted but the railings have not. Rust remains at both and must be removed soon and the metal rust treated before thorough painting.
80. Better would be replacement in new galvanised and painted steel. Alternatively if especially the gates are not beyond use the existing steelwork could be dismantled, shotblasted, galvanised, pickled, three coat painted and refixed.
