Diocese of Durham

**JARROW GRANGE
CHRIST CHURCH**
(109)

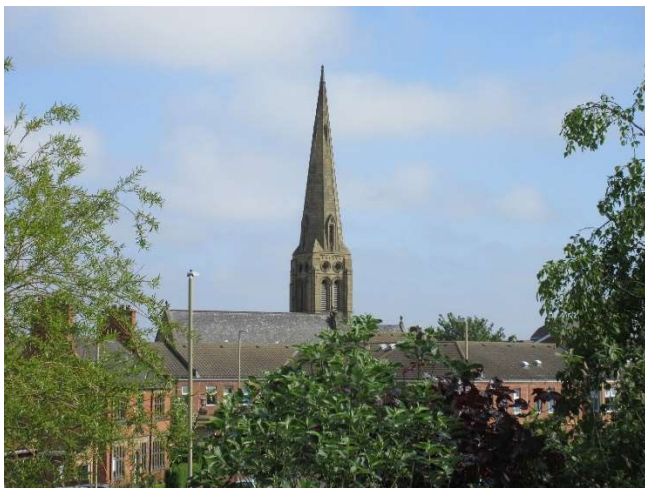
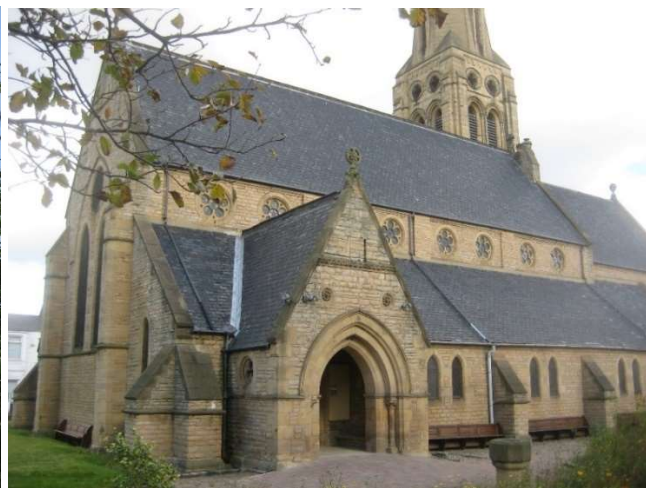
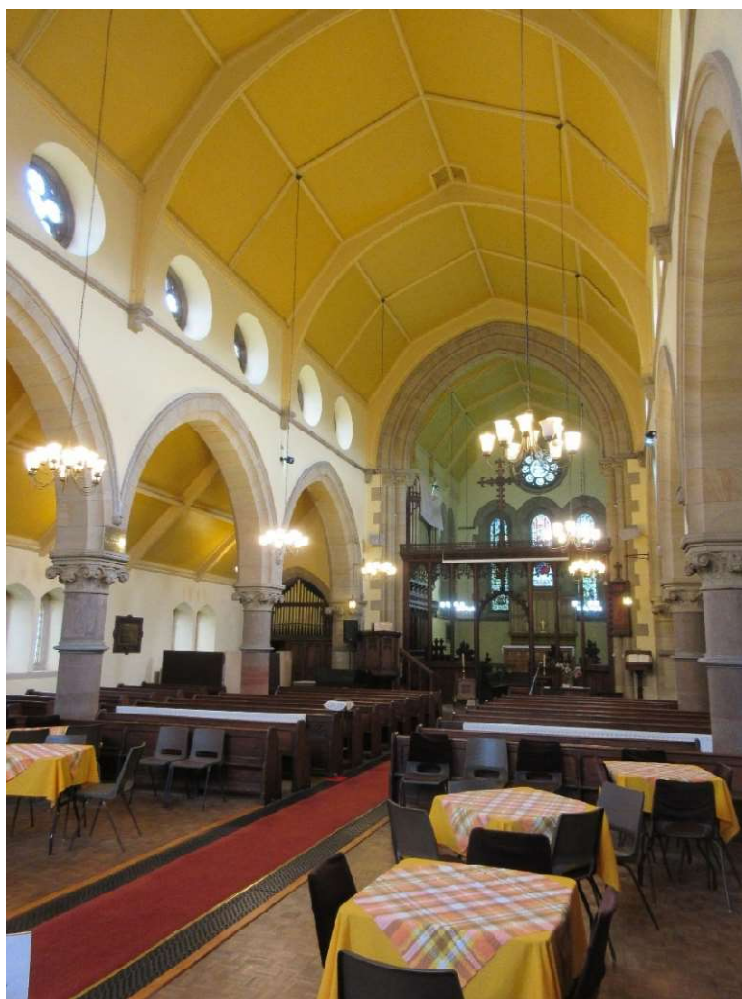
IAN NESS
ARCHITECT
26 GROSVENOR PLACE NEWCASTLE upon TYNE NE2 2RE
tel & fax
0191 281 2559

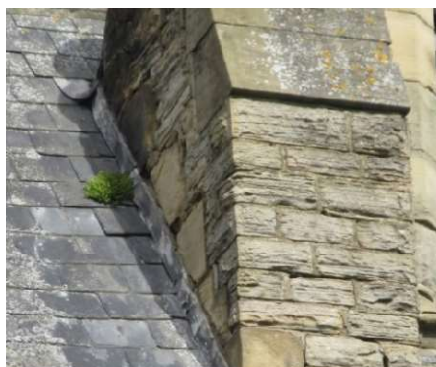
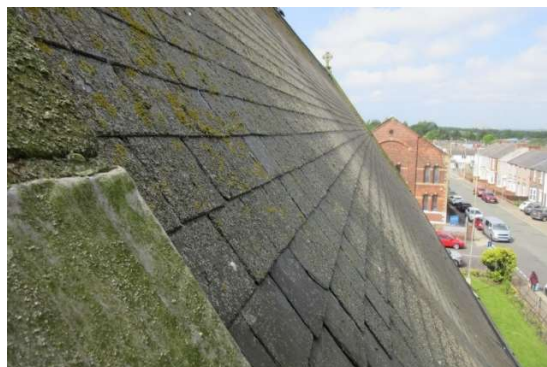
20. Where the Tower intersects the Nave roof plants again grow in silt part blocking all the back gutters.

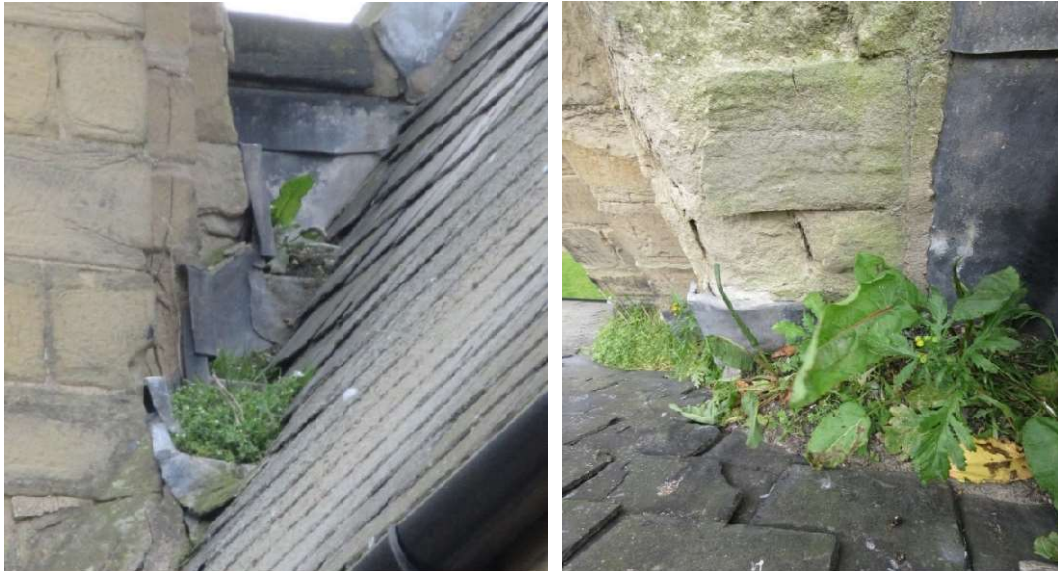
Blocked back gutters between Tower and Nave and deep decay at Tower SW buttress

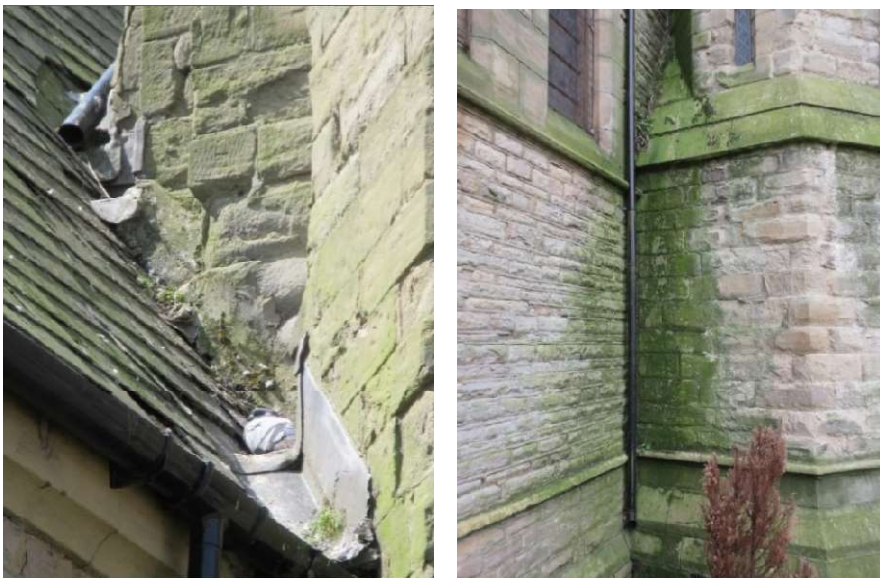
Plants in back gutters between Tower and Chancel and damp masonry between Chancel and Stair

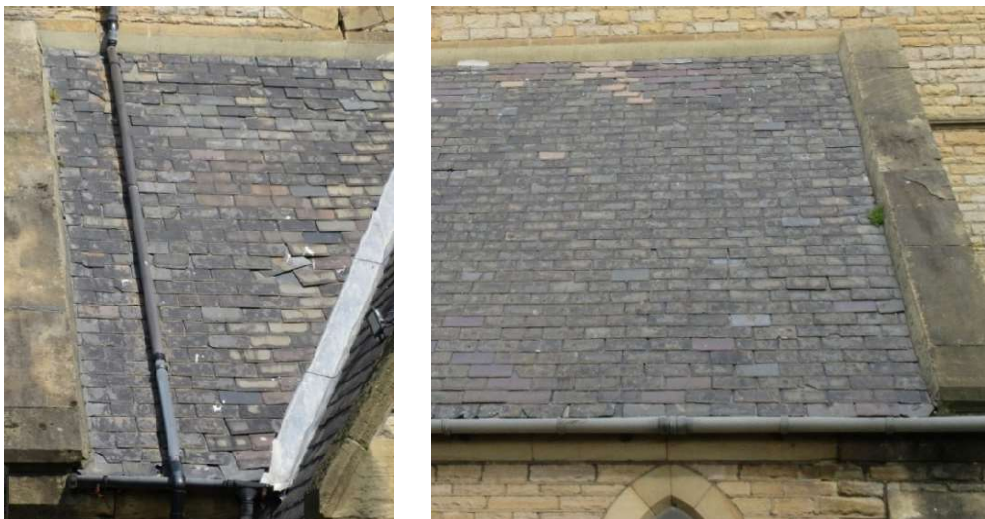
22. **Porch** slate and lead valleys fair.
23. **N Aisle** slate fair. Patched and uneven in places but better than last inspection. Several slipped or broken slates close to W end. Fewer wired slates than S Aisle.

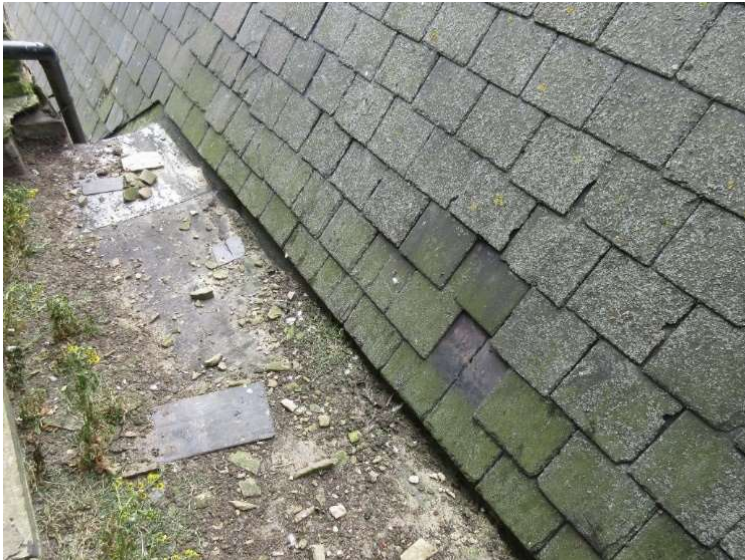
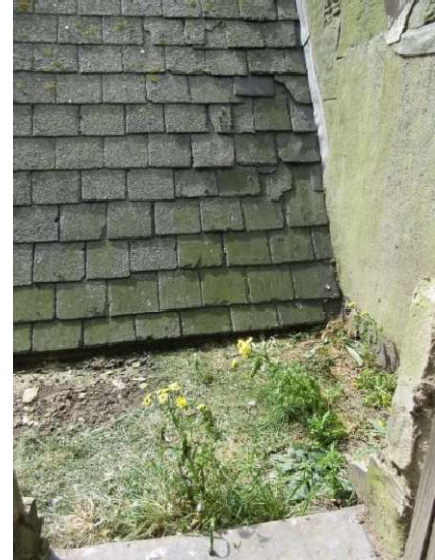
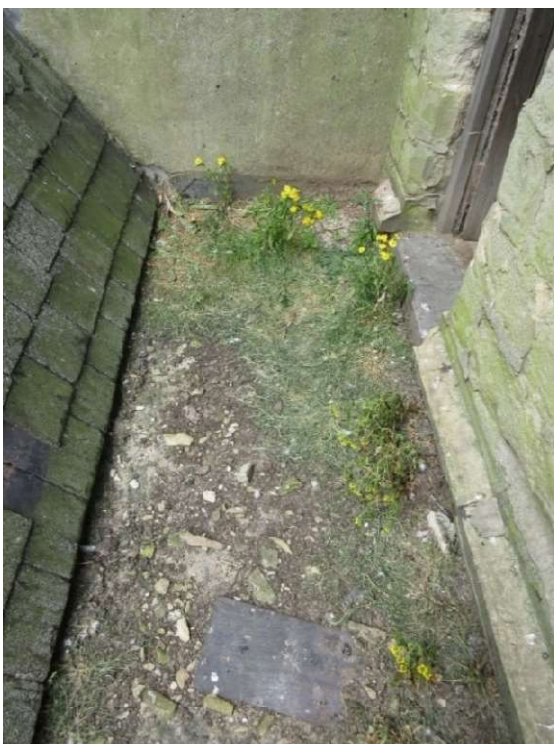
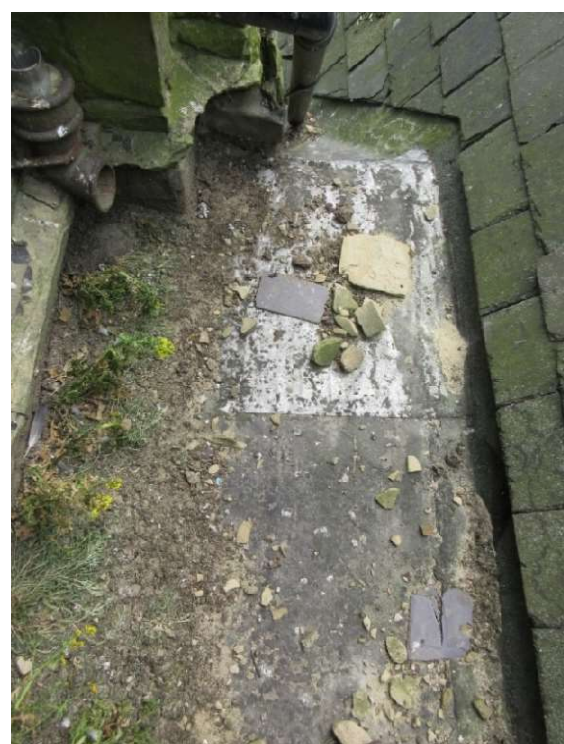
Plants growing in silt forming in sand and stone fallen from the Tower

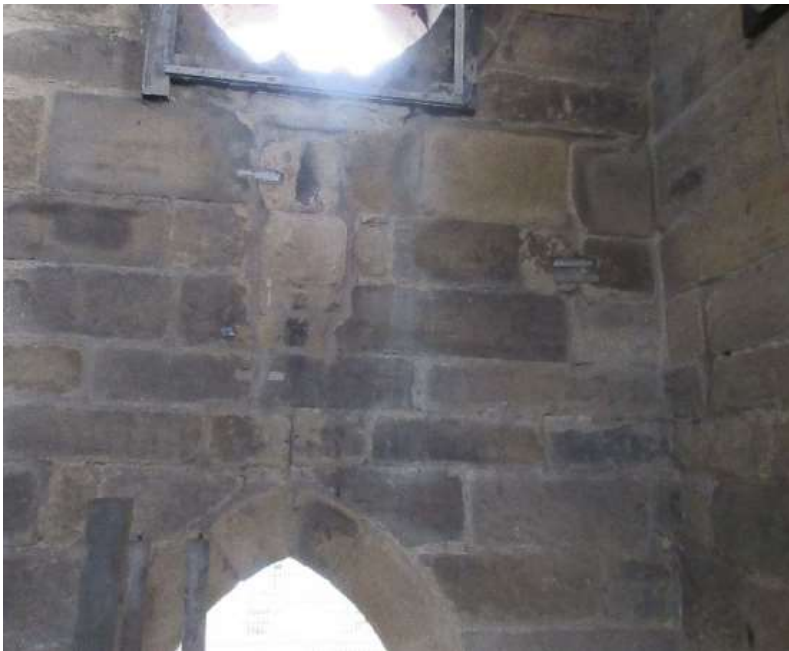
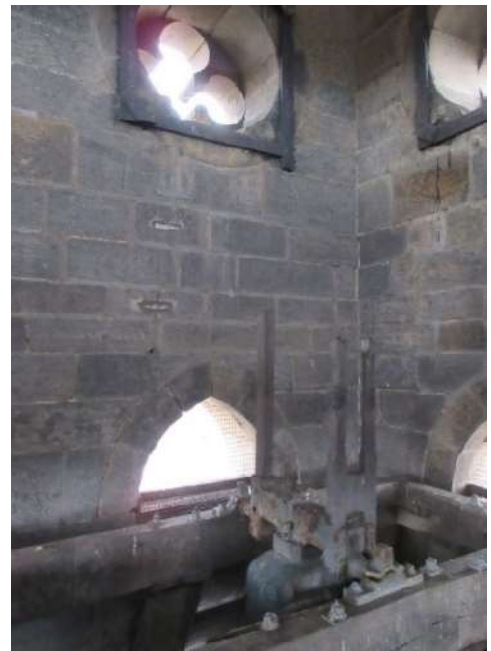
1992 stapled cracks between Belfry openings

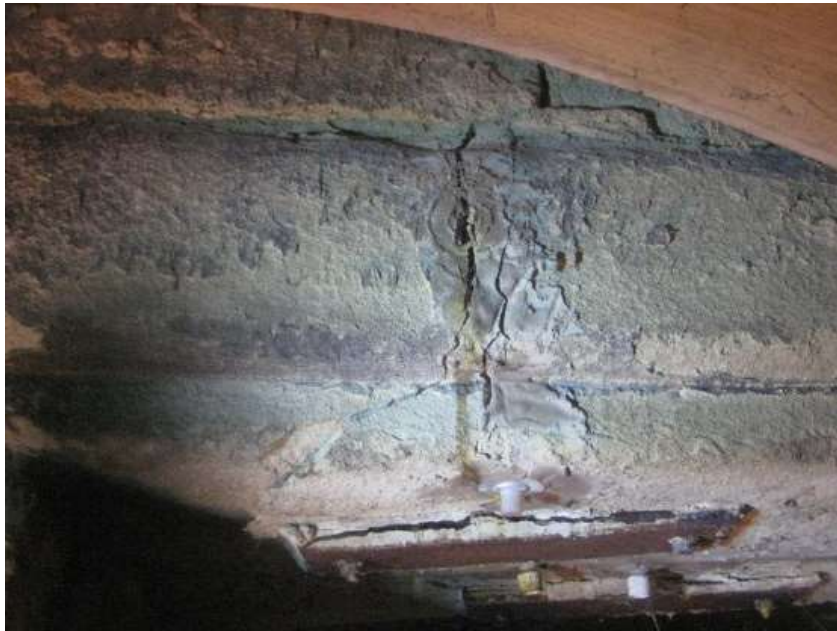
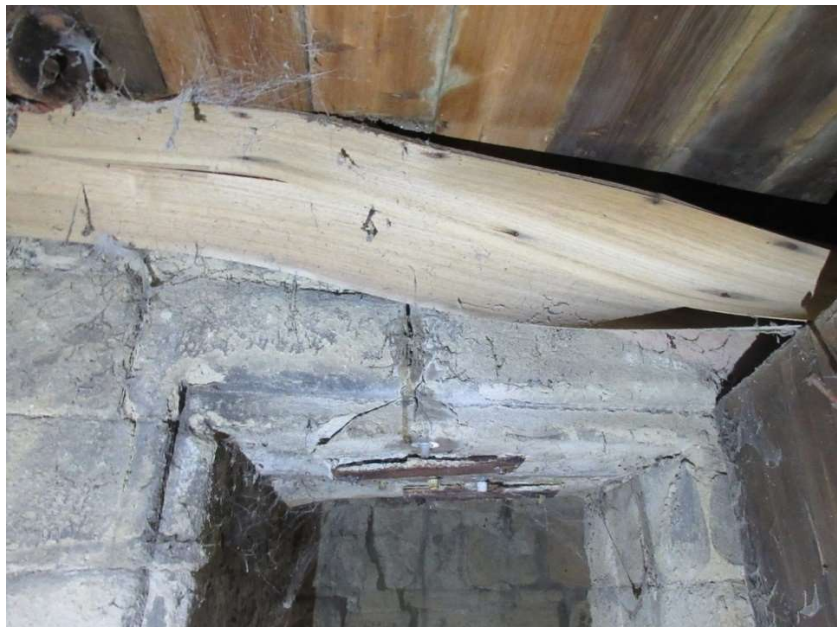
Cracked Lintel of Top Door from the Chamber side. Rusting steel plates no longer in close contact with Lintel.
Board Ceiling patched over

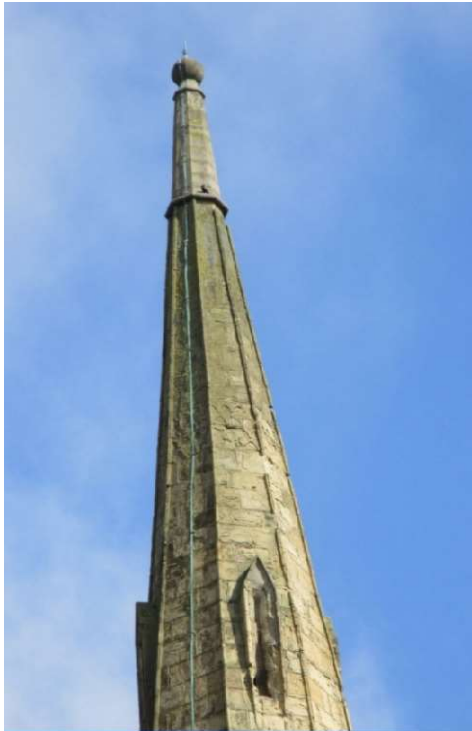
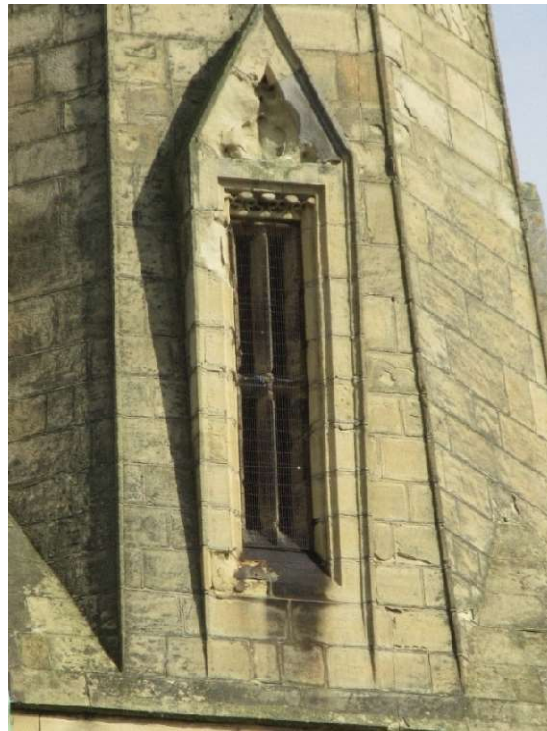
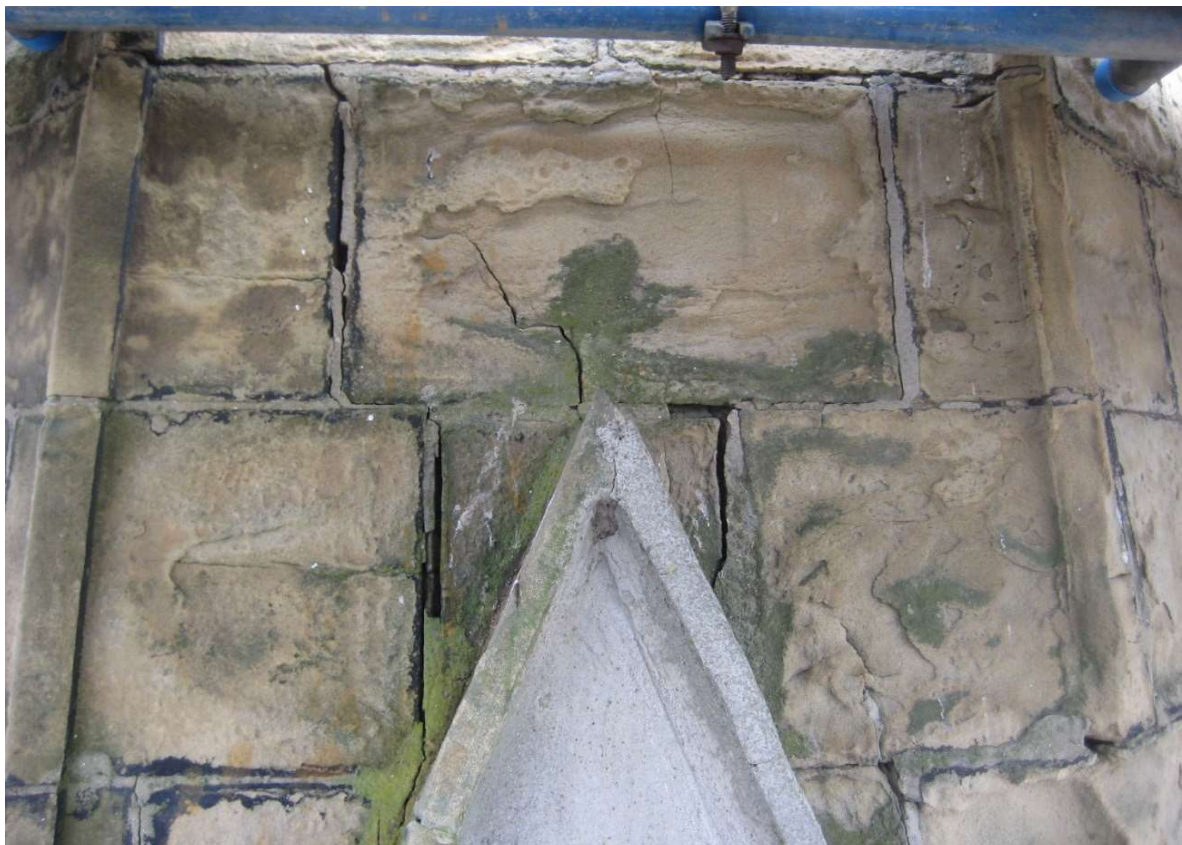
COMMON SPIRE DEFECTS 2011 photos – cracked stones and joints, past mortar patching at openings and further wind erosion

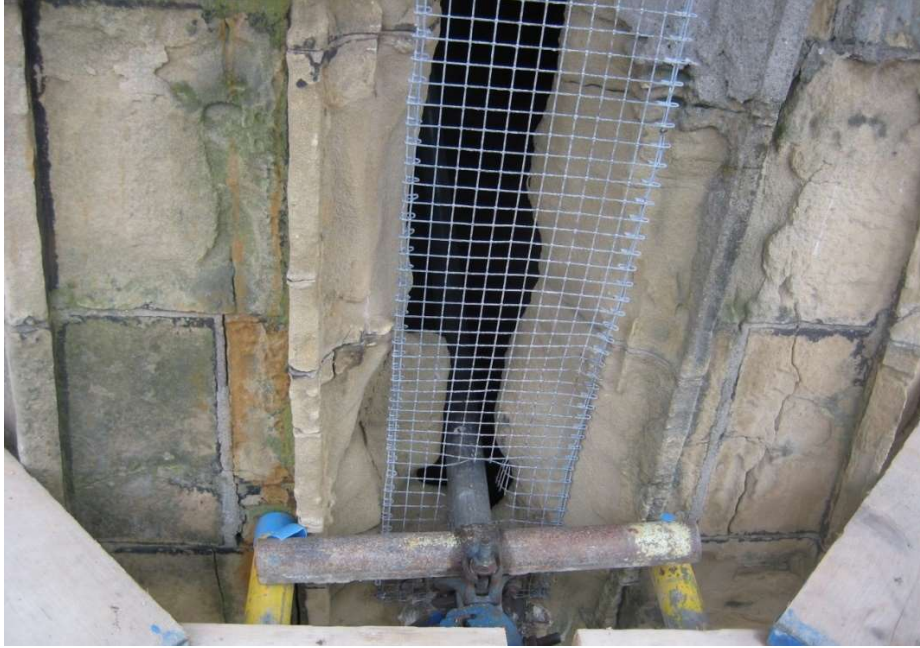
45. The Tower is losing surface more severely than the Spire, especially at the buttresses and the S and W sides in the stage below the bell openings. Some plain panels and large parts of some buttresses have lost almost all their surface, exposing stones to further wetting and decay.
Deep decay of the buttresses and sills under the louvres and many of the mouldings meant to throw off water means that the rest of the masonry is no longer protected as intended.

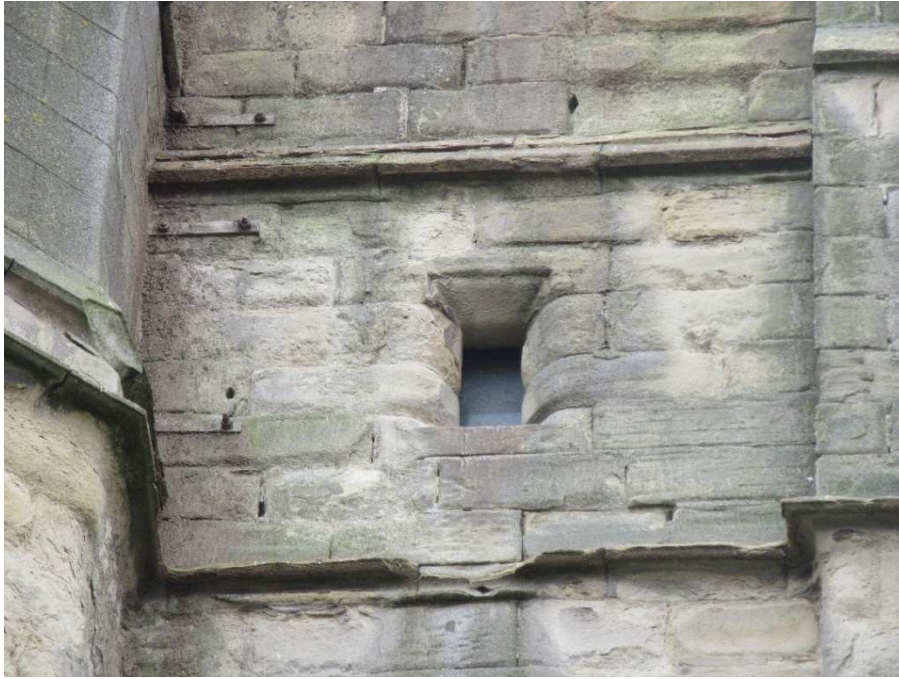
Masonry at E windows

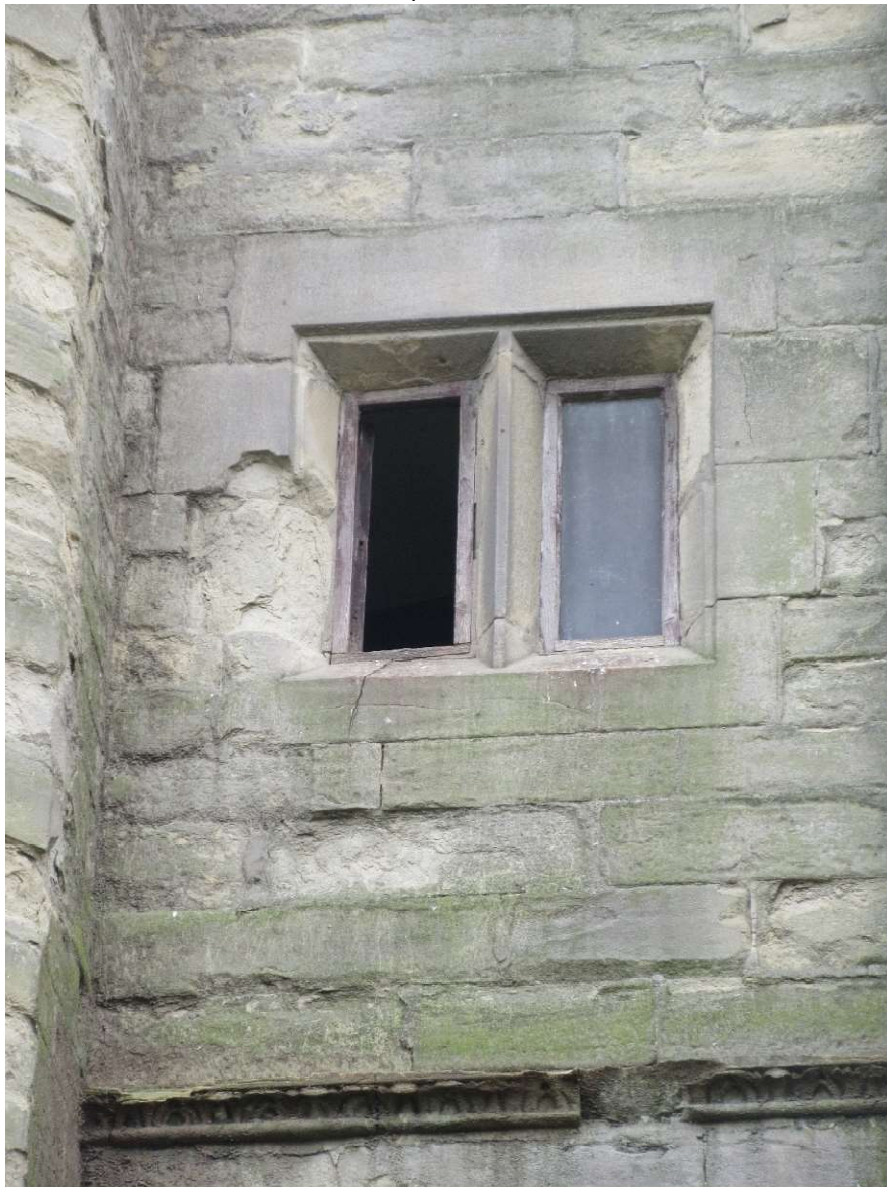
Ringling Chamber E window before casement was held shut with furniture in 2023

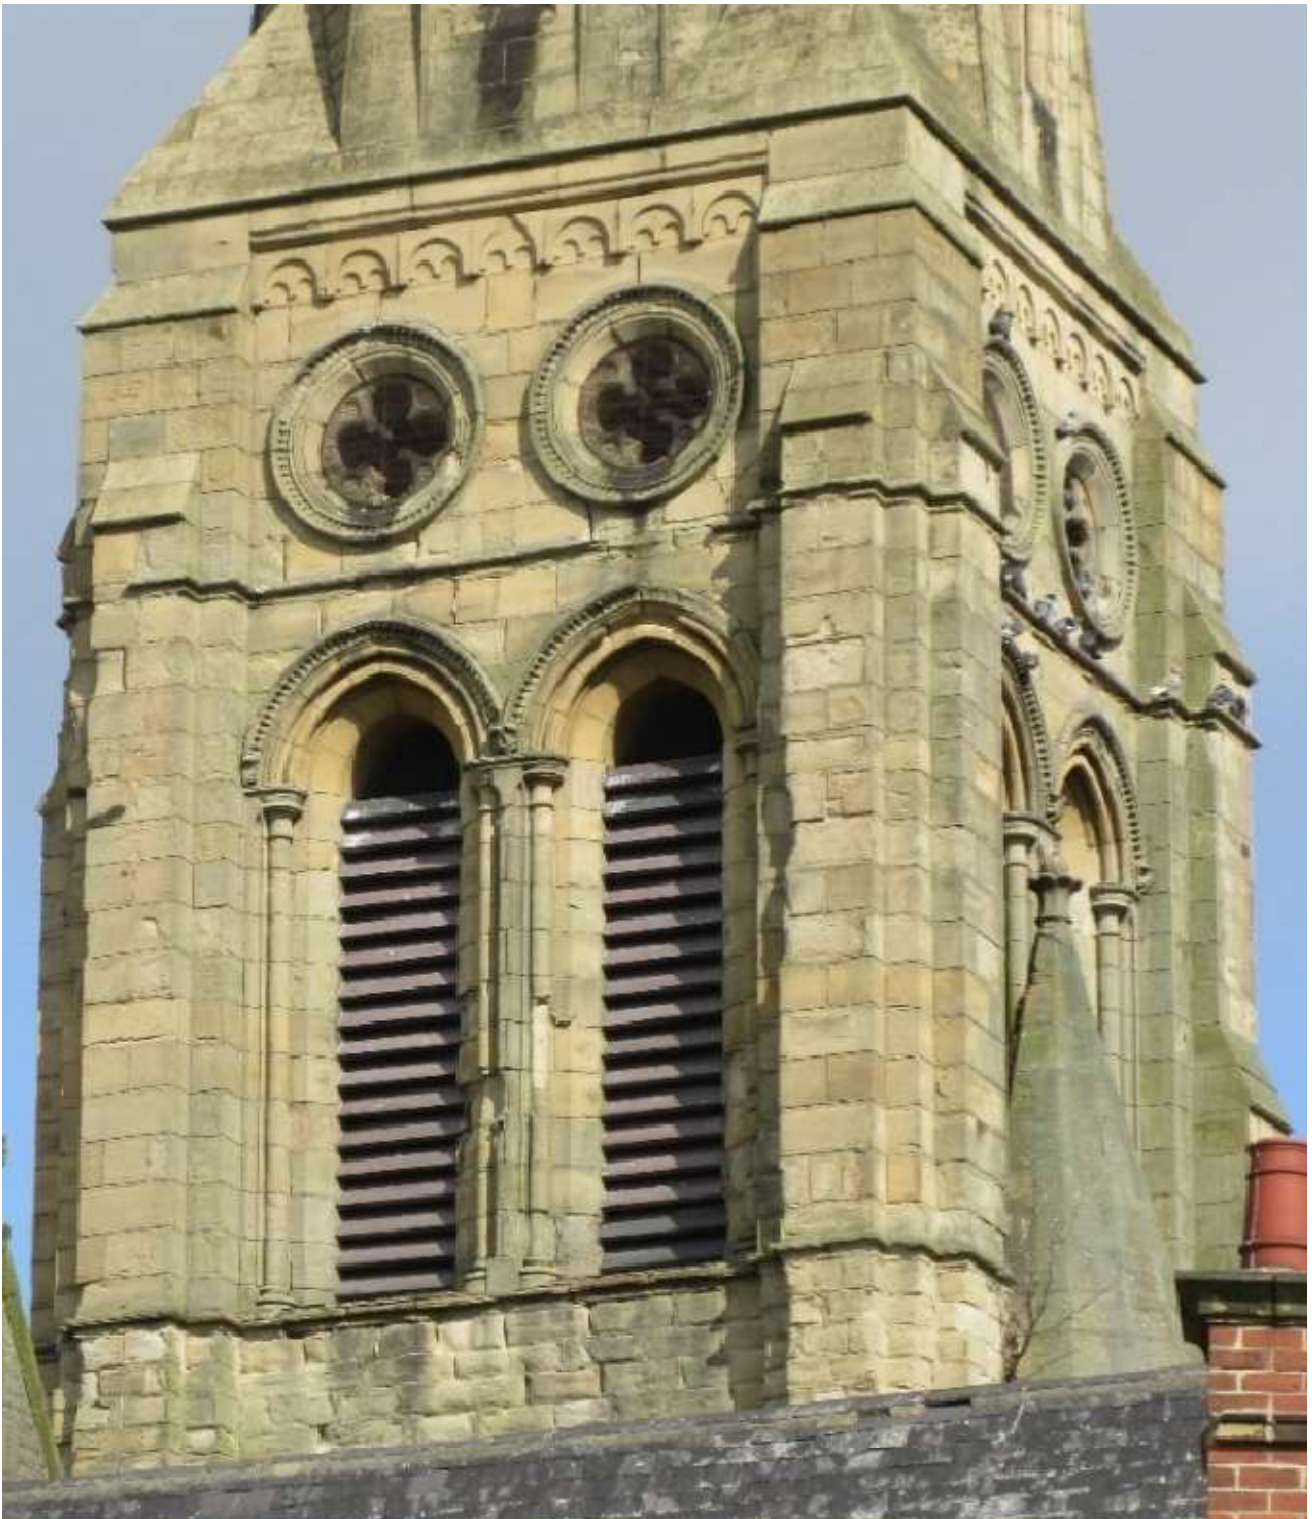
53. **S of Tower** (facing Chancel roof) continues to decay slowly. The protective top string course is about 30% missing. Large parts of the reveals, mouldings and shafts in the Belfry openings are now missing. Below the Belfry the wall surface is all weathered away and many joints opened by deep erosion, especially around the door into the abutment gutter. Both buttresses are very decayed, especially the SE. New stone debris adds to the gutter blockage.

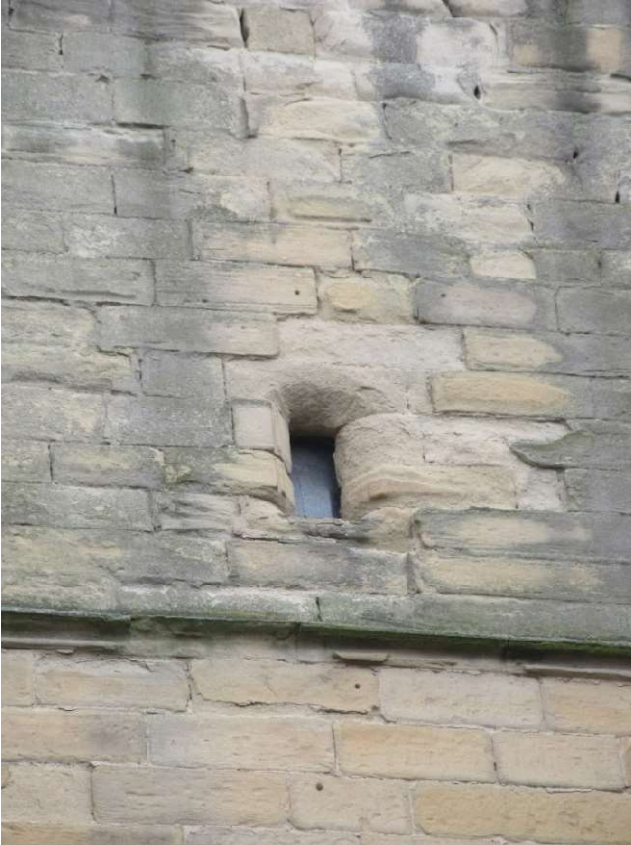
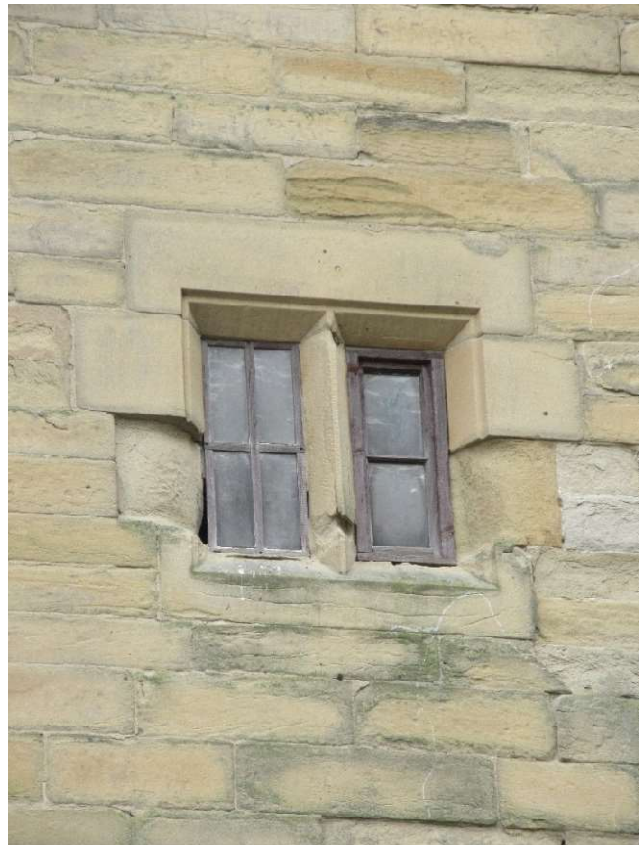
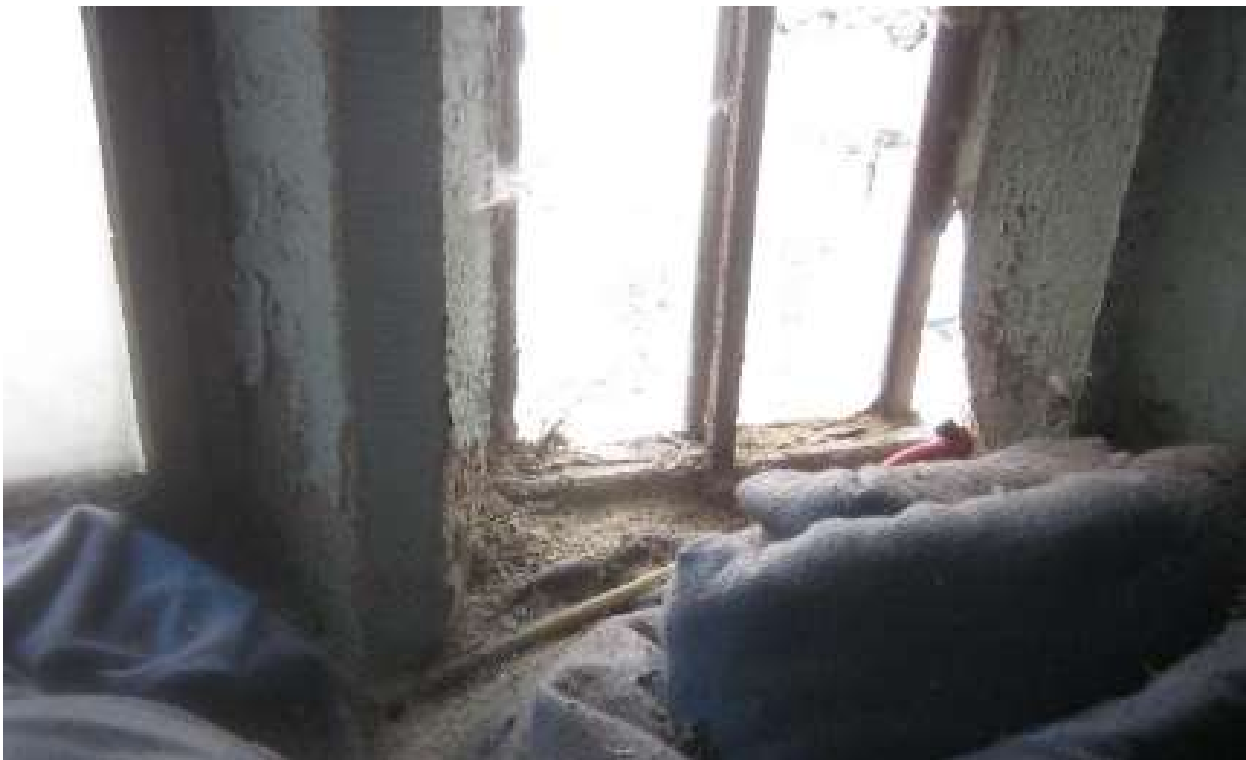
54. **W of Tower** Mouldings framing the round bell openings are about 30% deep decayed. The moulded string above the louvres is almost all destroyed. Several decayed reveals at the bottom of both louvres. Below the louvres almost all stones in the plain panel and its buttresses have lost their surfaces and are deeply decayed from the joints. About 50% decay in the rest of the NW buttress. At the Ringing chamber left window a reveal stone is so eroded that over an inch gap has opened between stone and iron window frame. Wind scour increases stone erosion here. Otherwise fair except random surface or edge decay.

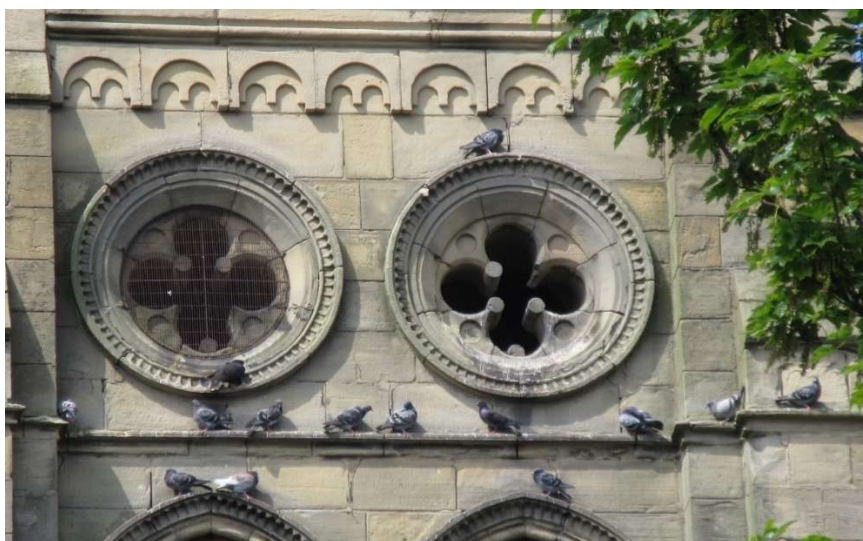
Mesh missing from one E round opening. It lies by the basement steps instead of keeping pigeons out

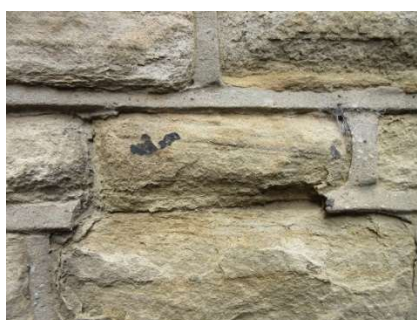
62. Part of the **Nave E gable S side** (above the Chancel roof) and especially the **W side of the chimney** have many open joints which should be deep raked and repointed in medium strength mortar.
63. **S Clerestory and S Aisle** good condition.
Porch good condition except three quoins decayed, loss of string course left of its arch, open joints under the **W valley gutter** and some rising damp which may be encouraged by the raised paving inside the **Porch**.
64. **W end of Nave and Aisles** dressed buttresses good, stone walling fair but beginning to erode behind hard pointing like **E end**. Minor decay in edge of **Nave S watertable**.
 Open joints in the **gable peak**, under the **gable cross** and in the **watertables**, (plants grow at **N and S**) at the **kneelers** and other isolated patches should be raked and pointed.

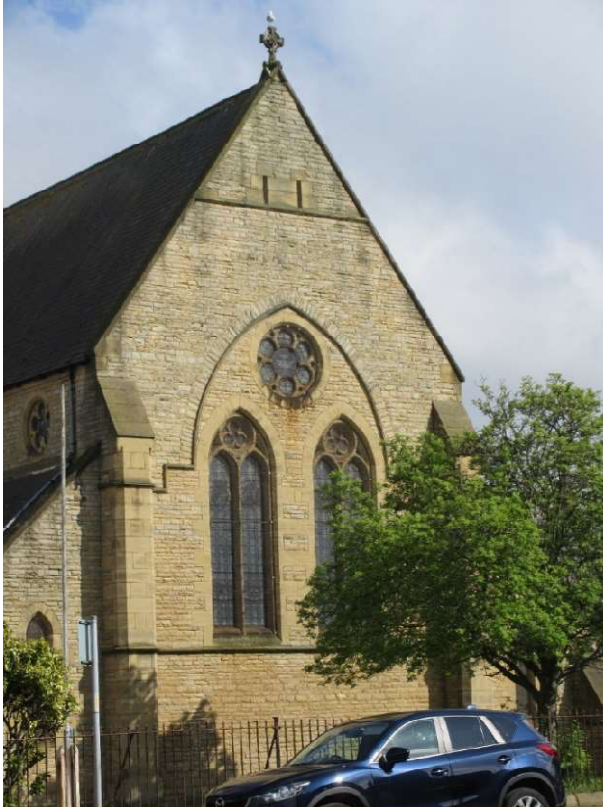
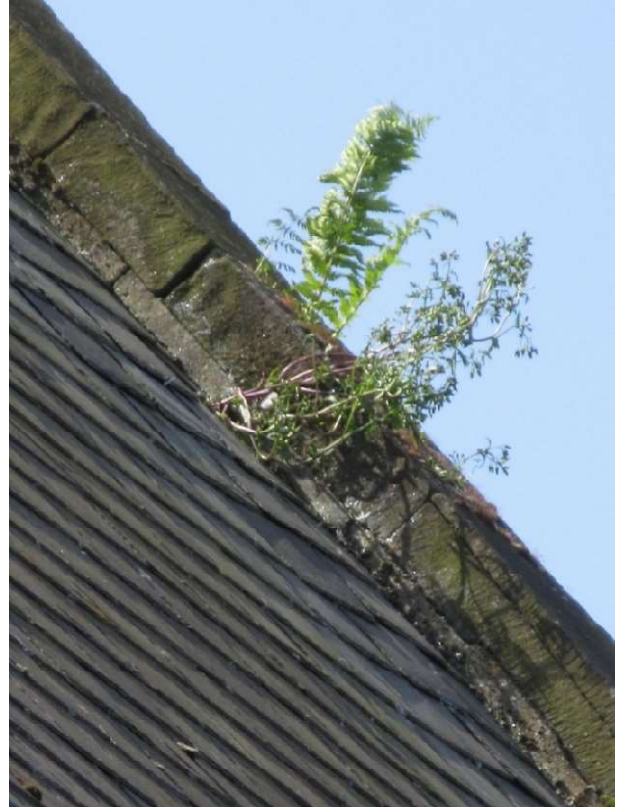
65. **N Clerestory and N aisle** stone in good condition, mainly cement pointed.

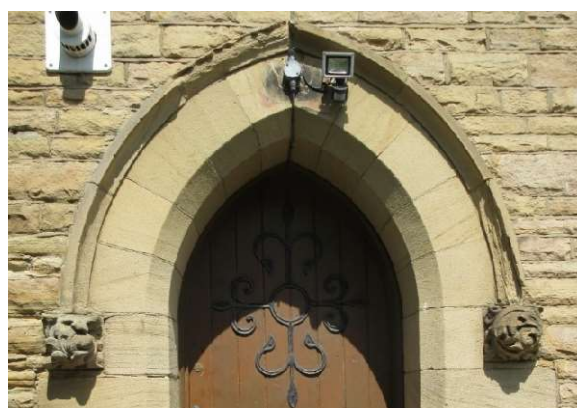
70. **N and S Clerestoreys** 8 cinquefoil windows in each. Fair but eroding from many cusp tips like E Chancel. Some old mortar patching of the tips. At S second window from W part of the bottom cusp is missing.

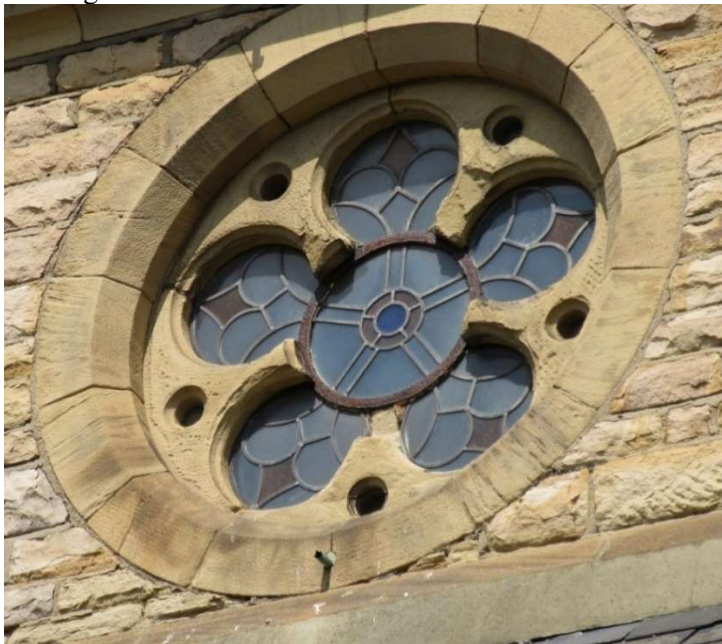
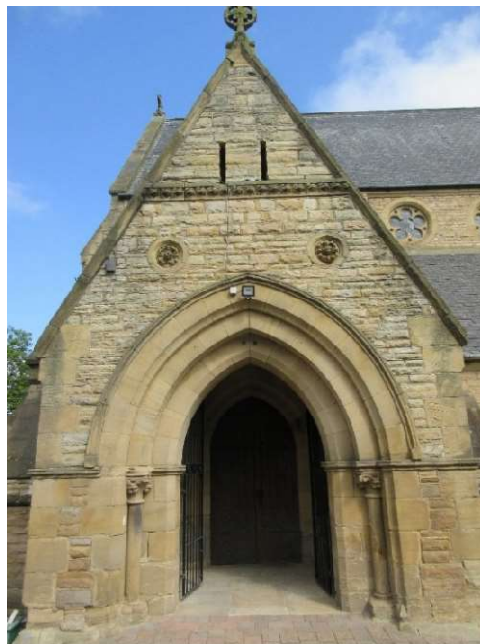
71. **Porch** good except one piece of string at arch and two pieces of hoodmould are decayed.
W end 2 major, 2 minor lancets, multifoil round window all fair.
Some decay in wide hoodmould over the windows.

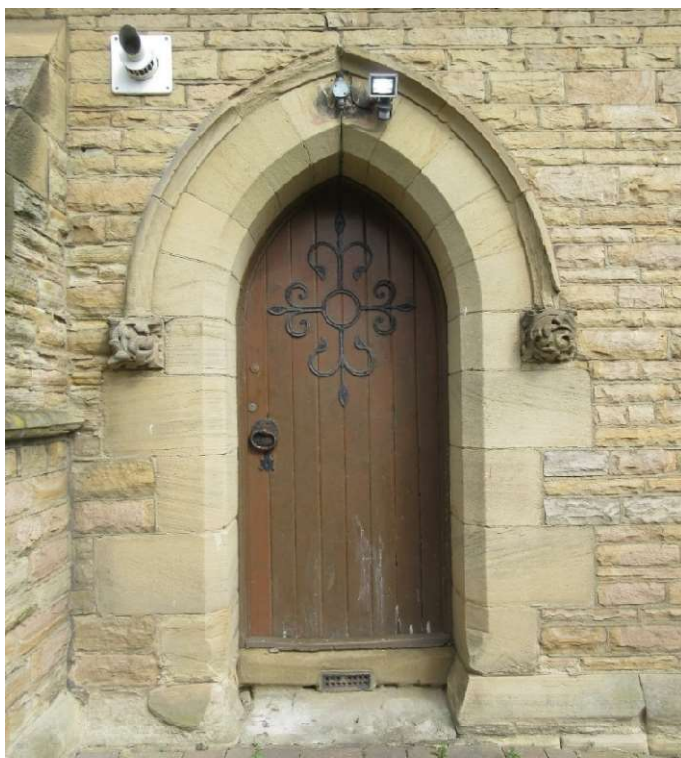
74. The small Tower door has lost its iron decoration and still needs paint.

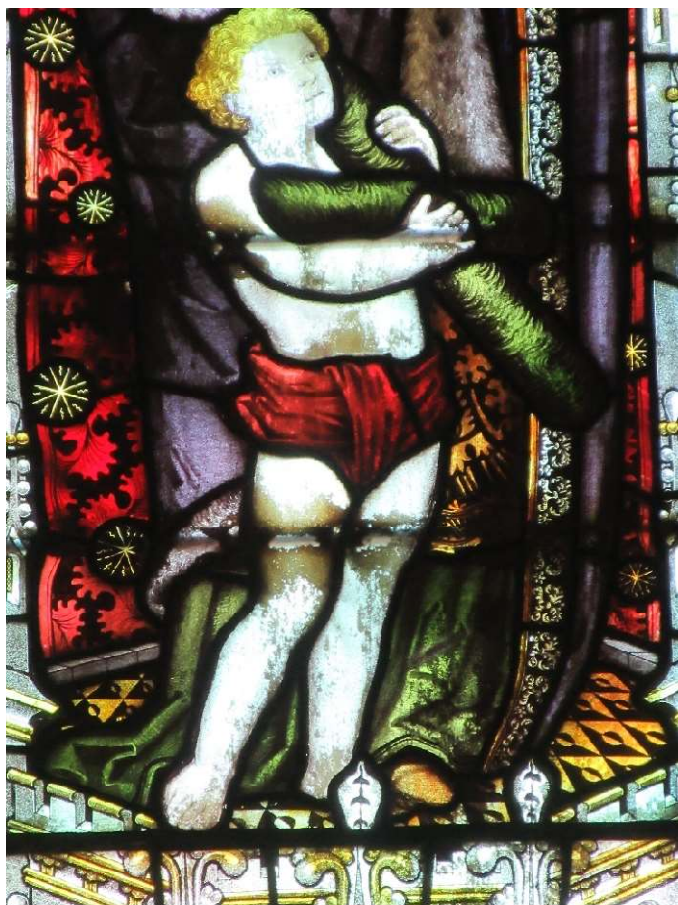
N Chancel – some loss of paint at figure

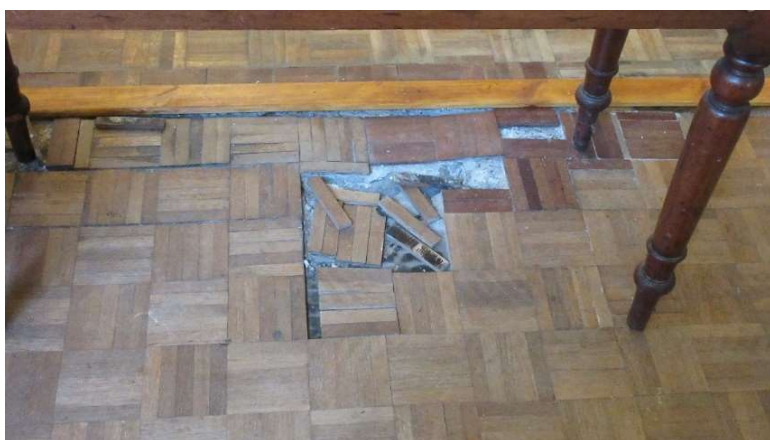
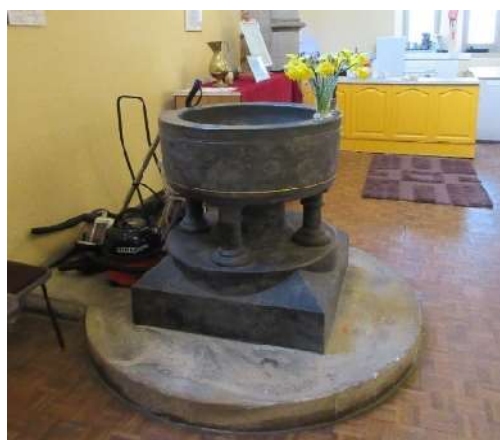
99. Small holes in the Aisle floors at former heating pipes must let in draughts. Some tape over heating grills.
100. Carpet runner over the Nave centre walkway.
101. The Vestry has fitted carpet on a ventilated suspended floor over the brick vault ceiling of the former boiler room below.
102. Porch is riven York stone flags at slight slope, flush with floor for level access.
A wooden handrail at the basement steps.

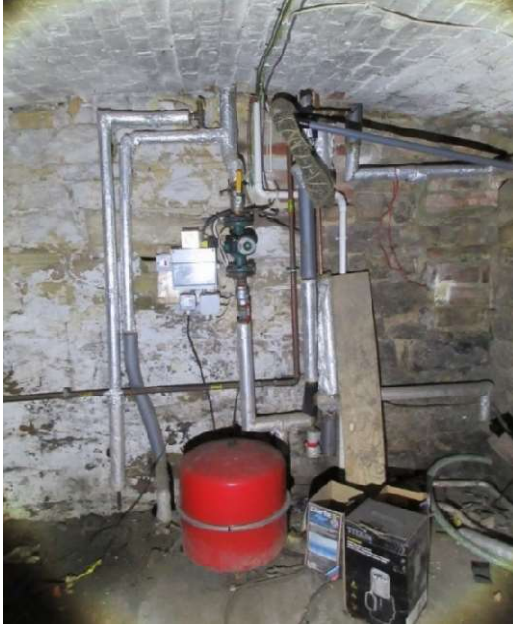
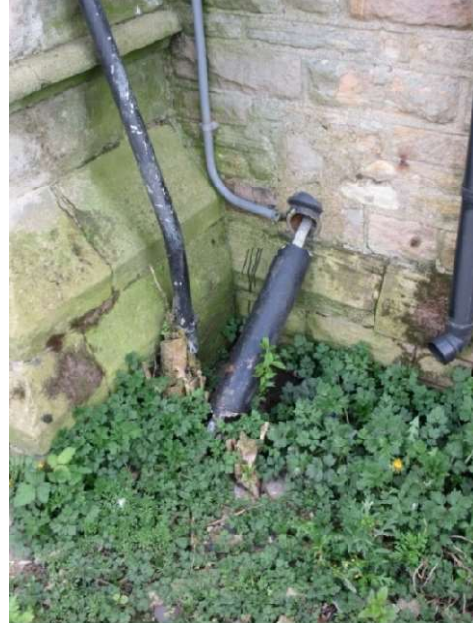
109. Four modern radiators in the Chancel, one in Vestry. Four at W and two central in the Nave. Some warm air from finned pipes with reflective foil below in the trenches under the cast iron grills in the walkways.
A pumped loop in the NW corner.

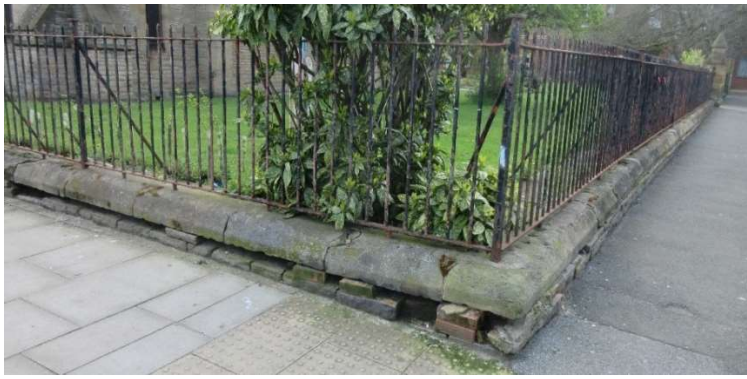
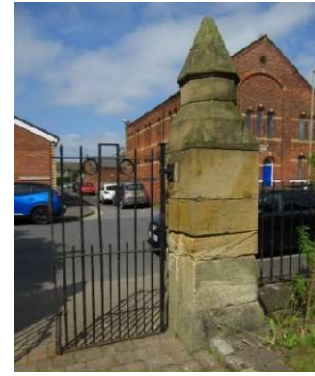
132. The timber and steel sign at the NE corner has been remade but lacks edgings to protect the plywood and sign lettering.
At NW a short flag pole has lost its top and pulley and lacks paint.
