Diocese of Durham

**JARROW GRANGE
CHRIST CHURCH**
(109)

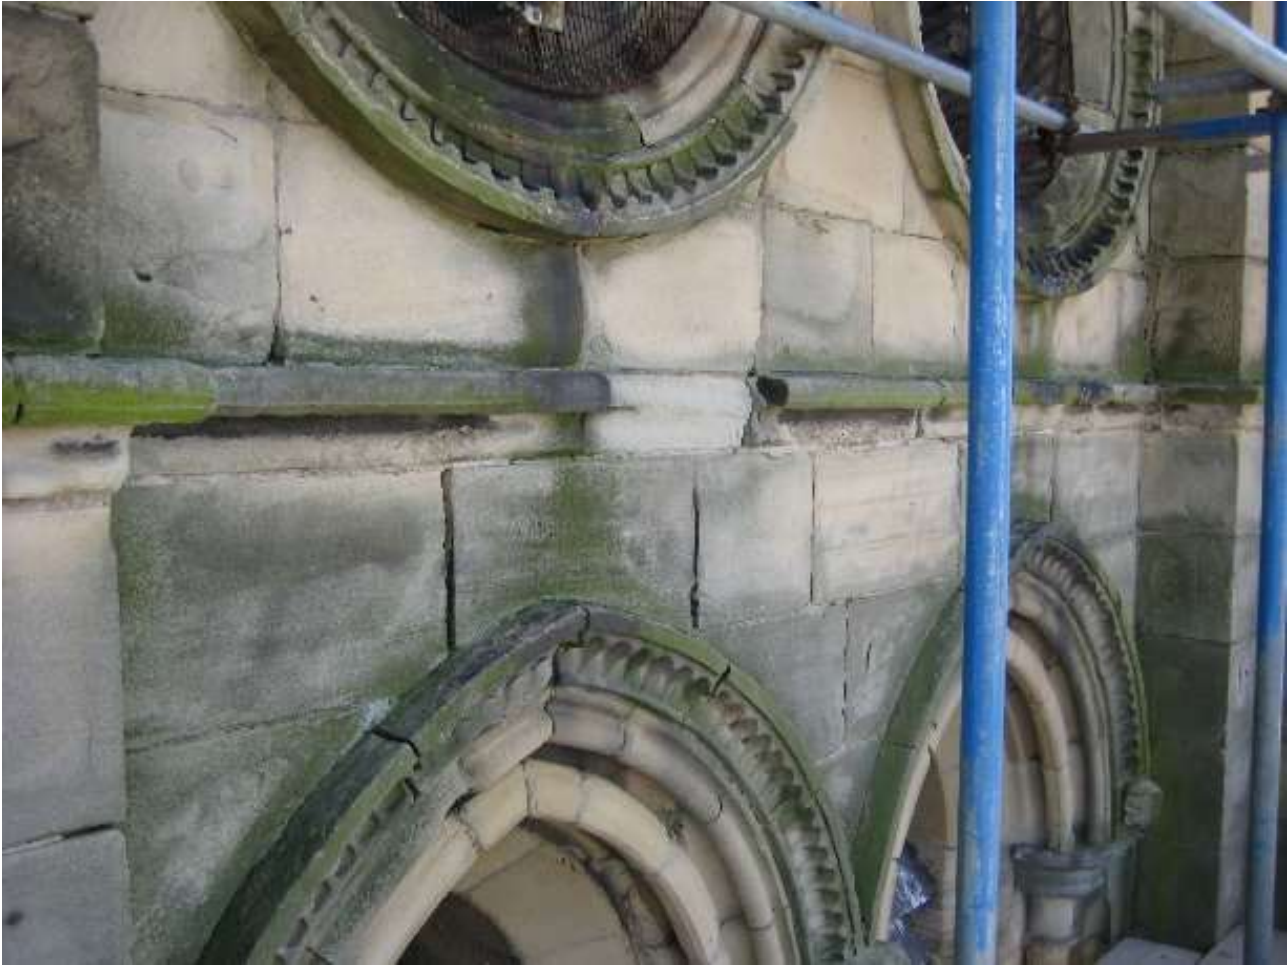
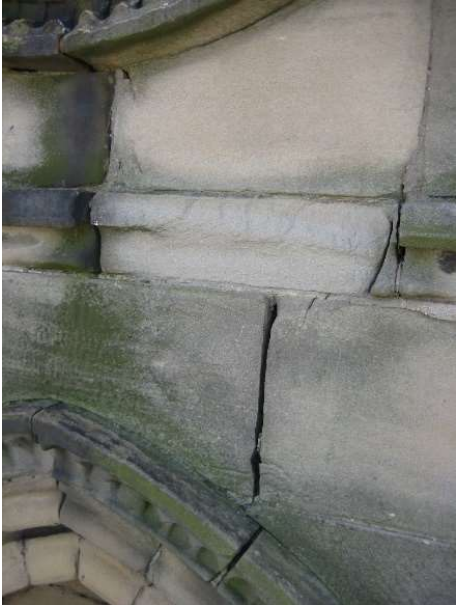
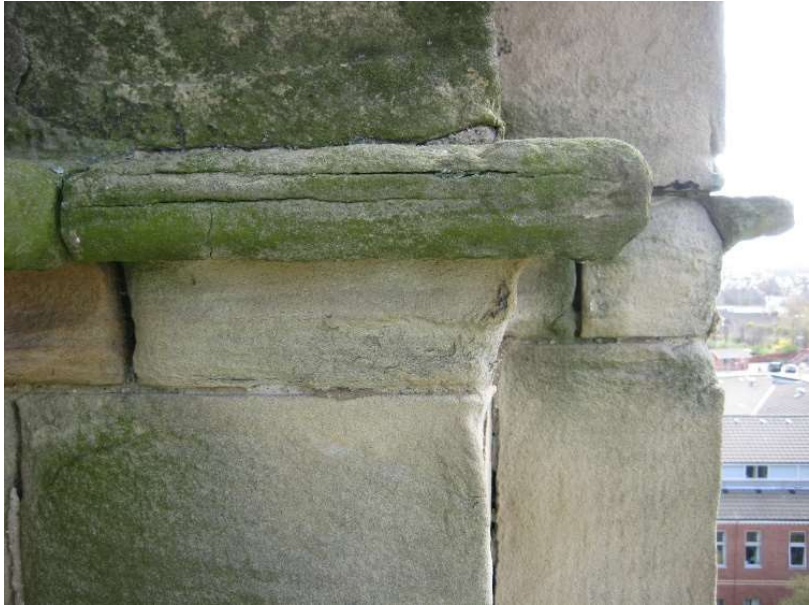
North Tower top lift 4
