QUINQUENNIAL INSPECTION REPORT

CHURCH OF St. PETER
YORK AVENUE, JARROW, NE32 5LP

NOVEMBER 2022

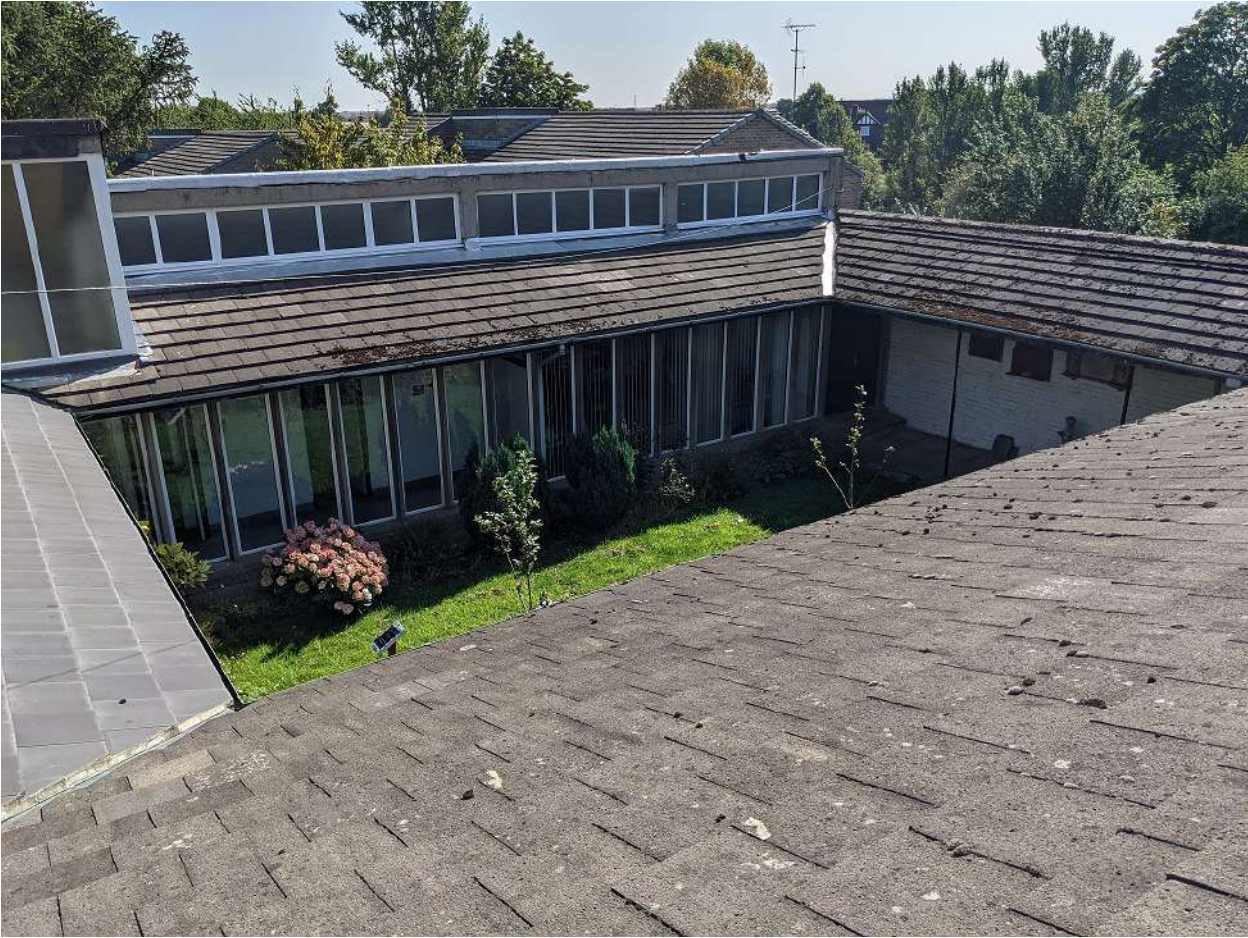
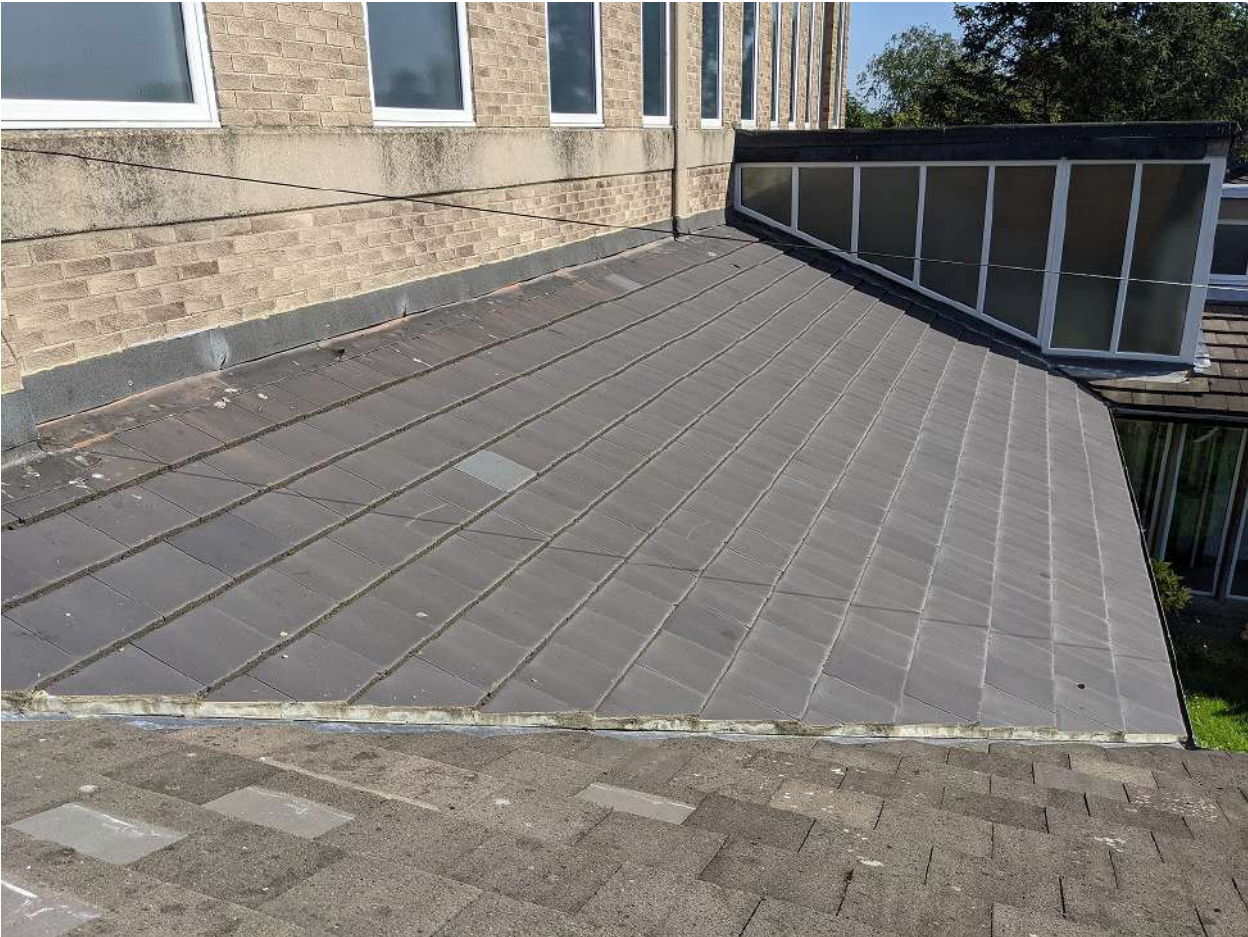
Lead valley gutters exist at the junction between each lower roofing slope. Lead flashings have generally been removed due to previous incidents of vandalism and theft. These have been replaced by a mix of materials, such as 'flashband' and 'lead alternative' flashings – Ubiflex.

There is evidence also of flashbanding to the abutment junctions and ridge to the courtyard complex, these are short life solutions and temporary in nature. Design detailing at the abutment junctions do not allow for sufficient upstand flashings to the walling elevations. This is a technical feature inherent in the original architect's design and as such may well provide a weakness for water ingress. Some of the 'flashband' is flaking and loose in nature.

R1		It is recommended that in conjunction with the church architect an assessment of the roof flashings is carried out by a competent and experienced roofing contractor.
R1	3.2.2	It is recommended that a schedule of work and specification is drawn up for flashing repairs to the courtyard roof covering.
R2	3.2.3	Carry out flashing repairs to the courtyard roof covering by a competent and experienced roofing contractor.
M	3.2.4	As a routine item of maintenance, the roof covering is checked twice yearly by a competent and experienced roofing contractor.

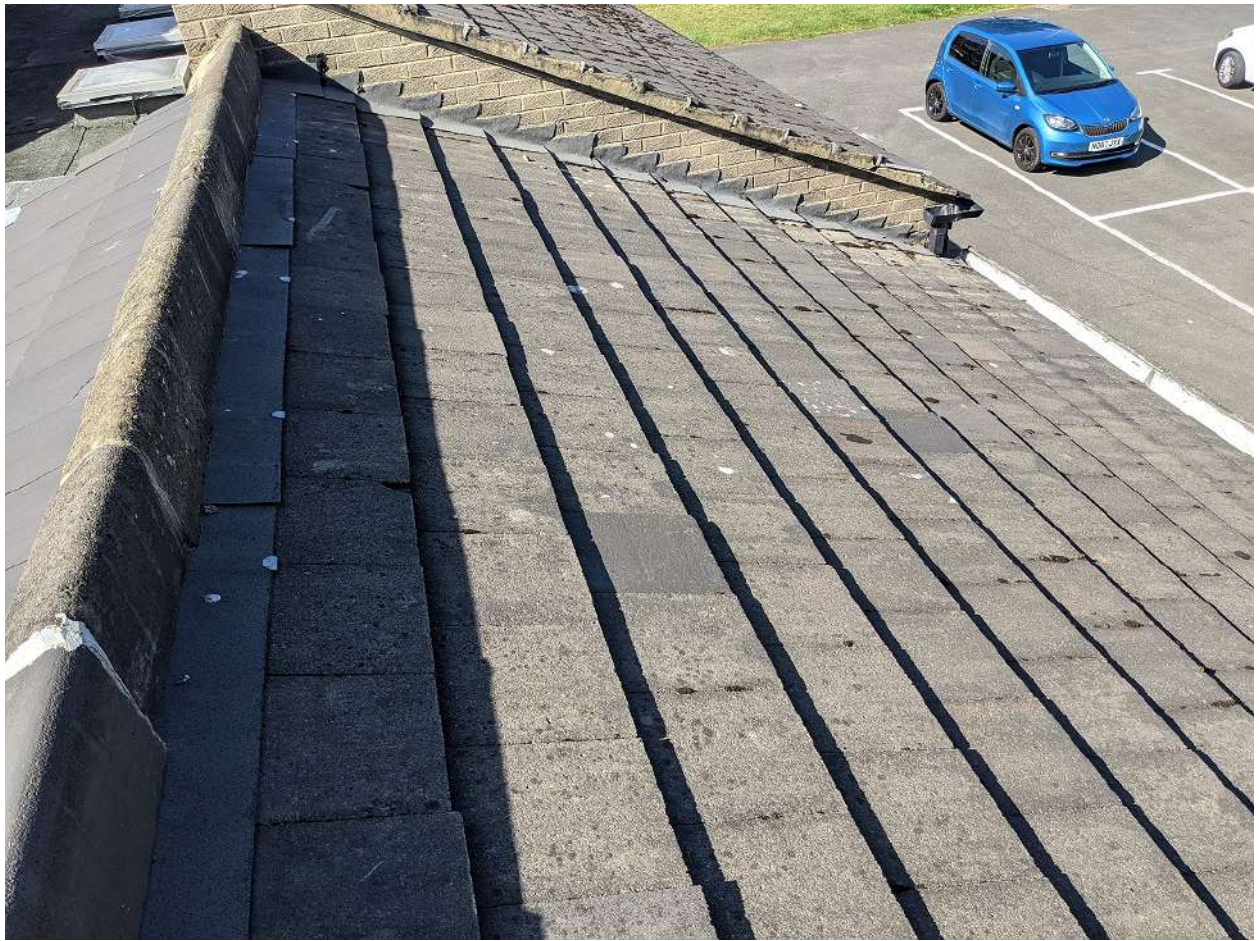
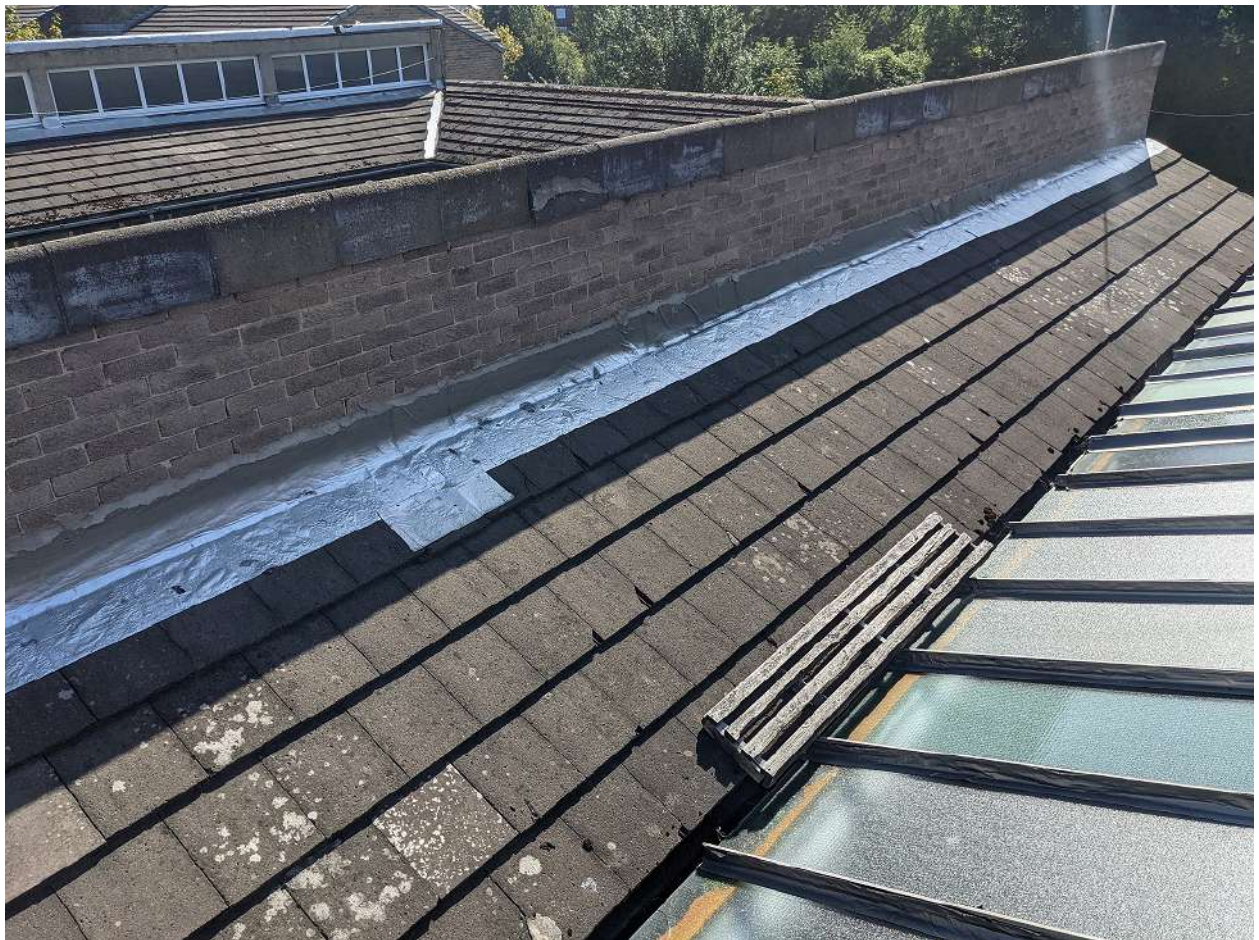
Lead flashings have generally been removed over the course of the preceding quinquennium through vandalism and theft. In part these have been replaced by a 'lead alternative' flashing material – Ubiflex. These appear to be in good order.

There is evidence however of excessive use of flashbanding to the abutment junctions to the roof covering beyond the entrance porch roof, these are short life solutions and temporary in nature.

R1	It is recommended that in conjunction with the church architect an assessment of the roof flashings is carried out by a competent and experienced roofing contractor.
R1	3.3.2 It is recommended that a schedule of work and specification is drawn up for flashing repairs to the entrance porch + link roof covering.
R2	3.3.3 Carry out flashing repairs to the entrance porch + link roof covering by a competent and experienced roofing contractor.
M	3.3.4 As a routine item of maintenance, the roof covering is checked twice yearly by a competent and experienced roofing contractor.

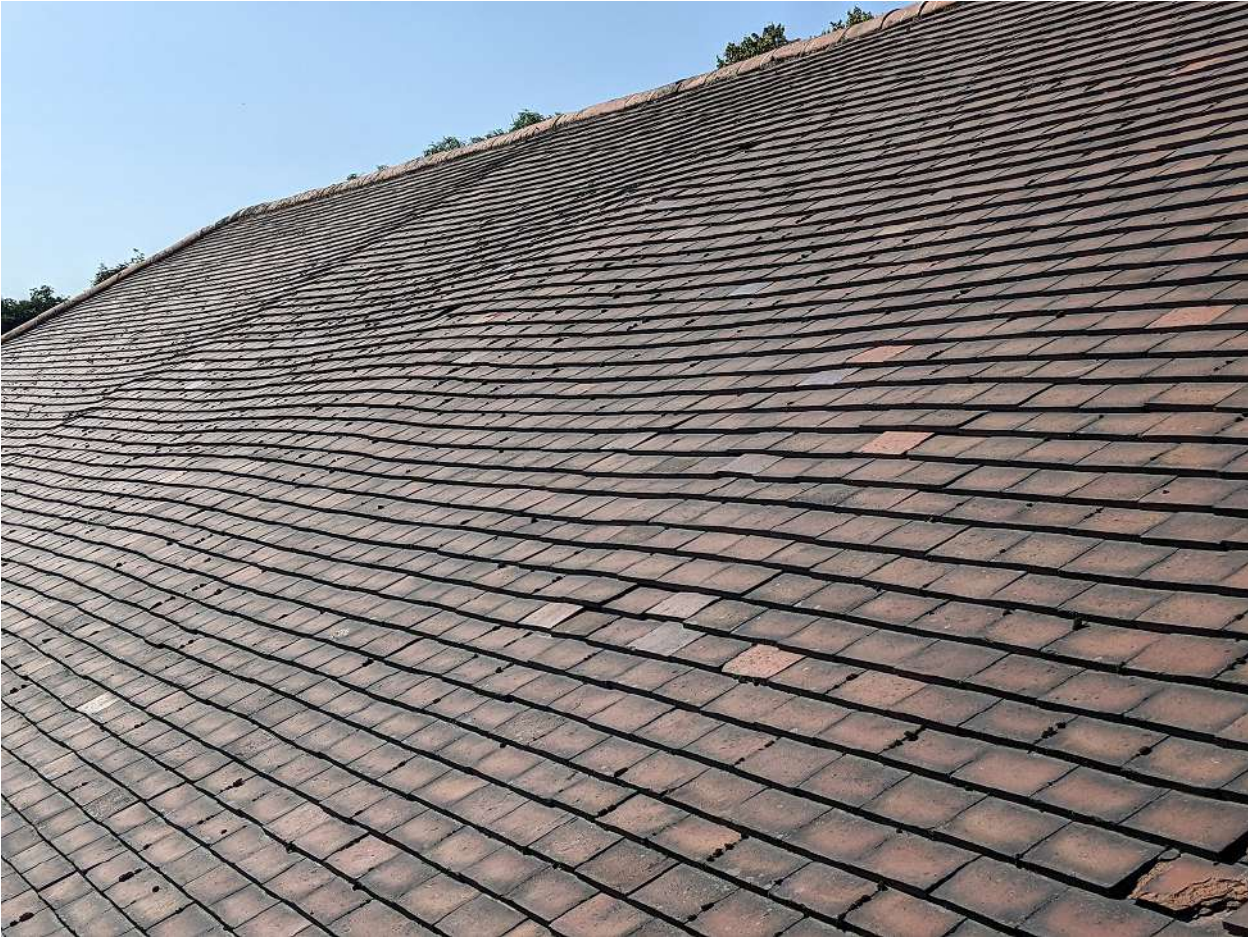
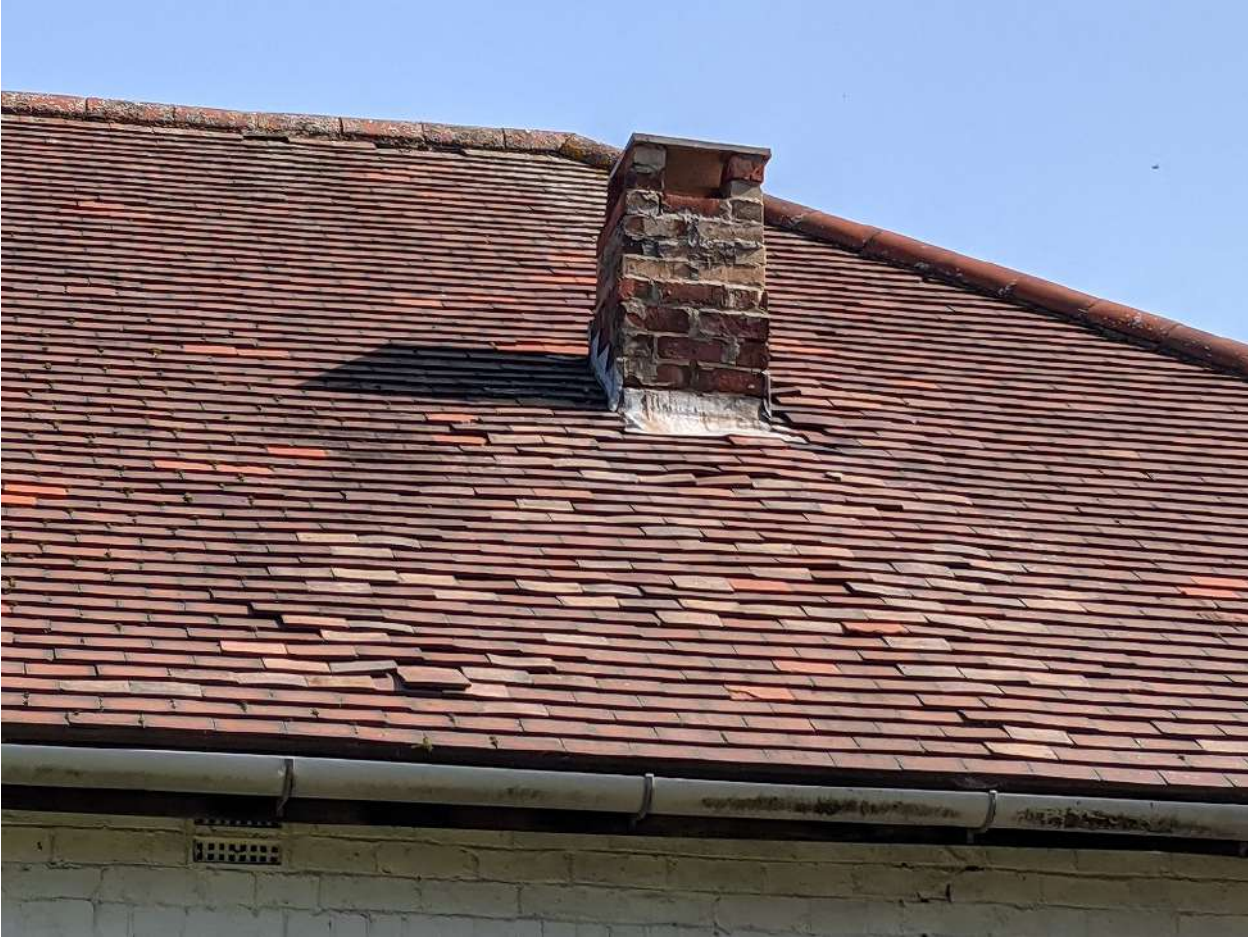
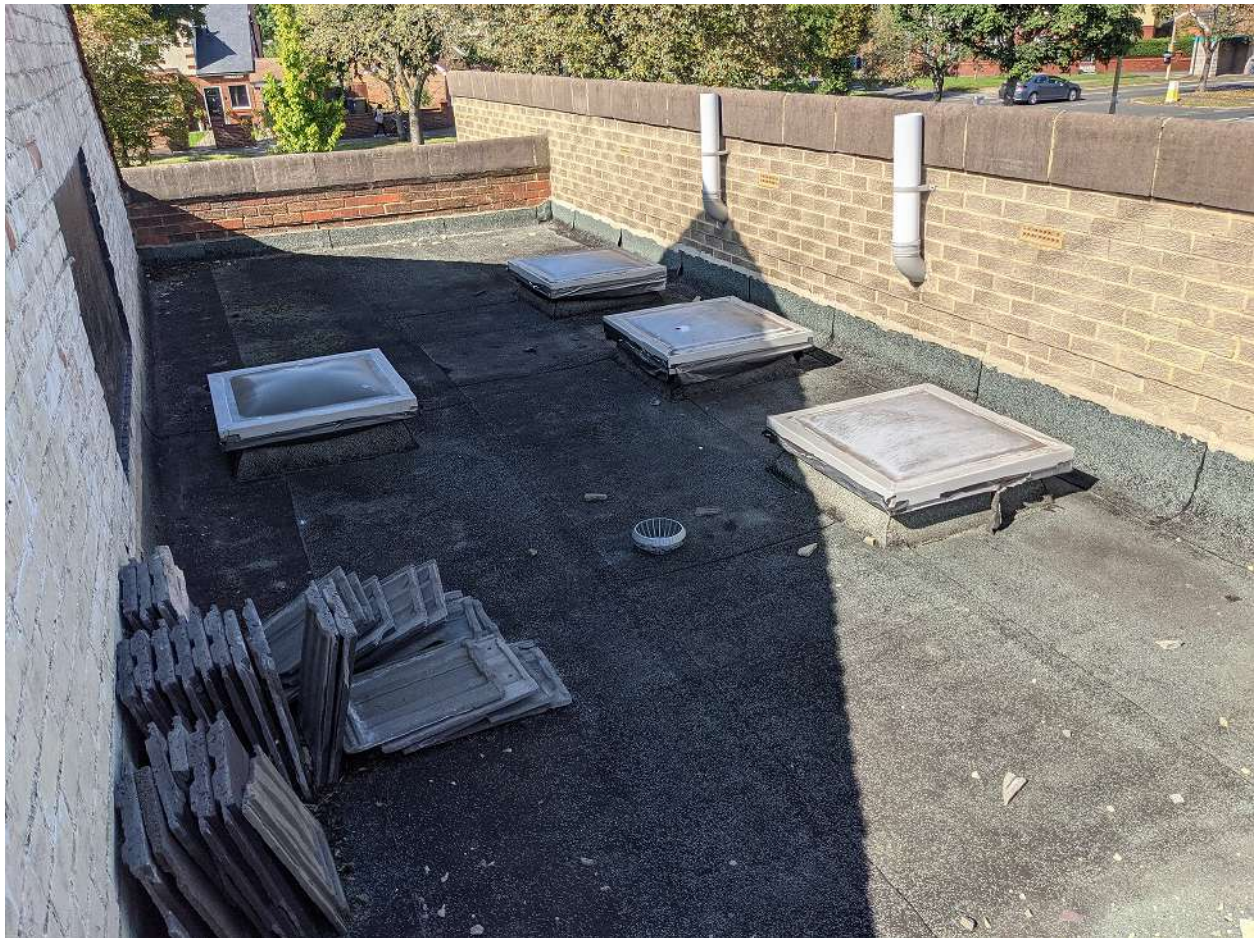
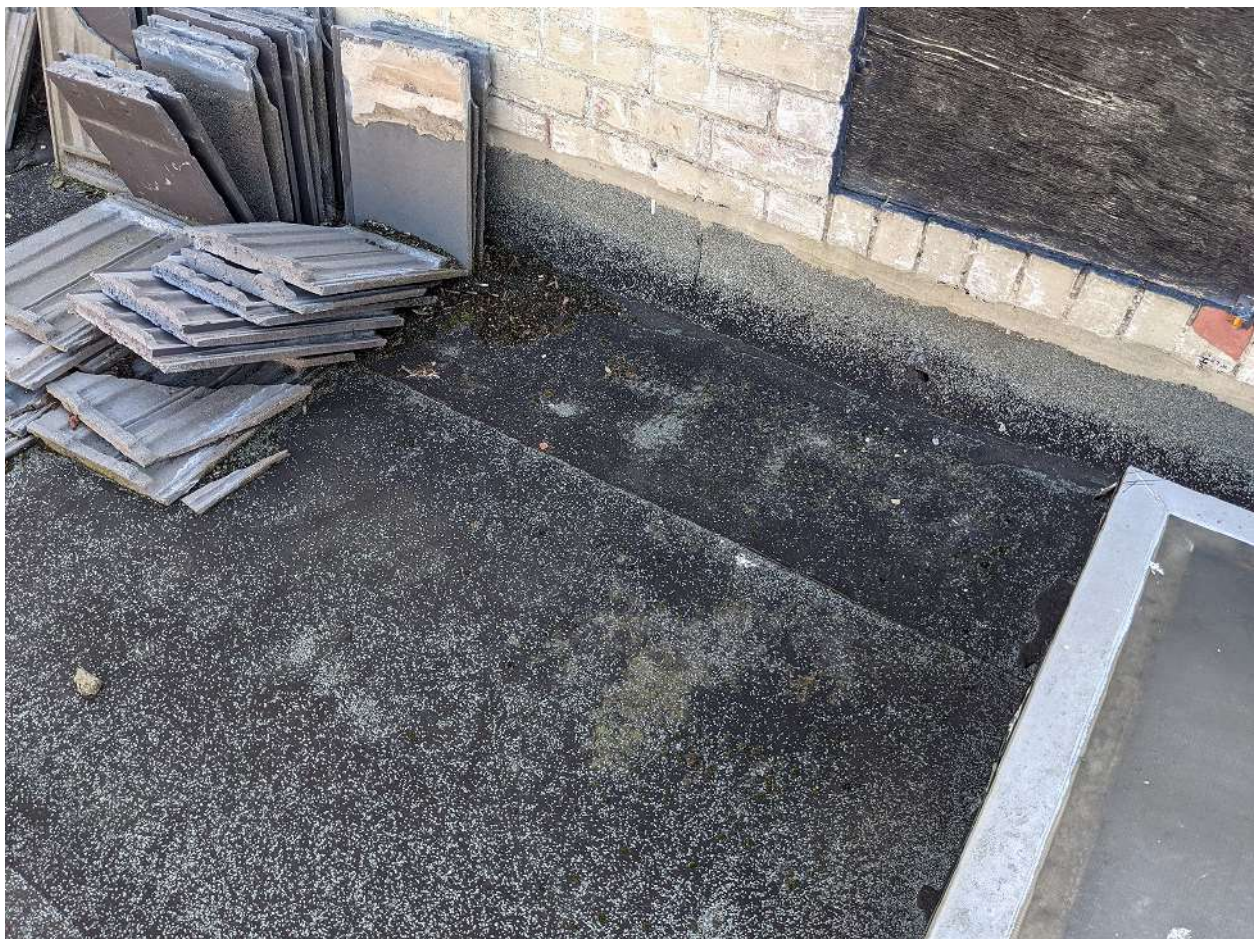
To the east slope there is the occasional slipped and/or missing clay plain tile. To the west slope there is disturbance to the clay tile finish at the sound end. The mortar bedding ridge tile appears to be in a sound fair condition.

3.4.2 The bituminous felt flat roof covering is in a slowly deteriorating condition. There is the occasional 'bubbling' to the surface finish and several joints are slightly raised, suggesting the weathertight seal locally is susceptible to water ingress, although none has yet been reported internally. There are several concrete tiles resting on the roof covering which would benefit from removal and storage elsewhere. The felt junction with the internal downpipes is in poor condition and deteriorated.

R2	It is recommended that clay tile repairs are carried out by a competent and experienced roofing contractor.
-----------	---

R3	It is recommended that the roof covering is replaced over the course of the quinquennium by a competent and experienced roofing contractor.
-----------	---

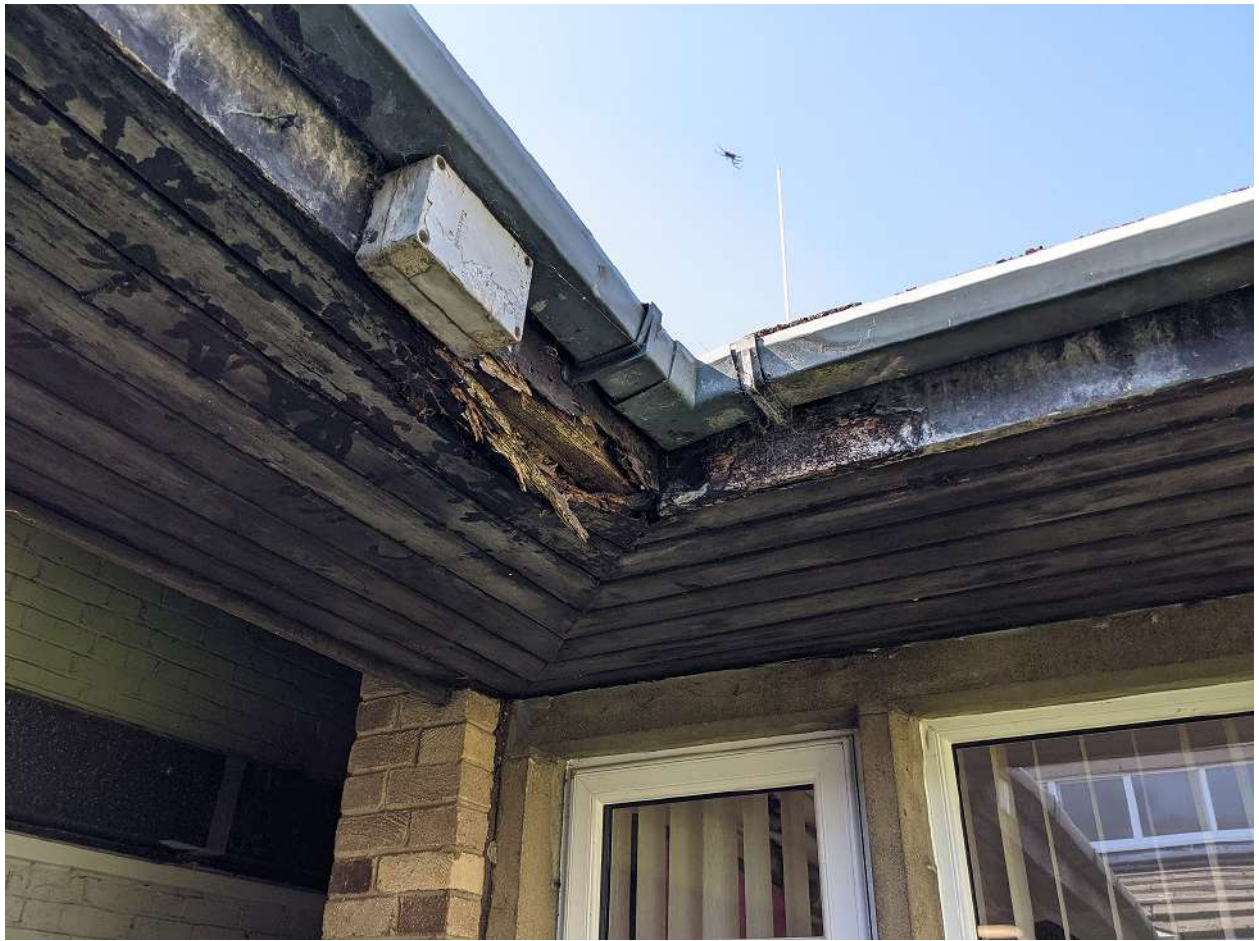
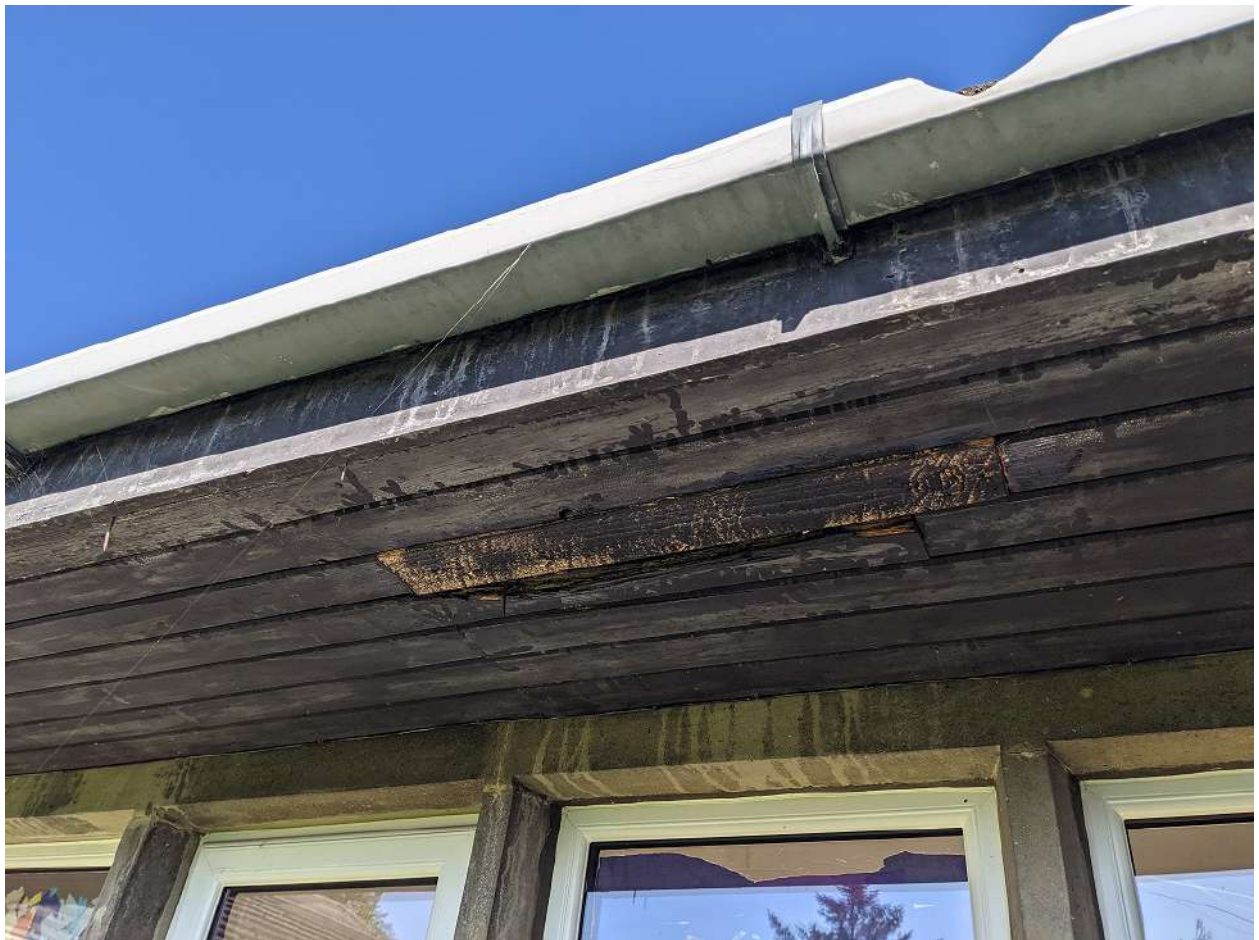
4.2.1 At the time of inspection the rainwater goods to the inner roof sections were exhibiting several defects including leaks via cracks in the gutter joints, damaged sections to the face of the gutter, inadequate discharge areas adjacent to the base of the valley gutters, damage to the deep timber eaves soffit and possible incorrect positioning of gutters to catch rainwater run-off.

R1	It is recommended that a schedule of work and specification is prepared for the replacement of the gutters and fascia boards.
-----------	---

R2	4.2.2 Carry out repair of the rainwater goods by a competent and experienced roofing contractor.
-----------	--

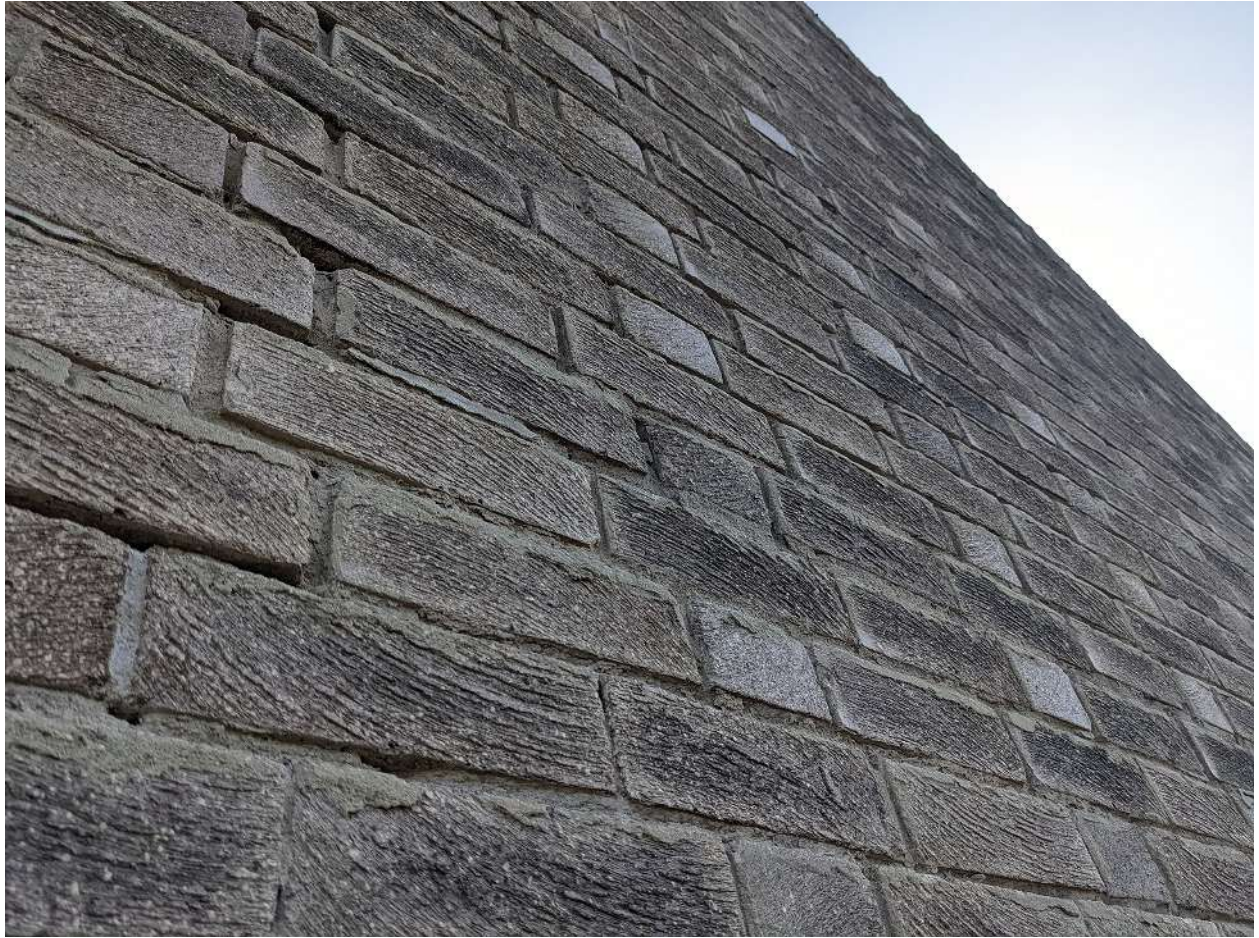
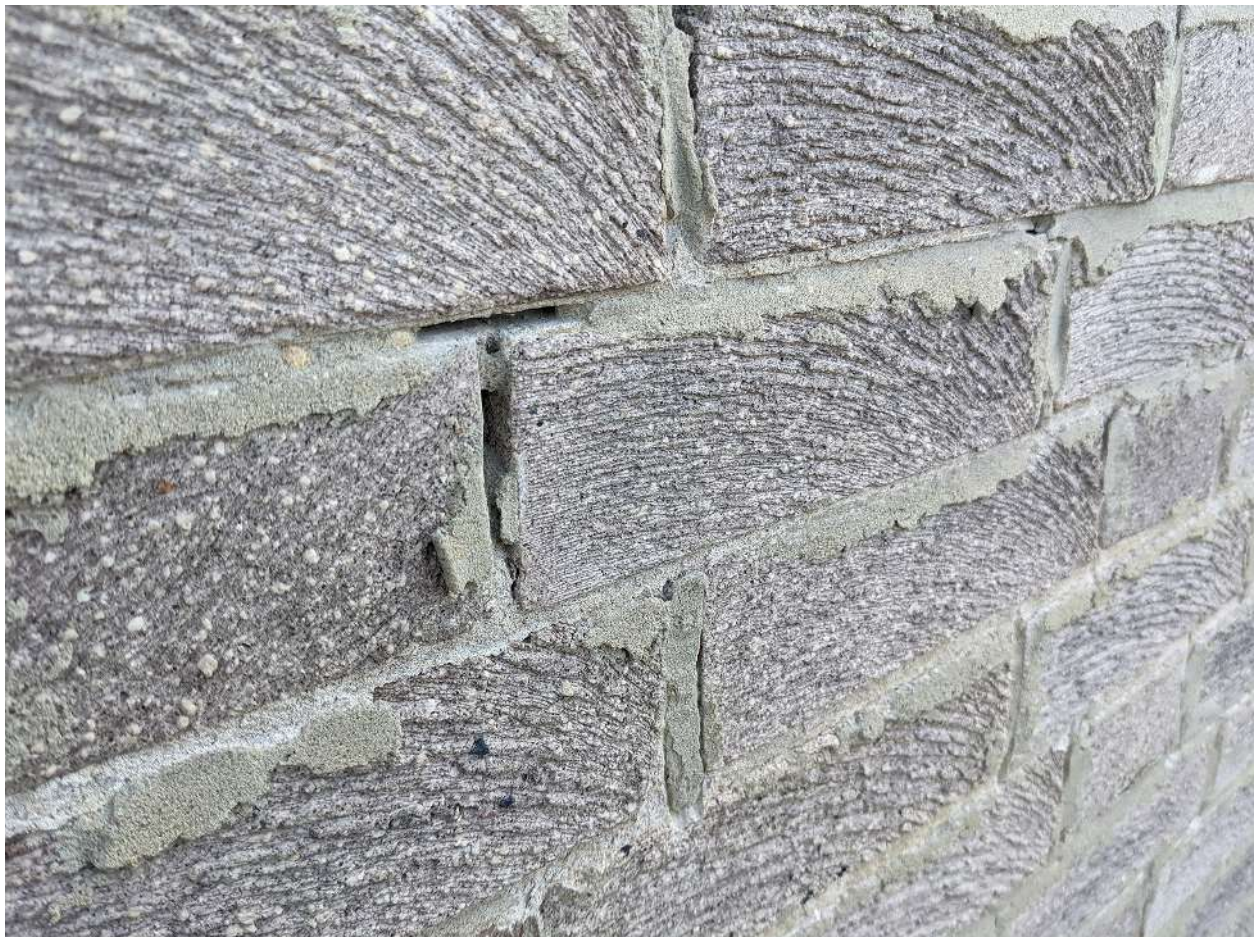
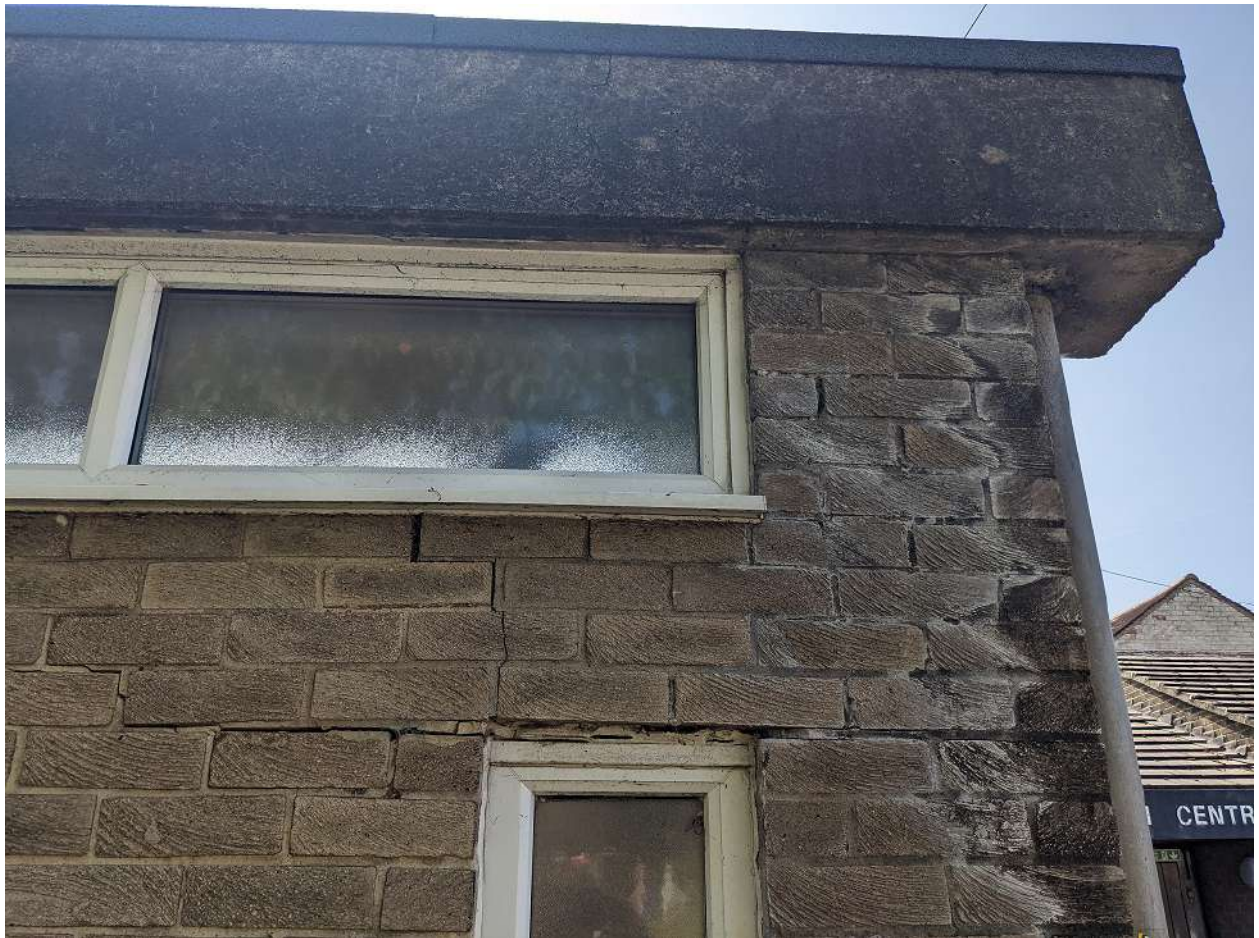
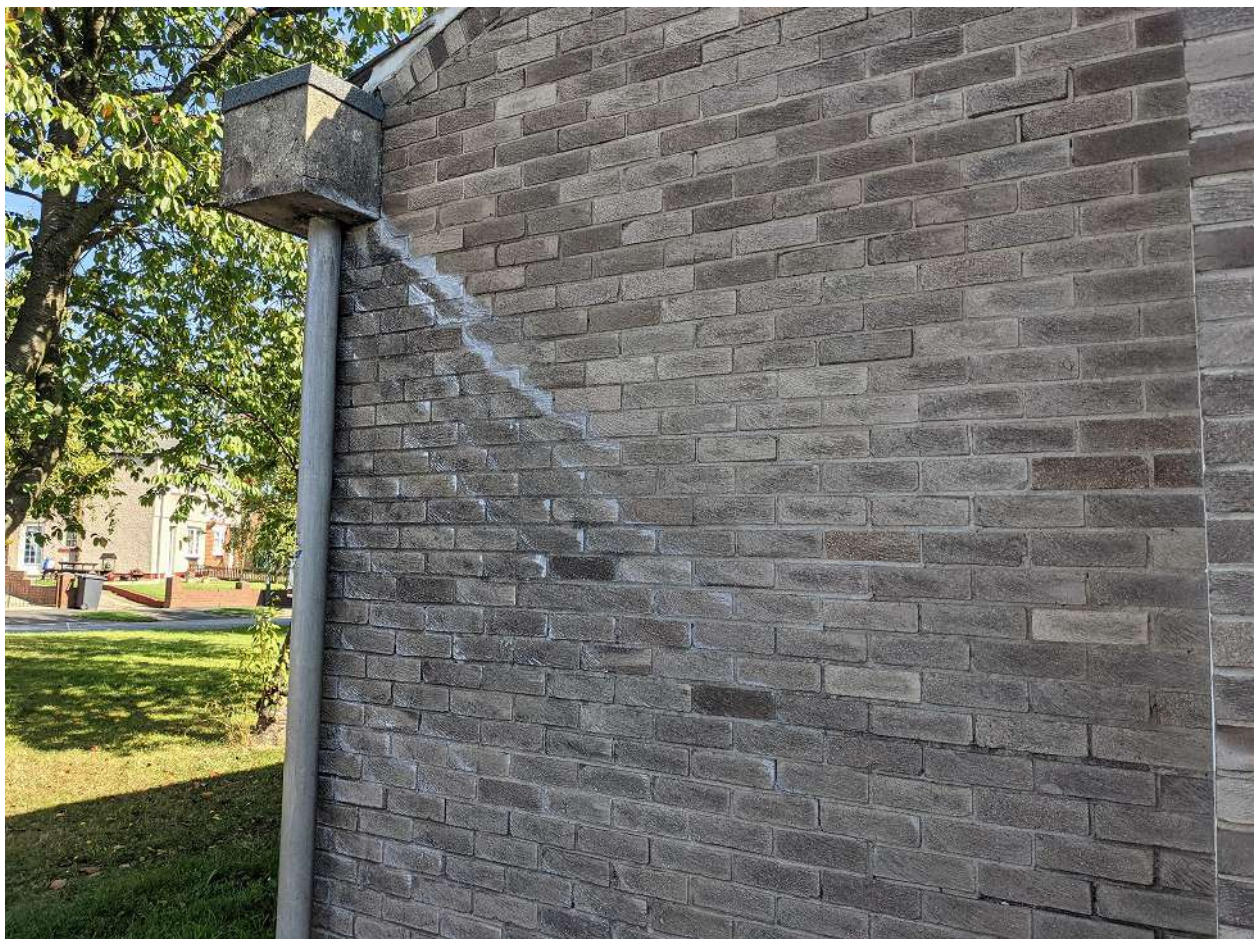
- There is a lean top joint at the extreme south end and the mortar is loose in places.
- Some movement is evident around the end of the concrete gutter where the reinforcement is showing at the north end and where some distortion of the brickwork has occurred.
- Graffiti evident at low level adjacent to bell tower.

- There are lean mortar joints at mid height and at high level, disturbance to the brickwork parapet noted in the previous QIR has been repaired over the course of the preceding quinquennial period.
- Steel reinforcement is visible to the corner of the end of the concrete floor of the belfry and an open joint exists between the concrete gutter and vertical wall of the belfry.
- Vegetation at high level, noted in the previous QIR has been removed.
- The timberwork and decoration of the belfry screen is deteriorating.

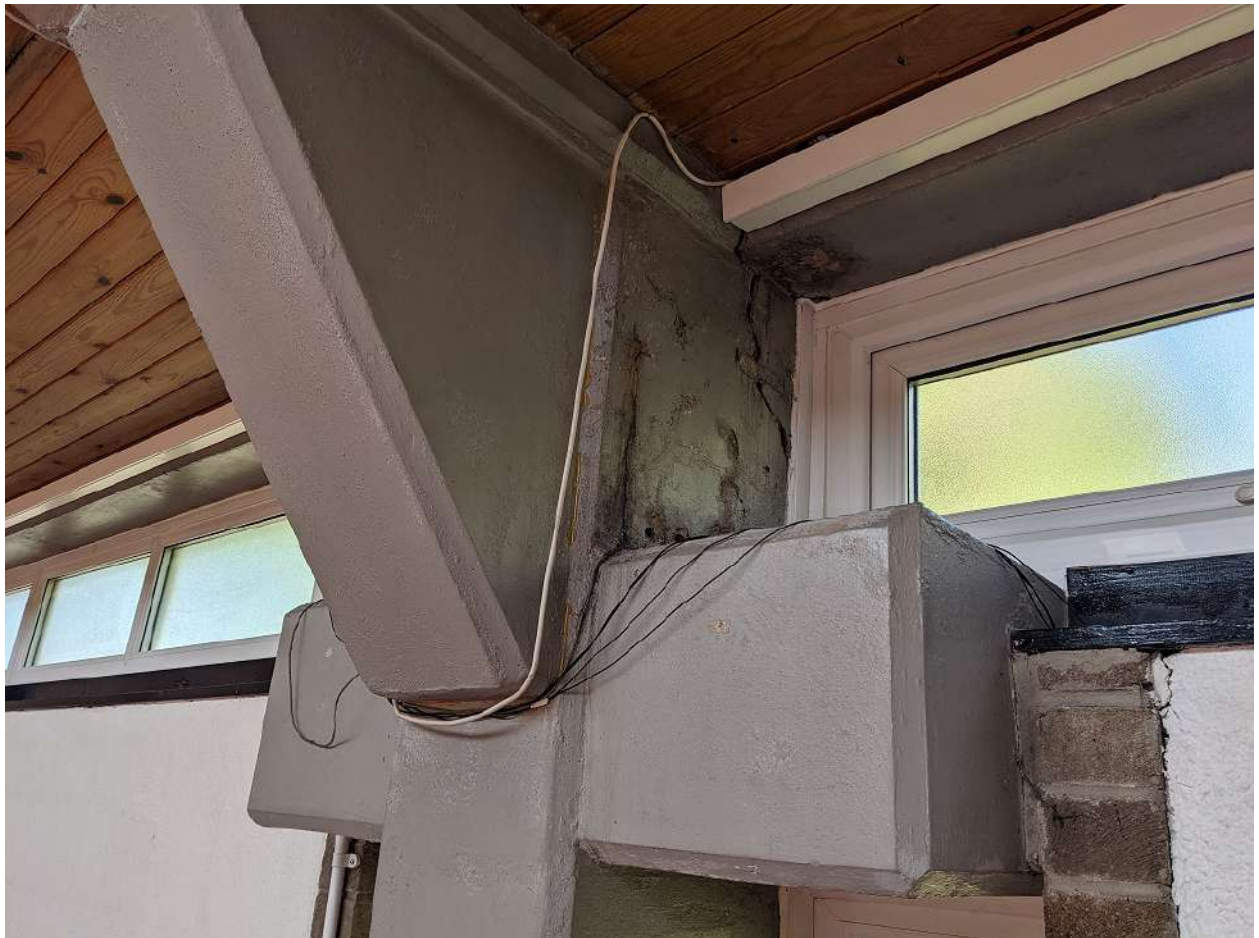
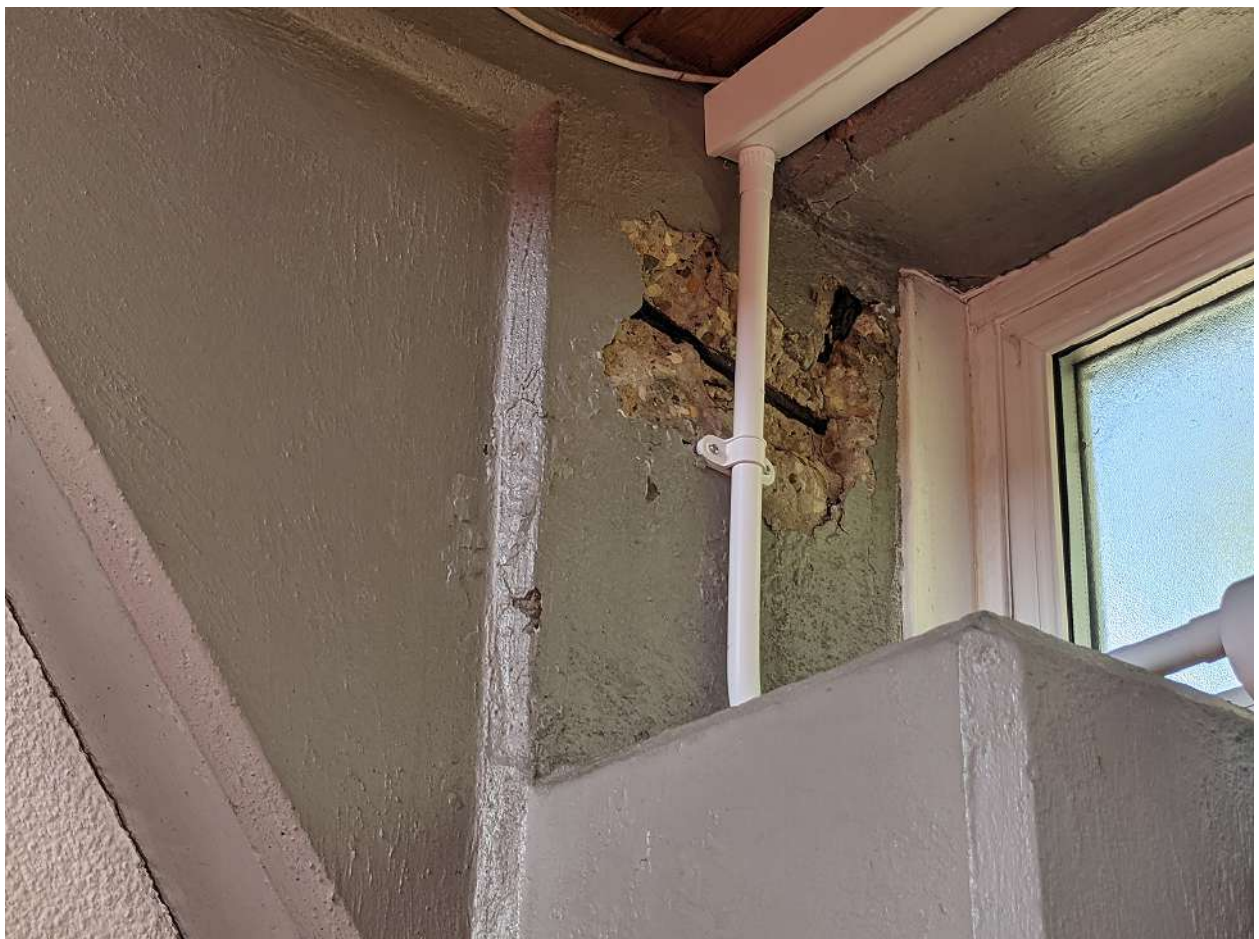
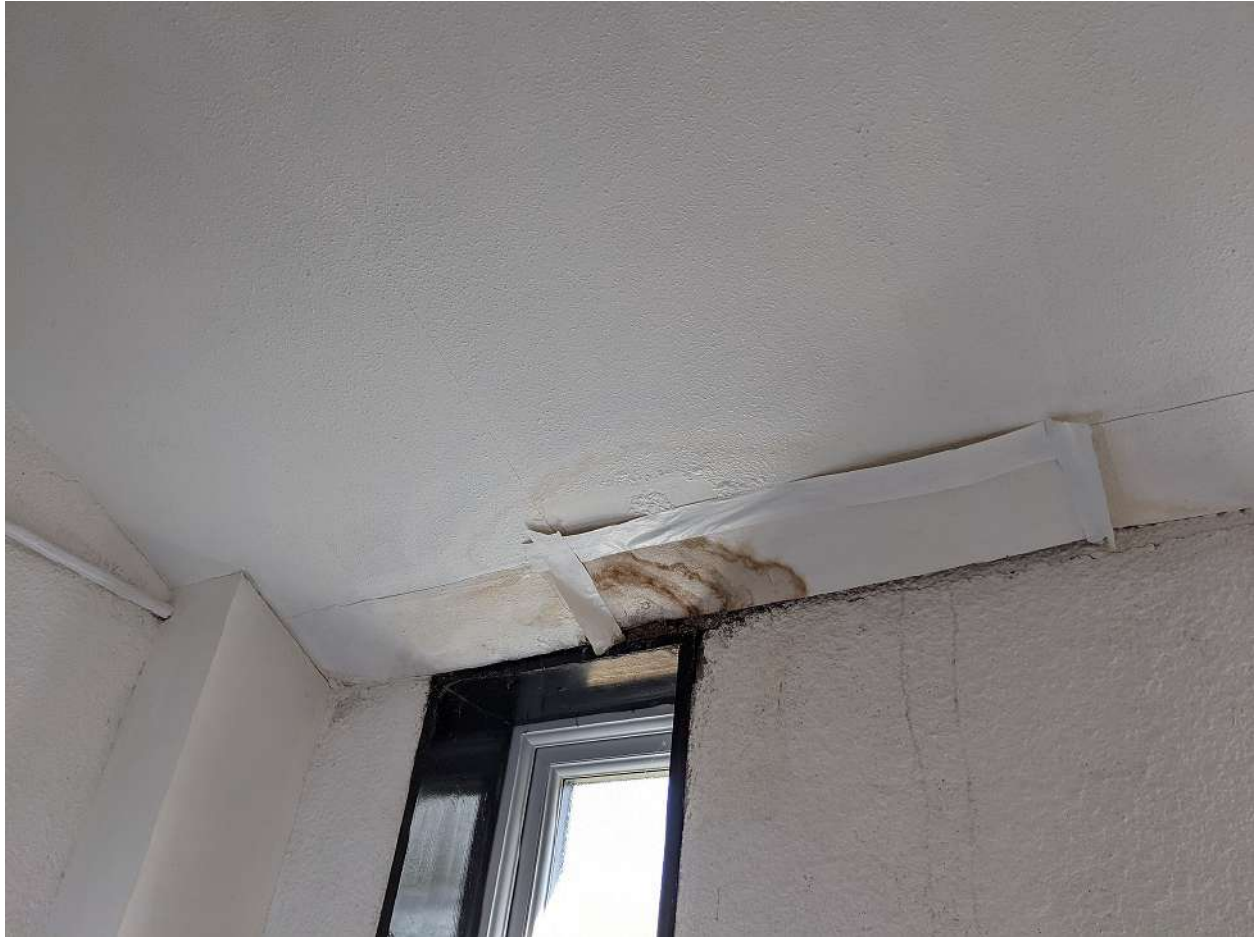
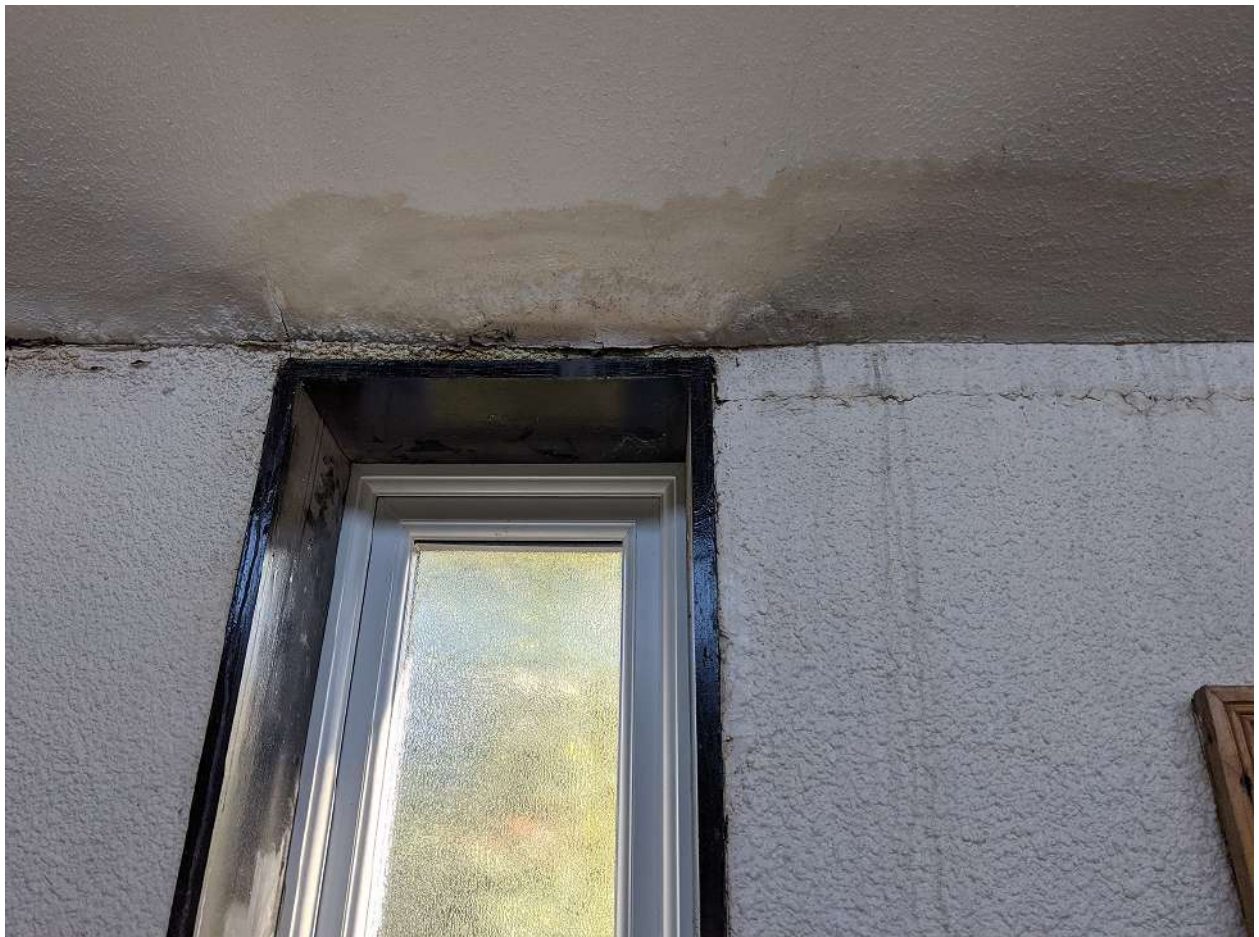
All is generally in a sound condition, albeit with evidence of old and fresh water staining above the northeast. Refer to item 3.1.2.
