QUINQUENNIAL INSPECTION REPORT

CHURCH OF St. PETER
YORK AVENUE, JARROW, NE32 5LP

NOVEMBER 2022

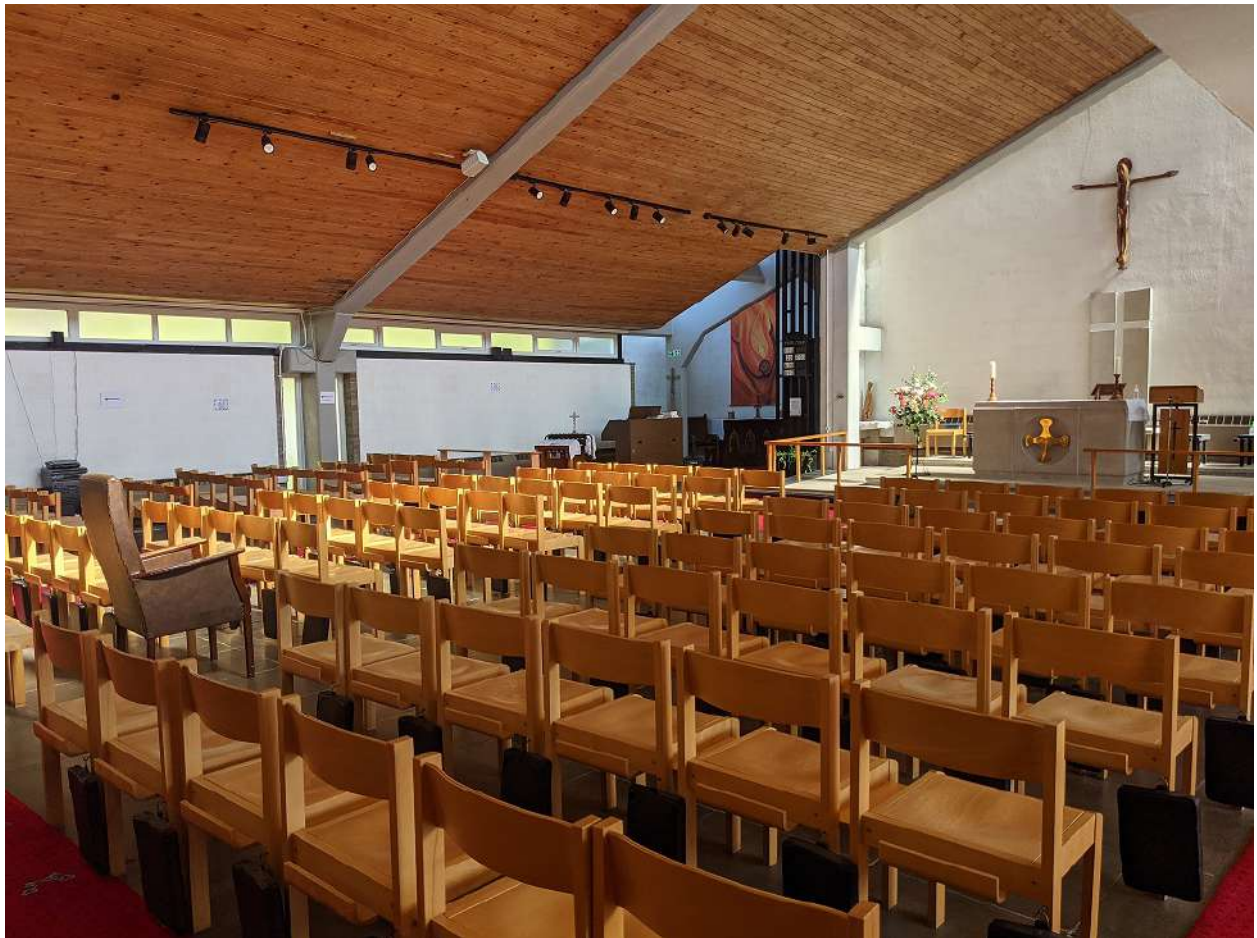
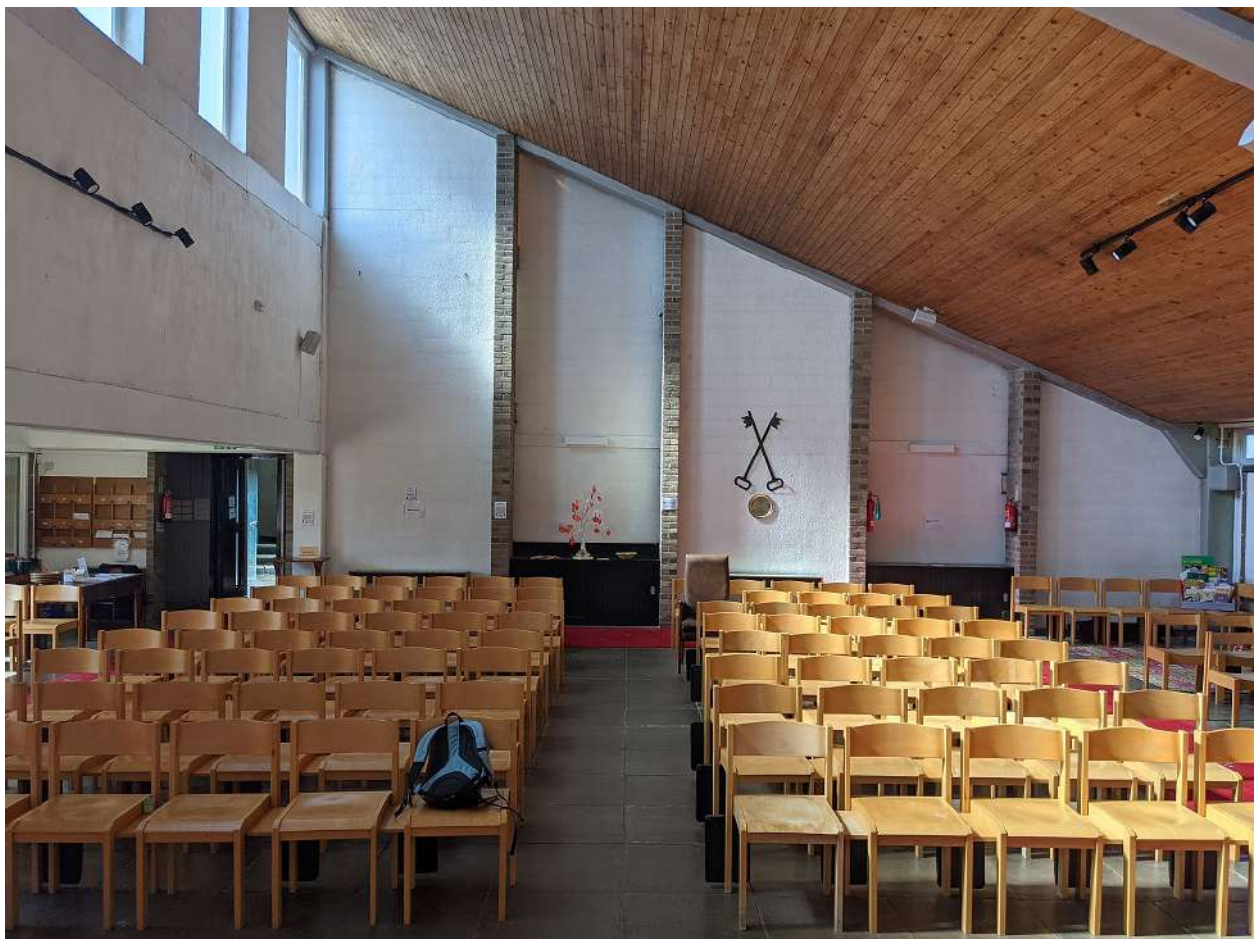
1. Horizontal and vertical cracks to the south wall of the church (now partially obscured by redecoration).
2. Left side of window jamb adjacent to rotating ring beam and at 2 further points on north wall of the church (now partially obscured by decoration).
3. Full wall height vertical cracks at 1-3 positions and to corners; horizontal cracks on line of concrete beams at high level to east wall of church.
4. Horizontal cracking to lintel over external door and ring beam on east wall and vertical crack to external corner of organ chamber.
5. Horizontal cracks to 2 'forward' panels to west wall of church.

On inspection these all appear to be stable with no further movement evident.

M As a routine item of maintenance checking of movement cracks is to be carried out in this area for signs of any further movement. Notify the church architect immediately if this is the case.

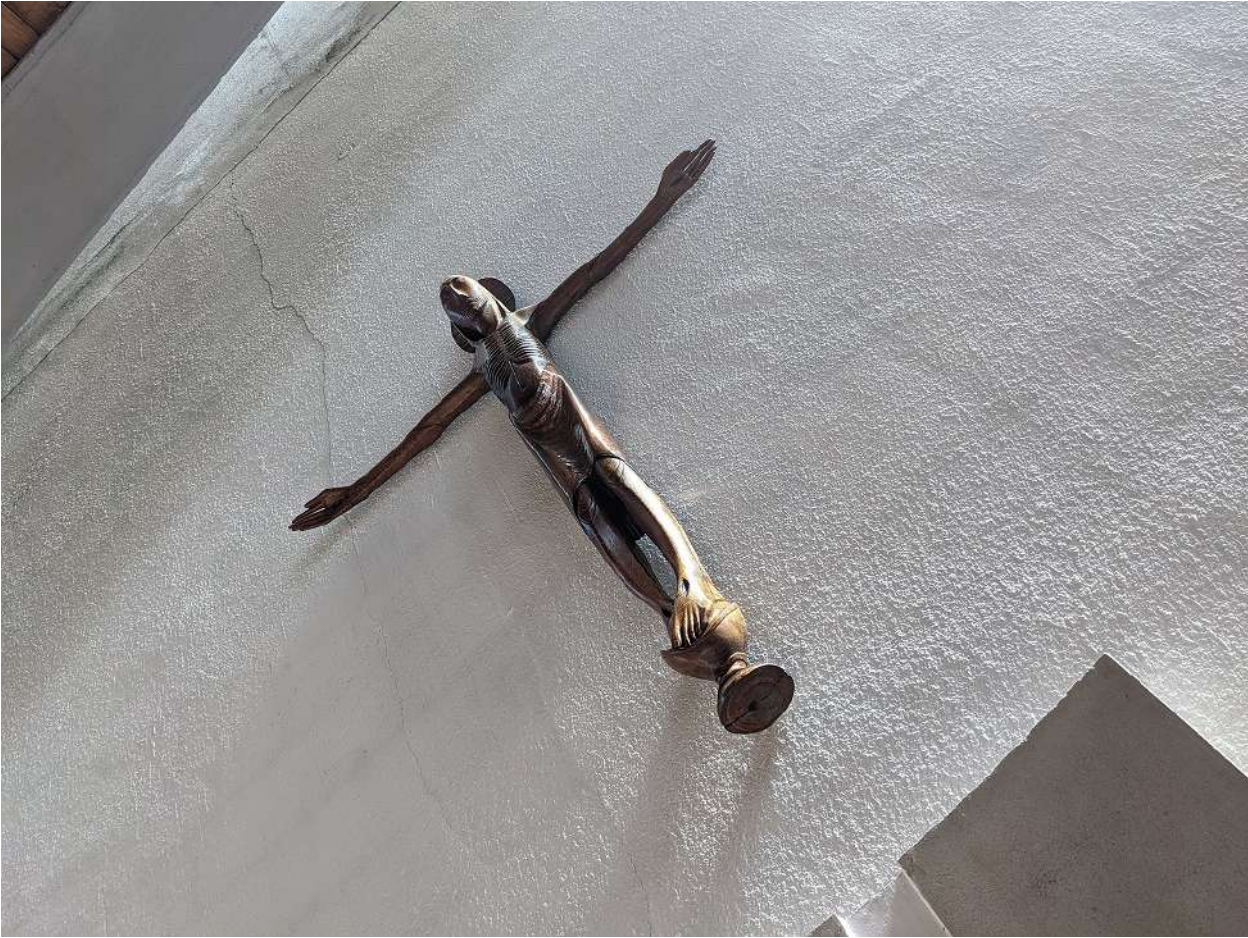
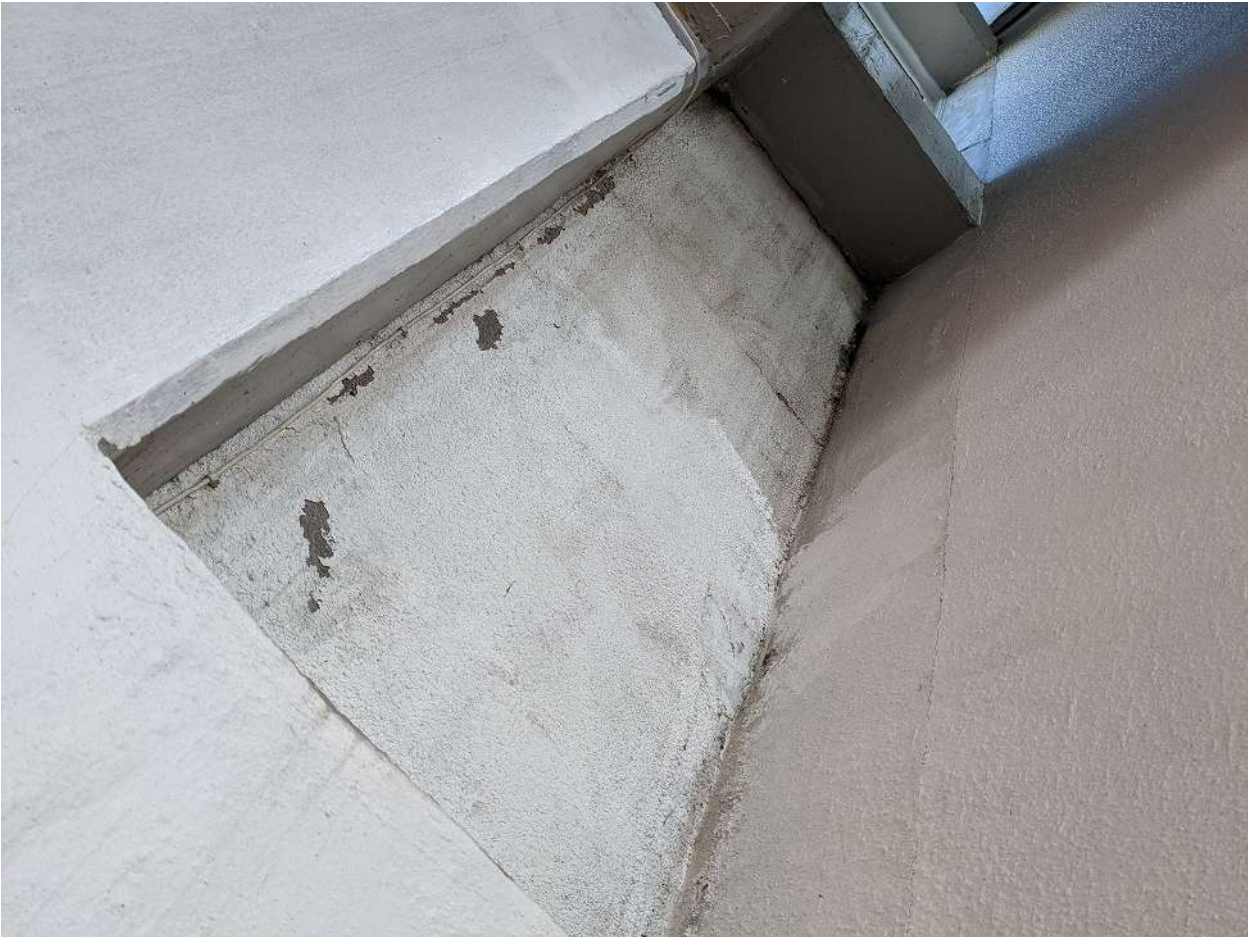
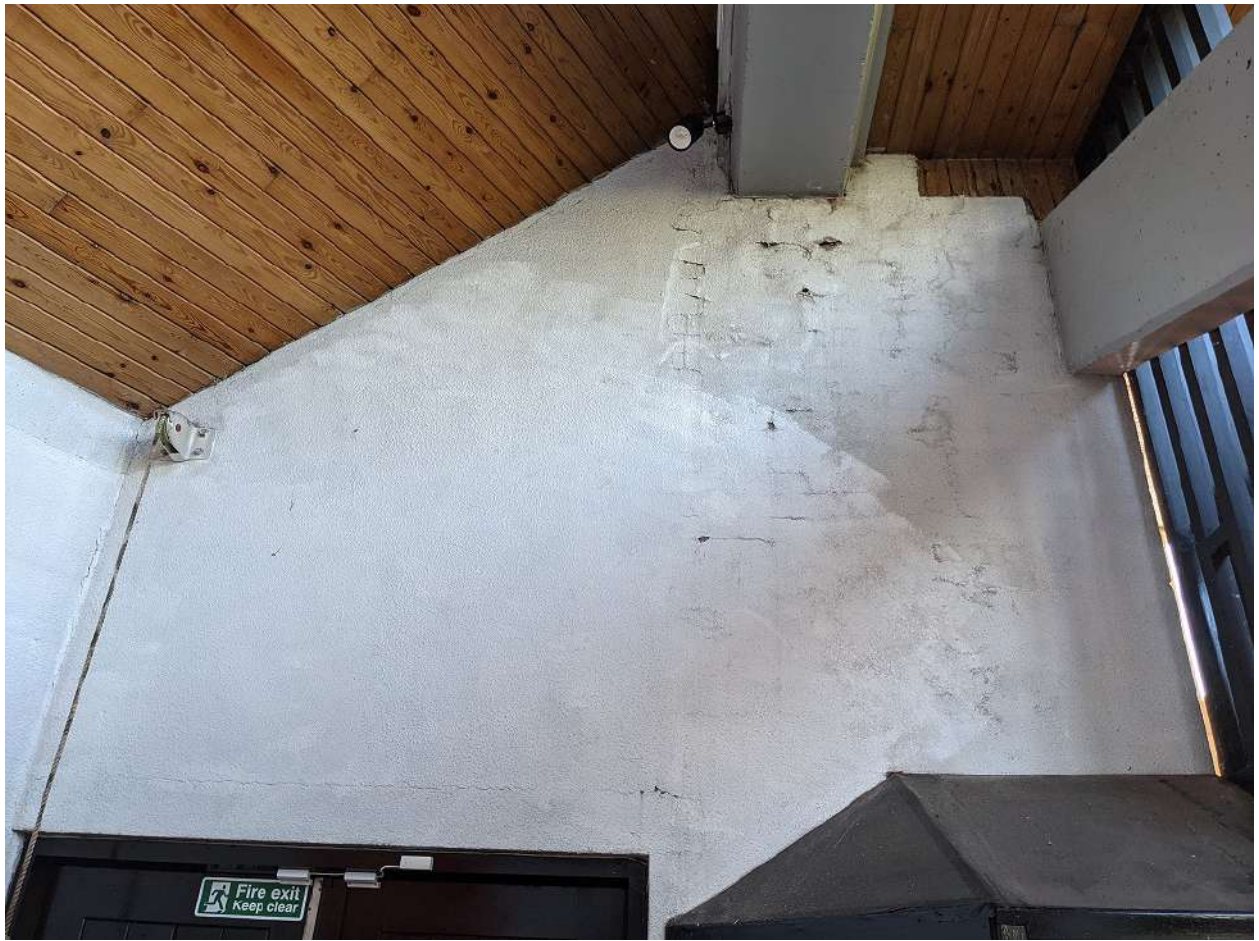
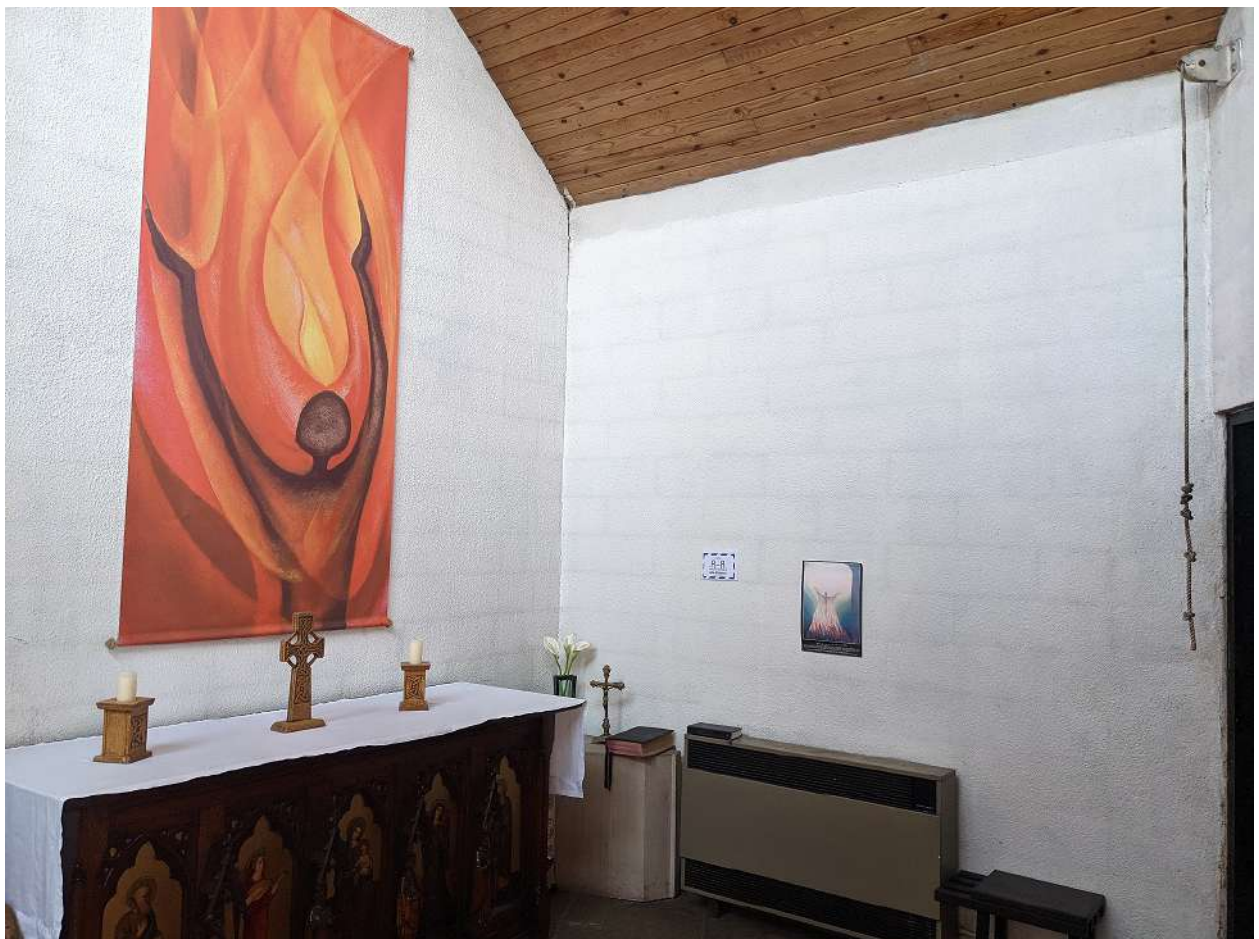
17.1.6 The internal finishes of the worship space are still in a fair, satisfactory condition however beginning to look a little tired. Redecoration in full will naturally help the appearance of the space.

This would be best carried out following rectification of the defects noted above, particularly in connection with repairs due to movement cracking and damp penetration where the plaster finish has failed.

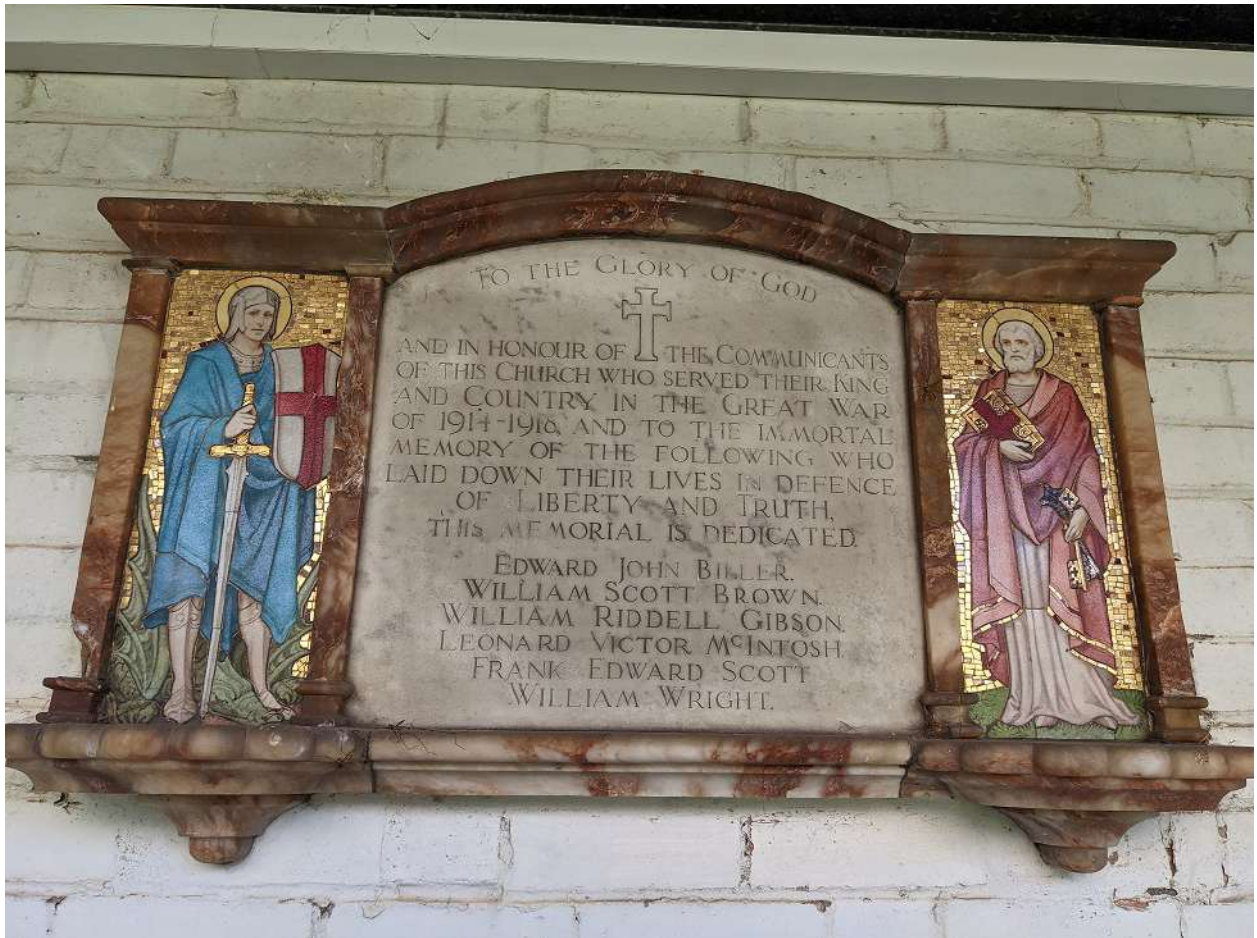
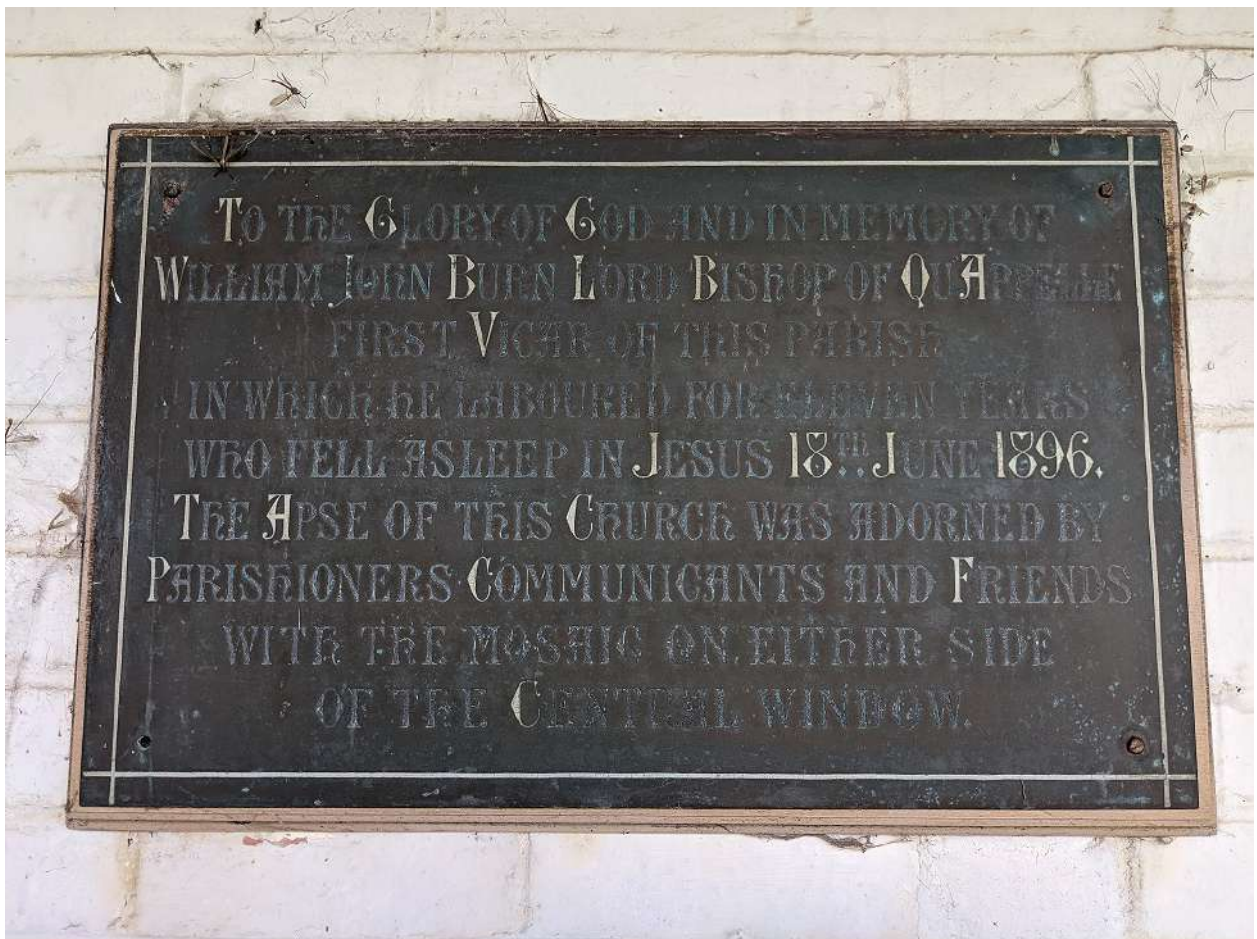
There is some damage to the marble at low level to the left-hand side of the memorial, otherwise in a satisfactory condition.

R2 It is recommended that a condition report is commissioned regarding the Memorial by an ICON registered conservator.
