ST HELEN'S KELLOE
QUINQUENNIAL INSPECTION REPORT 2020

Directors:
Chris Granger
Chloe Granger
Paul Crosby
Associates:
James Innerdale
Harvey Bloor
Naomi Hatton

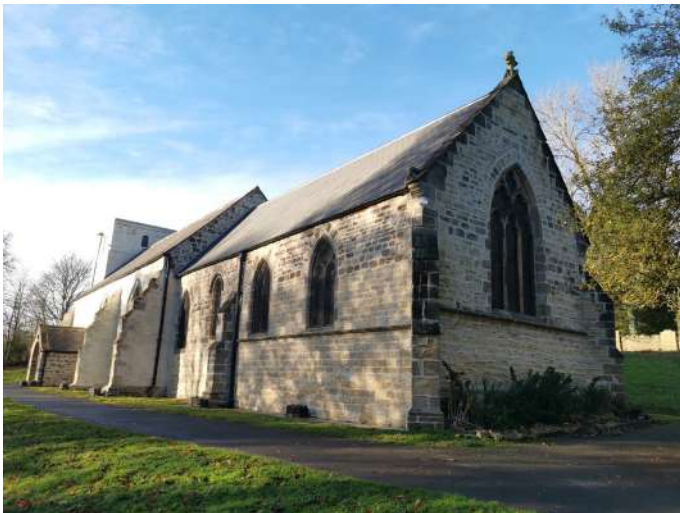
South eastern of chancel - new roof and apex cross

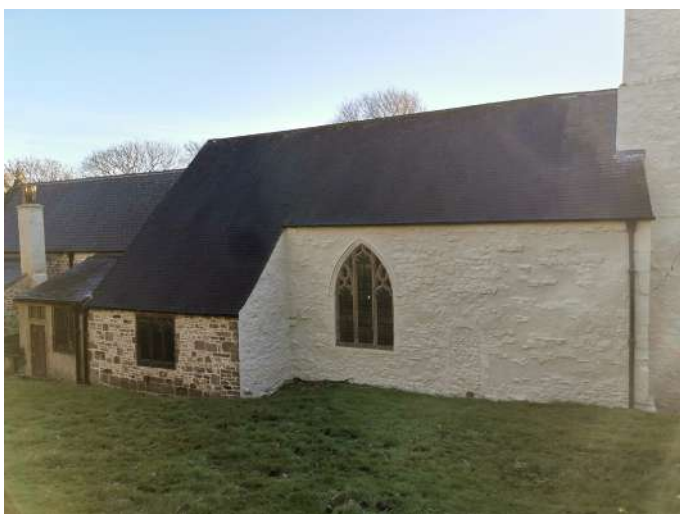
Nave roof with cat-slide roof over Thornley Porch - repairs required

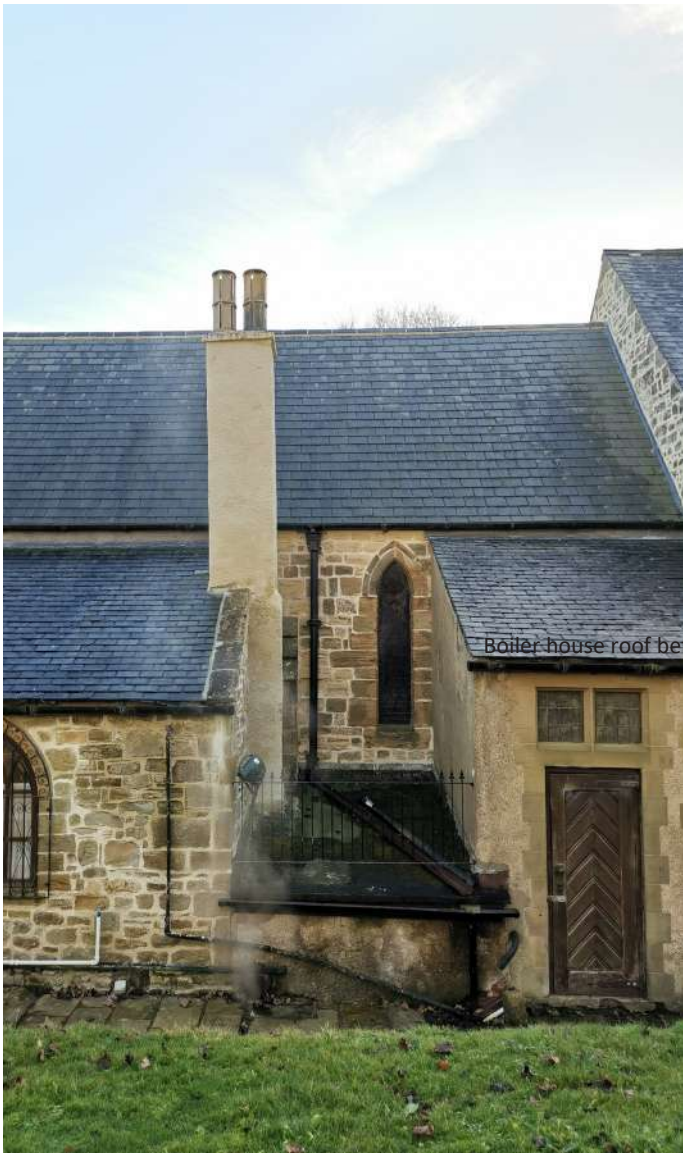
The flashing of the Organ Blower room against the east gable of the nave is shallow, but in fair condition.

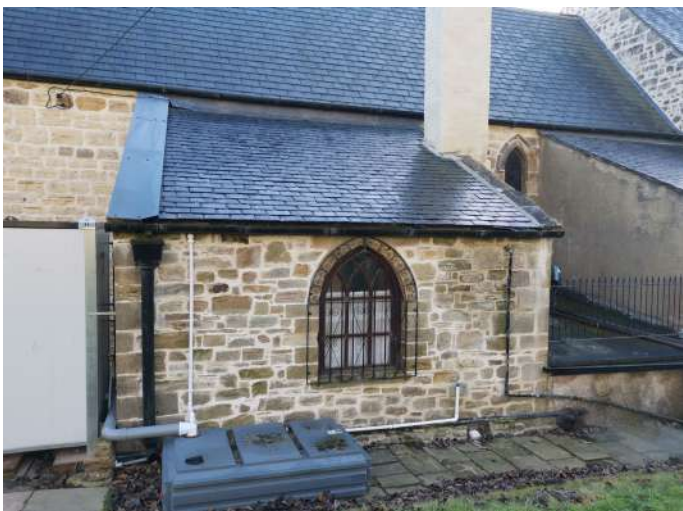
Vestry roof - damage to eaves at western end, and temporary covering to copings on east that require investigation and repair

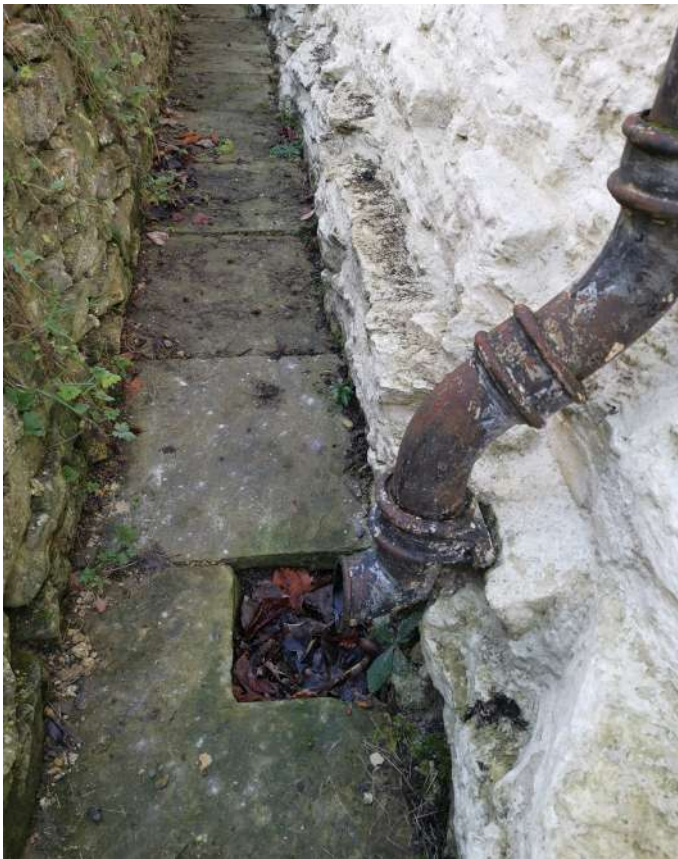
Gullies restricted by leaves, downpipe rusting

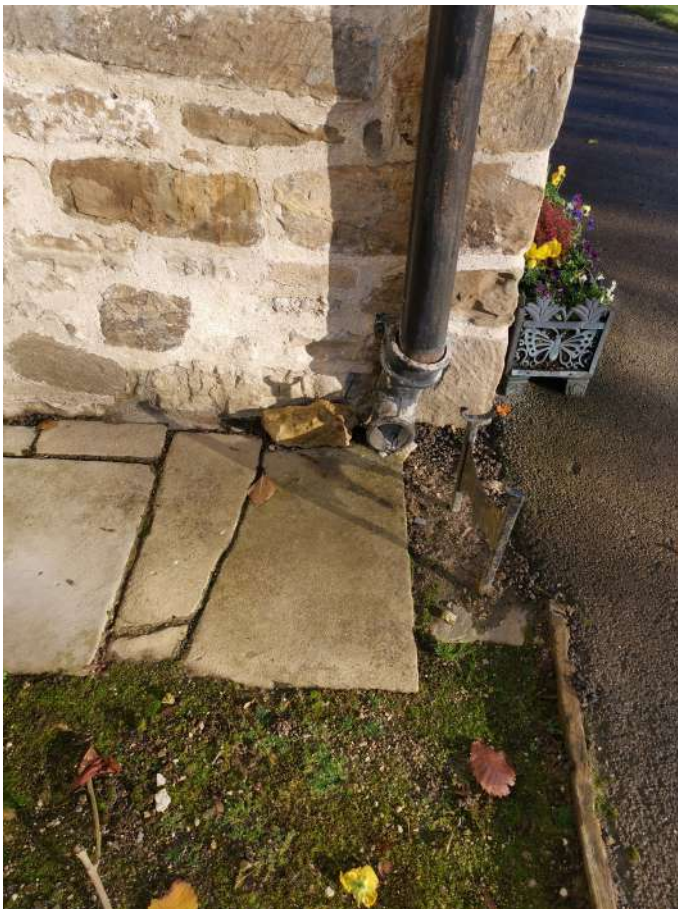
Porch downpipes discharge over ground

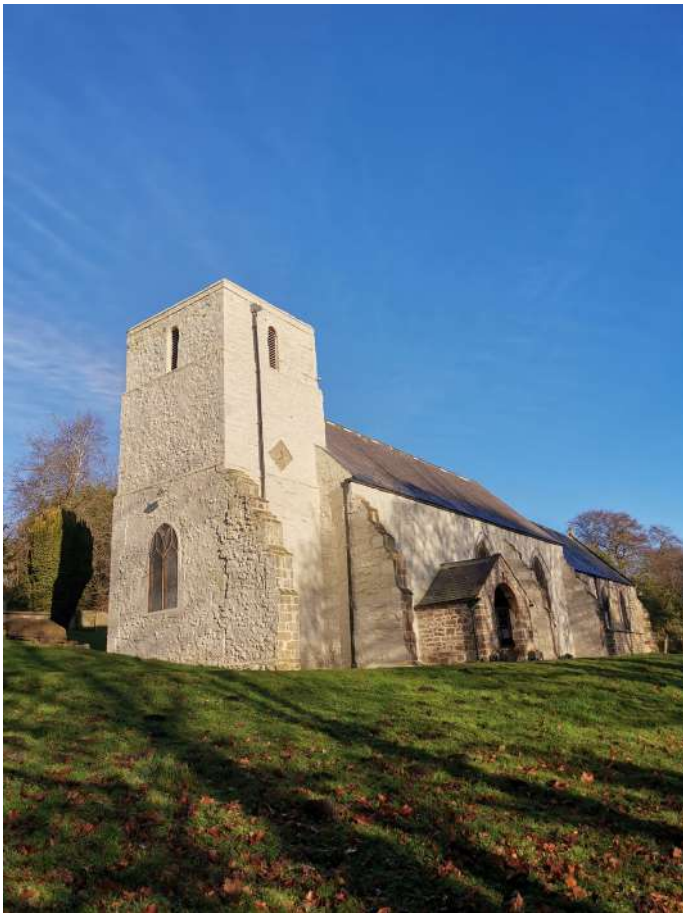
Stone consolidation to tower and buttresses

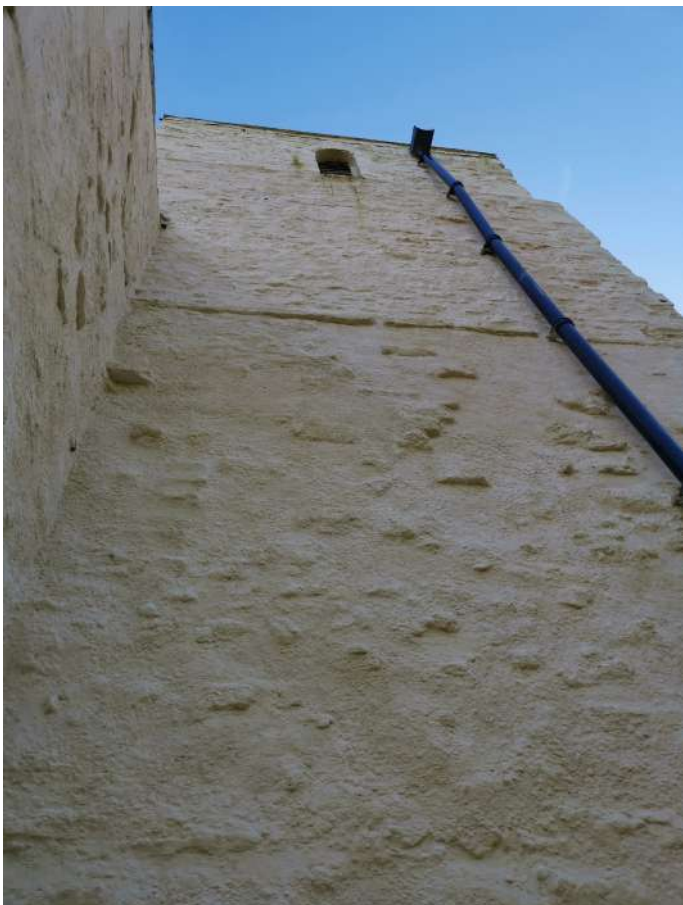
Heavily deteriorated masonry received mortar coating to bring out face and protect - all limewashed

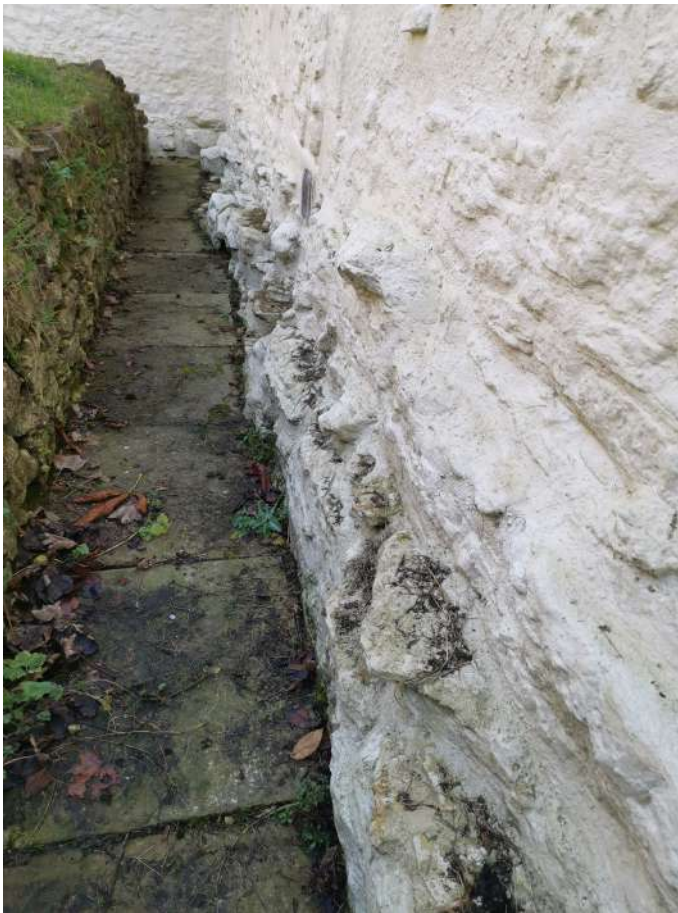
Exposed foundation stones to north of tower

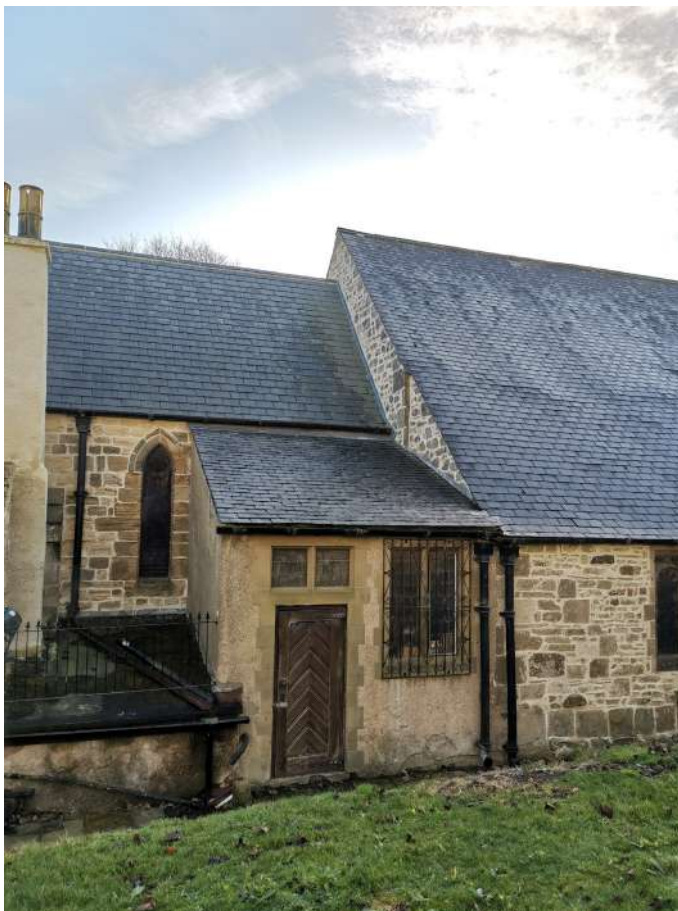
Organ blower and boiler room at lower level, both brick rendered in cementitious pebble-dash - require re-rendering in future

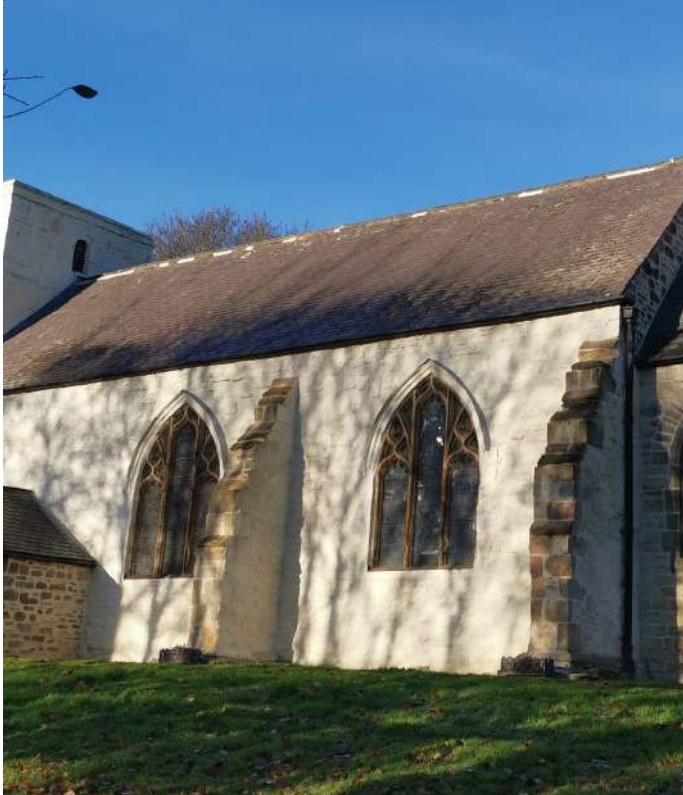
Hoodmoulds with mortar repairs and lead caps, but tracery and reveals still require repair

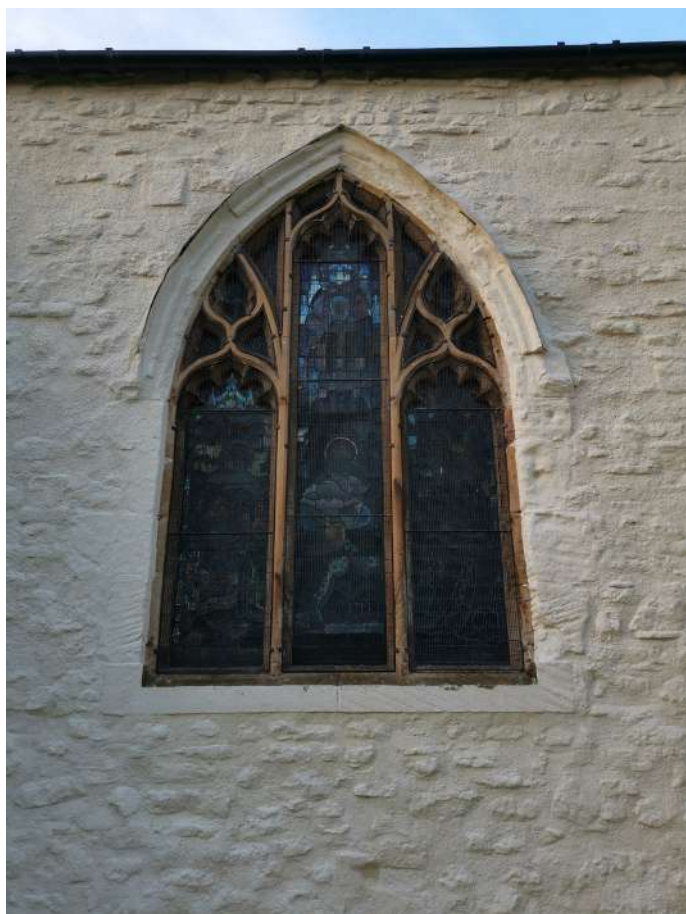
Window on south nave - stonework surrounds heavily deteriorated. Hoodmoulds now protected with lead

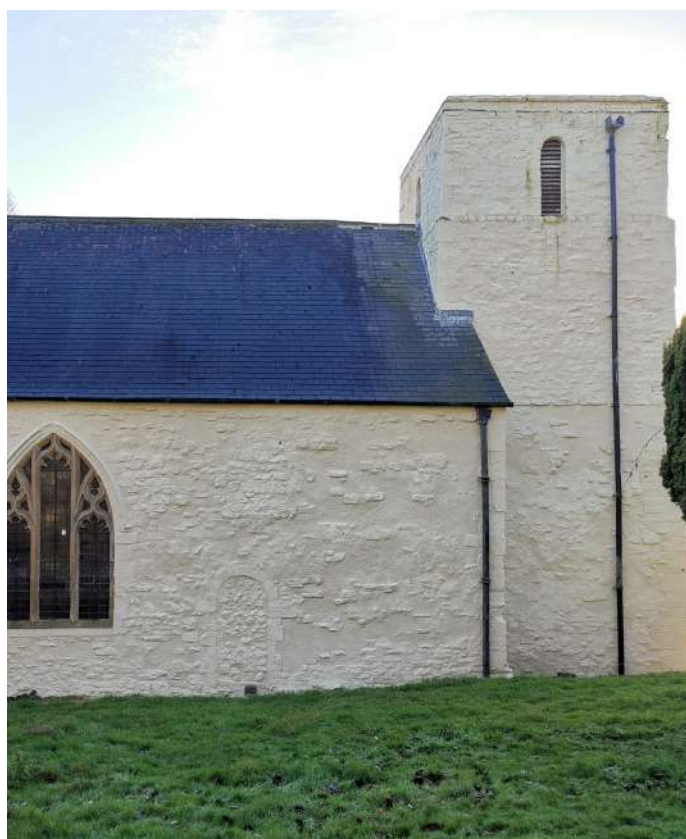
Former openings in north wall of nave

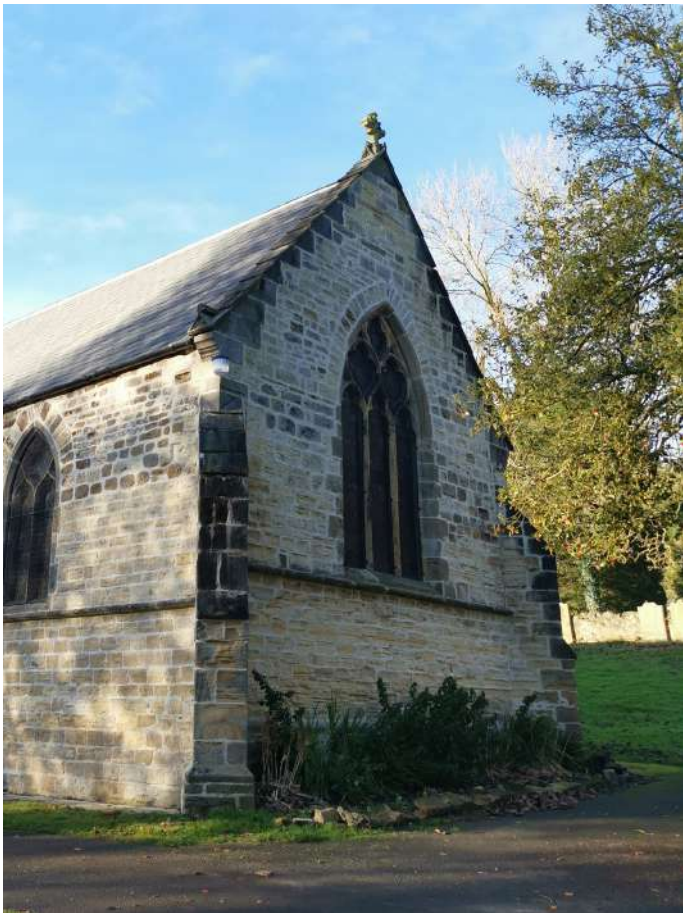
Main east elevation and principal east window. Minor stone deterioration

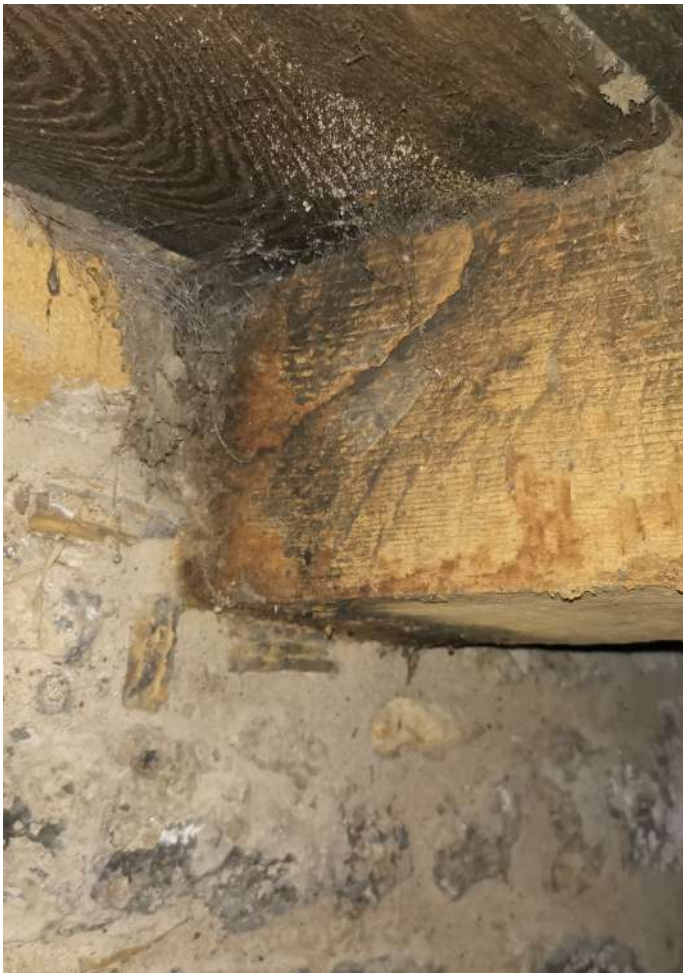
Timber joist embedded into north wall of tower damp

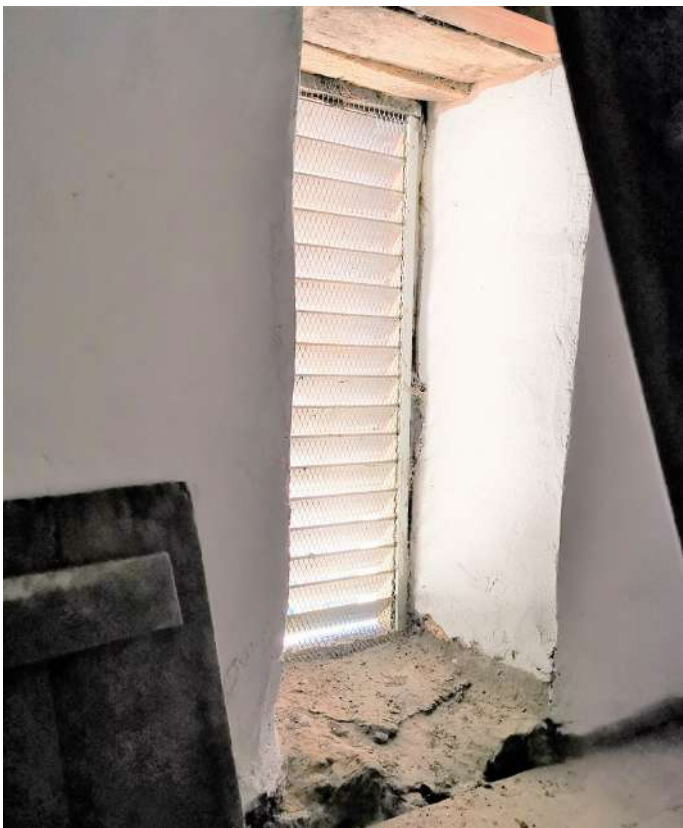
Lintels to south louvre still timber, in good condition. All others concrete. Metal grills in good condition, fixed securely

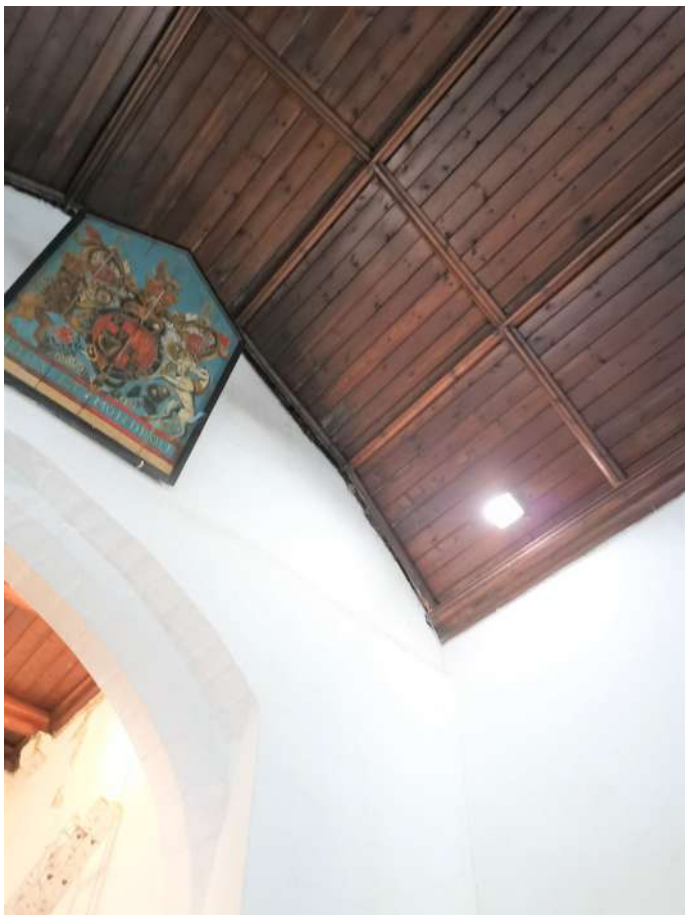
Nave ceiling boarded. Gap between ceiling and tower wall would benefit from clearing of debris and filling

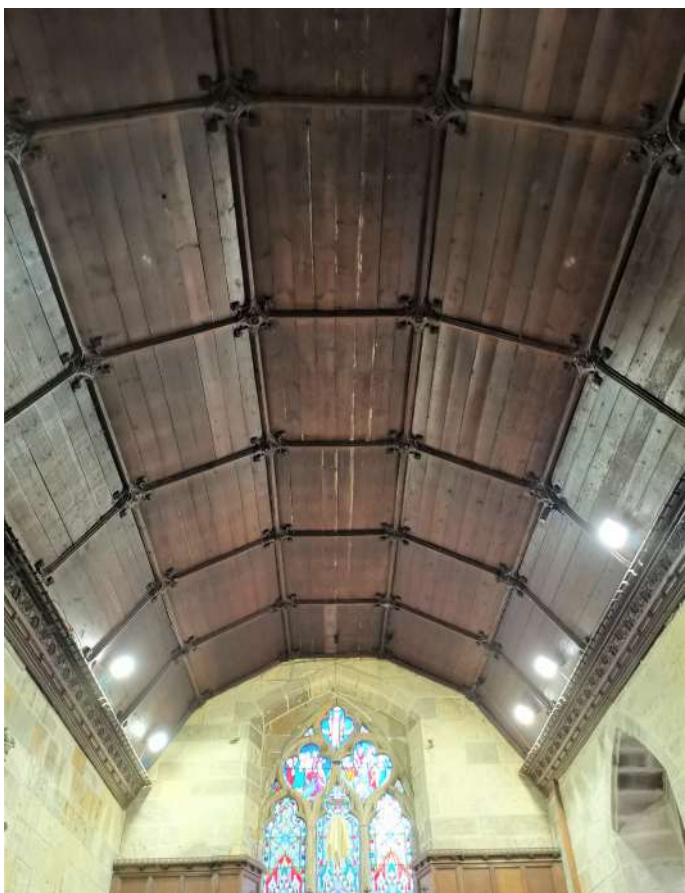
Chancel ceiling, water staining historic

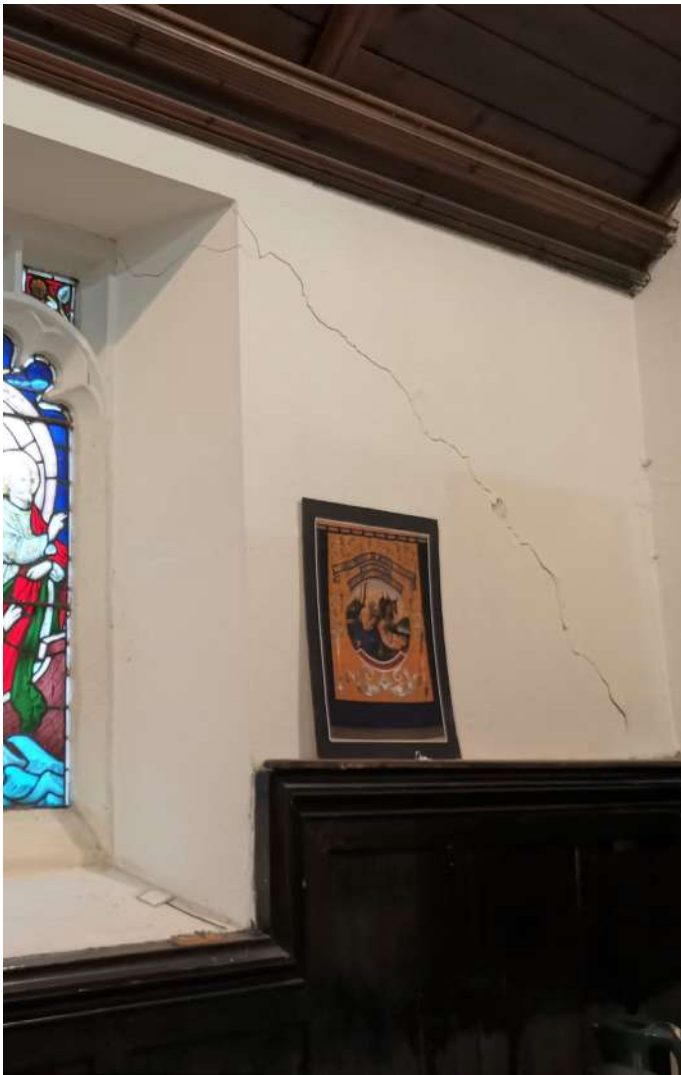
Crack to right hand of window in Thornley Porch

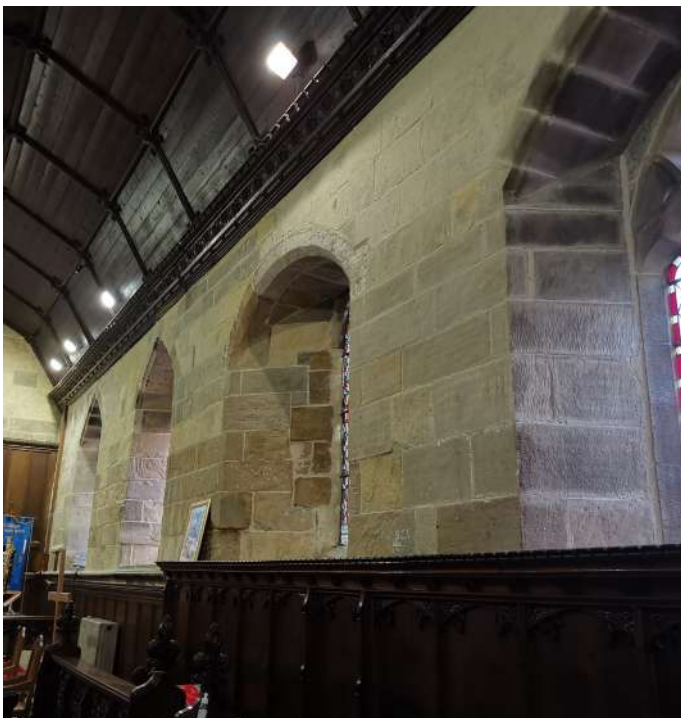
Internal chancel masonry has been cleaned, repaired and re-pointed

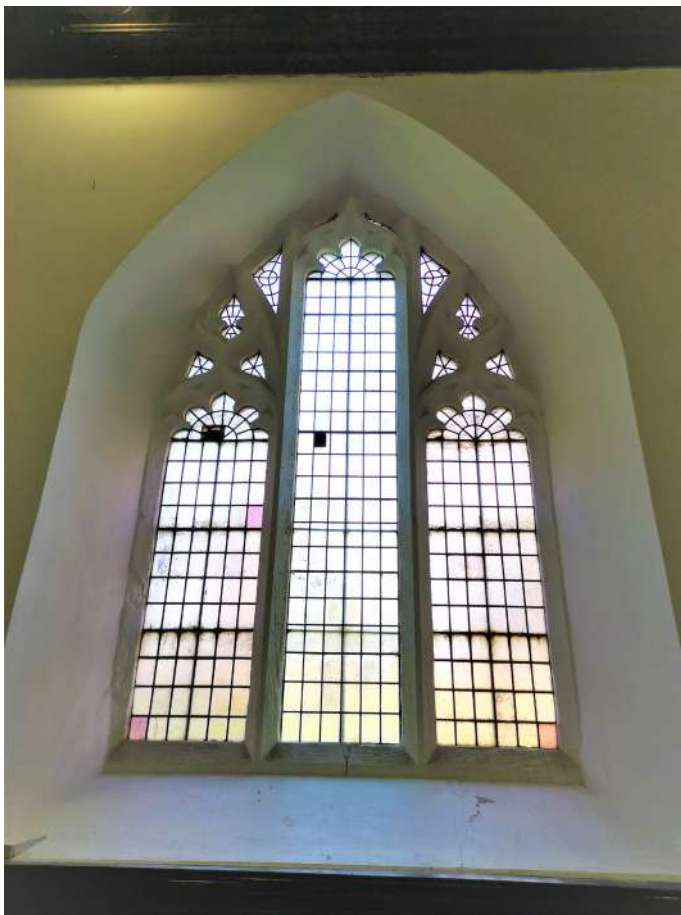
Window in north of nave has several broken square quarries and some leadwork distorted

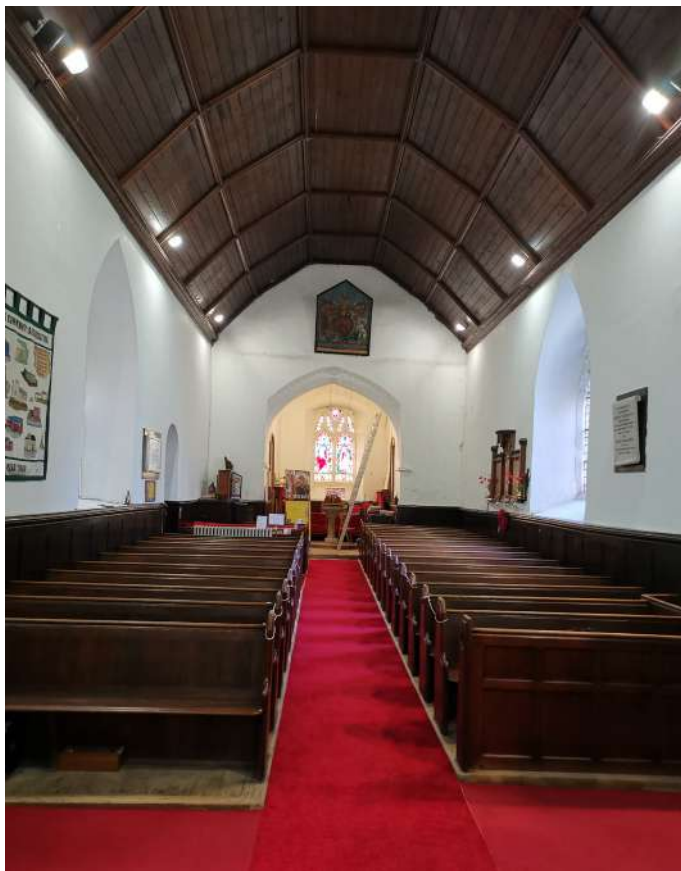
Pews on timber platforms, carpet laid over flags

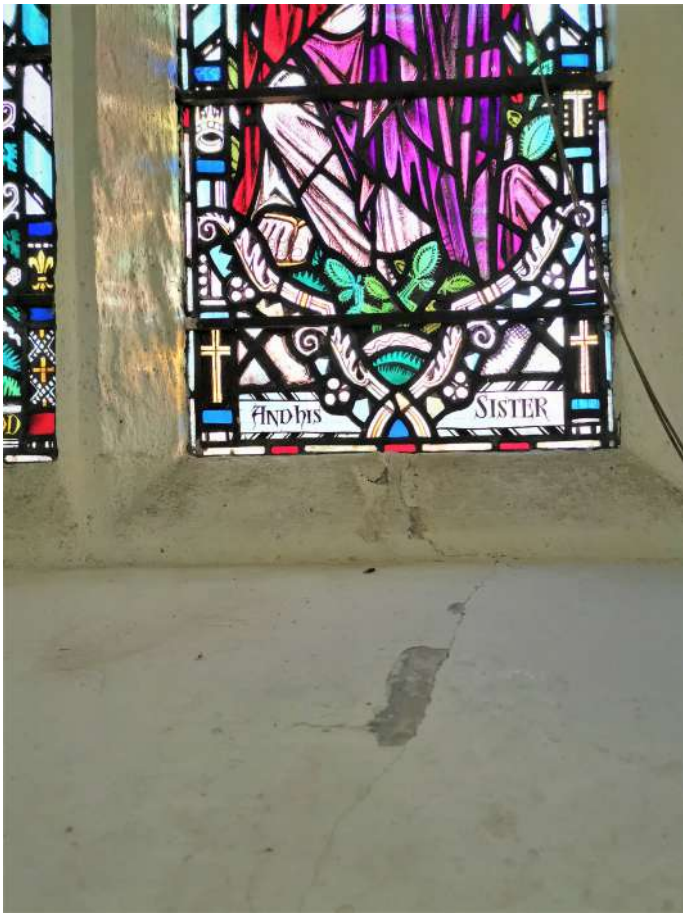
Impervious paint peeling in areas of damp or condensation, particularly noticeable at window surrounds. Minor cracking in several cills

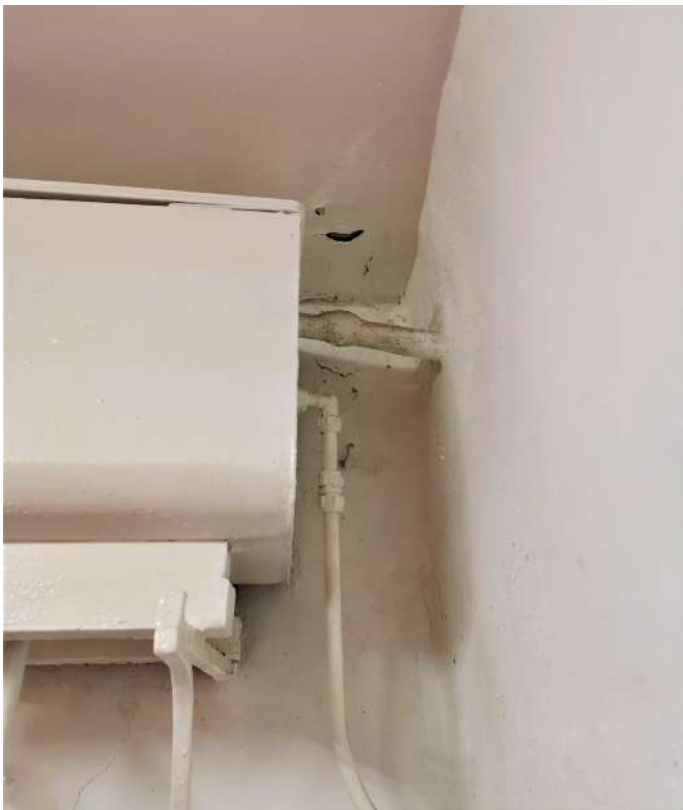
Damp around header tank, possibly leaks from above eaves slating

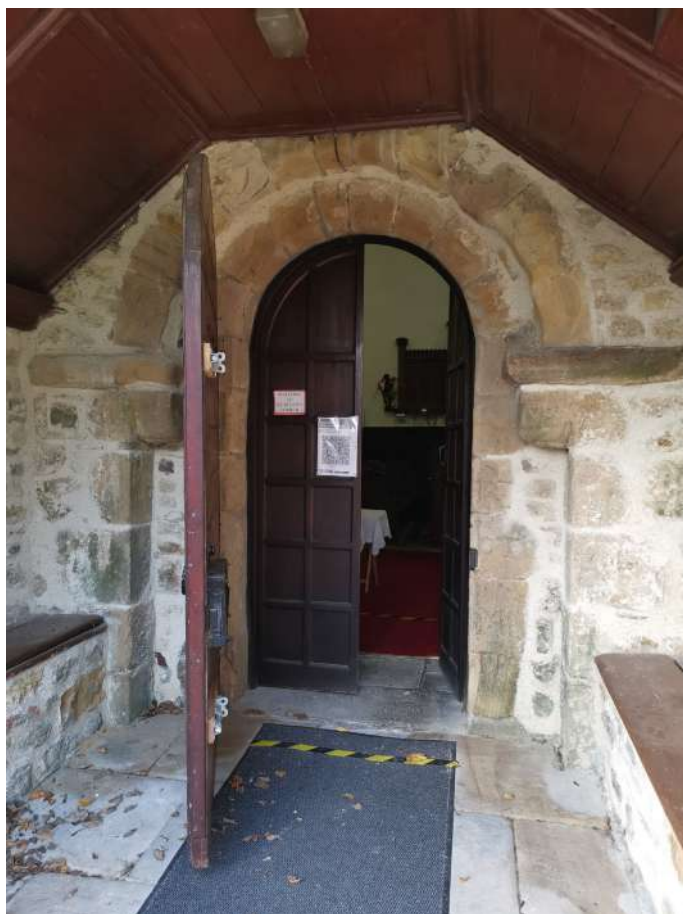
Flat central section of ceiling cuts off the top of the original round-headed opening of the medieval doorway. Consider reconfiguring ceiling, and possible removal or external door

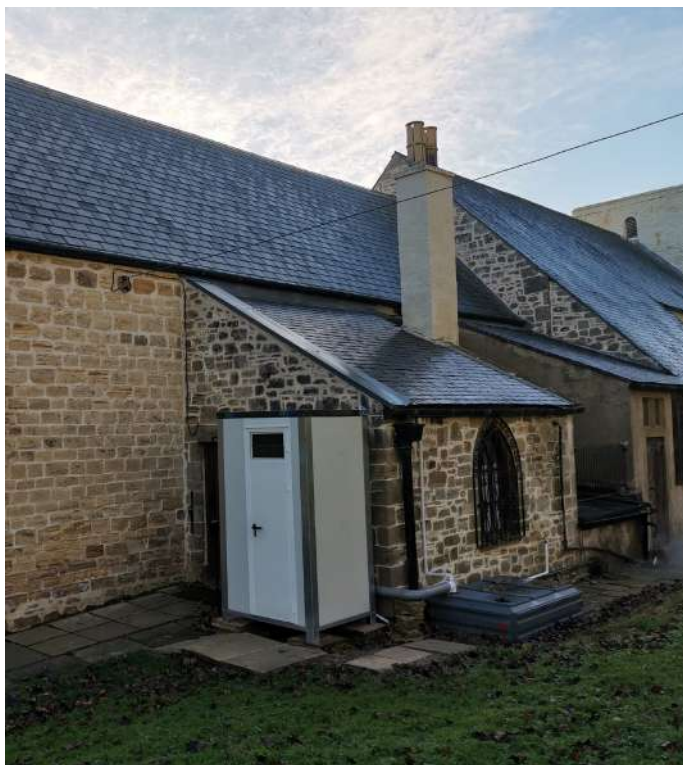
Temporary port-a-loo next to vestry, providing much needed toilet facilities

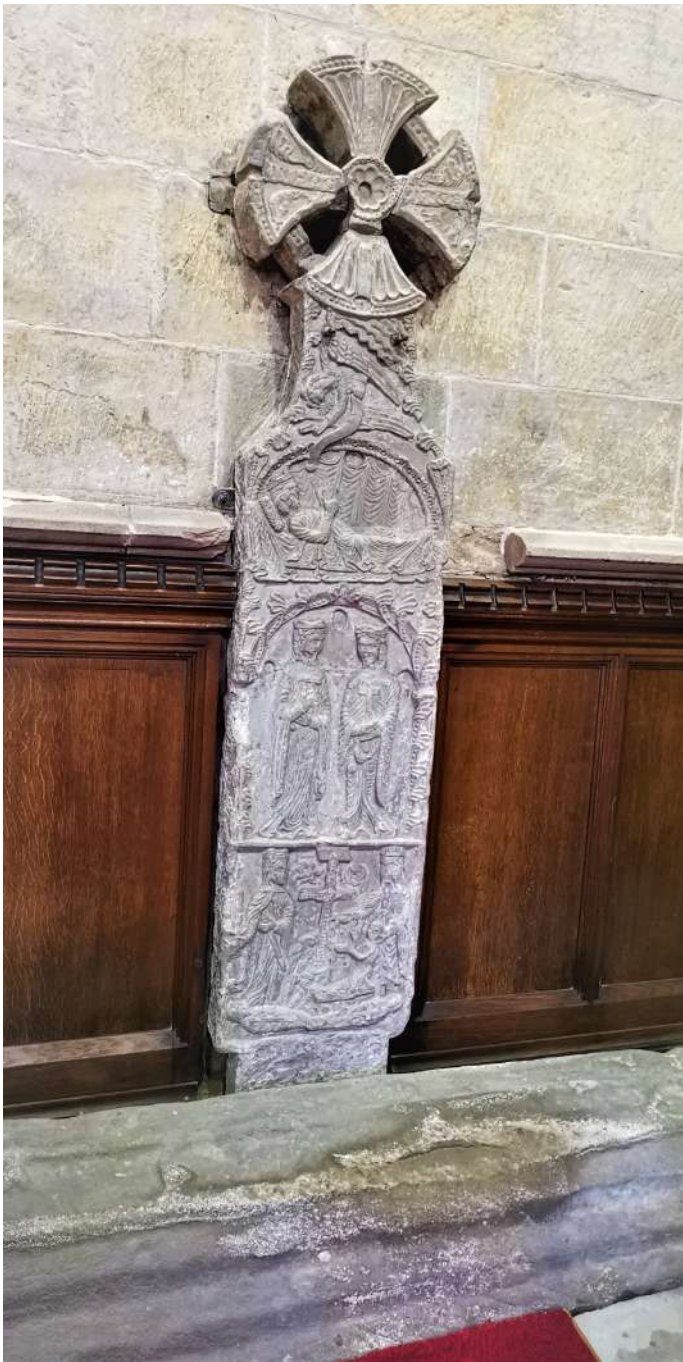
It is an intricately carved cross, decorated in three illustrated panels, displaying the legend of the finding of the True Cross with Saint Helena and Constantine. It would have originally been set with semi-precious stones and decoration, and probably one of a pair. Despite it being historically broken in several places, with some pieces missing, the stonework and carvings themselves remain in good, sound condition.

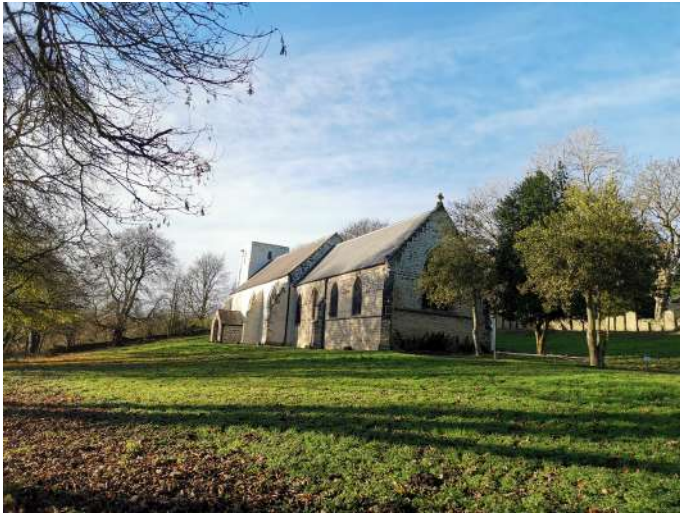
Churchyard cleared of headstones. Some stacked up along northern boundary wall

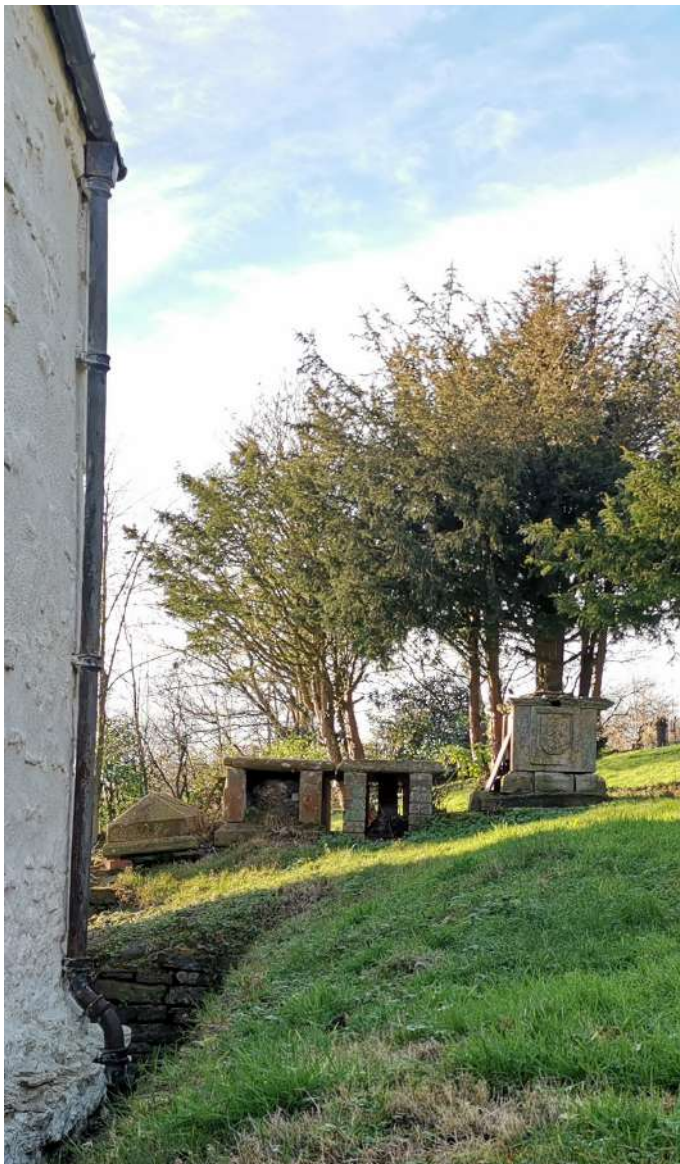
Tombs to north-west corner of tower in perilous condition

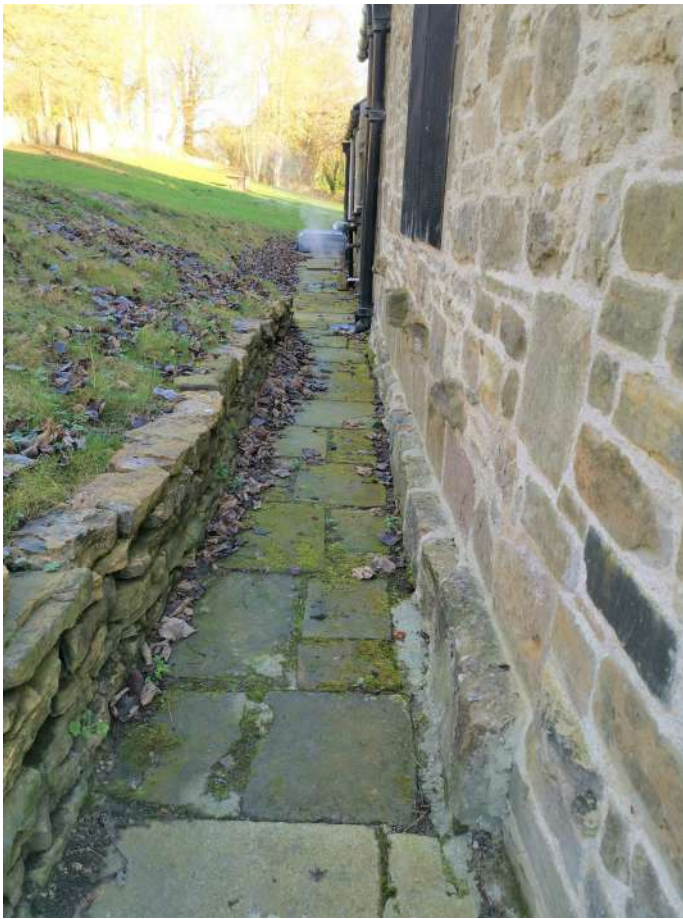
Hardstanding against base of wall will be trapping moisture - consider removal and laying grass directly up to base of walls
