QUINQUENNIAL INSPECTION REPORT

CHURCH OF St. PHILIP & St. JAMES OAK CRESCENT, KIMBLESWORTH, COUNTY DURHAM

NOVEMBER 2021

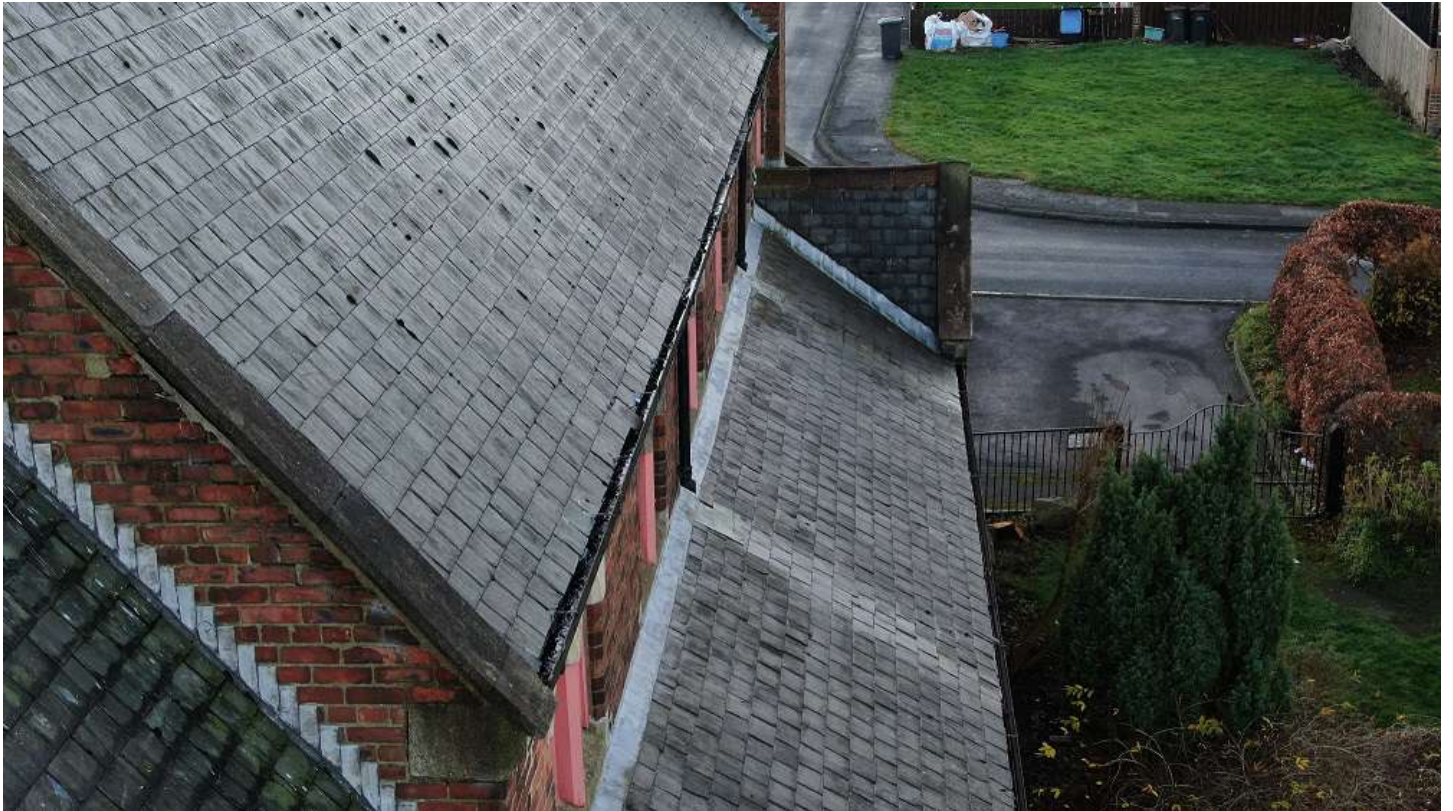
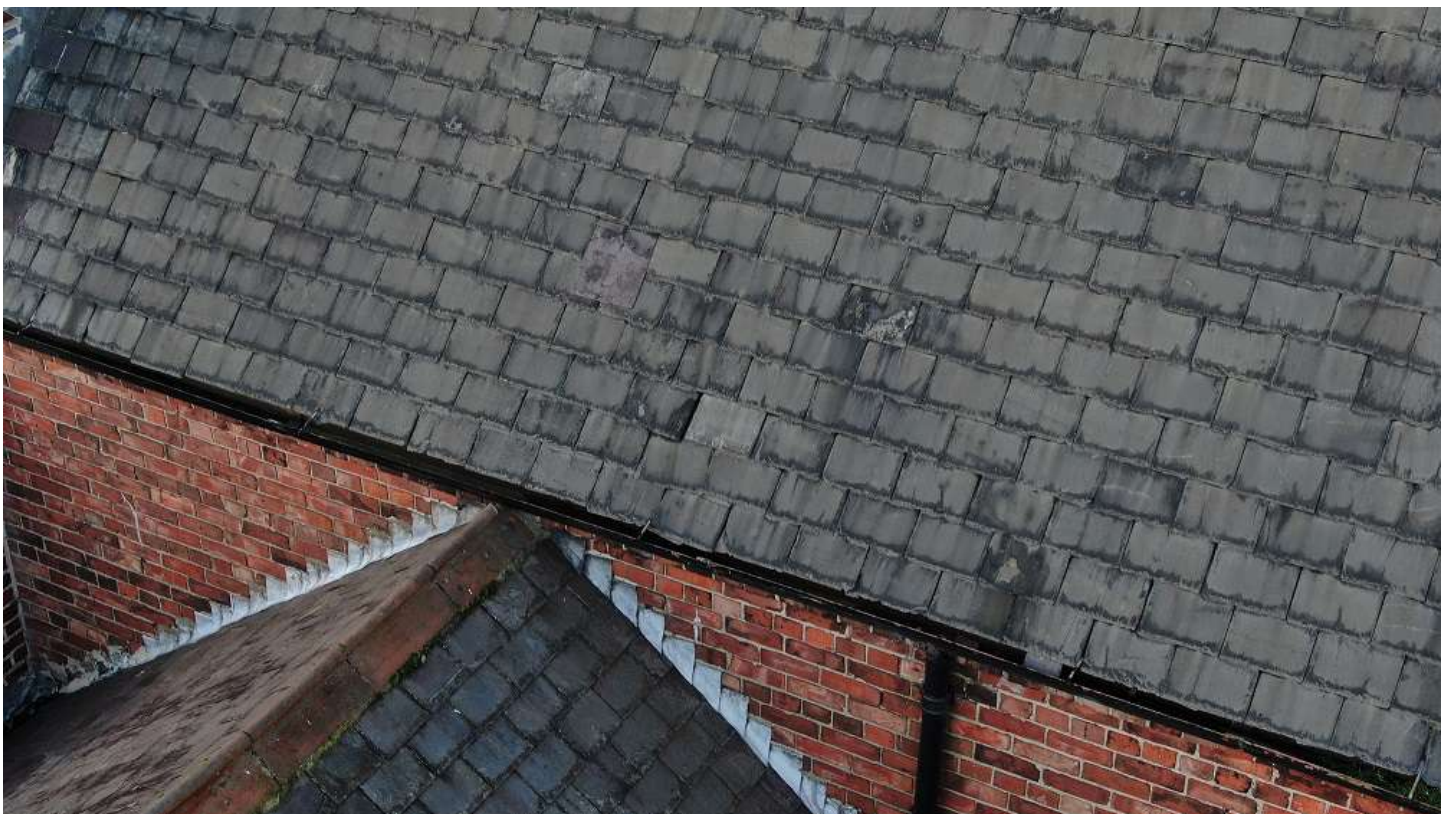
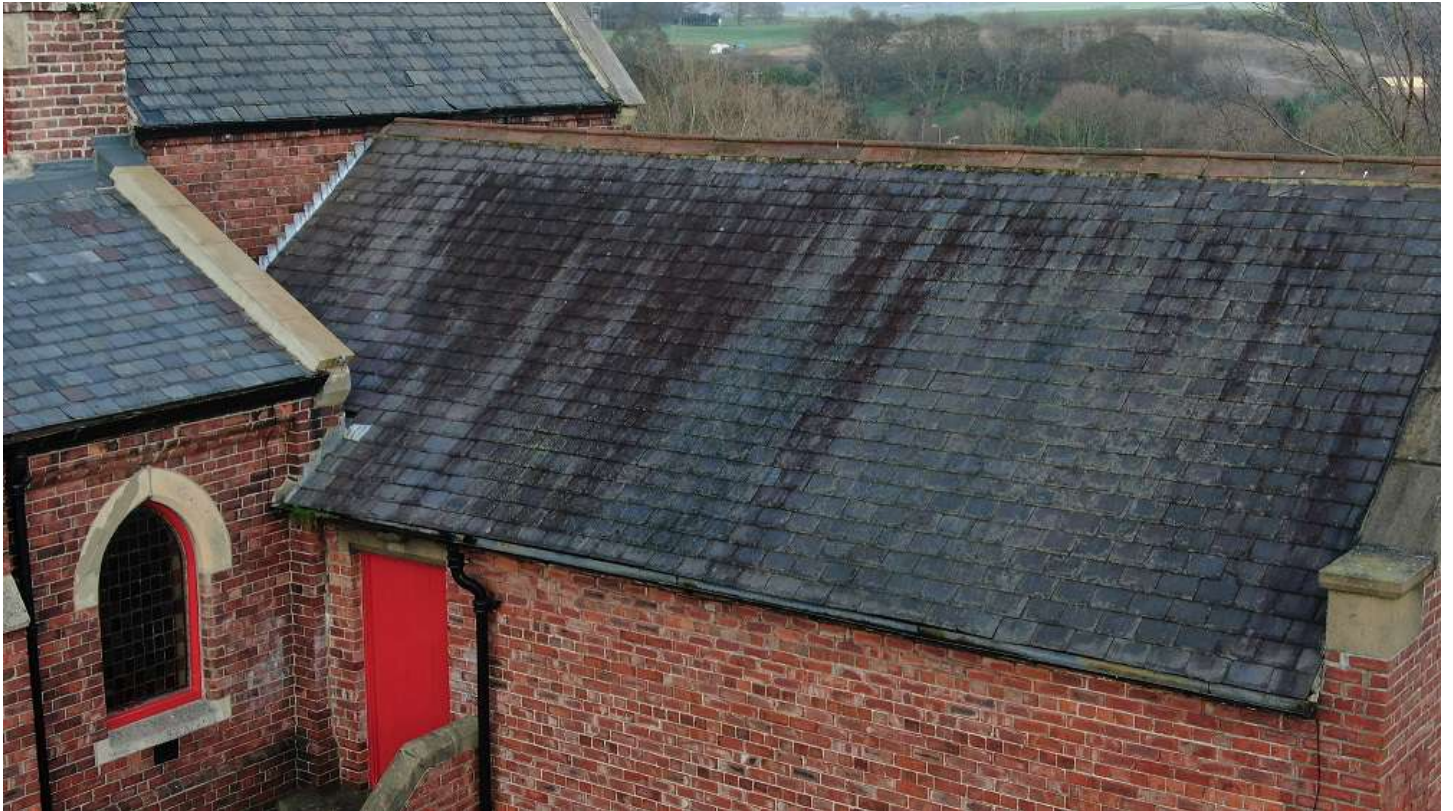
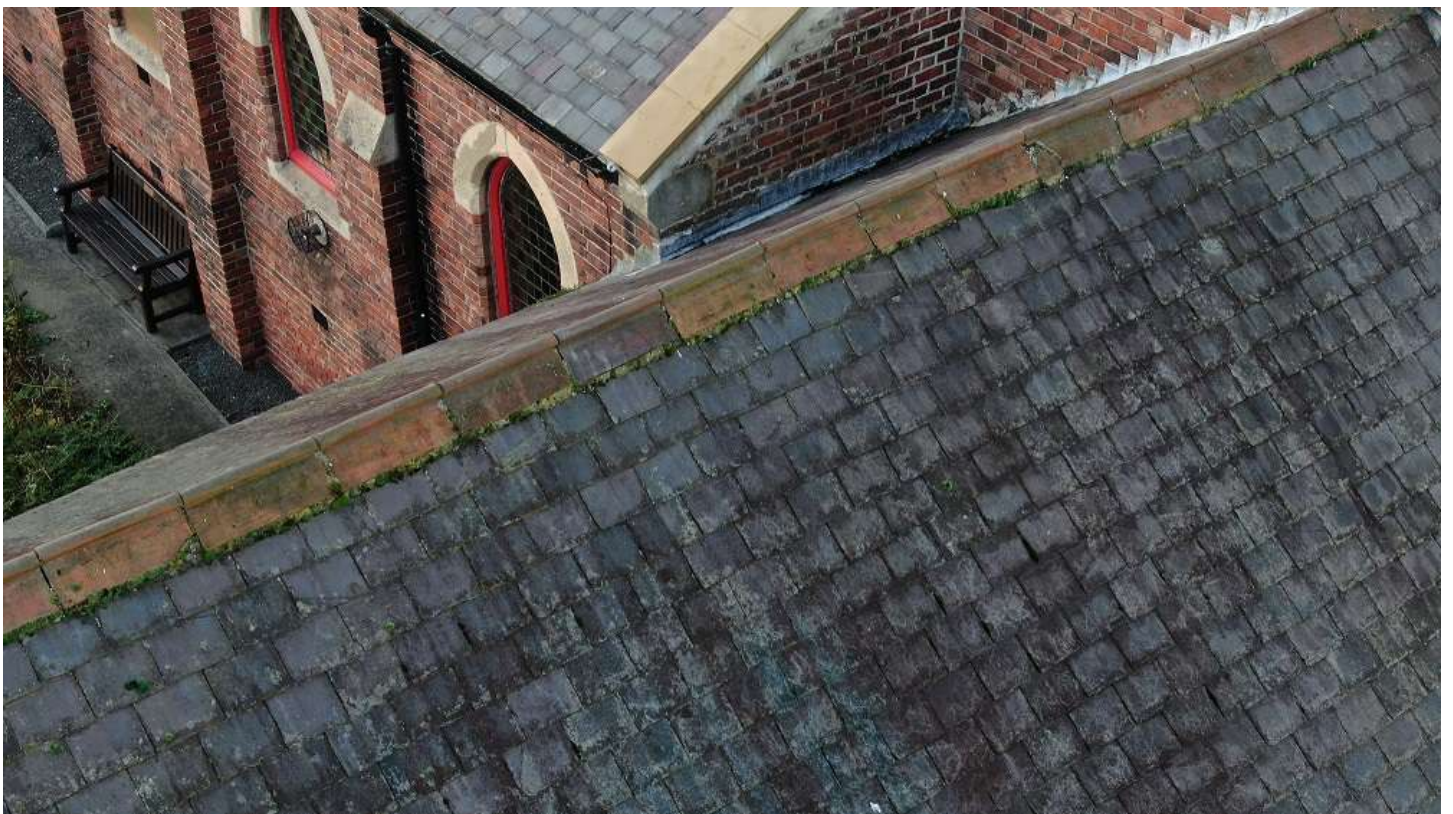
On inspection generally the roof covering appears to be in a good, sound condition. There is a cracked section of ridge tile to the east face but appears to be mortared well in position.

M It is highly recommended that as a routine item of maintenance the roof covering should be examined and repairs undertaken on a twice-yearly basis.

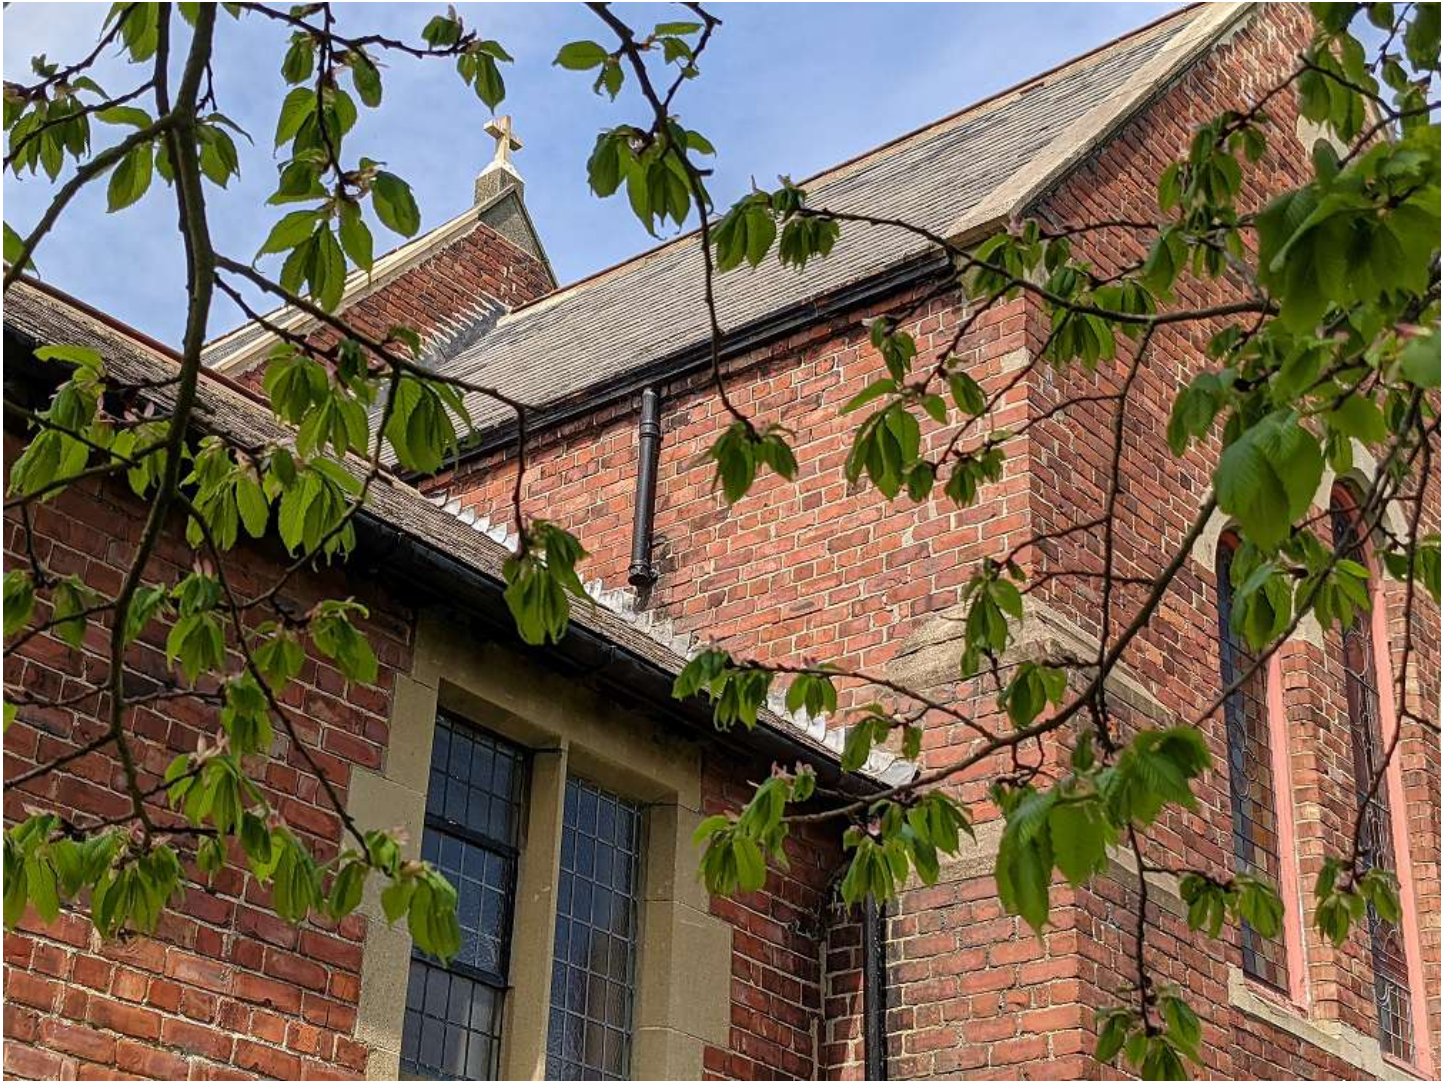
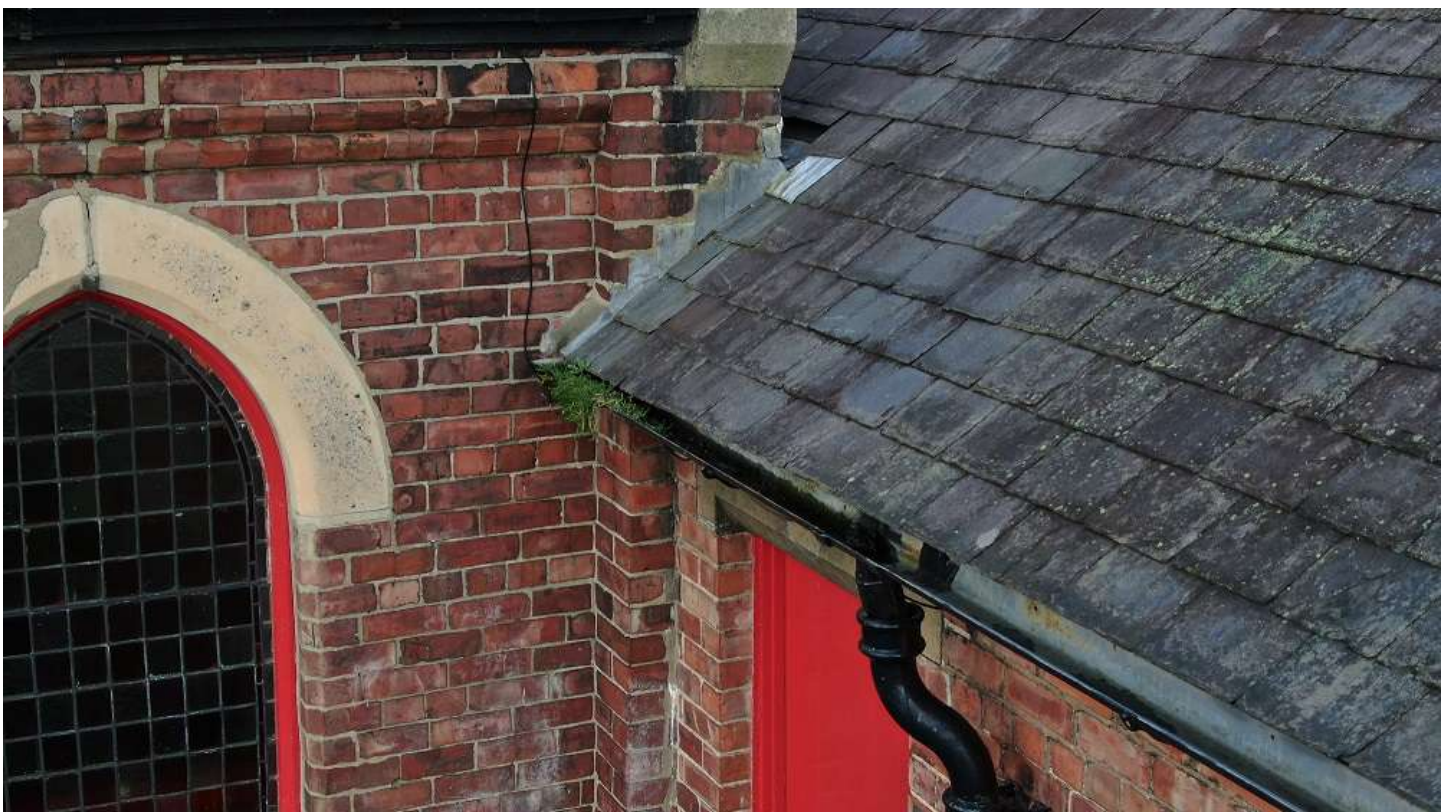
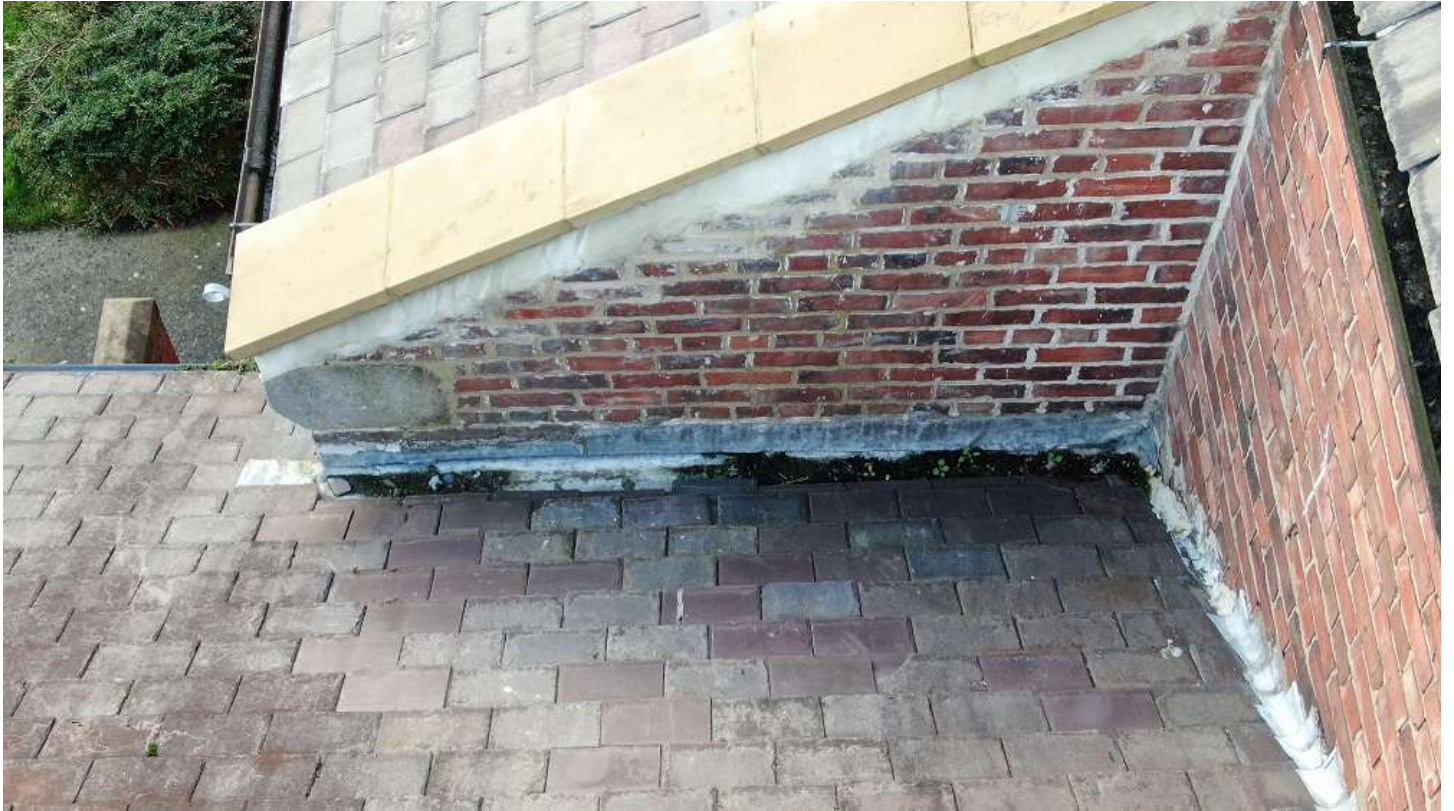
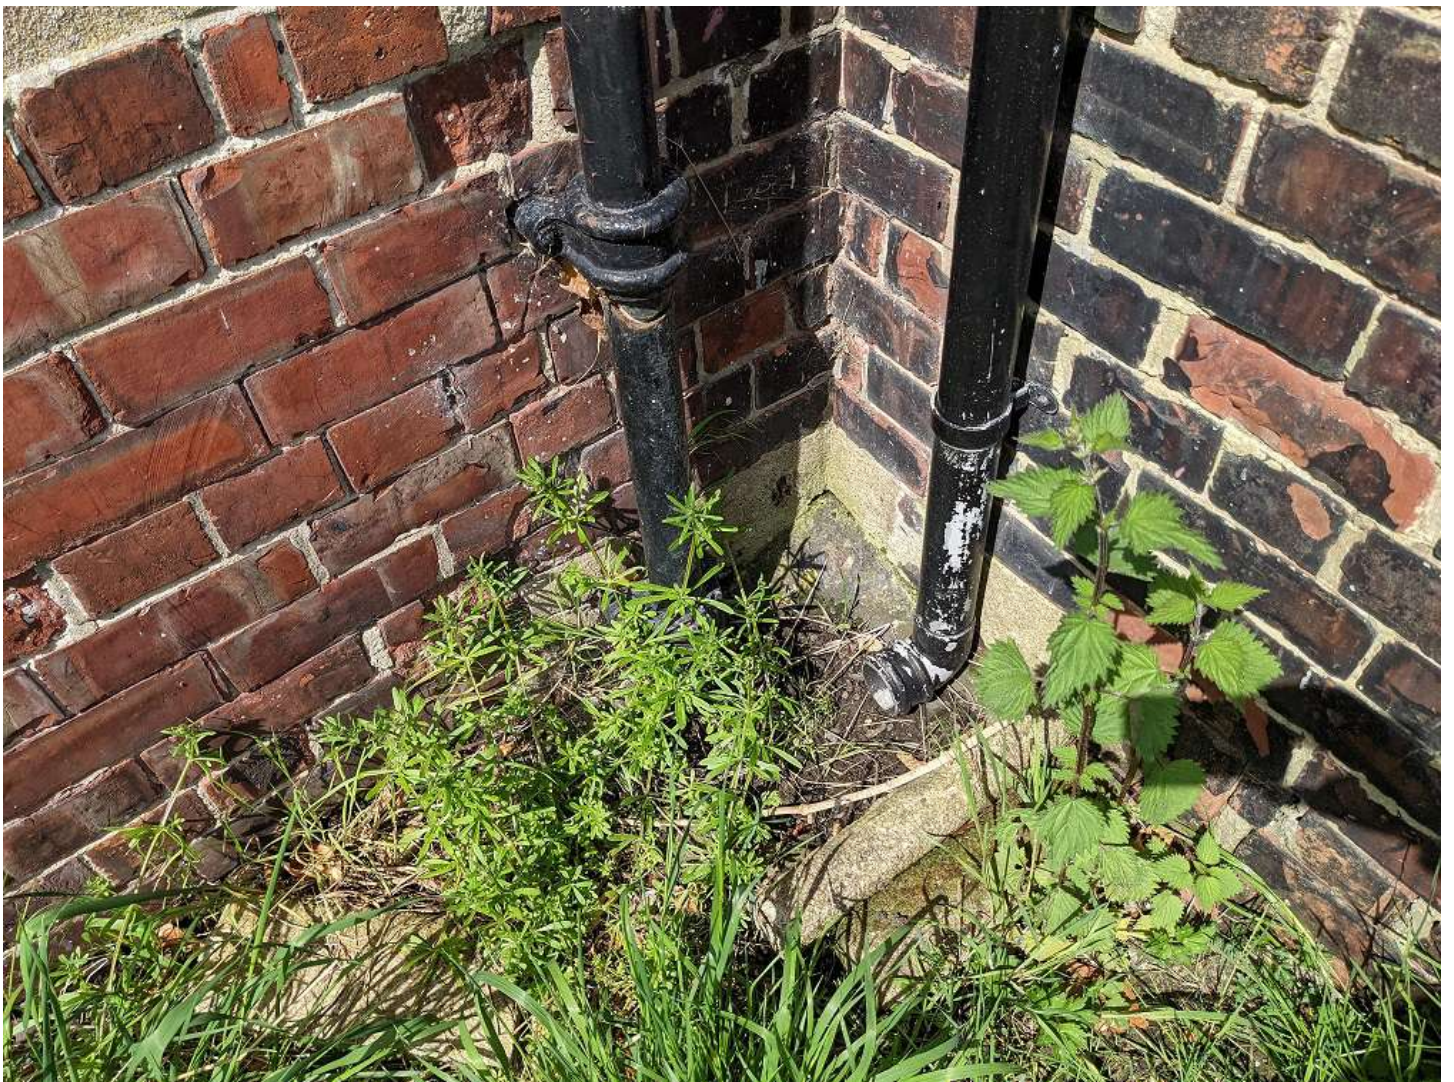
A lead lined box gutter exists at the junction between vestry and south aisle. At ground level all downpipes are fitted with shoes and clay gullies to assist future maintenance. All rainwater goods are painted black.

The rainwater goods are understood to be operating satisfactorily. The lead lined box gutter is hidden from view and regular checks for blockages and/or plant growth should be undertaken. At the time of the inspection leaves/plant growth were observed in the clay gullies.

R4	It is desirable for the rainwater goods along the east elevation to be replaced in black cast iron to match existing elsewhere.
-----------	---

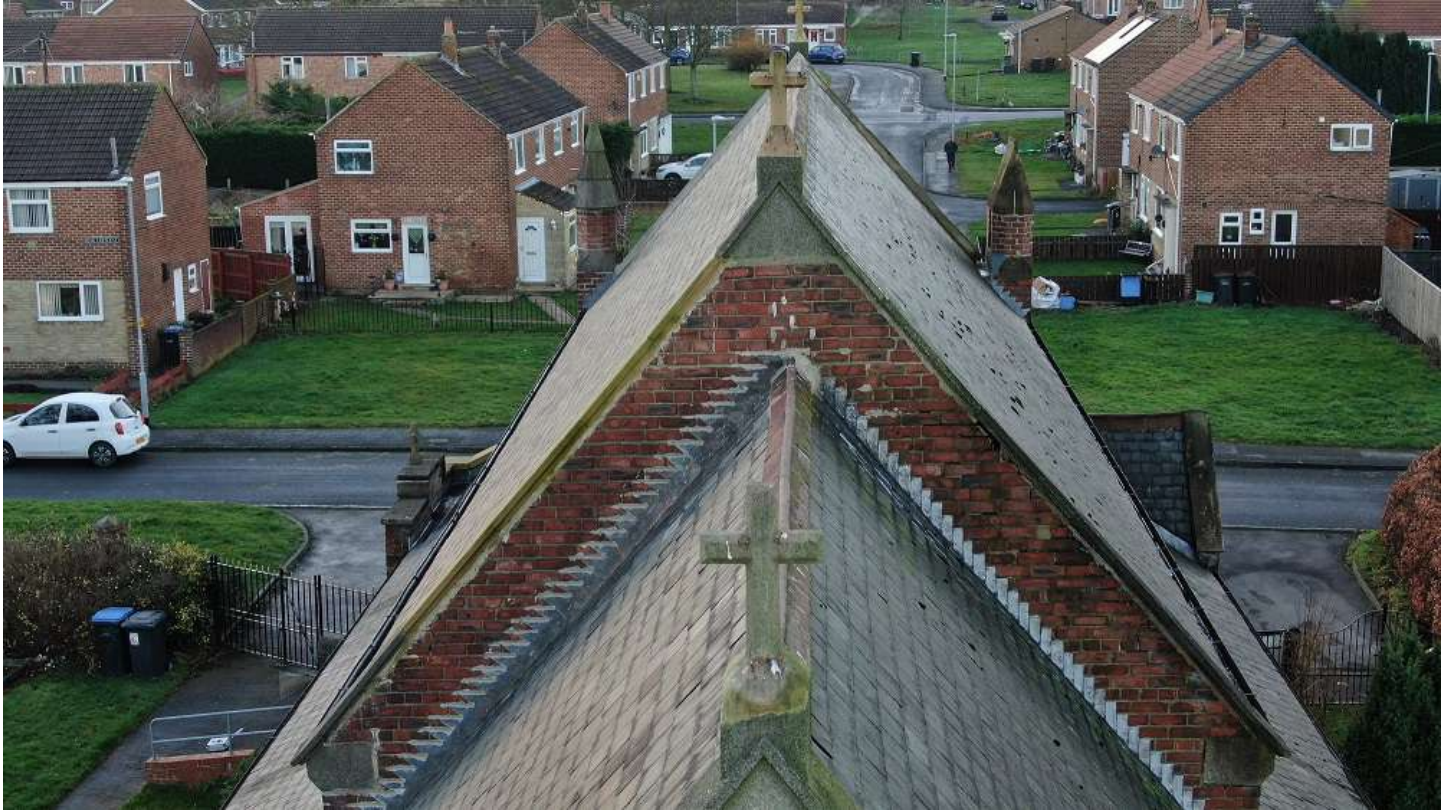
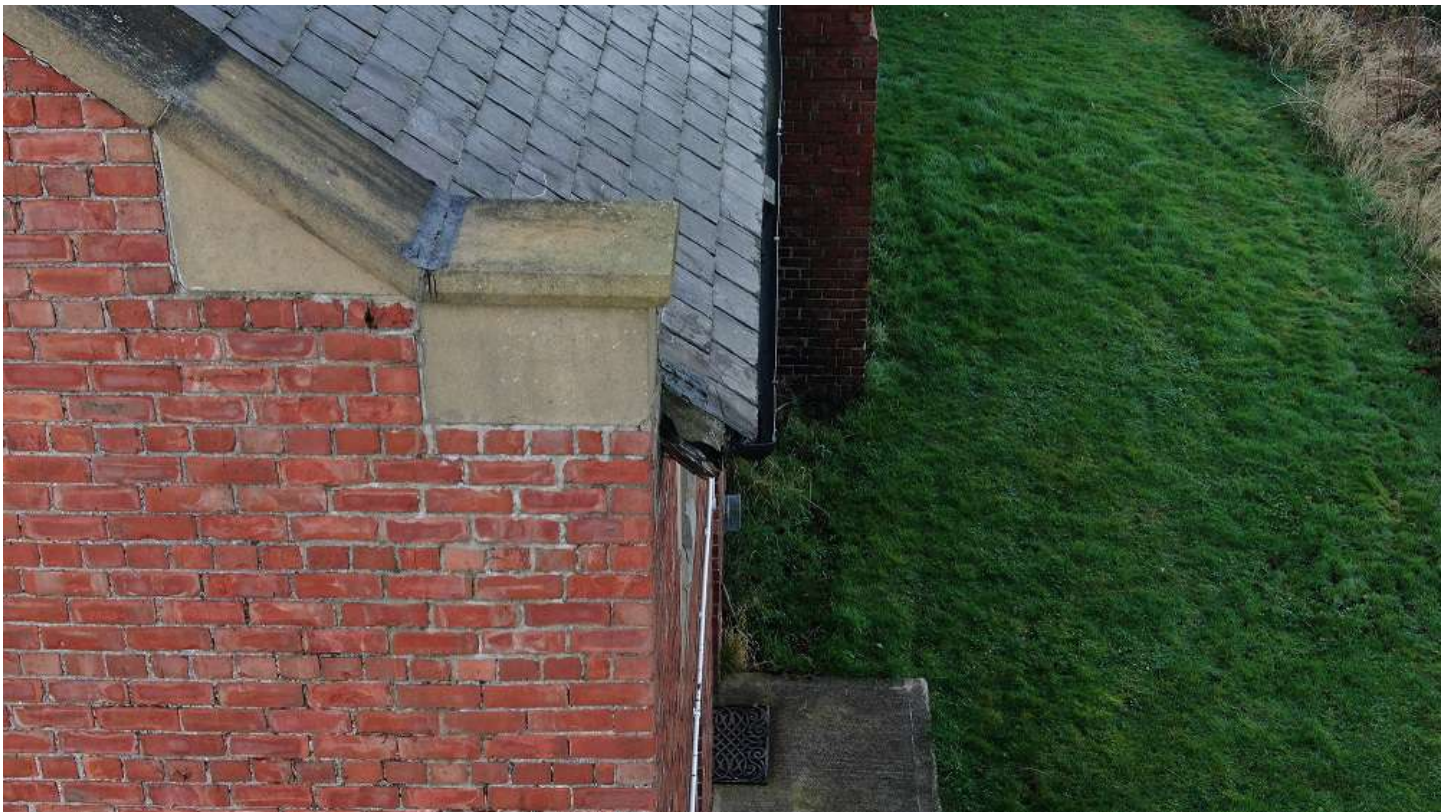
The west gable end of the north aisle is known to be in a poor condition, albeit internally the condition of paintwork locally in this area is holding up. It is anticipated that repairs to the water tabling in this area will be needed in the short term.

R2	It is recommended that water tabling repairs/replacement alongside full rebedding in a lime : sand mortar is carried out.
M	6.1.2 Carry out inspection of the water tabling stones in conjunction with the roof covering and rainwater goods (item 3.1.2 and 4.1.3).

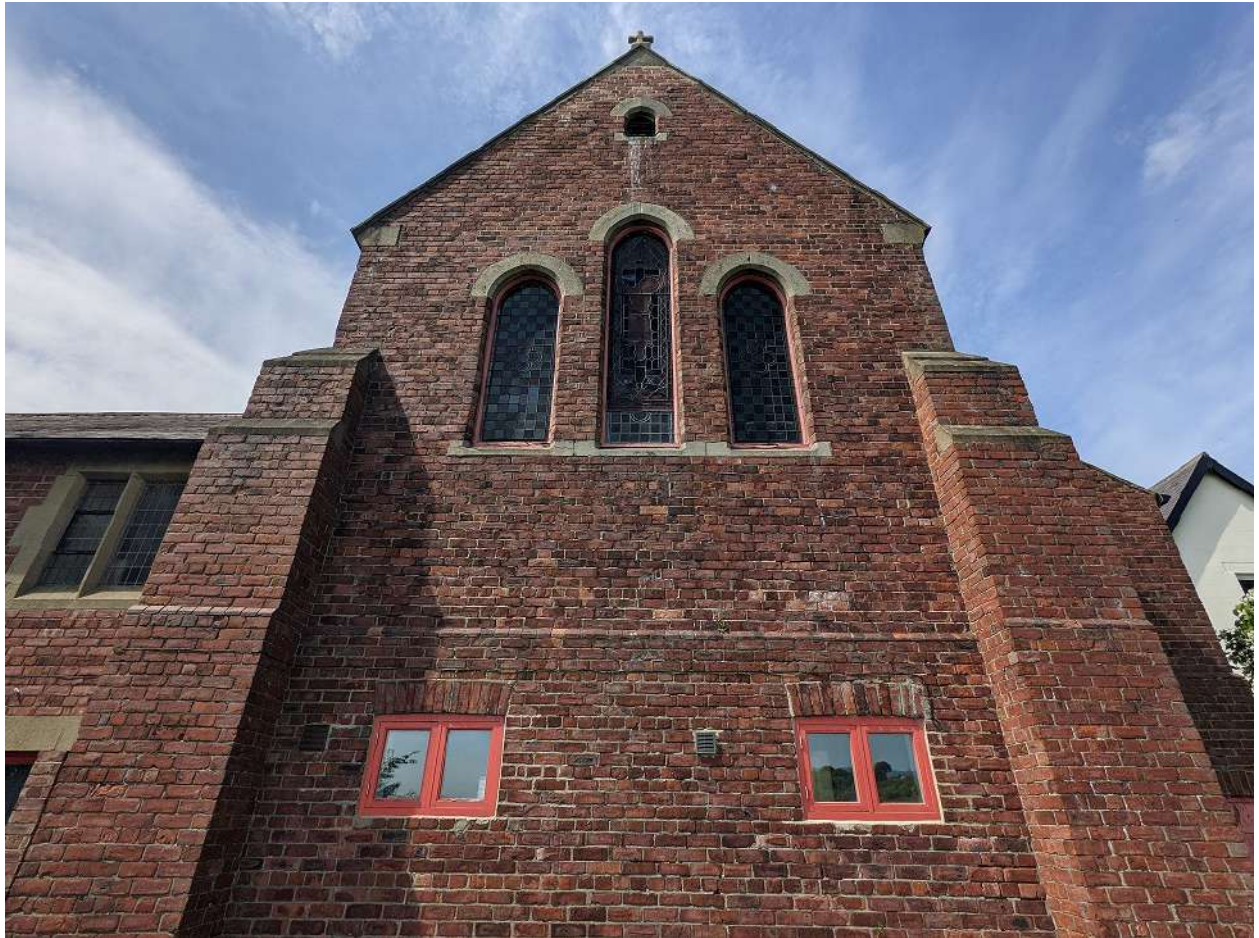
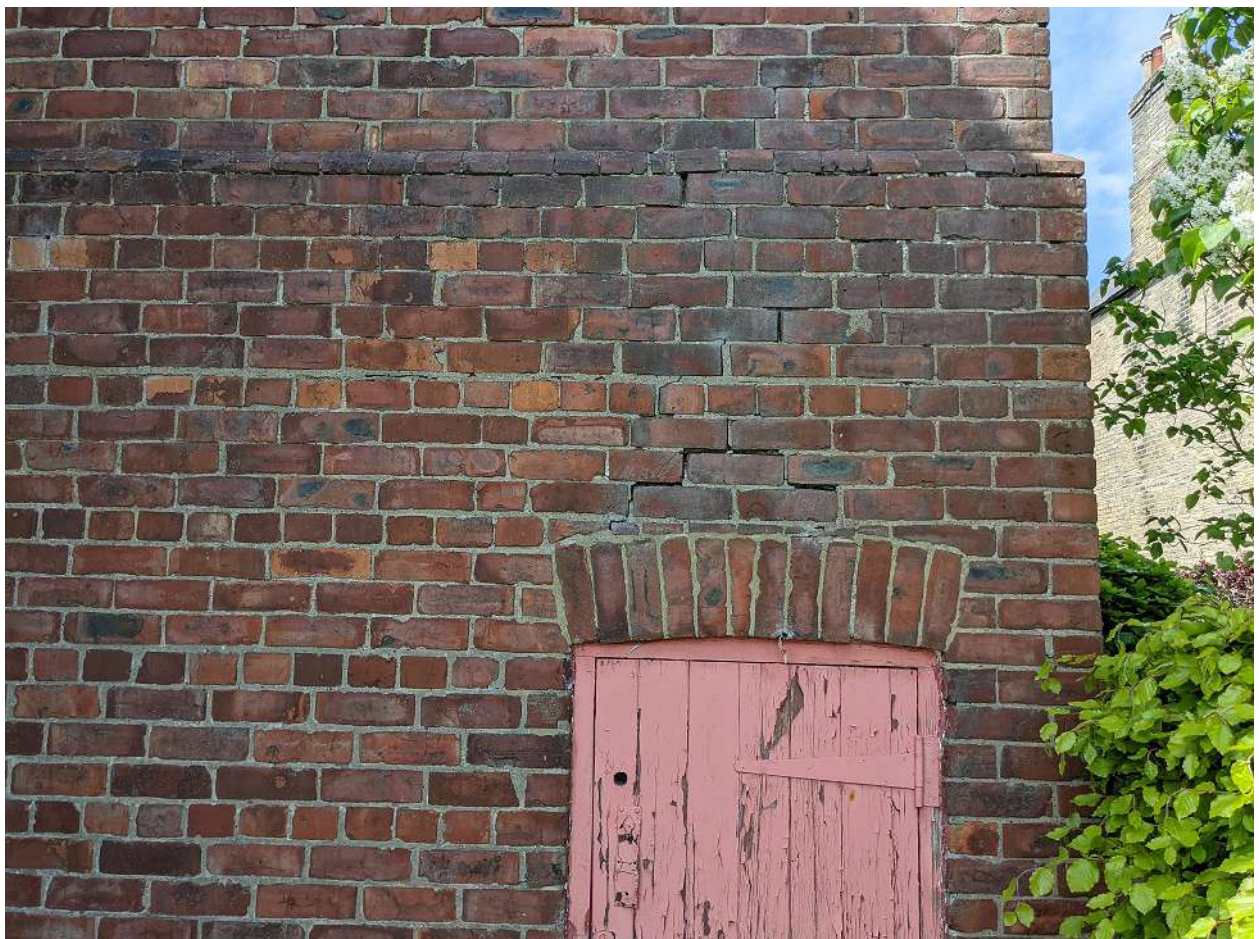
7.1.2 Other areas of movement to the external fabric are noted as follows:

- a. West gable of the north aisle where a hint of slight movement is evident above the apex of the window.
- b. Immediately above the arch of the former boiler house door in the east elevation of the chapel/north aisle.
- c. Slight hint of movement beneath kitchen window at low level to the east wall.

R2 It is recommended that these areas of movement are pointed up in a soft lime : sand mortar.

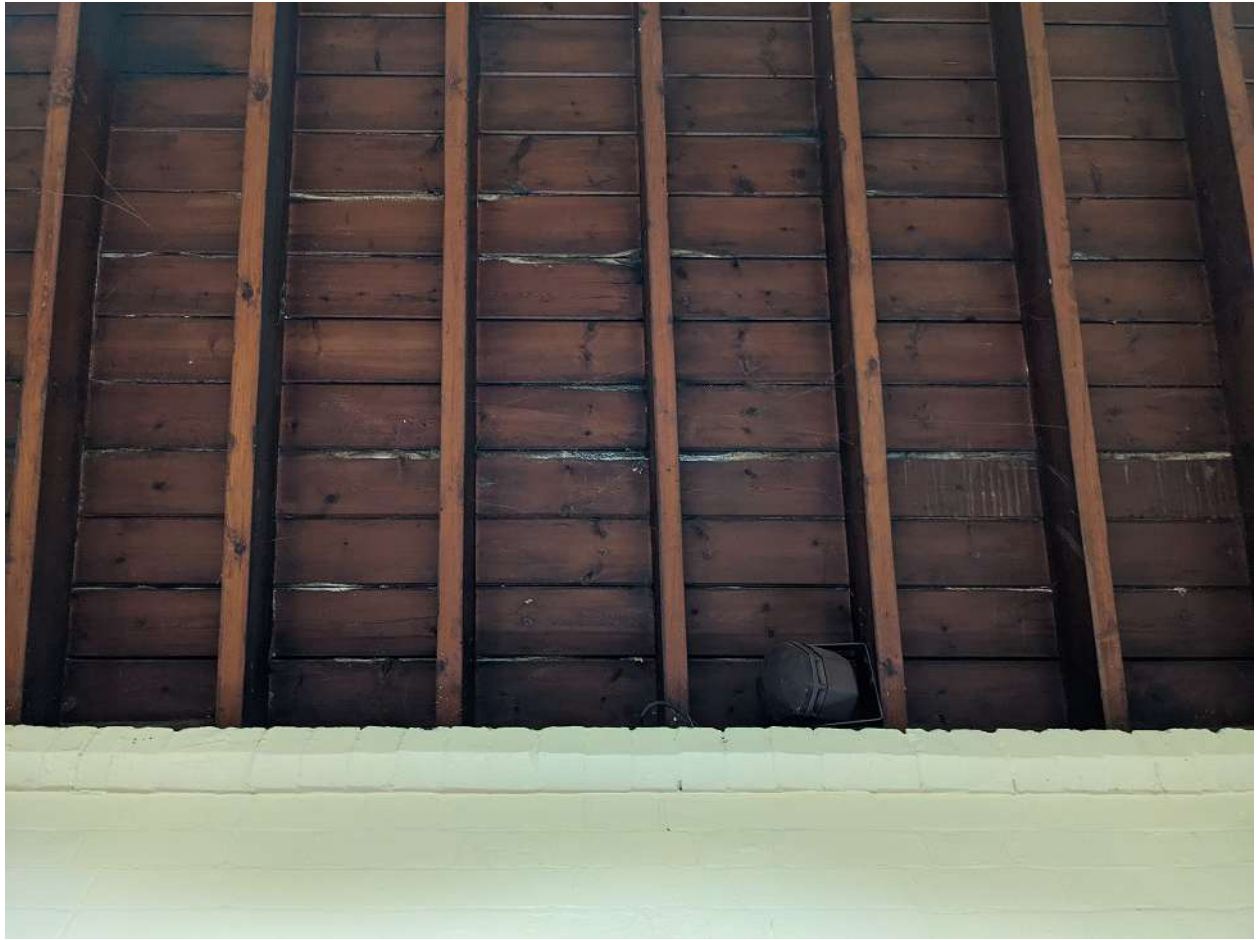
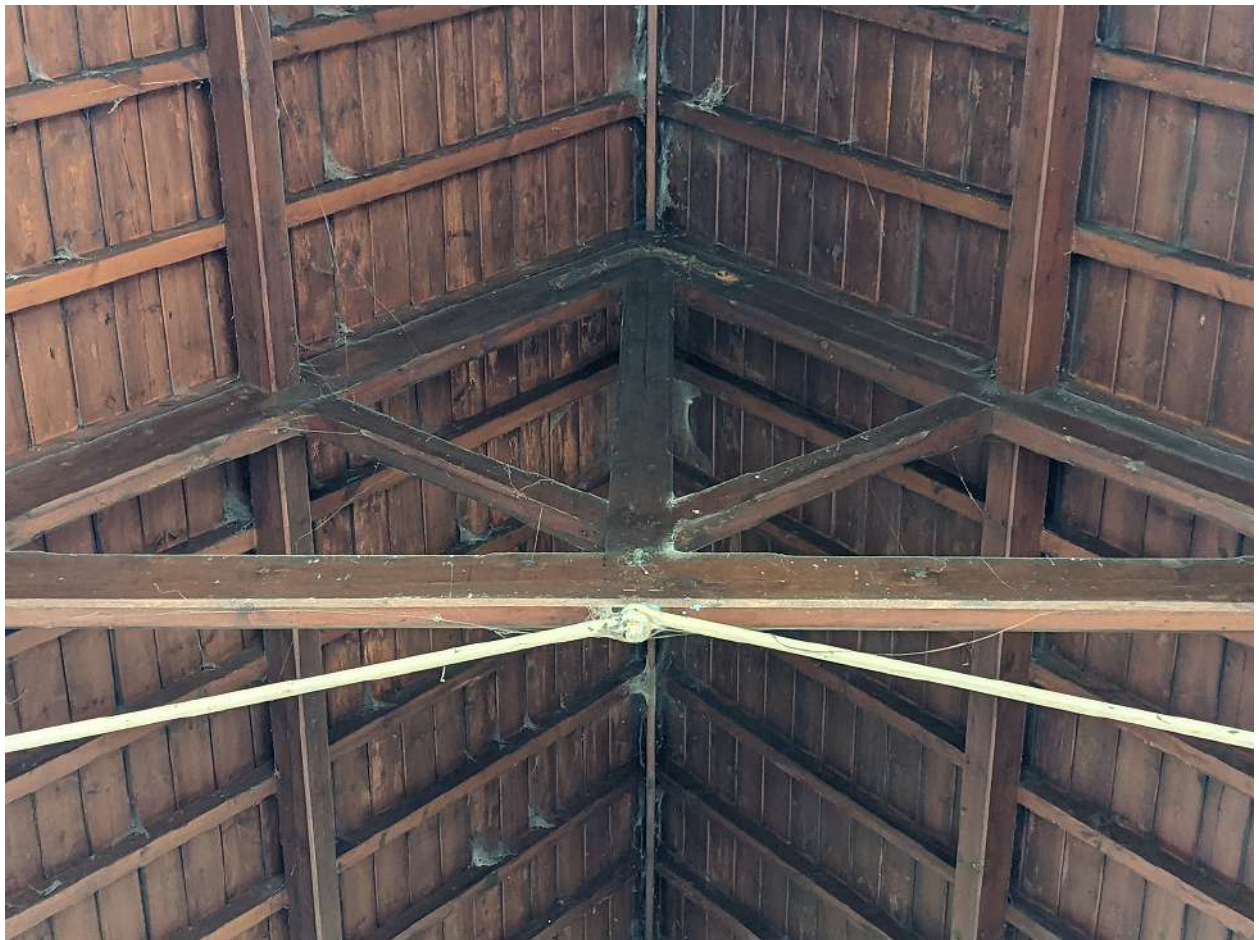
13.1.4 There is no evidence of recent water ingress and as such the roof structure appears in a good condition.

Cobwebbing is prevalent across the exposed roof structure over the chancel.

R1 It is recommended that this cobwebbing is removed.

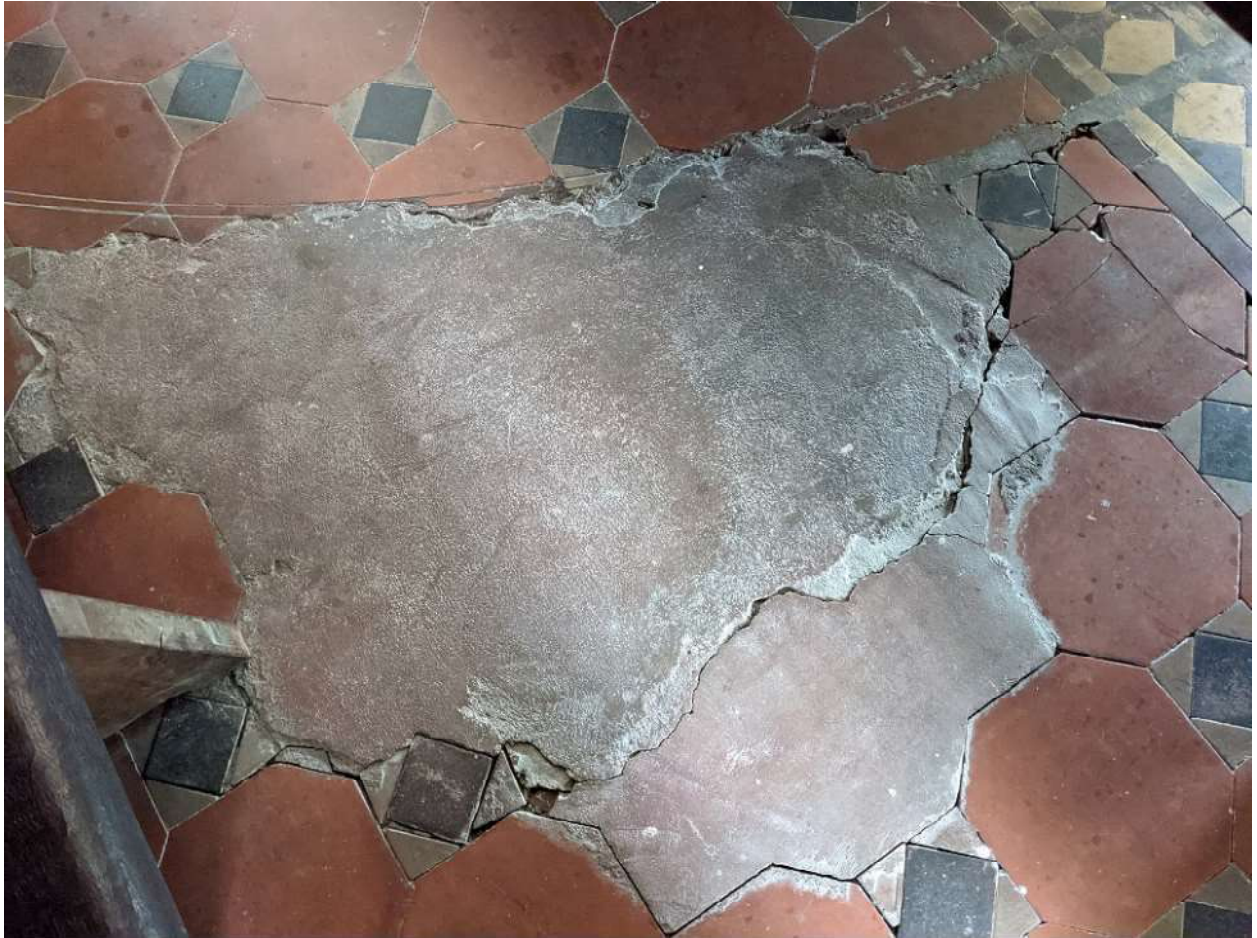
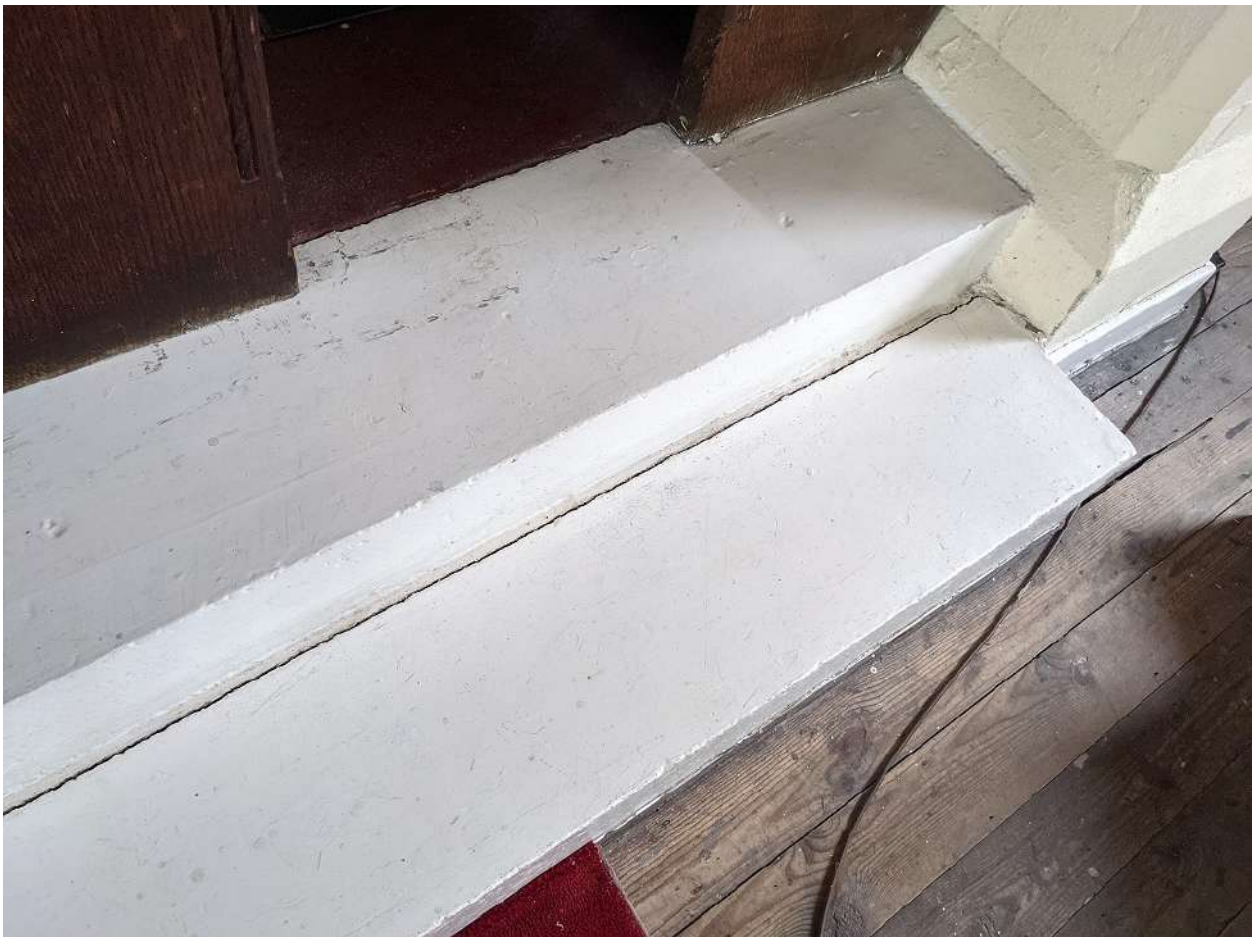
17.1.1 Previous QIR made mention of deterioration and breakdown of the decoration finish at high level on the south side of the nave concentrated around the two easternmost bays. This has been addressed as part of the church fabric repairs carried out in 2019.

There are signs however of breakdown of the decoration finish at eaves level on the north aisle to the east of the 'Creation and Harmony' window. This is assumed to be linked to water ingress via the guttering and eaves slating in this location.
