IAN NESS
ARCHITECT
26 GROSVENOR PLACE NEWCASTLE upon TYNE NE2 2RE
tel & fax
(0191) 281 2559
i.ness@btinternet.com

9 July 2020

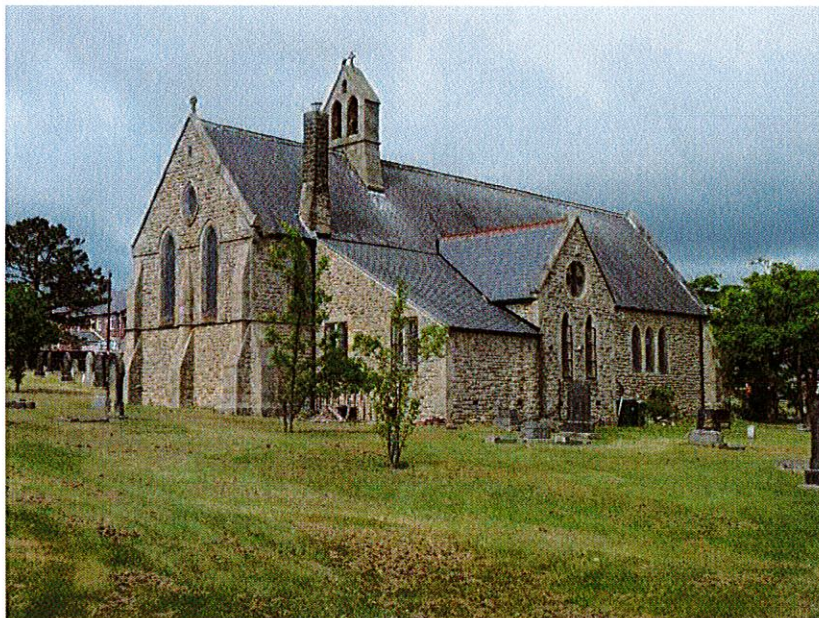
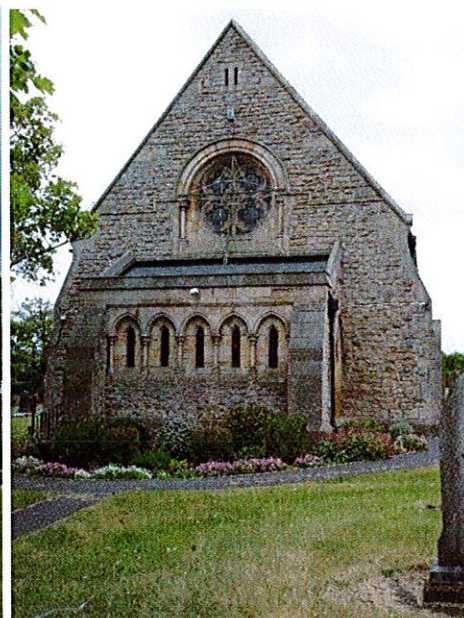
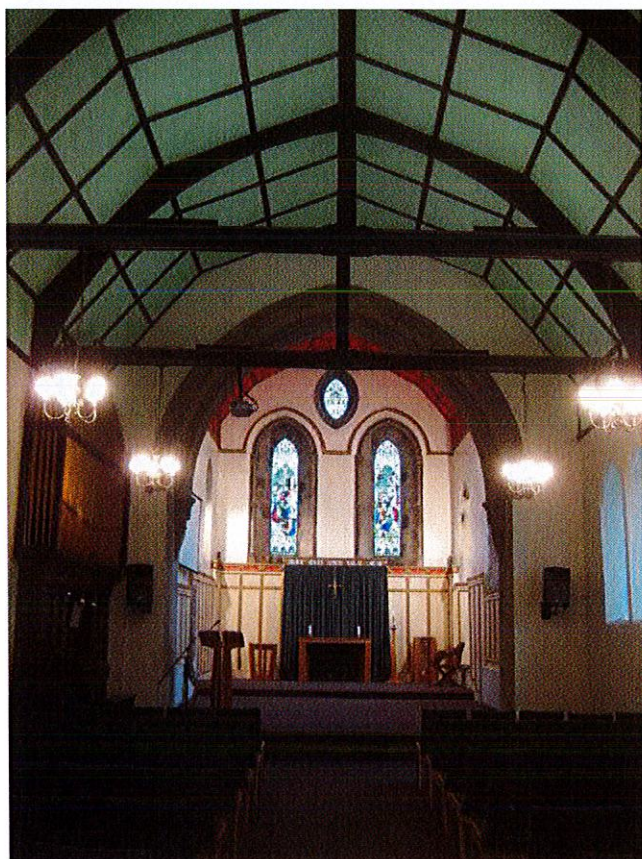
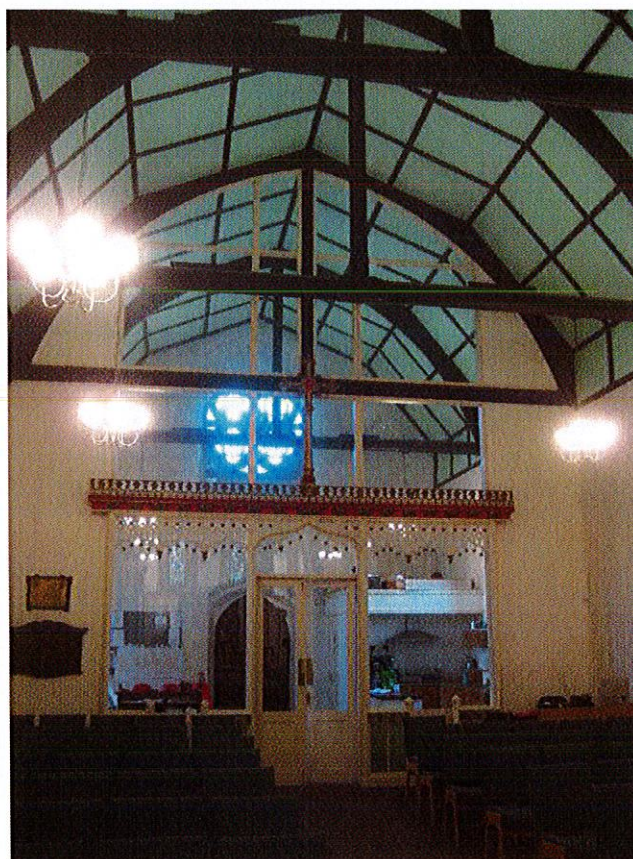
26 GROSVENOR PLACE NEWCASTLE upon TYNE NE2 2RE
tel & fax
0191 281 2559

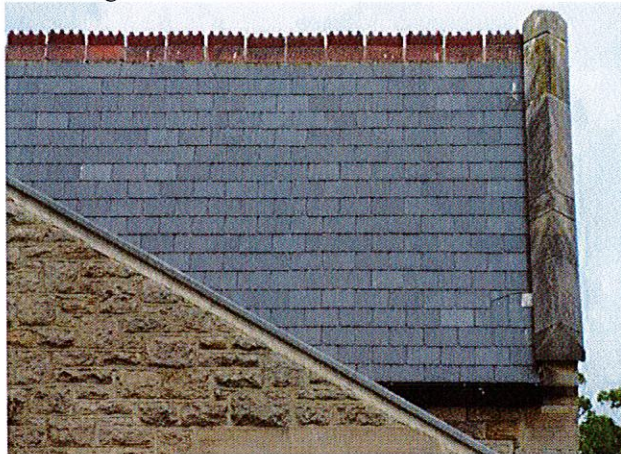
16. N Chancel good except a slate missing from ridge close to bellcote, one slipping near E end of ridge and another from under the bellcote.
At chimney lead back gutter and secret side gutters.
17. Vestry catslide recent slates good but one broken across near top and one slipping at eave.
EPDM rubber sheet at top apron and as cover flashing at W against the organ wall.
The E verge is covered by metal bent over the slates over cement mortar covering the ends of sarking boards. A short length of missing mortar exposes end grain which may eventually decay. Mortar is not permanent protection.

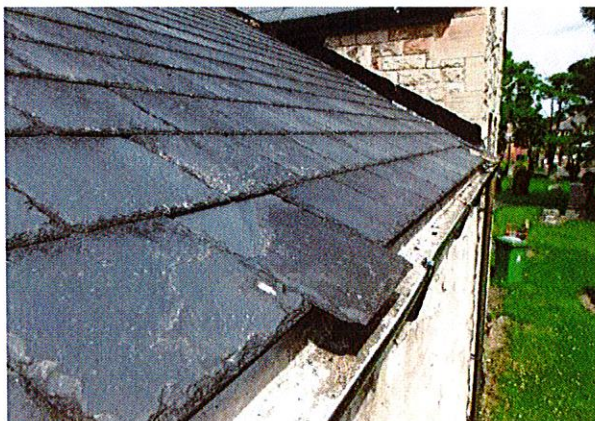
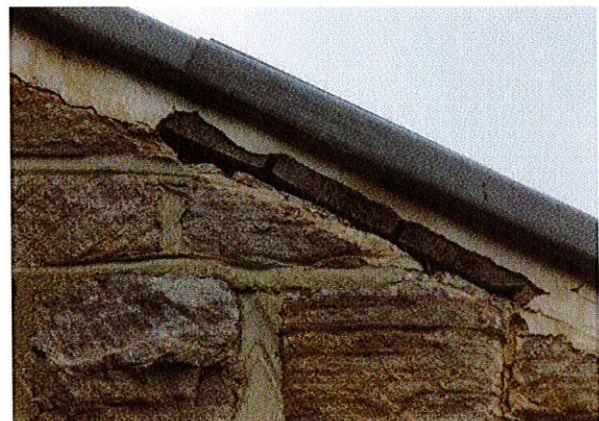
18. Porch lean-to under a stone drip at its head. Parapet gutter to a S outlet. All renewed. Slates good except three broken (some by fallen cross) sealant repair failed. EPDM sheet head and side flashings and parapet gutter lining and outlet. Loose timber batten in gutter.

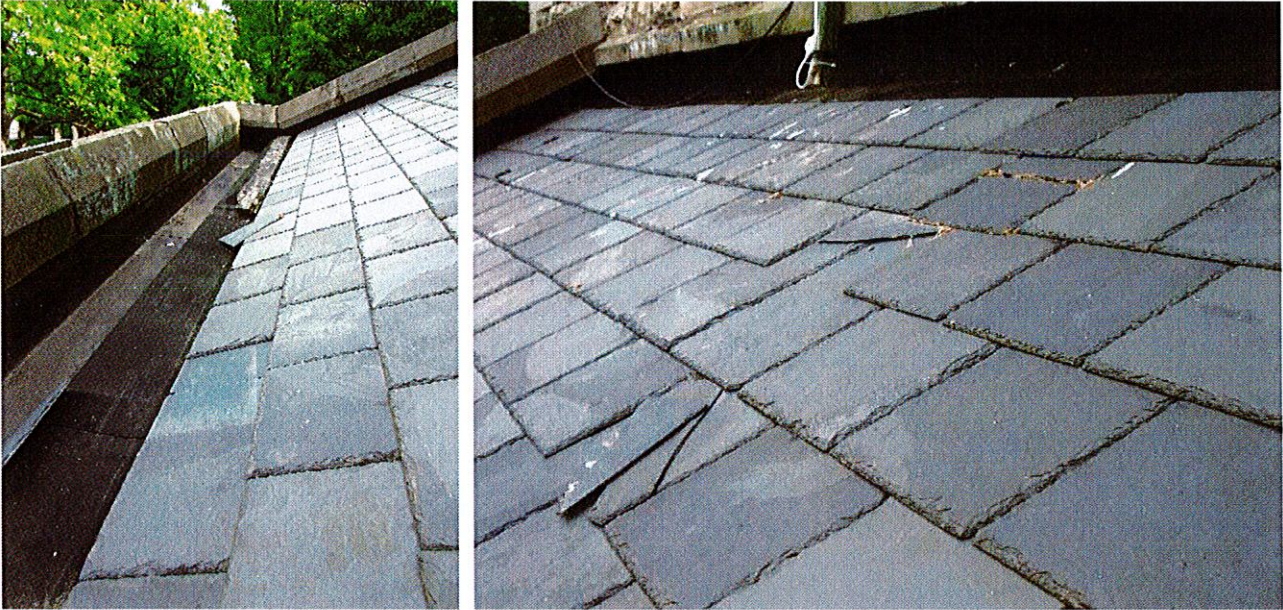
Rainwater System, Drainage

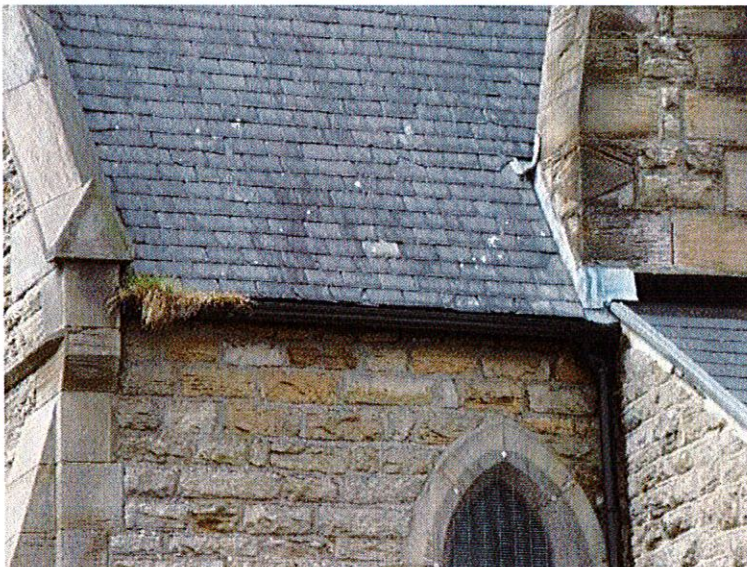
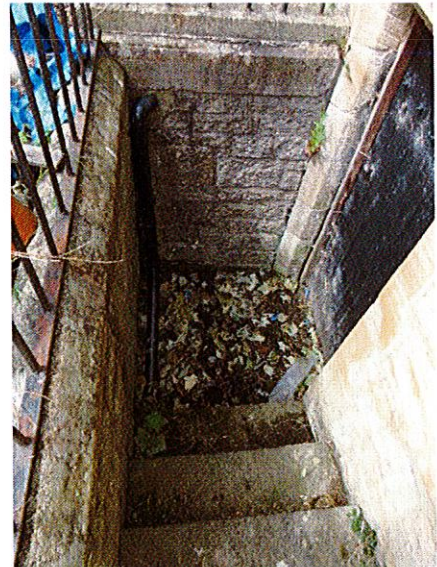
Well at boiler room steps

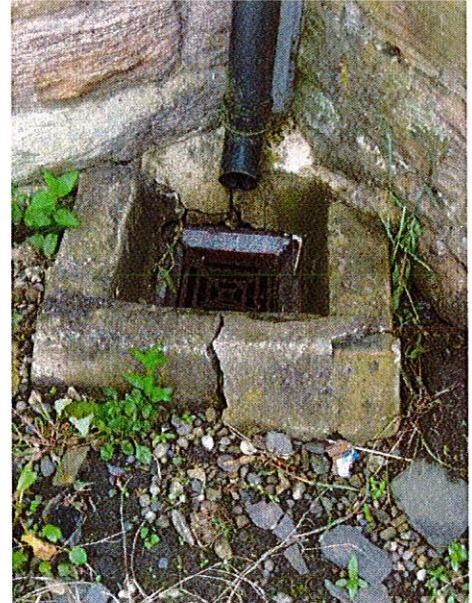
Cracked gully surround at SE nave-para 24

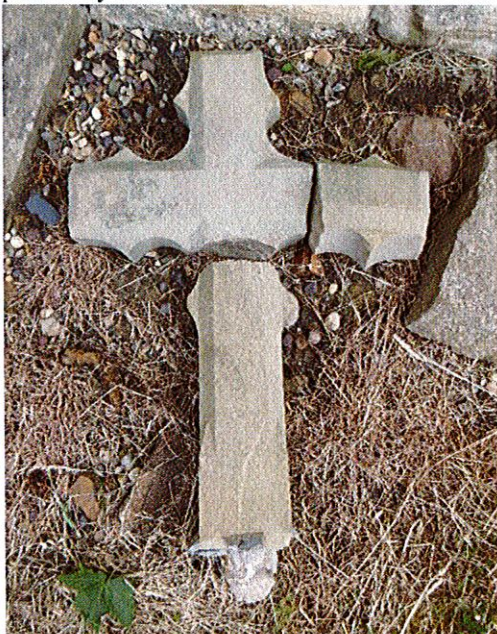
W cross complete but broken

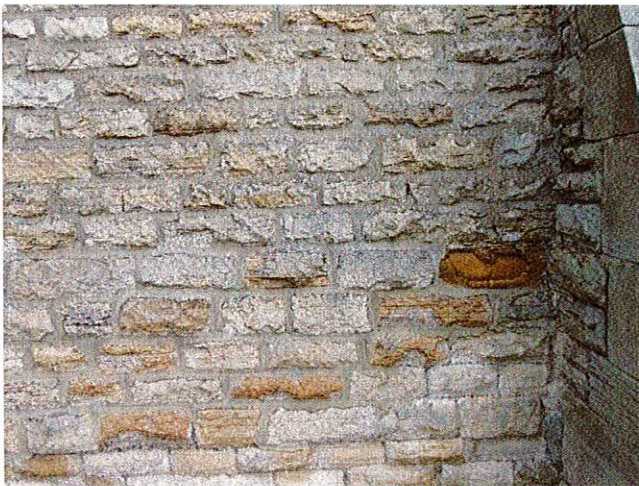
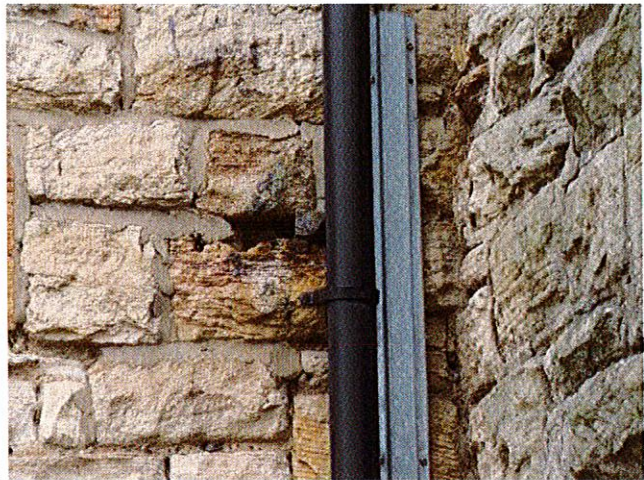
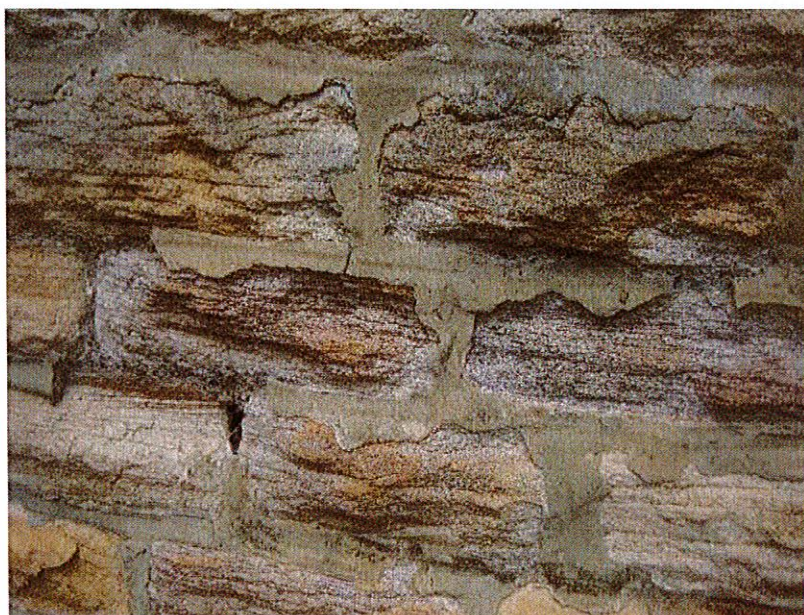
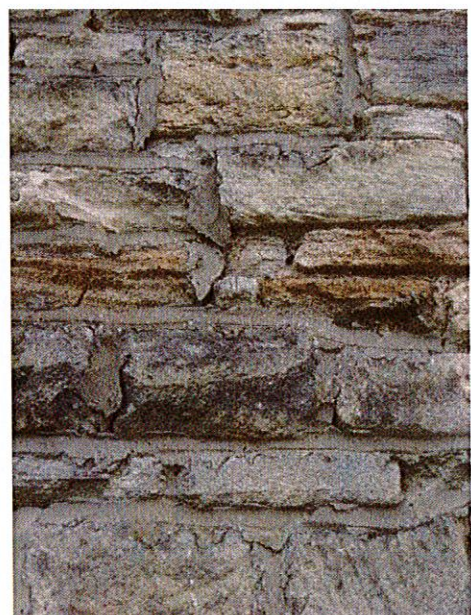
typical pointing at nave – stone decay accelerated by cement mortar pointing which is itself loose in places

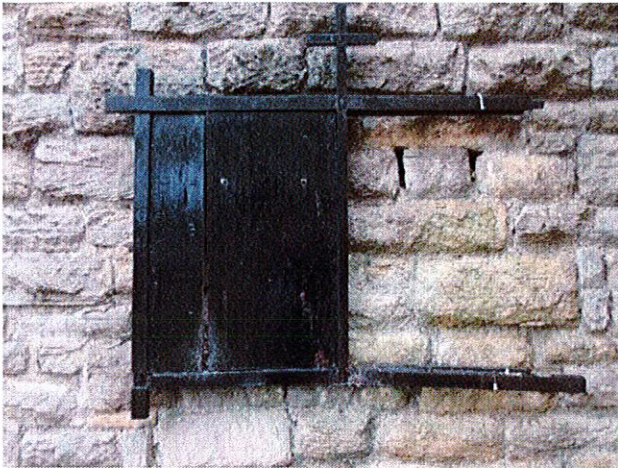
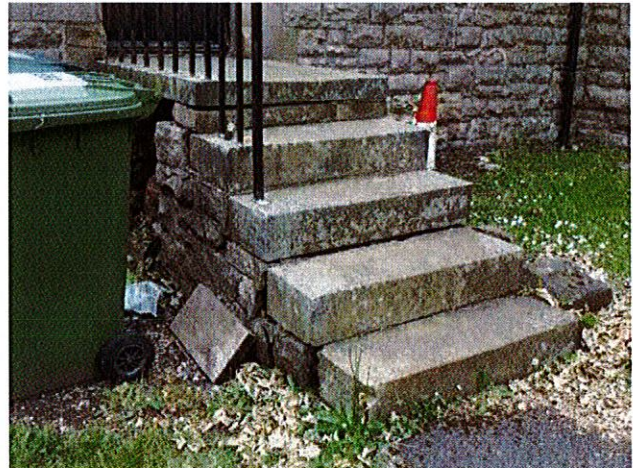
35. The Porch has old pointed joints and is fair apart from some decay behind hard mortar at the lower W and upper S sides. The ashlar upper W wall has some surface decay and decay in soft beds. At least three coping joints are open.
36. The organ chamber W wall is sound with tight joints well pointed. The N gable is fair with wider old pointing. Open joints in the watertables.
The stone steps to the door landing and its stone walls have spread.
37. The tall chimney seems sound. Vestry fair but many open joints in the N wall.

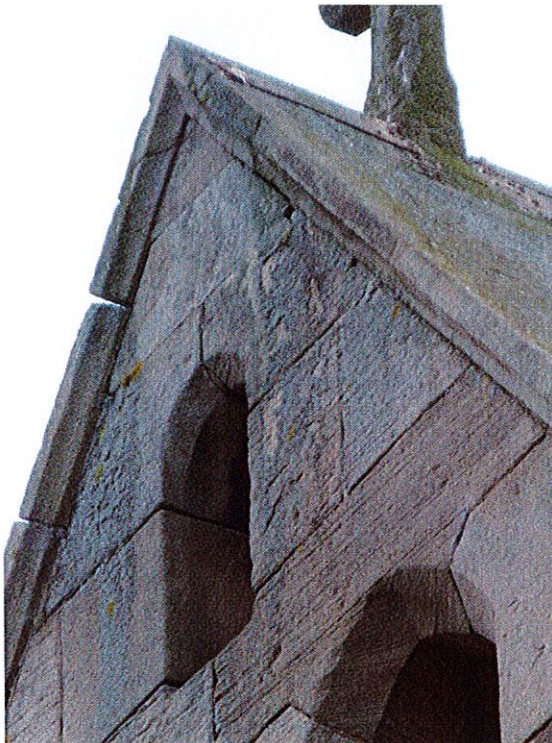
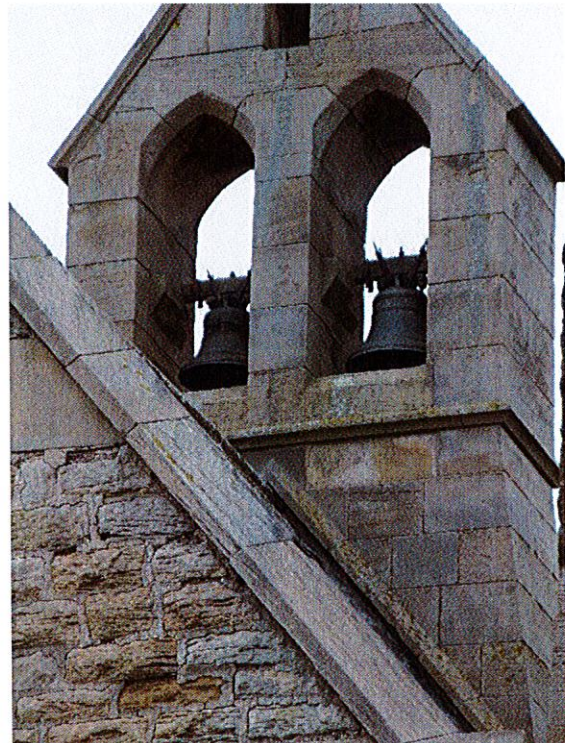
39. Two bells on metal I beams on bearings. Bell levers no longer connected and S bell cracked. The remaining N pull tube said to be sealed and the ropes concealed in the roof void. The bearings said to have been poor when last rung and must now be further corroded. Restoration would be possible.

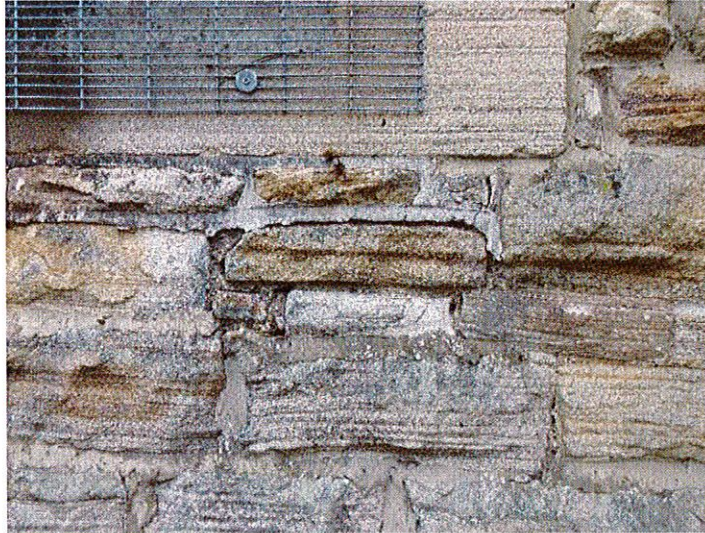
43. At Porch door arches minor decay in both hoodmoulds and in the top of the S arch. Decay in one S door E reveal stone.
At N door surface decay at the W side of the arch and reveals may be hastened by the open coping joint over.
44. In Porch W wall five small lancets in a miniature wall arcade. Some decay in weak beds in window reveals and surface shaling between windows 2/3 and 4/5 counting from left. Decay in most of the six turned capitals and the backs of the stone shafts. Both perhaps worsened when the gutter over leaked.
45. W gable rose window and surround appear sound. Iron ring armatures rusted but probably stable.
46. Two groups of triple lancets in N Nave, Vestry door, two lancets and higher quatrefoil in organ gable, two pairs of rectangular windows in windows in Vestry E wall and single N Chancel lancet all sound.

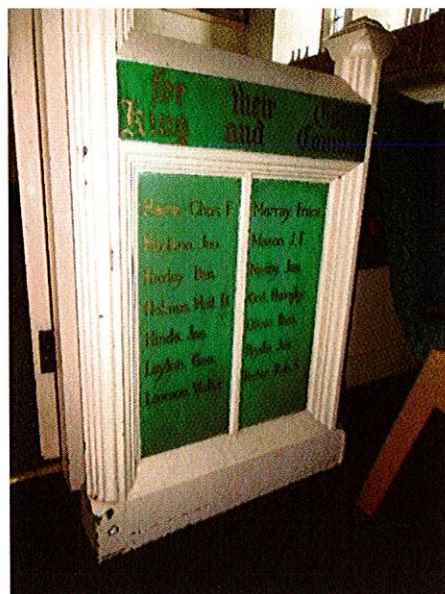
56. Large wc compartment at NW double plasterboarded with heavy ceiling and solid flush door for good sound separation.

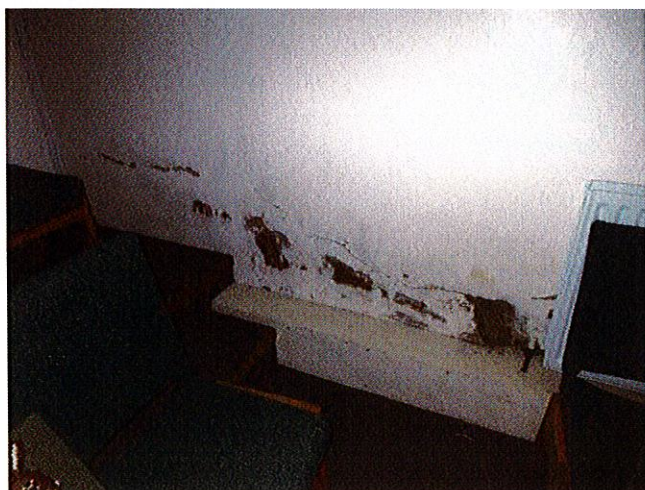
The latter two Nave damages are worse than at the last inspection, suggesting rising damp has continued though it may now be limited by the recent drain and ventilation work. Render/plaster and paint repair now would improve appearance and help trace need for further damp works. One twin socket may suffer from being very close to damp plaster.

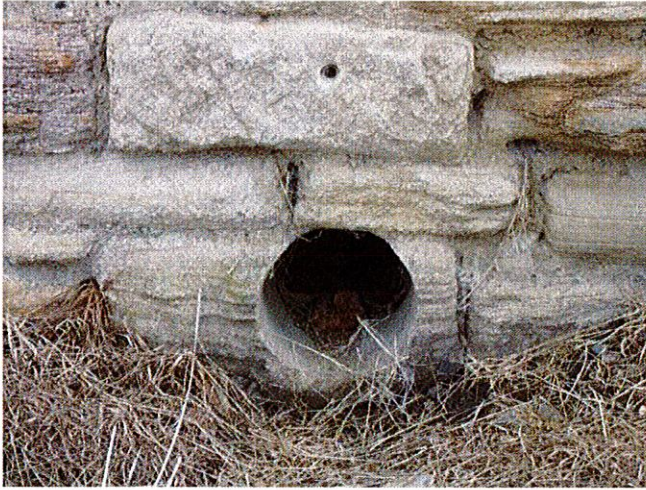
66. Recurring rot by the kitchen in 2013 and 2017 has been repaired with reported further air pipes through the solid walkway for better cross draught. In 2017 one new vent hole was drilled through the Nave N and S walls but are not yet cut square and fitted with air bricks to keep out vermin. The S hole is open, the N hole is temporarily bunged with plastic sheeting which defeats clear ventilation. Two airbricks lying disused on the basement floor would suit.

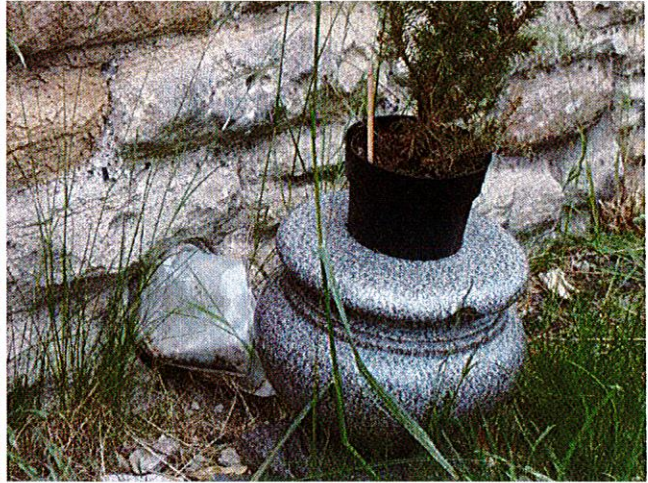
N side – drilled hole loosely plugged by plastic sheeting

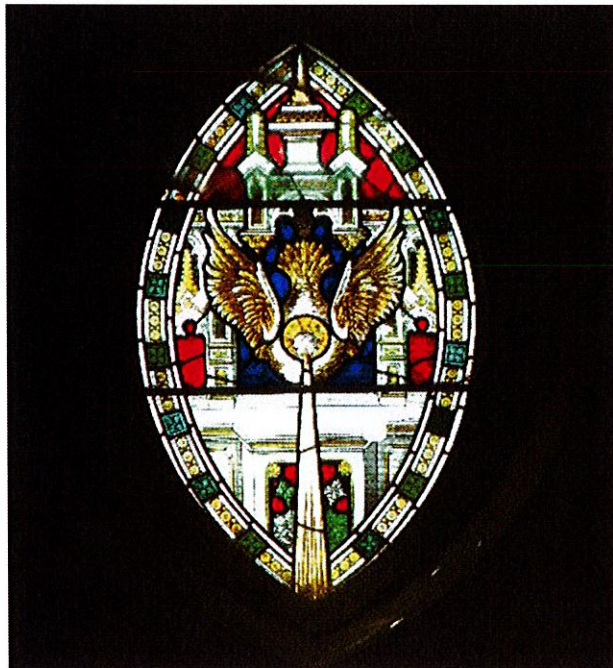
69. E gable two lancets with sound stained glass Revd Samuel White memorial 1892 'I was sick and you visited me, I was hungry and you gave me meat'. Above them a vesica with dove stained glass where two holes may be pellet damage through the mesh. Some dirt.

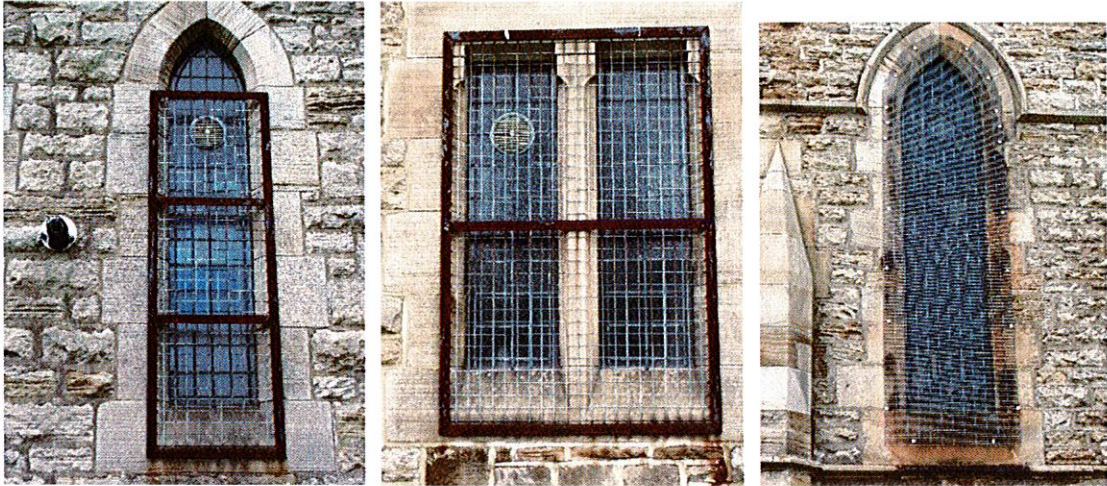
74. At N Nave the W triple lancets have sound white quarries. Original ferramenta. In the E triple lancets stained glass Berkley memorial by Atkinson Bros 1912, Light of the World, St Peter, St Cuthbert, sound.
75. At the organ gable quatrefoil sound white quarries very dirty. Two N organ lancets and two pairs rectangular lights in the Vestry E wall have sound white leaded quarries.
76. At Vestry and organ lobby mesh protection in rusting steel frames not fitted to openings look poor. Frameless galvanised mesh protection fixed with washers and screws into mortar joints and some stones across all other openings except nil at five small Porch lights.

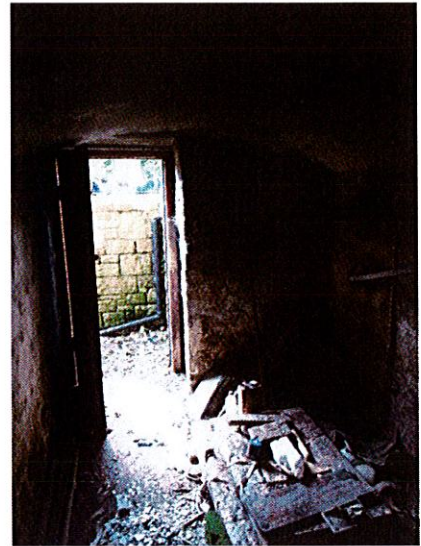
87. System fully renewed 2004. Twin wall gas boilers with flues through the N lobby wall. Exposed gas meter between boilers. Copper pipes to twin panel steel radiators throughout including the N lobby and Porch. Timer, room thermostat, thermostatic radiator valves. Effective.
88. Empty basement boiler room dry, well ventilated. Ceiling part vaulted under the Vestry. Disused stainless flue and terminal remains on stone chimney.

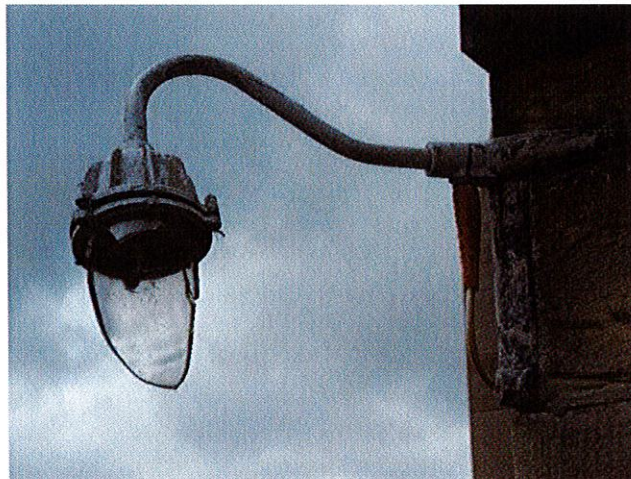
93. Security lights over the doors, intruder alarm (said to need attention), sound system. A very poor looking broken external light on the Vestry corner should be removed.

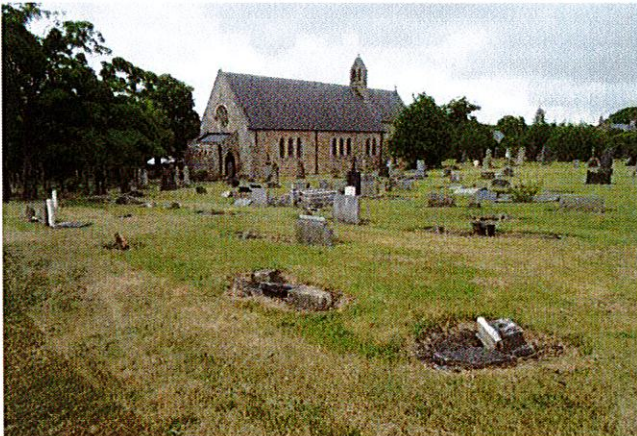
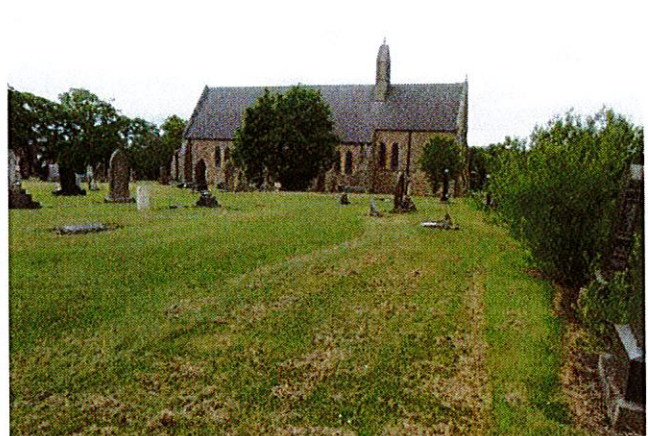
101. A large square sloping yard with burials in most parts and avenues of trees at the N and W paths. Closed and maintained by Gateshead Council.

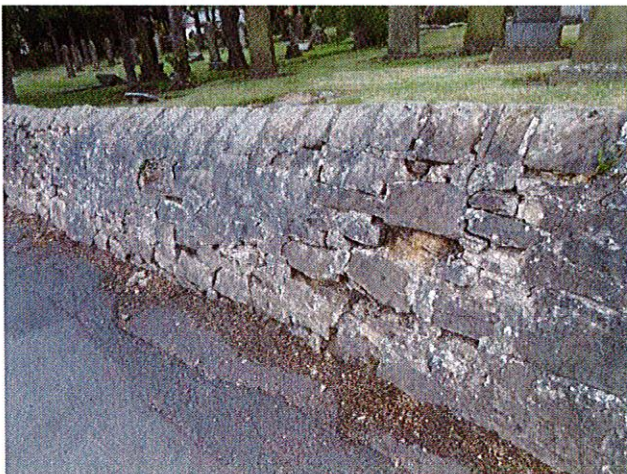
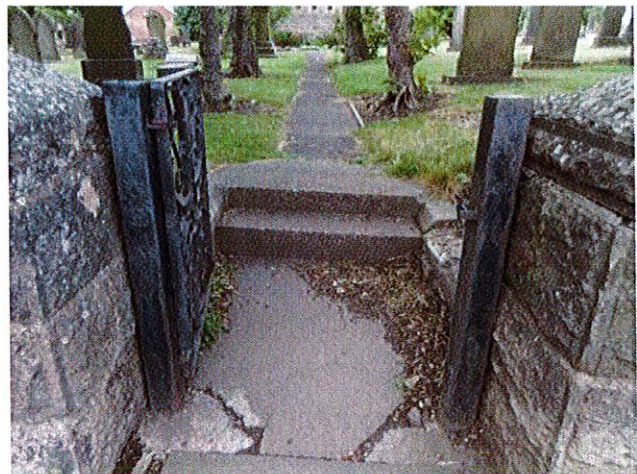
103. At N and NW the wall is low and broad enough to resist the soil pressure at present but small holes and mostly loose pointing make it precarious.

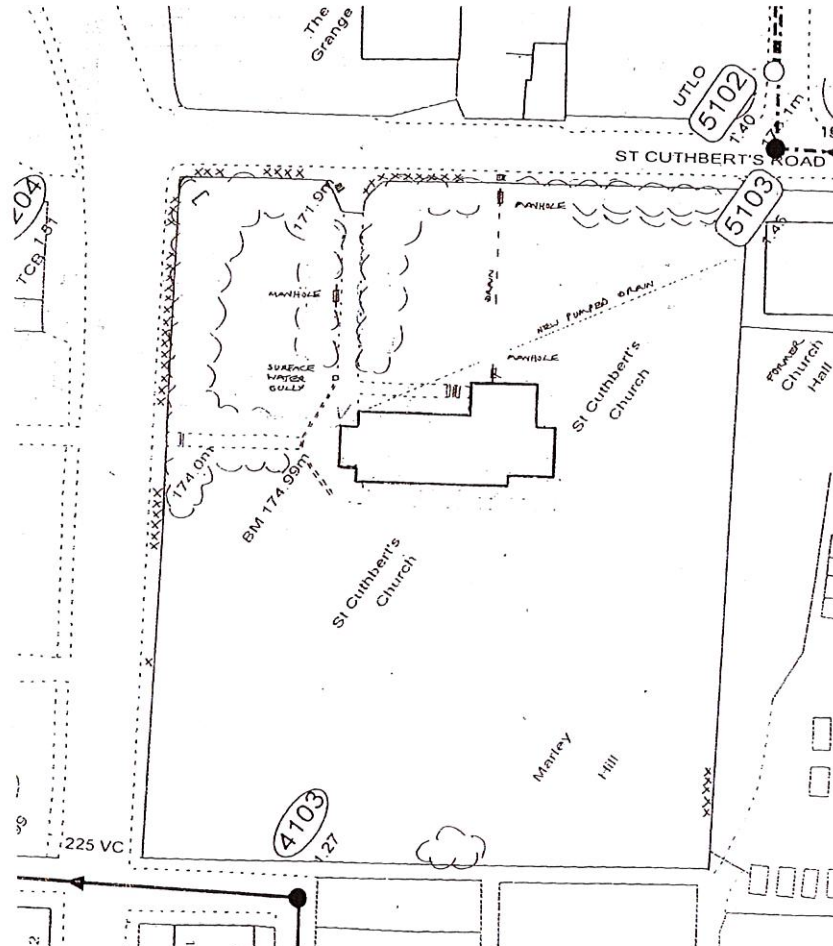
107. A twin stemmed sycamore not far from the Nave S side. A scots pine by the S boundary. Numerous other mature trees. Maintenance by the Council does not relieve the parish of its duty of care to report any sign of a tree becoming dangerous. Note the Conservation Area means the trees are protected and work should only follow Local Authority Consent and faculty.
108. Head stones of all descriptions, mostly in good condition but many, especially the smaller stones are leaning steeply or laid flat. In about 2002 Gateshead tested their stability. It would not be a major effort to set most of the flat stones up again. One by the Vestry is flat and broken.
109. A tomb S of the Chancel in poor condition.

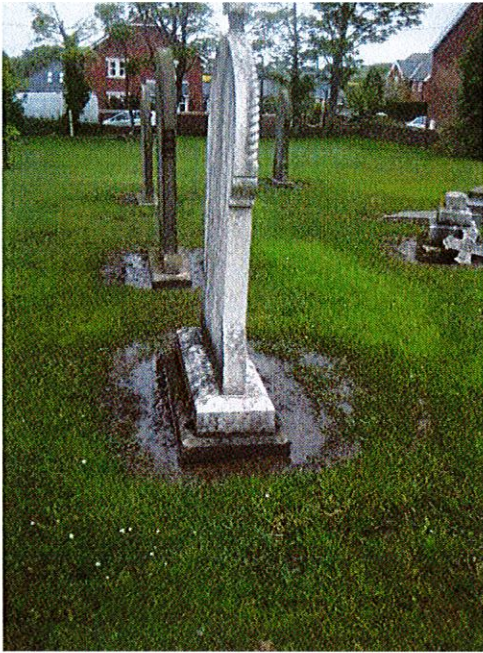
Standing surface water often found around a headstone

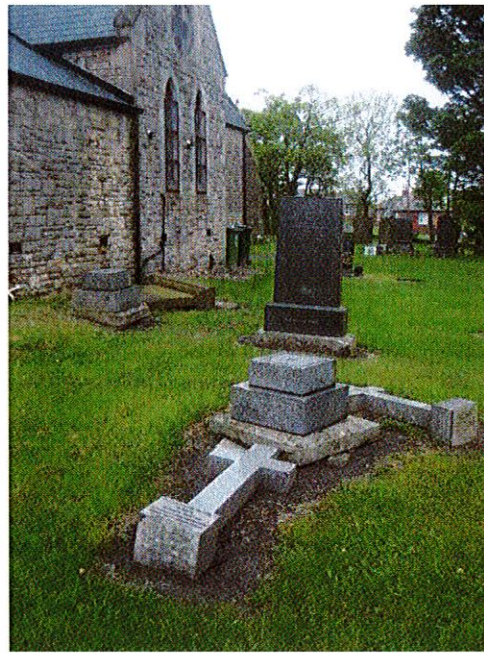
typical mixed condition of stones

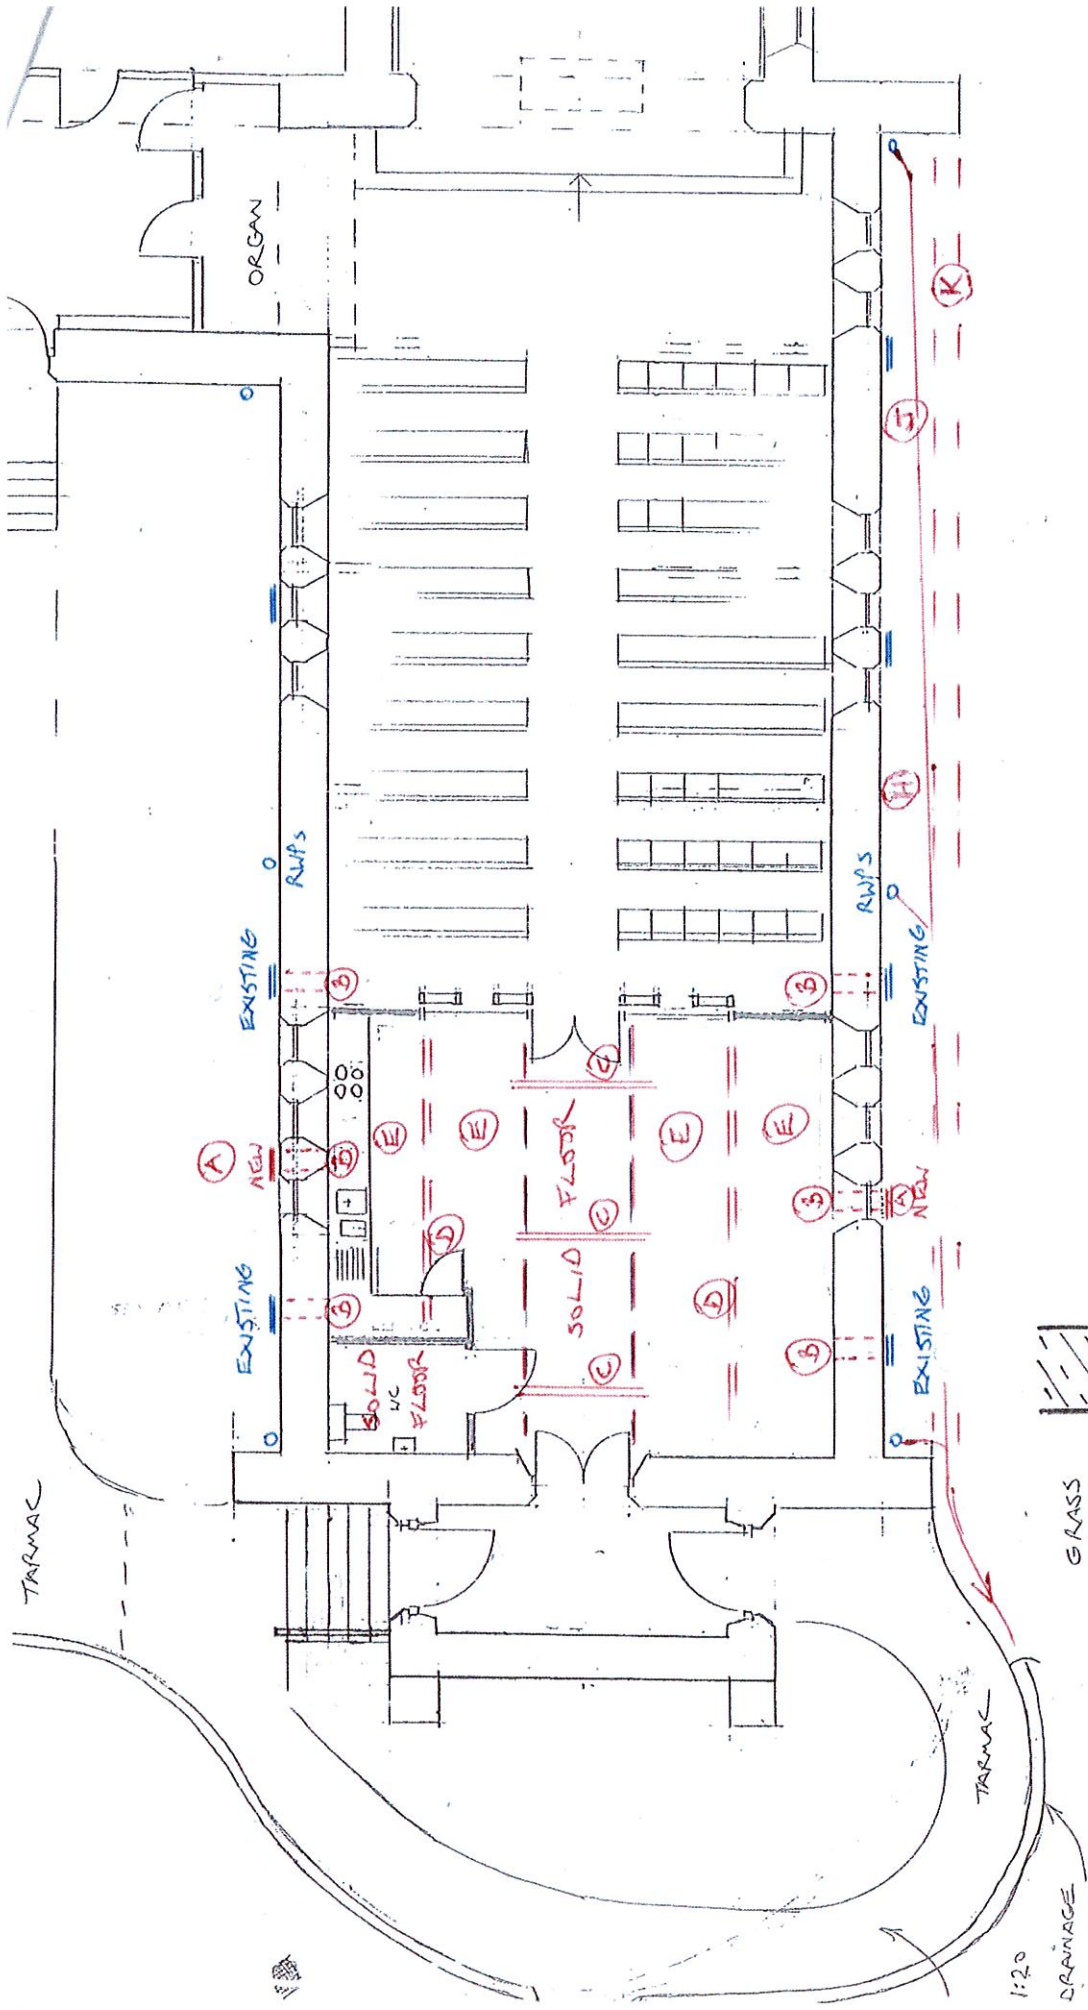
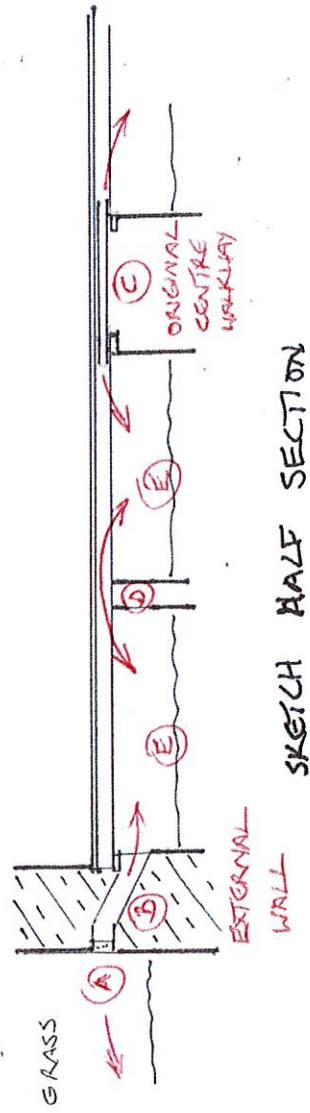
ST CURRIBEN'S
 MARLEY HILL
 October 2017
