St. Mary Magdalene Parish Church,
Medomsley

Diocese of Durham

Quinquennial Inspection Report
April 2019

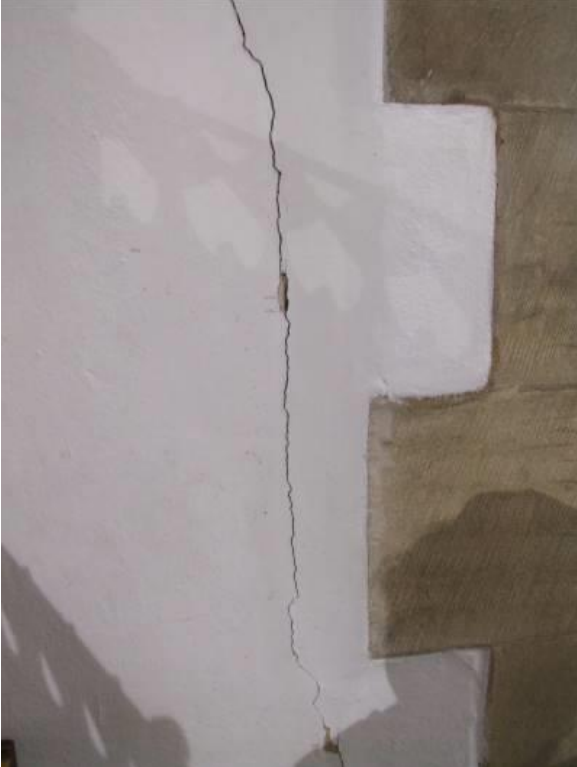
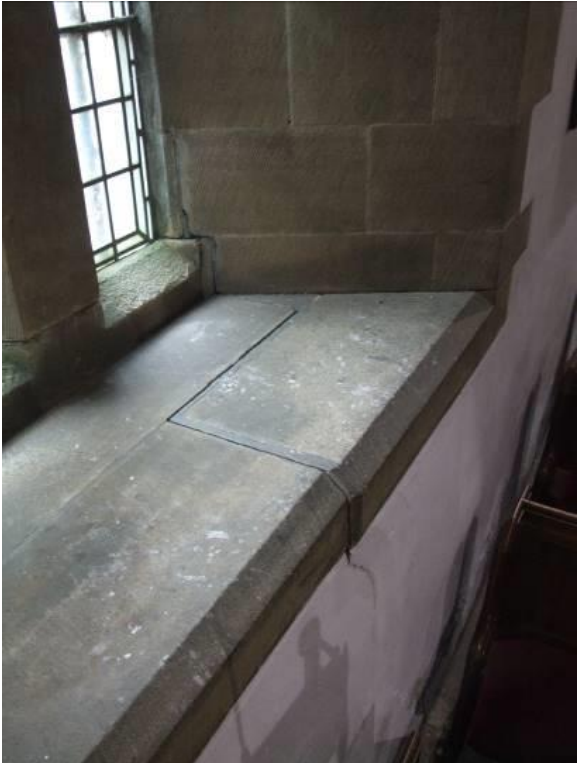
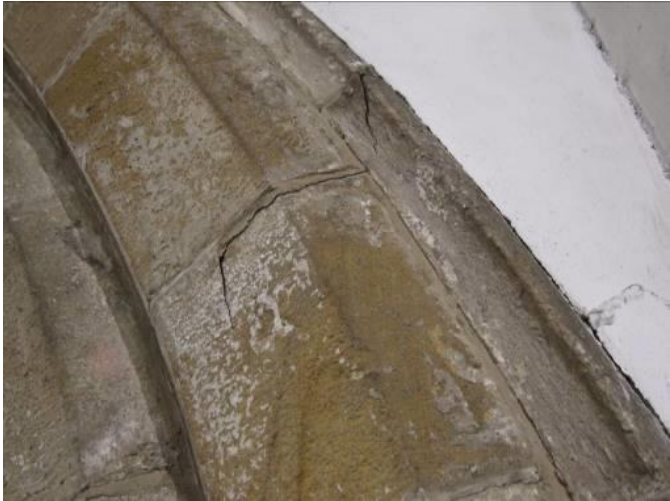
| 2.1 | <p>The Church appears to be structurally sound. Movement at the chancel arch and southeast nave windows previously recorded show signs of hairline cracking and in the chancel side walls at the east end. Tell-tale glass markers have been installed at various places in the Church, but these do not appear to have been installed correctly and do not serve any useful purpose in recording movement.</p> <p>The pattern of cracking is most pronounced at the eastern end of the south wall of the nave, in the vicinity of the pulpit and adjacent window. I do not believe that there has been additional movement since my last inspection, however the combination of cracking to the sill, vertical wall and to the nave face of the chancel arch corresponds to external cracking, and irregularly-faced stonework in the vicinity of a rainwater downpipe and gully.</p> |

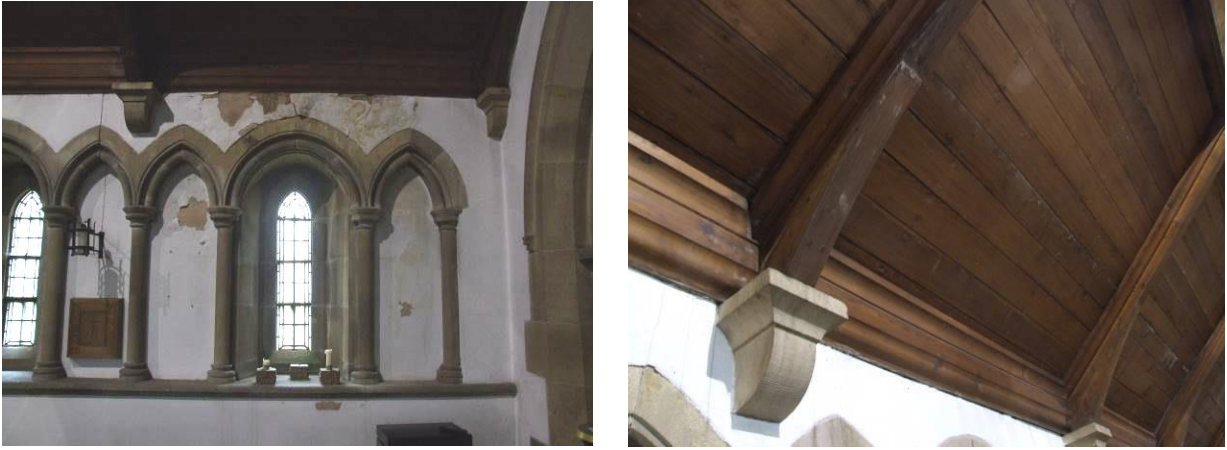
| 2.2 | <p>Of greater concern is the evidence of continuing and accelerating water ingress to the north aisle roof and wall:</p> |

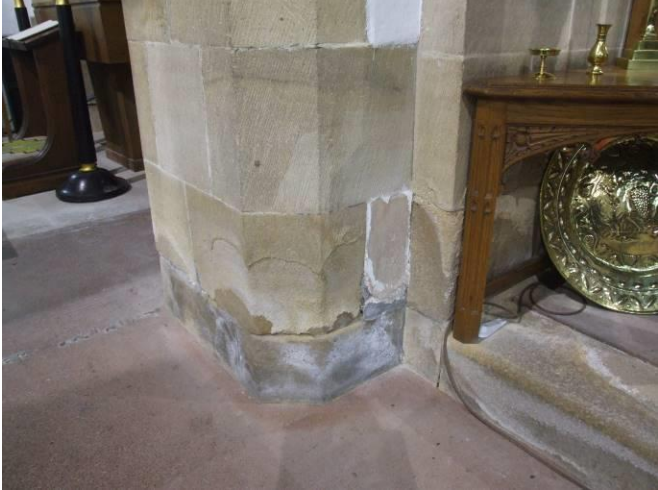
| 2.3 | <p>Rising damp continues to be present in some of the external walls and internal column bases, but this appears to be at the same levels as previously inspected. This was especially noted on the south nave walls. Gravestones in the chancel floor appear to be damp.</p> |

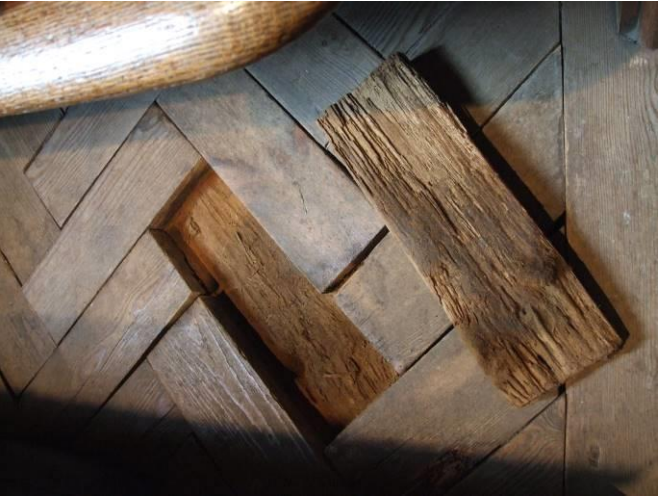
| 2.4 | <p>The extent of uneven and loose wood block flooring under the pews in the nave has now increased and poses both trip hazards and a significant disincentive to pew use. Ongoing damp-related underside deterioration now requires a damp-proof membrane, a new screed and floor covering.</p> |

| 12.1 | Loose woodblock flooring in the nave under the left- and right-hand side pews are still uneven and insecure and due to the underside dampness related decay cannot successfully be re-used. The proposed treatment would consist of complete removal of the failed pine woodblock flooring throughout, installation of a liquid DPC and a new screed onto which would be laid carpeting to match elsewhere. |

| RECOMMENDATIONS | |
|---|---|
| Remove defective timber block flooring, install DPC and screed, carpet as elsewhere | |

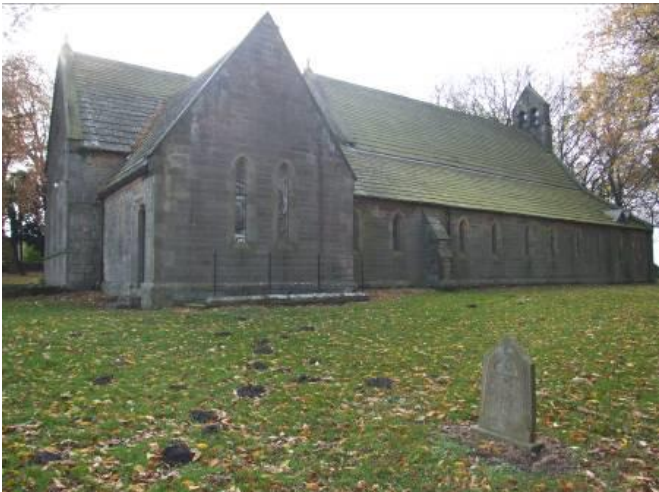
| 3.4 | <p>CHANCEL ROOF: Pointing to the ridge tiles has been undertaken where 3 no. open joints were noted, in cement-rich mortar. Stone crosses on the nave and chancel gables are perished and require close inspection and testing for stability.</p> <p>Some table stones have open joints which will admit water and need close inspection, stemming and re-pointing in lime mortar.</p> <p>The lead flashings to the chancel gable north slope table stones are still loose and require resetting and pointing.</p> |

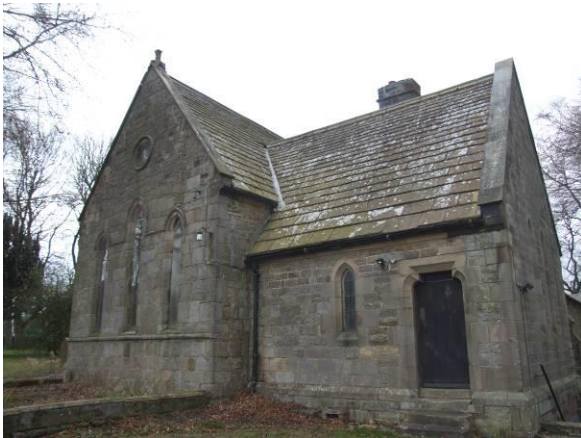
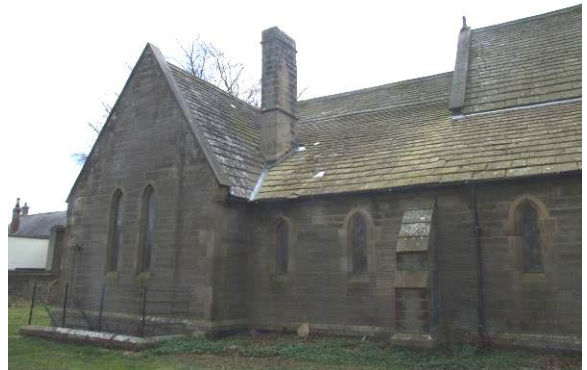
VESTRY ROOF:

The chimney stack rising out of the vestry roof is showing signs of erosion and will need re-pointing. Work has been undertaken during the quinquennial period to the flashing, however stone slates in this area have experienced damage and lead sheet repair and replacement.

Loose flashings to the north gable wall require attention and re-pointing to both sides of the roof.

When working on the stack the flue should be checked for ventilation as closed flues can cause condensation and dampness.

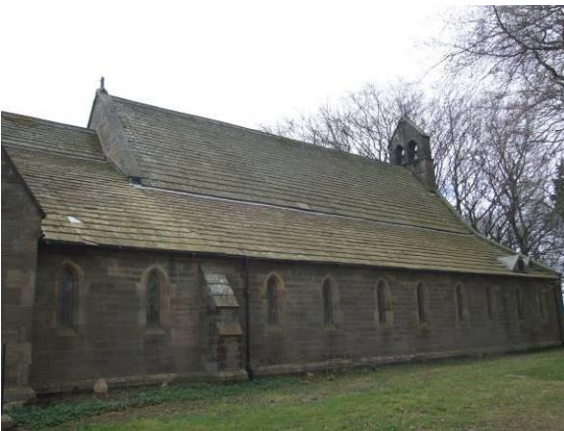
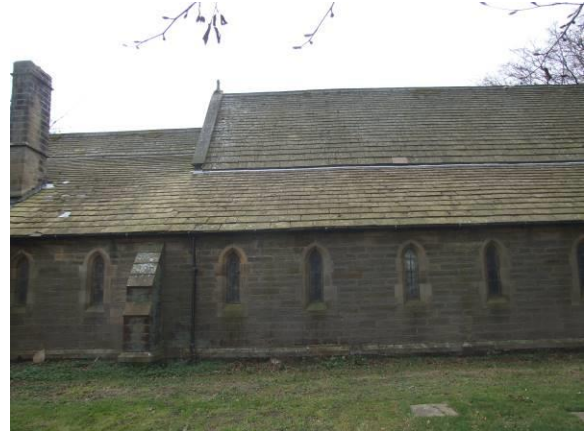
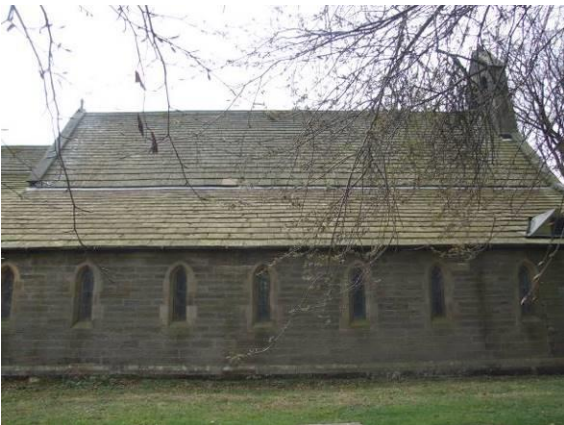
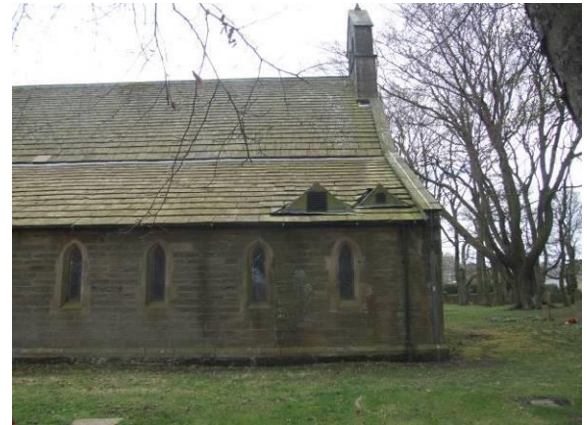
NORTH AISLE ROOF:

There are significant concerns on the continuing water penetration in this area.

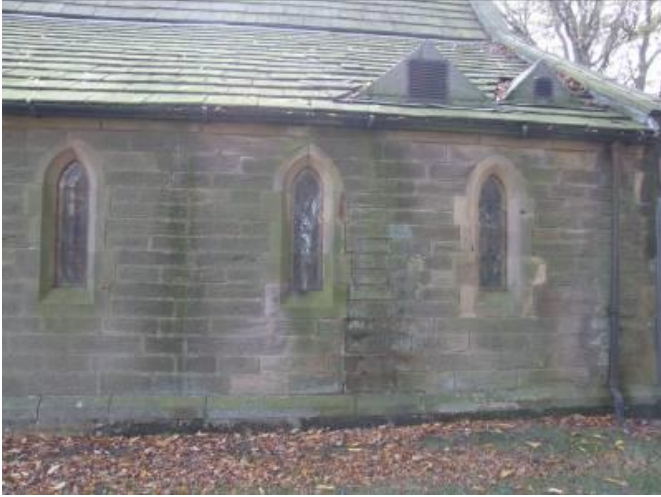
| 4.1 | <p>All rainwater goods are cast iron and appear to be in working order but should be cleaned annually. It was not possible to check the gutters for water tightness, but this should be undertaken in rain to check for leaks. Every 5 years gutters should be recoated with bitumen paint and caulking of joints checked and repaired as required.</p> |

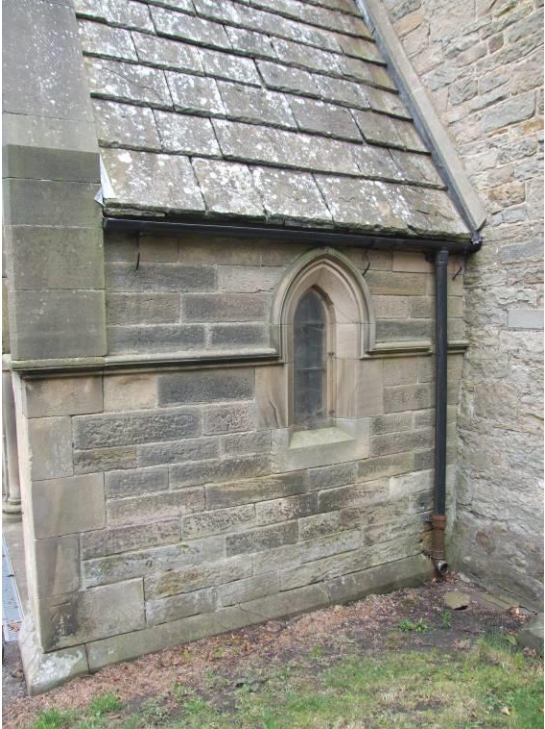
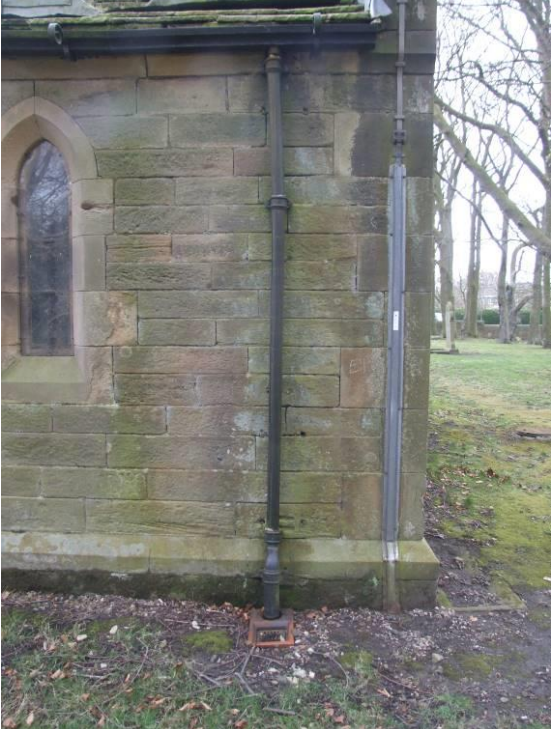
| 4.2 | <p>The downpipes require regular repainting and uncaulked joints in both downpipes and gutters can cause moisture saturation of wall foot and wall head respectively.</p> |

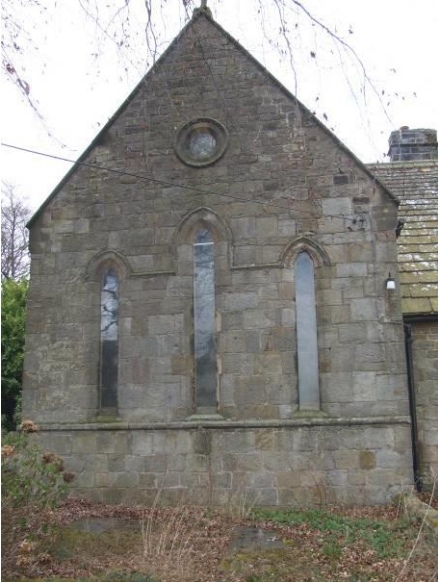
| <p>6.3</p> | <p>EAST GABLE: Re-pointing is still required at the upper parts of the gable face and this should be undertaken when the table stones are re-pointed, all in appropriate mix and finish.</p> |

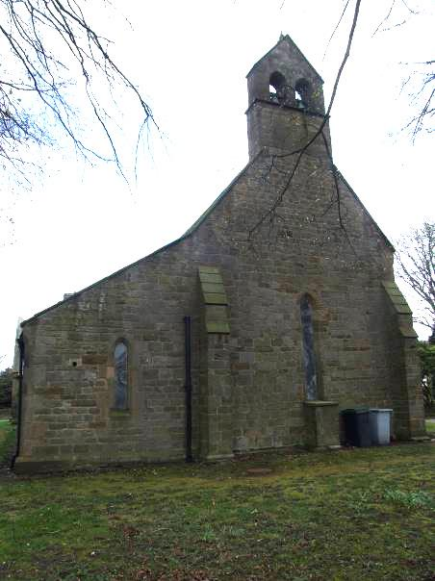
| <p>6.5</p> | <p>WEST ELEVATION: As reported previously some re-pointing is required to masonry on and below table stones on the North aisle.</p> |

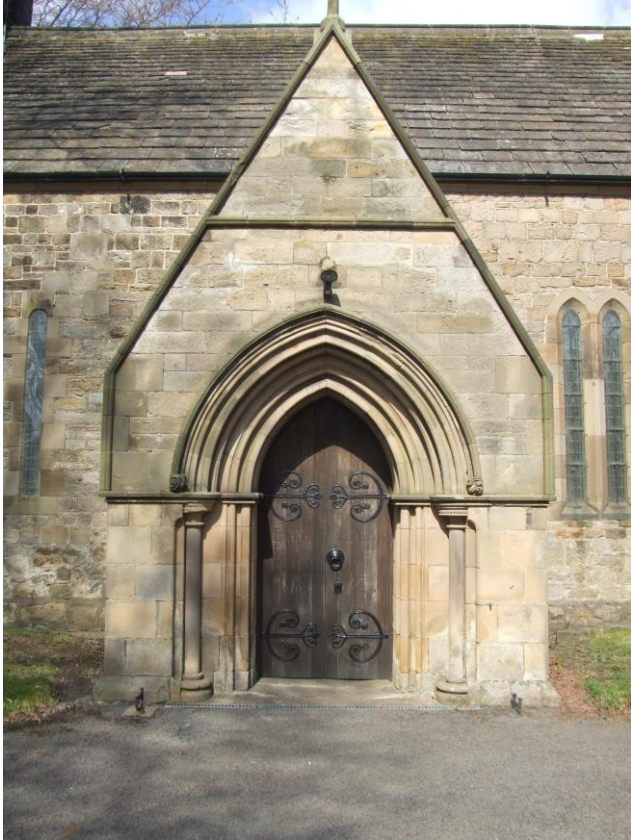
| 7.1 | <p>The main entrance doors to the porch are a pair of oak doors on metal strap hinges. The oak needs retreating with linseed oil. The metal ring handle and escutcheon require touching up in matching black paint.</p> |

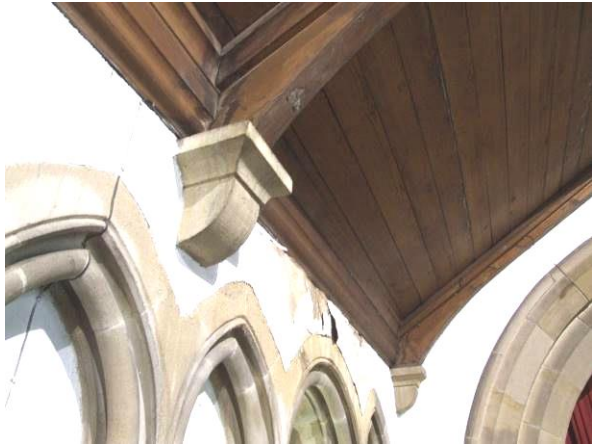
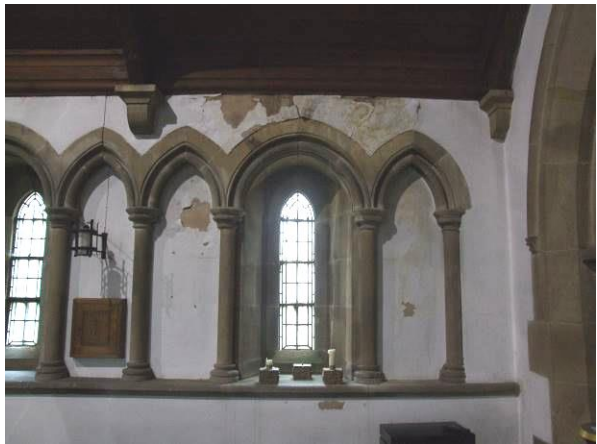
| 9.2 | <p>The roof voids were not accessible or inspected.</p> <p>Evidences of water penetration to the north aisle appear to have accelerated over the quinquennial period, during which a Listed Places of Worship Roof Repair Fund bid was unsuccessful).</p> <p>The delamination of plaster surfaces below the easternmost roof bay on the north aisle, and the staining truss foot and surroundings, require urgent attention in combination with comprehensive works to the entire pitch above.</p> |

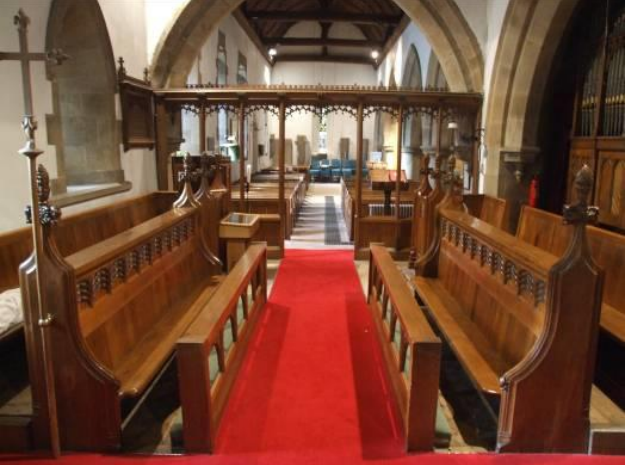
| 13.5 | <p>CHANCEL SCREEN: This is oak, highly decorated, by Hicks and in good condition. Note the abutment gap at the south end with the wall, which indicates movement of the south wall since 1898.</p> |

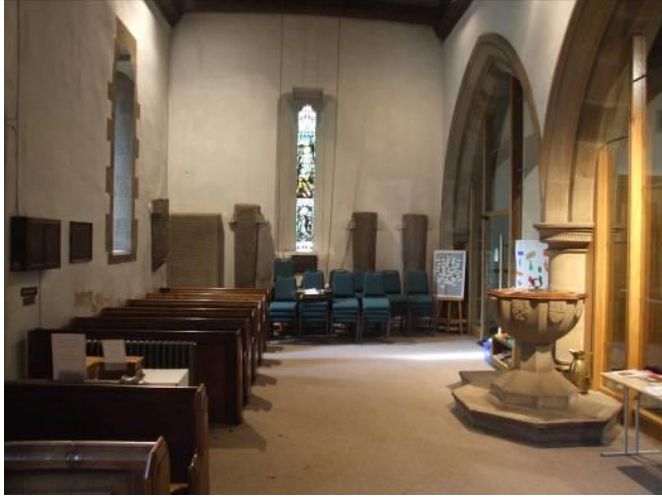
| 13.7 | <p>FONT: An octagonal stone chalice design with oak lid; drainage system reported to be out of use. The stone piscina was relocated on the south wall of the chancel on metal brackets in the 2003 reordering scheme.</p> |

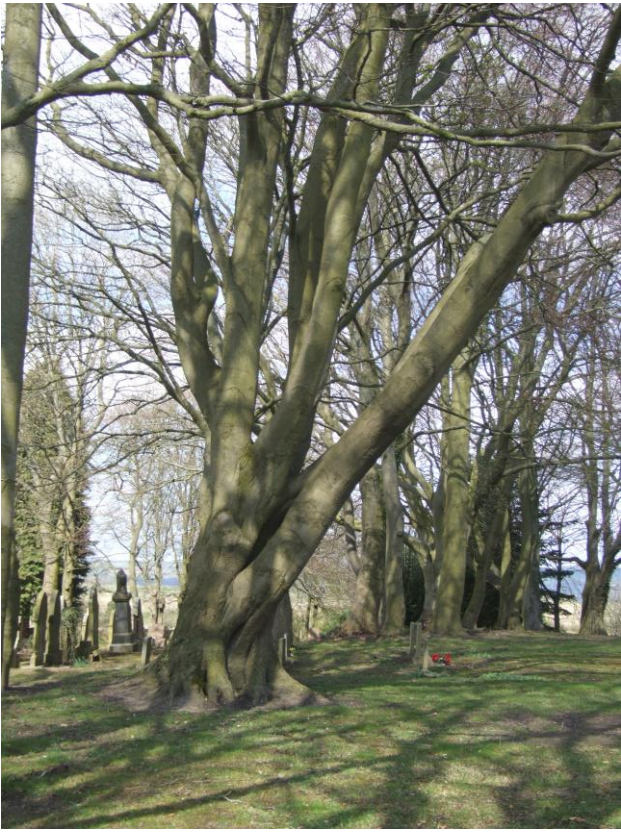
| 21.4 | <p>TREES AND SHRUBS:</p> <p>There are a wide variety of mature trees in the churchyard comprising horse chestnut, beech, copper beech, yew, laburnum, laurel, elm, sycamore, holly, ash, cypress, and hawthorn. The local Planning Authority has advised that there are no Tree Preservation Orders relating to the churchyard.</p> <p>Some young trees at the east end of the church, against the boundary adjacent to a house, were previously removed.</p> <p>There are many trees crowded together and in need of thinning out. Advice should be sought from an arboriculturalist.</p> |

| Arboriculturalist to check tree condition and need for thinning out etc. | Local Auth. |
