2022 QUINQUENNIAL INSPECTION REPORT

CHURCH OF ST.MARY MIDDLETON-IN-TEESDALE

(Ref: 2217)

Date of Report: 28th July 2022

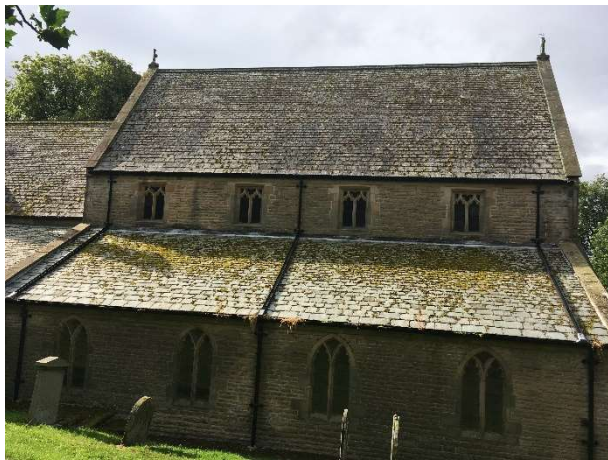
9.1 Roof coverings

2. Gables are coped and roll top stone ridge is all in intact.
3. Heavy moss covering on Porch and North Aisle. Lighter moss deposits on north side of Nave and Chancel. Also, light wallpepper growth on Chancel and Vestry roofs.

Moss and wall pepper growth especially north side

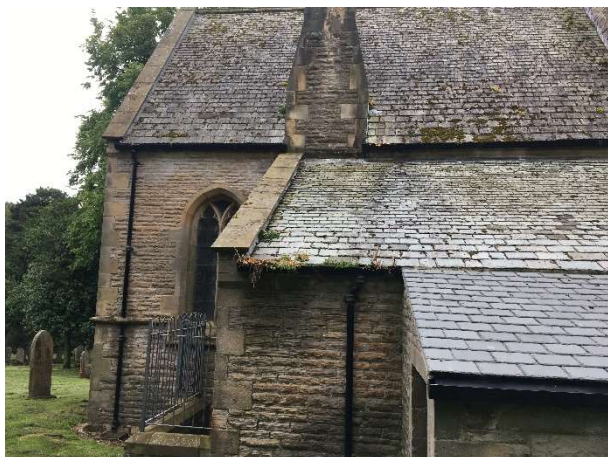
9.2 Rainwater goods and disposal systems

Vegetation build-up in gutters, leaf guards removed to rear.

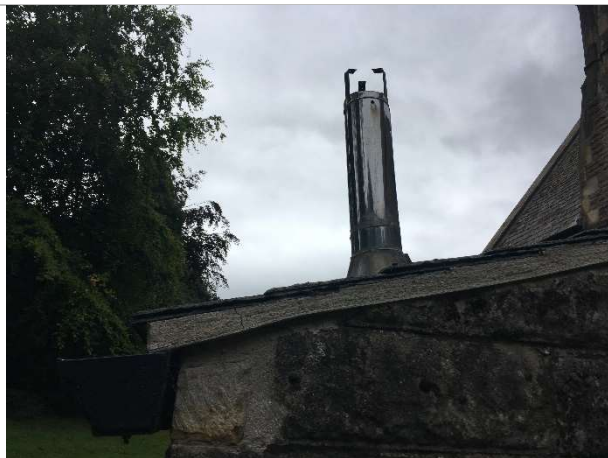
9.3 Bellcotes, parapets, chimneys and verge upstands

5. GRP flag pole and halyard fixed to Porch south gable appears serviceable.
6. The oil flue is missing its terminal allowing water to run into boiler beneath.

Condition: Boiler flue terminal missing.		
Action: Replace terminal if boiler is to be retained.	A(M)	200

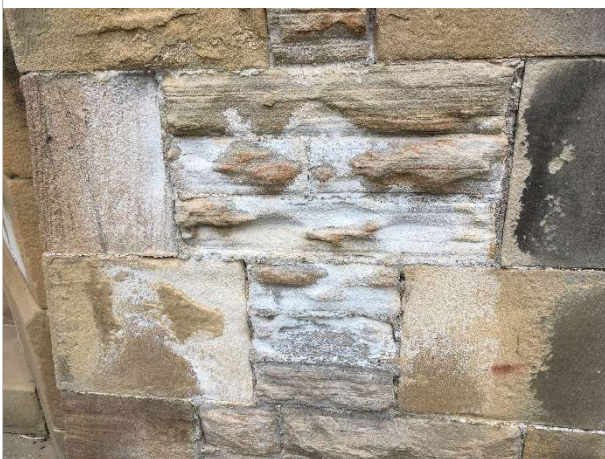
2. Stone is generally in good condition except for some localised erosion of walling on south face of Porch where there is also pronounced efflorescence, north face of Vestry, and some less pronounced erosion on east gable of Chancel, South Aisle and chimney stack.

Condition: Localised erosion of stone.		
Action: Monitor over quinquennial period.	D(M)

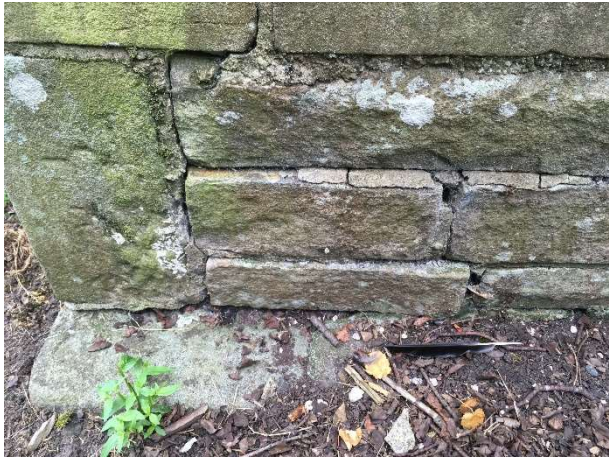
4. 2No. loose stones on low retaining wall to former Boiler Room steps.
5. External cracking as follows:
 1. Vertical cracks adjacent South Aisle east window surround, 1-3mm wide since last repointed in cement.

Condition:
Loose stones to Boiler Room step wall.

Action:
Re-bed in lime mortar.

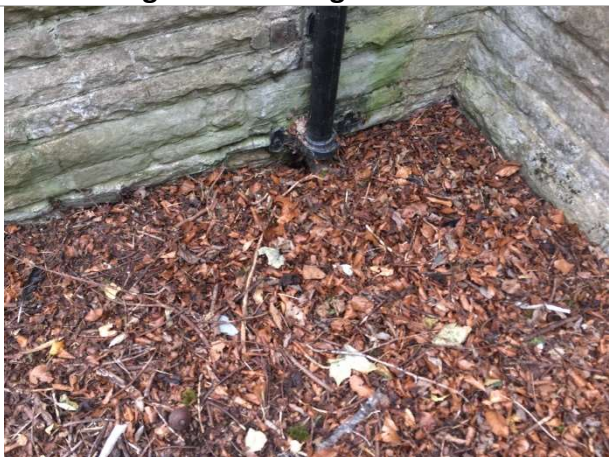
9.7 Below ground drainage

Condition:
Gullies blocked north side

Action:
Remove leaves and debris from all gullies.

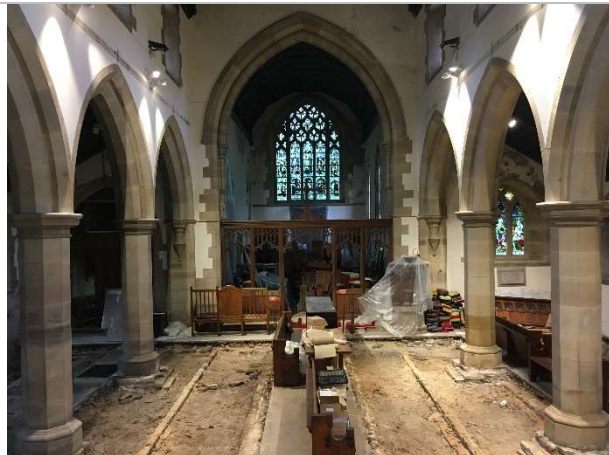
10.7 Ground Floor timber platforms

1. Suspended T&G pine boards below pews removed (2021) after dry rot outbreak. This revealed a mid C20 floor, presumably after original floor had suffered a previous dry rot outbreak. Sleeper walls now covered in efflorescence.
2. North Aisle floor west end replaced with concrete over DPM (2004/5) with sheet vinyl finish in reasonable condition.

Condition: Extensive dry rot outbreak in worship area pew platforms removed 2021 caused by damp and poor ventilation.		
Action: Replace with ventilated beam and block floor.	B	110000

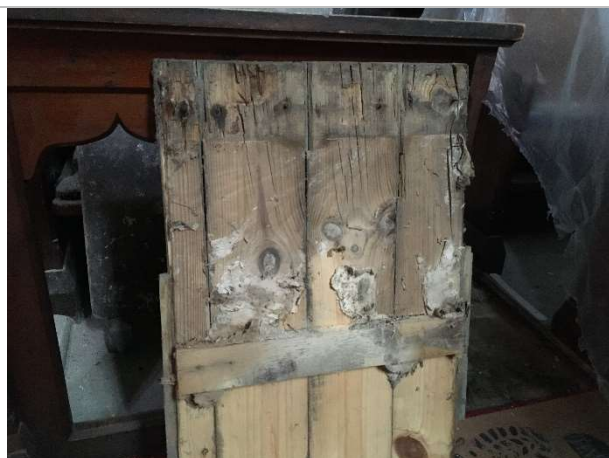
Condition: Dry rot still present in choir stalls.		
Action: Remove infected timber, treat remainder with preservative solution.	A	3000

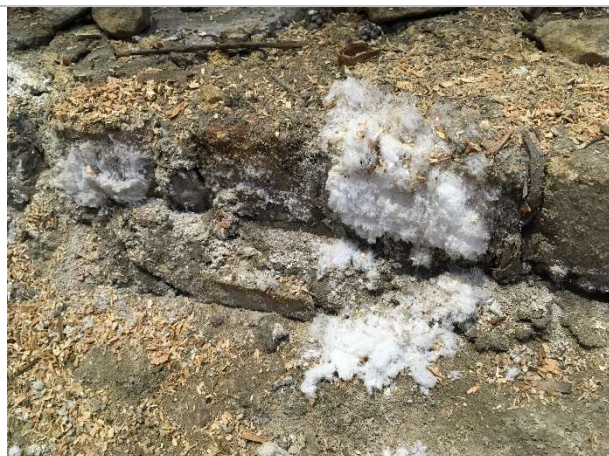
Condition: Damp sub-floor and sleeper walls now drying out and causing efflorescence.		
Action: Avoid solid breathing floor option as this will lead to damp in floors and walls.	C	Inc.

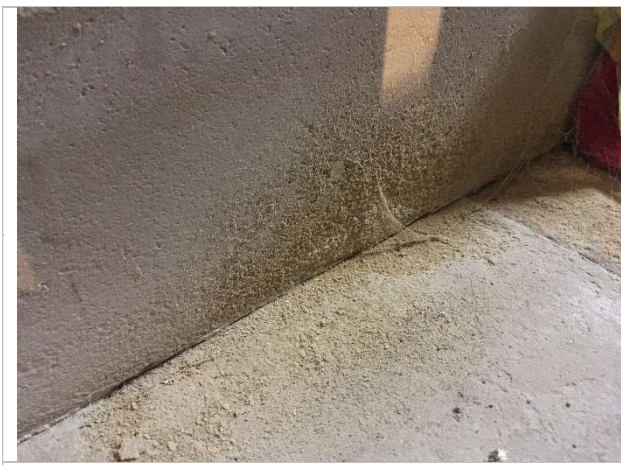
<p>Condition: Damp and stone decay on sanctuary steps.</p>

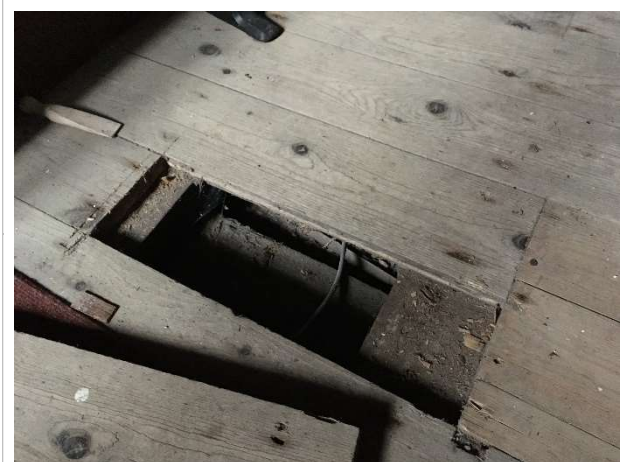
<p>Condition: Damp is causing nails in organ and Vestry floors to rust. Also lack of ventilation in shallow void is at risk of dry rot infestation.</p>	A (M)	Inc.

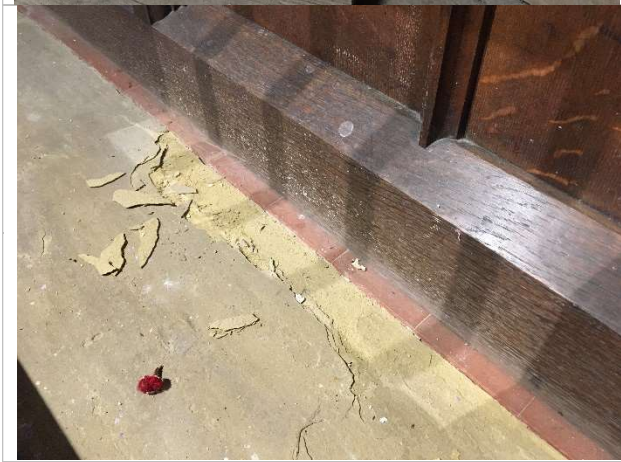
<p>Condition: Chancel steps damp and delaminating.</p>	A	Inc.

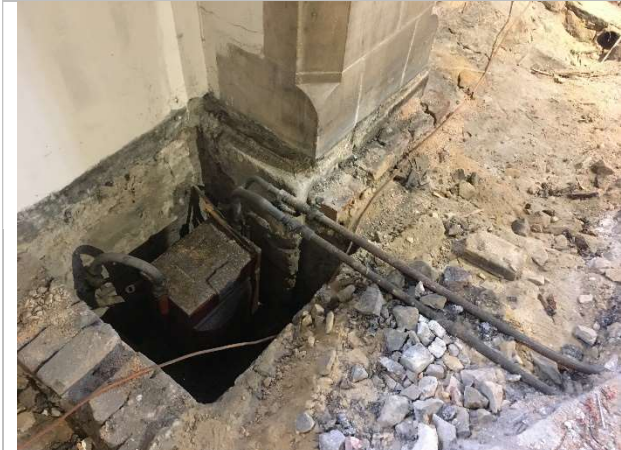
<p>Condition: Former gas boiler beneath South Aisle floor.</p>	A (M)	Inc.
	<p>Action: Remove and infill void.</p>	B	800

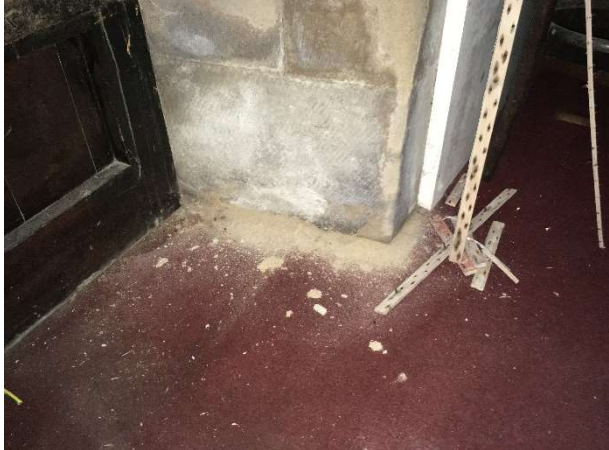
1. Walls are plastered between stone dressings to windows, doors and arcades.
2. Rising damp in Vestry south and north walls has caused serious recent masonry erosion mainly at low level. Damp extends upto 1800mm at east side of north door where soil level is 1200mm higher externally.

<p>Condition: Rising damp and erosion of Vestry walls.</p>

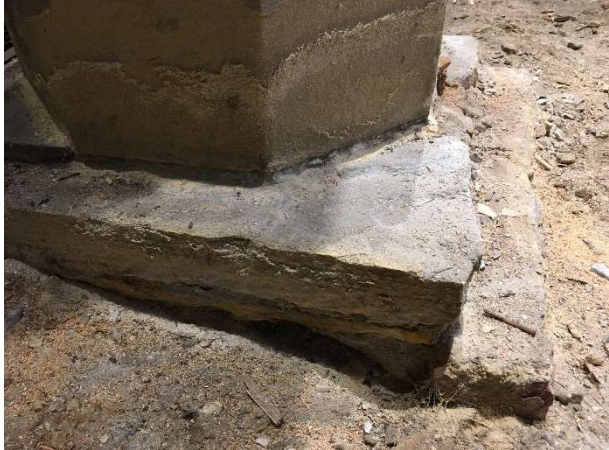
<p>Condition: Rising damp and erosion of arcade plinth blocks.</p>

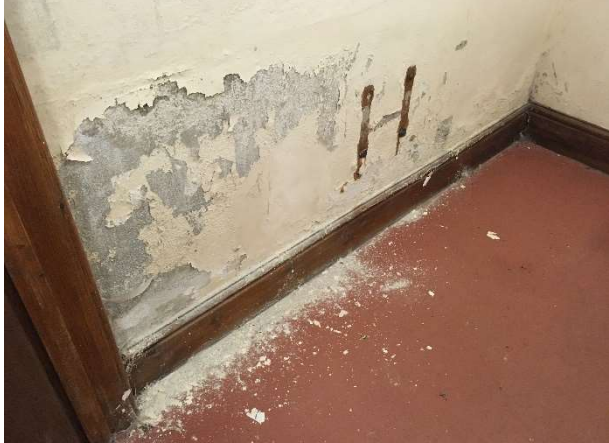
<p>Condition: Rising damp on WC west wall exacerbated by solid floor.</p>		
	<p>Action: Clean gutters/gullies etc., repair window hoppers and ventilate building.</p>	A (M)	Inc.
	<p>Action: Avoid breathing floor option as this will exacerbate erosion.</p>	C	Inc.
	<p>Action: Replace using lime plaster after installation of ventilated beam and block floor.</p>	C	1000

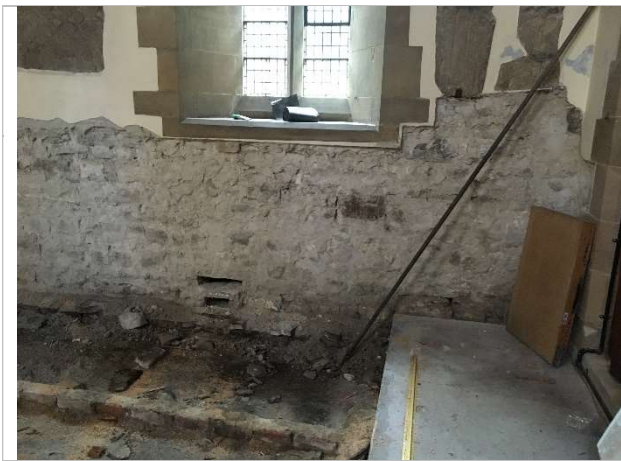
<p>Condition: Water damaged plaster on North Aisle.</p>

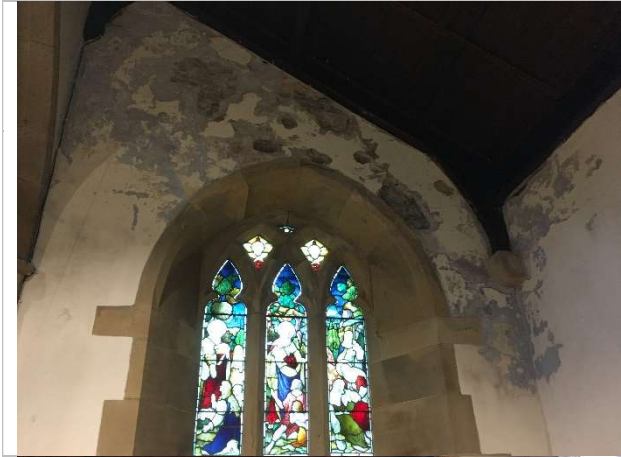
<p>Condition: Plaster damage below leaking coping, now repaired.</p>

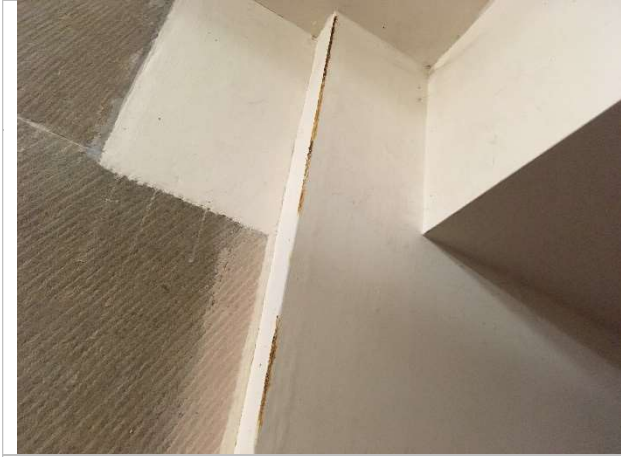
<p>Condition: Plaster damage below leaking coping, now repaired.</p>		
	<p>Action: Re-finish using lime plaster.</p>	C	800
	<p>Condition: Plaster damage below leaking coping, now repaired.</p>		
	<p>Action: Re-finish using lime plaster.</p>	C	1200
	<p>Condition: Plaster beads rusting full height at west door due to damp.</p>		
	<p>Action: Replace using stainless steel</p>	C	400
	<p>Condition: Decoration in poor condition.</p>		
	<p>Action: Re-paint after completion of repairs</p>	C	20000

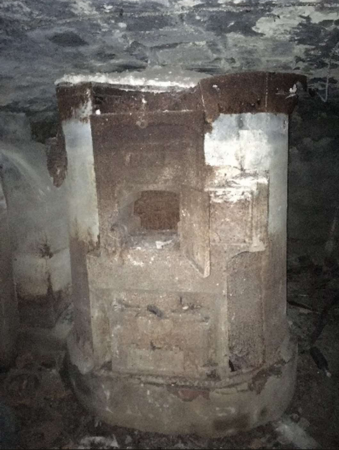
11.10 Asbestos

Condition: Friable asbestos around former boiler.		
	Action: Block off duct from church interior, restrict access and provide signage.	A (M)	500
	Action: Remove asbestos.	E	6000

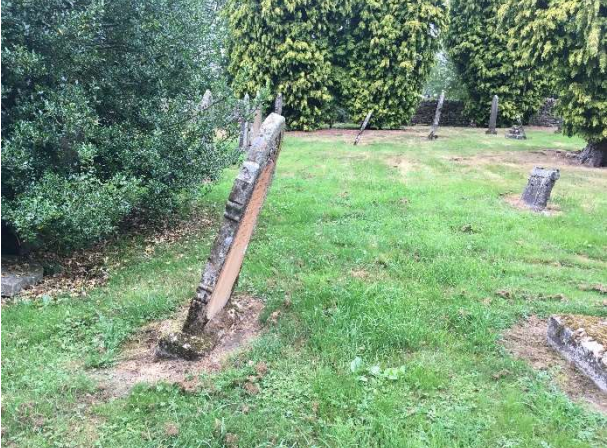
Condition: Leaning headstones.		
	Action: Test for stability, lay flat if necessary.	B	600

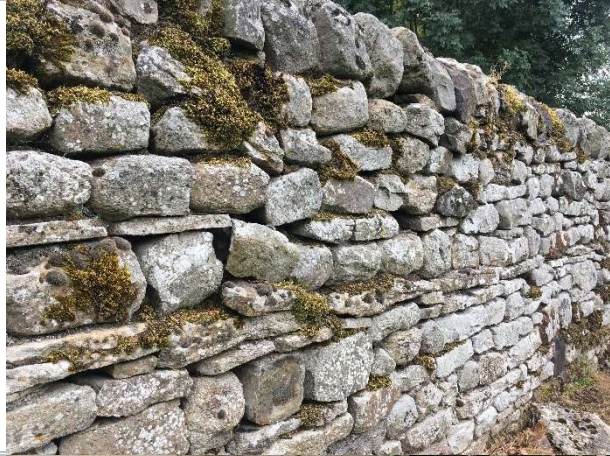
1. West boundary wall to road bulging outwards with ivy growth re-established.
2. Southwest boundary wall is ivy covered to 4m height
3. South boundary wall has loose stones in several places and earth banked up to 1200mm height at east end, otherwise in reasonable condition.
4. Low east boundary wall collapsed below beech and holly hedge
5. Low north boundary wall to former Vicarage is collapsed in places and overgrown with trees. Curved end to belfry is leaning inward and cracked.
6. Stone dividing wall to churchyard extension is moss covered and has several loose and missing stones, otherwise in reasonable condition.
7. Stone west wall to former Vicarage has loose upper stones and copings and moss-covered, otherwise in reasonable condition.

Condition:
Loose stones, cracks, collapsed wall to north, missing copings to east, bulging wall to west, ivy growth.

Action:
Remove ivy, stabilize and repair walls.

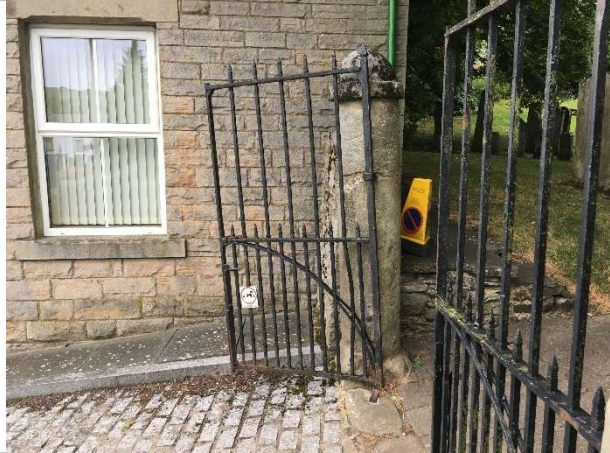
Condition:
Corroding entrance gates with leaning gate piers.

Action:
Prepare and re-paint gates.
