**Quinquennial Inspection Report  
The Church of All Saints', Monkwearmouth  
Parish of Monkwearmouth  
Archdeaconry of Sunderland  
Diocese of Durham**

Report prepared by

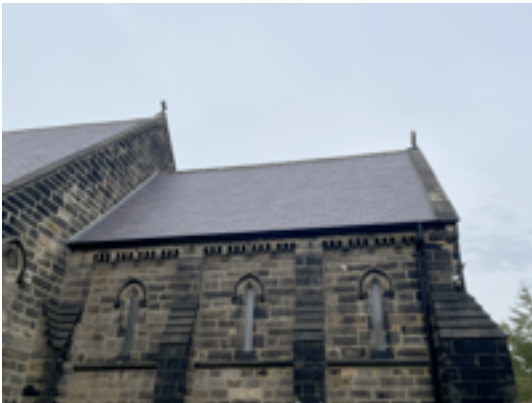
**Chancel and Vestry Roofs**

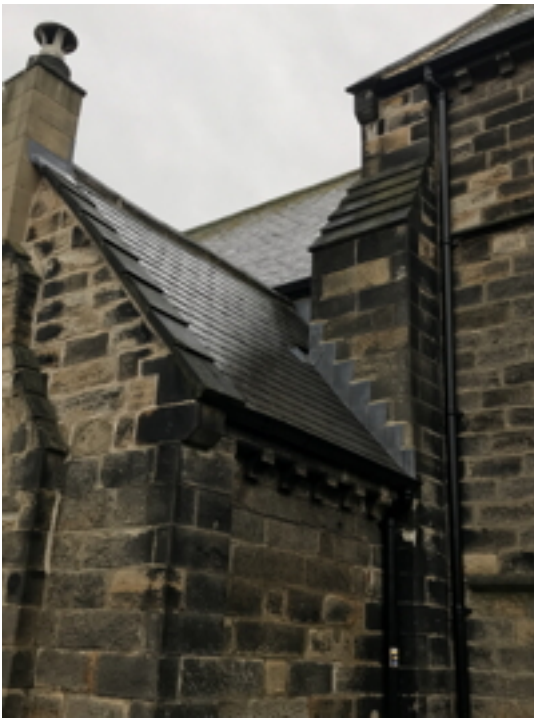
**Vestry and Nave Rainwater Pipes and Gutters**

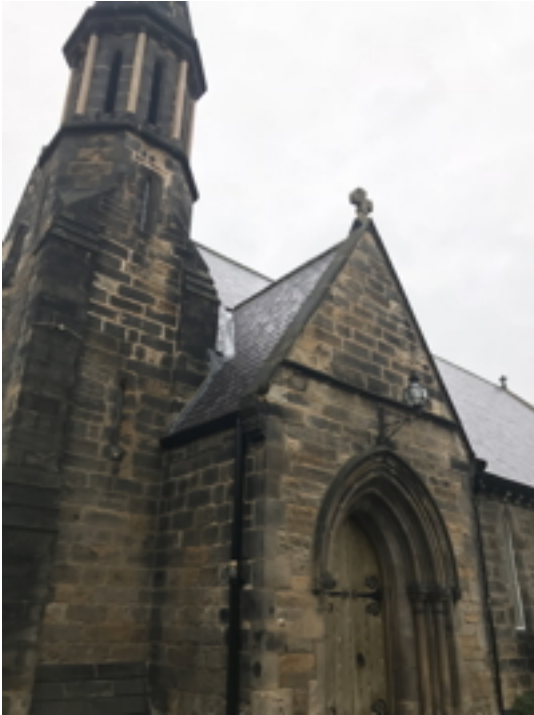
**Vestry Water Tabling**

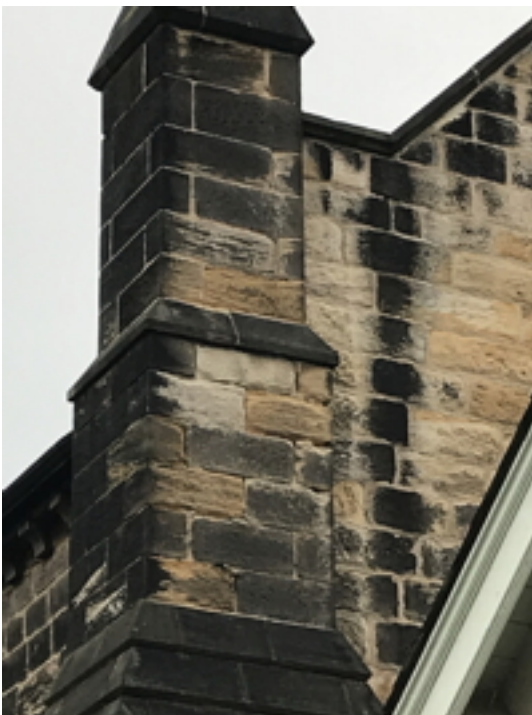
**Open Mortar joints to Nave West Wall, North West Corner**

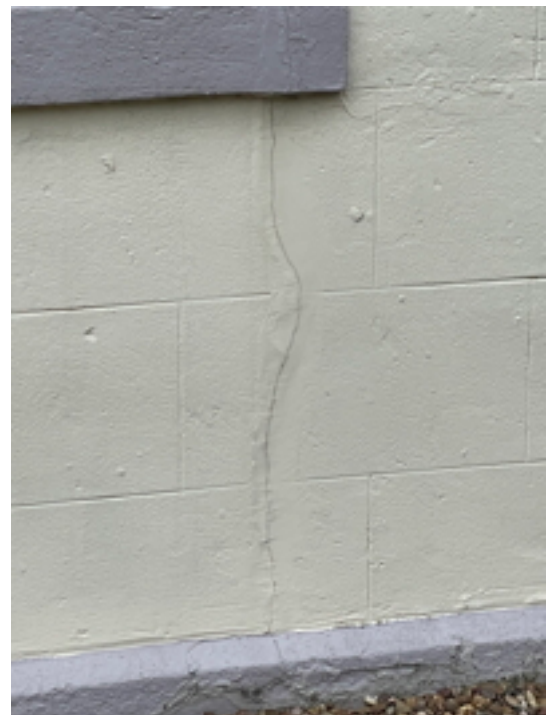
**Cracking below Meeting Room windows west elevation**

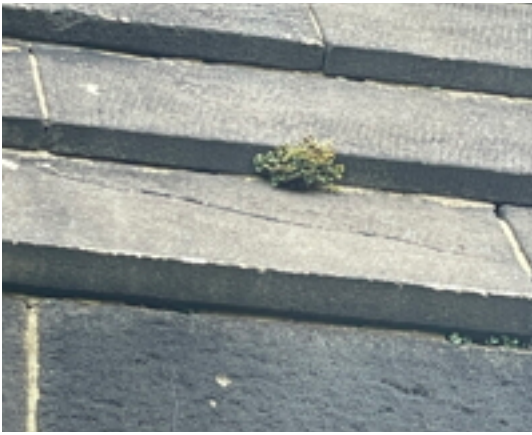
**Plant growing on Chancel south east corner buttress**

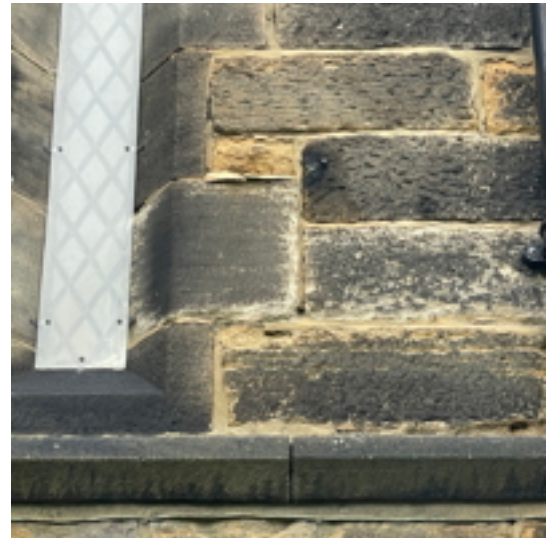
**Loose mortar pointing Chancel south elevation east end**

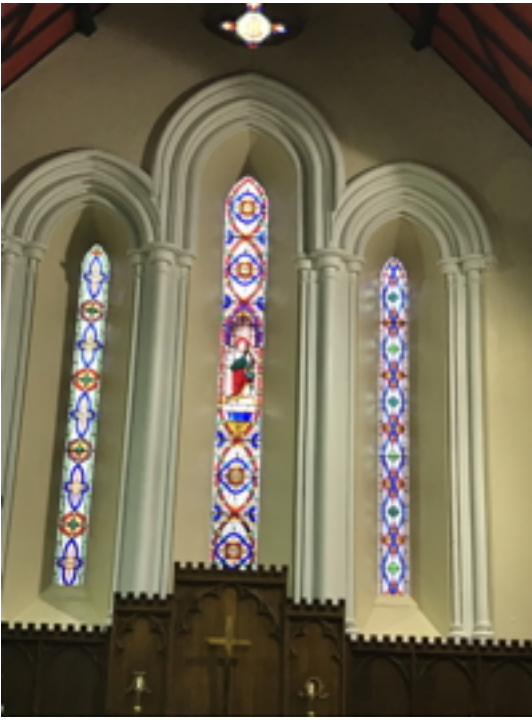
Nave north elevation five pairs of lancet windows, four with clear and colour glass leaded lights and one with stained glass.

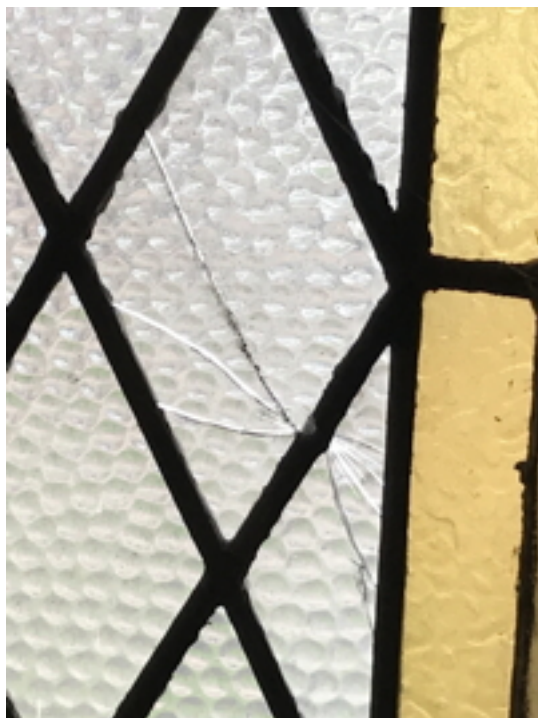
**Cracked glass panes visible from organ loft**

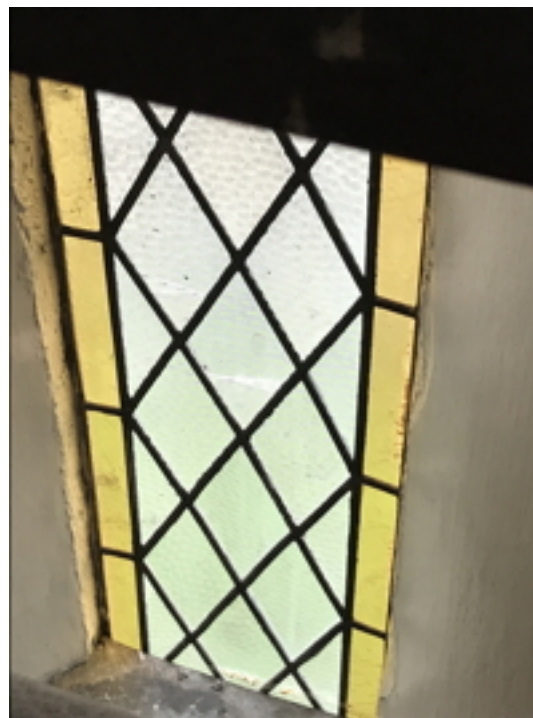
**Cracked glass panes visible from organ loft**

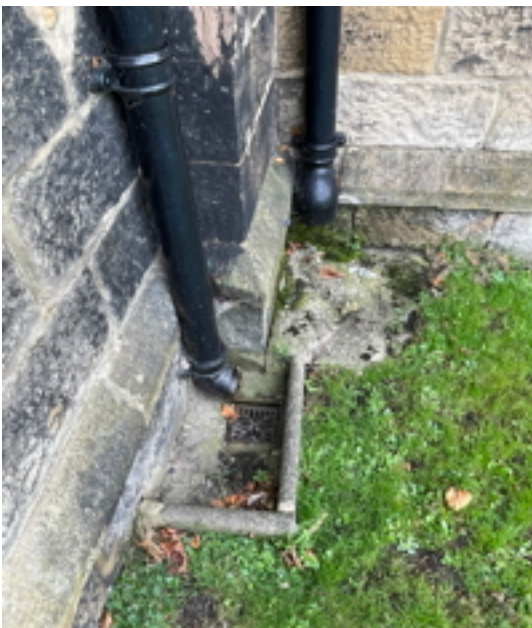
**North Elevation Gully**

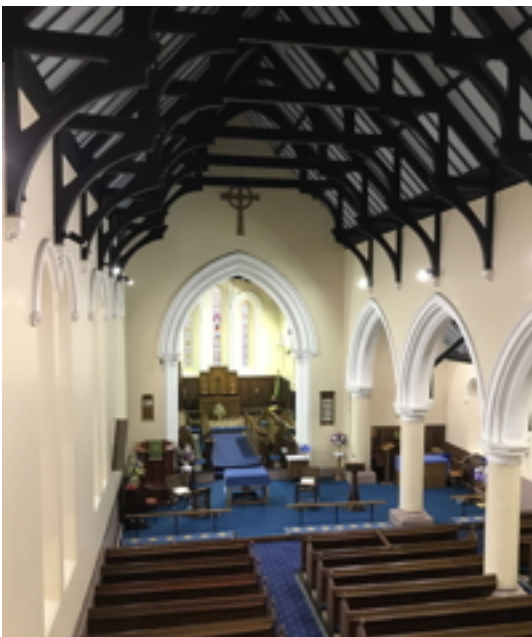
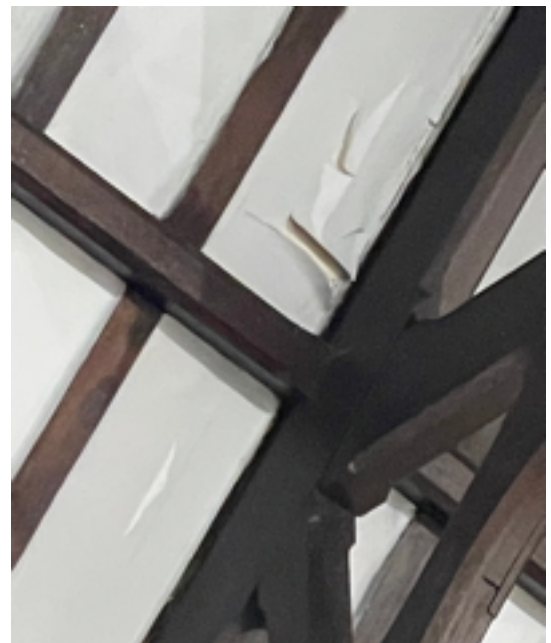
The roof structure is a very complicated cantilever open truss with timber purlins with painted plaster panels between timber rafters, all timber is stained dark brown finish.

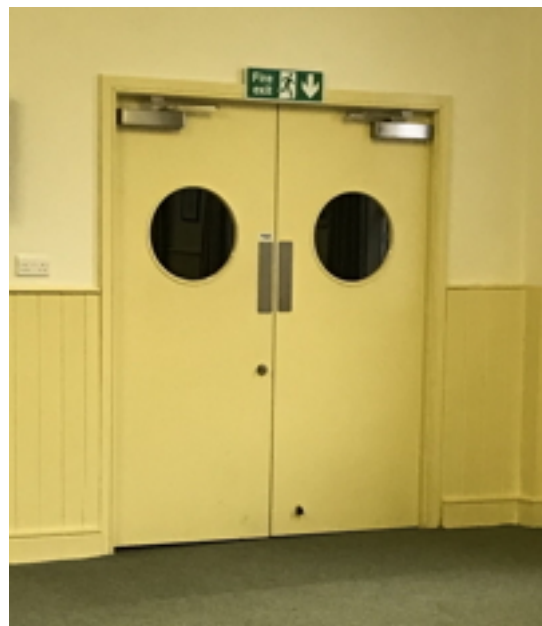
**Meeting Room/Entrance Lobby  
Doors**

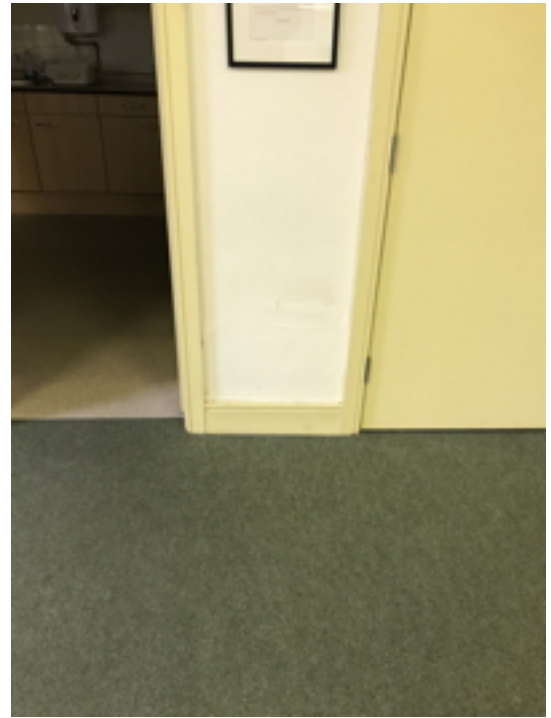
**Hall carpeting and sheet vinyl flooring**

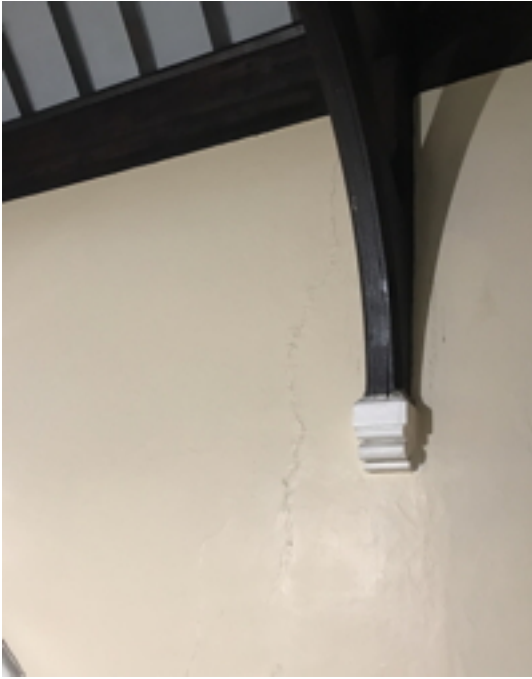
**Crack to South Wall**

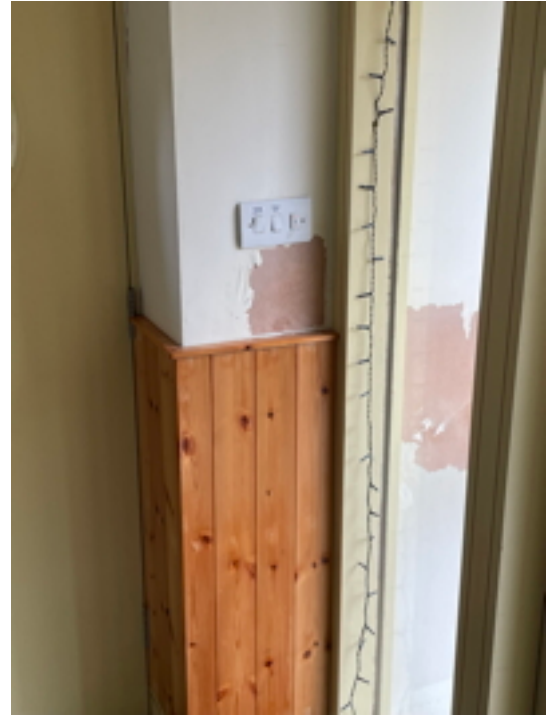
**Peeling paint at Meeting Room entrance doors**

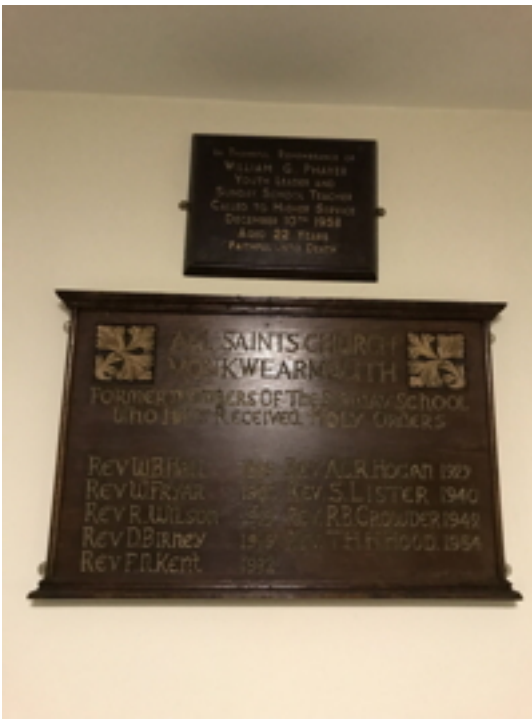
**Memorial to William Phayer, Youth Leader**

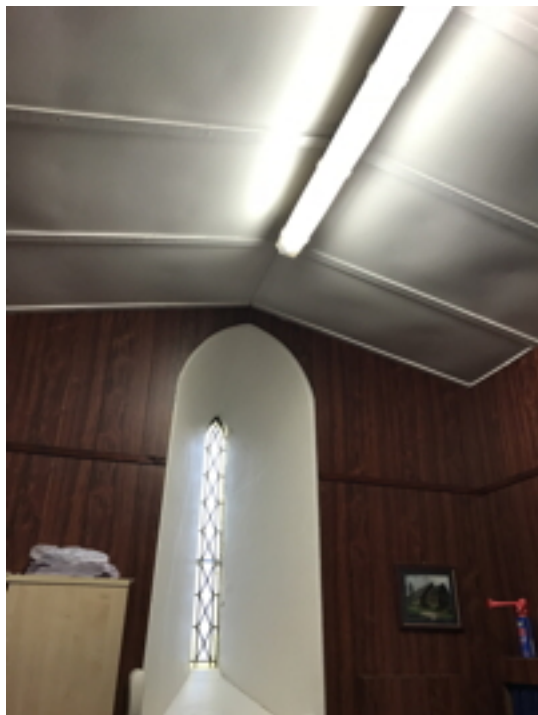
The Vestry has a carpeted floor. The walls have boarding in cherry veneered finish. The ceiling follows the slope of the roof and is panelled and strapped.

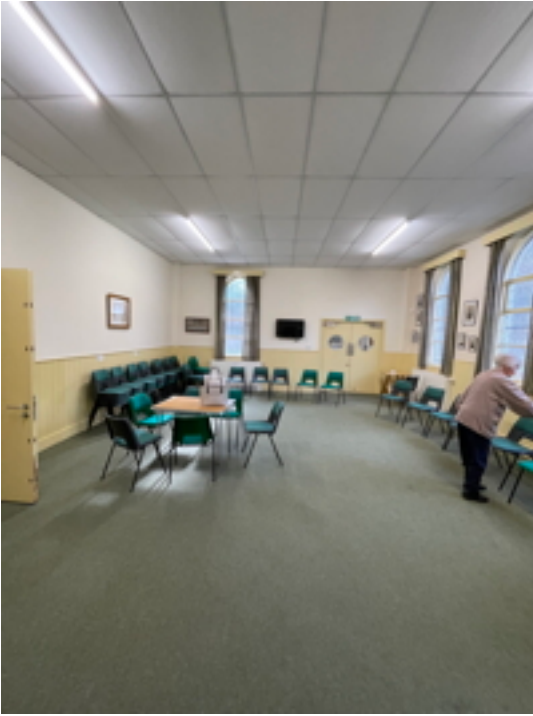
**Meeting Room looking towards Entrance**

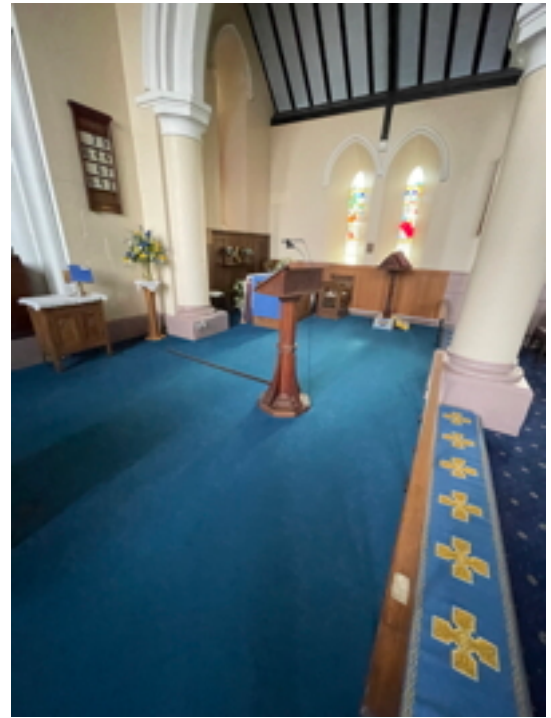
**Lectern and assorted Nave Altar  
Area Furniture**

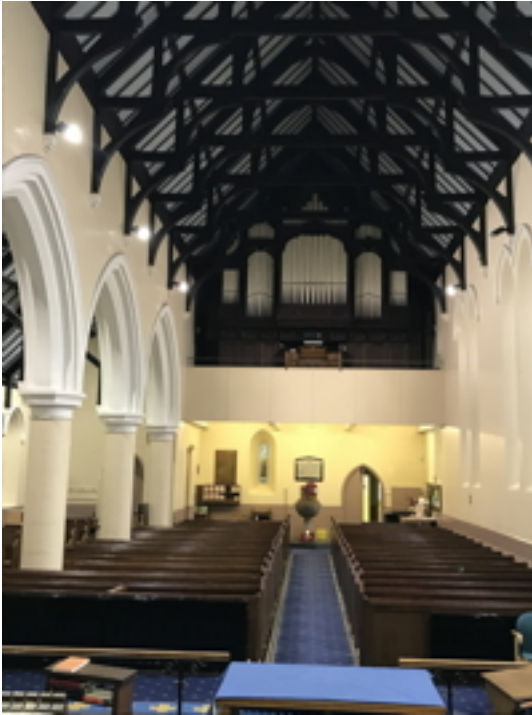
It was bought for £650 and transferred to west gallery replacing 1886 Vincent organ divided either side of Choir, which itself replaced an earlier organ of 1854. It was last reported as tuned on 5 February 2023 by Steven Middleton Organist/Organ Builder. Further details at <http://www.npor.org.uk/NPORView.html?RI=N15166>

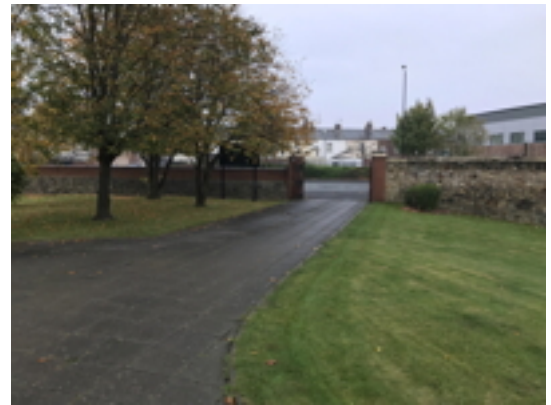
**South East Corner Entrance Gates**

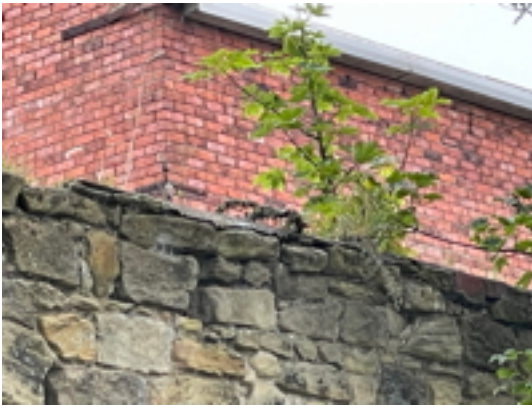
**Sycamore seedling to west boundary wall coping**

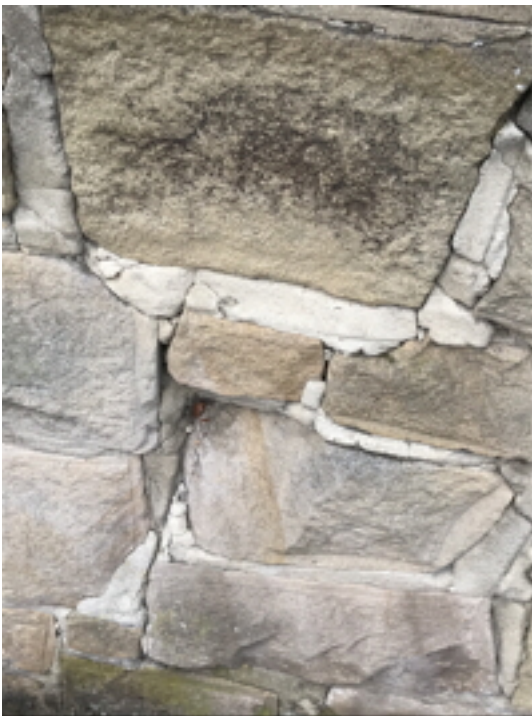
**Loose Pointing to East Wall Stonework**

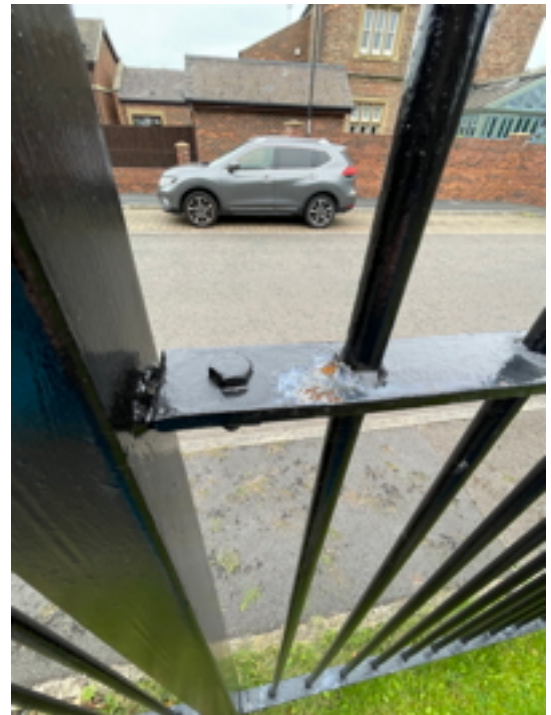
**Rust to North Boundary Railings**

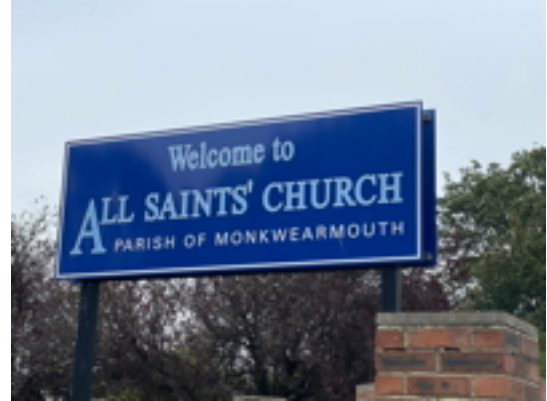
**North East Corner Noticeboard**

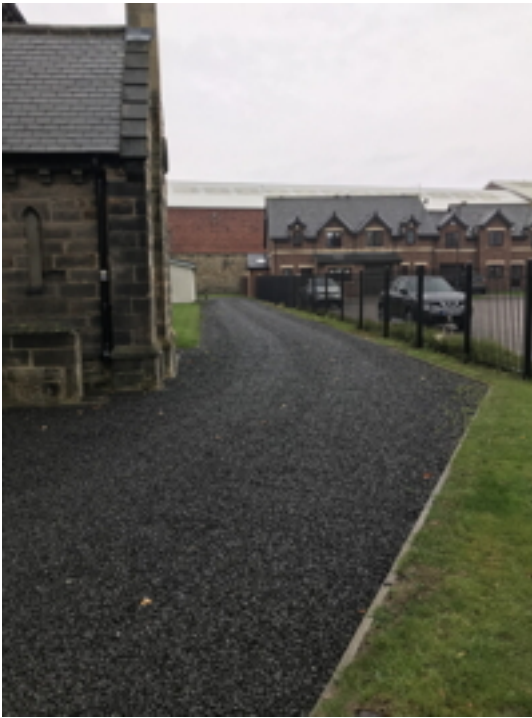
**Gravel Driveway to North Elevation**

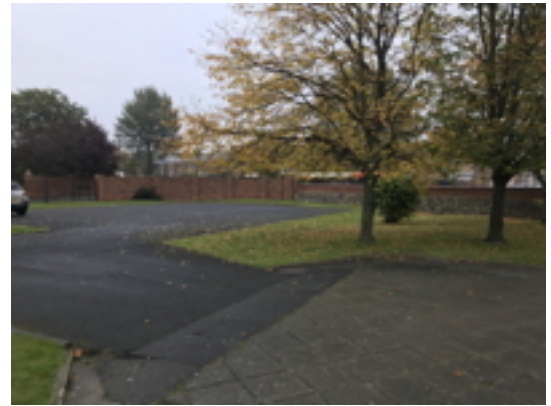
**Tarmacked Parking Area to North East Corner**

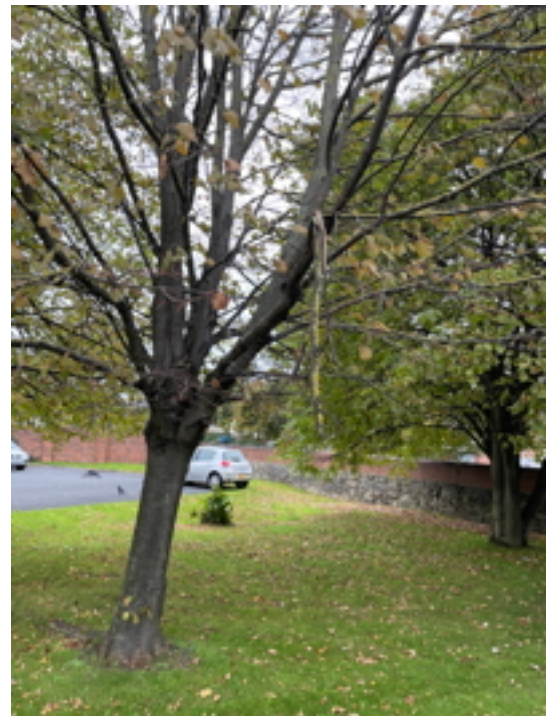
**Lime tree with hanging branch**

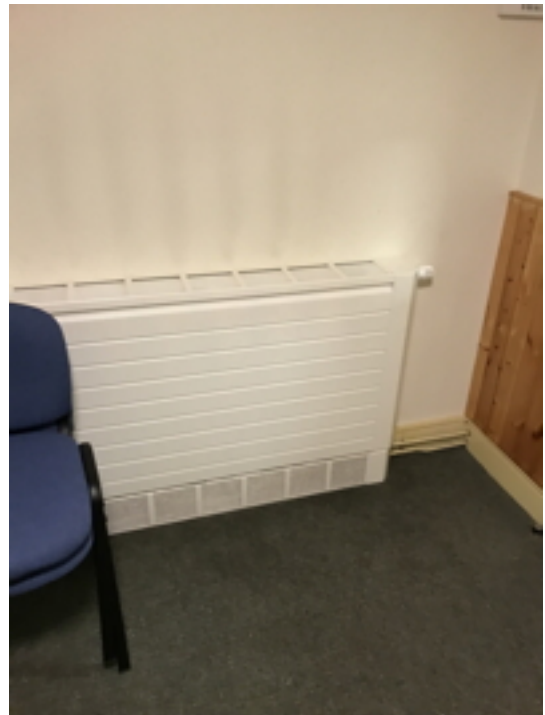
**Typical Hall Radiator**

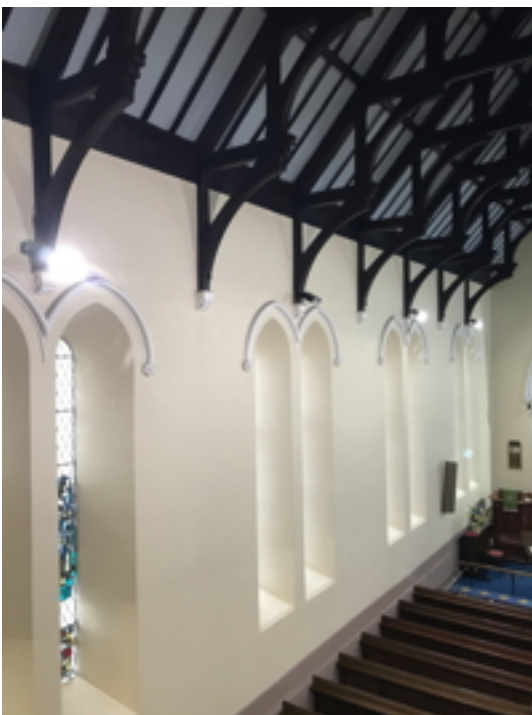
Fluorescent lights to the Vestry and Hall. Security lights externally to Church and Hall replaced October 2021 and May 2022.

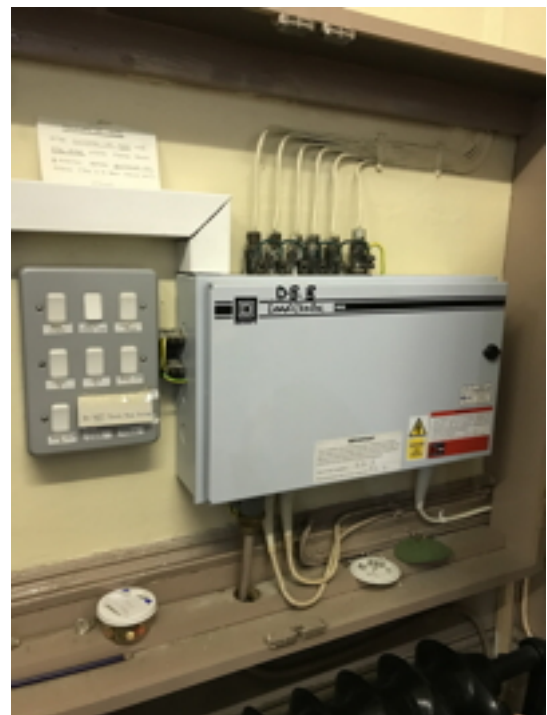
**West End Distribution Board**

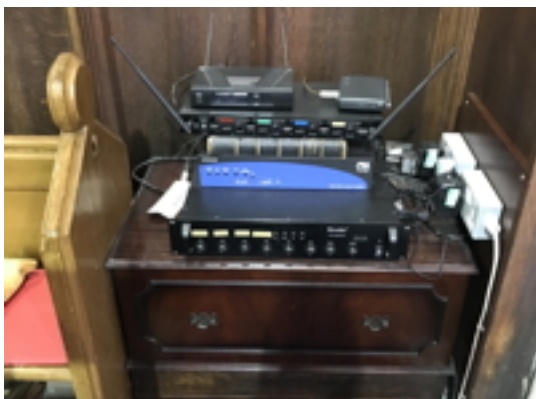
#### **Sound System**
