Church of St. Andrew,  
Roker  
2037

The Care of Churches Measure 1991  
QUINQUENNIAL REPORT  
February 2021  
(Delayed from 2020 by Covid19)

Church of St. Andrew, Roker  
Archdeaconry of Sunderland

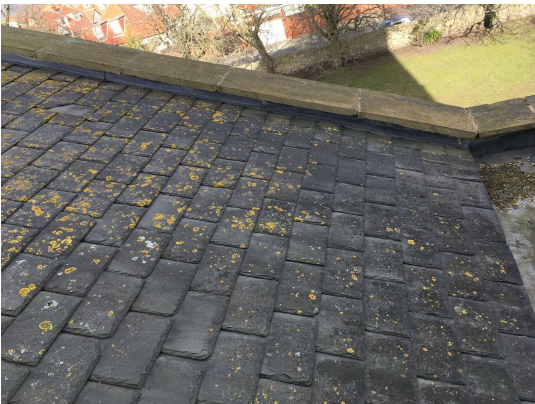
4. North Transept roof over organ chamber has blue slates at approximately 20° pitch with lead valley gutters to Nave, and walk-in lead gutters to east and west. Repaired c2000; intact and in good condition following recent repair below Tower RWP except for 1No. broken slate (Photo 3).

Photo 3  
Broken slate on North Transept.

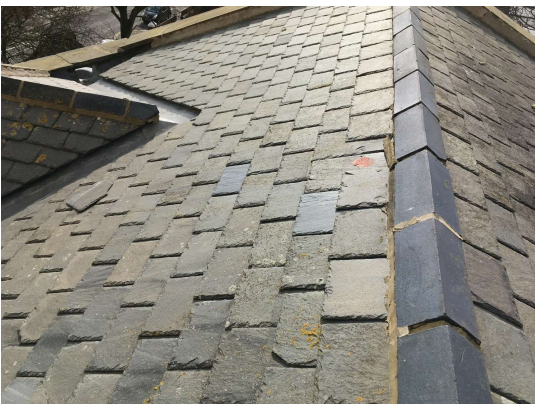
5. South Transept roof over Lady Chapel is similar to North Transept except for splays at south end of walk-in lead gutters; all intact and in good condition except for missing slate below ridge (Photo 4).

Photo 4  
Broken upper slate on South  
Transept.

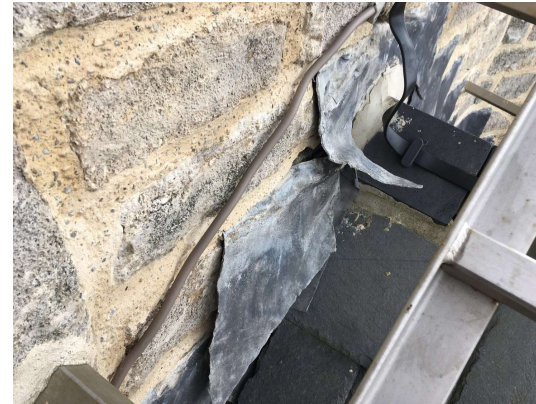
Photo 5  
Loose flashings at Tower abutment.

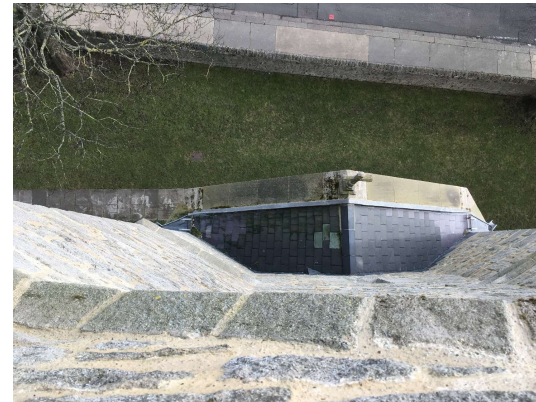
6. East end of Chancel has small blue slated roof at approximate 40° pitch. Sumps each side were slated over in 1990s so that water ran down the wall face causing damp ingress on painted wall and ceiling mural below. New lead slates installed above new lead spitters with stainless steel grilles to catch pigeon droppings. Dampness and algae north side indicates a potential blockage (2018). Grille north side partially blocked by debris (Photo 6).

Photo 6  
Missing slate and debris build-up  
north side of Chancel.

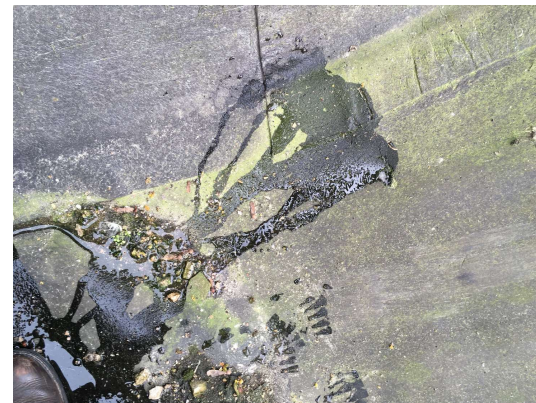
Photo 7  
Holed nave gutters contain water  
between layers.

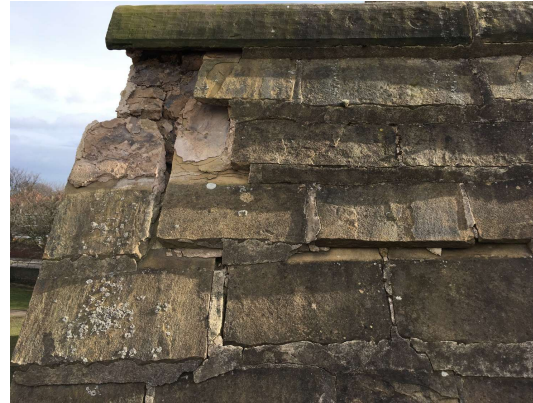
1. Nave has 900mm high parapets to north and south which run between 5No. perpendicular stone pinnacle buttresses, and is finished with a rough-hewn round-topped block coping bedded in mortar over a flat drip course. These are of a poor quality stone which is delaminating in several locations. They also have minimal projection and provide little protection to the walls below, where there is widespread vegetation growth in the joints and extensive frost damage to recently applied lime mortar. The south stone pinnacles were repointed and slates re-fixed (2012) using stainless steel masonry screw and washers, and appear in reasonable condition. The north stone pinnacles are in a poor condition, many slates have slipped and are liable to drop onto the slate roof, gutters or ground below (Photos 10 - 12).

Photo 11  
North buttress slipped and missing slates.

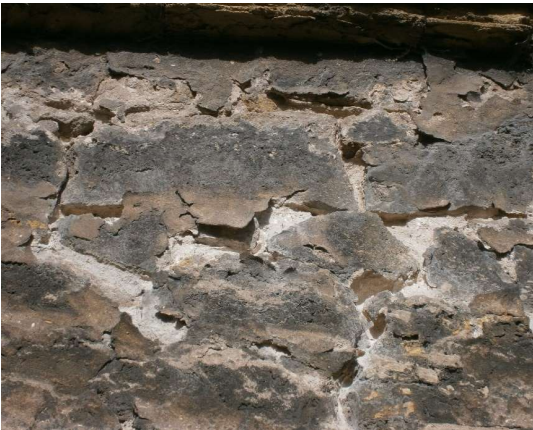
Photo 9  
Eroded lime mortar behind cement pointing below cills on Nave.

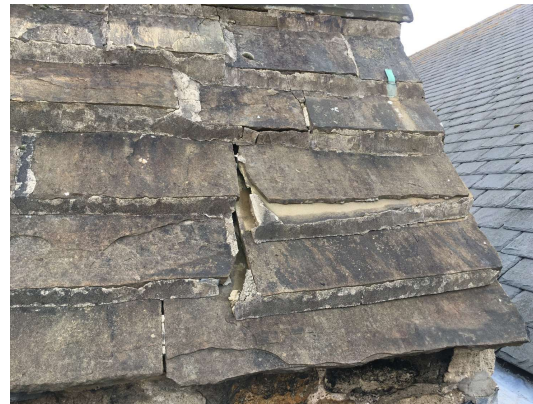
Photo 12  
North buttress slipped slates.

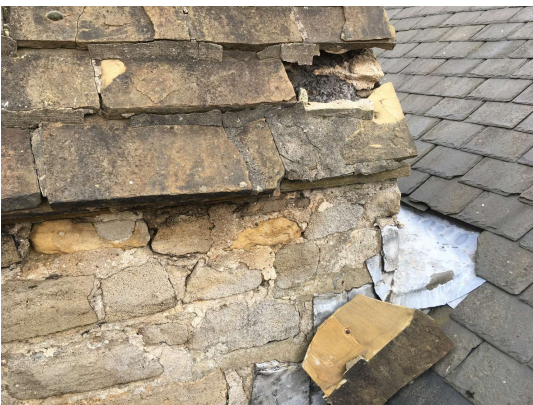
Photo 10  
Slipped slate north buttress.

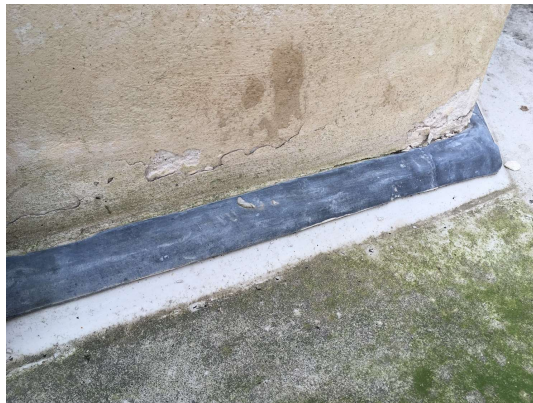
4. 4No. stone corner turrets to the Tower were originally slate covered. These deteriorated since roofs were removed in early C20 and have recently been re-covered in concrete and asphalt, and lime-rendered on inside elevations (2018). In excellent condition except for frost damage to lime mortar immediately above the recently installed lead trays (Photo 13).

Photo 13  
Frost damage to lime render above lead tray on stair abutment.

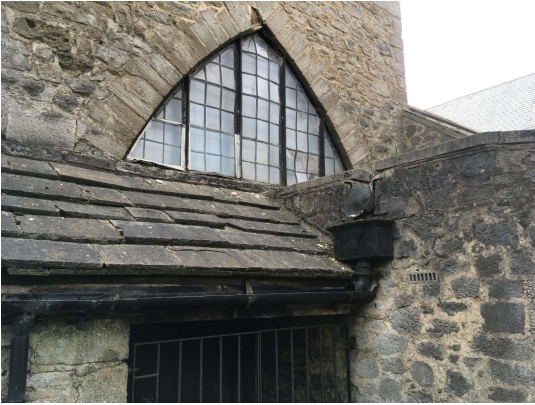
9. Small triangular window over southwest porch re-glazed using slab glass in stainless steel frame by Barley Studios (2000); in good condition.
10. Small triangular window over north porch is in a poor condition with corroded angle iron frame supporting 5No. bowed leaded lights with many cracked and loose panes (Photo 14).

Photo 14  
North Porch window with bowed and broken panes, and corroded steel frames which are damaging masonry.

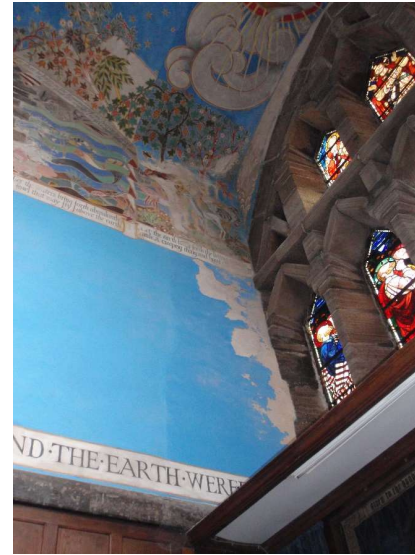
1. Chancel has curved plaster ceiling with tempera mural executed by Macdonald Gill in 1927 to the design of Prior. Refurbished c1995, it is now watermarked and deteriorating owing to longstanding defective rainwater disposal, particularly on the northeast corner (Photo 17).

Photo 17  
Water damage to mural in Chancel.

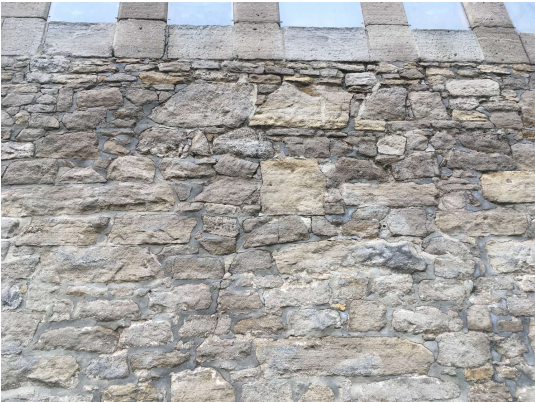
2. Walls were built in lime mortar though many have subsequently been repointed using cement mortar (Photo 15 ). This has been detrimental as it has sealed moisture into the walls and reduced evaporation from the mortar joints. Several repointed areas are now affected by efflorescence. Remaining lime mortar is eroded in many locations, especially on the south and west, and this is allowing water ingress which has dissolved lime within the core of the walls (Photo 9). This erosion is more extensive than at the previous inspection, especially after the damage during the February 2021 frosts.

Photo 15  
Cement patch pointing on South Transept.

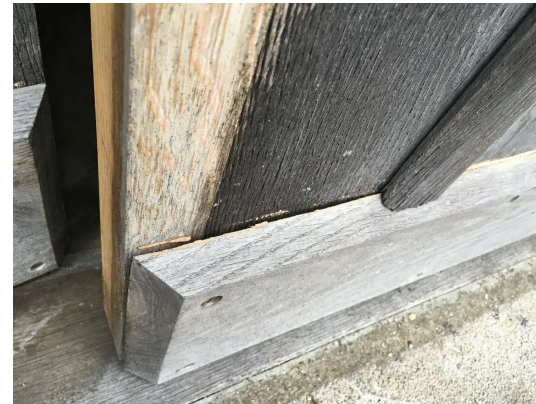
1. Heavy pegged oak plank doors in large oak rectangular frames in pairs to north porch (XD1), southeast porch (XD16), and as double pairs to the main southwest porch (XD17 & XD18). Similar single door on west side of Vestry (XD9). All are weathered in finish, particularly those which have no canopy projection. Southeast porch doors repaired (2019). Reasonable condition except weathermould requires tightening after shrinkage (Photo 18).

Photo 18  
Shrinkage on rear of repaired weathermould southeast Porch.

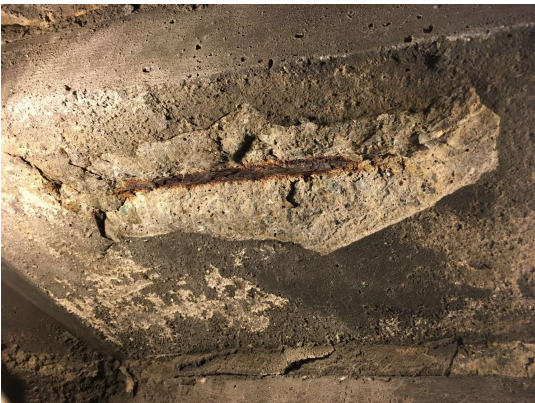
1. Newel stair with individually pre-cast reinforced concrete treads. Upper surfaces in good condition, lower surfaces spalling at high level owing to water ingress through embedded edge, and rusting of steel reinforcement (Photo 16). These no longer appear wet following Tower repair (2018) and sections may now be shrinking as they dry out. Curved wall faces are a combination of stone and red brick in reasonable condition but many bricks have deteriorated on faces owing to previous water ingress. Redundant black electric cable runs full length around newel.

Photo 16  
Eroding stair soffit with corroding reinforcement.

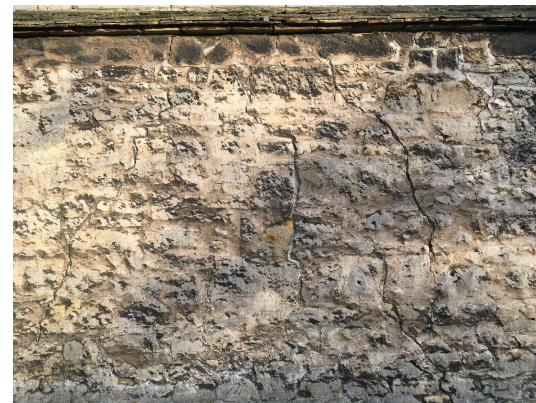
Photo 19  
Cracking below west window.

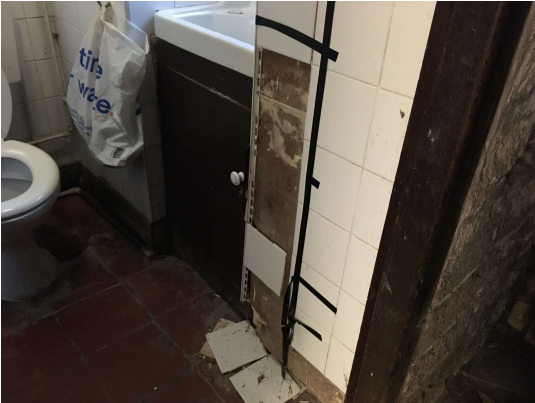
Photo 20  
Loose tiles in Vestry WC.

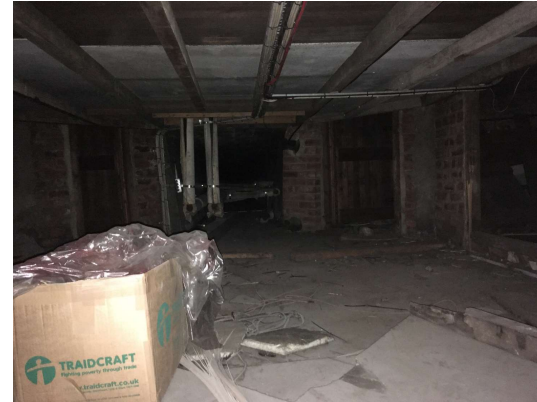
10. Undercroft below Chancel has several store and service rooms used previously in conjunction with the original hypocaust heating system, now redundant. White painted concrete ceiling has crack over passage otherwise in reasonable condition. Asbestos ceiling panels also visible.

Photo 23  
Asbestos cement panels on soffit  
and possible asbestos insulation to  
pipework of undercroft.

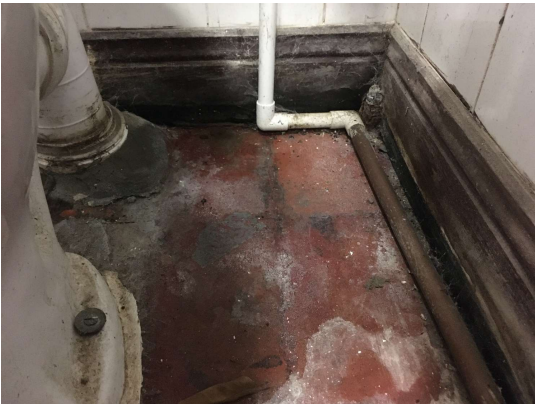
Photo 21  
Leak in Vestry WC.

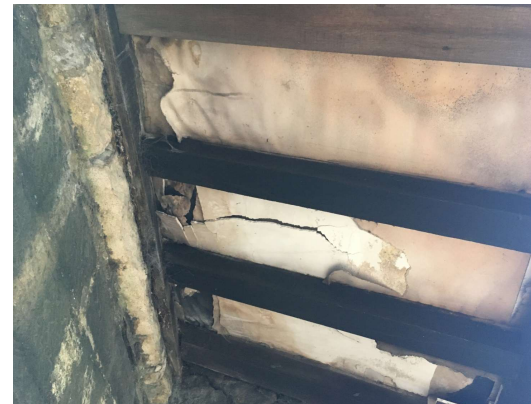
Photo 24  
Loose mortar above southwest  
Porch.

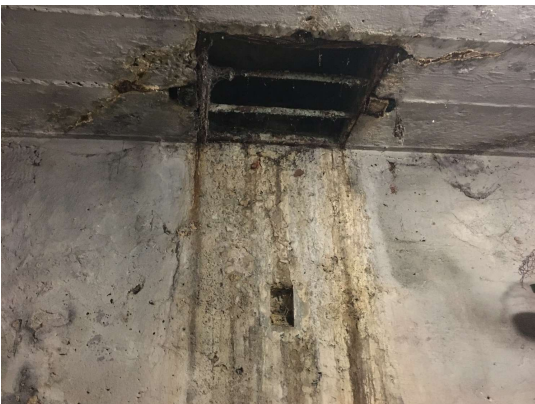
Photo 22  
Water staining below ventilator north  
side of undercroft.

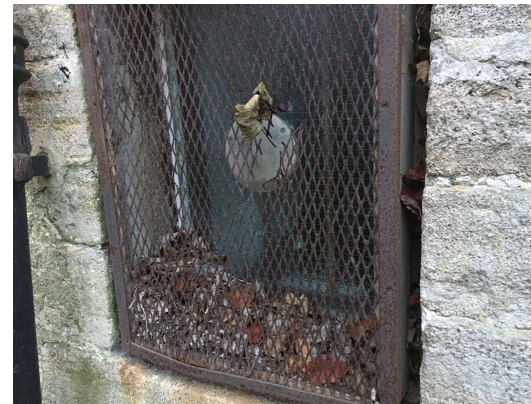
16. Store window W8 has recently lost its boarding over externally (Photo 26)
17. WC window W9 is protected externally by a corroding steel grille (Photo 25).

Photo 25  
Corroded grille to vestry WC  
window.

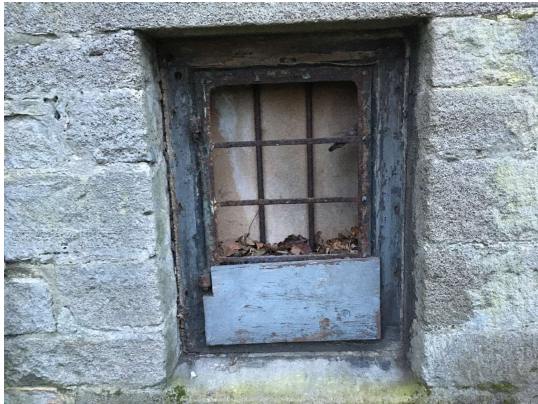
Photo 26  
Dilapidated (blocked) window (W8)  
to rear of safe cupboard.
