# Holy Trinity

## Durham

### Quinquennial Report

**30<sup>th</sup> September 2020**

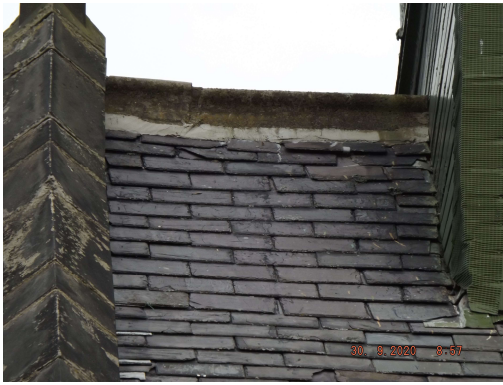
- 5.2. Chancel slates are in good condition.
- 5.3. One slate has slipped to the north nave but generally in good condition.
- 5.4. Fairly extensive repairs to the south nave remain in good condition. Some slight displacement at west gable ridge.

Remove vegetation from external gutters	6.1
Clean out rain water gullies and channels	6.3
Replace slipped slate to north elevation	5.3

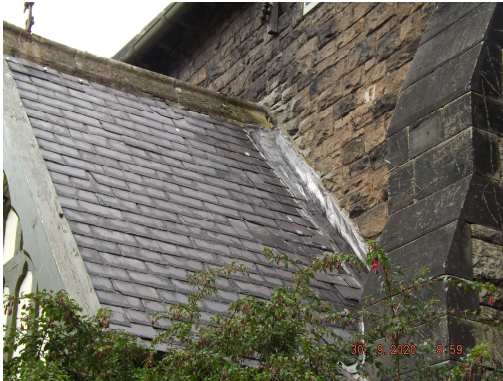
5.7. Porch slates are in fair condition but some patching against the nave wall. Flashings have been painted possibly to disguise the lead but may be Flashband.

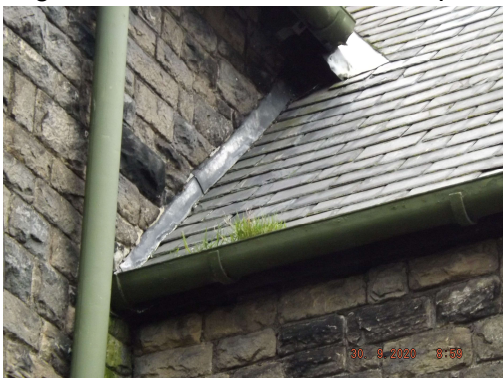
6.1. Gutters are generally deep flow cast iron supported on iron brackets fixed to the top of sarking boards. The gutters appear to be in generally good condition but vegetation should be removed to prevent over-flowing.

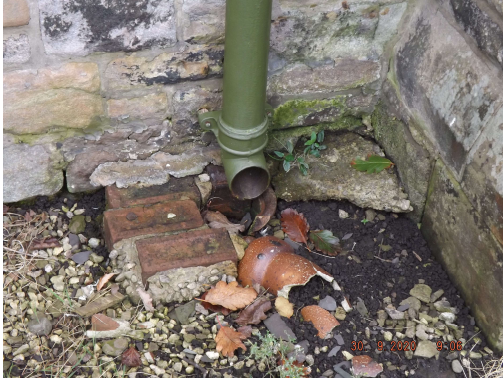
- 6.2. Rain water pipes are round cast iron supported by iron brackets off external walls. Paint finish is in fairly good condition but some redecoration is required. Rainwater shoes should be cleaned out.
- 6.3. Drainage appears to be via soakaways. North side of nave rainwater discharges to gullies and salt glazed earthenware channels but these are in poor condition and may lead to erosion of ground and undermining of foundations. There was no evidence of moisture ingress internally in this area.

Redecorate porch gable timbers	10.2
Paint security gates to main entrance	10.2
Replace hinge to south entrance gates	27.9
Replace steel gate posts to north entrance	27.10
Replace lifting sections of laminate flooring	18.3
Seal gap between chancery arch and altar ceiling	13.3
Redecorate external rainwater goods	6.2
Repoint and reset slabs at edge of entrance ramp	25.1

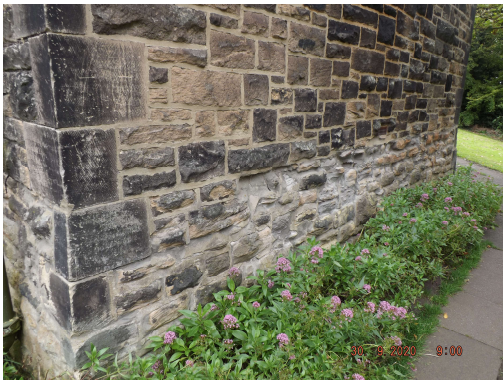
- 7.1. External walls are generally of snecked rock faced sandstone with ashlar copings to gables. Stonework is in good condition. Lower stonework to the south and east below floor level is of rough sandstone, uncoursed and is suffering from some erosion to the face of stones and joints. Repointing has been carried out using a cement based mortar which potentially accelerates the erosion. Replacement of pointing should be carried out using a lime based mortar to match the original. A dressed plinth cap is provided to the later chancel only.

Repoint open joints to window cills	9
Replace failed laminate panels to lobby doors	14.4
Clean or replace polycarbonate and clean dirty glass	17.8
Rake out cement mortar pointing to stonework and replace with lime based mortar	7.1

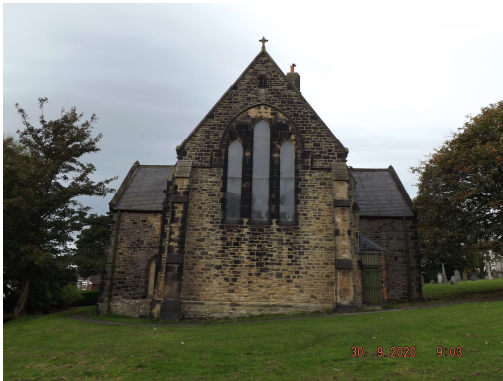
- 9.1. The east window comprises stepped triple lancets in plate tracery with hood mould. Condition is good but minor repointing is required to open joints and slight decay at cills.

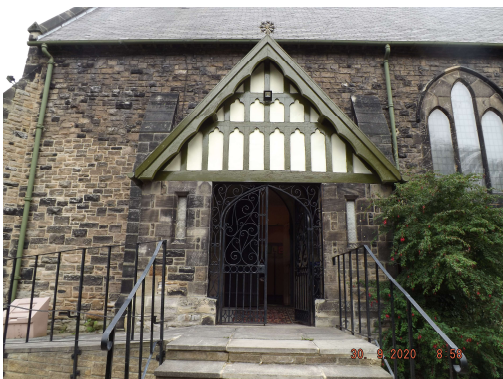
- 10.1. Shiplap cladding to the bell tower is in reasonably good condition following repairs and decoration in 2017.  
10.2. Timber framing to the porch gable is in only moderate condition and requires redecoration.

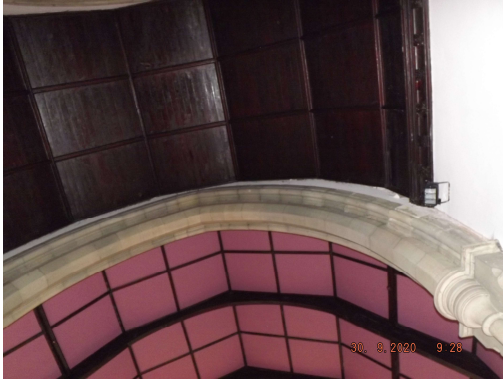
- 13.1. The chancel arch is a double chamfered pointed arch in good condition. Transept arches similar and extended to floor level. Erosion of stone noted at north floor level.
- 13.2. The north arcade is formed with four pointed, double chamfered arches with octagonal piers. All appear to be in good condition. No further movement was detected at the western pier where a cracked stone was noted at low level.
- 13.3. Debris was noted to be falling on the altar floor from the gap between the chancel arch and the plastered ceiling. The gap should be sealed with a flexible sealant.

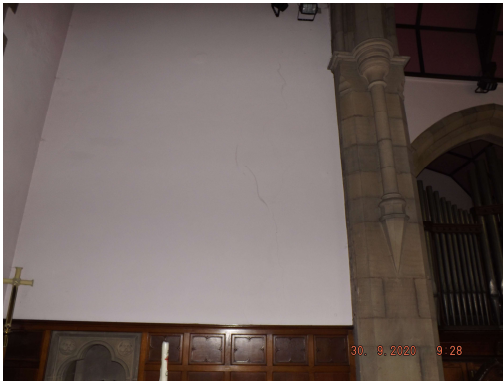
- 15.1. Plasterwork generally is in good condition. Some minor vertical cracking to the south side of the chancel but not serious.

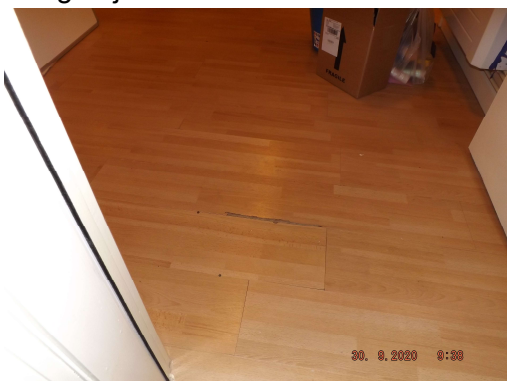
- 18.1. Carpet floor finishes are provided throughout the nave, chancel and transepts preventing an inspection of the floor below. Three step altar platform is solid, two step nave platform is suspended timber.
- 18.2. Fitted carpet is continued over the nave walkway with cord carpet to the seating area.
- 18.3. Timber laminate flooring to the western ground floor is generally good but lifting adjacent to the accessible wc door.

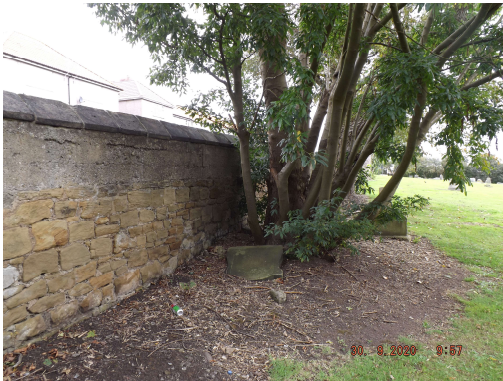
- 27.3. Trees at boundary and adjacent to church. Tree preservation order 1984.
- 27.4. Some trees close to north and west boundary wall are affecting the stability of the wall and should be pruned back.

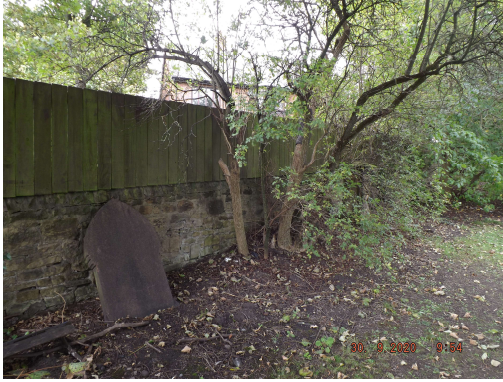
- 27.5. Wooden paling fence to north east churchyard extension, some temporary bracing off trees.
- 27.6. Stone wall to north boundary with brick top and copings. Failed render outside and affected by trees. Leaning particularly adjacent to gates.
- 27.7. Stone wall to west in moderate condition, some cracking and repointing required.

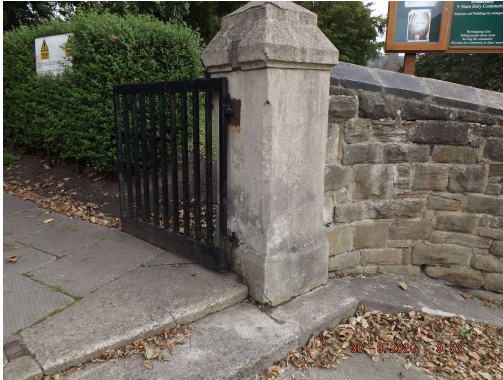
- 27.8. Retaining wall to south in reasonable condition but some vegetation growth and repointing required. Stone gate piers worn and rendered over in poor condition.

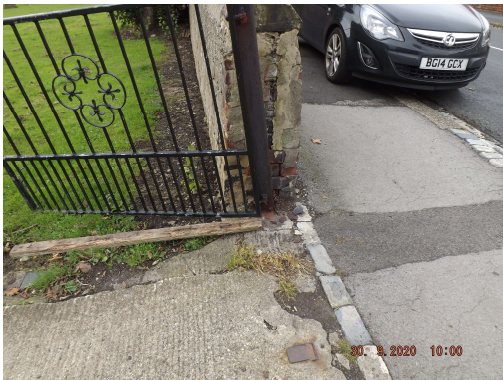
- 27.9. Gate hinge to south entrance broken.  
27.10. Steel gate post to north entrance corroded.
