Oxclose Church, Washington
(CH. No 300)

Quinquennial Report

16th August 2021

Sarah Harrison RIBA

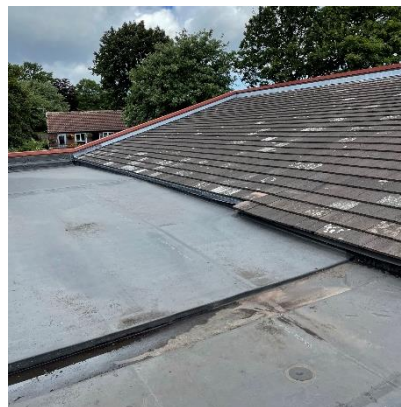
12. Mono-pitched roof to **East end of worship area and above side chapel**. This roof has brick parapets to three sides, with the lowest edge draining onto the central flat roofed area. Previous signs of movement to the southwest corner of the parapet have been filled with a mastic substance. There are aluminium upstand and cover flashings, along the lower northern abutment these have been replaced. Plastic soakers have been installed to south abutment and uPVC eaves protector tray under bottom row of tiles. The vent pipe from the kitchen has no cowl/cover. The tiling appears to be in average condition.

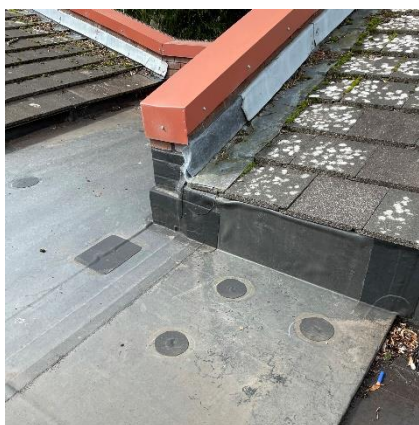
14. Mono-pitched **roof above Church Office and Activities Room**. Similar to items 12 & 13, the mono-pitched roof has aluminium flashings, soakers have been replaced with uPVC and drains onto flat roof area. The lower area to the West has cracked brickwork and the flashing has cracked, otherwise, this area of roof appears to be in good condition.

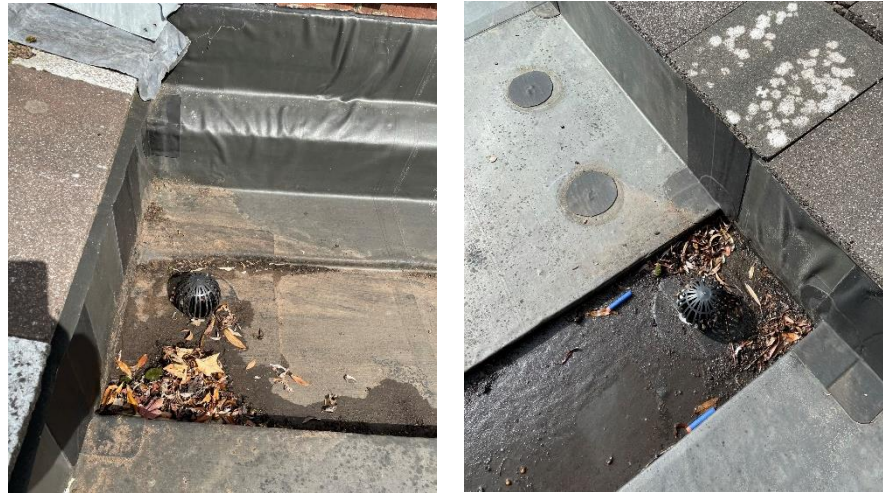
16. The two 110mm Ø flat roof gutter outlets have internal downpipes. As these are boxed in it was not possible to inspect the outlets and their efficacy.

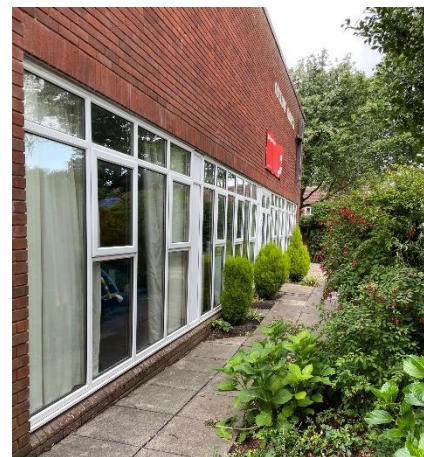
18. **East Elevations.** The brickwork generally appears sound, though some individual mortar joints are lean or uneven particularly at ground level and some areas at high level. A section of precast concrete paving has been laid at the double entrance doors to the Worship area and cement mortared adjacent to the brick plinth. This may compromise the damp proof course. There is a large area of uPVC curtain walling, there is slight variation to the lintel height but no signs of current movement.

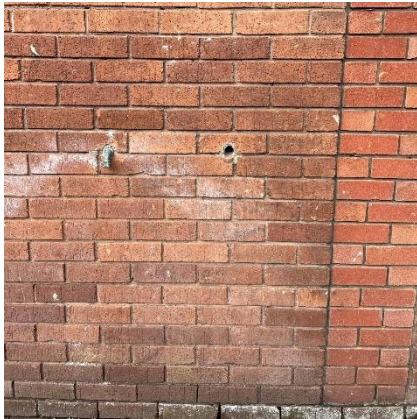
20. **West Elevations.** The brickwork generally appears sound, though a limited number of individual mortar joints particularly the perps are lean or uneven. The damp proof course is generally less than 150mm above the finished ground level, and as such some of the mortar joints immediately above DPC level are weathering. An area of

raised concrete at a former door opening, has an increased localized risk of breaching the DPC. As noted on the previous report, all mortar joints below DPC level are open or lean. 1No. hole as pictured below observed from former service penetration. Original door and window openings have been bricked up.

Fig 1 – Holes to west elevation

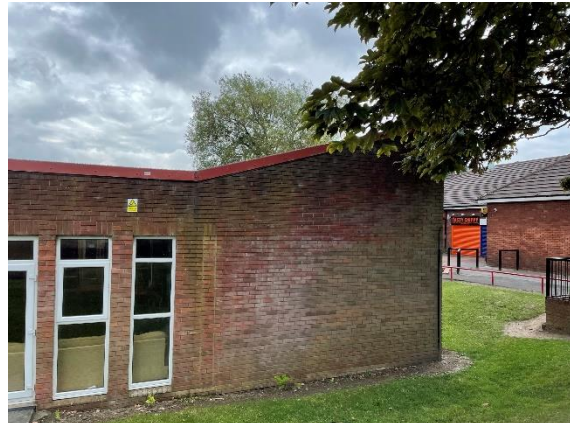
Fig 2 – North elevation former sign area

- 21. North Elevations.** The brickwork generally appears sound. Some mortar joints below DPC level are slightly open, as are some joints above the doors. As noted in the previous report, the movement joint above the fire exit door is cracked, however no pictures were included to see if this has worsened. One brick under the parapet is spalled. The emergency exit doors open onto a level landing with a ramped access to the grassed area adjacent. The mastic pointing to the perimeters of the new uPVC window frames on this elevation is uneven with a hole to the top right of the central panel. An original sign, most probably of individual letters has been removed but the fixing pegs remain.

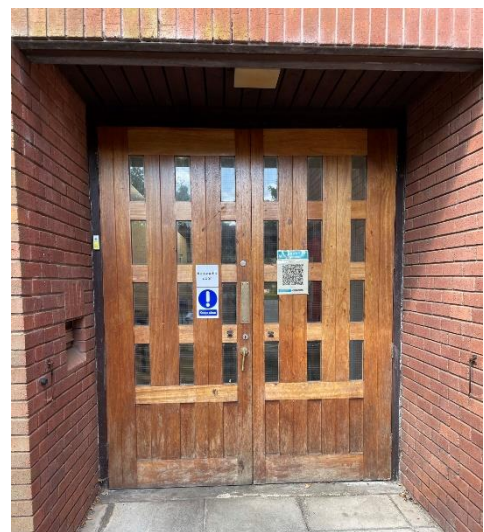
- 22.** Oak 'feature' timber entrance doors to the east elevation, each door has a 12 panel glazed section. The finish is worn, specifically to the bottom rail and requires re-coating. The lever handle to the outside is broken.
- 23.** A large 22 bay uPVC curtain wall system occupies the east elevation, there is some fluctuation to the lintel head height but no signs of movement. 15No. of the double-glazed units have failed. The central mullion to the central doors appears to have dropped.

Re-decorate cross to east elevation	29		
B	Add uPVC eaves ventilator tray to bottom row of tiles	13		
B	Prepare and re-coat front door with exterior grade varnish	22		
B	Investigate condition of ceiling above side chapel, inspect for further leaks now fixed	36		
Category C - Requires attention within the next 18-24 months.				
C	Fill open vertical joints and lean lower joints to south car park wall. (This may not be the responsibility of the church; in which case it should be reported to the Local Authority for attention)	83		£1000-1500
C	Securely re-fix timber infill to southeast corner of the church building	88		
C	Re-point lean joints to east boundary wall and cut out and re-paint full height crack to first outer corner to right of main entrance	84		
C	Re-point broken brickwork area of parapet and fix flashing	14		
Category D - Requires attention within the quinquennial period.				
D	Replace old water damaged ceiling tiles inside chapel, WCs and accessible toilet.	35,36	£250-500

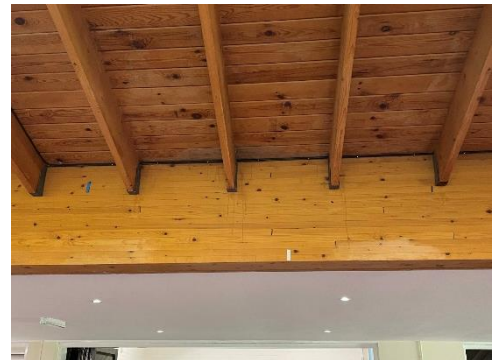
30. The roof structure is mainly exposed in the worship and creche areas, and comprises exposed rafters supported by the brick walls or on pine glulam beams, which in turn are supported by brick piers. The underside of the roof deck is generally exposed tongue and grooved softwood boarding, with a new plasterboard finish within the main 'street' circulation area.

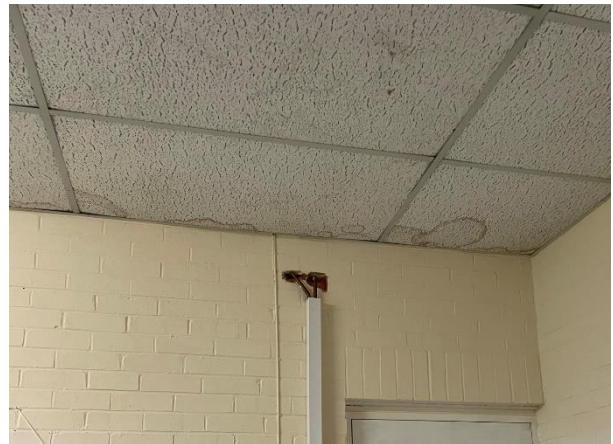
36. Within the Side Chapel there is a lowered exposed ceiling grid with drop-in ceiling tiles. As per the previous inspection report there is staining to 4 No. tiles above the door leading into the Main Entrance Lobby, but this does not appear to have worsened. The room generally has a damp odour, this is believed to be due to historic leaks but the area above the ceiling tiles could not be inspected.

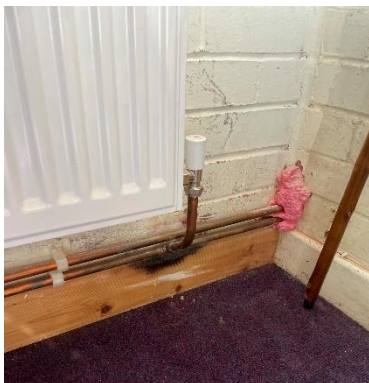
39. All walls are emulsioned brickwork supported on steel lintels above openings. The brickwork is generally half lap stretcher bond with 1 soldier course above all lintels. Within the Worship Area internal brick buttresses support glulam beams and generally appear structurally sound. The slight deviation from the perpendicular, noted at the top of the taller buttress on the east wall in the previous report, is very minor. Similarly, the minor cracking following bed joints emanating from the junction with a rafter on the north face of this buttress, does not appear to be any worse. As noted on the last report, the brick arises that have incurred damage at low level have now been painted over.

40. As seen in the photograph above, in the side chapel there are areas which require filling around newly installed heating pipes. This is also the case in the consultation room (shown to the left), which have been filled with expanding foam.

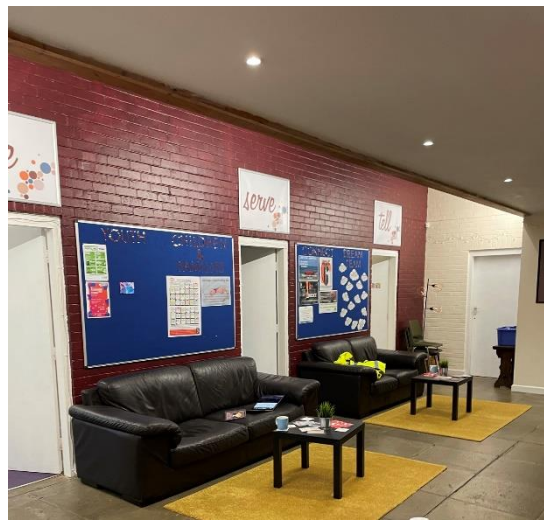
45. All the internal doors leading off the Main Entrance Foyer are flush doors having ply veneer to both faces. All have satin anodised aluminium lever handles. The church office has a second lever lock fitted for additional security, the additional lock to The King's House has been removed. The consultation room also has an additional Yale lock. The frames to all these doors are robust and serviceable. The church office door meeting stile which had previously been split on the face above and below the lock mechanism, has since been repaired and a metal plate fitted to the frame surface to prevent further weakening.
