Diocese of Durham

St Thomas Church, Petersfield Road, Sunderland, SR4 9BD

Quinquennial Inspection

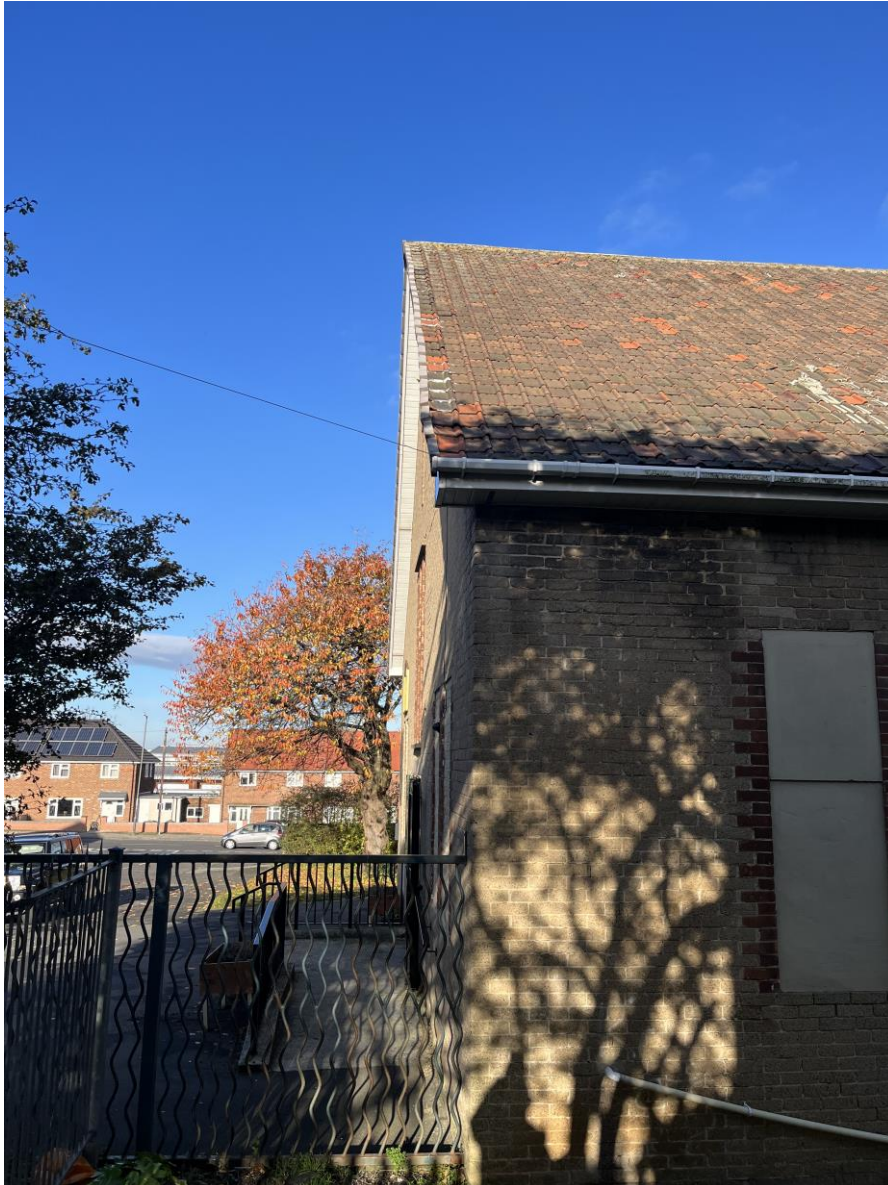
- 5.1 The main roof is pitched and covered with red single roll clay tiles with wet mortar clay ridge and UPVC dry verge system. The verge system is coming away from tiles and requires re-alignment.

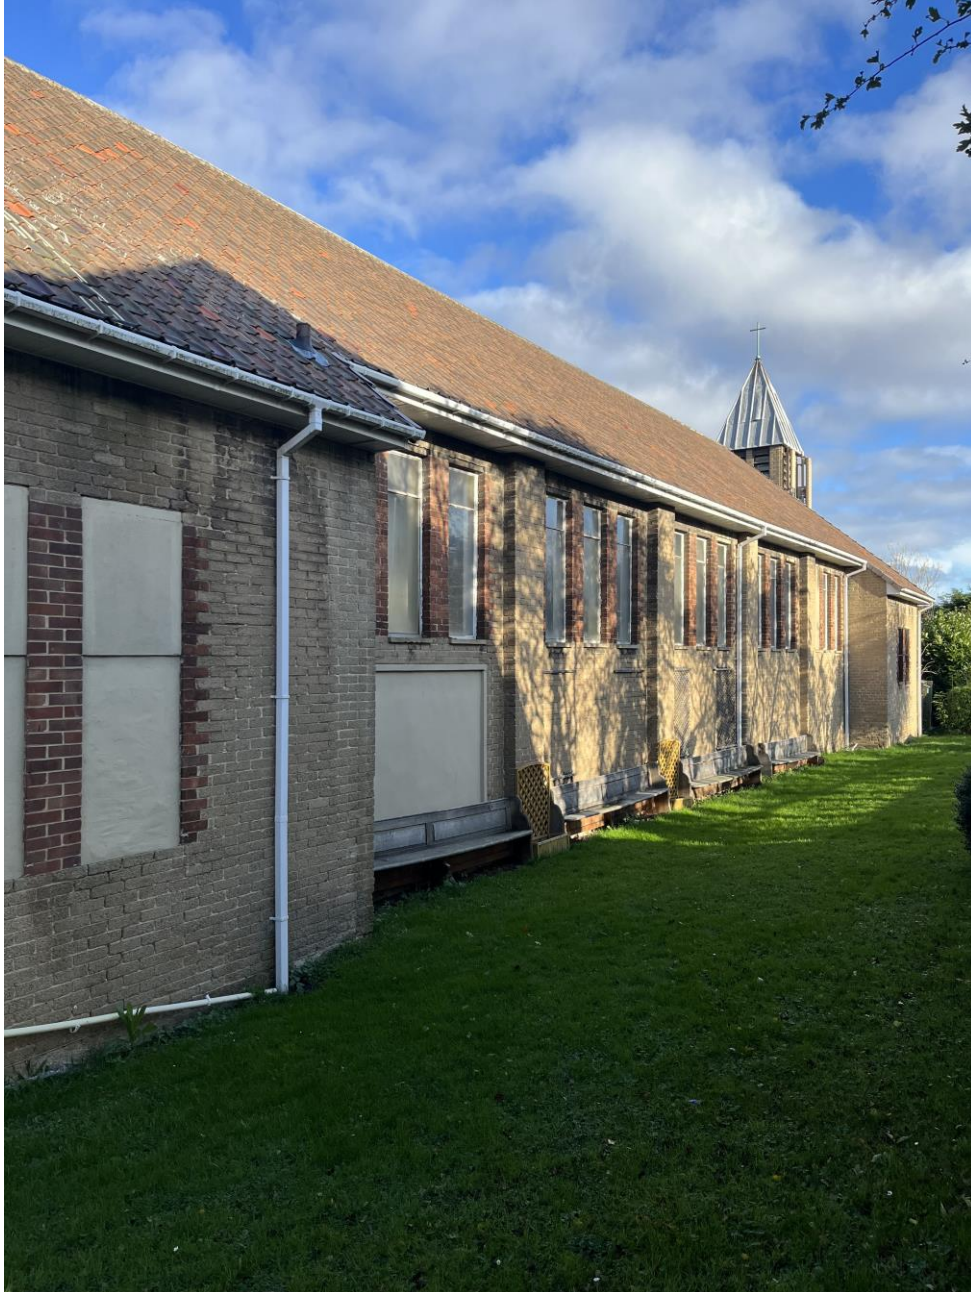
The bell tower roof is covered in lead. A lead sheeting panel has lifted to the east side.

There is a small flat felt roof to the north-east porch entrance, this is in good condition.

- The bell tower roof is covered in lead. A lead sheeting panel has lifted to the east side.

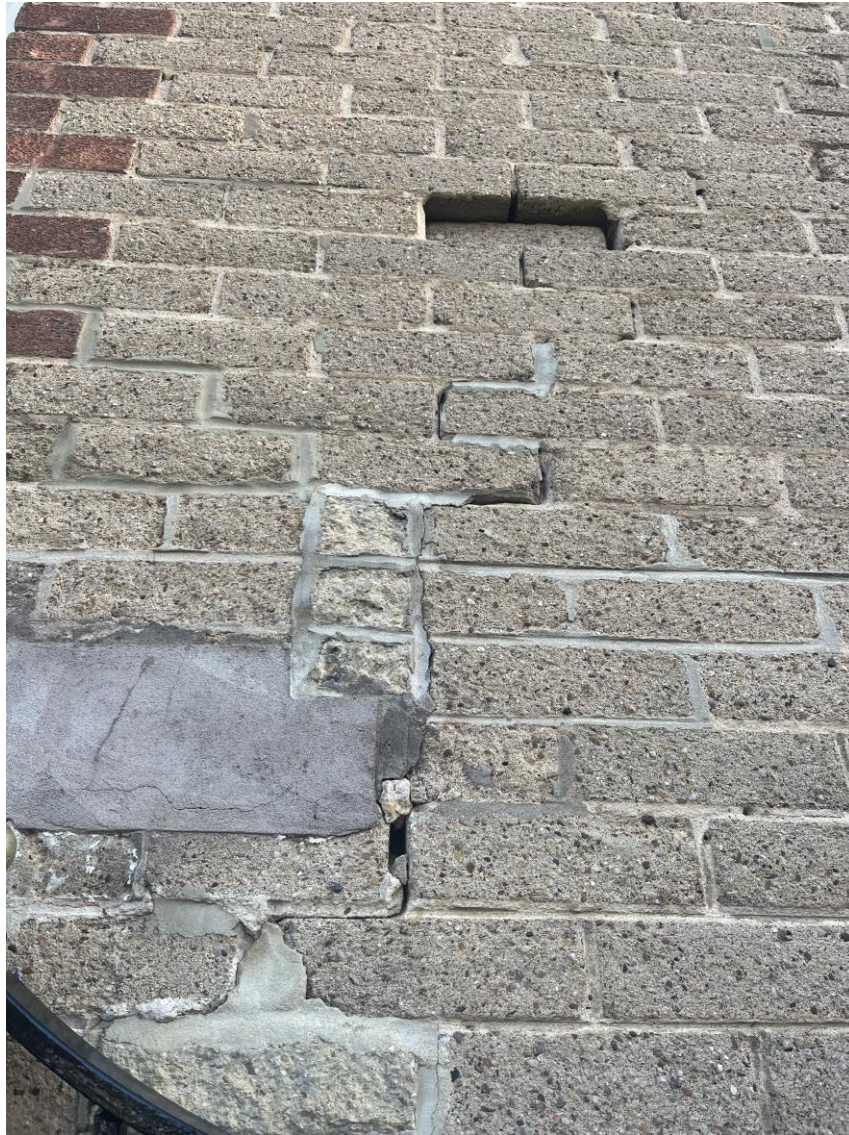
- 5.3** The buff rough-faced bricks have structural cracks in various areas. It isn't fully clear why so many have cracked but the previous report noted it was due to *'boot lintel construction, west and east end modifications, minor differential foundation settlement to the alterations, seasonal ground movement and slightly sloping ground'*.

A brick to the west elevation has moved at the head of a crack.

- Various structural cracks evident to the brick external leaf. A separate inspection and advice by a structural engineer to take place. Please contact - BDN, The Old School, Simpson Street, Sunderland, SR4 6DR. Tel; 0191 535 6189 bdnltd.com

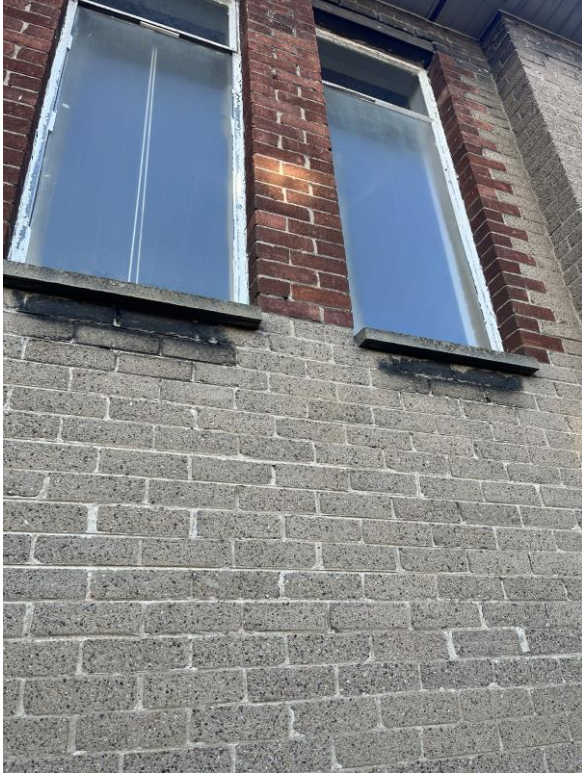
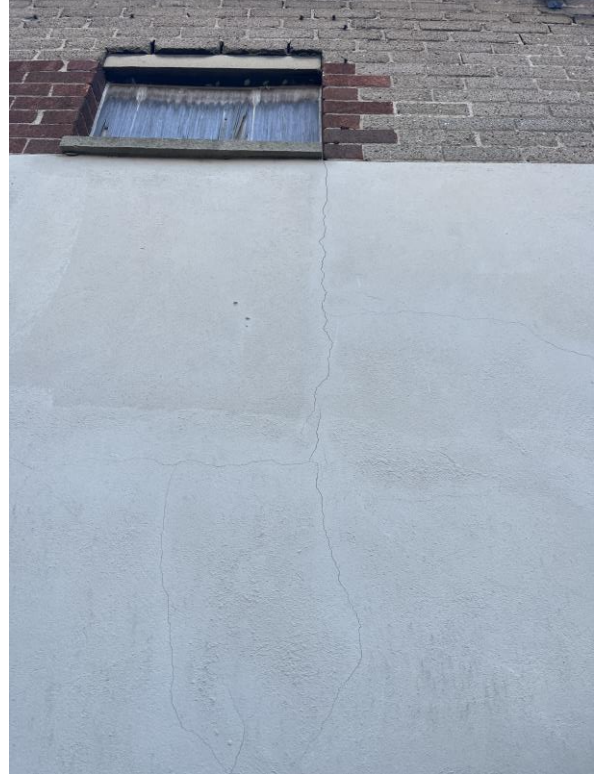
The bricks under the cills to the north elevation have blackened which is most probably a damp penetration issue and they are delaminating.

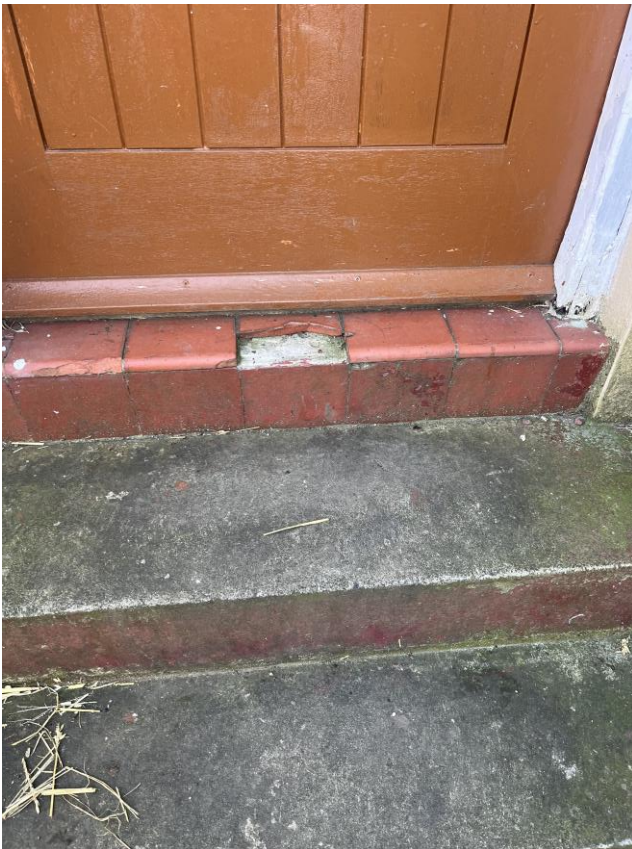
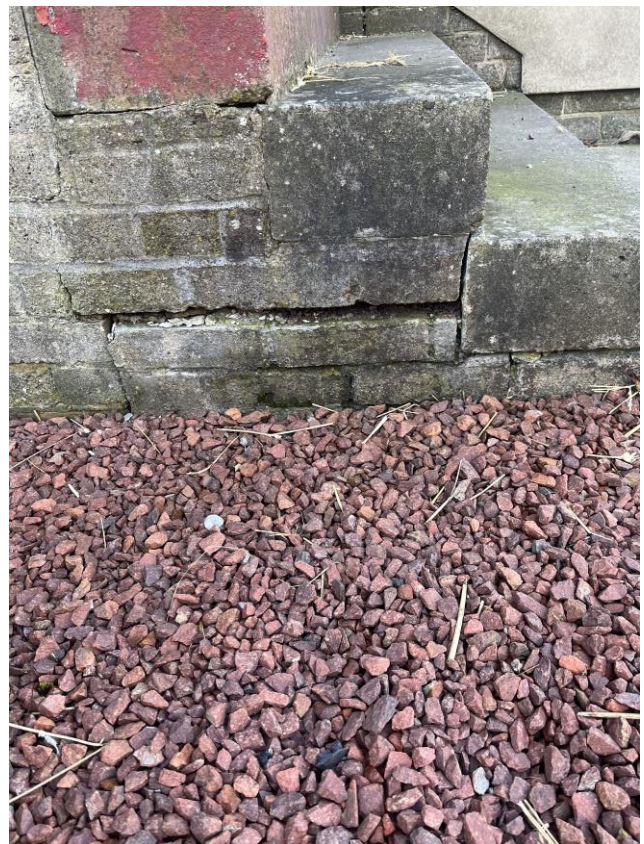
The rear porch door has a broken tile to the step. The same step also has a large mortar bed missing.

- The rear porch door has a broken tile to the step.

- The same step also has a large mortar bed missing.

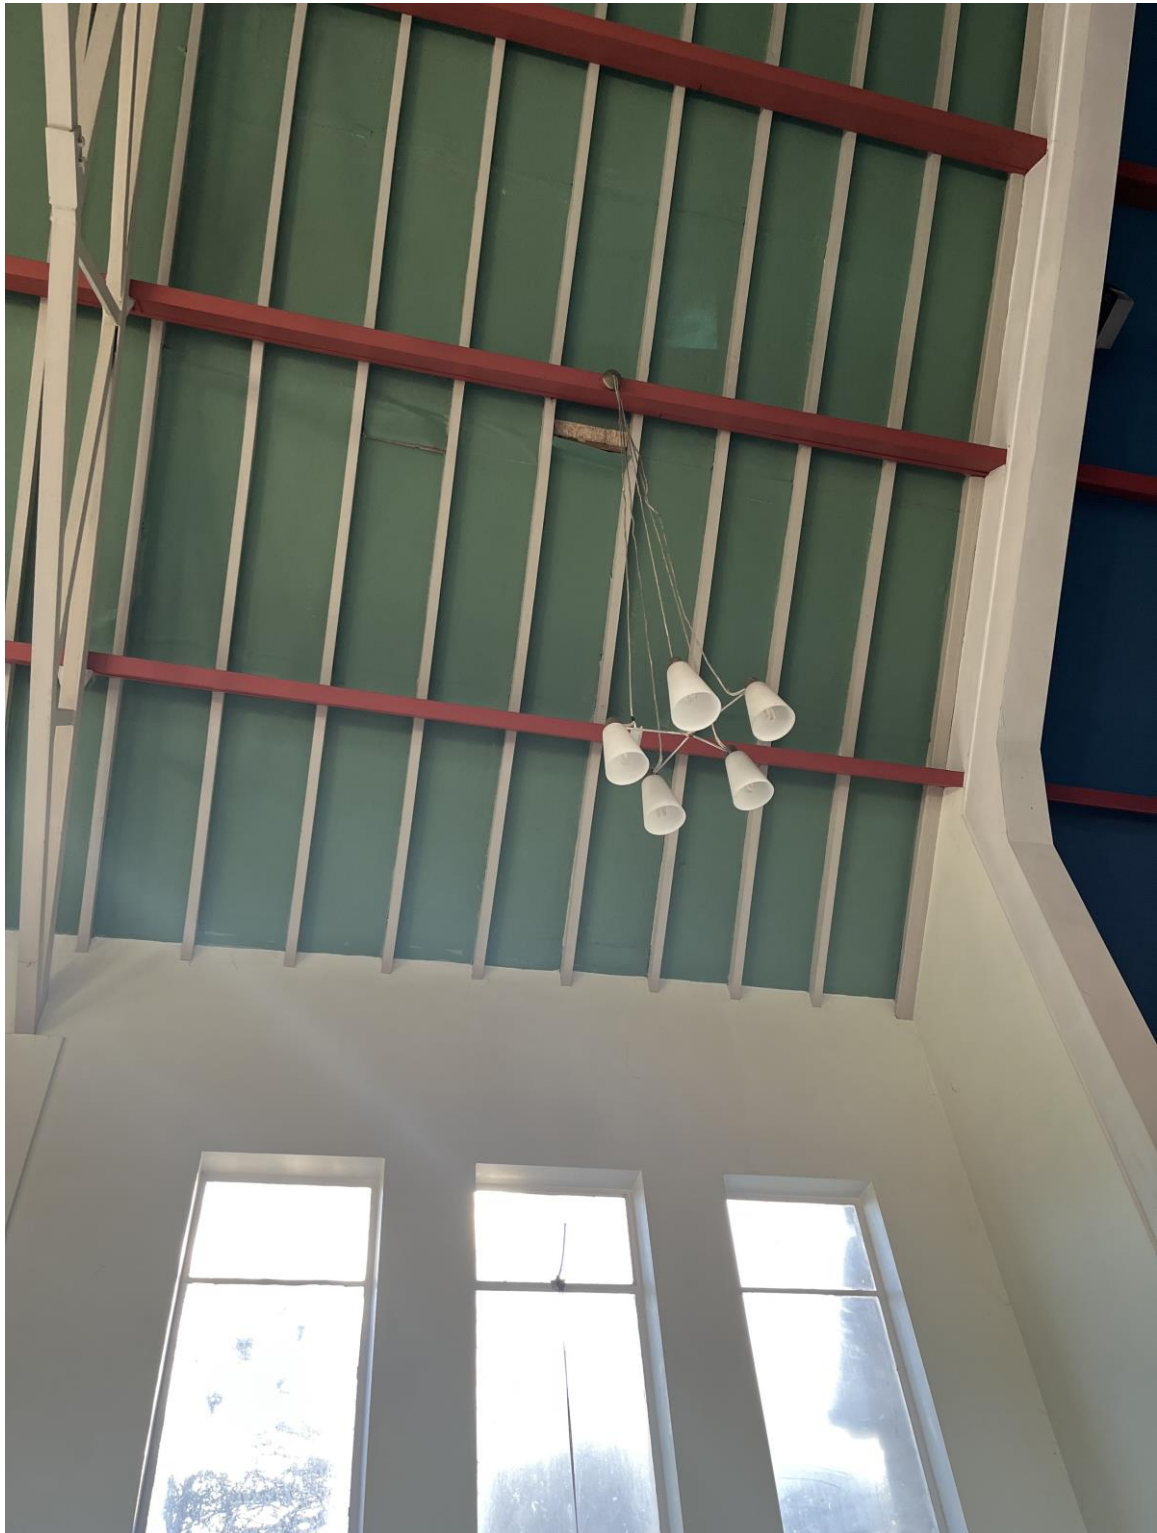
- 5.5 The ceiling appears to be paper faced OSB boards, several boards have the paper coming away. Whilst this probably won't cause any issues visually it is unappealing.

- OSB boards to nave area, several boards have the paper coming away and it requires fixing back.

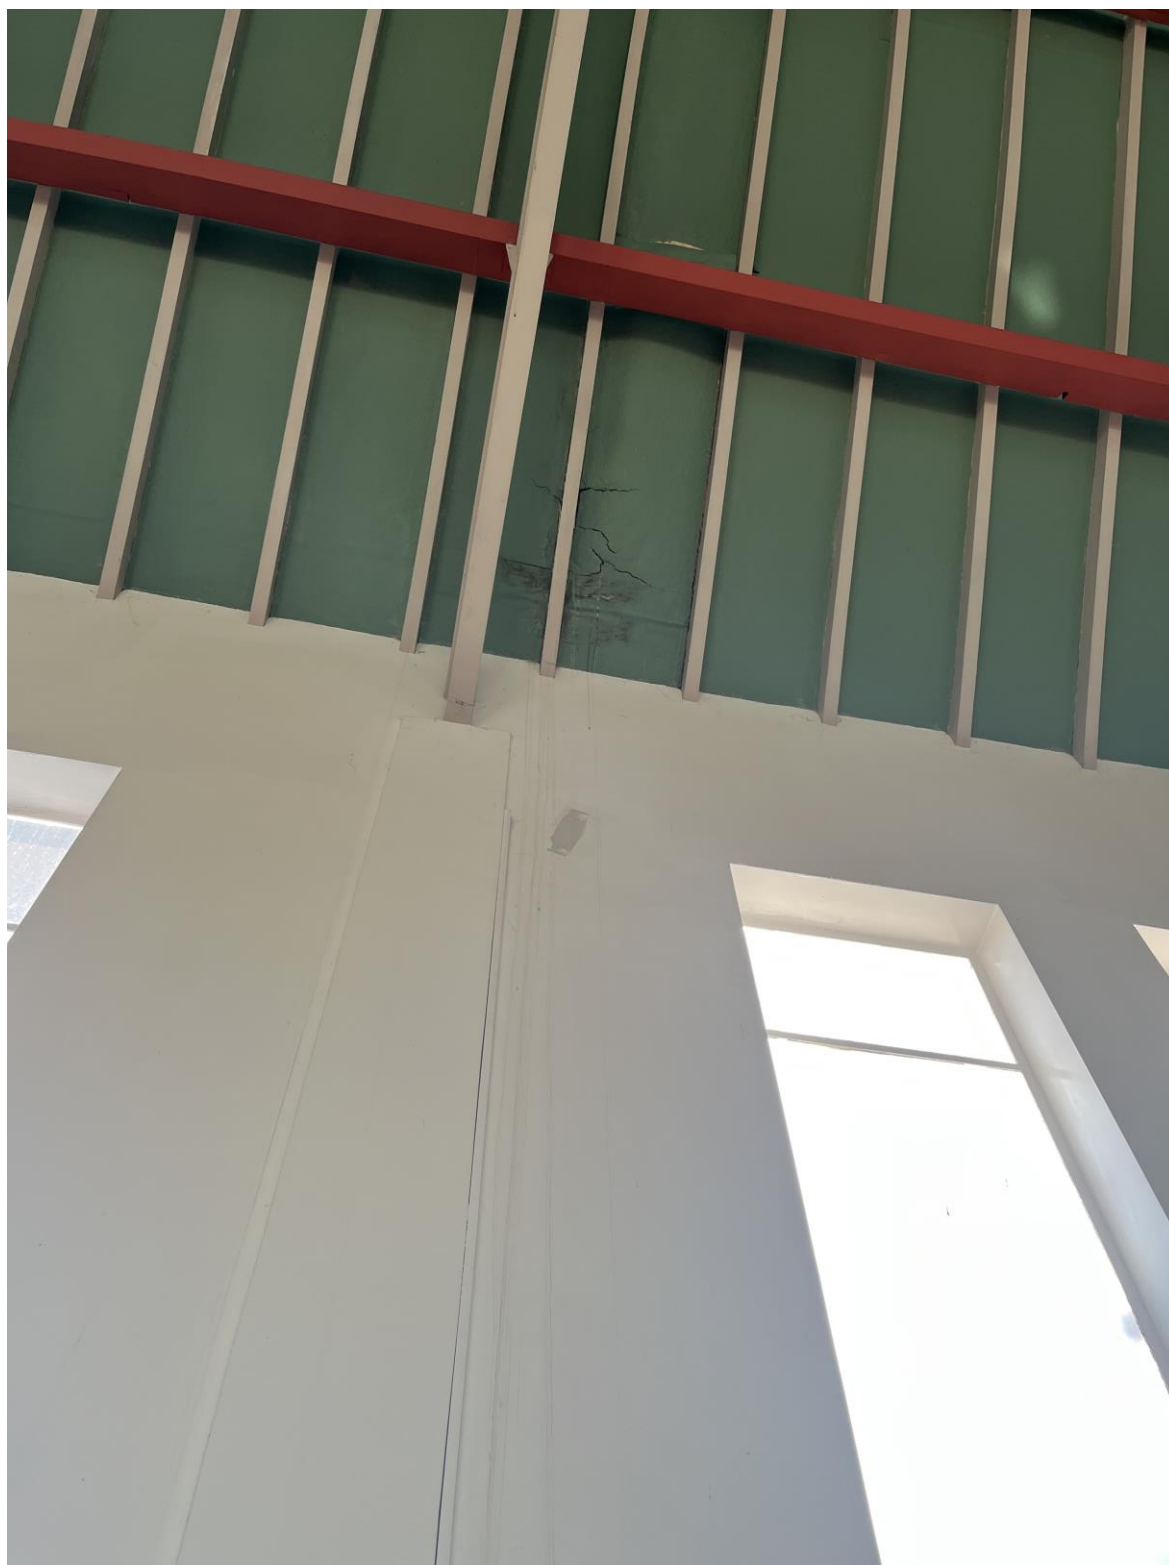
The eastern end of the nave on the south side what looks like damp penetration from probably a slipped tile is evident.

- Eastern end of the nave on the south side has damp penetration to ceiling boards. Board to be inspected and possibly replaced or paper faced covering to board to be replaced.

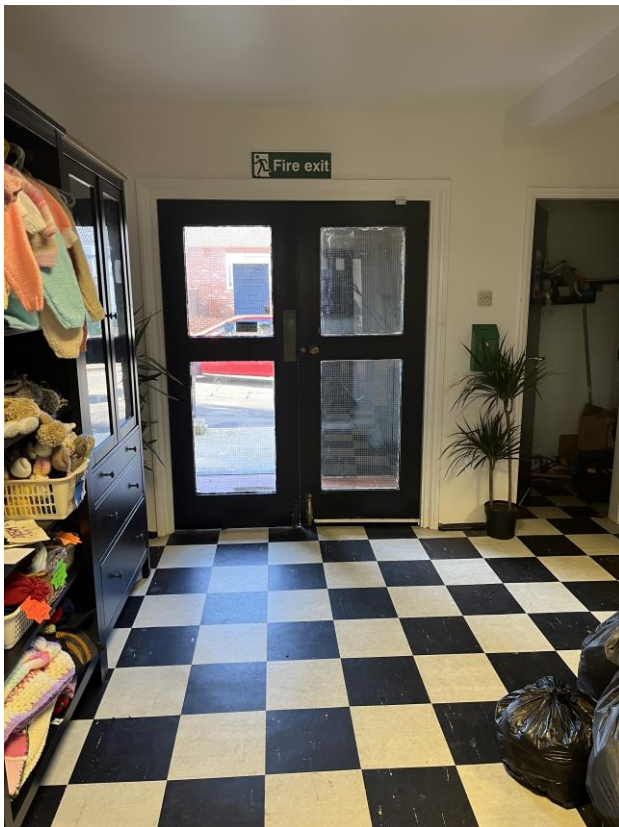
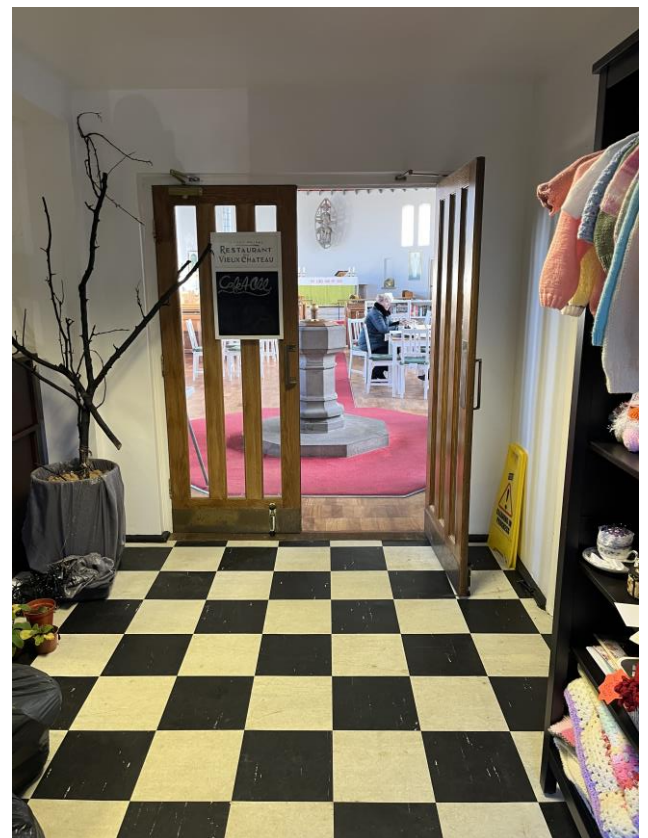
- 5.6** The large painted timber double entrance doors open to a small lobby. The doors are in good condition. Internally to the lobby a set of further double doors are situated, these are Georgian wired for fire protection.

The nave to entrance hall is separated by a further set of double timber doors, these doors are clear glazed with toughened glass but are not fire rated.

None of the internal fire doors or frames within the church have the correct fire or smoke seals.

- Add fire and smoke seals to doors

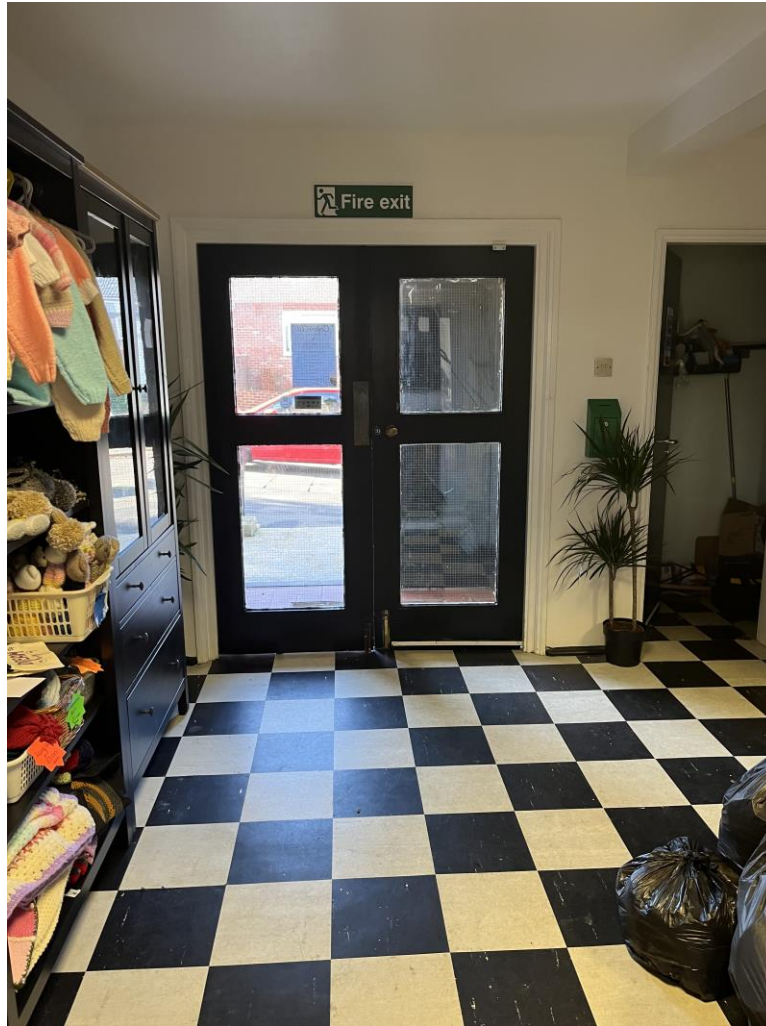
- 5.8** The floors in the entrance link are black and white chequered vinyl floor tiles. The tiles showed no damage and are in good condition. They didn't appear to be non-slip type and may become slippery when wet which should be monitored.

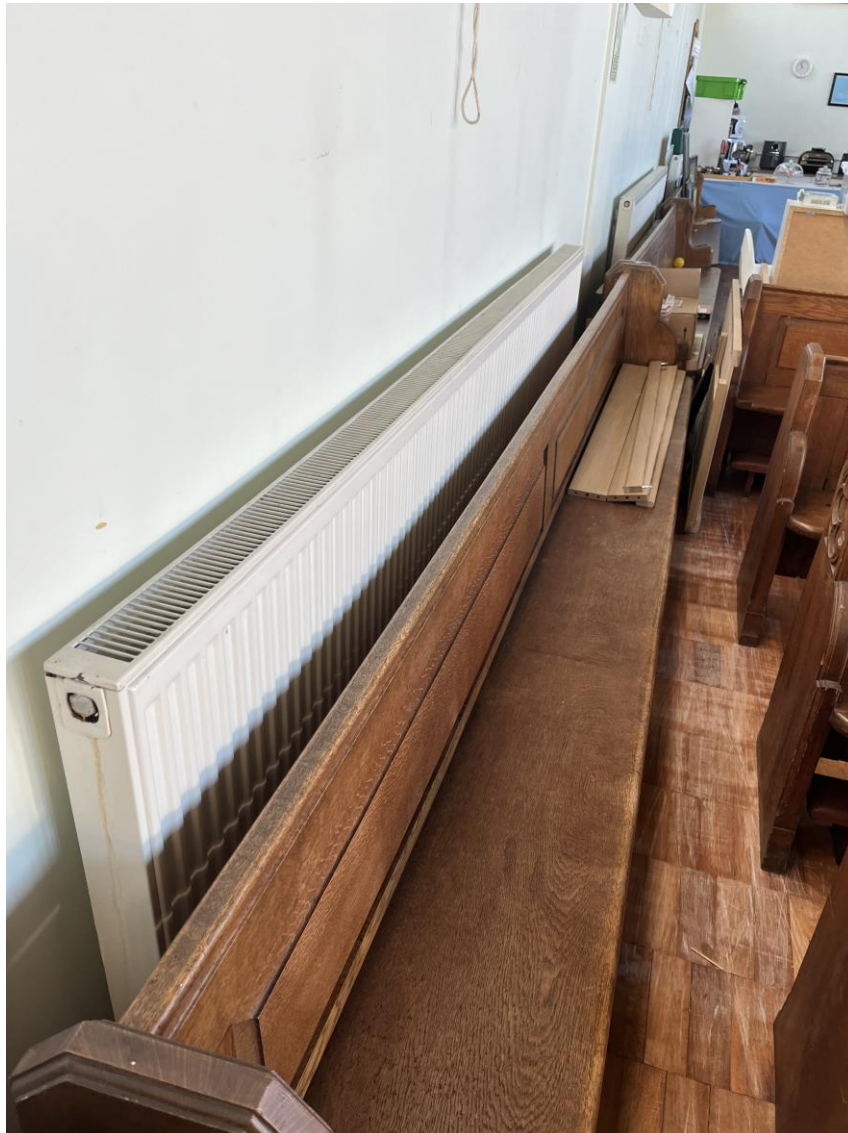
The large panel radiators in the nave are hidden by the Pius which will be preventing the heating from being circulated accordingly.

- Move Pius to increase heat distribution from radiators
