Church of All Saints, Penshaw

Diocese of Durham  
Archdeaconry of Sunderland  
Deanery of Houghton-le-Spring

Quinquennial Inspection Report  
March 2023

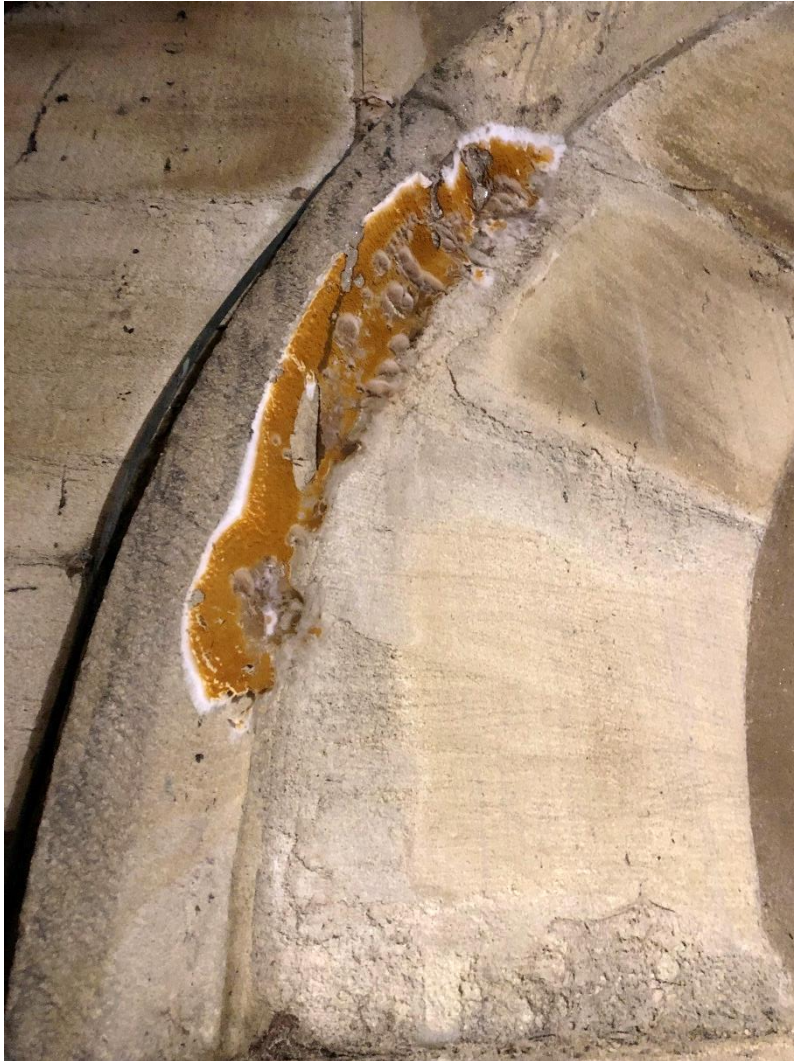
8.5	There are salts showing to the south wall at low level.
8.6	The porch has damp stonework to the east side at low level and west side at high level. There is very clear and concerning evidence of a potential fruiting body, indicating dry rot.

P1 (0585):  
Fungal body, south porch

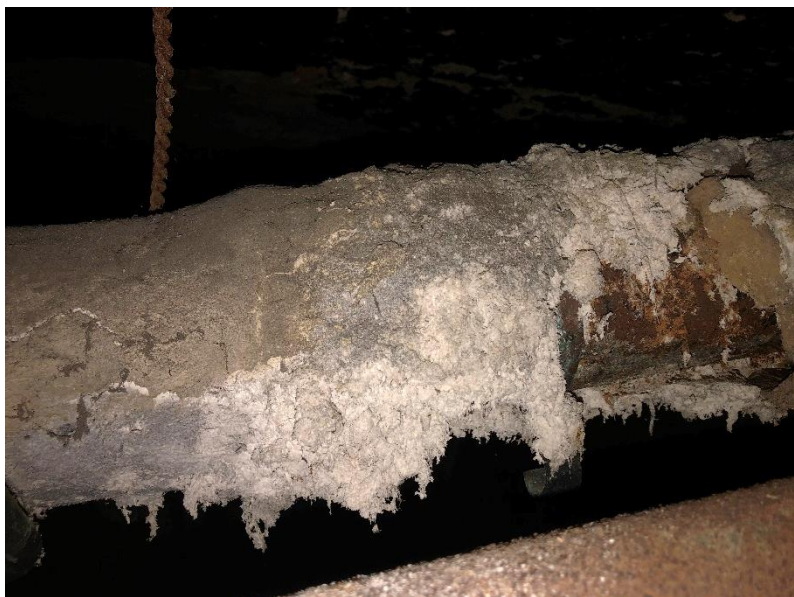
14.5	There are several areas where pipework is showing signs of corrosion.
14.6	There is no insulation to the boiler room pipework and a section that may be asbestos lagging should be analysed and safely removed by a licensed specialist before taped, sectional insulation of all pipes is undertaken.
<b>15.0</b>	<b>Electrical and Lighting Installation</b>

P2 (0651):  
Deteriorated pipework insulation  
(asbestos containing material?)

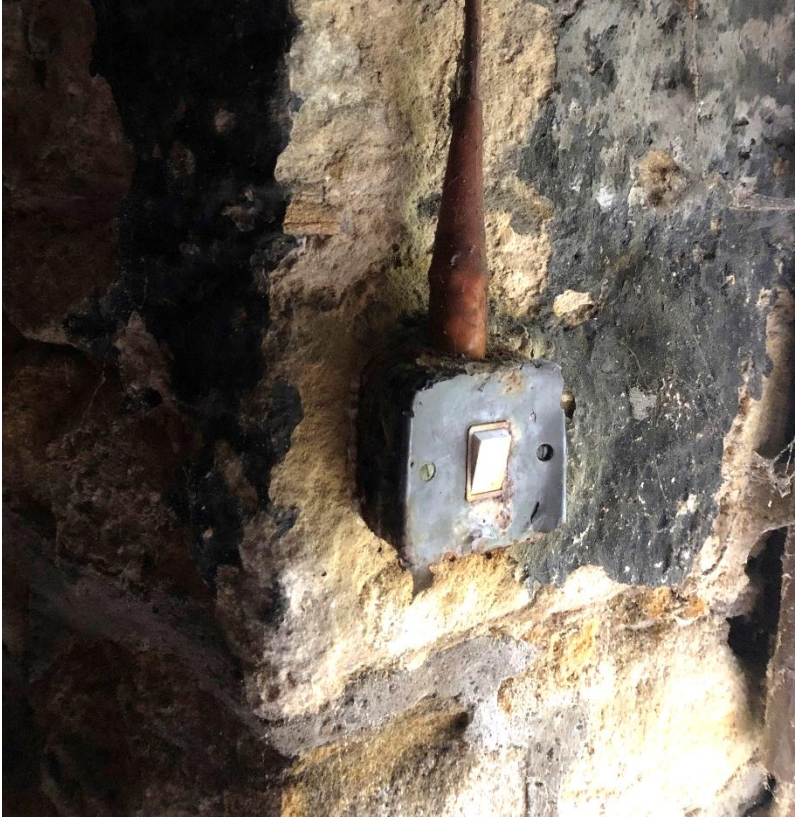
14.2	The electrical conduits serving the boiler at floor level are rusting and unsupported. This requires urgent attention.
14.3	The gas-fired, low pressure hot water system serves large bore cast iron pipes.

P3 (0649):  
Deteriorated lighting installation,  
Boiler Room

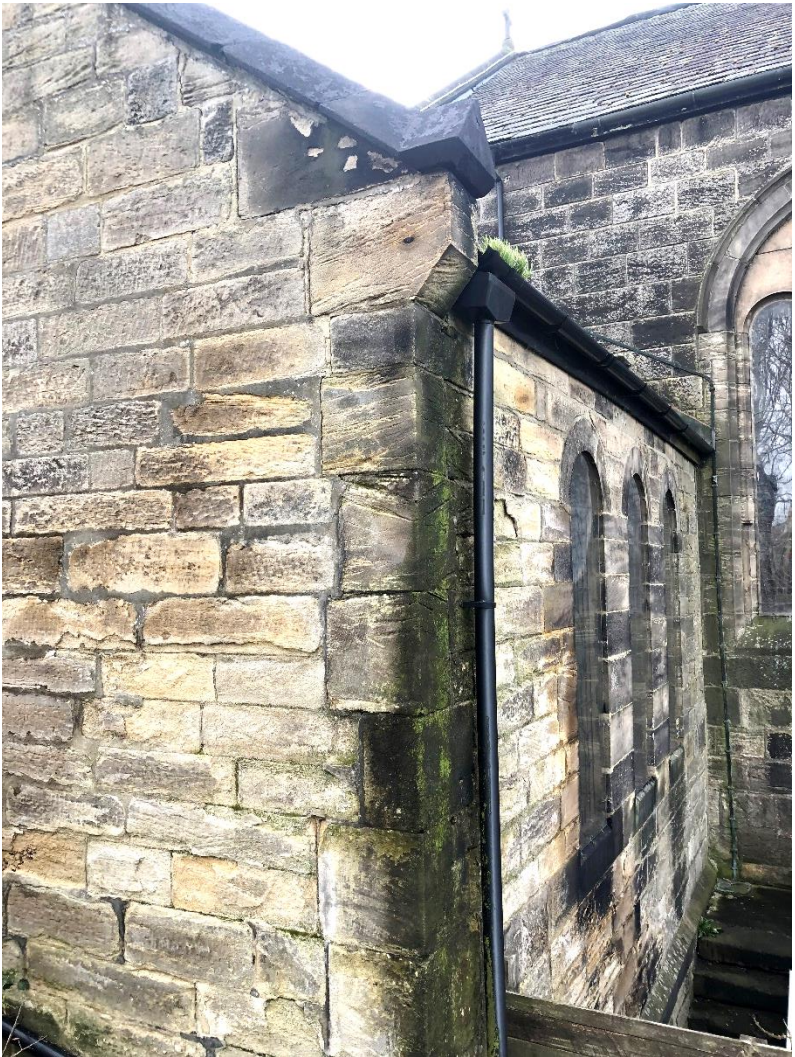
4.7	The vestry gutter southwest end is displaced and has grass at the outlet, leading to stonework damp saturation to the northwest corner. The vestry gutter to the east elevation is heavily rusted and misaligned and the rainwater pipe has a plant growing out of it.

P4 (0555):  
Vestry gutters blocked

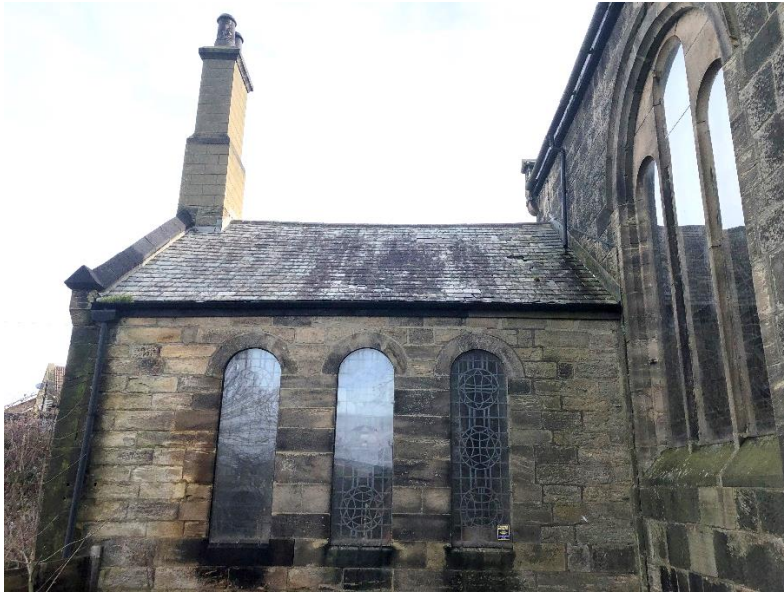
P5 (0561):  
Vestry roof, missing slates

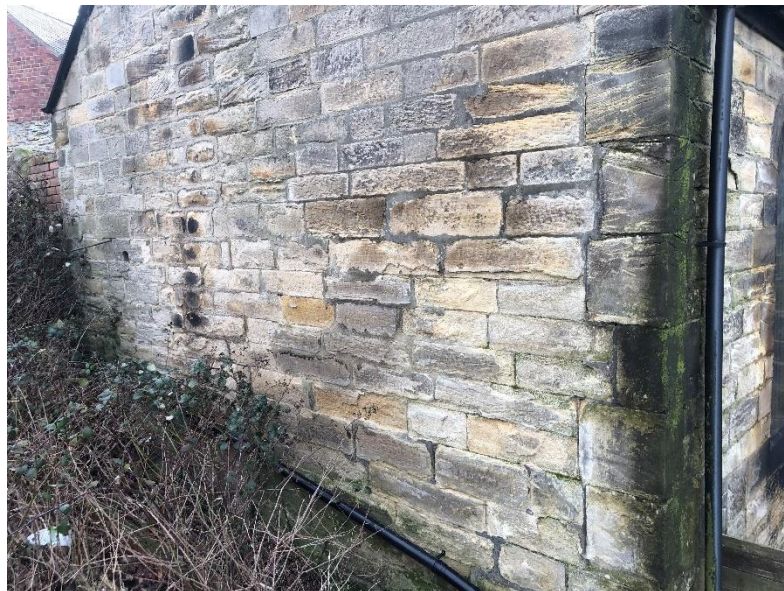
6.10	Vestry stonework to north elevation is damp and smaller/poorer condition than elsewhere, with damp evident in the WC internally. Significant stonework erosion is evident behind the west downpipe and in quoins at the northwest corner.

P6 (0554):  
Pointing issues, north Vestry wall  
and elsewhere

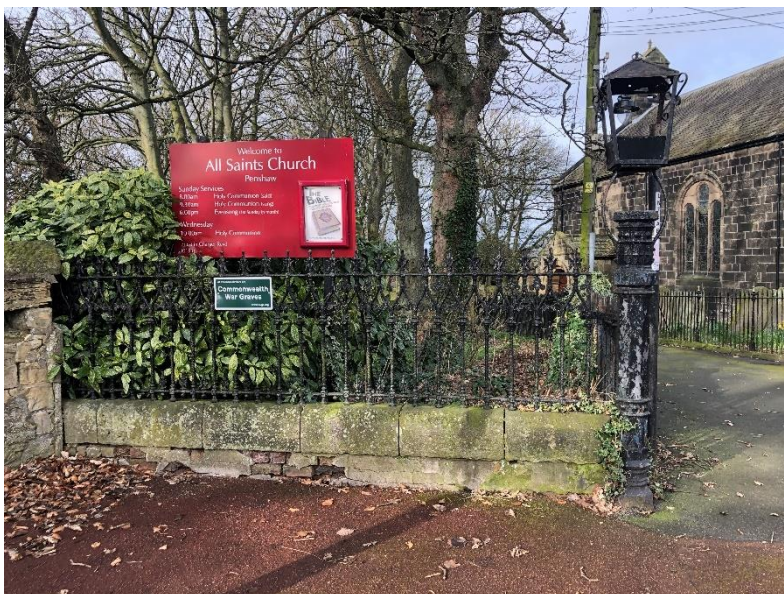
P7 (0584):  
Boundary entrance wall, lost  
render (ironwork maintenance  
responsibility, Sunderland City  
Council)

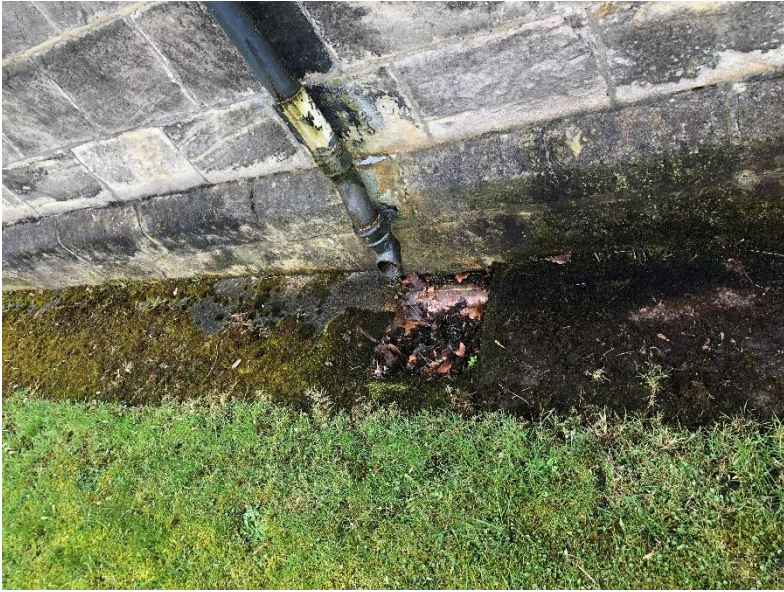
P8 (0570):  
Gulley/stone channel to be  
cleaned; downpipe/gutter  
maintenance needed

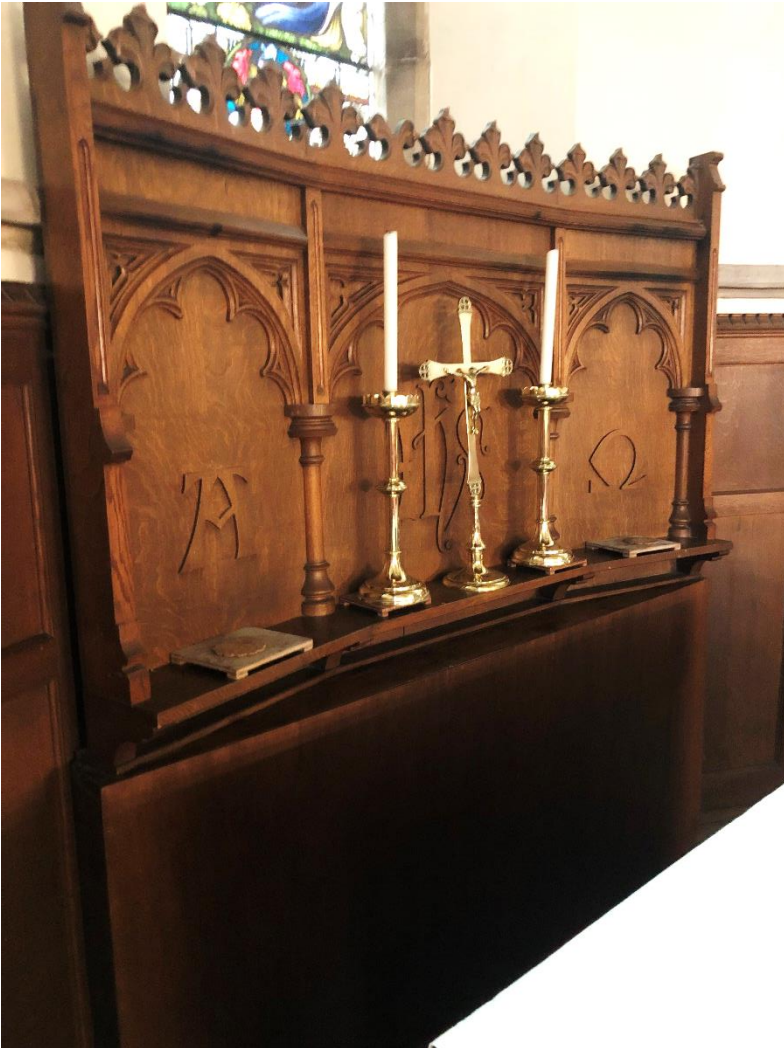
13.5	<i>Reredos:</i> Slightly Art Nouveau (1902) with ply infill panel under; one small piece of carved oak cresting is missing.
13.6	<i>Organ:</i> The organ, in the southeast nave, dated 1883 is a two manual by Harrison & Harrison of Durham. Pneumatic action was installed in 1964 by J.W. Walker & Sons. The organ is tuned twice a year, with a major overhaul in 2008 including polishing of all pipes. Current condition is good.  The organ has an Historic Organ Listing from the National Pipe Organ Register. Further details available at: <a href="https://www.npor.org.uk/survey/N04249">https://www.npor.org.uk/survey/N04249</a>

P9 (0618):  
Missing cresting to reredos

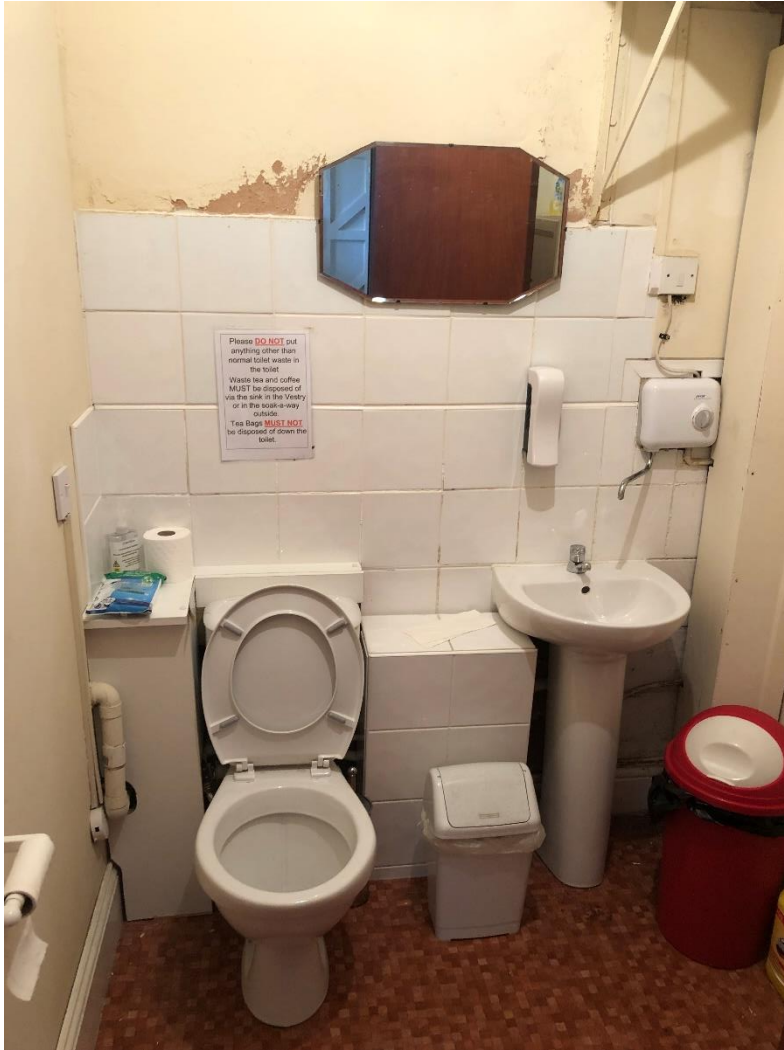
P10 (0636):  
WC improvements necessary  
(Doc M pack)

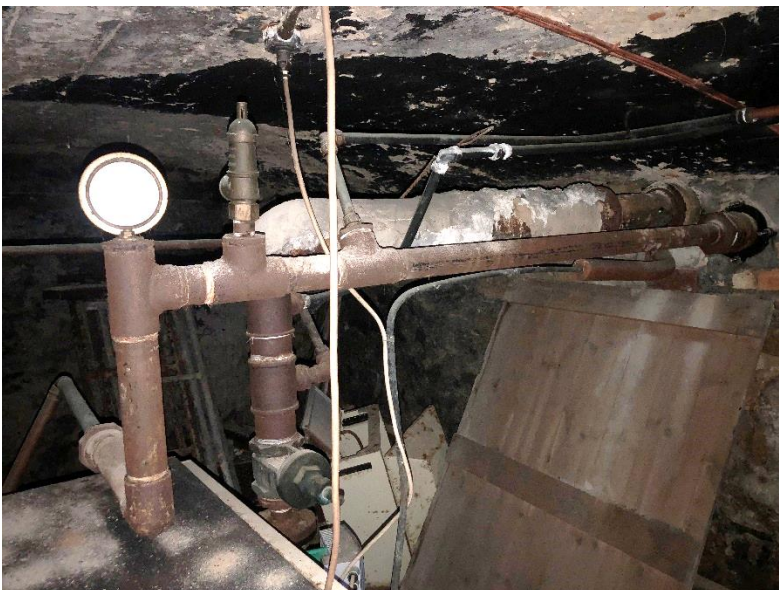
P11 (0646):  
Boiler room to be tidied

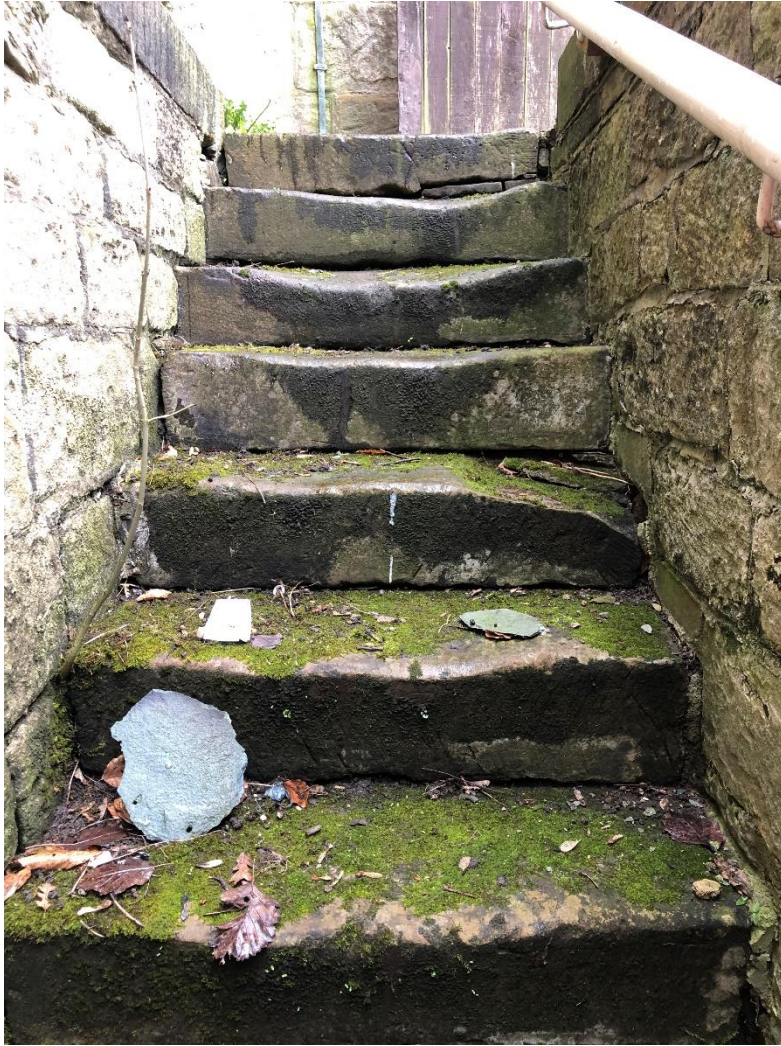
P12 (0653):  
Boiler room steps to be cleared
