QUINQUENNIAL INSPECTION REPORT

PETERLEE, ST CUTHBERT

**QUINQUENNIAL INSPECTION AND REPORT
January 2024**

David Beaumont BA (Hons) Grad Dip, RIBA, AABC

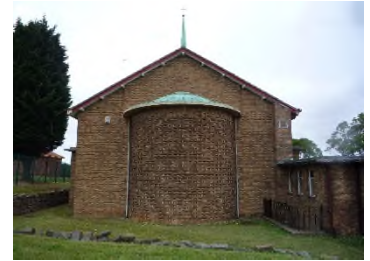
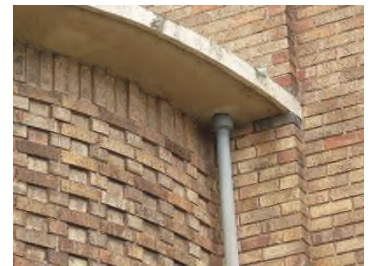
Nave/Chancel Pitched roofs covered in 2019 with new Bridgewater clay double roman tiles and clay ridges. Including new Roofshield underlay and 75mm Kingspan insulation. Loss of verge pointing at east end.

Leaking to the concrete roof light/roof junction. A scheme to add a new dome over the rooflight and replacement mineral felt is expected to be carried out in Spring 2024

Recommendation: carry out stair roof repairs, repair verge pointing

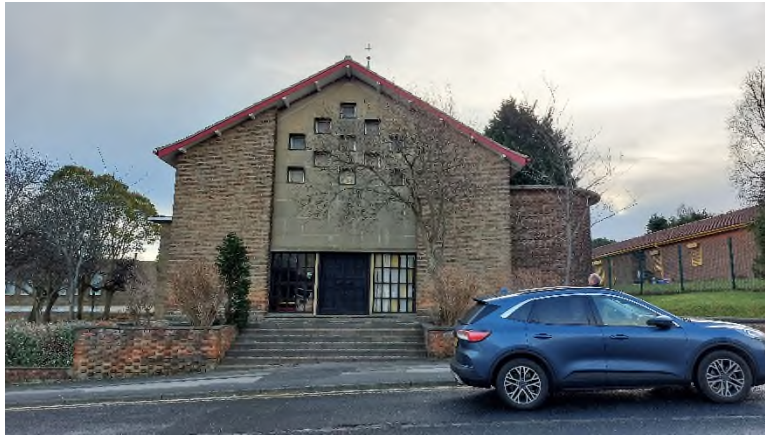
- Nave west gable– some cement repairs to the slab facing at upper level and seem to be holding. The brickwork has been re-pointed in cement flush unlike the original lime recessed joints elsewhere.

Recommendation: none

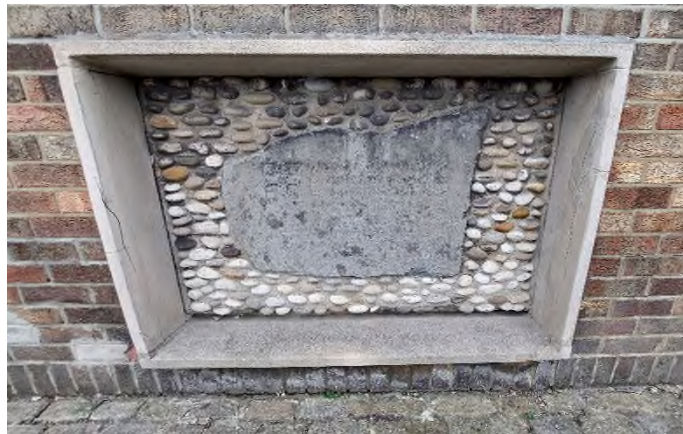
There is some dirt showing to the commemorative panel. The ornamental slate within the concrete frame and cobble surround has eroded so much so that it is illegible now. Slight spalling to frame.

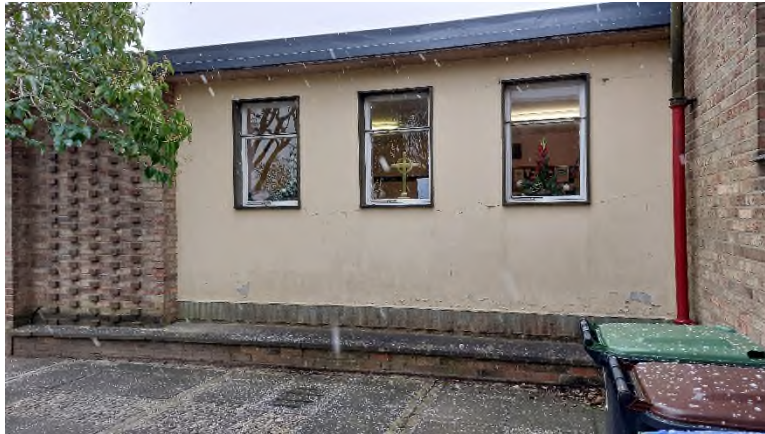
The west elevation is rendered and there is cracking showing at the cills between the windows, but this just requires patching and filling.

The brickwork panel adjacent to this has unfortunately had cement repairs.

Recommendation: fill and redecorate render

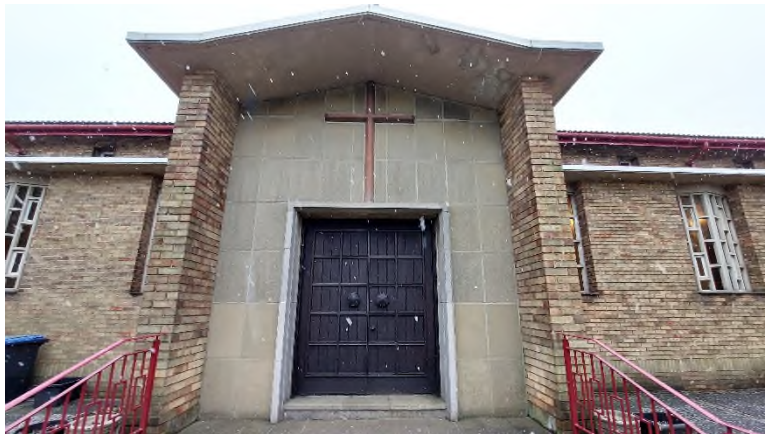
The west entrance doors and glazed screen are stained hardwood, darkening with age. Ok

The north entrance doors have fine panel work with planted beads and feature hexagonal knobs as the west. Ok

Recommendation: none

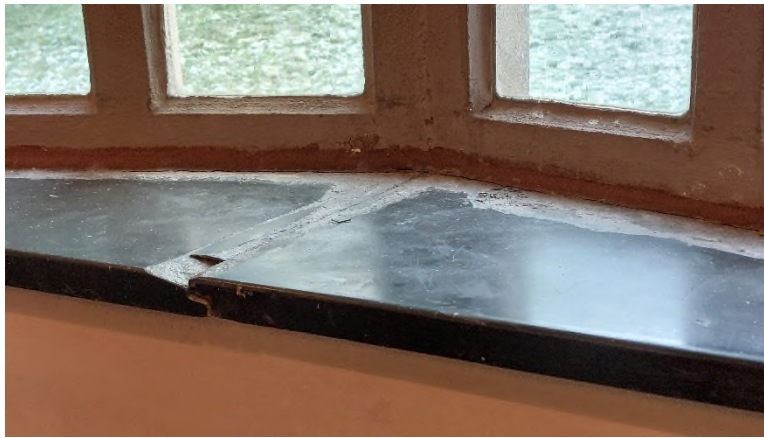
windows are simple metal casements. There is a slight crack to a couple of the panes. Silicon pointing is failing.

Spalling of concrete is caused by rusting reinforcement which requires a specialist repair. Needs to be looked at in about 5-10 years.

The window frames are sat on slate cills that are in two rebated halves; it appears that there is no weather bar to stop moisture coming through the sills and this has eroded the sills slightly over time. To reduce water inside, they have been pointed both internally and externally with silicon. This has hardened and has come away.

Recommendation: monitor concrete windows. Too soon to embark on a round of frame repairs- see what other defects occur in the next 5-10 years. Paint exposed reinforcement with derusting paint. Strip old silicone and look to re point possibly in a lime or burnt sand mortar- but under architect specification and instruction. The detail needs working out.

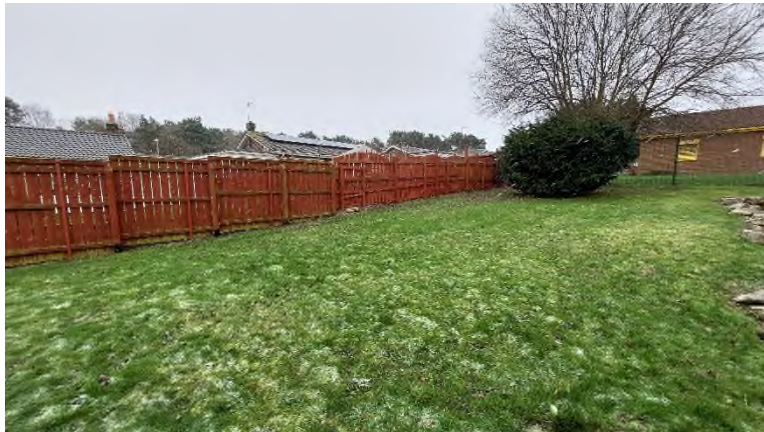
E East Side:

This has fencing onto housing which looks ok. Who's responsibility is it?

Recommendation: establish ownership and repair liability

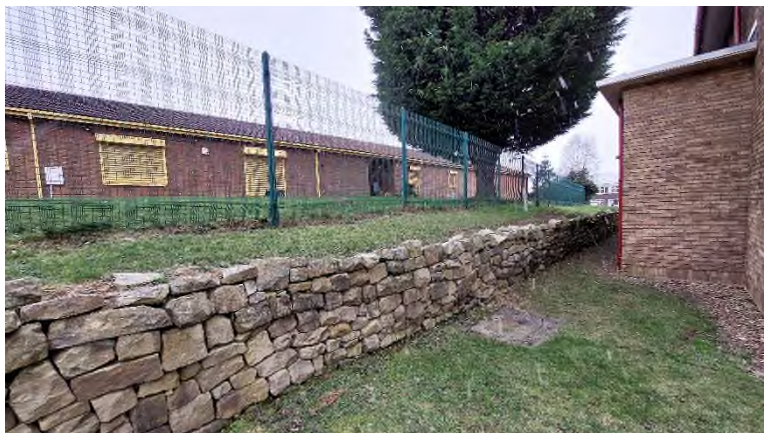
- South side:

This has a low retaining wall in drystone walling which is reasonably satisfactory though it doesn't have a coping. This retains a grass bank that leads up at higher level to a metal mesh fence which doesn't contribute to the church surroundings.

Recommendation: none

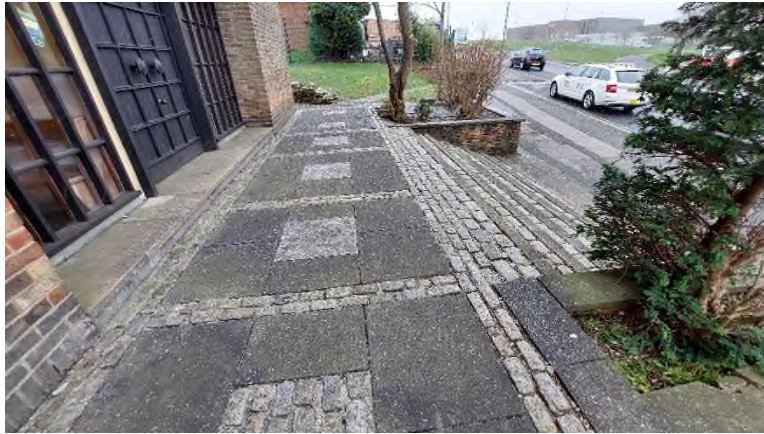
D West side:

There is a patched tarmac pavement to the steps to the west doors. Steps are stone setts. There are planting bays within dwarf walls and some of the slab copings are chipped and uneven. Towards the north-west corner, the paving slabs are undulating rather badly.

Recommendation: remake the uneven paving slabs.

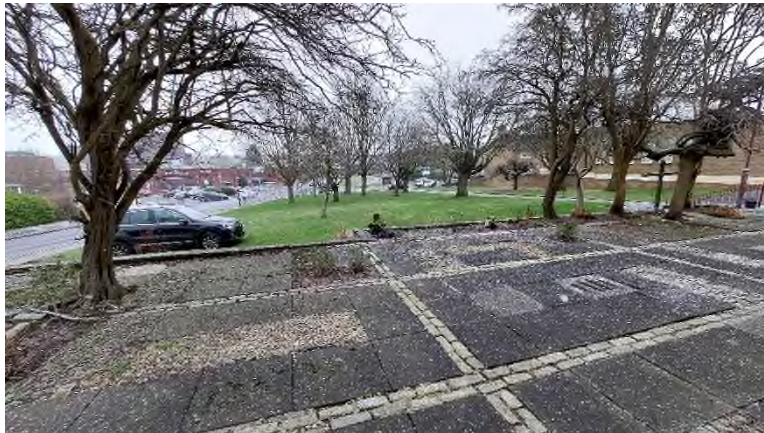
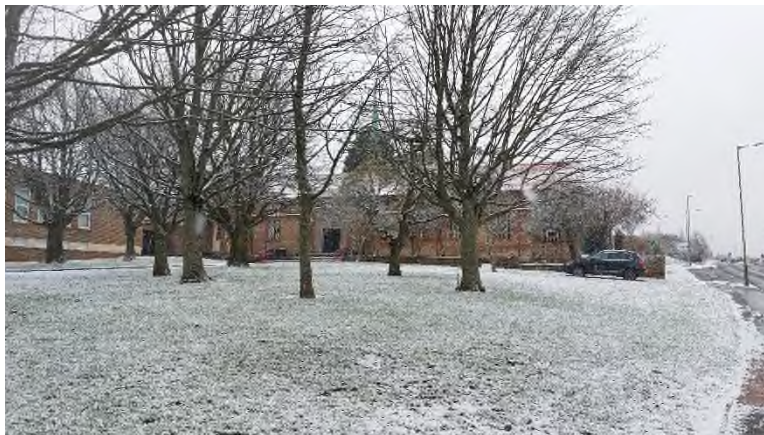
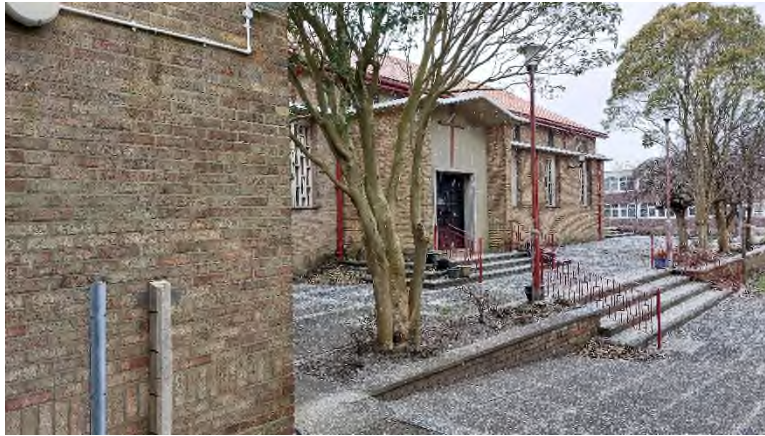
- North side:

A large, terraced area of granite setts picking out a rectangular pattern with precast concrete flags within, with occasional mosaic or granite set squares, which are part of the architect's original design feature. They are somewhat undulating now. Whilst not yet a trip hazard, if they are not maintained, they will be in the future.

The north retaining wall is in fair condition, though there are some slabs missing at higher level.

Recommendation: none

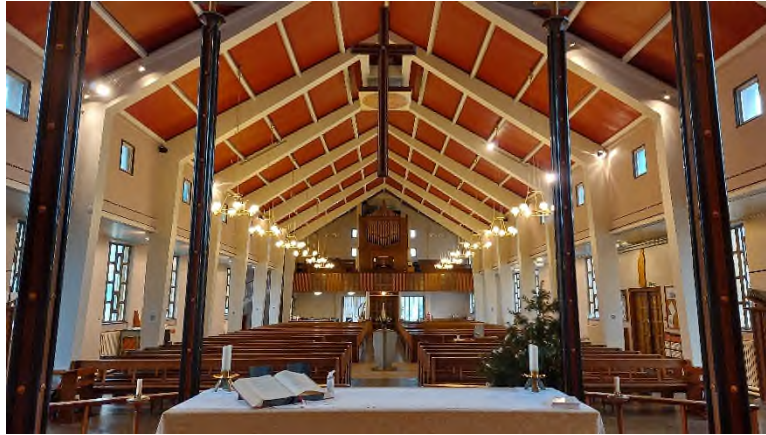
The nave has pre-cast concrete portal frames and these are sub-divided by purlins with a fibreboard ceiling between the purlins. The fibre board was to provide some acoustic property and a modest insulation (there is now additional roof insulation). There is the odd spot of water damage from the past.

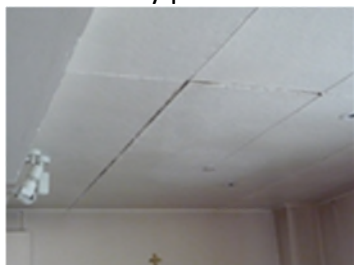
Ceilings under the balcony are suspended fibre board panels and uneven

Recommendation: none

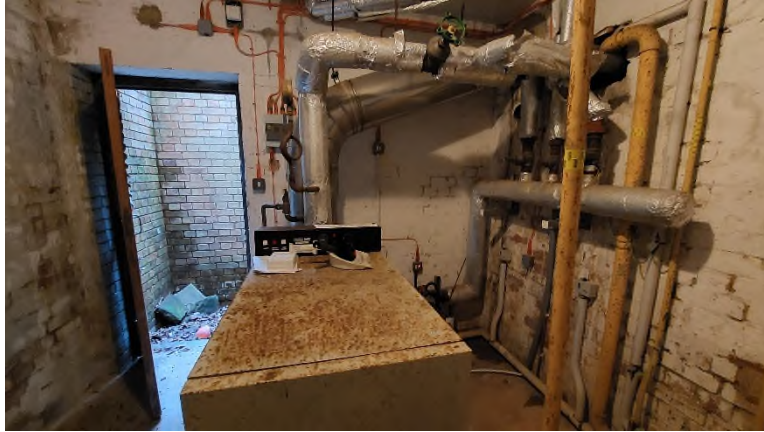
- **Boiler Room:**

- Ceiling – painted over panelling – fibreboard perhaps (no asbestos declared the church).
- Walls – walls and brickwork have been painted over with some of the decoration failing. No change since last QI
- Floor – concrete and patched slightly.
- General – the room contains Hamworthy Broadstone boiler with expansion vessel and Grundfos pump. The room is dry and has a submersible sump pump reported to be working.

Recommendation: none
