St Cuthbert, Redmarshall

Quinquennial Report

18th January 2024

Sarah Harrison RIBA

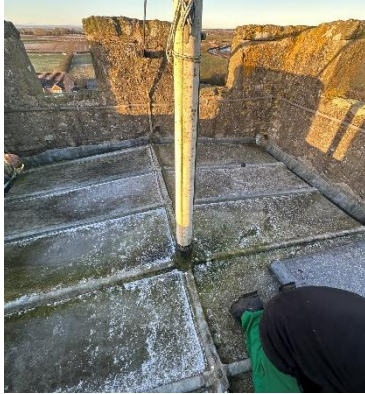
Figure 1- Tower roof

6.1.1 Ancient low ridged lead with continuous box gutters to N & S falling through holes in the W elevation onto the unlined tops of two stone outshoots (reported as gargoyles in last QI). There is a very low drip joint E of centre on the south side, corresponding to the stone decay inside. A similar step at N gutter is closer still to the E end, making the main length about 3.5m long. As previously reported, the lead lengths are too long by modern standards, but the falls are ok, and the gutters currently seem sound, though staining the beams beneath denote past issues. They may stay sound provided they are kept clean of silt; the timbers below should be checked regularly.

6.1.2 Lead roll joints at ridge and between six bays of moderate size. Reported repairs to overlaps near NW and SE corners appear ok. Cover flashings in shorter lengths into parapet appear sound.

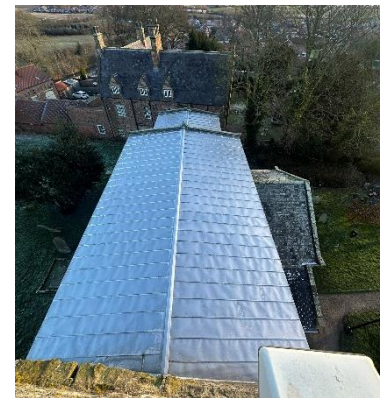
Figure 2- Nave roof from tower

6.2 The **Nave and Chancel** roofs were re-covered in 2012 with standing seam stainless-steel. The lead cover flashings embedded in the irregular stonework were retained and appear sound. The roof has some rippling, as expected with long bays of stainless-steel.

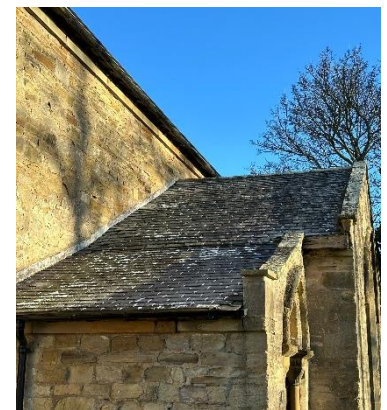
Figure 3- Porch and S Chancel

6.3 The **southern Chapel** has green Westmorland slate with lead soakers and cover flashings against the nave. Mortar fillets against the gable watertables. Ridge looks to be bedded stone. The entire roof is very moss covered, several slates are slipping and it has reportedly been in a similar condition for some time. It is due to be replaced in the near future which is necessary.

6.4 The **Porch** roof is a continuation of the chapel roof to the west and is in similar poor condition, slates at the slight angle change are lifting and slipping. As reported at the last inspection, there is a risk of decay in the SW corner battens, these and all other timbers should be carefully checked when the roof coverings are stripped. The small area of fascia/soffit is also rotten and requires replacement.

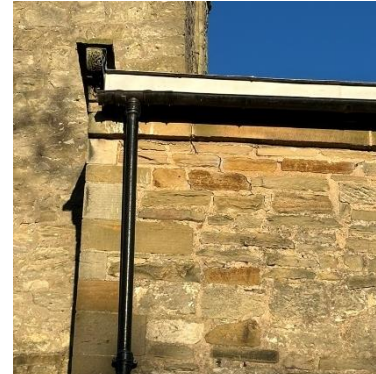
Figure 4 - Gutter to S Nave

7.2 The overall condition to the Chancel and Nave are ok, apart from some staining and rust now beginning to show at joints. To the west end of the S side, the gutter end is dropping slightly.

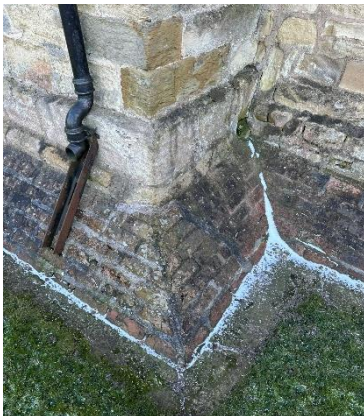
Figure 5 – Brick Plinth

8.7 The brick plinth and trench all around the church may have been added to keep the base of the walls dryer by throwing rain off. It may also protect the tops of shallow footing stones exposed when the trenches were dug. Clay airbricks inset in the slopes may be meant to ventilate under the bricks or more likely through the walls and under the suspended floors. On the shady N side some algae shows that the stone course above the bricks stays damp. Any benefit from the brick plinths will be lost if they are not kept pointed and the trench drainage clear.

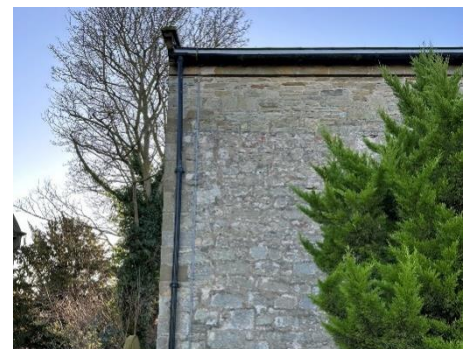
Figure 6 – Chancel E gable movement

8.1 The very slight cracking between the chancel E gable and its N and S walls is still evident, no historic photos are provided therefore unable to confirm any changes. However, there is still no evidence of this internally and therefore deemed to be settled.

8.5.4 Monitor the east gable at lower levels and above window for replacement in 5-10 years.

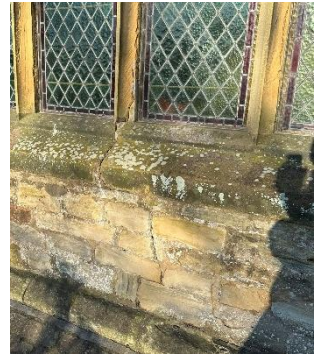
Figure 7 – S Chapel crack below window

8.3 There is a crack to the S chapel on the S façade beneath the window. This does not appear to have been reported at the last inspection and therefore should be monitored for any progression.

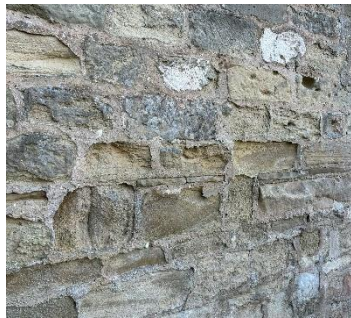
Figure 8 – eroded stone to N

8.5 The stone is eroded across most facades, there are also areas of stone erosion which is moderate to severe. Therefore, limited stone replacement to the following locations needs to be considered:

8.5.5 Isolated stones in the lower N nave wall, where some previous replacements are evident.

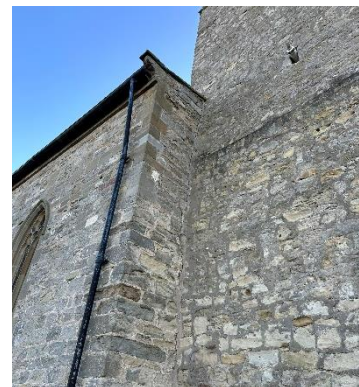
Figure 9 – N joint Tower to Nave

9.3 As per item 8.6.2 regarding areas requiring re-pointing, there are cracks between the tower and the nave W gable at both sides, slightly more pronounced at the N side where it also appears the gable has moved N a little. It was thought to have stabilised at the 1996 inspection and still not visible inside following the 2008 decoration, so movement is deemed to have stopped.

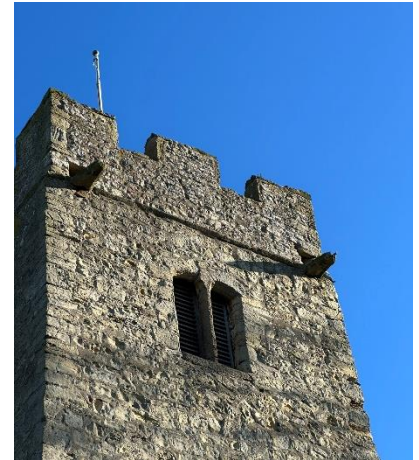
Figure 10 – West tower elevation

9.2.1 **Top stage** (to string course) – fair but some open joints to N and W sides. Stone erosion is particularly bad near the rainwater spouts, worse at the southern spout. Flush parapet coping stones deeply weathered and reportedly very ancient. Weathering is not taking its course as pieces of delaminating stone removed at the time of inspection. This stone should be regularly monitored to ensure no loose pieces pose threats of falling.

9.2.2 **Second stage** (from string course to step in masonry) – Fair but scattered open joints and decayed stones including four SW quoins deeply decayed. When access is provided for other work the upper string course joints should also be pointed. The mullions to all facades have eroded and now look to have open joints to the base of the mullions at the N and W sides, the E was unable to be seen.

9.2.3 **Bottom stage** (below step in masonry) – Western window has a cracked cill, cracking also to the southern edge of the lancet alongside open joints to top (corresponding with inside condition at item 9.7)

9.4 Minor stone replacement will be needed soon at the tower lower stage S and W sides. The hard pointing would be better removed and re-pointed in lime mortar to delay decay and help assess whether movement continues to the west side.

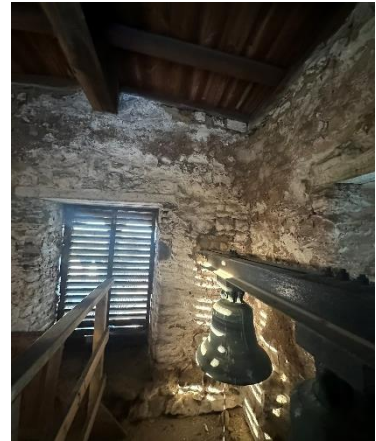
Figure 12 – Belfry beams

9.5.1 Pair of steel C-sections built into walls for three fixed bells with hand chime hammers inside. Not in Diocesan Bells Catalogue but PF Ryder reports that one is C14th-15th and the other two may also be medieval. The steels are painted but the narrow gap between them would be difficult, if not impossible to coat.

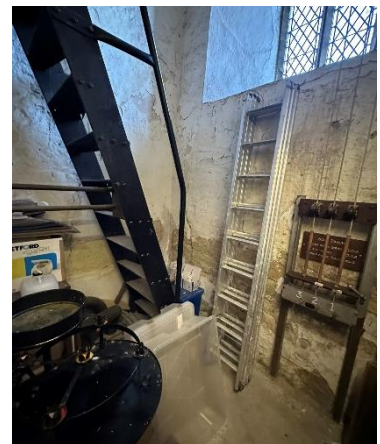
Figure 13 – Bottom stage ladder

- 9.6 **Mid stage** - whitewashed stone, all eroded with raised mortar, worst and more recent erosion at upper N wall and NE corner. Steel ladder up to belfry, secured at base and top.
- 9.6.1 A small louvered vent opening at S, timber aged but all louvres remain, one shows sign of former rot and insect attack and the frame is in poor condition.
- 9.6.2 Gas boiler on N wall with balanced flue punched through a former vent opening and steel heating circuit pipes down to vestry. Another vent to W side has air bricks which appear to be stacked loosely to the outer face, these should be fixed/replaced.
- 9.6.3 Opening in wall to the west has been blocked off, the area is full of loose debris.
- 9.6.4 Softwood floor with hatch and safety rail which is slightly loose. Flooring has some small gaps but not causing an issue.

- 9.7 **Bottom stage** contains a tall vestry/ storeroom with the organ in the tower arch (Unmolded arch on plain imposts). The room is again whitewashed, the W window has cracking to the head and loss of plaster/ decoration at lower level. This does not all appear recent but was not commented on in last report. A steep steel ladder with alternating treads. Heating pipe distribution from above. Room also contains the Distribution Board (DB) and has a safe built into the wall. It is full of lumber, this should be cleared, specifically to the base of the ladder to upper stages.

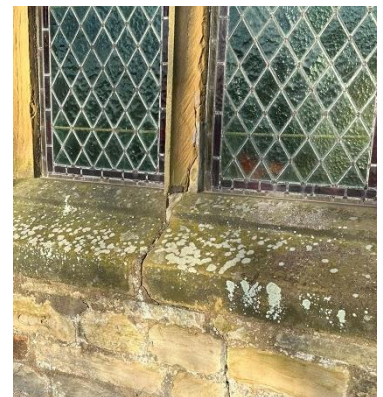
Figure 14 – S Chapel mullion

- 10.1 To the South Nave, at the western most lancet, the stone reveal is delaminating and needs to be monitored. The window also has a rusted hopper.
- 10.2 The South Chapel window's central mullion has a split at the base which continues to the cill and stonework below. In comparison to the photographs included in the last report there has been little to no worsening of the mullion condition, but it is unclear if the joints below the cill were open. The previous inspector also suggested it could be due to a rusted dowel. Replacement was also recommended. There are also slight open joints to the hoodmould and tracery which require pointing.

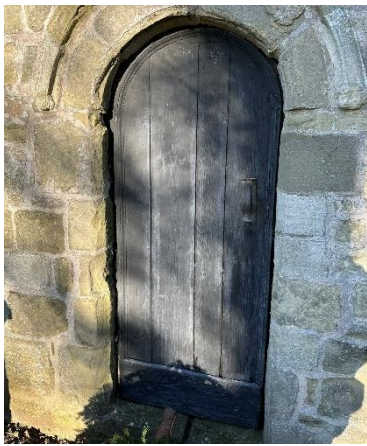
Figure 15- Flower Room door

11.2 The Flower Room outer door is boarded over inside. This is an ancient door, which has seen a repair to the base, to replace rotten boards. The paint is holding up but should be re-coated soon.

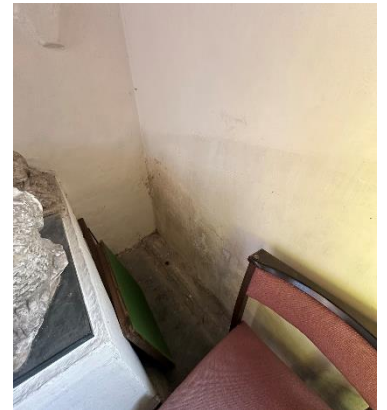
Figure 20- Damp to S Chapel

14.3 The last QI reports that in some areas not all the previous emulsion paint could be removed so there may be future peeling due to incompatible substrates. No such peeling at present. The last redecoration appears closer to a breathable masonry paint than to limewash.

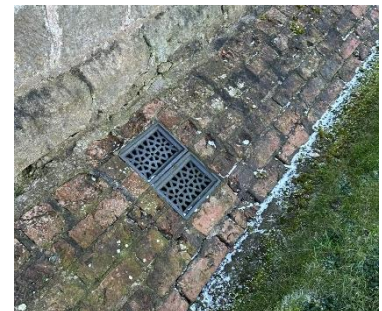
Figure 22- Vents in plinth

16.2 The air bricks in the top of the brick plinths may be ducted through the walls to ventilate the suspended timber floors, there is no access under the floors to check this. Some rain is likely to also enter these air bricks, so the effect is uncertain.

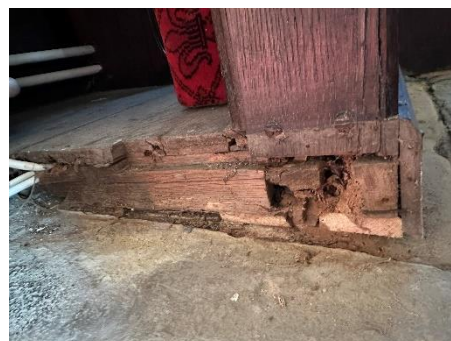
Figure 24 – rotten raised pew platform N Choir

15.2 The base of the northern chancel pew has become rotten, and the end piece is falling off. The general condition of the plinth should be checked for further rot.

18.4 Stone flags at the passageways and suspended timber under the pews to Nave and Chapel. The suspended floor under the N choir stalls is dropped close to the N wall which suggests decay in the joist ends where they span onto the wall, also linked to item 15.2, as pictures at figure 24.

28.2 The N choir floor still needs to be opened up to investigate the apparent decay, as recommended in the last report. There is no evidence that this has been carried out.

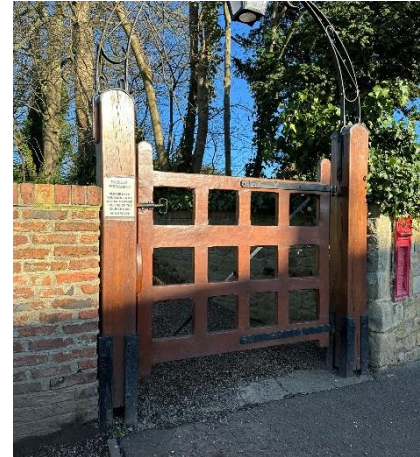
Figure 27 – Gate to S

27.3 Fonner oak gates and heavy gate posts now replaced in softwood fixed into shoes made of steel angles to keep them away from the damp ground. Shakes (natural shrinkage cracks) have appeared in the posts but may not quickly lead to decay because small lead caps have been fixed to the rounded post tops, under steel overthrows for lights. Clear and coloured stain or a form of varnish will need to be maintained.
