Diocese of Durham

St MARY SEAHAM

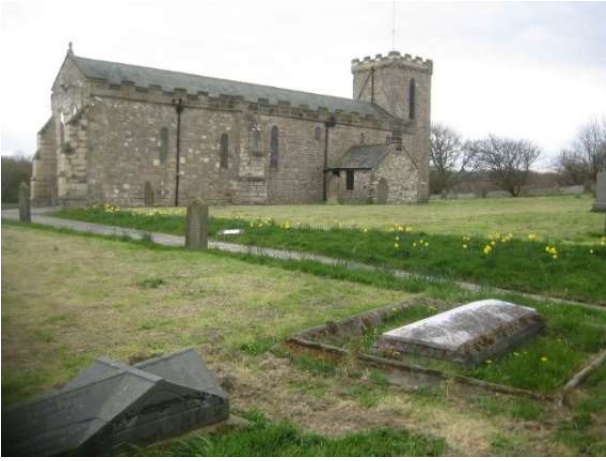
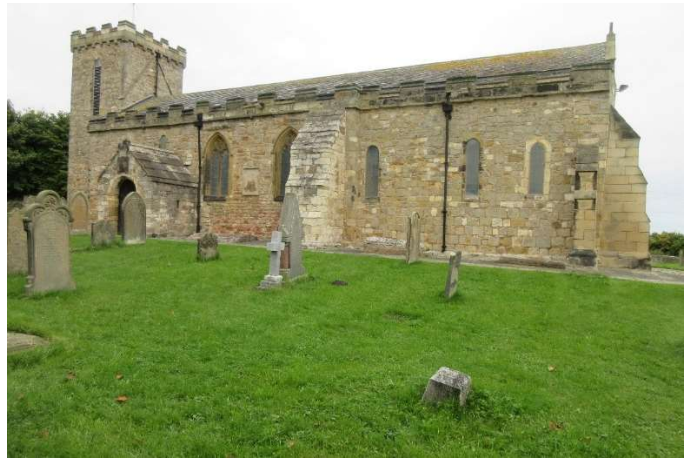
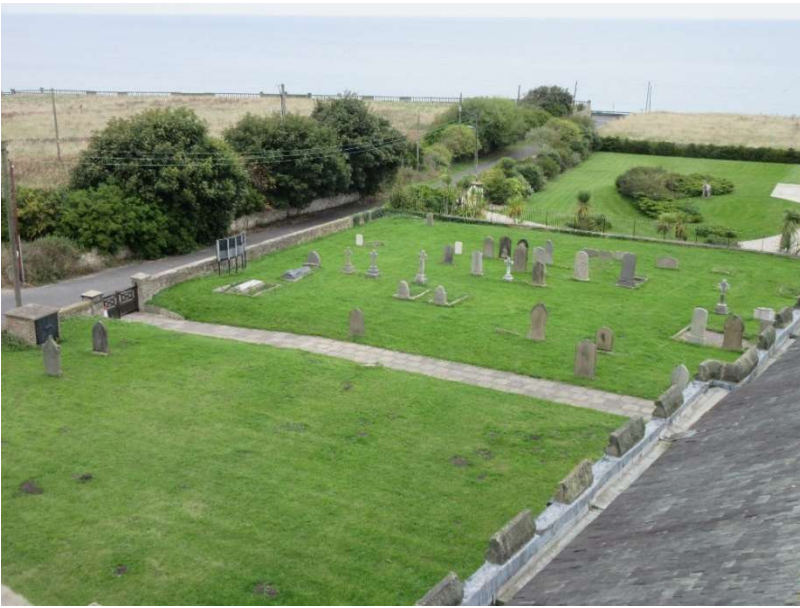
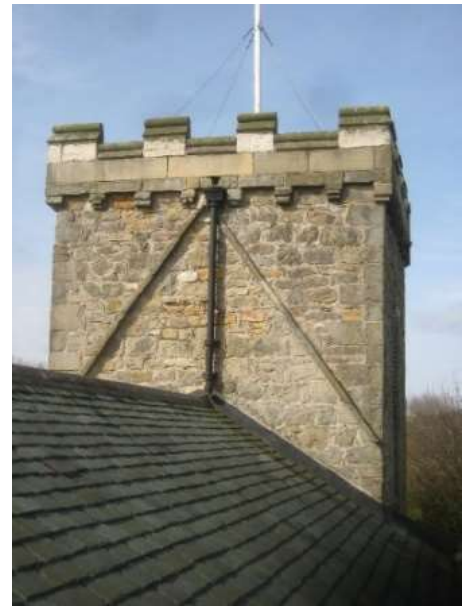
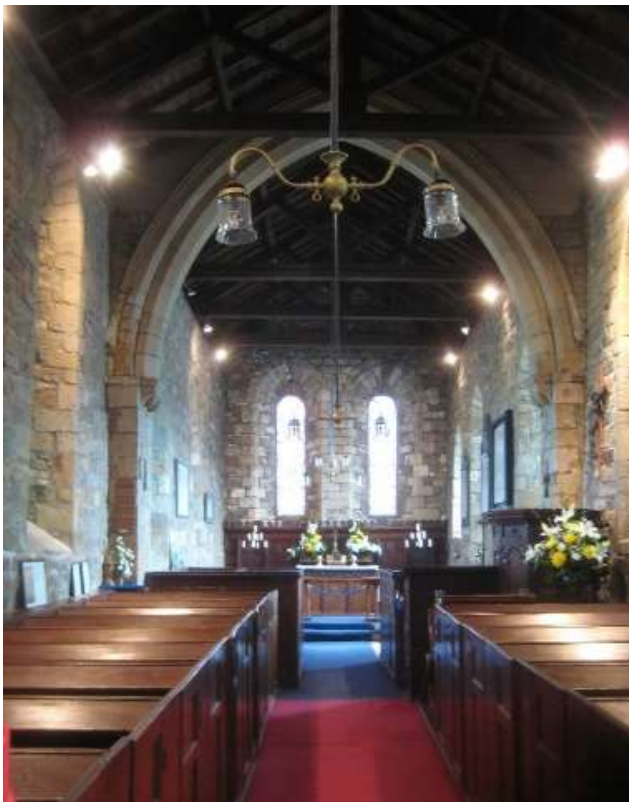
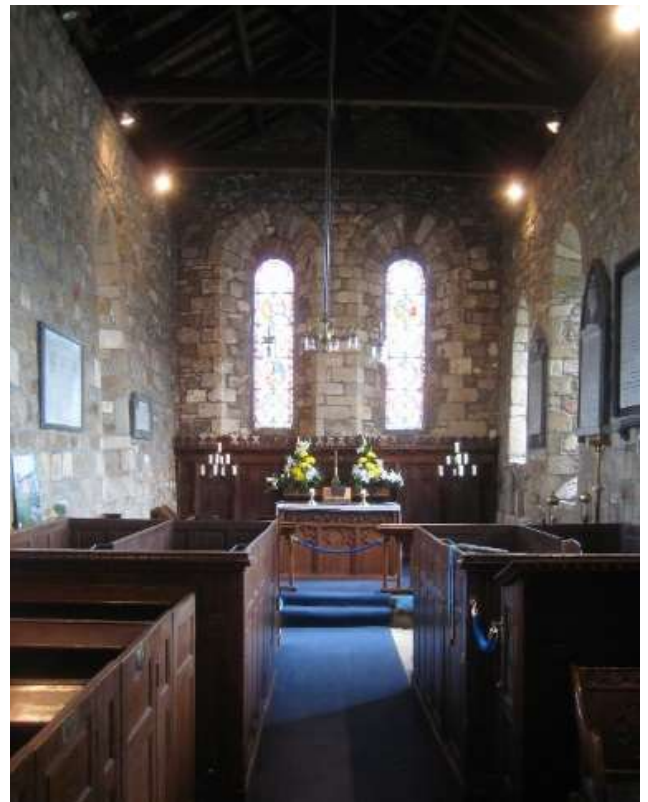
26 GROSVENOR PLACE NEWCASTLE upon TYNE NE2 2RE
tel & fax
0191 281 2559

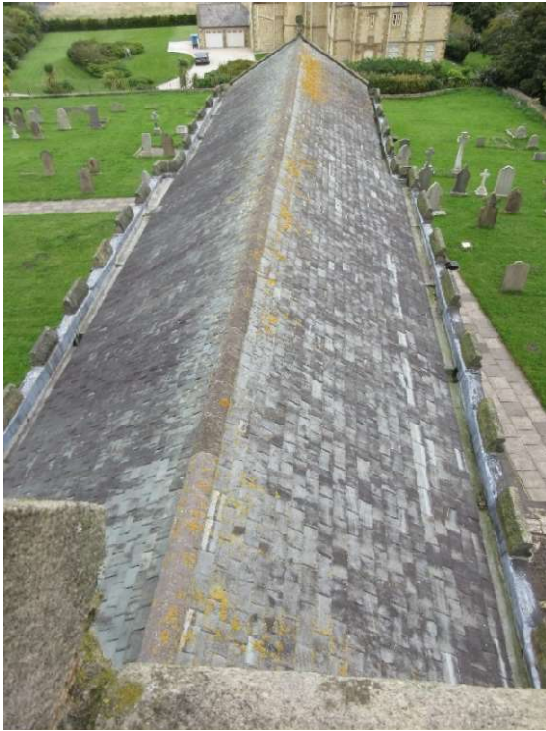
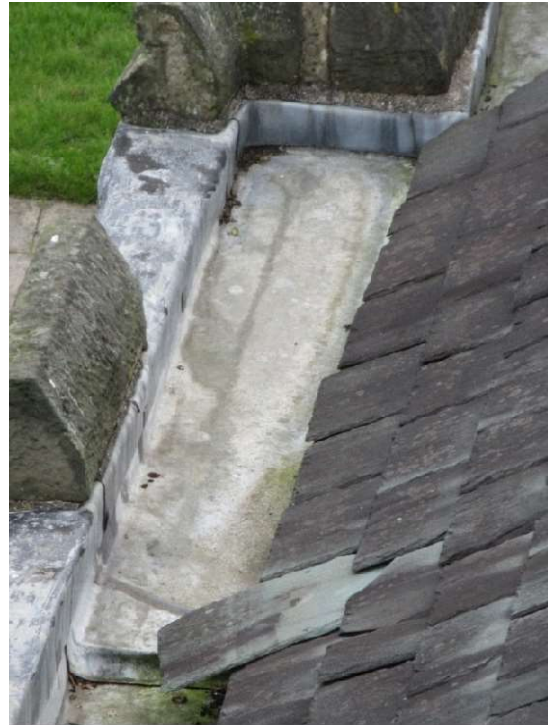
Slipped slate at NE Nave

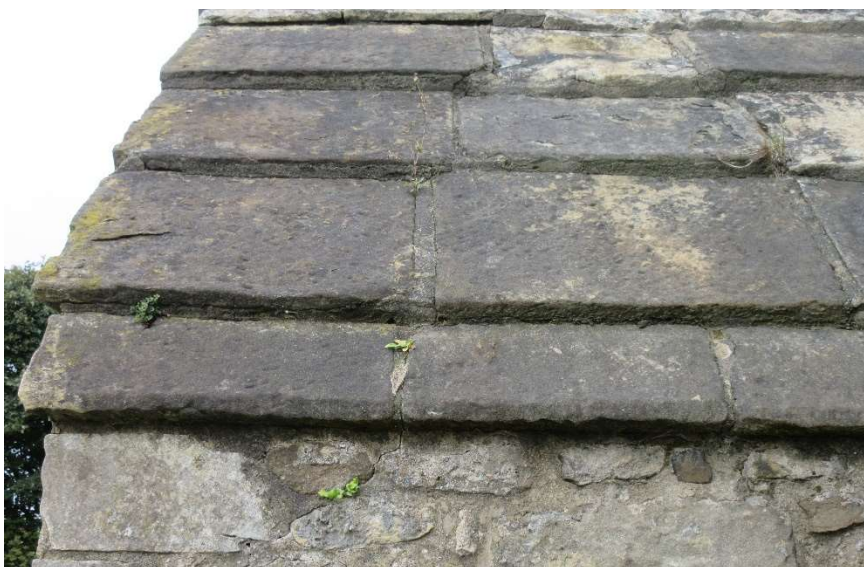
Rainwater System, Drainage

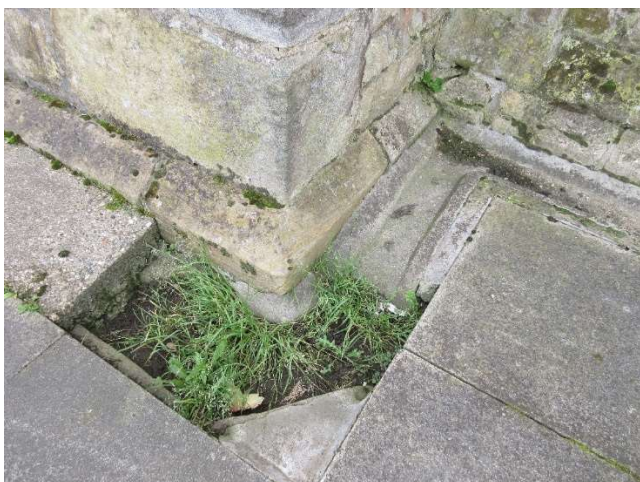
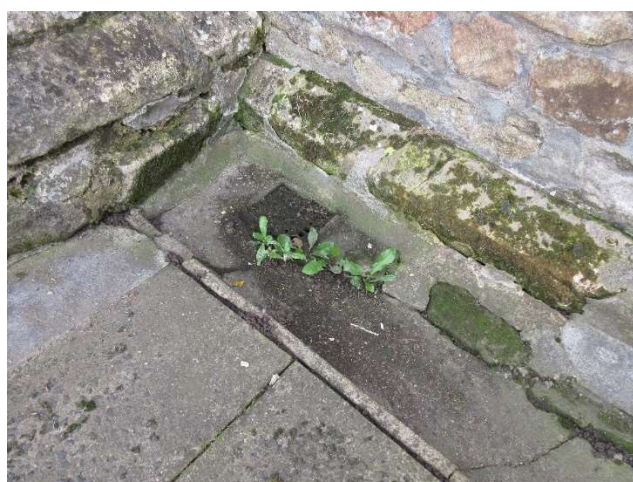
24. Not all gullies are clear. It is not easy to clear drains to soakaways but they should continue to be cleared to keep the building as dry as possible.

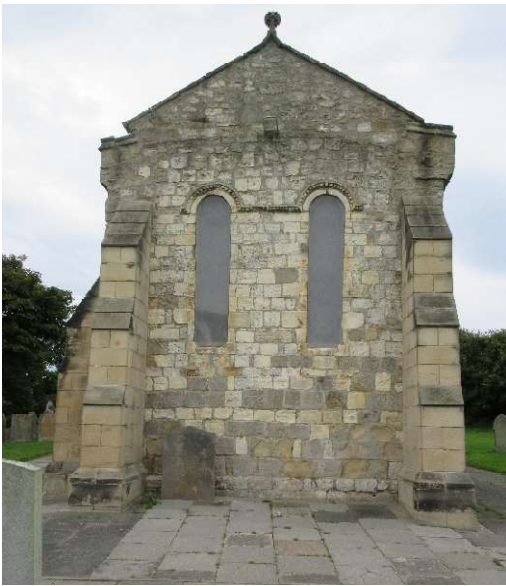
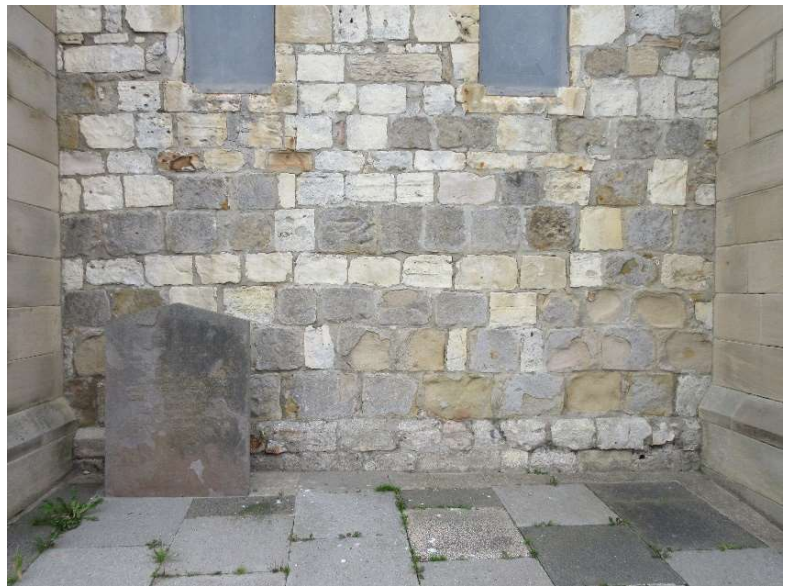
29. **S Chancel** mainly sandstone, similar. Decay in several of the concave corbel course stones under the parapet. Ten sandstones are eroding slightly. Well pointed.

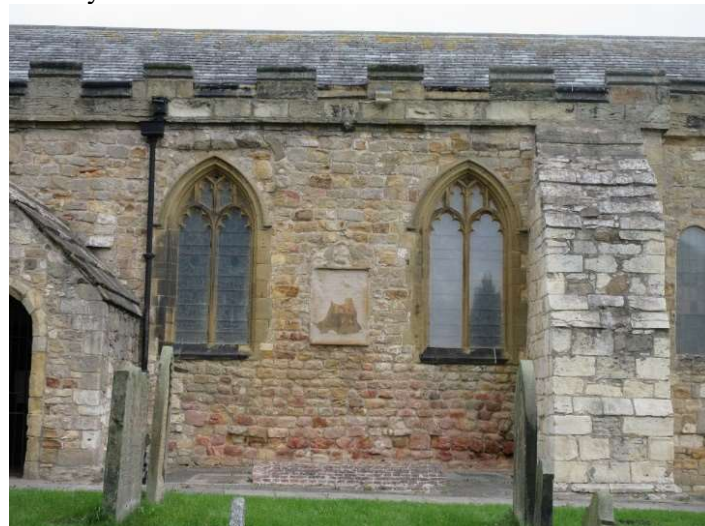
32. Stone debris in the ground gutter due to continuing decay. Worst at bottom E corner where some stone renewal may be needed in say a decade.

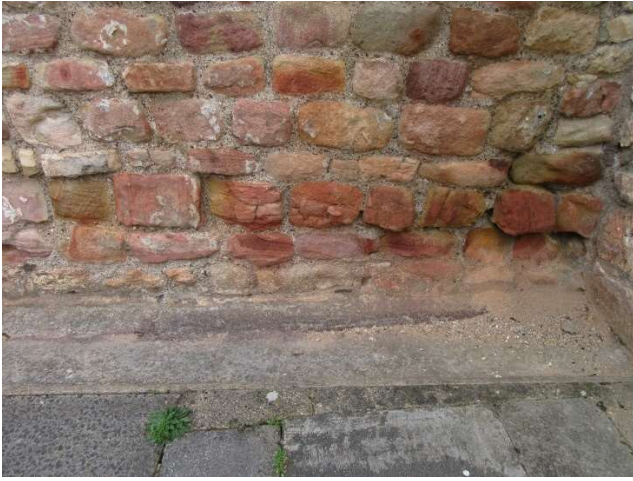
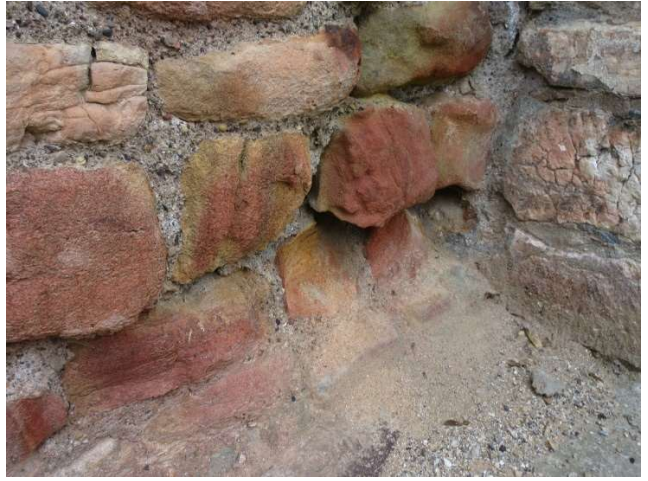
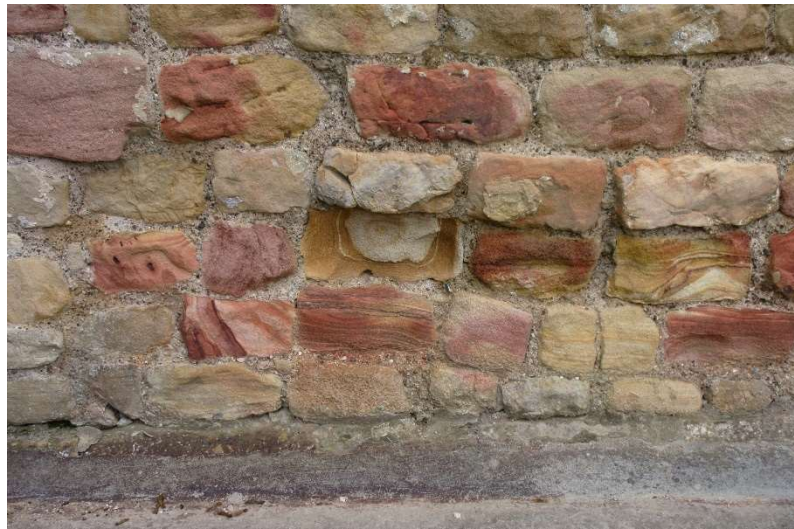
33. Erosion of the large sandstone tablet between the windows continues. Crude cement mortar patches do not preserve the decayed top carving. The lettered surface may be totally lost in a decade or so. The text is known from histories.

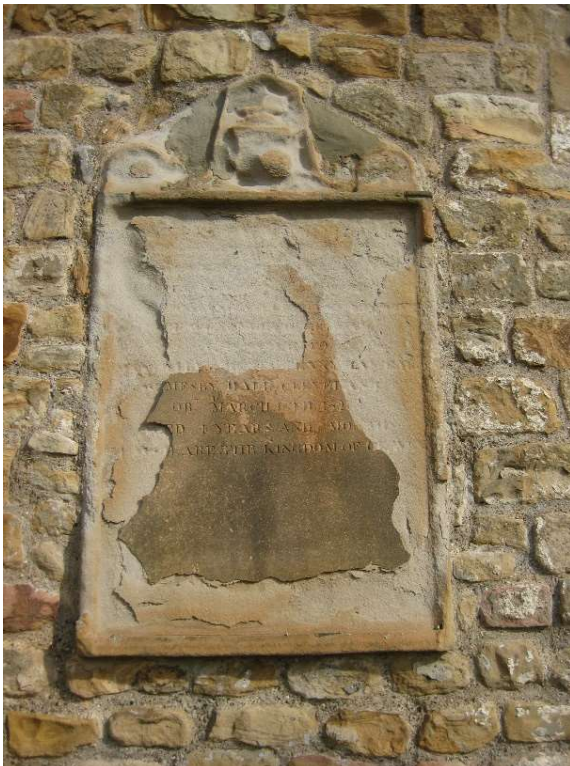
The loss could present an opportunity for a completely new monument or work of art.

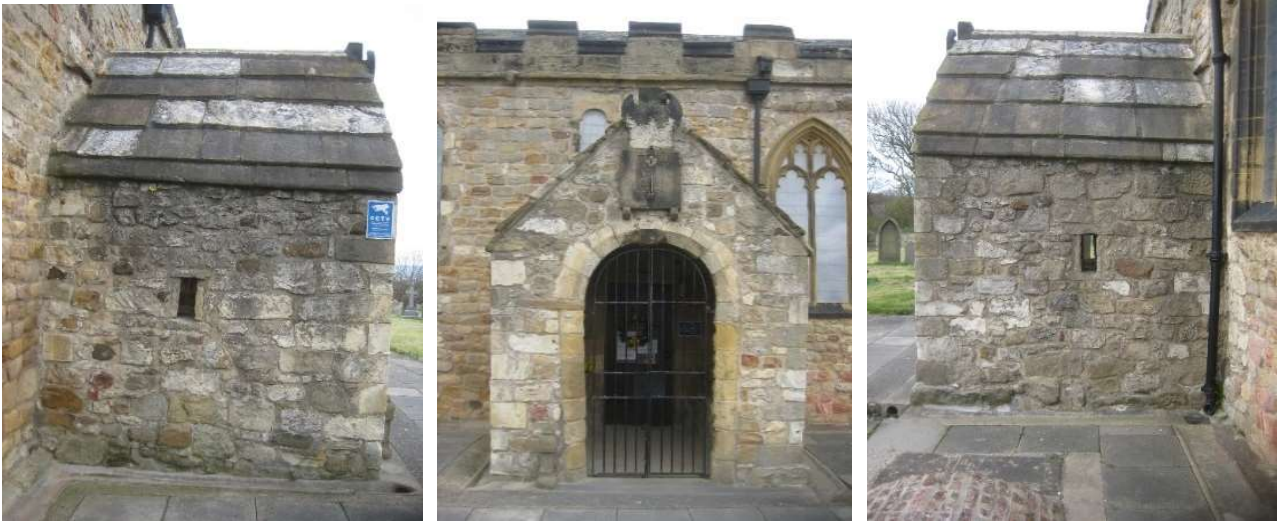
35. Two ancient chamfered stone arches and a modern stone A frame against the Nave support the stone roof.

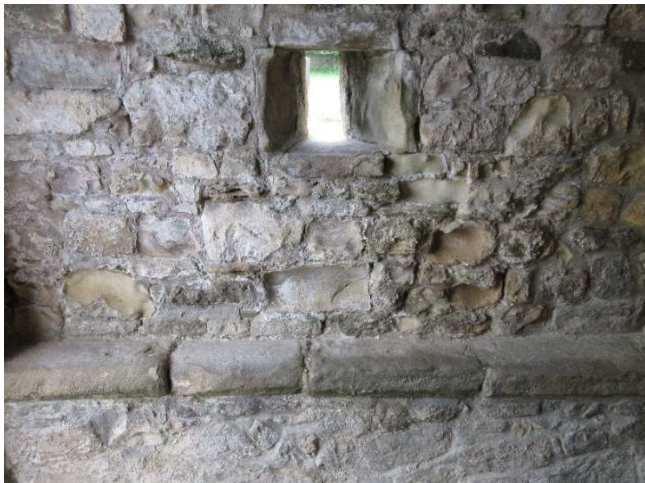
36. Deepening erosion inside. Surface decay especially in E seat and the course above (a hole at one joint is getting larger) and at W between the slit opening and the seat. All reveals at both slit side openings are decaying. Salts inside the W wall suggest soaking by driving rain, perhaps worsened by the small eave overhang without gutter is hastening decay.

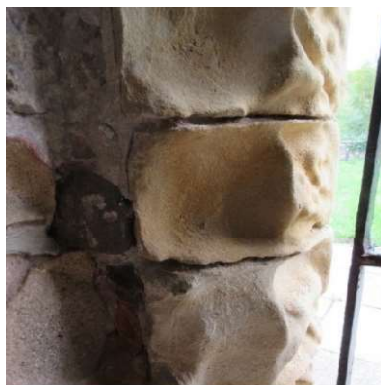
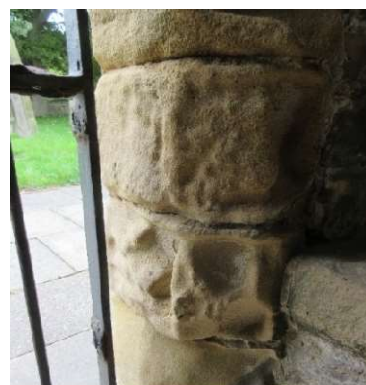
37. Most severe is erosion of the sandstone reveals of the round arched gateway which are deeply pocketed. Stone fragments like flour lie in each pocket with more on the flag floor. Wind swirling through the arch and side slits must make vortices in each stone pocket, the loose fragments grinding deeper into the stones. More joint mortar has been lost, opening the joints and exposed more stone to erosion. In addition to stone repair there is a case to fit thick glass in the side slits to reduce wind scour.

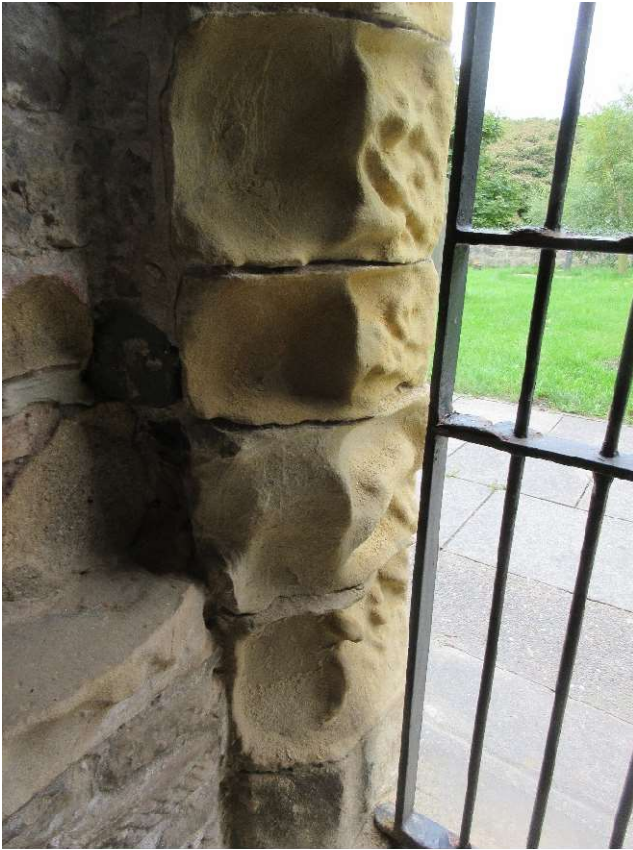
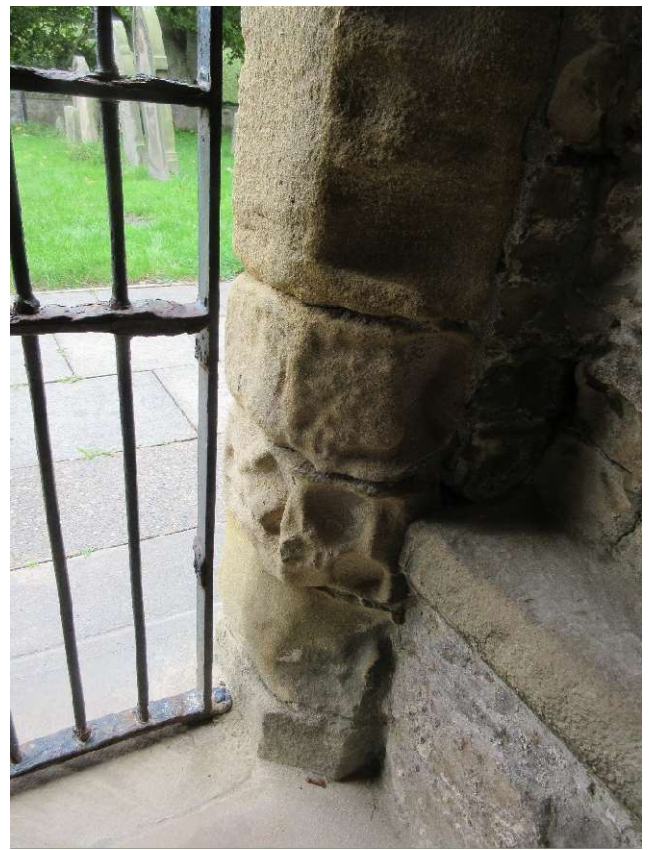
38. Some roof rib stones show surface decay and minor spalling especially at the outer rib.

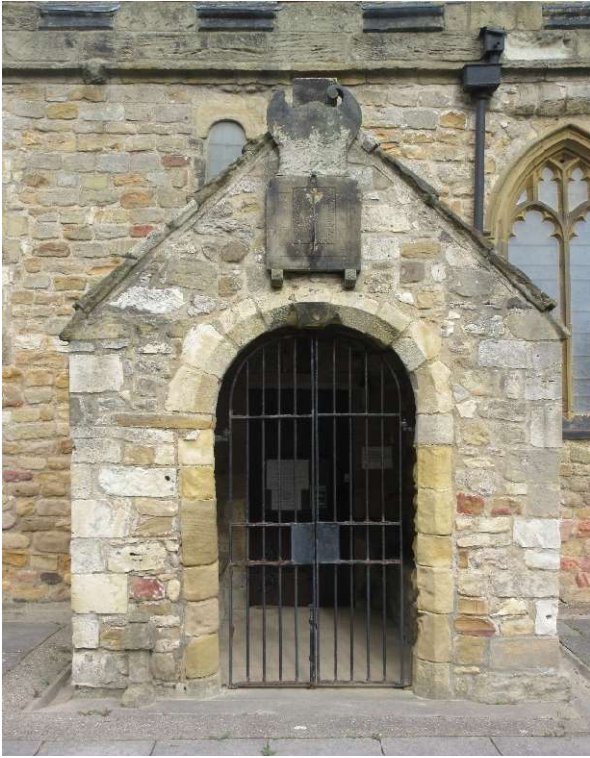
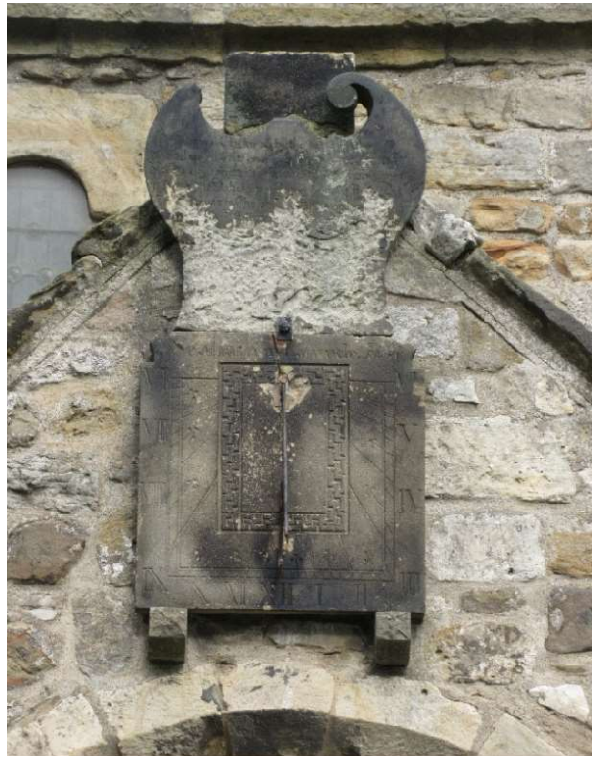
39. A modern replacement sundial over the arch is now cracked vertically at its rusting iron gnomon. Over it an 18th century stone tablet with a broken swan neck pediment, inscribed with a verse (half lost due to loss of surface, unchanged) though it is recorded. The remaining stone surface is blackened and illegible. See also paragraph 133.

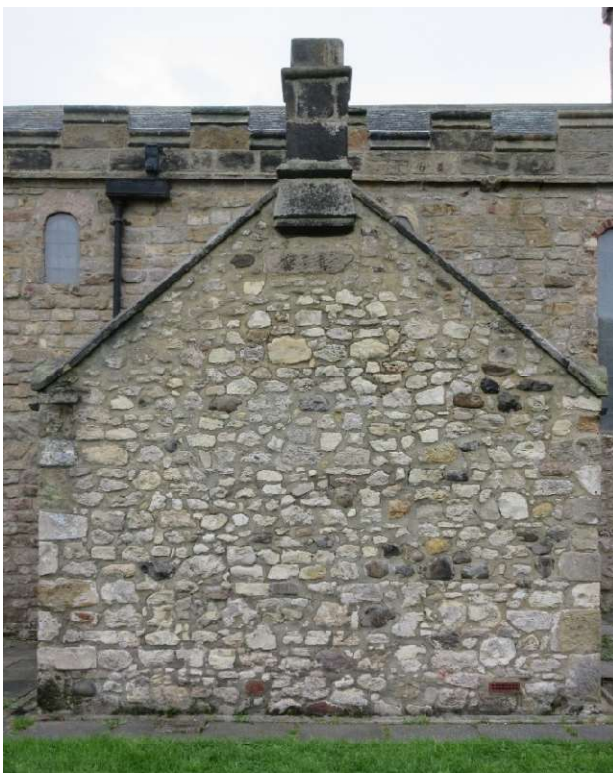
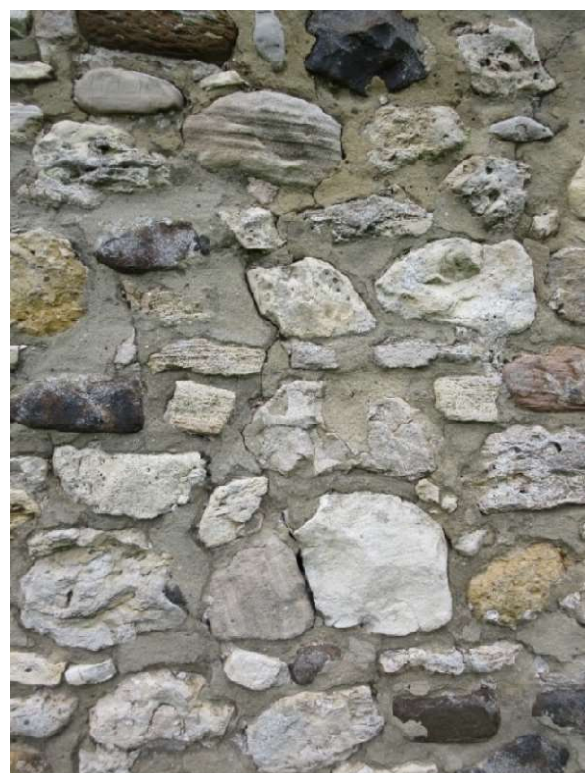
42. **N Chancel** good condition. A very slight crack in the pointed-up vertical crack at poorly bonded masonry close to the E end buttress, no action required.

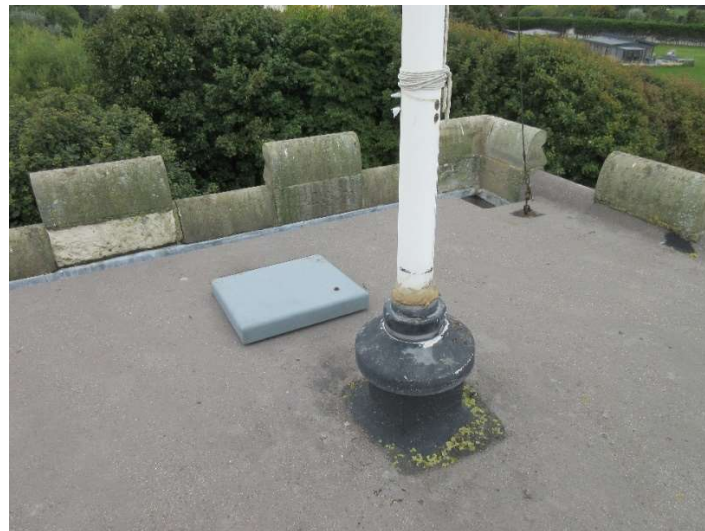
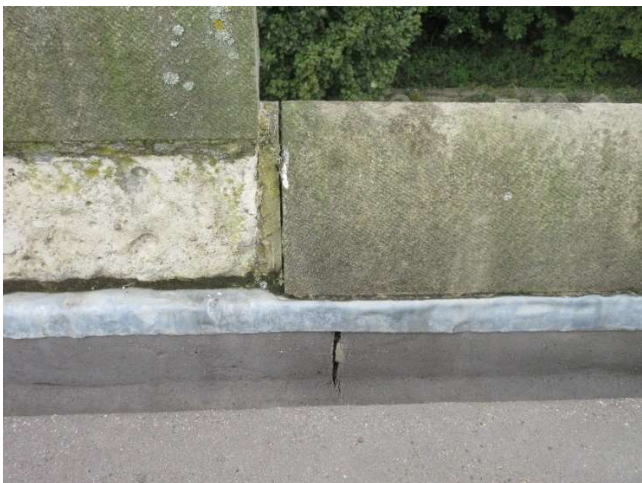
Split asphalt upstand and opening joint
between parapet stones at middle of W side

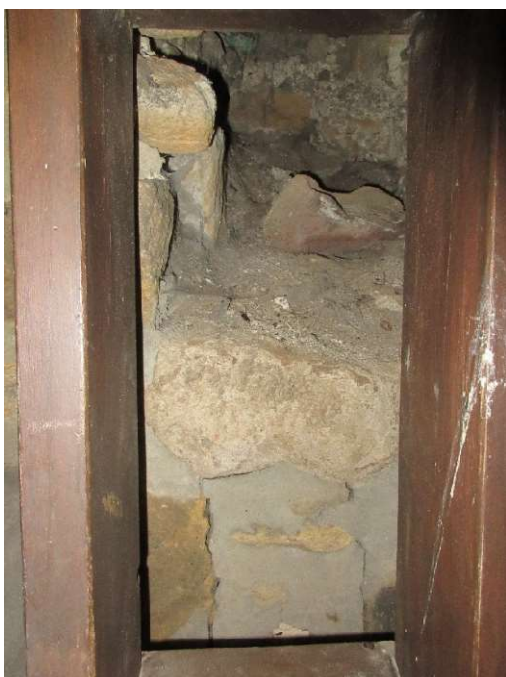
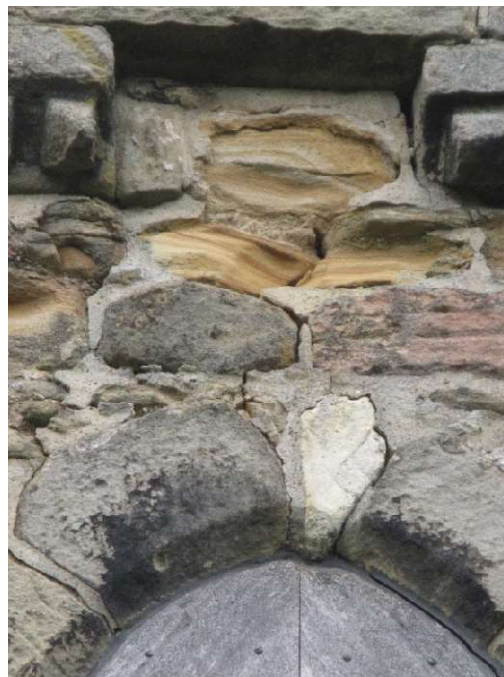
Internal recess and decayed external stones over W arch

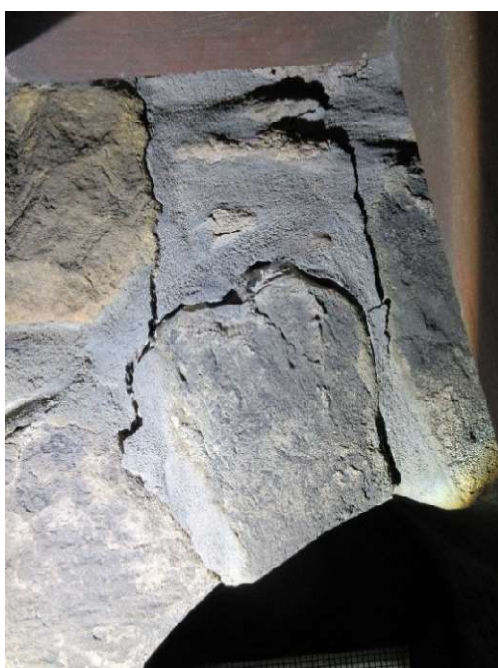
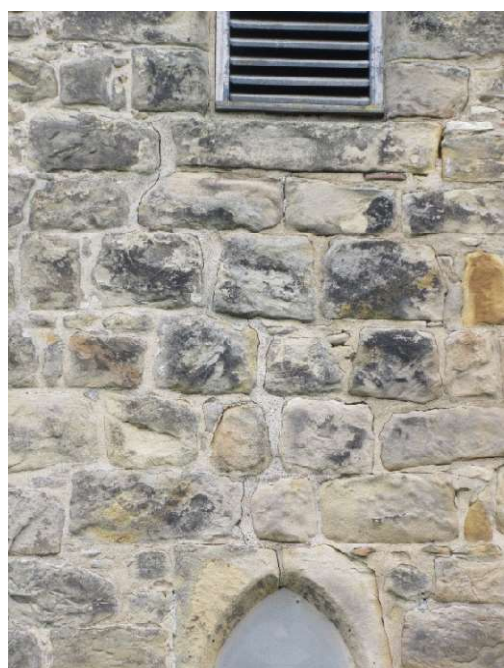
Opening of internal arch over W louveres W side cracked joints between louvres over window

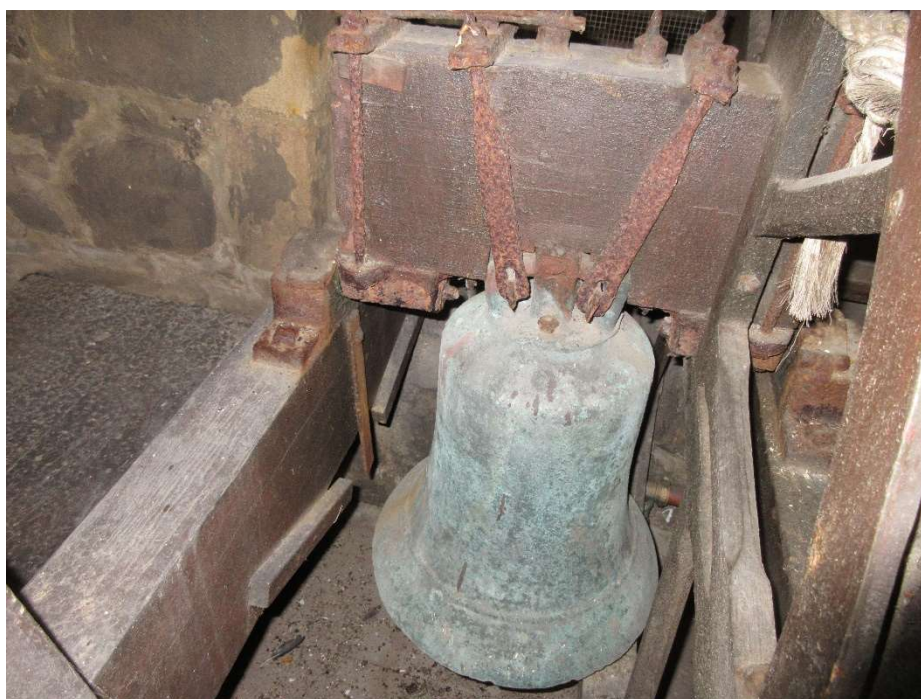
56. The ground floor Baptistry stone walls are bare with traces of whitewash. Varnished ceiling boards are cut out for the heater blower grill. Chamfered arch to Nave with four large nail heads carved at each bracket.

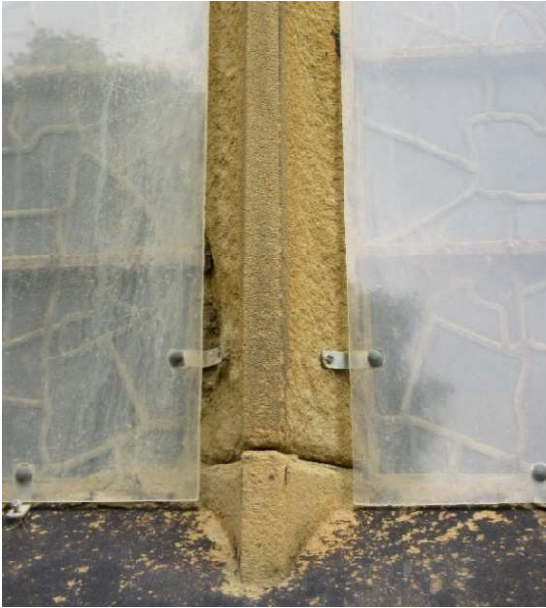
57. E Chancel – two good limestone round headed lancets with dogtooth hoodmoulds and decayed horizontal connecting mould.
58. S Chancel – three lancets, two with plain round heads cut from single stones which may be saxon from the S Nave reused in the extended Chancel. Cills patched with slate and mortar, loosening at the centre light.
59. S Nave
Two Victorian yellow sandstone traceried windows good except slight surface erosion and one split beginning under the E sides of the arches and hood moulds and down the E reveals. Joints opening. Some decay in both one piece mullions, especially at bottom of W mullion.
One long and one short lancet with plain round heads, carved inside. Very ancient, sound.

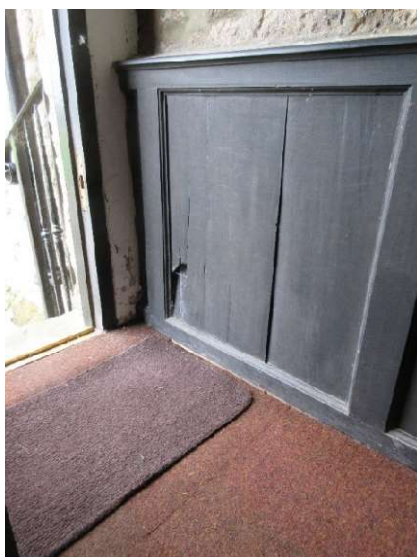
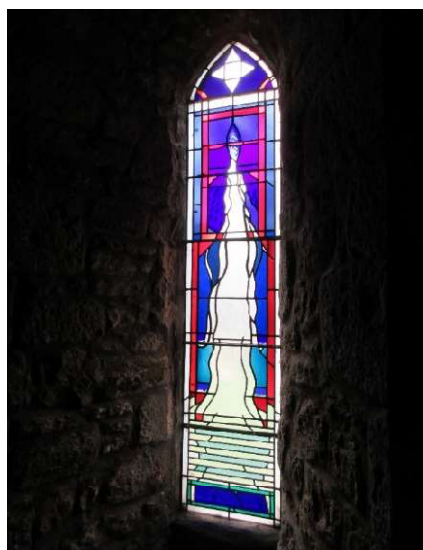
80. In Vestry plain stained Victorian dado panelling. At least against the earlier Nave wall (between the two doors) decay has weakened a panel which is now broken through. Other panels likely to be affected.

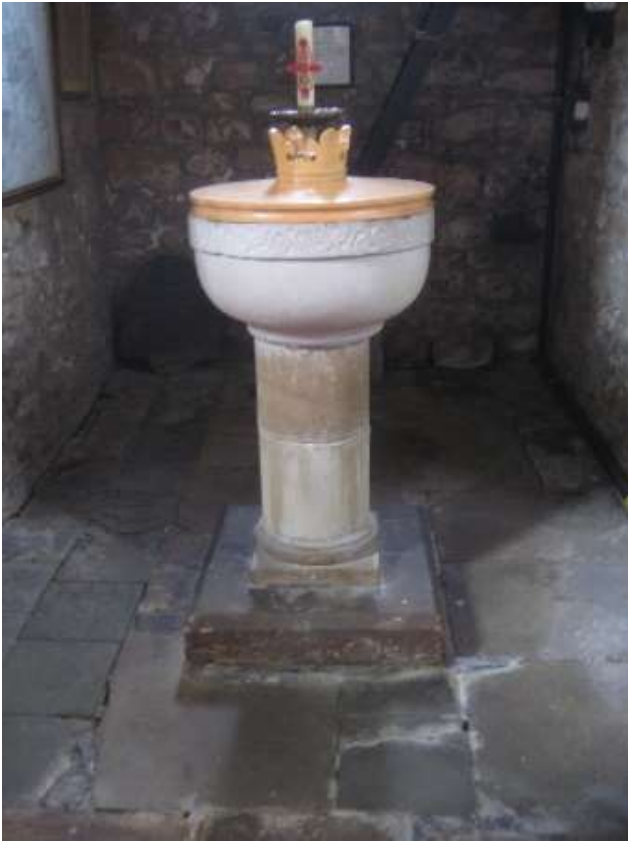
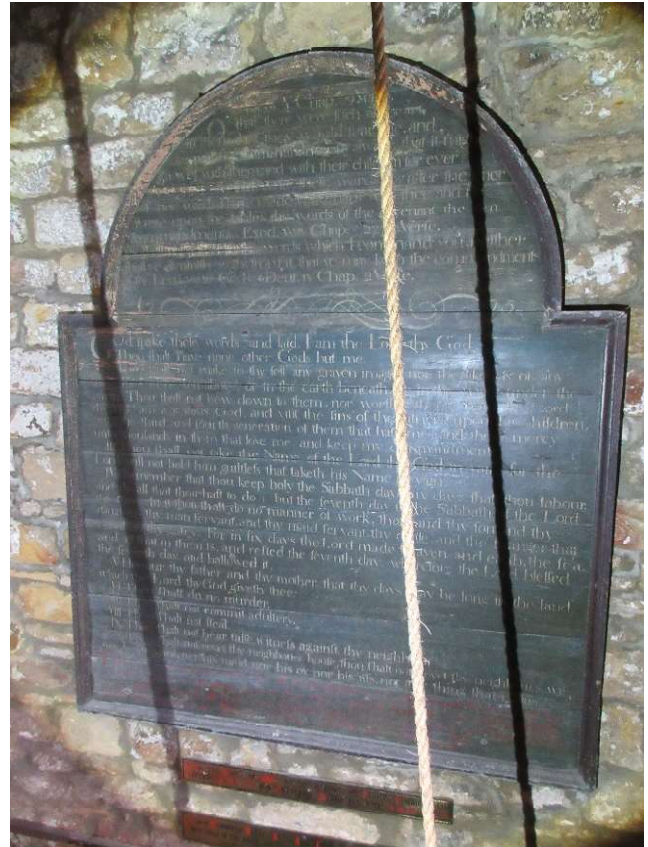
102. A circular stone pedestal font with a 1997 maple cover. A Jacobean cover is set aside. Painted Ten Commandment board 1755 in the Baptistery.
103. Marble and mosaic Great War memorial and three brasses in good condition. Five stone tablets in Chancel in good condition except Marchioness of Londonderry 1920 slightly crumbled at edges of frame and paint lost from lettering. The tablet appears to be artificial marble composition.
104. Small organ by 'Positive Organ Co. Ltd' London. In use, maintained and said to be in good condition. A small electric blower with a trailing lead to a socket.
105. At Vestry a table is built into a settle fixed to W wall and too inaccessible to examine. The W wall is vulnerable to damp due to high ground level without airbrick but the gutter has been improved.

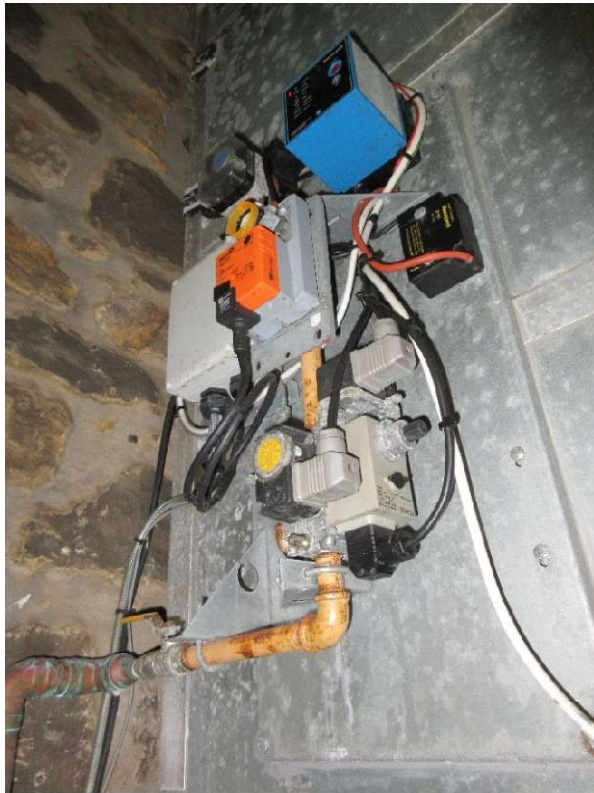
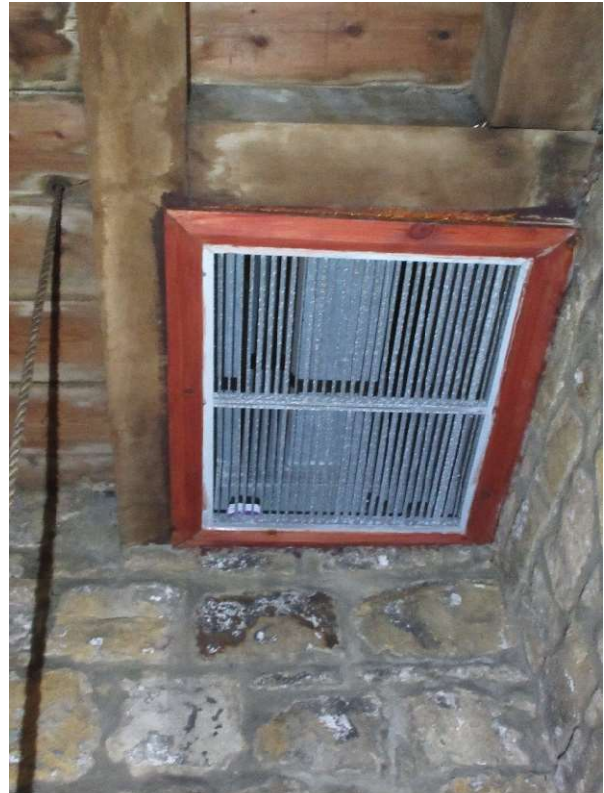
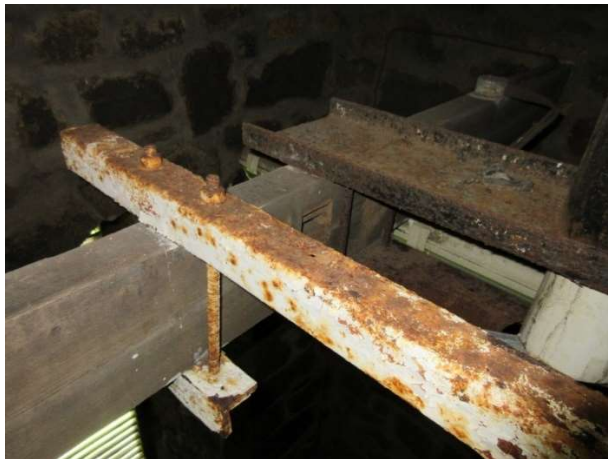
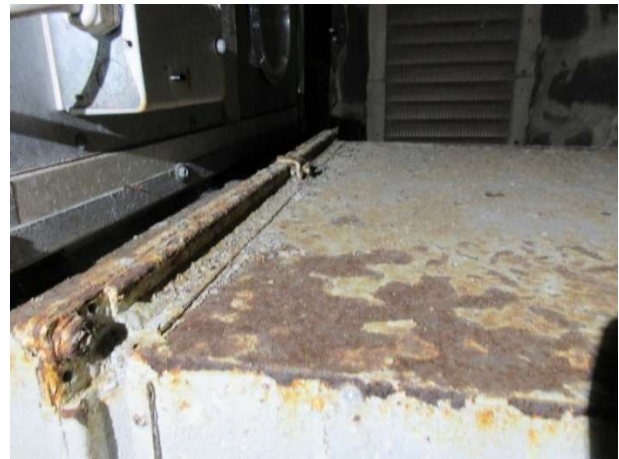
107. The unprotected metalwork of the ducting and suspensions exposed to salt-laden air for over 20 years continues to corrode.
It may be worth determined stripping of paint and rust, treatment with rust inhibitor and high quality repainting to keep it going perhaps another twenty years. If not tackled the rust may lead to heating failure.
108. Supplemented by an electric tube heater under a rear pew with wire guard and red pyro supply cable drop down the stone wall.

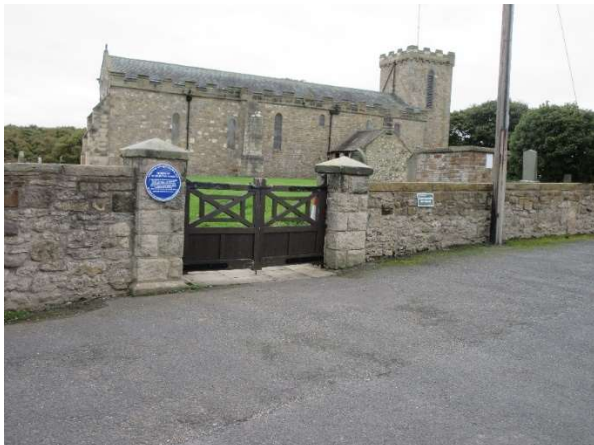
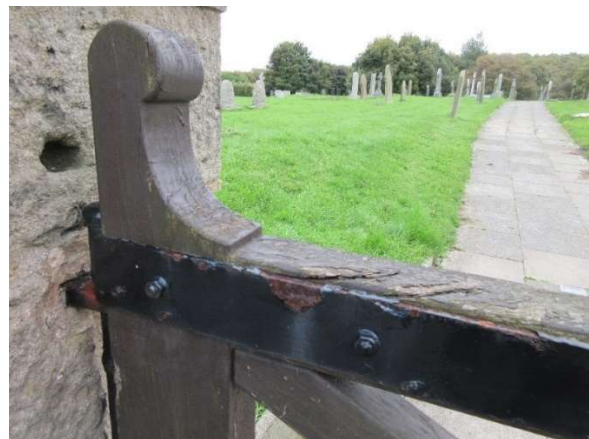
122. Scattered good headstones of many ages. Simple concrete flag paths. A metal sign with good lettering. A blue plaque fixed to a gate pier refers to 'Seaham Conservation Area', a non-statutory nature conservation area.

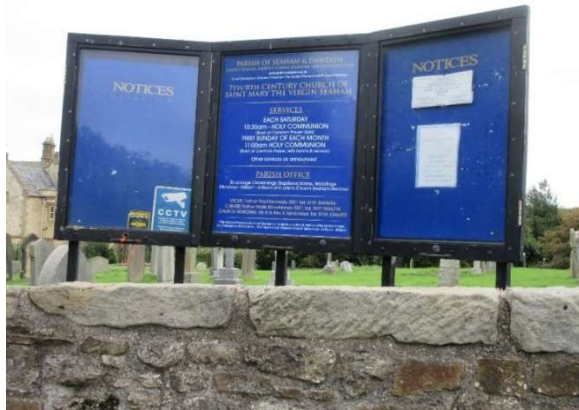
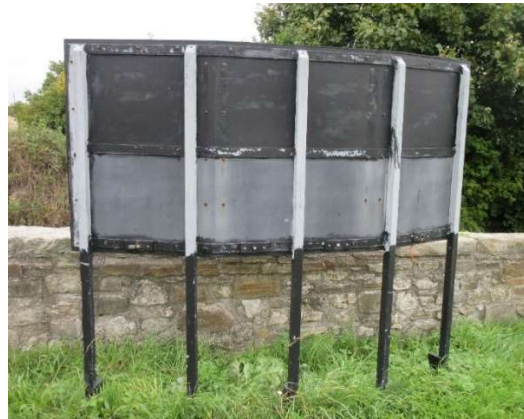
123. By the Nave S wall the top of a brick vault rises from the ground next to a cracked stone reading 'Entrance to the vault'. The exposed bricks and pointing are sound.

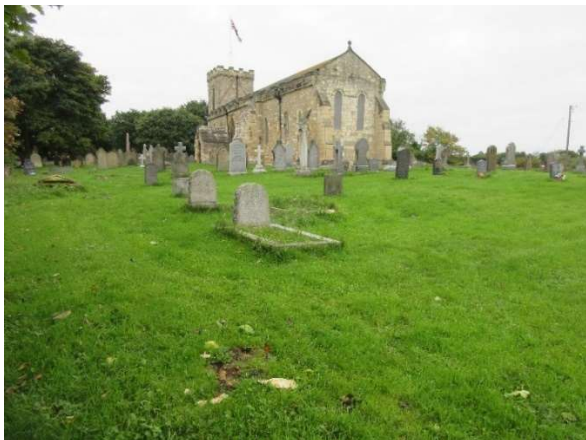
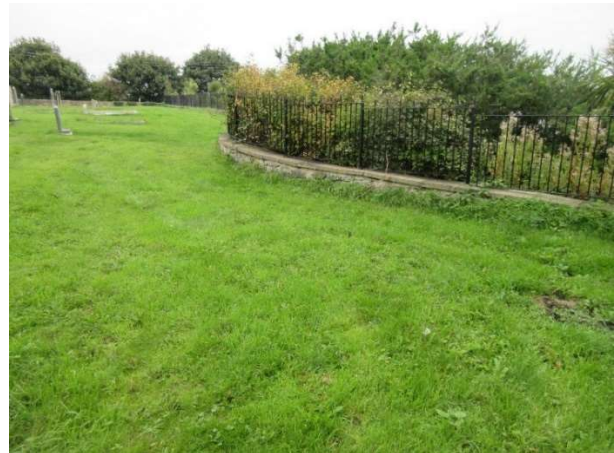
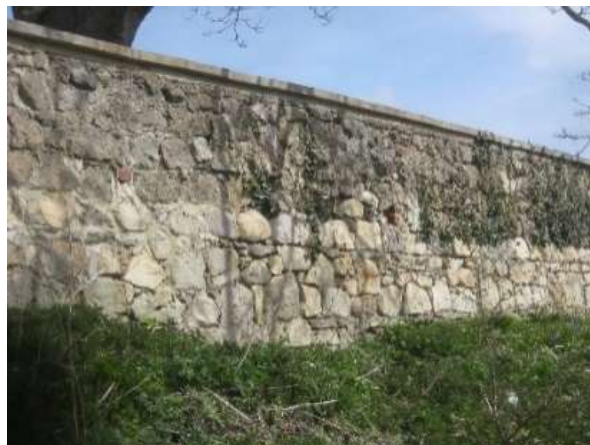
Outside of churchyard S wall in 2015 – now overgrown
