St John's Church, Shildon
(CH. No 184)

Quinquennial Report
On the architect's inspection of

26th August 2021

Sarah Harrison RIBA

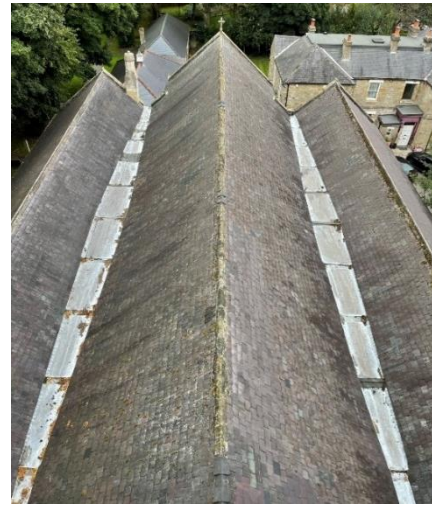
Item 13&14- Roof and Valleys from Tower

14. There are two 10-bay lead lined valley gutters, these have been patch repaired following previous leaks to both the north and south gutters. The repairs to the south valley over the Prayer Chapel failed in 2015 and had been covered in 5 locations using bitumen cover patches. All bays show some signs of repairs many patched using self-adhesive 'flashband' or bitumen. Some areas of felt patching were removed during the last quinquennium as they were exacerbating the leaks, due to the large steps created water was not simply flowing over the top, but finding paths to the side and underneath at any weak points in the seal.

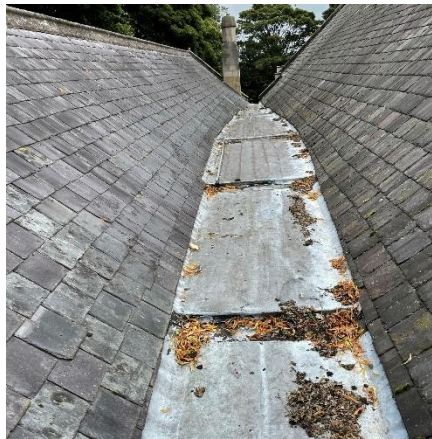
Item 21- North Valley

21. **North Valley Gutter** – 4 No steps and to the east with 1 No split-fall mid-bay and 4 No steps at the west side all had been repaired with bitumen or flashband during the previous quinquennium, however most of these have now been removed. There is a large patched felt area to the western most end of the valley, onto the nave roof. Some undulation and soft under boarding in places (edge of 4th bay from west). There are signs of persistent leaks internally beneath the east end of this valley, as noted at item 94.

27. Given the present signs of leakage the parish should be planning both lead valleys replacement to modern standards in the near future. Logically, this would co-incide with replacement of the slate roofs given the nail fatigue noted at item 13 and overall condition. The replacement could be done in a phased nature to allow fundraising, focusing on areas where there are most leaks. This could, for example, be prioritised to replacing the valley and adjacent slate roofs to the south valley, south nave and north side of the south aisle, in order to protect the organ from damage, whilst also continually monitoring the north valley for any worsening of condition. In the meantime, ensure good clearance of leaves twice a year, with frequent observation inside for new or worsening signs of damp.

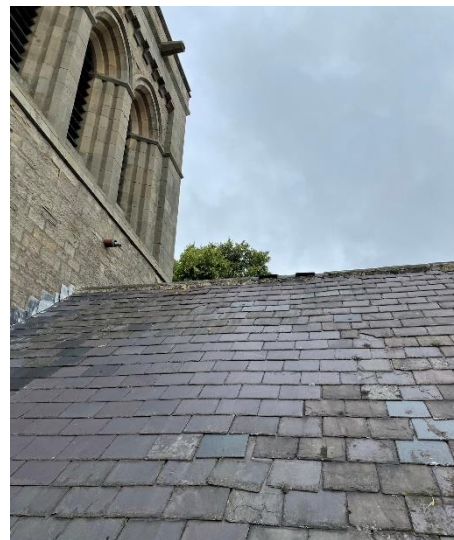
Item 18 & 31- Area of patched fibre slate & Ridge Vents

18. **South side of Nave** – The covering appears to be generally complete but many slates are laminating, centrally there is one cracked slate, missing a large section. Two large areas at the west end and a number of individual slates have been renewed to match, a number have been replaced with fibre cement slates. Flashings to tower appear sound.

30. **North Aisle.** These are made of artificial stone in a roll-topped design. They are complete but the cement bedding has been patched in places and other areas are open.
31. **Nave** This consists of angular natural stone and is basically sound. 3 pairs of ridge vents have been incorporated. The east end section of about 2m has moved towards the north side but it appears from the cement bedding that it may have been this way for some time. The bedding mortar is missing or loose or cracked in a number of places.
32. **South Aisle** The ridge is of the same type as the north aisle and appears to be sound on the north side although this is heavily mossed over to the north face.

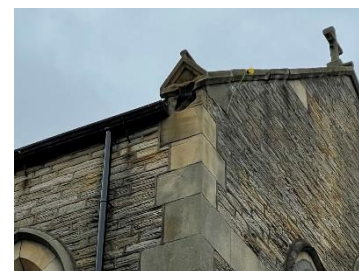
Item 39- Eroded kneeler & quoin

42. The south facing coping to east gable shows evidence of slipping slightly as the bedding slightly cracked. This alongside the issue at item 39 appears to be causing a damp issue internally, discussed at item 93.

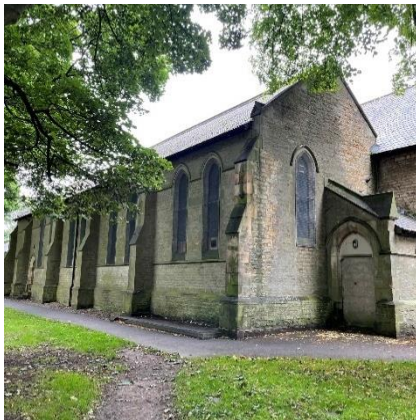
Item 50&52- North West Elevation

52. This side is generally sound with no obvious faults. The top left-hand quoin to the NW corner buttress has spalled where a metal fixing existed previously. The string course

has some damage to the far west and the stonework in this area is free of moss and algae, suggesting water has been overflowing at the end of the gutter and down the wall.

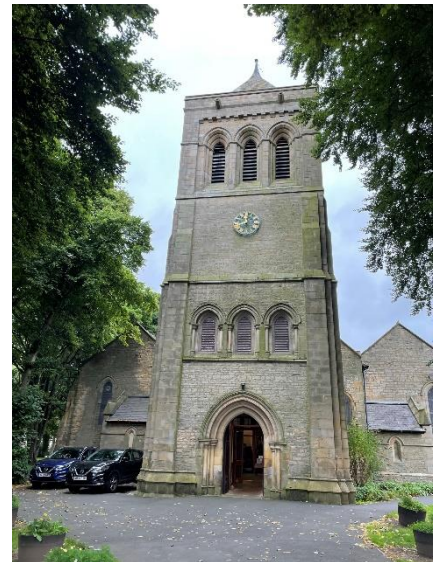
Item 60 - West Tower

60. **West Tower** - Damaged or eroded stonework to the first level openings and to the west doorway were replaced in 2005/06. Vegetation currently growing from string course.

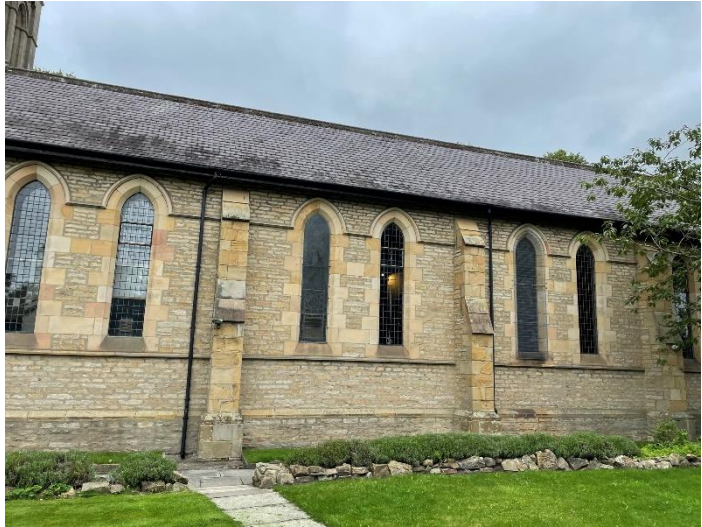
Item 64- Southern Windows

64. All windows are leaded with galvanized wire guards on the north side and more recently added to the stained or more vulnerable windows on the other sides.

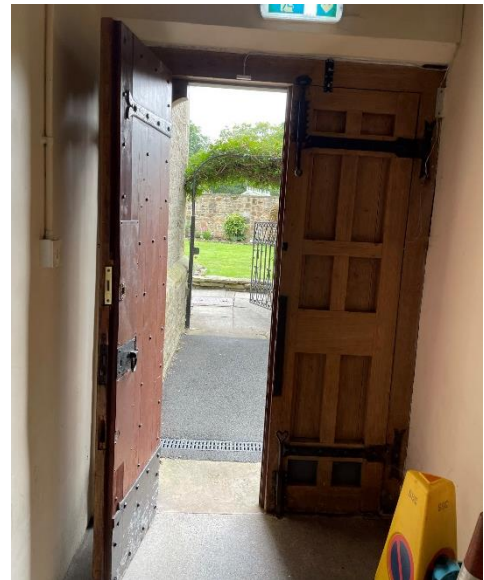
Item 68- South Porch Entrance Doors

68. External doors which are stained and varnished are in fair condition. The south porch entrance doors show a little wear to the bottom rail and the paint is flaking in this area. They look to have been previously repaired with a metal plate over this area.

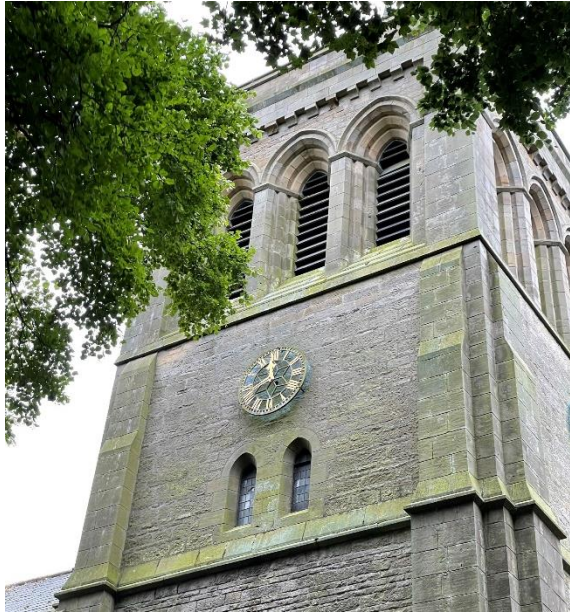
Item 72- Timber Louvres to Tower

72. The timber louvres to the belfry are in ok condition generally, to the north elevation there is one louvre which has slipped. All sides require re-decoration.

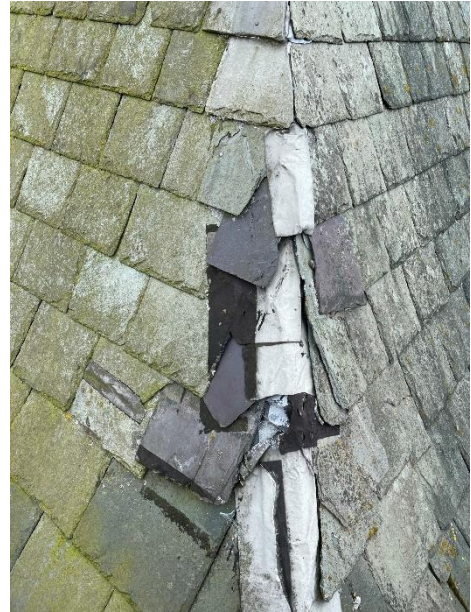
Item 80- Mitred Corner to Tower

80. The lower sections of all four mitred slated hips to the tower roof have been patched repaired using self-adhesive 'flashband' and cover to the N.W. corner is very uneven, this could cause future leaks.
81. The stone parapet is sound, but the joints are becoming a little lean or open in places.
82. The lead parapet gutter and cover flashings appear sound except that the cement upper joint point is becoming a little loose in places.

2	Coping to east gable to be re-bedded with a recommended lime mortar mix.	42	
2	Replace/re-fix slipped slates to tower roof and replace missing lead soakers to hips.	80	
2	Repair open joint to lead cap of tower roof. – Lightening conduct. Roofers same time access	78	
2	Repair broken glazing to window to east, south and north facades monitor cacks.	97, 107- 109	
2	Clean down and re-decorate cast iron rainwater goods, including inside surface of eaves gutters where necessary, and check and reseal any leaking joints.	69	
2	Check for active woodworm to timber around/adjacent access hatch to bell chamber and treat professionally.	76	
2	Replace mortar between stone tiles and abutment to tower and monitor damp condition internally. – LEAVE UNTIL DONE	59	
2	Re-point open joints to west façade and coping to prevent water ingress.	50	
2	Repair timber louvre to north side of tower.	72	
2	Closely monitor softening of timber truss above choir vestry, fix any leaks above.	84

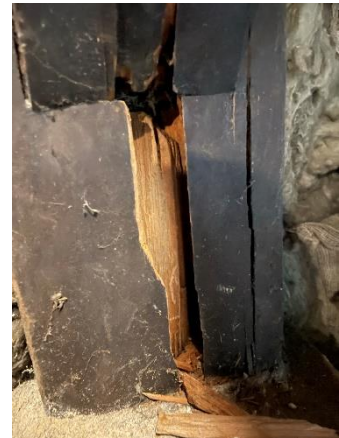
Item 84- Timber Softening

84. To the mezzanine storage space above the choir vestry there was softening to the brace of the first truss from the east, on the base of the south corbel. The area the tie meets the wall also shows signs of softening. The main timber members do not appear from ground level to be structurally compromised at this stage. This softening is likely to be a result of water ingress through the north lead valley, which recently had poor temporary repairs removed. It is now unclear if the valley is still allowing ingress in this particular area.

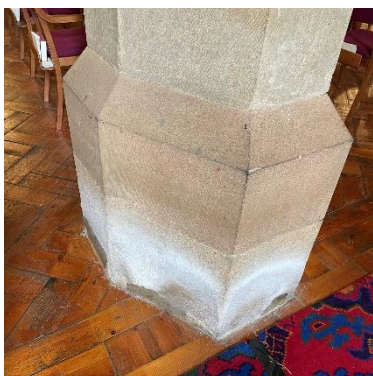
Item 91- Arcade Column Base

91. Arcade columns to the bases have signs of continued rising damp, left untouched this has only minimally affected the stone. There have been areas repaired to the base of the columns with a cement heavy render, this has come loose and arguably made the issue worse in these areas.

112. One pitch pine block lifted in the north aisle confirmed a bituminous layer beneath. This may exacerbate the rising damp issue noted at item 91.

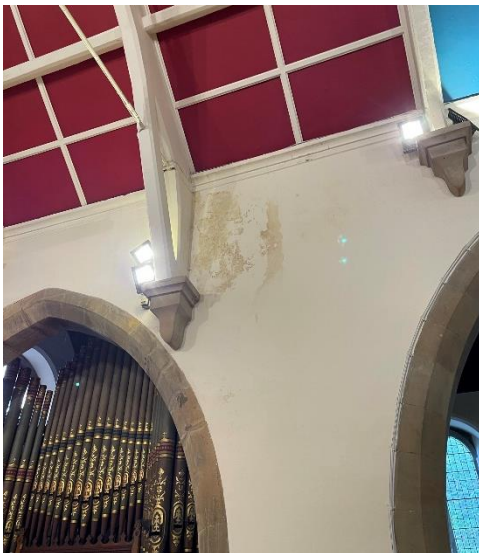
Item 97- Damp & Flaking Paint

97. **Decoration** - This consists primarily of painted plasterwork and is generally in good condition having largely been renewed in April 2000, except where affected by penetrating dampness in various areas, particularly around the organ to both sides of the arcade. The chancel and 1st floor hall have been recently redecorated.

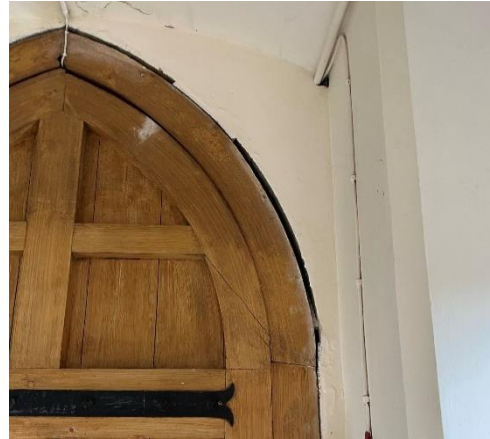
Item 102- South Porch Inner Door

102. The inner door to the south porch has a gap around the frame, the frame is secure, so this is only a decorative issue.

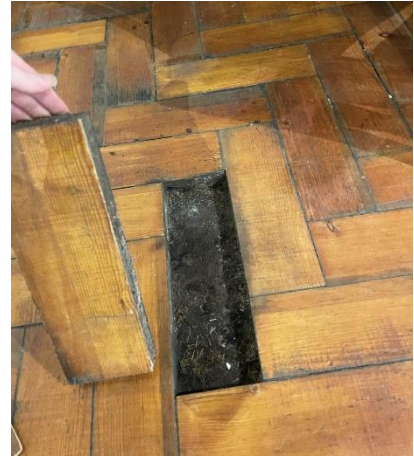
Item 110- Block Floor Loose Piece

110. The floor of the nave and aisles are of pitch pine blocks which are generally in good condition. There are some loose blocks to the north aisle and entrance. The area within the new rooms was sanded and varnished and the remainder of the nave area has been done more recently. The floor of the sanctuary and chancel is finished in 2' x 2' square concrete quarries and has a central carpeted area to the chancel.

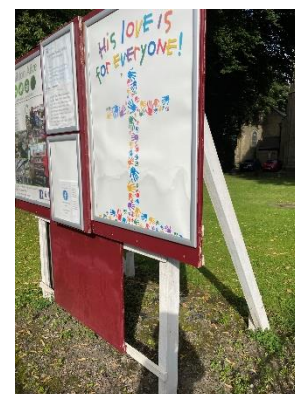
Item 157- Sign

157. There is a sign to the west entrance, which is overall structurally sound, however there is some delamination of the ply.
158. The PCC did not provide any information on trees protected by a Tree Preservation Order, or in a Conservation Area, or on the Gazetteer of ancient, veteran and notable trees. There are no trees which pose a risk to the church building at the present moment.
159. The pathways and churchyard to the north are the responsibility of the council to repair and maintain, however the paths appear to currently be in serviceable condition, there are no monuments which currently pose a safety risk, however this should be continuously monitored.
