QUINQUENNIAL INSPECTION REPORT

SHINCLIFFE, ST. MARY

QUINQUENNIAL INSPECTION AND REPORT

October 2021

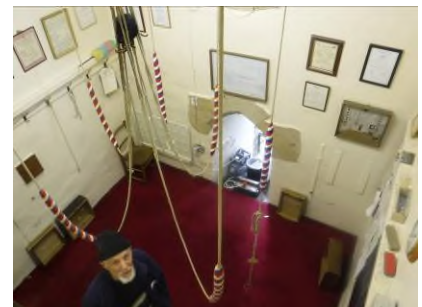
D Ringing Chamber:

Boarded ceiling looking ok, walls are painted and they are fine with minor hairline crack below the circular window leading to the keystone of the S side, it has moved in the past but there is nothing here really. Carpeted floor that is ok. Has a diaper leaded window with a ventilator that actually looks to operate though it doesn't close properly so there is a draught coming through it. Room has a simple Dimplex electric oil heater against the wall. The stair up to the belfry is a rather lightweight affair and not fixed very well at the head and the grabrailing needs improving. The grabrails at the

head of the stair from the room below are ok, though a further one would help as you just transfer off the top step.

The W window at high level has slight open joints at the arch ceiling of it but its ok there is no obvious movement, has had some cement work done in the past.

Recommendation: fix stair and add grabrails

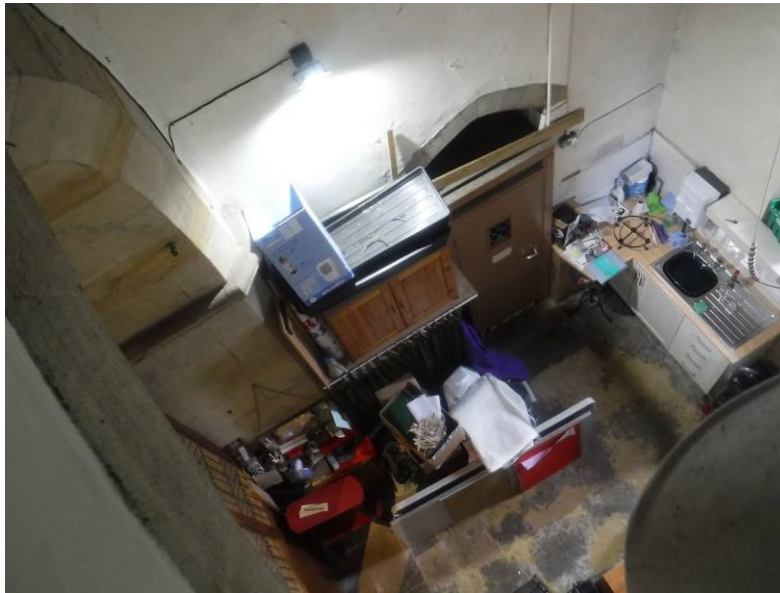
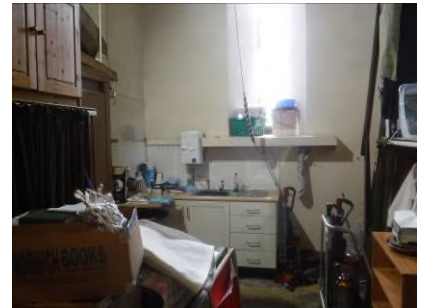
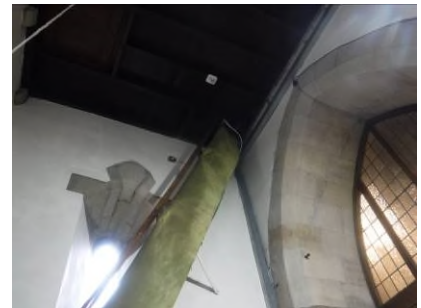
E Base of Tower:

Open jointed ceiling looks ok. Walls are painted plaster, peeling a little in places. Floor is stone paving that has been levelled up a little bit with some lime mortar that is a bit soft and is breaking up a bit in places. A window on the N has a slight crack at the arch which is the same as the last QI. On the S side the window runs up into the ringing room and that seems ok, the floor runs across it.

The arch to the nave looks solid and the window to the W has had some cracking in the arch but nothing problematic there. All the glass is diaper.

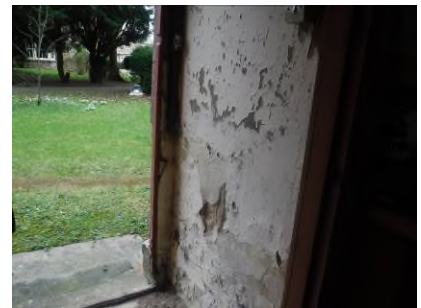
There is a door to the S which I suppose is the bell ringer's private door in a sense, it is in a little lobby in the thickness of the wall the door decoration has broken down and there is some slight cracking to the shoulder moulding of the lintel and the plaster work is breaking down of course in the damp. The floor is a little uneven and there is a threshold to trip over, the door is covered by a flush door just to keep the draught out, it is a bit rudimentary but it serves.

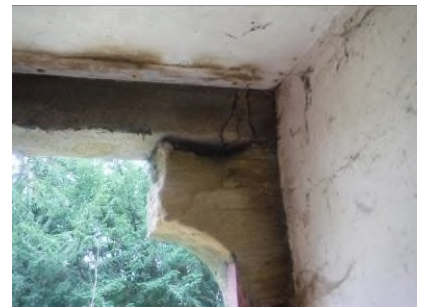
The room is rather a jumble of lumbar and there are plans to reconfigure all of this, it has got clergy robes in it, there is a bit of

a sink and a hot water heater and this is really where they serve their tea and coffee from.

Recommendation: update room

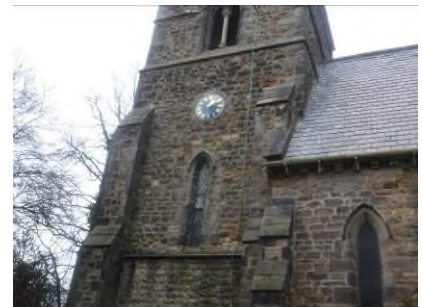
First stage:

walling eroded slightly by the nave and to the left of the doorway. Crack to the lintel of the doorway (same as last QI) and the door itself has decoration breaking down, same sort of design and colours as the porch door. The pointing around the step could be renewed.

Recommendation: renew pointing around step, redecorate door

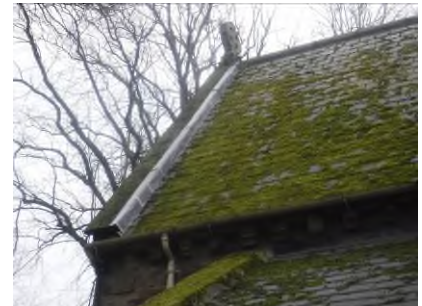
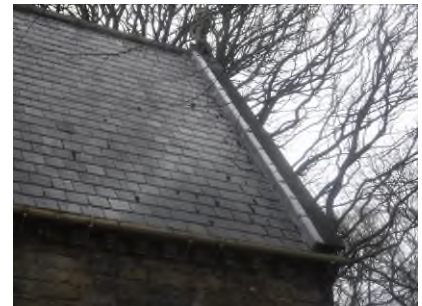
B Chancel:

All the ridge bedding is ok but it has been patched in the past, couple of cracked slates, some slipping the E abutment flashing to remedy.

Recommendation: remove moss, replace cracked and slipped slates

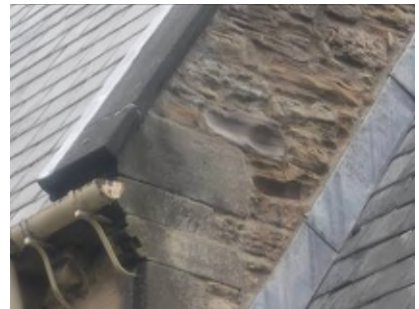
Ridge has a couple of open bedding, tower abutment flashing stepping looks ok maybe there is one not great right up at the apex. The E abutment is for remaking. Slating looks generally good on this elevation though it is a bit mossy.

Recommendation: check abutment flashings

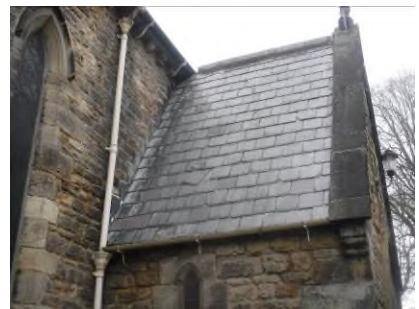
B Porch:

Ridge pointing coming out, some foreigner sates in there, the abutment flashing to the S in mortar cracking at the apex. Abutment flashing to the nave step flashing ok.

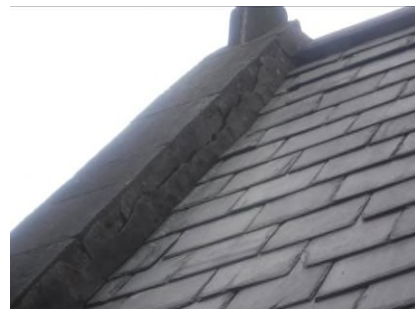
West Side

Ridge ok, W abutment ok, S mortar abutment is breaking up at the ridge as well, also a couple of slates slipping.

Recommendation: check abutment flashings, replace slipping slates

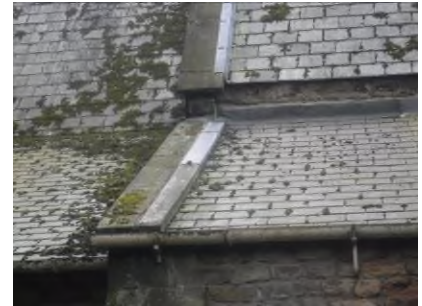
B North Aisle:

Ridge flashing looks to be in lead alternative particularly at the E end, or is it metal I can't really tell there is maybe two lines of it but it seems to be holding up, the abutment flashing is the same treatment as before, actually the flashing is missing I think at the lower part as it abuts the vestry above the boiler room? It needs investigation. This could be leading to the problem inside in the lady chapel. Slating is generally sound, roof is dishing slightly at the middle perhaps that is wall spread a bit.

Recommendation: check abutment flashing

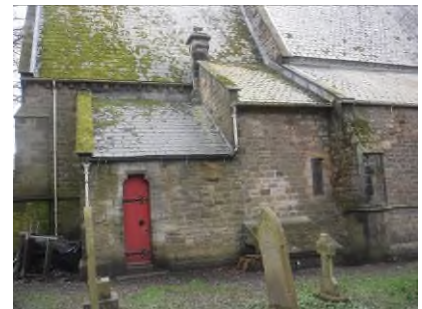
B Organ Loft:

Quite mossy it has got a junction to the chancel at its ridge which needs checking over, that could be a problem there. The abutment to the E doesn't look as if there is much in the way of mortar flashing there but it needs cleaning up. Abutment to the W is lead flashing, buckling a bit and very mossy at this point it needs cleaning off.

Recommendation: remove moss, check ridge abutment, remake e abutment, check w abutment when moss removed.

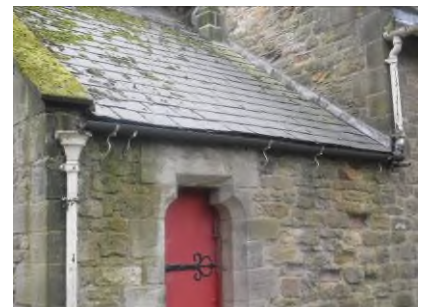
B Vestry:

Ridge flashing looks ok, abutment at the W mortar looks alright, abutment to the right is lead and that's ok. The slates generally look ok a bit worn and are mossy as well but they seem ok.

Recommendation: remove moss

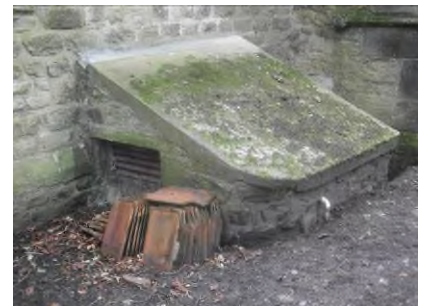
- Boiler Room:

This has a concrete lean-to roof that is a bit green but it looks sound.

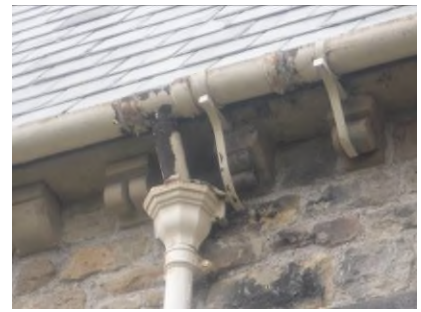
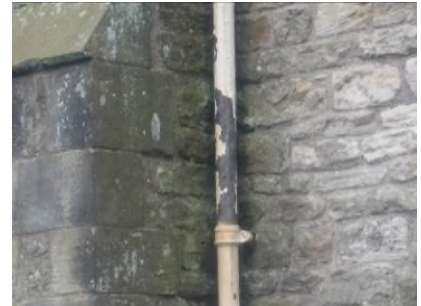
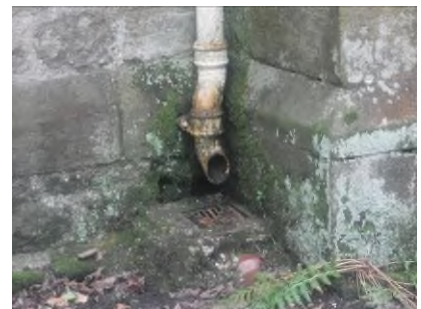
Nave – middle downpipe running outlet looking it's got a hole in it and the gutter above the porch has also got a crack in it, no shoe at the porch so it just discharges straight to the ground, there are some salt glazed gullies on the S side suggesting that there is some form of an underground system.

Recommendation: overhaul the guttering and downpipes system

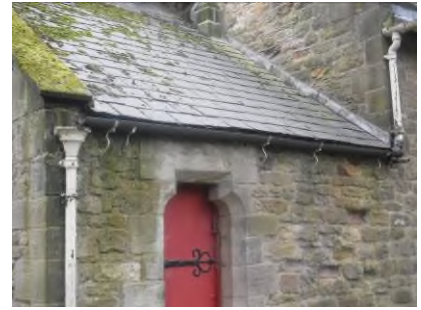
- **Organ Loft and Vestry:**

Gutter is coming adrift I think, it has got a funny downpipe to the plastic gutter on the vestry, it is not laid to fall properly and that downpipe is cracked, it looks like they were blue at one time.

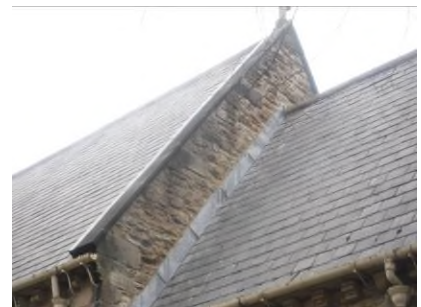
East: Open joints and eroded stonework.

Recommendation: replacement walling and repoint east gable, check stone band above north aisle below nave eaves

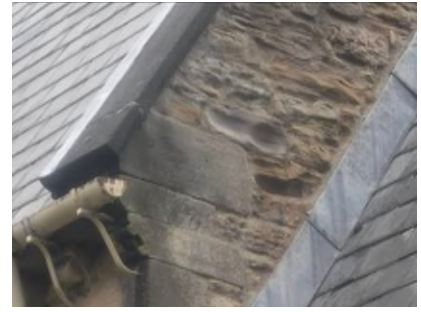
South Side: Corbel course ok, walling alright apart from the plinth that is worn through just damp erosion over time and there is some open joints to the W side, the buttresses look ok.

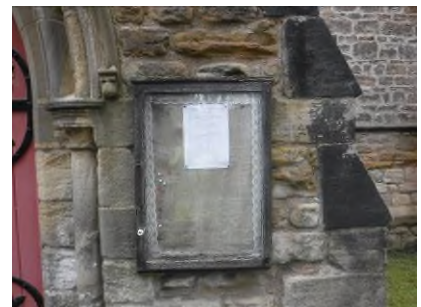
West Side

Couple of open joints that could do with repointing. Walling is a bit poor by the W buttress.

Recommendation: repoint open joints

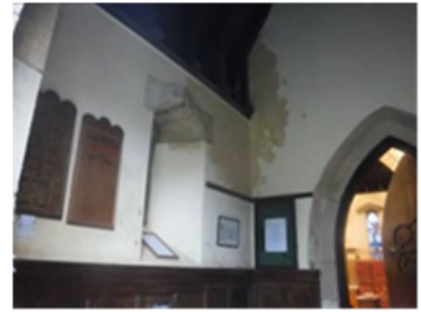
S side - to the W of the doorway and this is where there is some hairline cracking coming down from a roof truss corbel.

West above the chancel arch two patches either side of the apex of the arch which have grown in their magnitude.

Recommendation: redecorate after drying out.

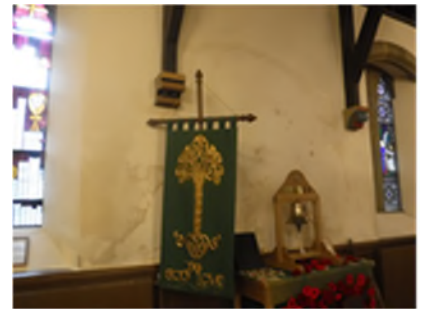
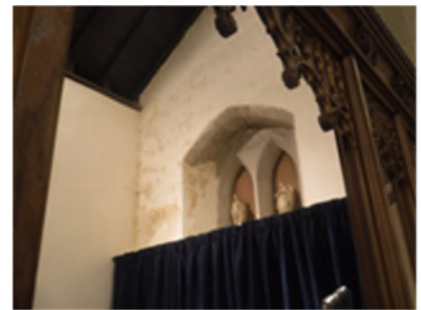
- North Aisle:

Discolouration by the spire memorial brass and towards the E end two last windows the panel in-between is quite spotty behind the Shincliffe bell this looks also as if it might have had a plaster repair in the past on one of the reveals is beginning to go now, perhaps it is incompatible.

And above the lady chapel next to the organ loft the W wall is quite badly damaged now.

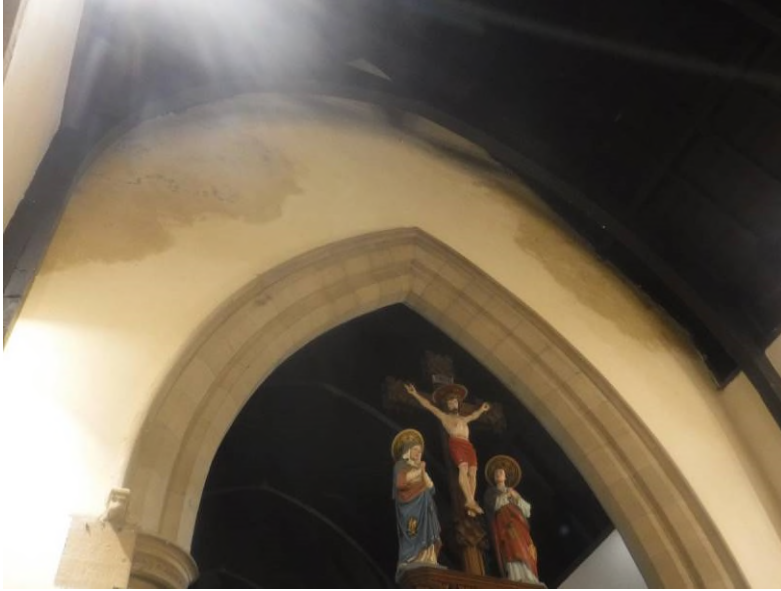
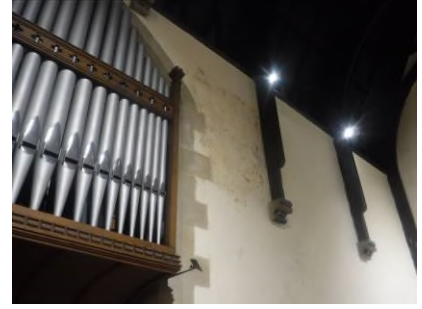
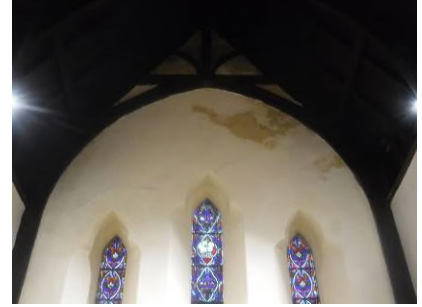
Chancel:

The S wall is ok. Chancel arch patchy.

N wall alongside the organ arch is a large area of plaster where the chimney has previously given problems but that has now been repaired.

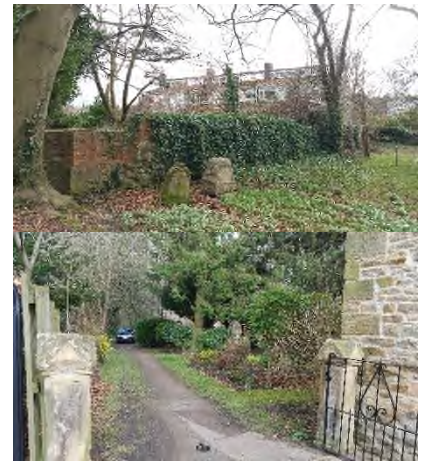
C Southern boundary:

This is the principal access on to the site from the village. Limited car access available across grassed and tarmac area. The boundary has a house and its adjoining garden walls on the boundary, whose wall is in reasonable condition. At the Easternmost end is another dwelling. At the South-East corner, the land has a piece taken out of it by a lean-to construction built in poor quality stonework and some brickwork which has multiple open joints.

The remaining part of the boundary is that house's garden wall which has open joints to the stonework.

Recommendation: repoint open joints

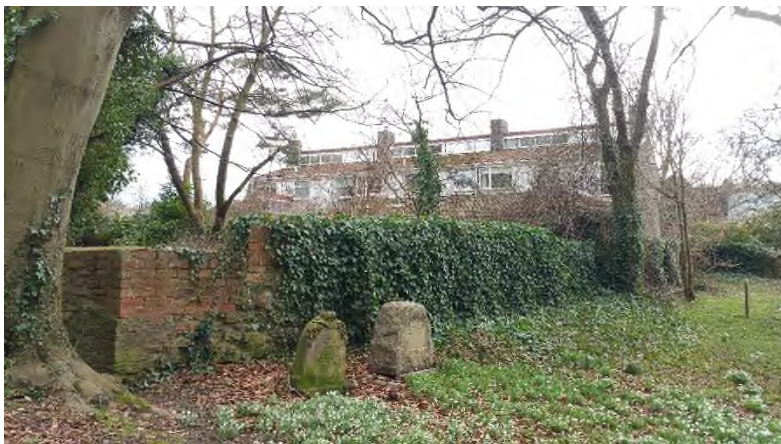
C Eastern boundary:

This has a dwelling behind a brick wall. The brick wall has raking brick buttresses. This wall is a combination of stone lower and brick upper. There are some settlement cracks to the wall, no doubt as a result of the close proximity of previous trees. There is ivy

growing on it and so it is not easy to examine all of it. Previous mortar works are smeared over the bricks and stonework. There are some open joints, particularly at the Southern end. The Northern end is mostly stonework with brick coping which is leaning in towards the churchyard.

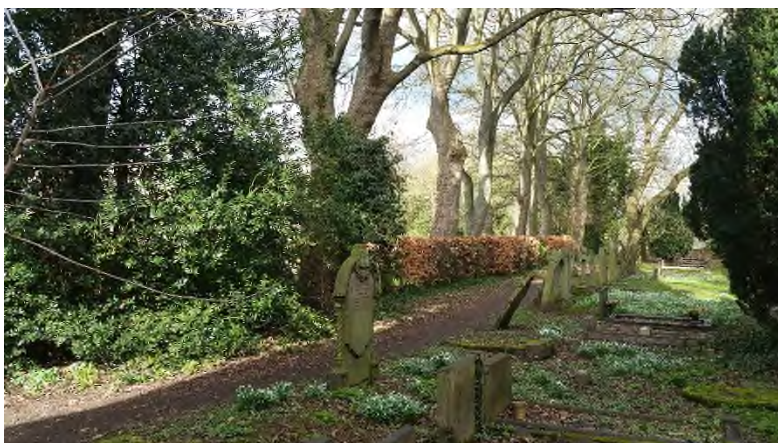
At its southern end it has houses beyond and the boundary is made up of a combination of beech hedging at the Northern end and timber fencing towards the Southern end. In the middle of this is a stone wall with open joints, which also has a modest ridged brick building adjoining it.

Recommendation: repoint open joints
