Diocese of Durham

St SIMON SOUTH SHIELDS
(119)

QUINQUENNIAL REPORT
on the architect's inspection on

14 September 2022

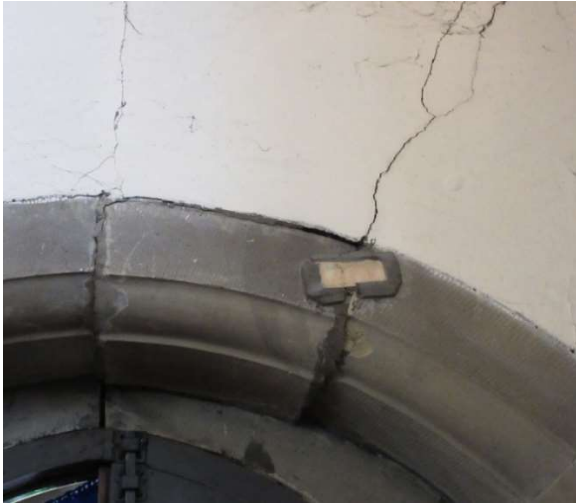
8. One stone in the inner arch between Porch and Nave has dropped. An unbroken glass telltale mortared across one of its joints is dated 1971 and further external telltales under the E and W windows in the S side of the Nave are unbroken (though the SW telltale has lost one side of its fixing mortar so is unclear but pointing of the wide joints below are barely cracked so again there is no evidence of continued movement).

Dropped stone in Porch inner arch

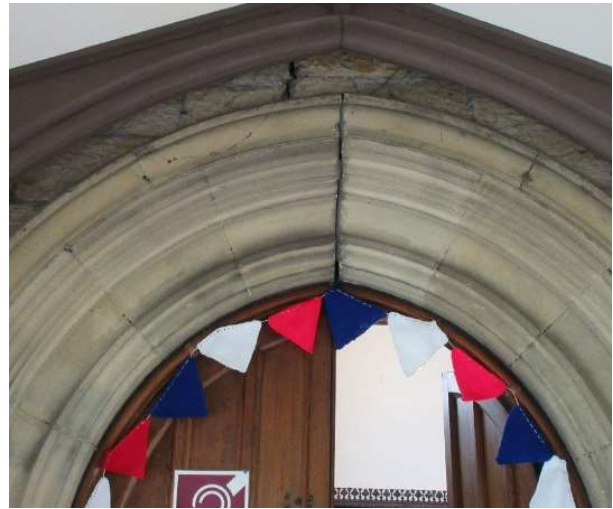
Open joints over Porch outer arch

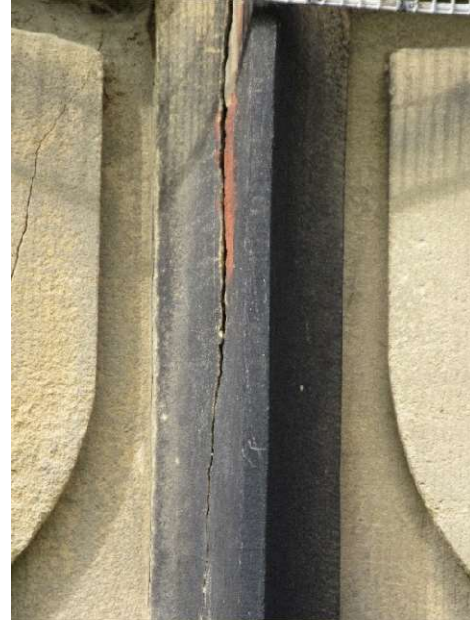
Panel under E window – split in 'mullion' N of centre

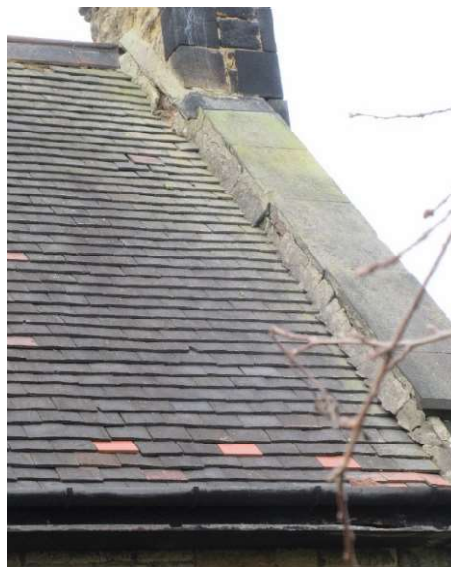
typical broken mortar fillets

E side of Vestry

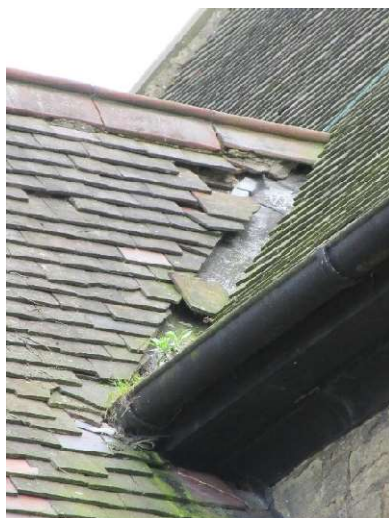
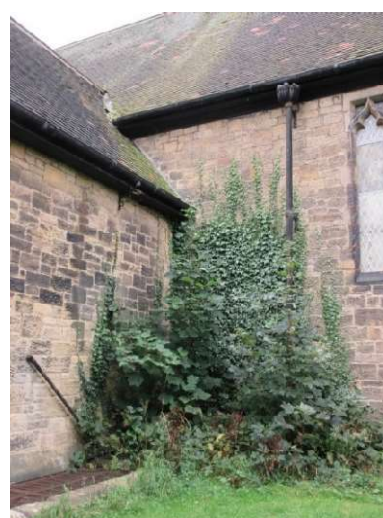
16. Problems are missing tiles (over the Organ arch) and plants in silt at the valley W of the Vestry and ivy again growing up the corner between Vestry and Nave which is now close to the Vestry tiles and may soon grow onto them.
Ivy pushes into gaps and may disrupt the fragile tiles. It should be carefully removed, cut and poisoned at ground level.

Missing Vestry tiles, plants in silt in the Nave gutter, saplings in corner and ivy getting close to Vestry tiles

Repair missing roof tiles at Vestry and Porch	16, 17
Remove and kill ivy and saplings in Vestry/Nave corner and against other church walls	16, 25, 99, 100
Clear and check the whole hopper and rainwater pipe at NW Nave	23
Replace missing rainwater pipe W side of Vestry	24
Renew two failed lights in Chancel	83

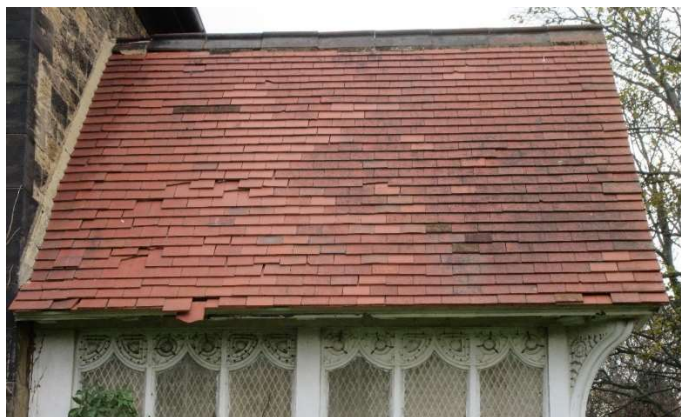
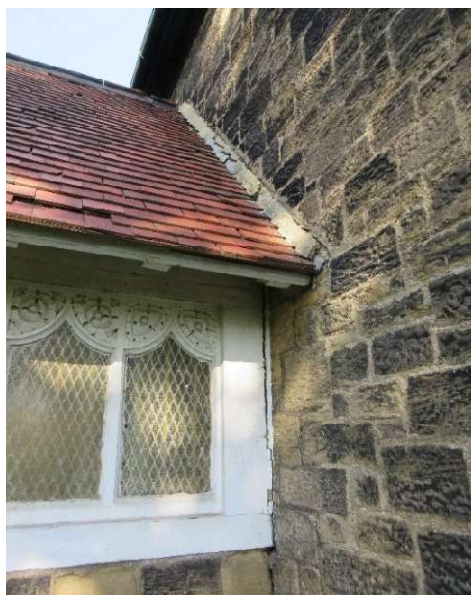
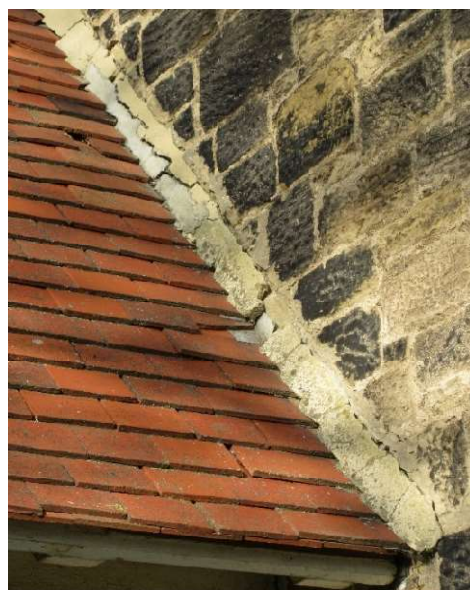
17. The 1978 **Porch** tiles remain clean red but eight at E and nine at W are broken.
A mortar fillet against the Nave wall is cracked and loose in parts and the whole Porch may have rotated slightly away from the Nave.

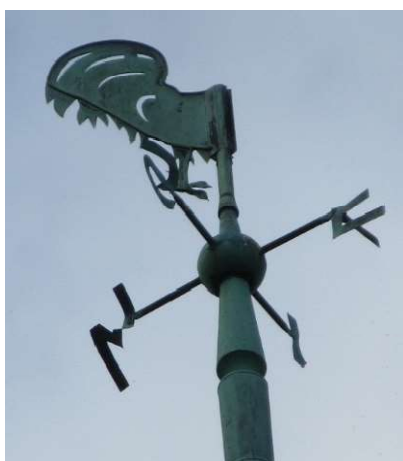
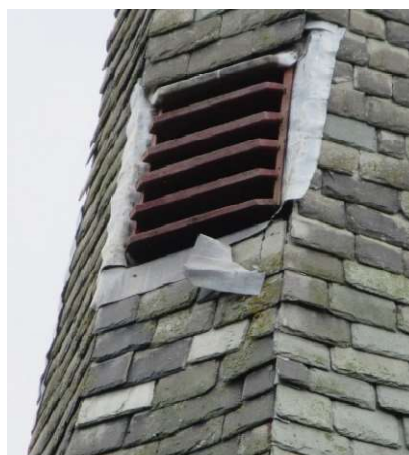
21. The bottom wooden louvres at E and W are missing.
The lead flashing under the N louvres has torn and one end hangs loose.

Replace damaged lead flashing under fleche N louvres	21
Obtain new electrical system test report in 2026	80 and Addendum
Obtain new lightning conductor test report	87 and Addendum

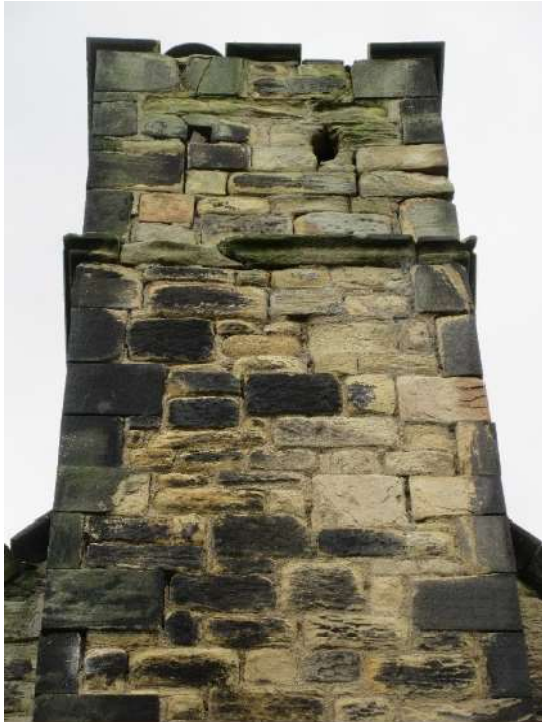
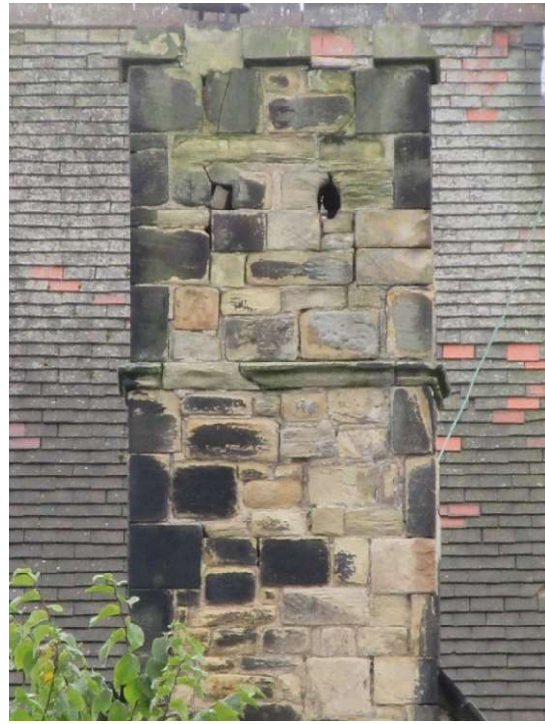
34. The disused **Chimney** has dressed quoins with squared rubble sides. Stone decay continues at all sides except E. Most pointing is lost. Some quoins and most rubble stones are decayed.
Part of the S string course has decayed away entirely and much of the N string is missing.
A small stone is missing at upper N and opposite at S a joint has opened through, showing daylight and allowing wind to pass through the whole chimney. Wind scour will increase the rate of decay.
Some cracking lower down the chimney stack. An inset carved shield is eroding.
35. The Chimney is probably not yet dangerous but the time approaches. Wholesale stone replacement and pointing would slow decay or the chimney could be taken down to at least string level and capped (change would require faculty) and the rest repaired.
More drastically it could be taken down to roof level and tiled over.

Chimney N side – general decay and daylight through holes both sides of one flue, letting wind through

At chimney at least rake and point and replace missing stone at N	34, 35
---	--------

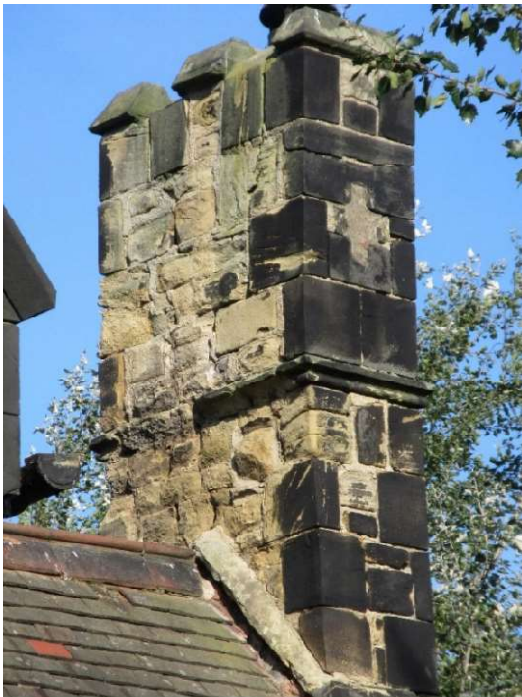
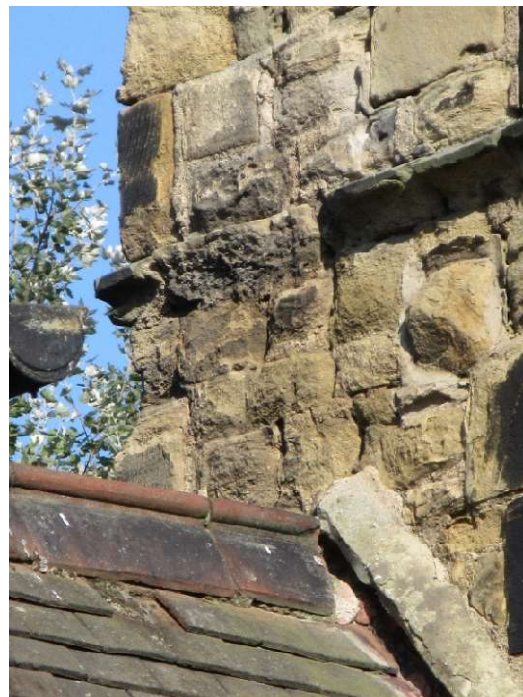
Chimney S and E – widespread decay, part of string course (should throw off water) missing and hole lets wind through

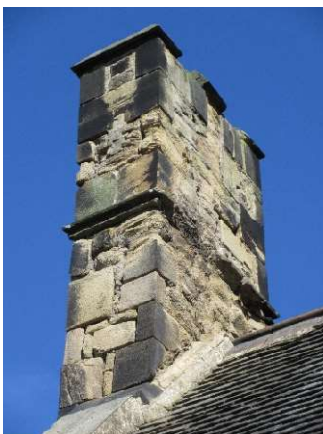
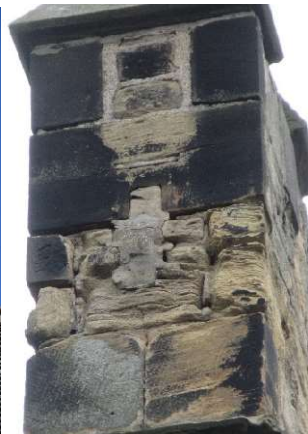
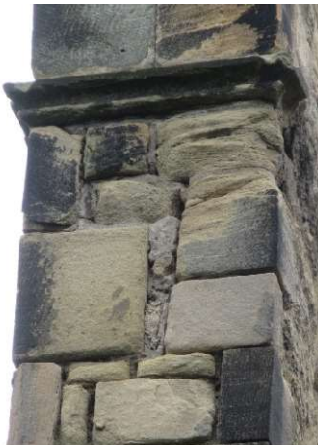
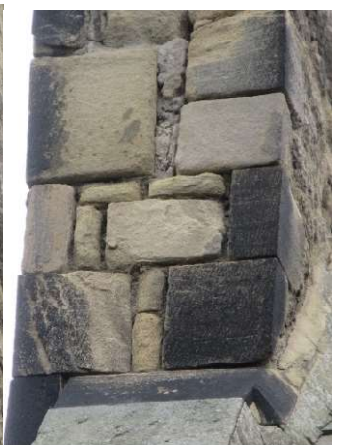
W end – little pointing and stone decay begun

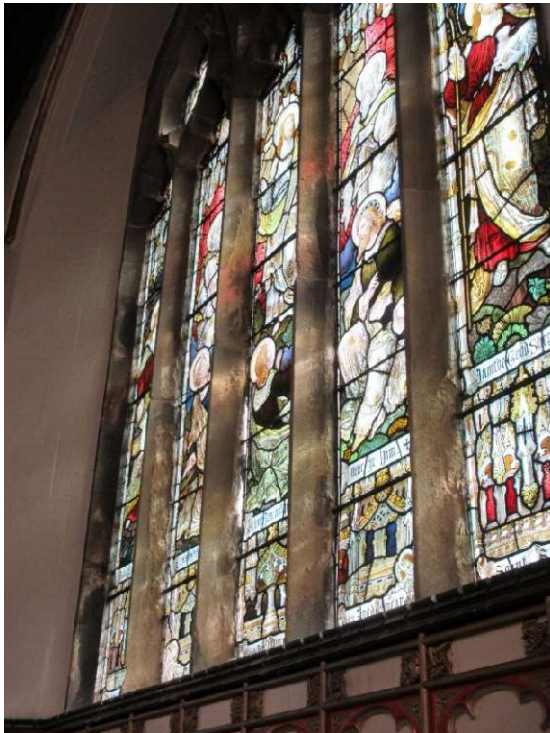
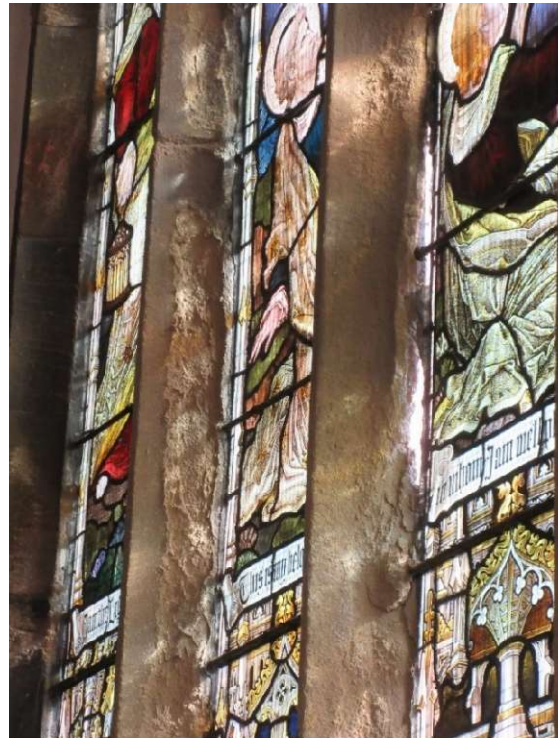
at **E window** widespread decay inside the mullions and outside the bottoms of the two mid mullions. This is more than the common pattern of bottom decay where rain run off soaks the bottoms of mullions. The worst is the mullion N of centre where near the bottom 50cm or so of one edge is missing, letting in daylight (and cold wind) between the glass and the remaining stone. Externally the bottom of the mullion is slightly split (photo next page) Outside the bottom of the mullion S of centre two lengths of stone have broken off and lie inside the grill. All mullions appear to remain strong enough at present but decay may continue and in time some replacement will be needed.

Details of two N mullions, daylight next to N central – see also photos after paragraph 56

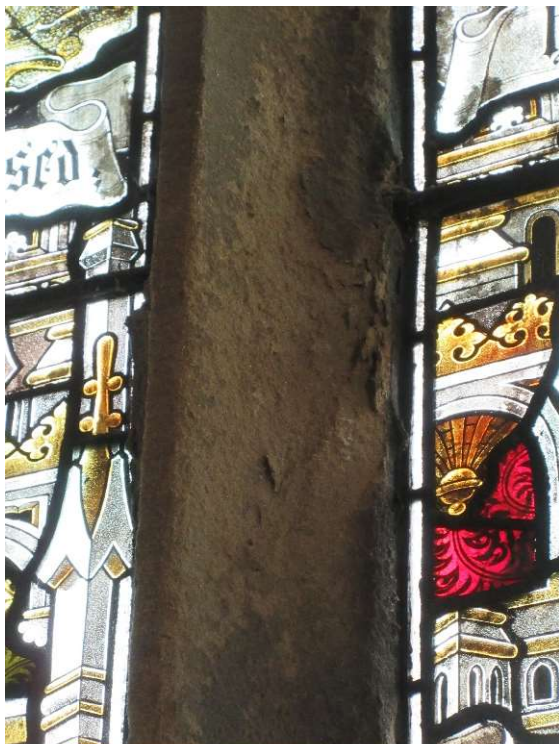
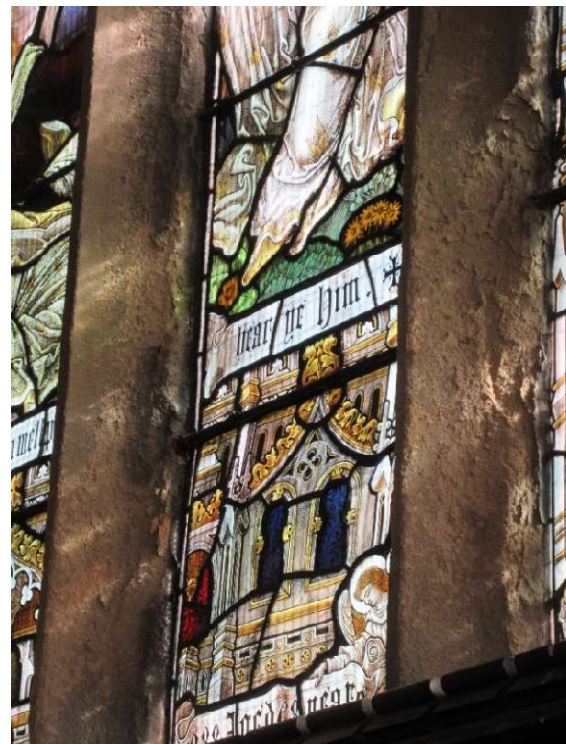
Details at two S mullions

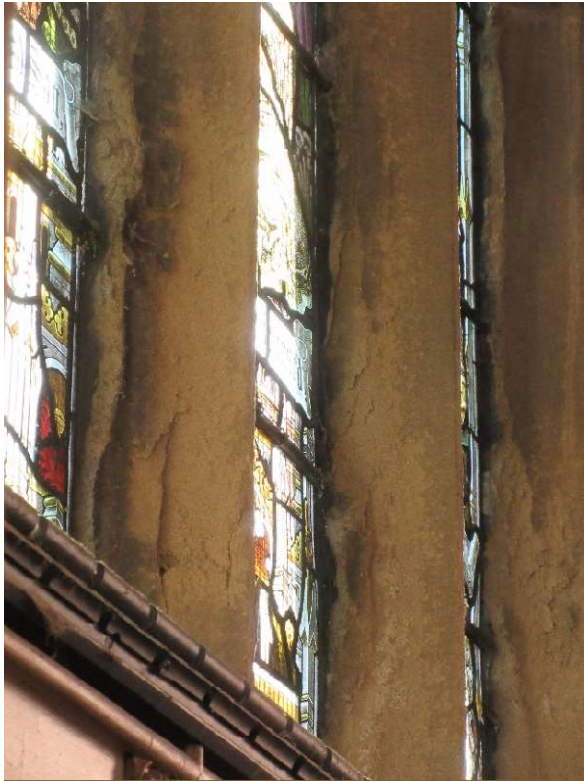
Details of N sides of centre mullions

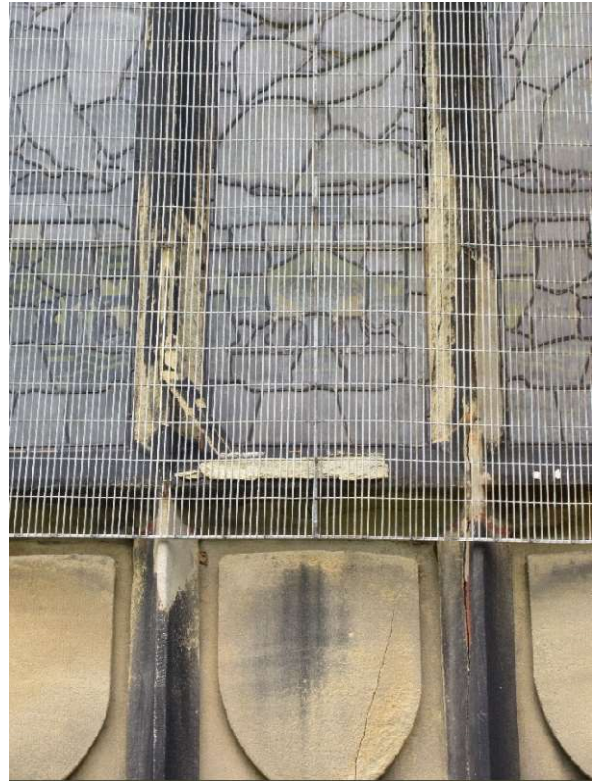
Outside two centre mullions

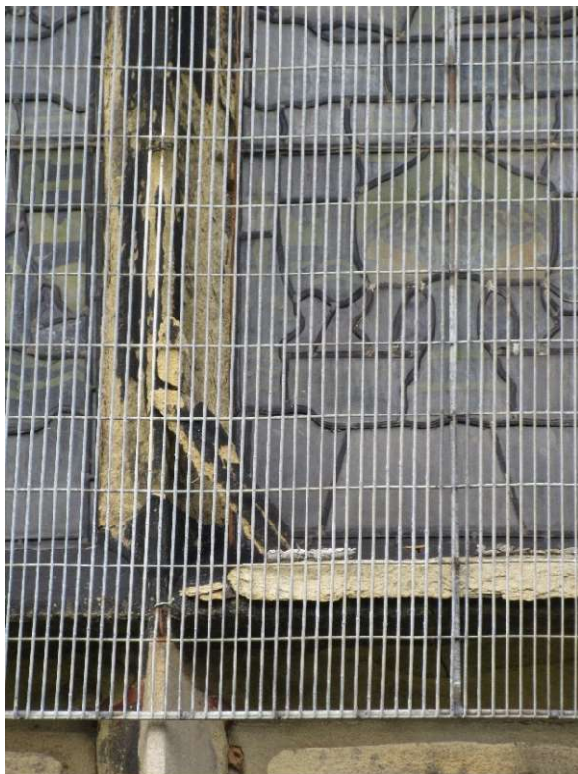
Base of S central mullion

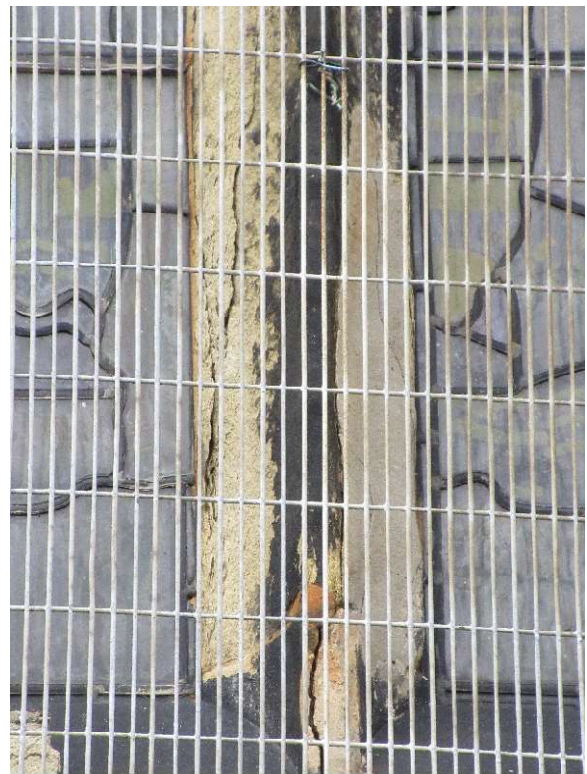
Base of N central mullion

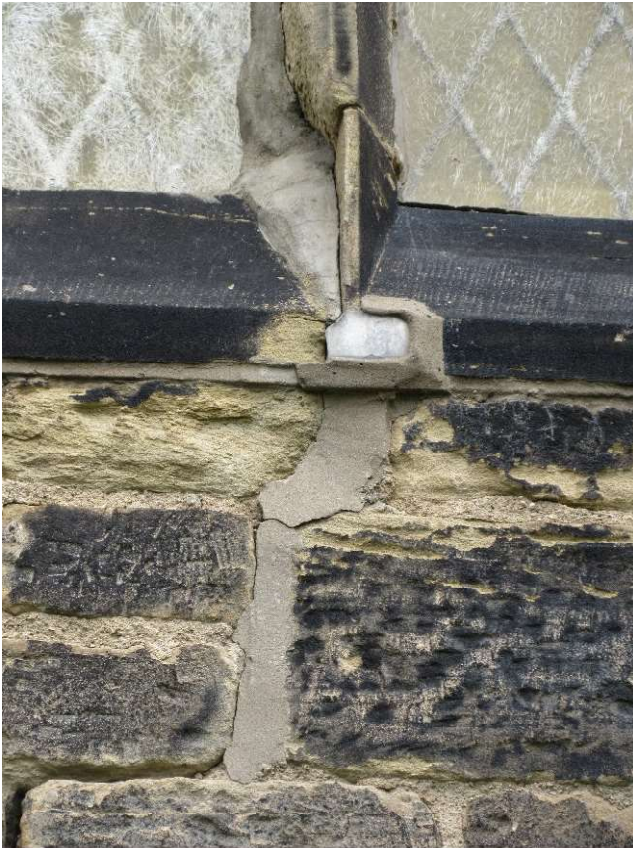
Nave SW window

S Nave W window similar but mid mullion worse with some bottom decay. One side of its cill table is all missing and patched in cement mortar (photo next page).

No action needed at present but observation should be kept and indents or mortar repair will be needed eventually. Most windows have visible cobwebs.

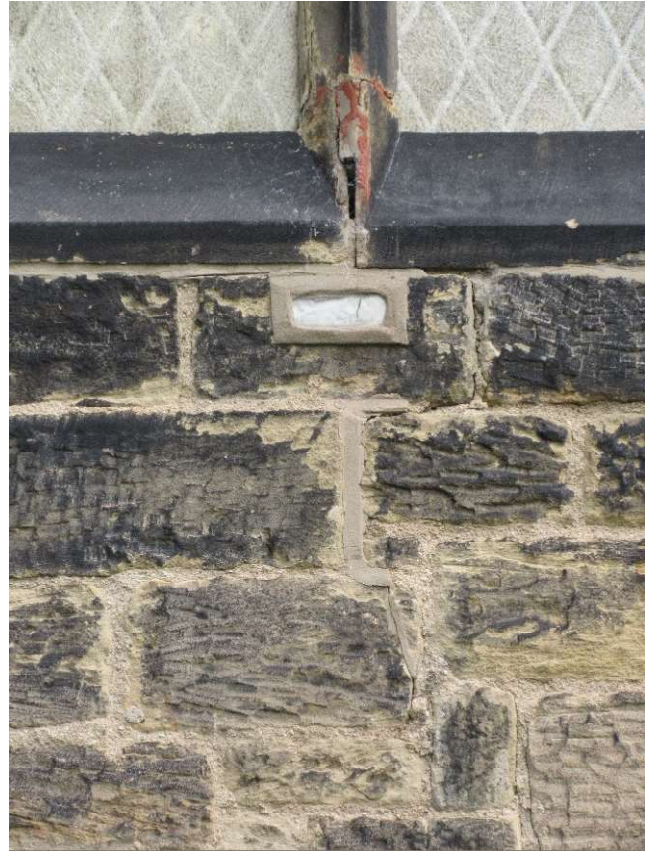
Nave SE window

S Nave E and mid windows – outside mullions slightly decayed at glass line and cill tables broken at the mid joints

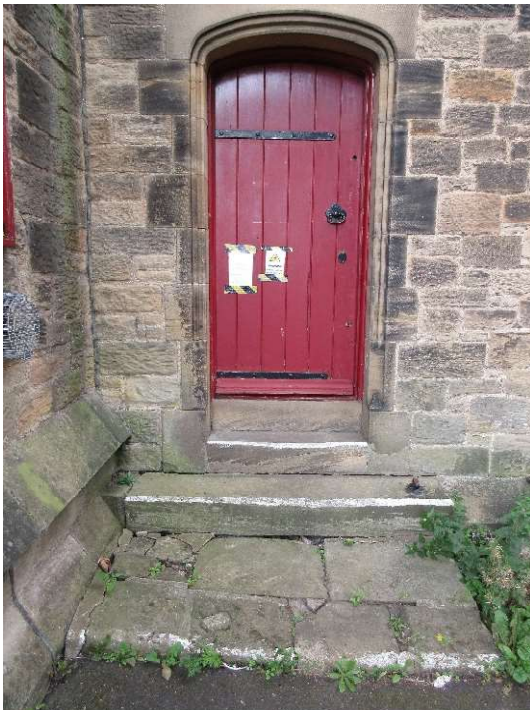
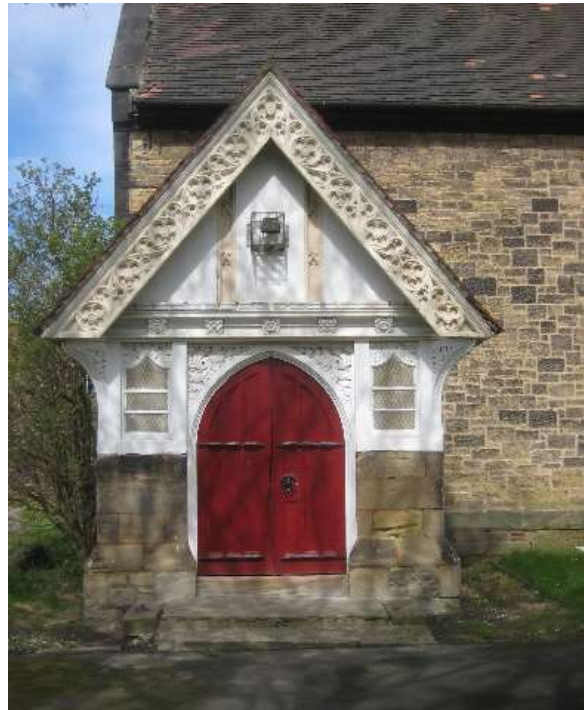
38. The external stone steps at both doors are in poor condition.

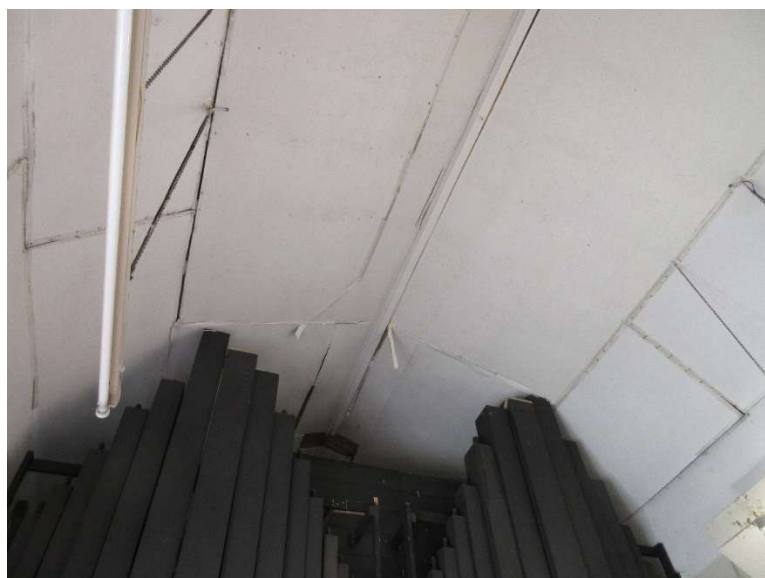
Vestry

46. In the **Vestry** sagging sloping hardboard is fixed under the trusses. Peeling paper strips over the joints look poor and let heat out. Painted insulated plaster or self finished insulation boards with timber cover laths would be better than hardboard and paper.

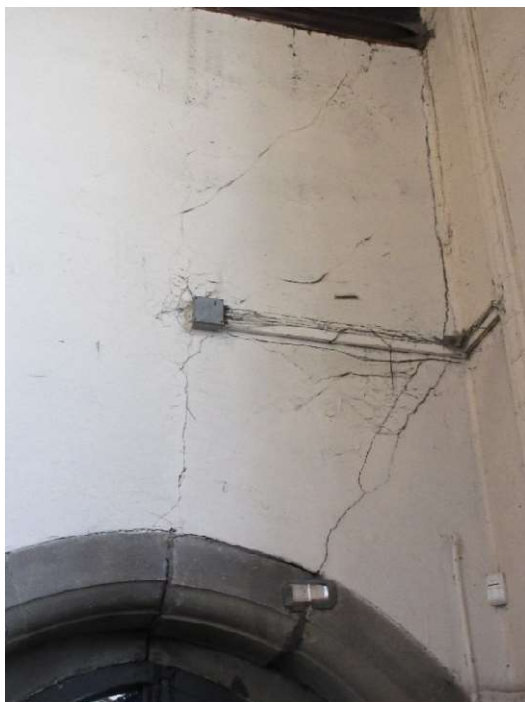
Nave SW

51. Church walls plastered and painted. Sound except movement cracks at all four corners, especially over the Porch doors (para 7).
No change in cracks over the E window since notes taken Oct 2001 though some mortar has fallen this month.

Fill cracks, clean and redecorate whole interior	7, 51 – 53
Carry out planned improvements to access including installation of wc	38, 64, 90
Remake Vestry ceiling and decorate whole room	46
Change all Meshlite to protected leaded glass with repair of broken glass in Nave tracery	57, 59, 62, 63, 94, 104
Redirect spot meant for pulpit	82
Renew external lights at both doors	84
Repair and repaint or renew the external sign or move to Wenlock Rd entry	98

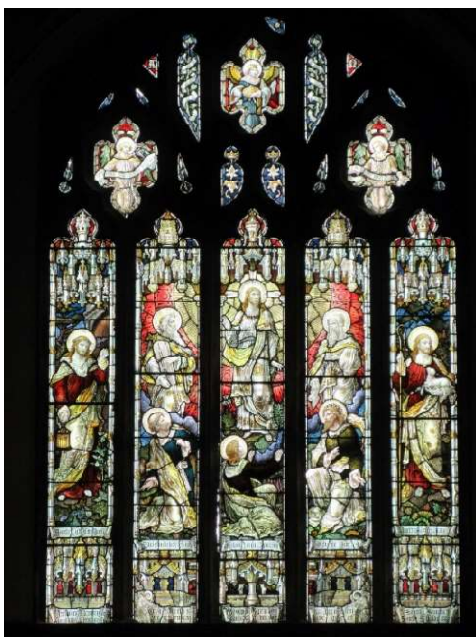
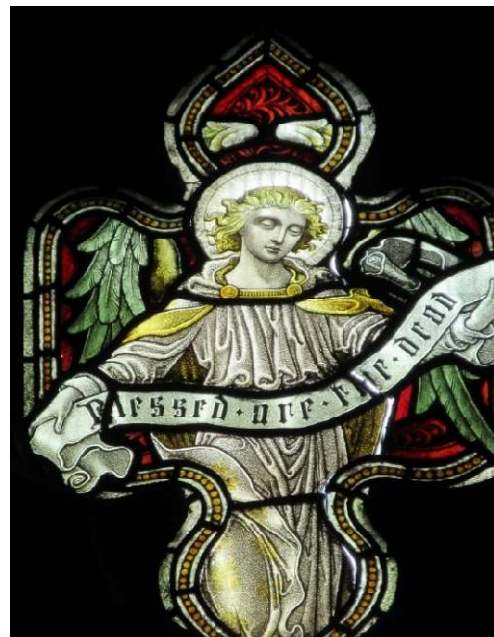
56. E window five light 1894, Light of the World, Glory, This is My Beloved Son, I am the Good Shepherd, well painted Atkinson Bros Newcastle. Internal iron saddle bars. Some distortion but appears sound though dirty inside. One very small tracery top light appears blocked. Minor gaps between glass and lead in angel in N side tracery due to very slight spread of gable. The L edge of the centre light is detached from a length of its mullion near the bottom by stone decay (para 36) letting in cold air. Slow decay will widen the gap. Galvanised wire mesh guard over whole window sound but visible against sun.

East window and detail of openings between lead and glass in the slightly spread tracery at the top left angel

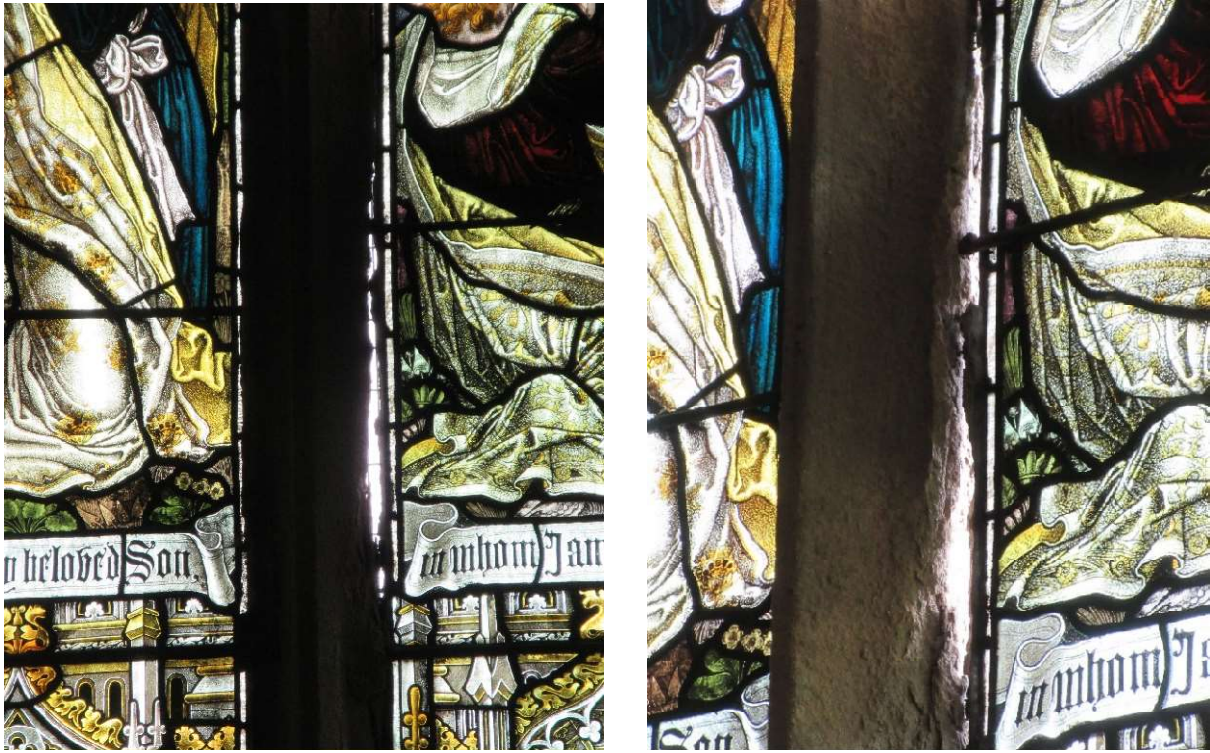
Daylight through the gap between the decayed mullion and the centre light glass

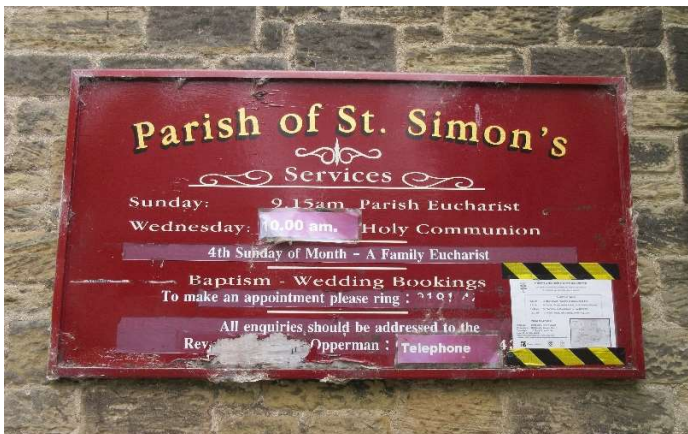
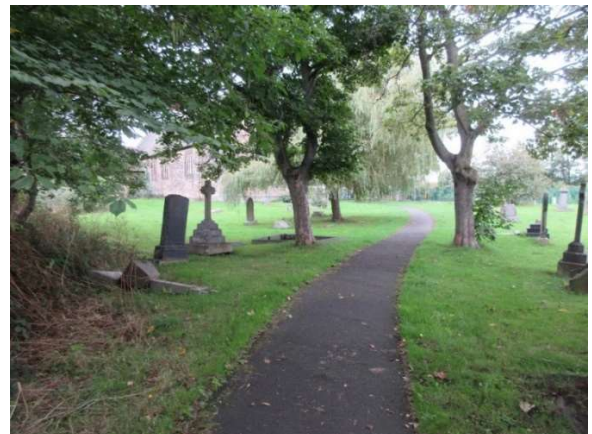
98. A well designed painted sign fixed to the Chancel N wall is well out of date and needs refurbishment and full repainting or replacement in a more durable material.

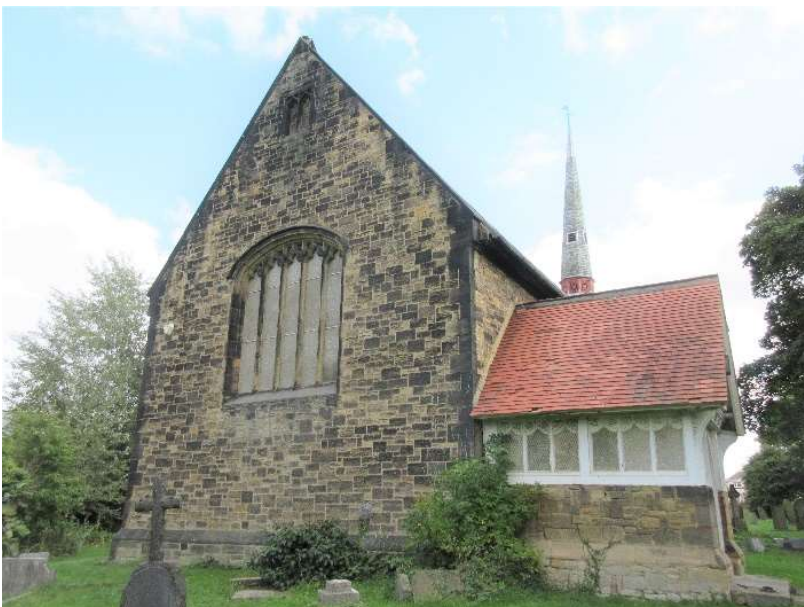
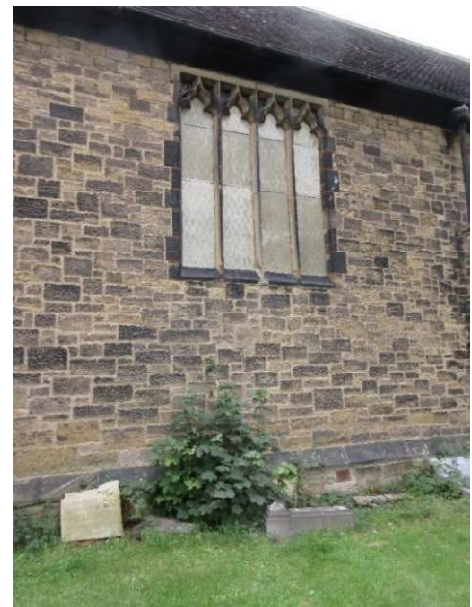
99. Two small trees tight against the Nave SW corner have been cut back but grow again and may damage the Porch roof or restart cracking of the Church walls unless removed permanently (dug out or poisoned).
