**CHURCH OF ALL SAINTS,
GIRSBY, COUNTY DURHAM**

QUINQUENNIAL INSPECTION 2017

DATE OF INSPECTION : 11 October 2017

**Malcolm R Cundick Dip. Arch.(Oxford) RIBA
ADG Architects
6 Pioneer Court
Morton Palms Business Park
DARLINGTON
DL1 4WD**

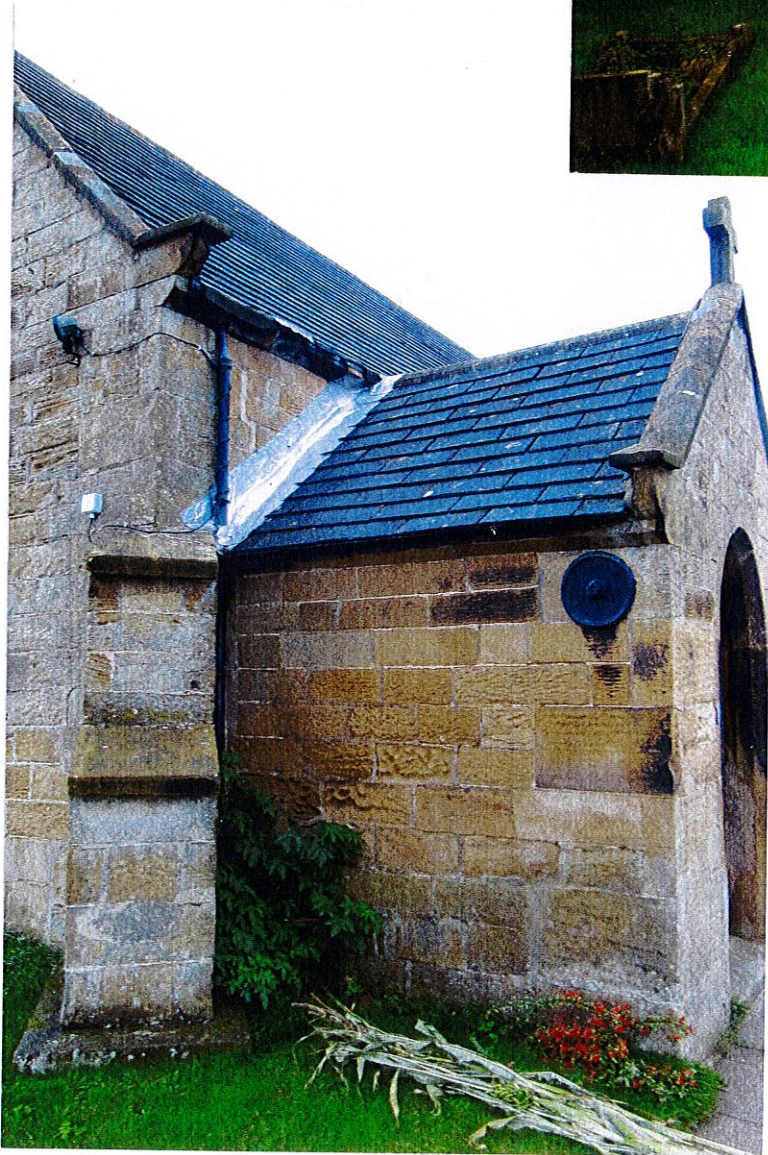
2

- 5.3.1 Flashband abutment of porch roof to main roof/south elevation. Temporary repair quality only, but still appears sound except for some lifting of ends.
- 5.3.2 Settlement of Porch apparently stabilised.
- 5.3.3 Broken cap to right hand tie rod.
- 5.3.4 Absence of gully to porch rainwater pipe.

1. West Gable with bellcote
2. Entrance Porch from South West. Note cap to tie bar and flashband abutment cloaking.
3. South Porch and lean-to.
4. South Porch gable. Note step at threshold

- 8.6 Make good render to lean-to : B (5.2.6) £40.
- 8.7 Review security of and consider replacement of Flashband abutment of Porch roof : B (5.3.1) £220

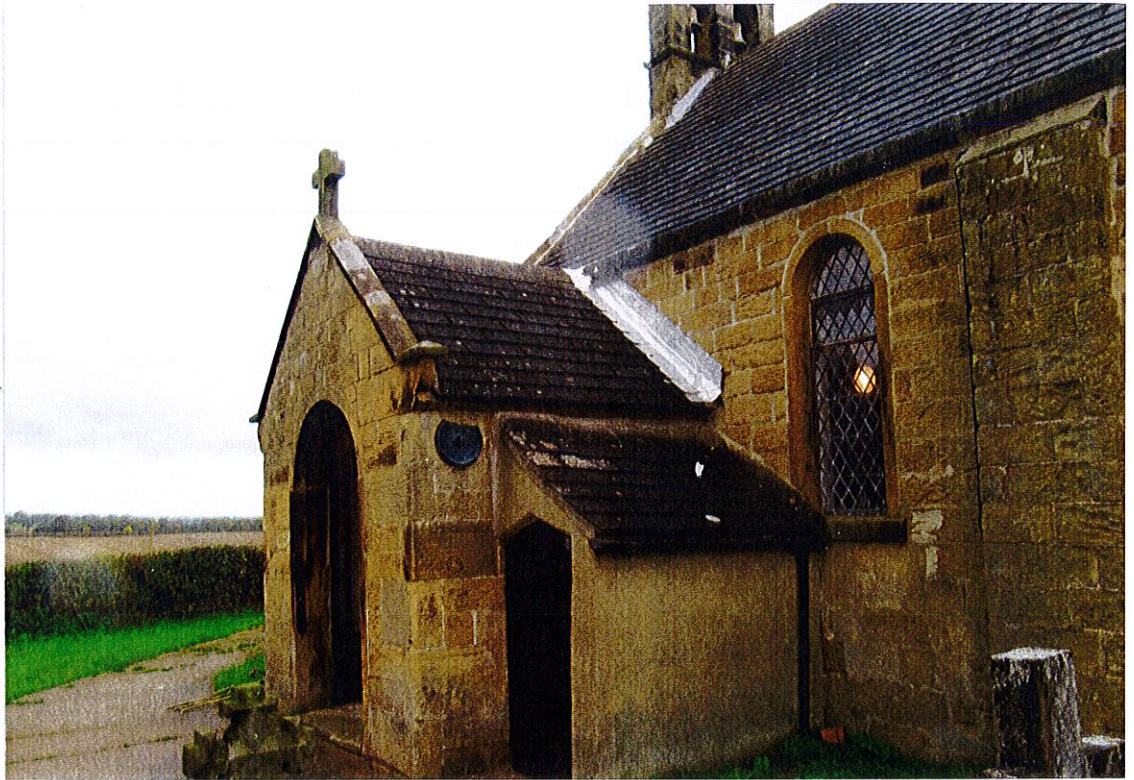
5

- 5.2.1 Roof generally in sound condition including recent renewal of haunching to copings/water tabling as noted under 2.1b.
- 5.2.2 Felt gutter linings to the box gutters have been replaced with lead disguised by a Flashband over layer as noted under 2.1a.
- 5.2.3 A mixture of stone types/quality indicates additional work at some time in the Church's history e.g. the North pier. All are in apparently sound condition.
- 5.2.4 Cast iron guttering to lean-to remains to be fully be secured and adjusted to fall to downpipe.
- 5.2.5 Door to lean-to remains in poor condition and requires replacement or at least re-decoration plus replacement ironmongery.
- 5.2.6 Some crazing remains to render to brick flank wall to lean-to.

5. Porch and lean-to from South East. Note broken cap to tie bar, flashband and settlement angle of the lean-to.
6. South Elevation from South East.
7. East Gable. Note tie bar.

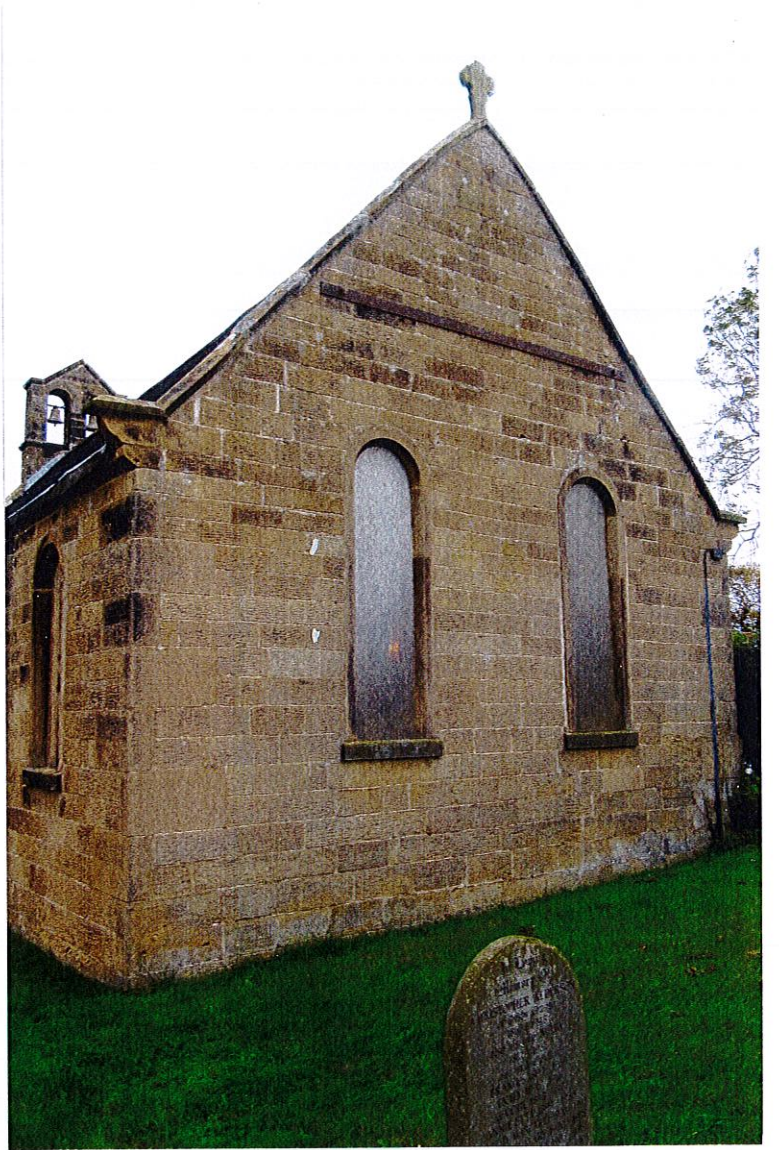
7

- 5.1.1 The high level structural tie bar is in apparently sound condition but, as noted previously, would benefit from decoration to maintain its integrity.
- 5.1.2 Stonework and pointing is generally sound but a stepped diagonal crack through stonework joints is now apparent running from the North-East corner kneeler to the adjacent window frame, where an open joint between the stone frame to the window and abutting stonework is now evident.
- 5.1.3 Polycarbonate sheet protection to windows in sound/secure condition.
- 5.1.4 There remain some minor open joints to the stone arch to left hand window.

20. South East corner of Chancel with Choir pews
21. Nave view to Chancel.
22. Chancel detail with stained glass windows.

- 8.1 Preparation and decoration of external tie bars to East and West gables : B (5.1.1 and 5.4.2) £60.
- 8.2 Installation of tell-tails to movement joints in East gable wall per item 5.1.2 to monitor any further settlement/deterioration.. A. £80

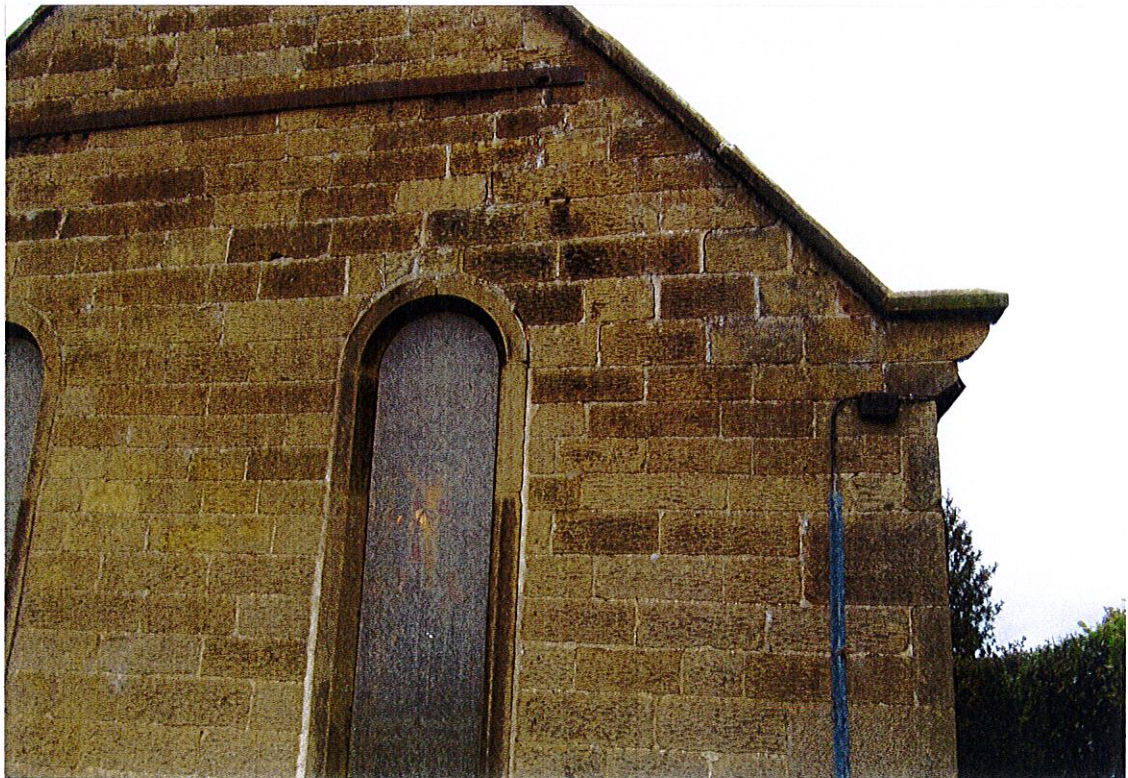
8

8. North corner of East Gable. Note stepped diagonal crack and open joint to stone frame to window.
9. North flank wall from East.
10. North flank wall from South

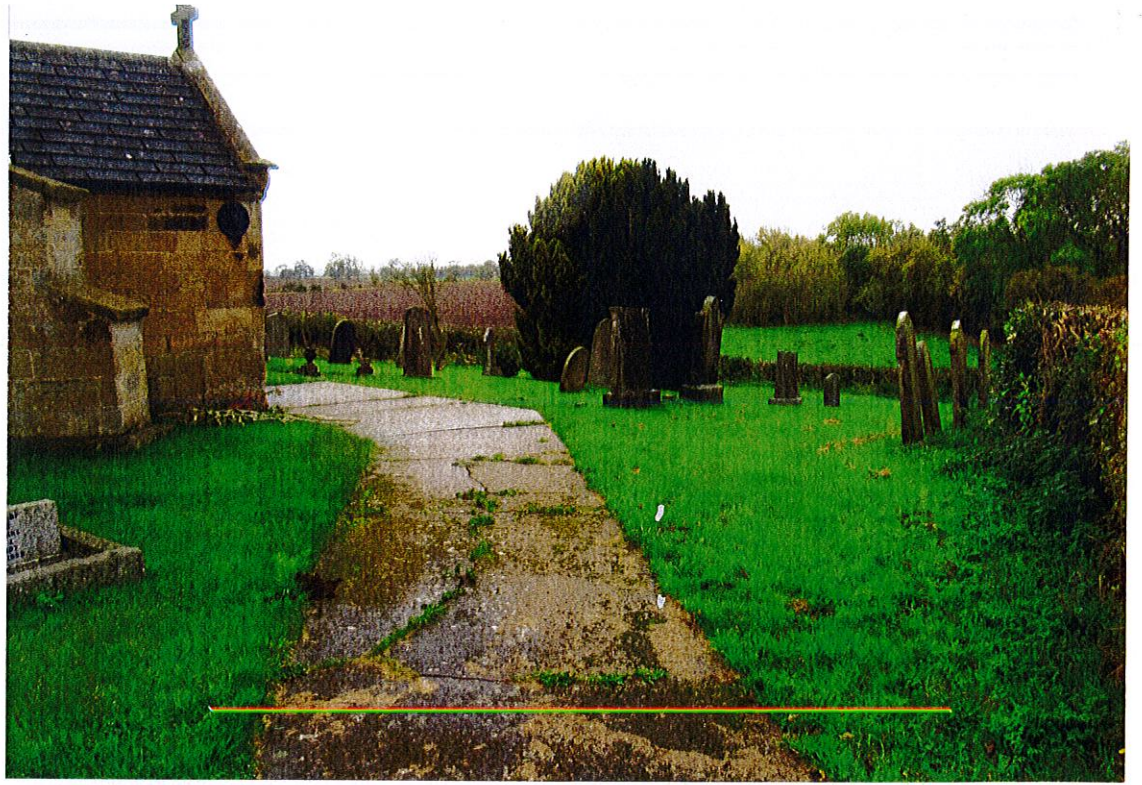
11

11. Approach footpath. Noted distorted and cracked condition of concrete
12. Approach footpath looking back to gate.
13. Consecrated Churchyard. Well maintained with watching brief on gravestone stability.

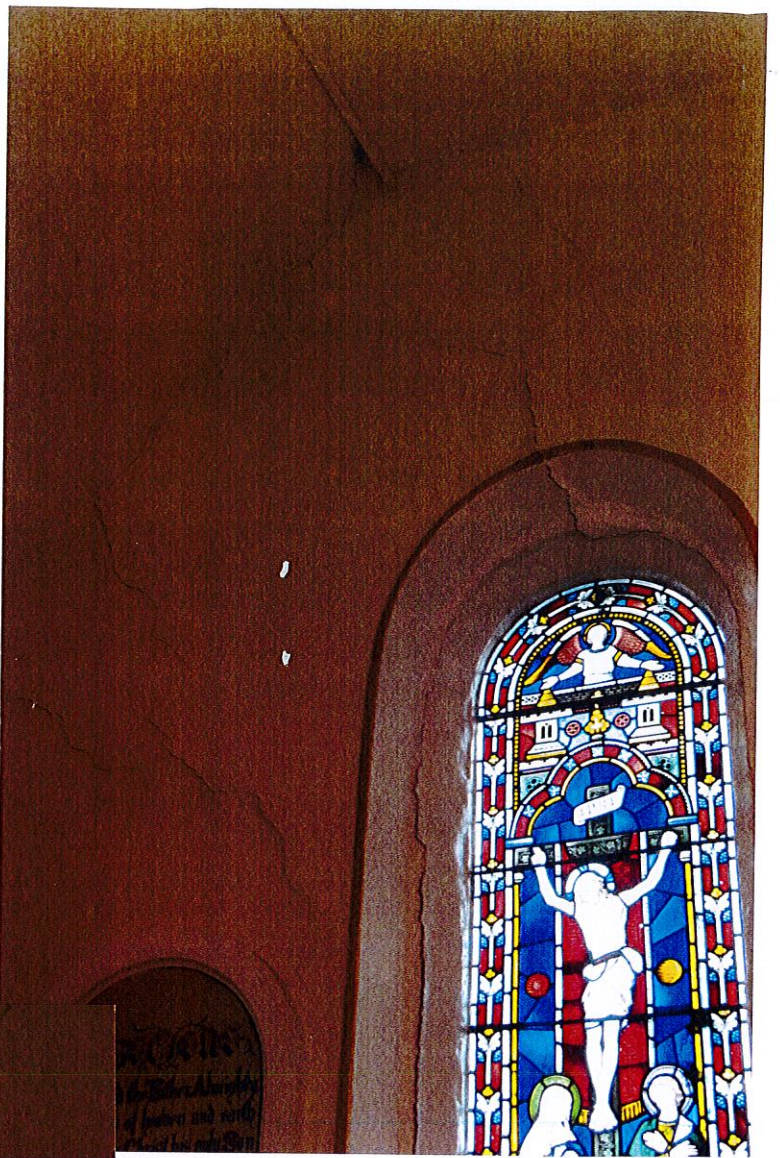
23

- 6.4 Two arched head windows in the East gable incorporate stained glass. Both are in fair condition. There is however evident development of movement cracks in plaster with diagonal cracks to both window heads and other surface crazing.

23. Movement cracks to window head coincident with external movement joint per photograph 8.
24. Diagonal crack to South East corner.
25. Exfoliation of decoration on South elevation.
26. Plaster failure coincident with gutter/peak to Porch
27. Nave looking West
28. Bell ropes and ceiling access hatch.

- 8.10 Scrape of decoration and plaster to East gable wall to expose movement cracks. Infill and redecorate. B (6.4) £800
- 8.11 Scrape off defective decoration and plaster at low level to West gable wall. Make good plaster to render specification and apply anti-fungicidal mist coat. Allow to dry before redecoration. B (6.5) £400

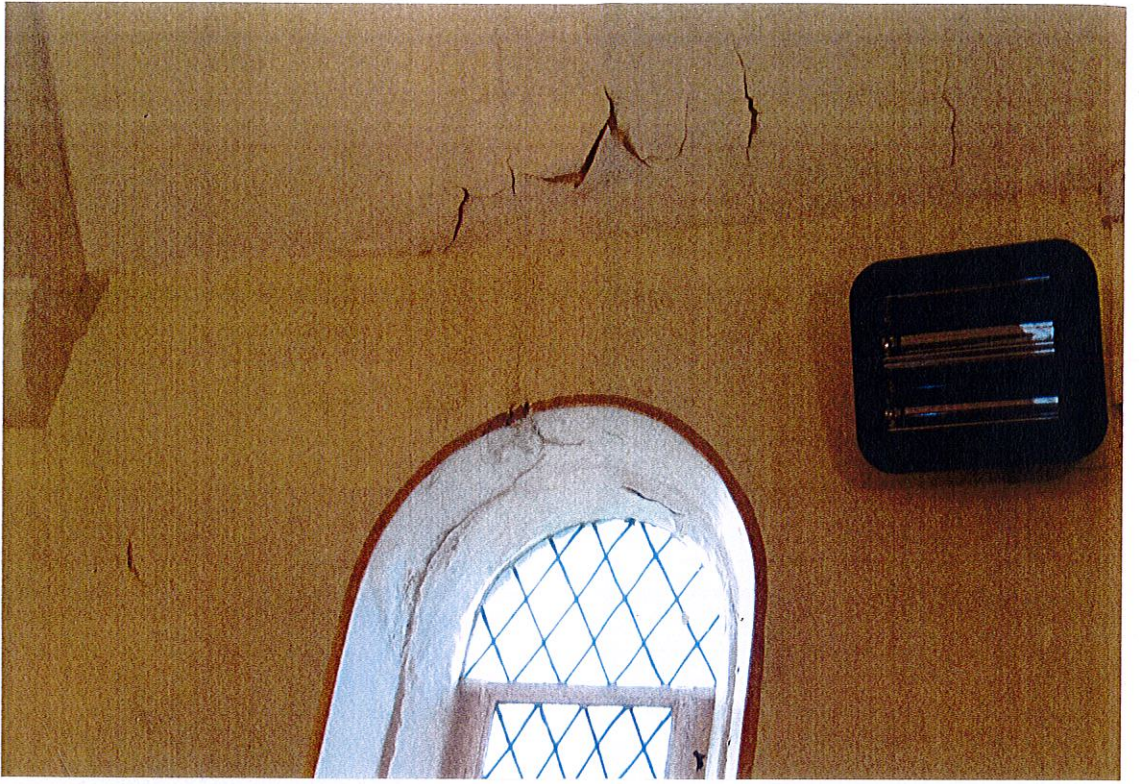
25

- 6.1 The 3 painted main roof trusses and supporting corbels remain in sound condition, enhanced by the post 2002 decoration.
- 6.2 The underdrawn ceiling is in predominantly sound condition and fair decorative order but there is some significant break down/exfoliation of decoration at eaves level on the South elevation in particular with a plaster de-lamination patch coincident with the peak of the Porch roof.

- 8.8 Repair plaster to Porch and redecorate : B (6.15) £100.
- 8.9 Carefully scrape off exfoliated internal decoration at eaves level to South flank wall together with renewal of defective plaster. Treat with anti-fungicidal mist coat and allow to fully dry before remedial decoration. B (6.2) £600
