St HILDA
SOUTH SHIELDS
(110)

QUINQUENNIAL REPORT
on the architect's inspection on

22 March 2019

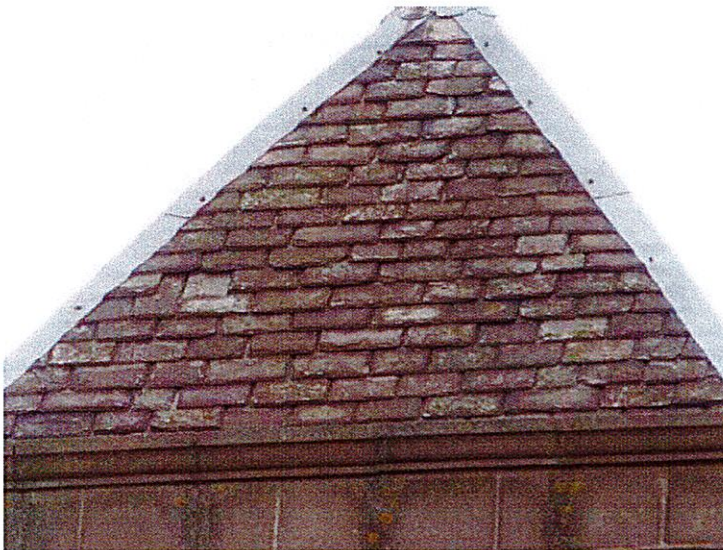
Slate missing from Tower N side

Replace missing slates at Tower N side (and clear Tower roof gutter and N secret gutter at same time)	17 – 20
Replace three Nave slates at N and two at S	21, 23
Clear gutters and outlets all sides of Nave	20, 27 – 31
Refix pipe from Song Room Porch to fall in hopper	34
Clear blocked hoppers at Kitchen and Vestry, refix Vestry hopper	35, 36
Refix ceiling fan at Access wc	85
Check and if needed refix shroud at Song Room flue	108
Check boiler in Song Room works	122

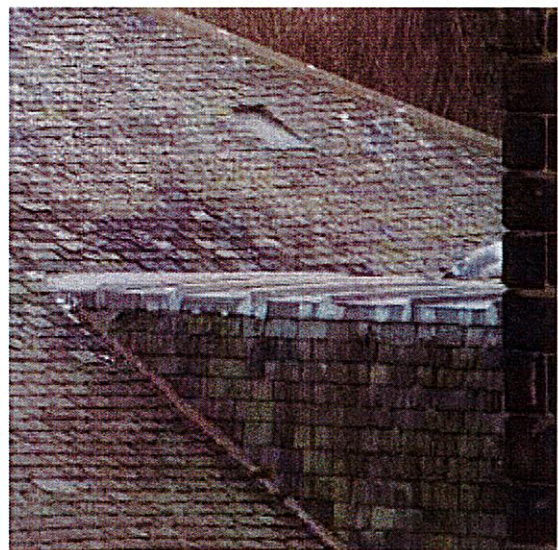
plants in cracked mortar fillet N of the tunnel between Tower and Nave roof

20. The Nave W hip slates are mortar torched inside, no felt. Large glass slate. Slate fair with some patching. Lead back gutters at the Tower, N renewed 2005. Plants grow in a blocked secret gutter between the N side of the hip and the Tower (wall wet below).

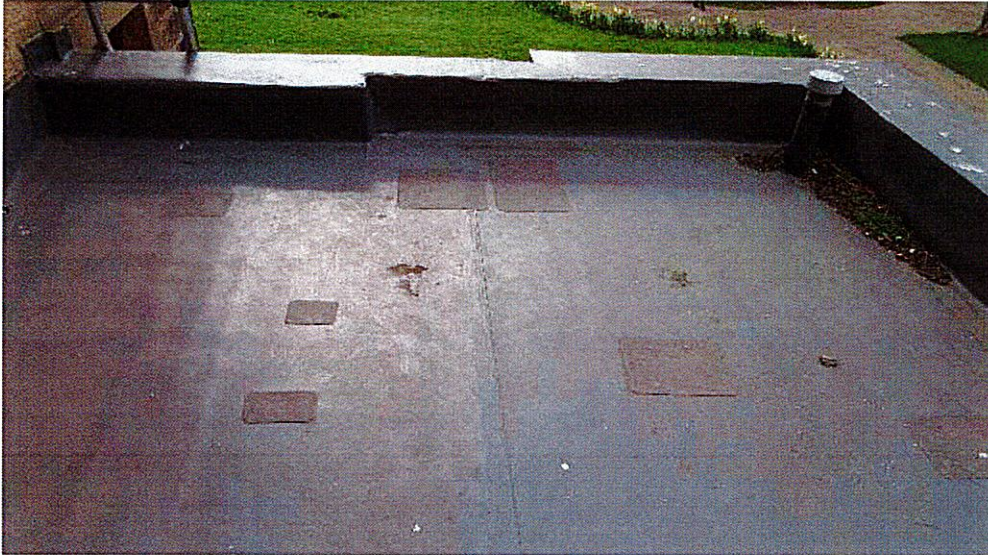
Kitchen roof

26. On Kitchen eight Sarnafil patches and some silt build up in corners.
On Vestry seven patches (four Sarna, three substitute – well stuck but limited life)

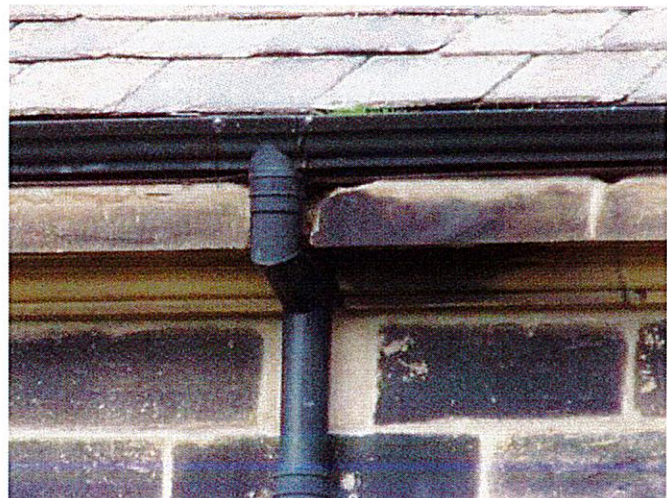
N gutter E outlet

31. Nave N gutter appears clear except plant by E outlet.

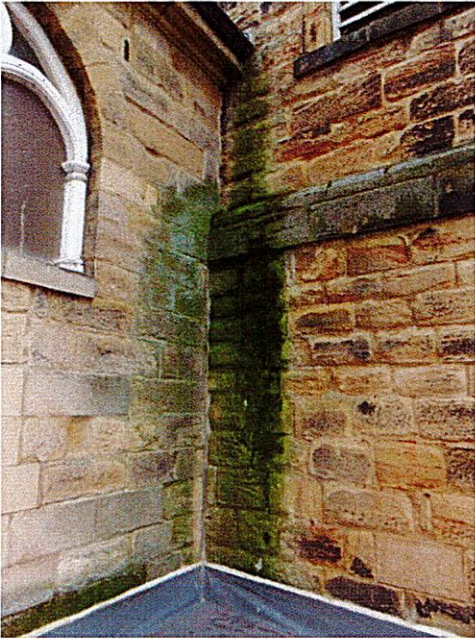
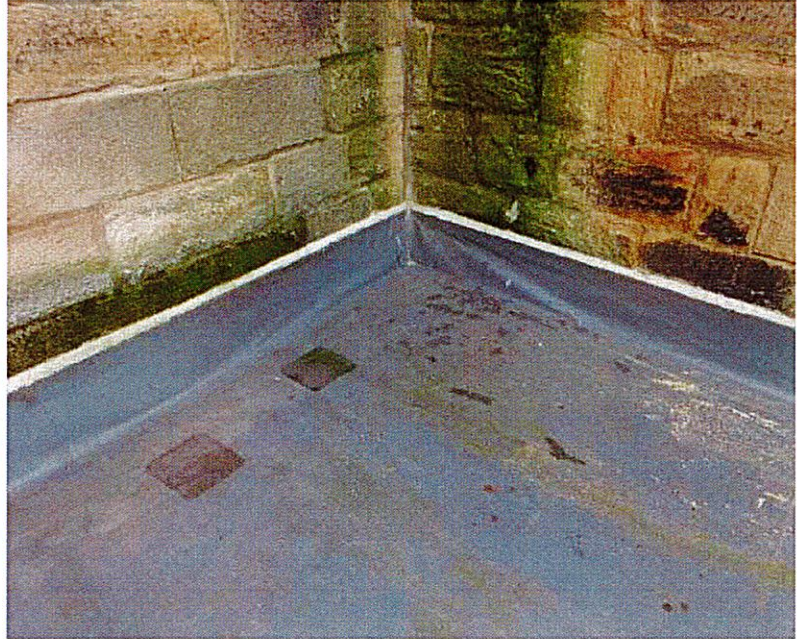
30. Water runs down the stone wall under the W end N gutter (over Vestry) which is green with damp. The secret gutter above (para 20) and perhaps the cornice gutter also need to be cleared. Reported damp in the Vestry below.

Wet wall over Vestry

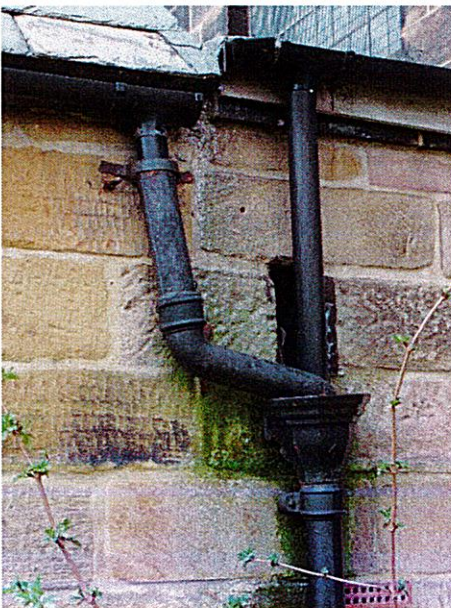
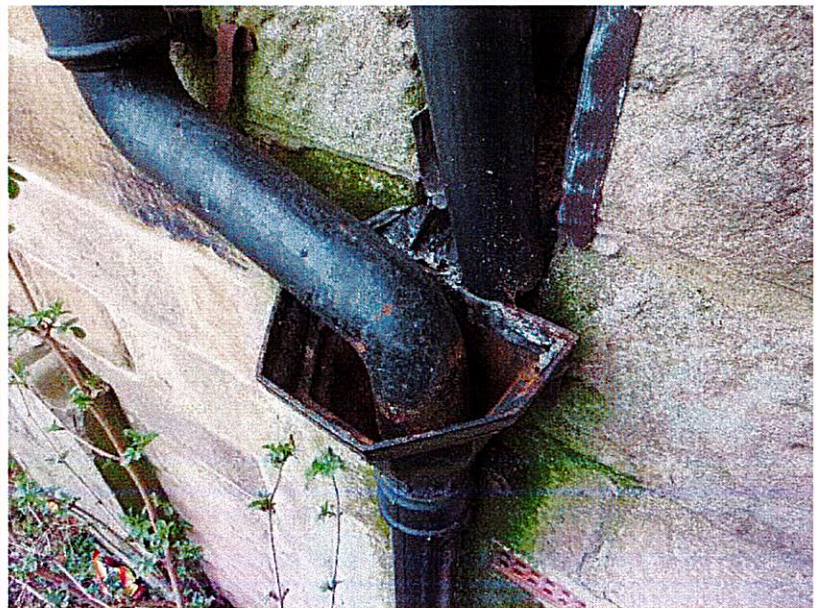
At Porch plastic gutter on fascias, one end loose. Its pipe does not fall over the shared hopper and the wall is wet.

Misaligned pipe misses the hopper E of the Song Room

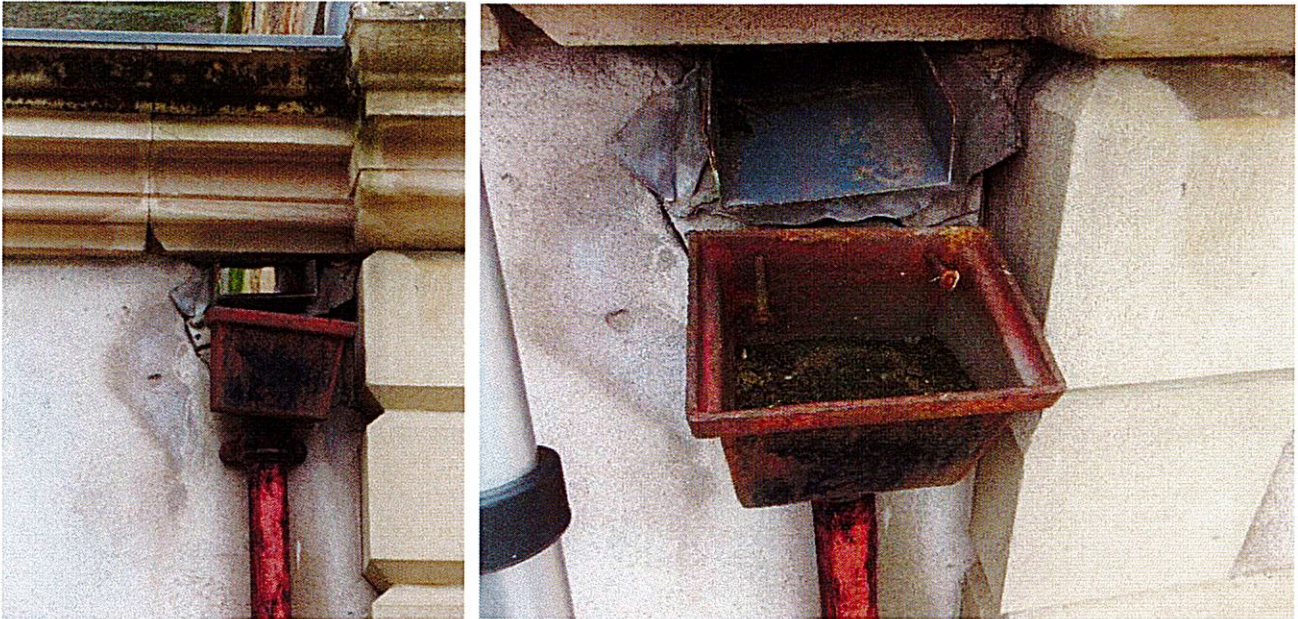
35. The Vestry and Kitchen sump outlets drain to cast iron hoppers, pipes and shoes. Vestry hopper loose from render. Both hoppers and gullies are blocked by soil. The blockages must wet the walls.

Vestry hopper loose, blocked and lacks paint

36. All hoppers, gullies and drains need to be cleaned regularly to prevent blockage and damp walls.

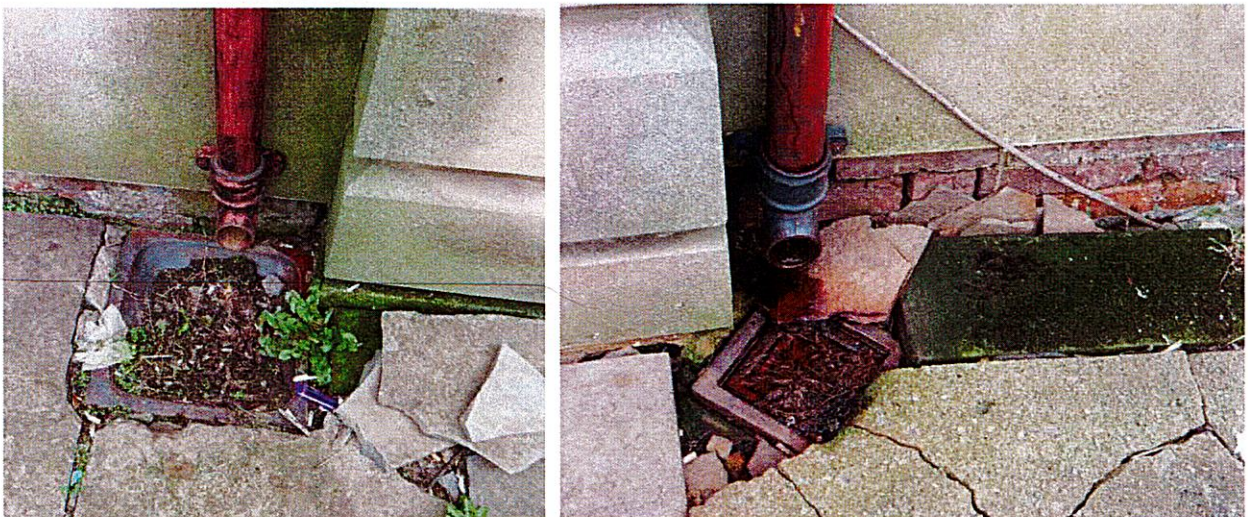
Vestry and Kitchen gullies blocked

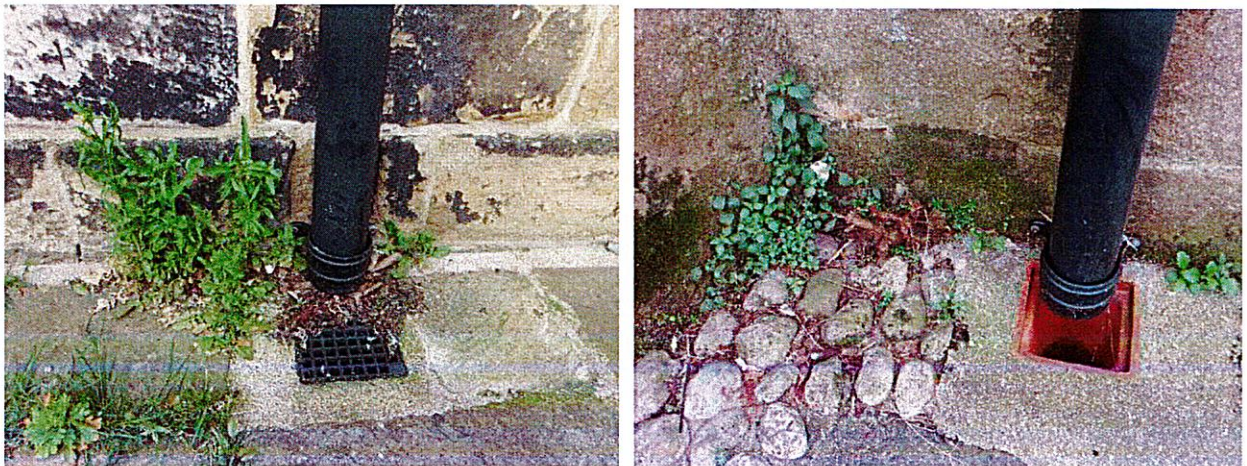
Typical Nave gullies

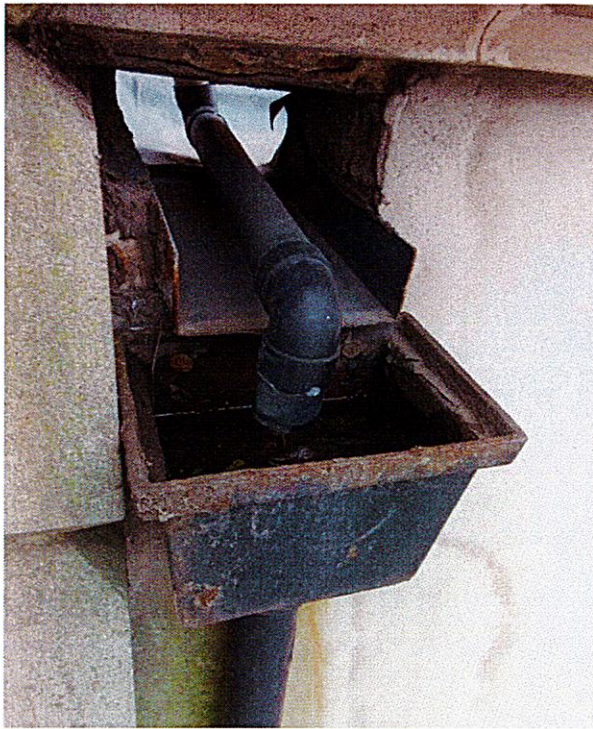
Kitchen hopper blocked and unpainted

37. All cast iron rainwater goods at Tower (E side high level), Vestry and Kitchen are rusting and need preparation and paint.

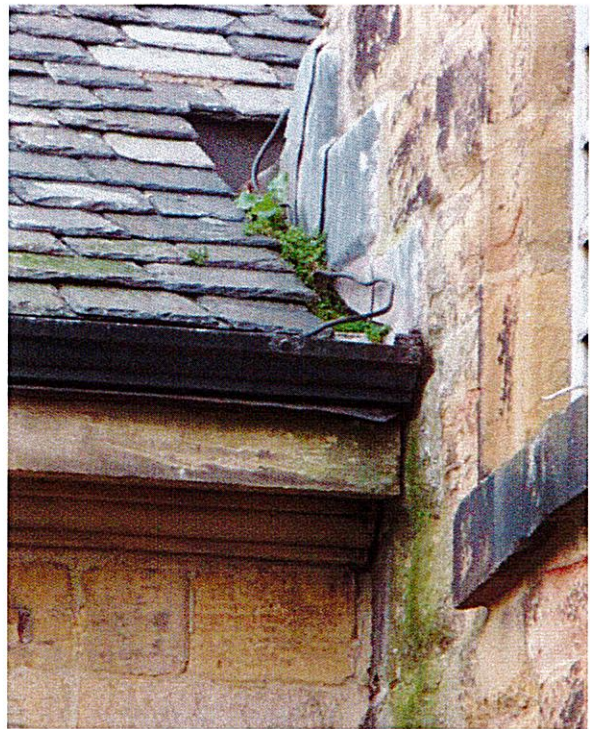
plants blocking secret gutter N of the Tower (paras 20,30) wall below wet

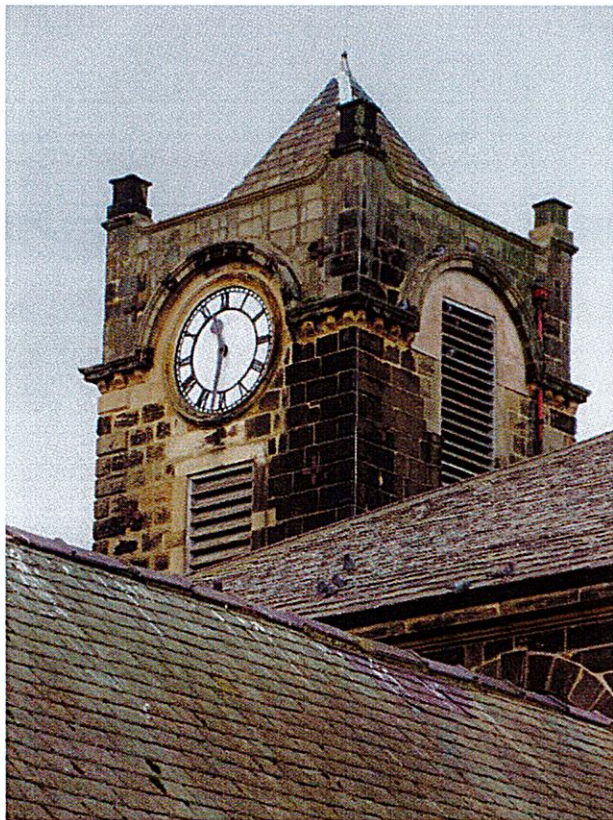
Tower E side – hard to access hopper and pipe

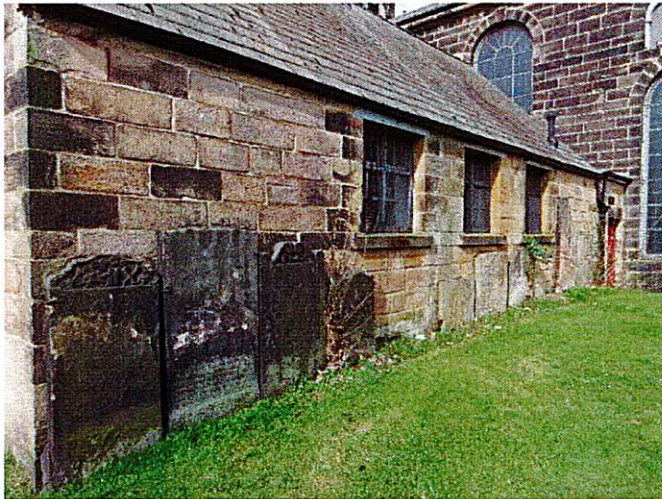
40. Against the Song Room E wall two saplings have been cut but not destroyed and grow again. A cut sapling against the wall N of the Apse is not dead and may need poison.

Saplings among moved headstones against Song Room

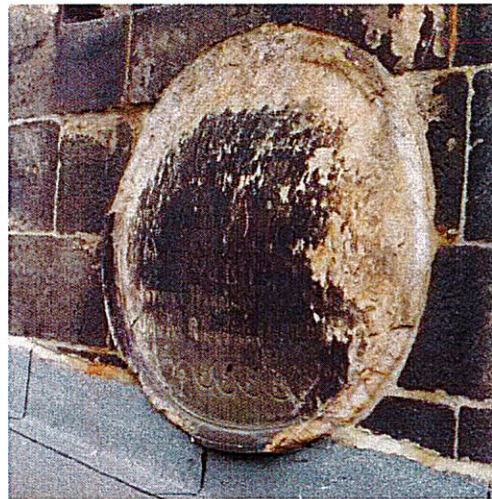
Hidden plaque over Song Room porch

41. A hidden oval tablet over the S Porch erodes from the top.

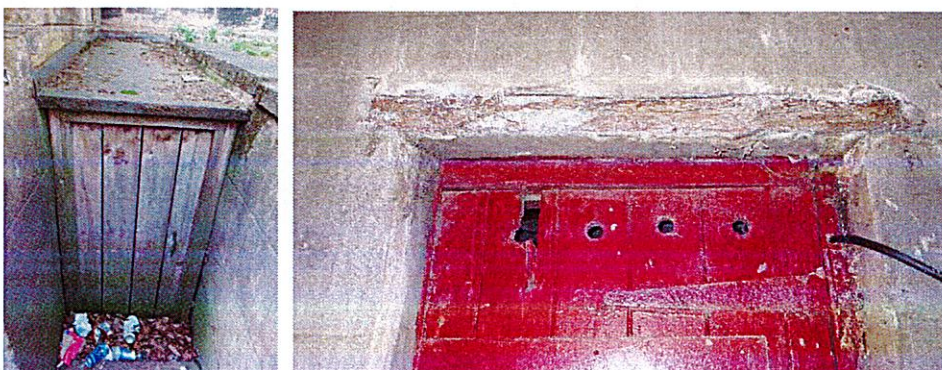
Decaying Lintel at Blower door

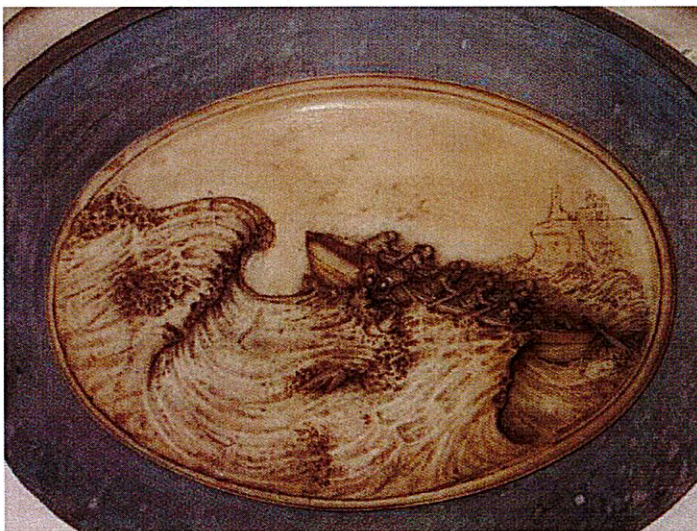
Example of fine but dirty marble monument

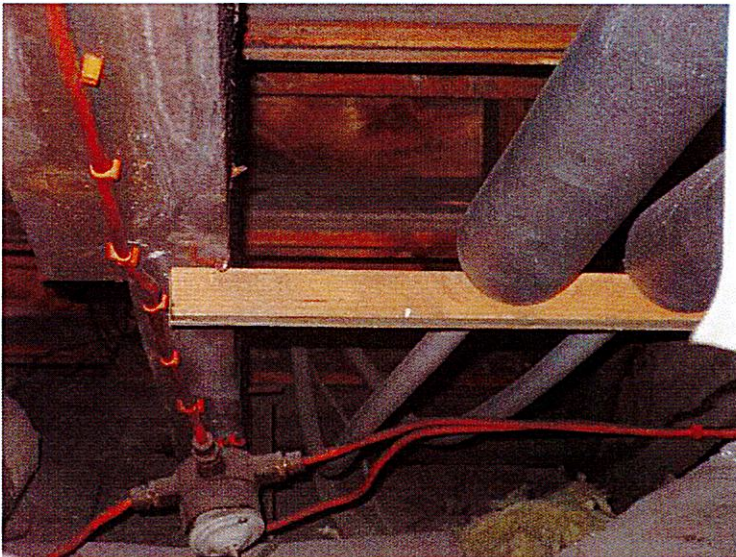
106. Small parts of the former cast iron pipe system remain, notably behind the organ where a test in 2003 showed that the thin insulation wrapped in canvas and chicken wire does NOT contain asbestos.
107. Heating installed 2010 reverted to a modern wet system of two wall mounted gas boilers on Gallery, concealed piping and panel and column radiators. A separately controlled circuit for the Visitor Centre. Thermostats and timers. Insulation at parts of plastic circuit pipework in the void under the Gallery.
108. A separate wall combi boiler at the Song Room, radiators and pressurised circuit above floor level. A shroud at the flue through the slates seems displaced and open to the weather.

Heating pipework under Gallery part insulated

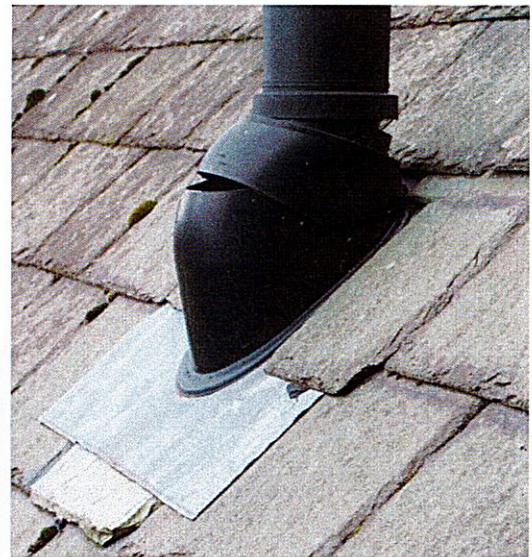
Combi flue at Song Room

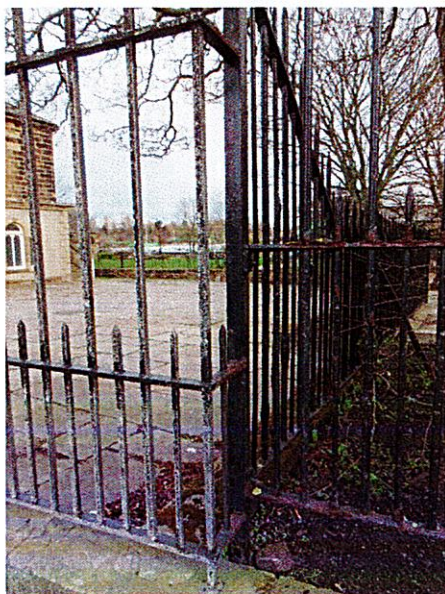
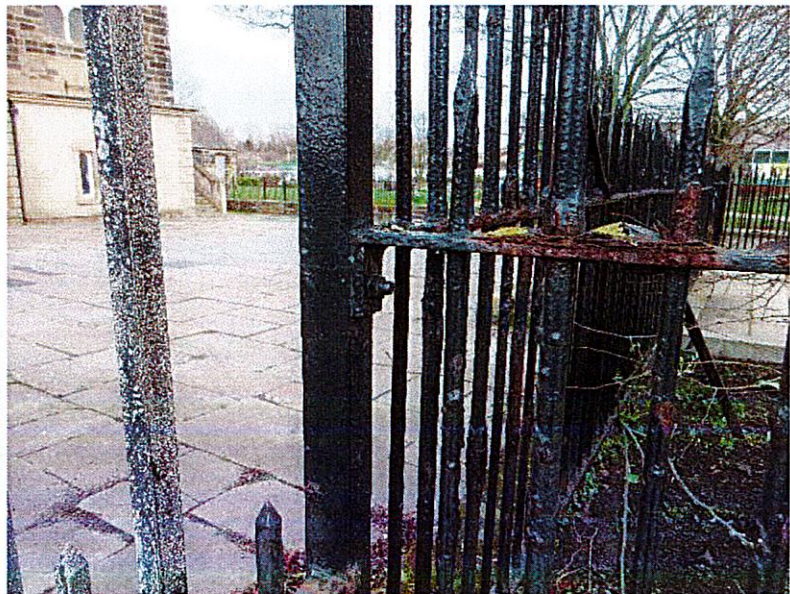
At NW corner of forecourt

130. The earlier iron railings around the rest of the churchyard are painted only. There is severe rusting and delamination. Such ironwork rusts slowly but it will destroy the railings unless they are thoroughly chipped, rust treated, primed and painted with suitable paint such as Hammerite.

Painted galvanised N railings at L, earlier unpainted now delaminating churchyard railings at R
