## Church of St John, Stillington

### Quinquennial Report

**1<sup>st</sup> February 2024**

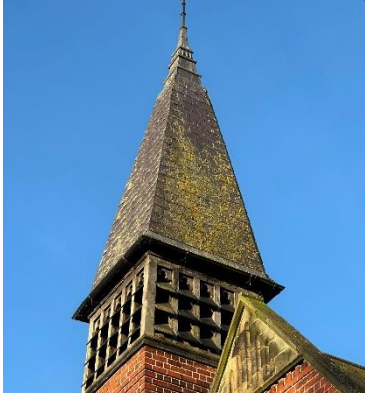
Figure 1- Tower roof

6.1.1 **South** - One hip slate still missing at the Western side. The overthrow looks ok.

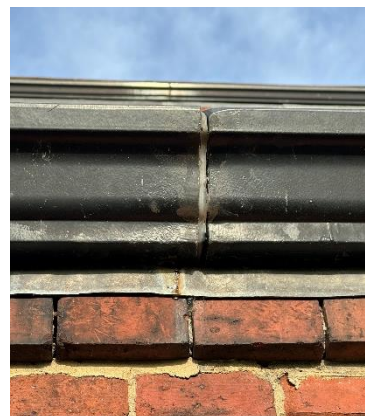
Figure 4 – Gutter joint to S Aisle

- 7.3 **South aisle:** The silicon is breaking down at the joints, which may lead to leaks. The swan neck still appears to be loose at the change of angle at the plinth.

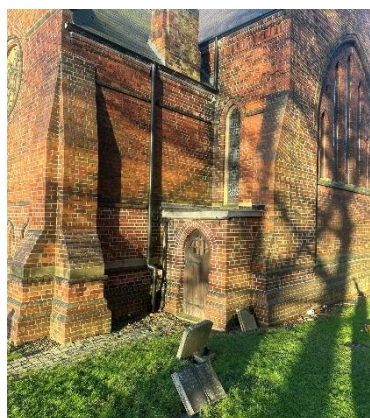
Figure 5 – East Transept & Organ Blower room

- 7.5.2 **East elevation:** Guttering appears ok, but should be checked in rain for any leaks. The downpipe has a loose connection just above the swan neck.

- 7.7 **Organ Blower Room** – Single gutter with downpipe to the west. A long fall from weathered surface to gutter and it is unknown if this collects the rain efficiently. The downpipe looks as if it could be leaking and is not connected into the gully at the base which could lead to damp in the walls.

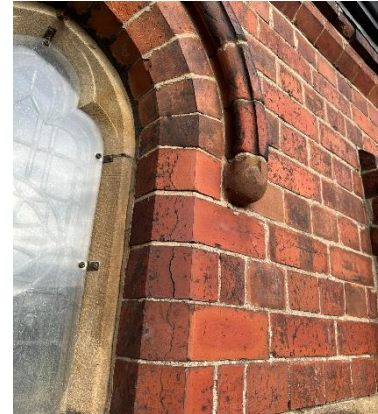
*Figure 6 – Window Reveal S Aisle*

8.2 **South aisle:** Some poor re-pointing in a cementitious mortar, by the eastern windows and there is some erosion to the stonework, filled with the same mortar, not currently problematic but could lead to further erosion. The hoodmoulds have a few open joints and one reveal has a historic fracture to the brickwork. The area below the string course has also been repointed in the past, although not completely down to the ground, so some of the string course and lower area have open joints. The buttresses have a couple of open joints at the angled brickwork at the top.

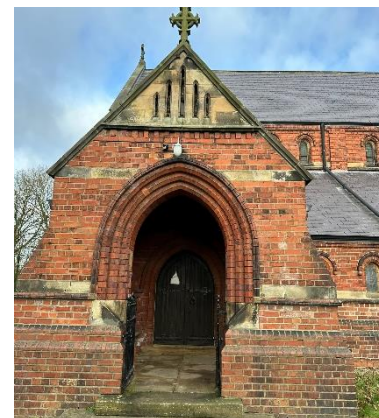
*Figure 7 – S Porch*

8.3.2 **South elevation:** The stone water table incorporates a triangular feature with five narrow lancets. The mesh is poor and offering no protection from nesting birds. This elevation is badly cement pointed and there are some open joints at the stone band course and the hood mould.

8.3.3 **East elevation:** As per the east, heavily cement pointed to the upper half. Some open joints to the lower section and to the buttress. The bricks to the hood mould and below are eroded.

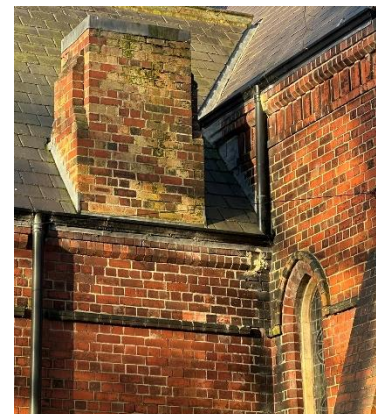
*Figure 8 – Chimney and poor mortar infills to E Transept*

8.4.3 **East elevation:** Repointed at lower level. Evidence of previous downpipes across elevation from staining and loss of string courses, alongside holes from previous downpipe fixings. There has been some very poor patching in of the end of the corbeled course under the gutter. The buttress is okay. At high-level there is a chimney which is stained and has a loss of pointing. It is unknown if this is capped but appears to have lead flashing to the top. It is notable that this chimney lines up with a damp patch internally at item 13.4.

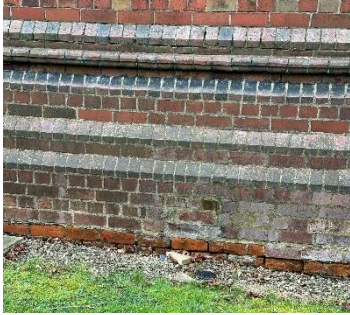
Figure 9 – Eroded brick to LL East

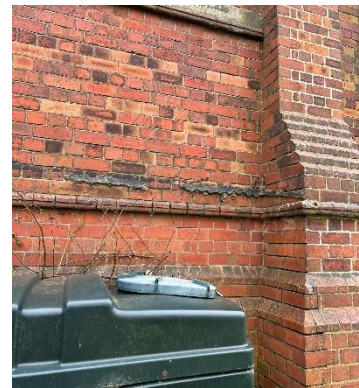
8.7.3 **Nave - Western end:** At the area of the oil tank, there is some silicon flashing remnants from a previous lean-to store. There are a couple of places where the brickwork needs infilling from previous downpipe fixings.

Figure 10 – Former lean-to flashing

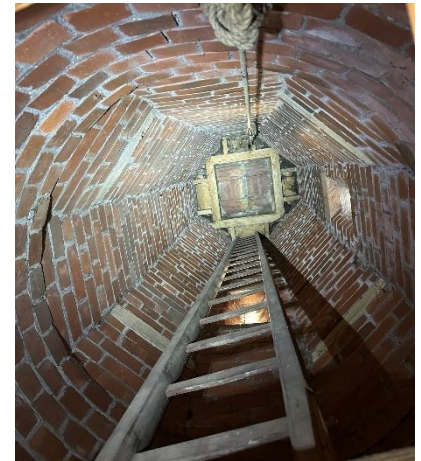
Figure 11 – Inside Tower from base

- 9.2.3 **Tower** – notes taken from the last report *‘Slight cracking in the South-Eastern corner but not a defect to worry about. Access up to the steeple via vertical ladder. Rot at the foot and not secured at the head so not deemed safe to use.’* The statement appears to be largely still relevant, though the condition of the timber at high level is unknown.

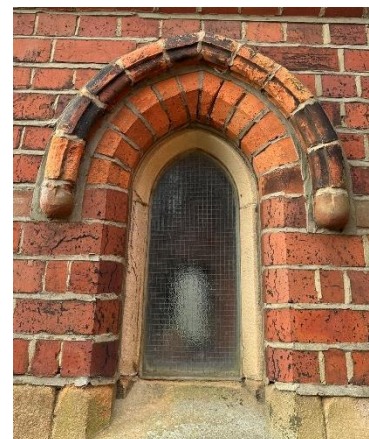
10.3 To both sides of the porch there is Georgian wired glass pointed into a sandstone frame, both are loose and rattle with minor winds. The cill to the west side is eroded with very open joints. The east side, the sandstone reveal is delaminating and its condition should be monitored.

*Figure 12 – East Porch window*

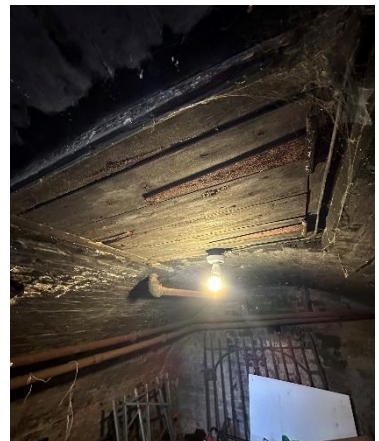
Figure 15 - Hatch to boiler ceiling

- 12.1.2 Ceiling is arched brick in black with timber access hatch. The access hatch has a broken latch and there could be safety considerations for combustible materials in this area. PCC to check with fire risk assessor.

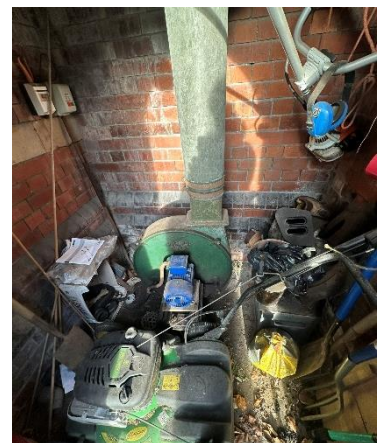
Figure 16- Organ Blower room

- 12.2 **Organ blower room:** This is a simple concrete flat roof in the South-East corner of the church. Brick walls. Reportedly, water has washed down one corner but it is thought this is historic as it now appears dry inside. The blower appears ok. The room contains more garden equipment and some lumber. The blower motor was replaced in 2004.

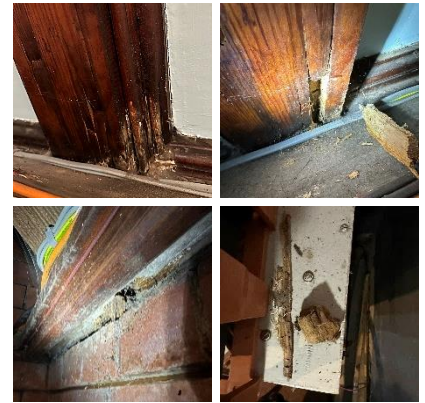
- 13.2.1 The infill timber between the first and second truss from the east has lost all its integrity to the base near the wall plate. Completely rotten, pieces break away easily as seen in the top left photograph at figure 18.
- 13.2.2 The coving also has rot, on inspection the loose pieces were broken away (as per two lower pictures at figure 18) to inspect that the new glulam base was intact but had no bearing onto substantial material.
- 13.2.3 There is woodworm to several rafters (3No with severe infestations). There are signs of frass indicating it could be an active infestation.
- 13.2.4 The purlin ends, particularly into the eastern wall (to the office) need to be inspected at closer proximity as if they could have also been affected by rot.

Figure 18 – South Aisle timber decay

29.1 Whilst the church overall seems in good condition, further inspections are needed of certain inaccessible areas. The timbers, specifically to the south aisle where defects have been found, need to be inspected by a specialist and defects rectified. A wider inspection of all timbers susceptible to rot should be carried out as soon as practicable.

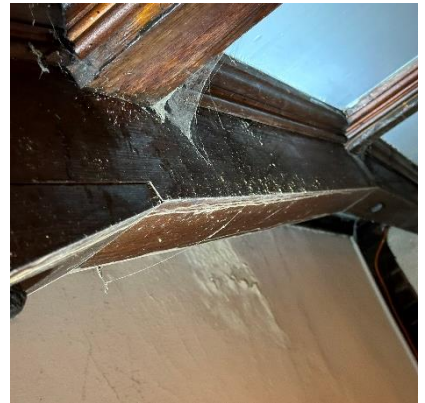
Figure 19 – S Aisle woodworm

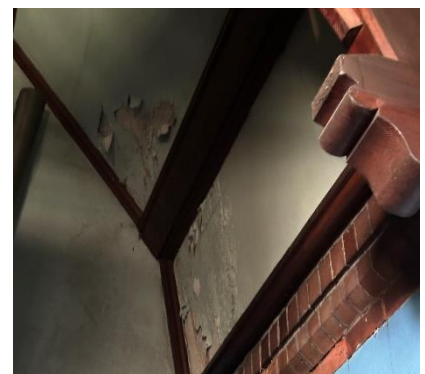
Figure 20 – Organ Loft E ceiling

13.4 **Organ Loft:** Arches, as per the nave, to west side there have also been replacements, a new 'glulam' corbel and plywood bracing to either side of the rafter. As item 12.1 this was reportedly due to rotten timbers. To east there is a damp patch to the infill panel which has lost its decoration, this is in the approximate location of the

chimney externally (as item 8.4.3). It is unknown if this is historic as not reported explicitly at last inspection, therefore I would recommend inspection of the roof and valley above and re-decoration if the inside is dry. To the west some historic hairline cracks in the plaster infill section above the door.

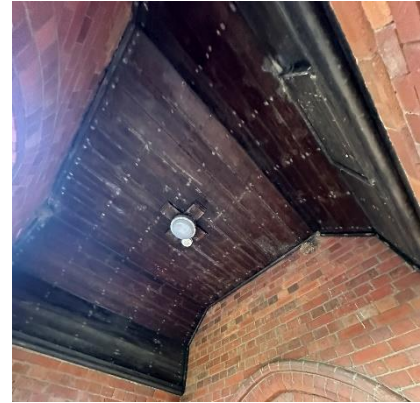
Figure 21 – Porch ceiling

13.5 **Porch entrance:** Boarded ceiling, the condition of the timber looks poor and requires re-decoration, nail fixings are stained. Bird nests persist.

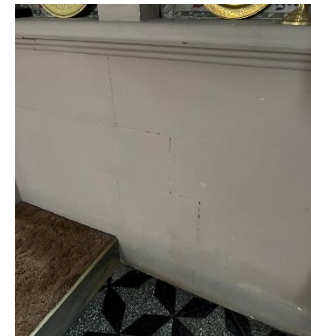
Figure 22- below reredos

14.2 **Chancel** – To the east wall, below the ornate reredos screen on the south side, there is a crack in what appears to be painted stone. This should be monitored for any further movement, no evidence of this externally.

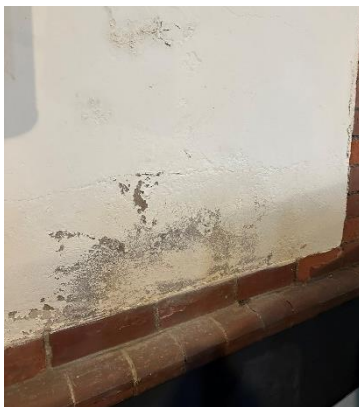
Figure 23- Damp to S Aisle

15.3 **South Aisle:** The walls on the South elevation are exposed brickwork, there is a lot of equipment up against them. Some efflorescence to the brick and flaking plaster between the lancets. In places there are open joints to the brickwork and some bricks are moderately eroded. The mortar pointing here is very black as if it could have had ashes mixed in. To the south west end the aisle, the plaster damage continues, un-reported previously but appears to have been painted over so unable to comment if this is an ongoing issue.

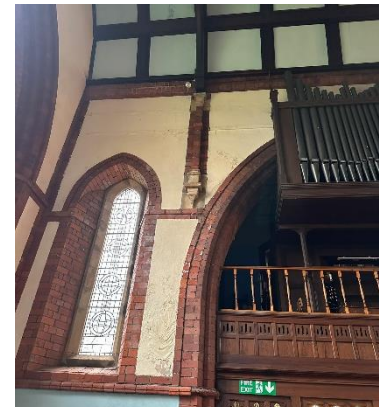
Figure 25 – S Wall near organ

15.1 **Chancel:** There is water penetration showing on the left-hand side of the organ arch which is where the previous downpipe repairs have reportedly been carried out and damage to the plaster was reported at the last inspection. Unknown if this is still an ongoing issue and would therefore benefit from re-decoration with breathable finishes.

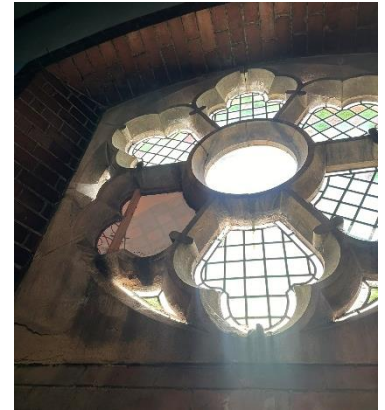
Figure 27- Rose window Organ Loft

10.2 To the south transept a rose window at high level has significant damage to the glass to the east side, currently propped from the inside. The tracery also has significant erosion.

18.2 To the **Organ Loft**, the rose window to the south has lost a significant amount of glazing to a large breakage. A temporary repair needs replacing with a more permanent solution.

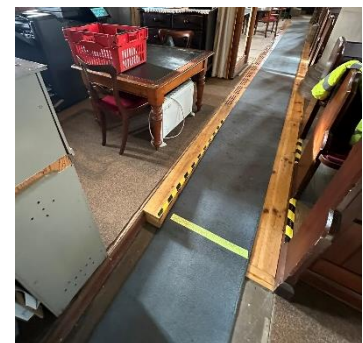
Figure 28 - S Ailse walkway

19.3 The South Aisle has a raised pew platform, and it looks as though the walkway has been recently raised to match this level, with a ramped access to each end. A loose runner in blue which has tape to indicate ramp as a rudimentary approach. To the edge of the aisle there is a grille, presumably for the heating vents.

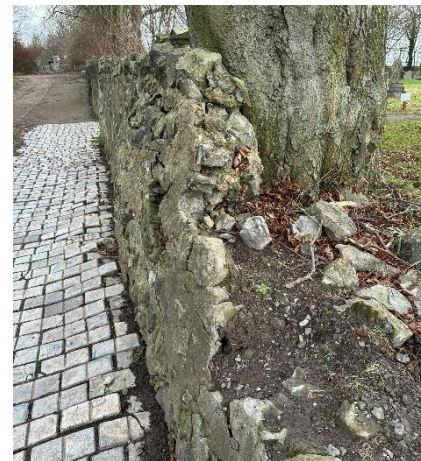
28.4 West elevation: An area of walling has collapsed on the Southern side close to trees. The Northern side is fair; it abuts a more modern large format brick wall which has a cement coping and intermediate buttresses. The brick pointing has broken down in many places. There is a crack on the angled corner adjacent to the footpath and to the reserve. This is alongside a public footpath that leads towards the school to the East.

Figure 31 – Collapsed wall to W

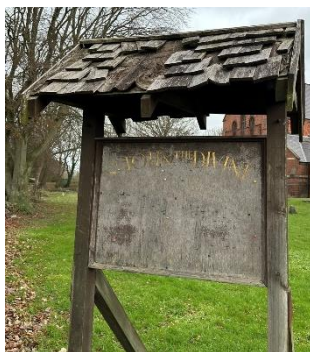
Figure 32 – Sign to SW

28.7 A sign at the southwest corner sits under a canopy, the signage has worn away and is no longer readable, the timber is beginning to rot. The roof is timber shingles and these have almost entirely become rotten, fallen away and left a delaminating plywood base visible.
