QUINQUENNIAL INSPECTION REPORT

HOLY TRINITY with St. MARK

UPSALL GROVE, FAIRFIELD, STOCKTON-ON-TEES, TS19 7QU

JULY 2022

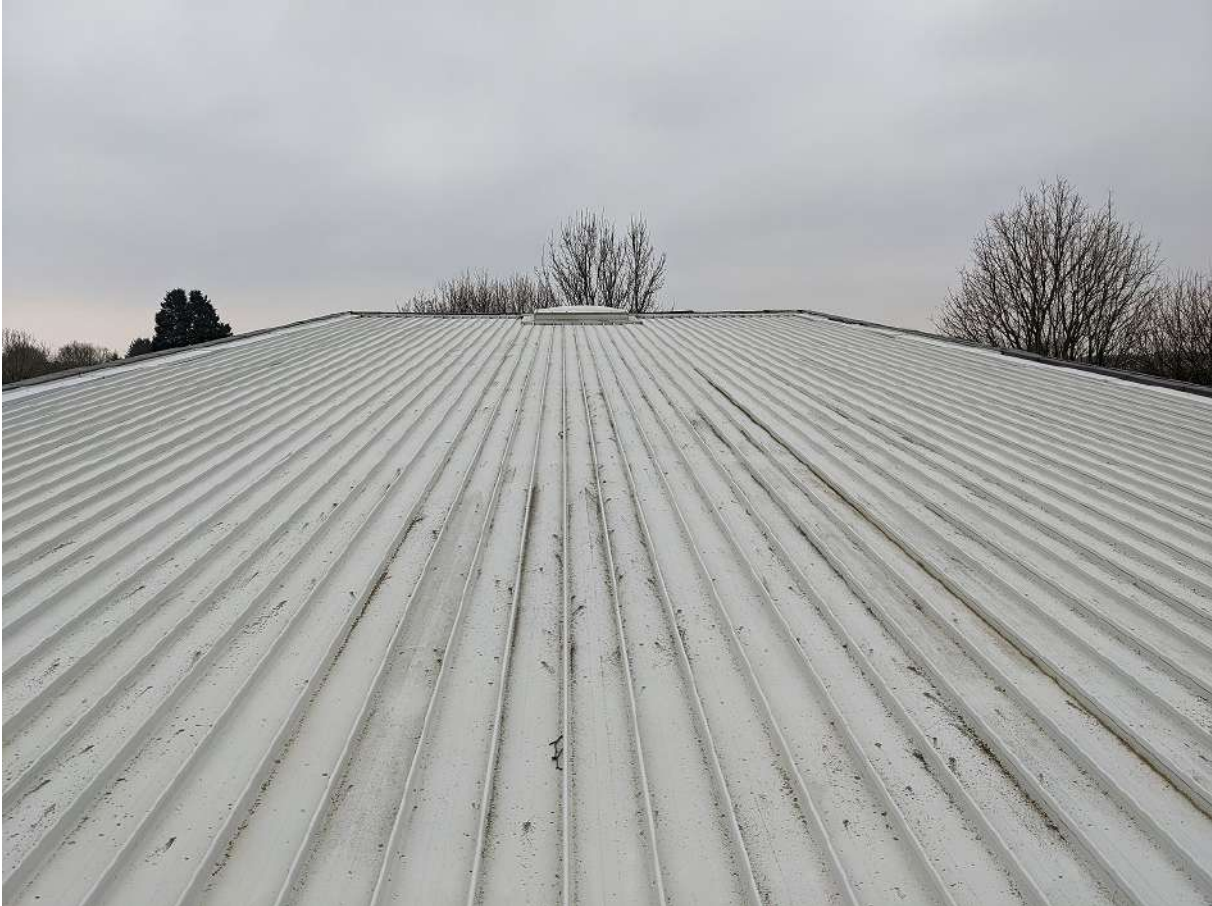
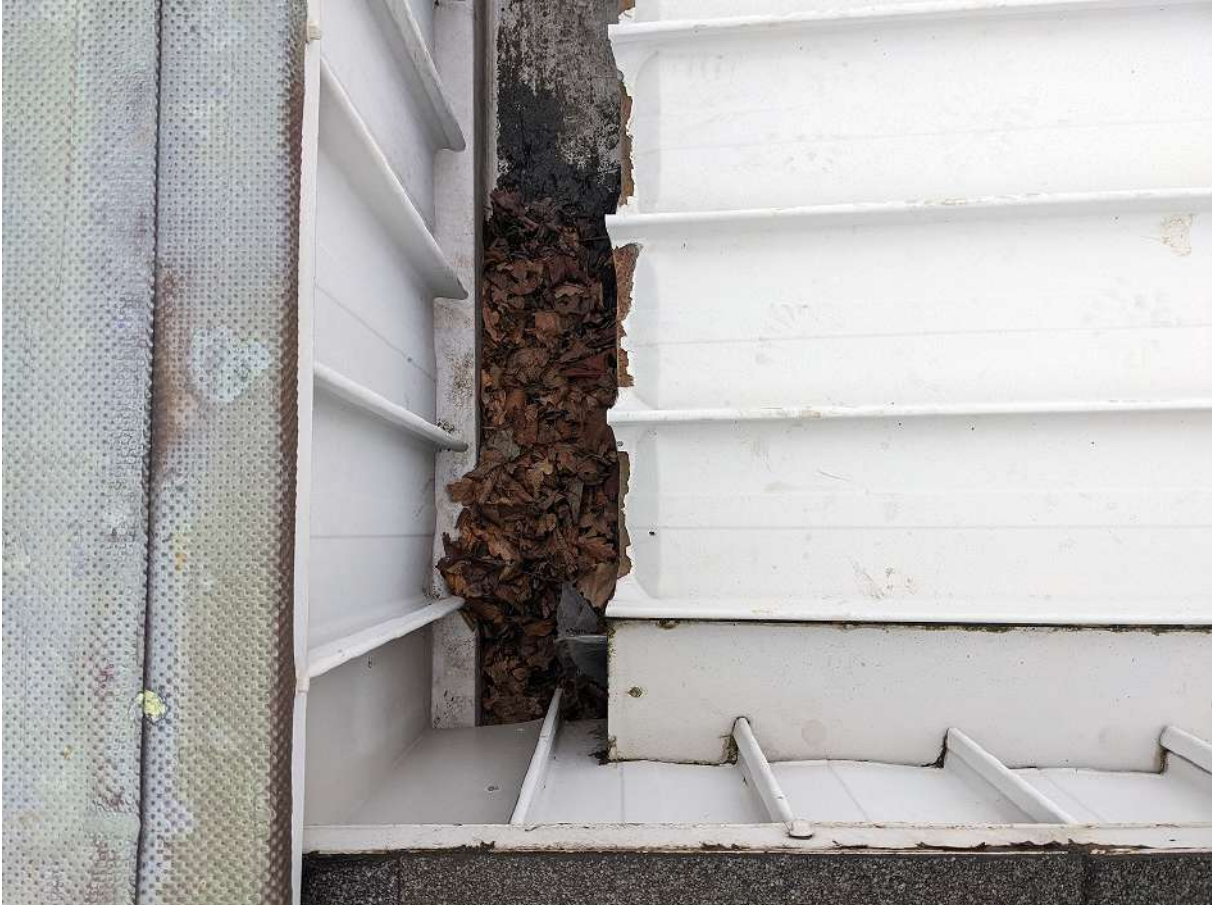
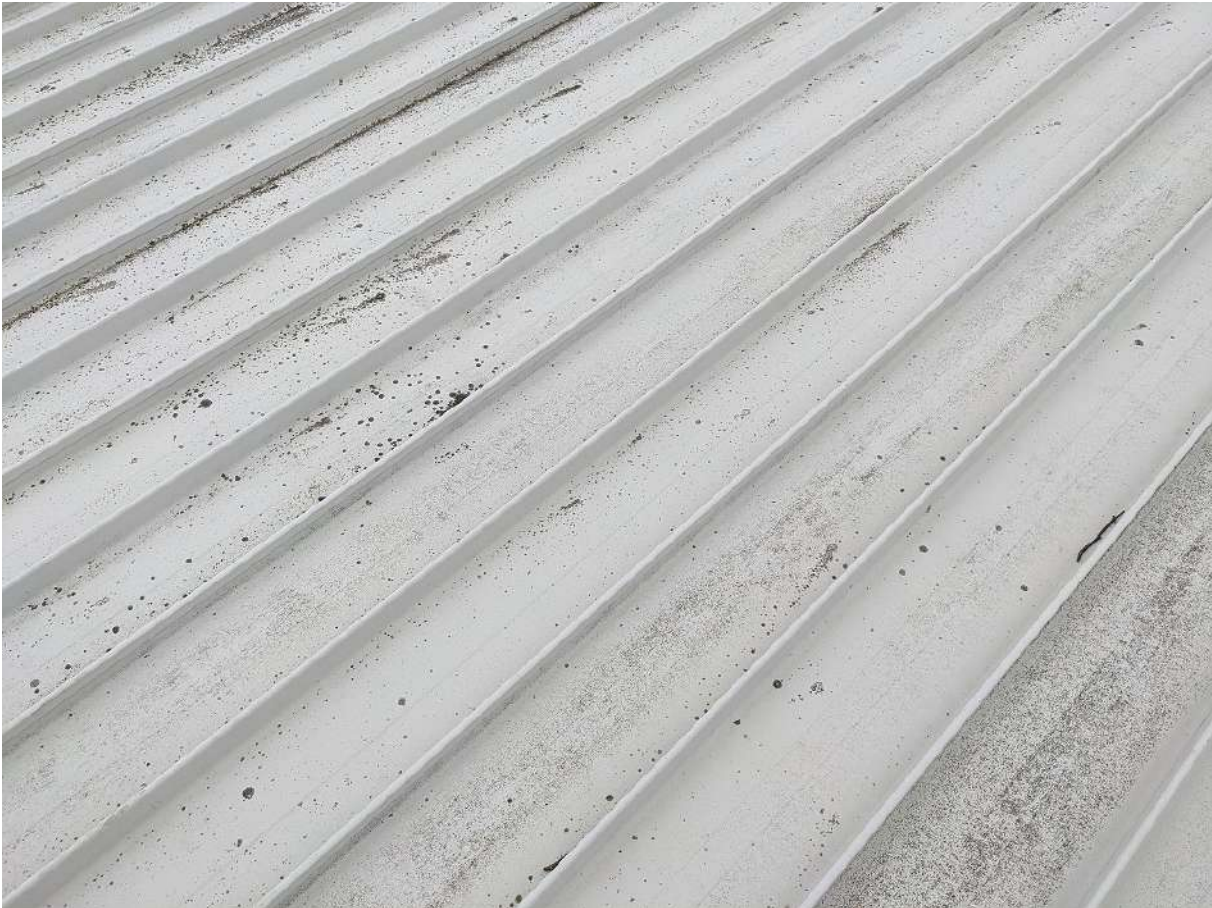
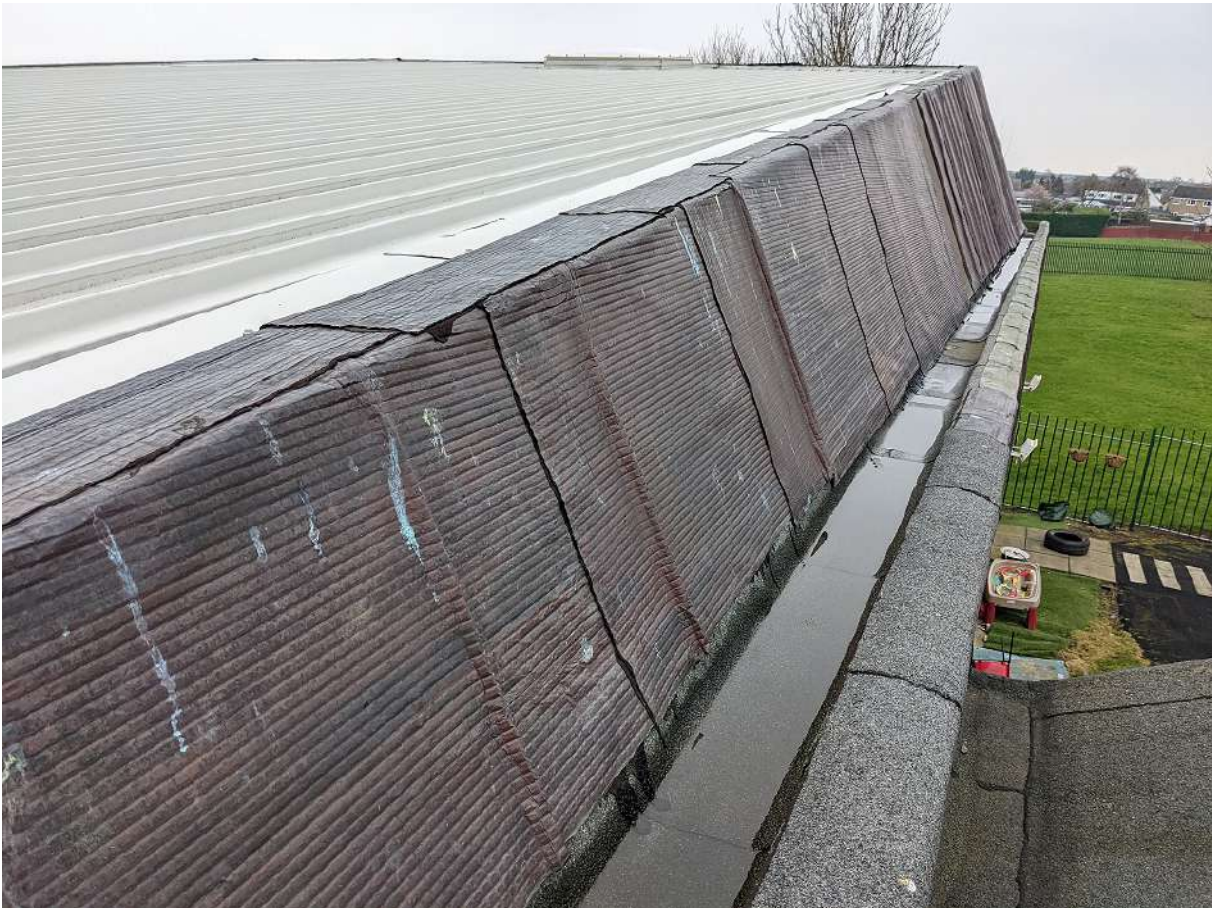
3.1.3 The surface of the mansard covering is generally in a satisfactory condition. There is evidence of patch repairs most prominently along the west edge where several incidents of theft and vandalism have led to the loss of the thin copper cladding. Replacement has been carried out in an elastomeric bituminous membrane coloured dark brown to match the copper cladding elsewhere.

The quality in workmanship of this repair could have been executed better; albeit tricky to execute due to the location and geometrics of the roof shape involved. The good news is that it is understood to be maintaining a watertight covering. Even better news is that there have been no further recent reported incidents of metal theft.

M	As a routine item of maintenance, the roof covering to the mansard is checked twice yearly by a contractor who specialises in thin copper faced high tensile or elastomeric bituminous membrane.
----------	--

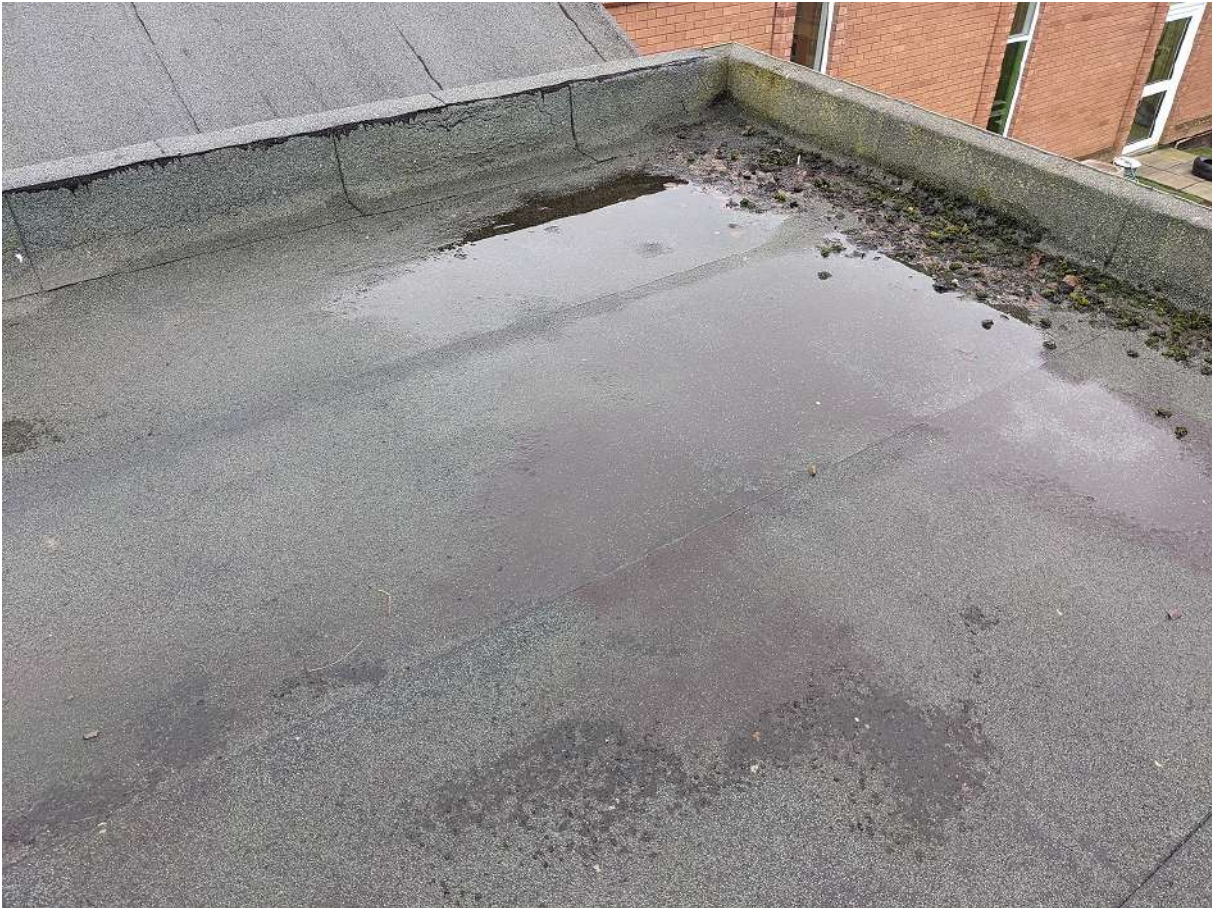
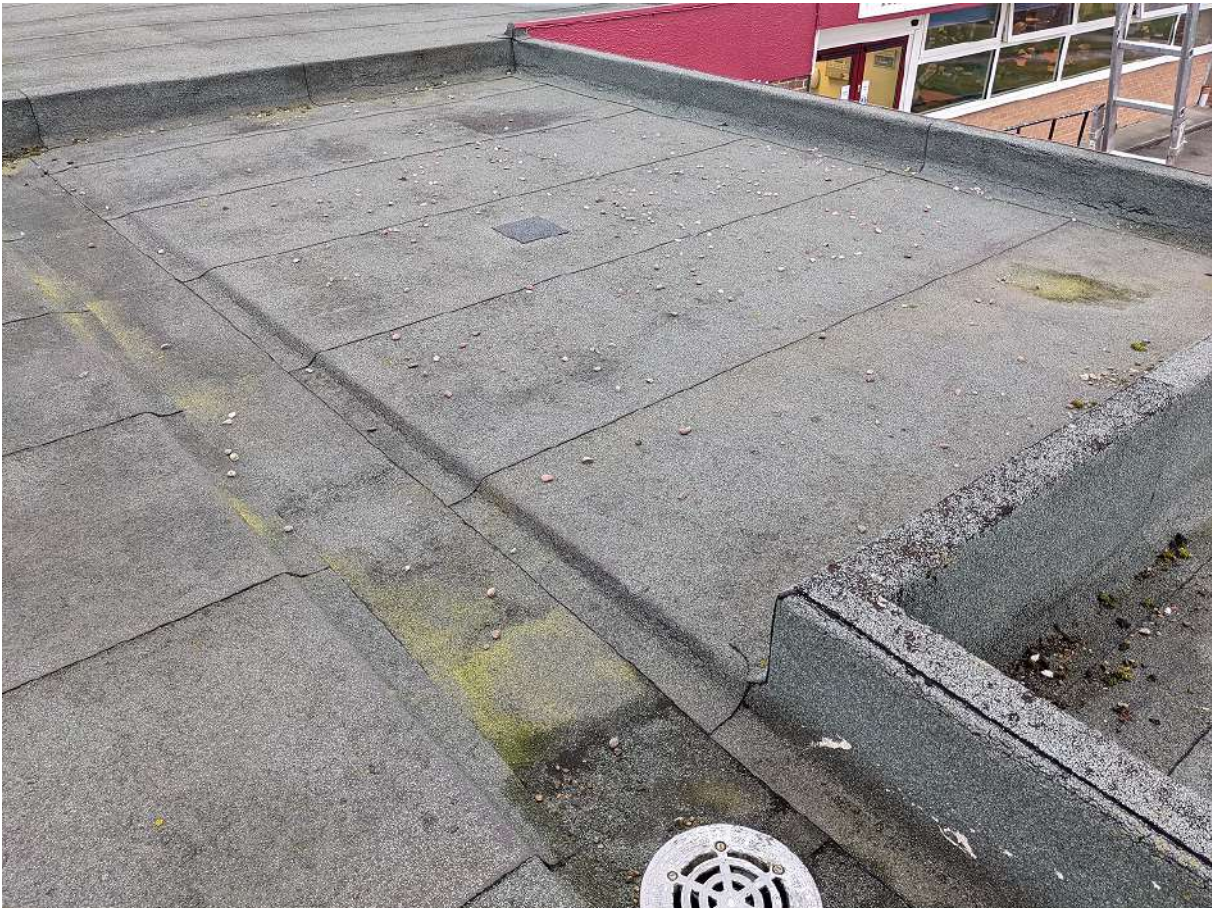
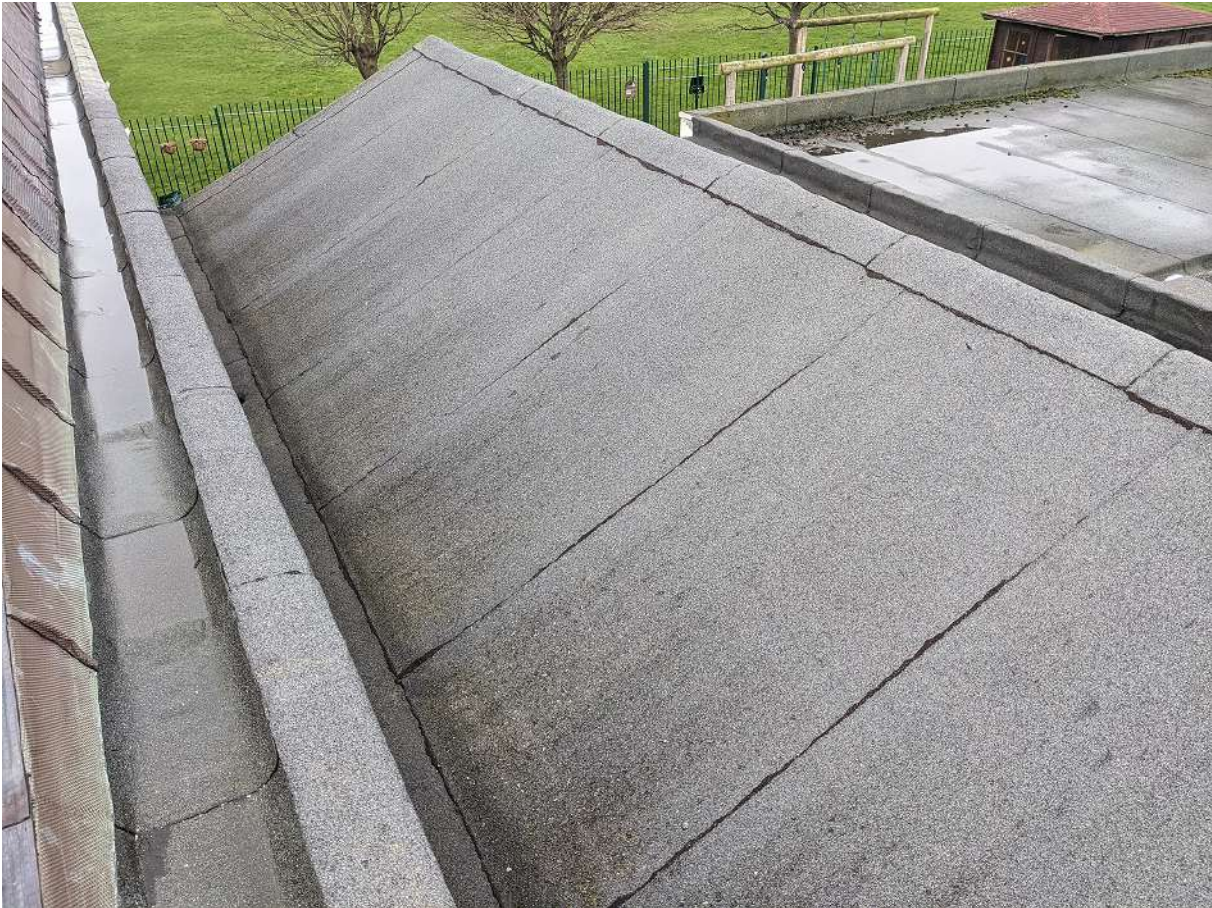
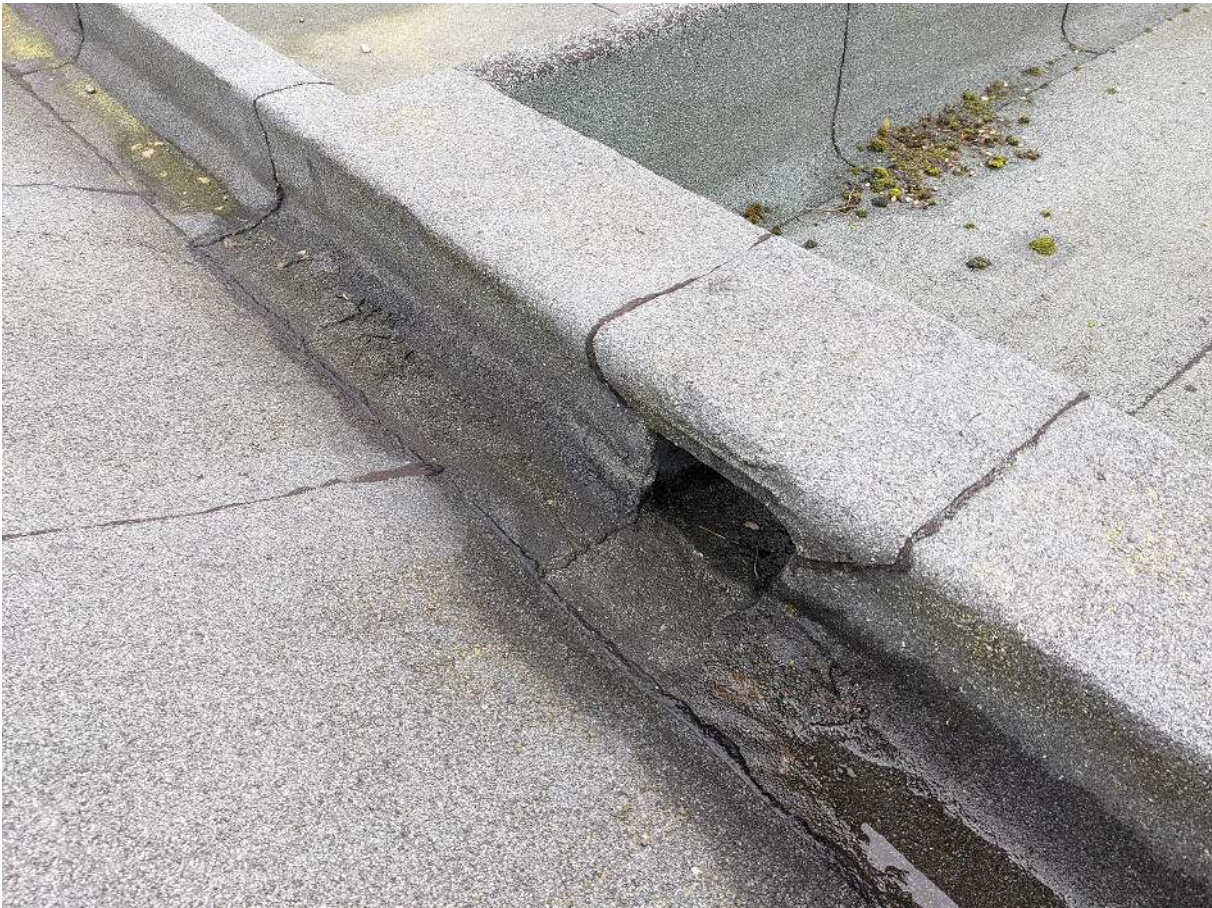
- 4.1.1 At the time of the QI the parapet box gutter to the north end contained leaves at both its east and west ends, covering the downpipe gulleys in both locations.

Previous QIR's made comment that the tendency for leaves to collect has probably been due to a combination of factors; inadequate cross section size of the gutter in relation to the quantity and intensity of rainfall, inadequate height of the upstand to the base of the gutter and close proximity to trees allowing regular catching of cyclical leaf falls.

The good news is that there are no reported incidents of water ingress beneath this gutter. The gutter lining therefore appears to remain in a sound, satisfactory condition.

The shallow parapet gutter running along east, south and west elevations appear also to be in a satisfactory condition, albeit there are considerable levels of standing water along its length.

M It is recommended that as a routine item of maintenance the rainwater goods (gutters, downpipes and gullies) should be checked and cleared on a twice-yearly basis.

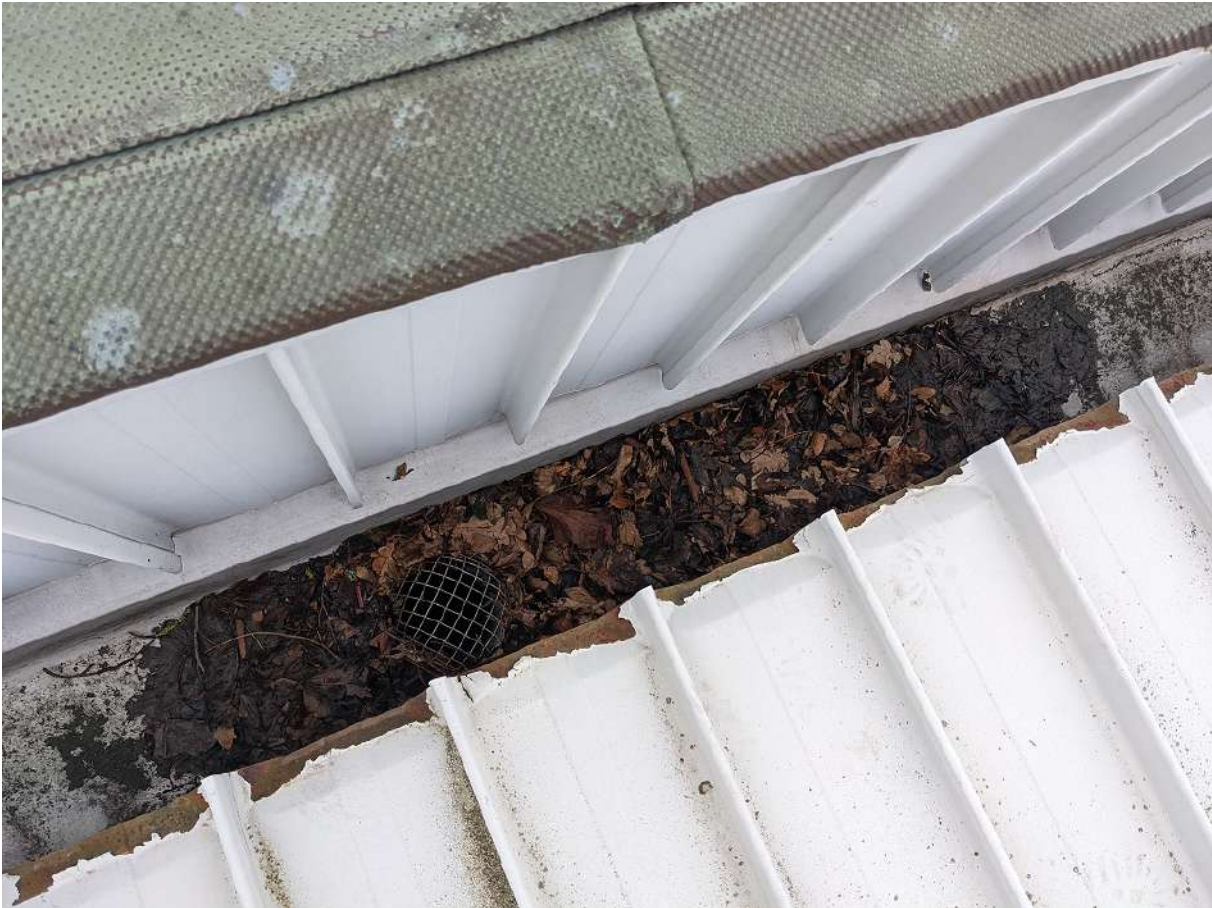
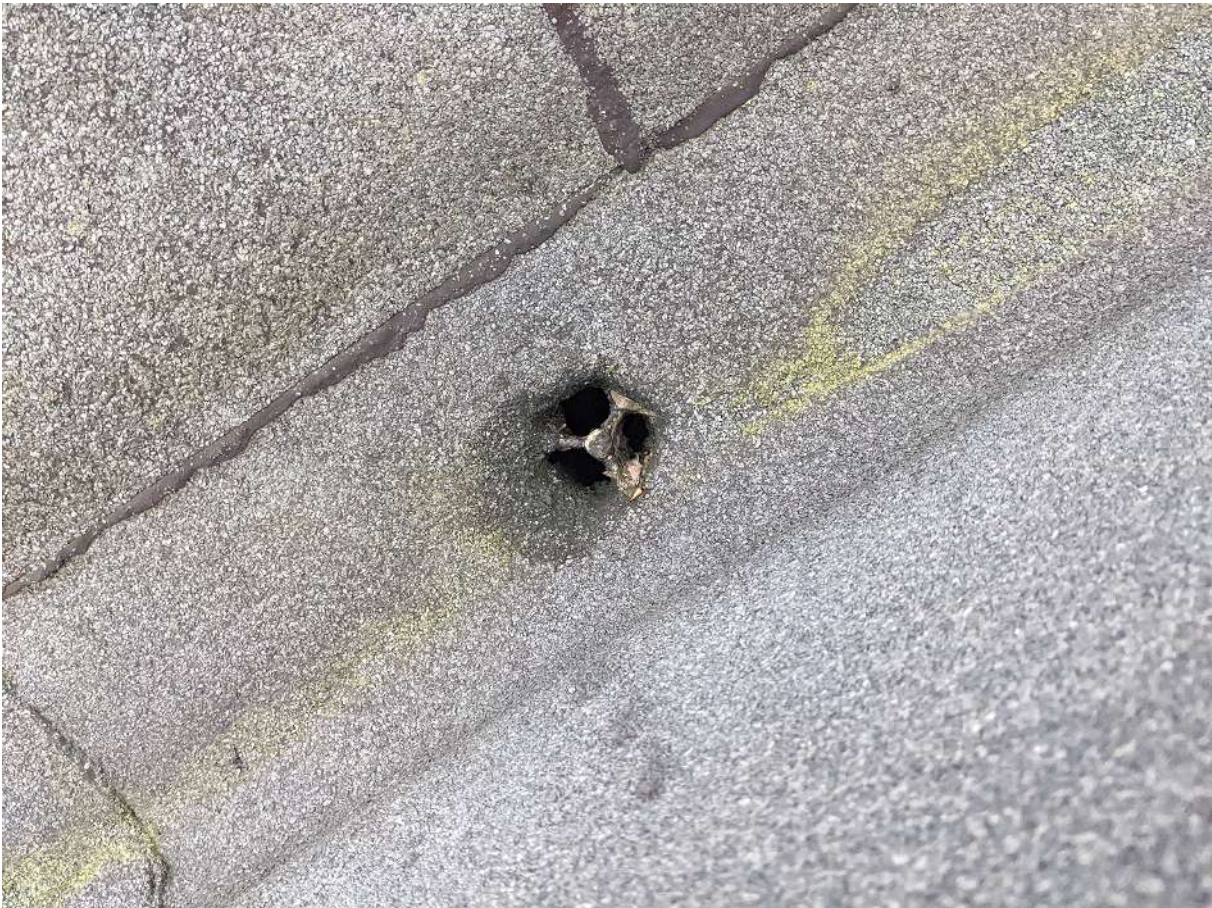
- 4.2.1 The problematic rainwater outlet to the west side of the pitched roof over the entrance foyer, as mentioned in the previous QIR has been bypassed by the introduction of an overflow as mentioned in 3.2.2. This has the effect of directing rainwater onto the adjoining flat roof and not into the downpipe. It is noted that there are signs of dampness in and around the entry of the overflow chute suggesting that in periods of heavy and/or sustained rainfall there is standing water locally.

The rainwater outlet to the east side of the pitched roof remains and similar comments can be made regarding its adequacy; it is narrow and not properly dressed into the downpipe. Nevertheless, all appears in a sound and satisfactory condition.

- 4.2.2 Gutter linings and gulleys across the flat roof section over the church office and WC's all appear to be in a sound, satisfactory condition. At the junction with internal downpipes there is a properly formed junction between the felt and downpipe.

R4 It is desirable that the east side outlet is properly formed that allows a wider draining point into the downpipe.

M It is recommended that as a routine item of maintenance the rainwater goods (gutters, downpipes and gullies) should be checked and cleared on a twice-yearly basis.

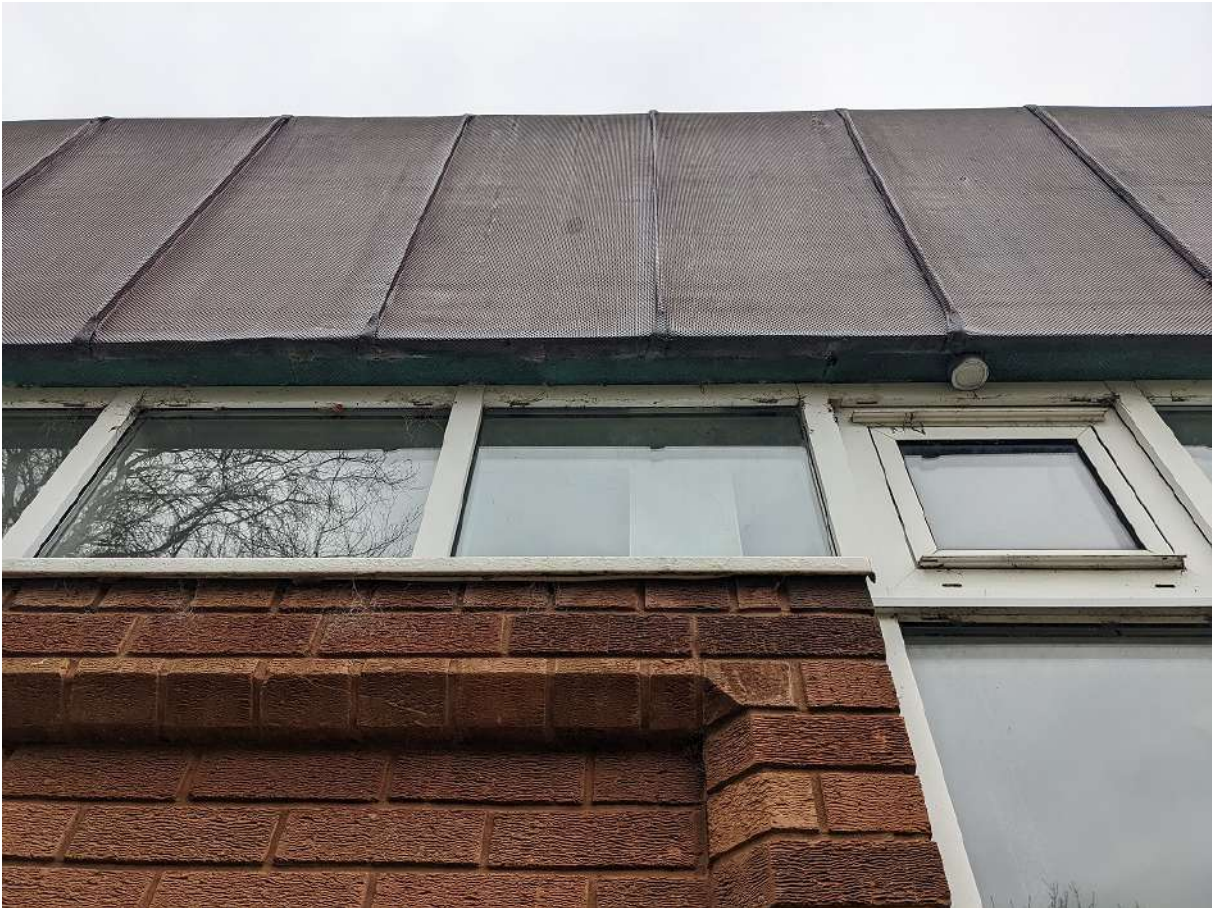
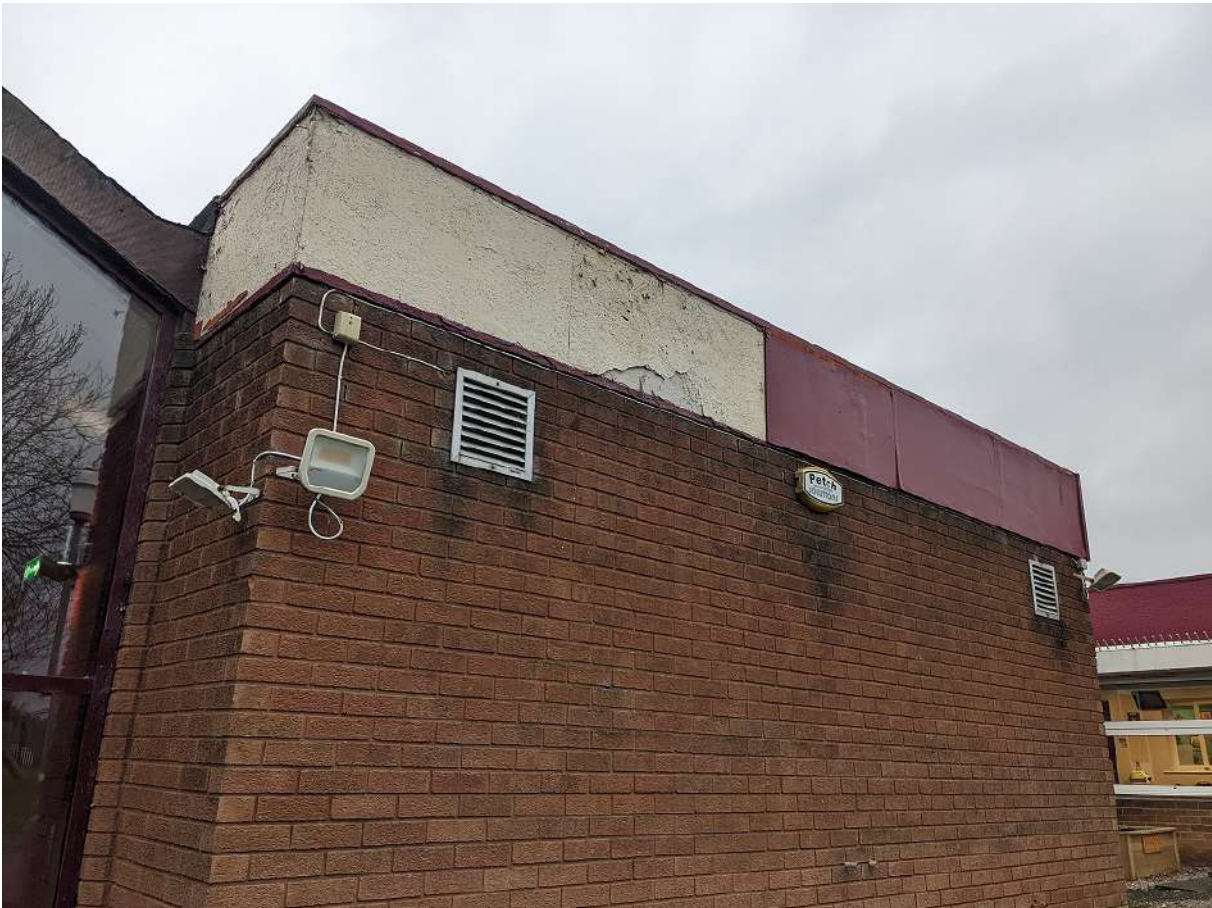
6.2.2 A boarded deep white fascia exists along both north and south elevations. To the north this fascia has been over boarded in a thin timber sheet and painted dark red. Recent storms have stripped sections away, particularly to the WC and deterioration is noted elsewhere to this new boarding. The nature of the damage has caused an untidy appearance adjacent to the main entrance of the church.

R0 It is recommended to carry out replacement of the damaged fascia.

R3 6.2.3 Carry out replacement of the dark red fascia in full using a robust material that will resist prolonged period of weathering.

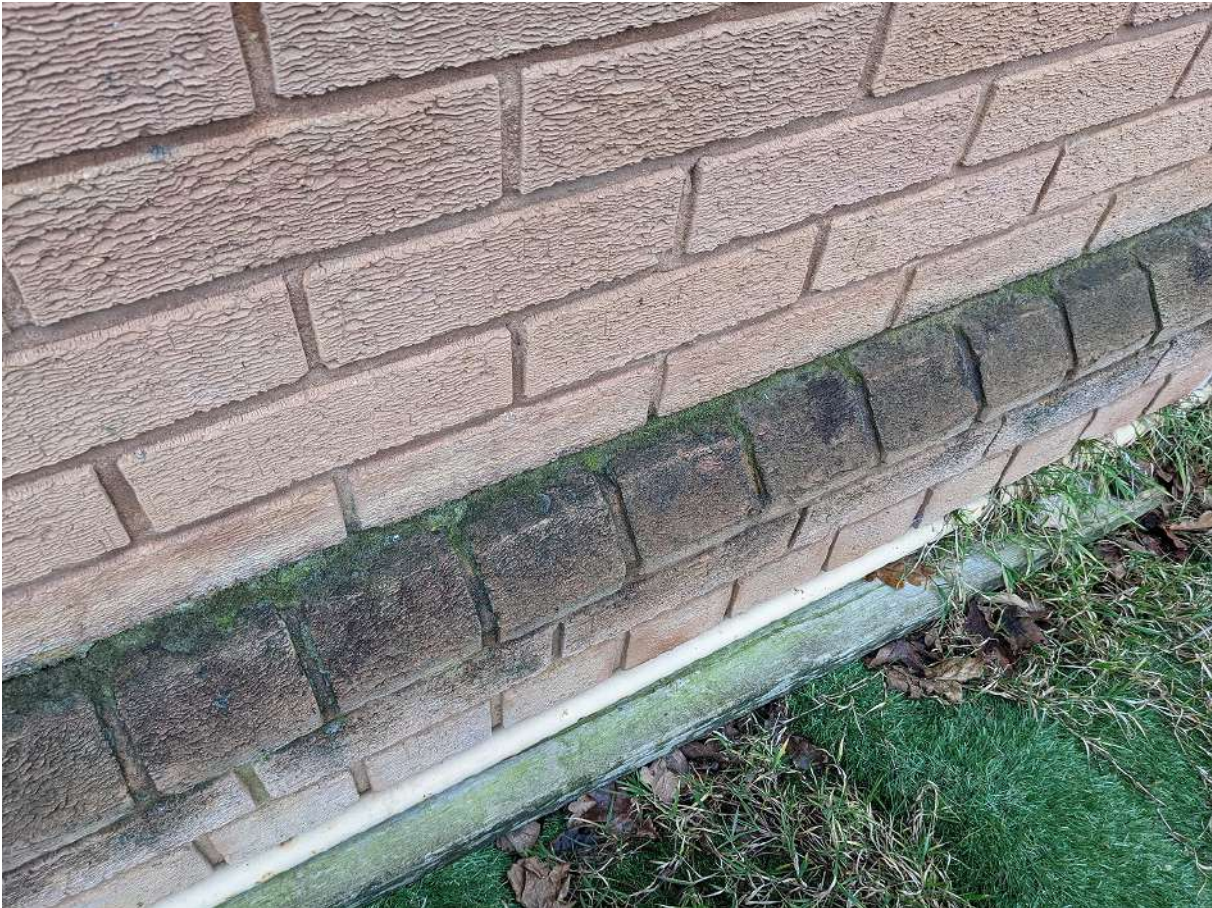
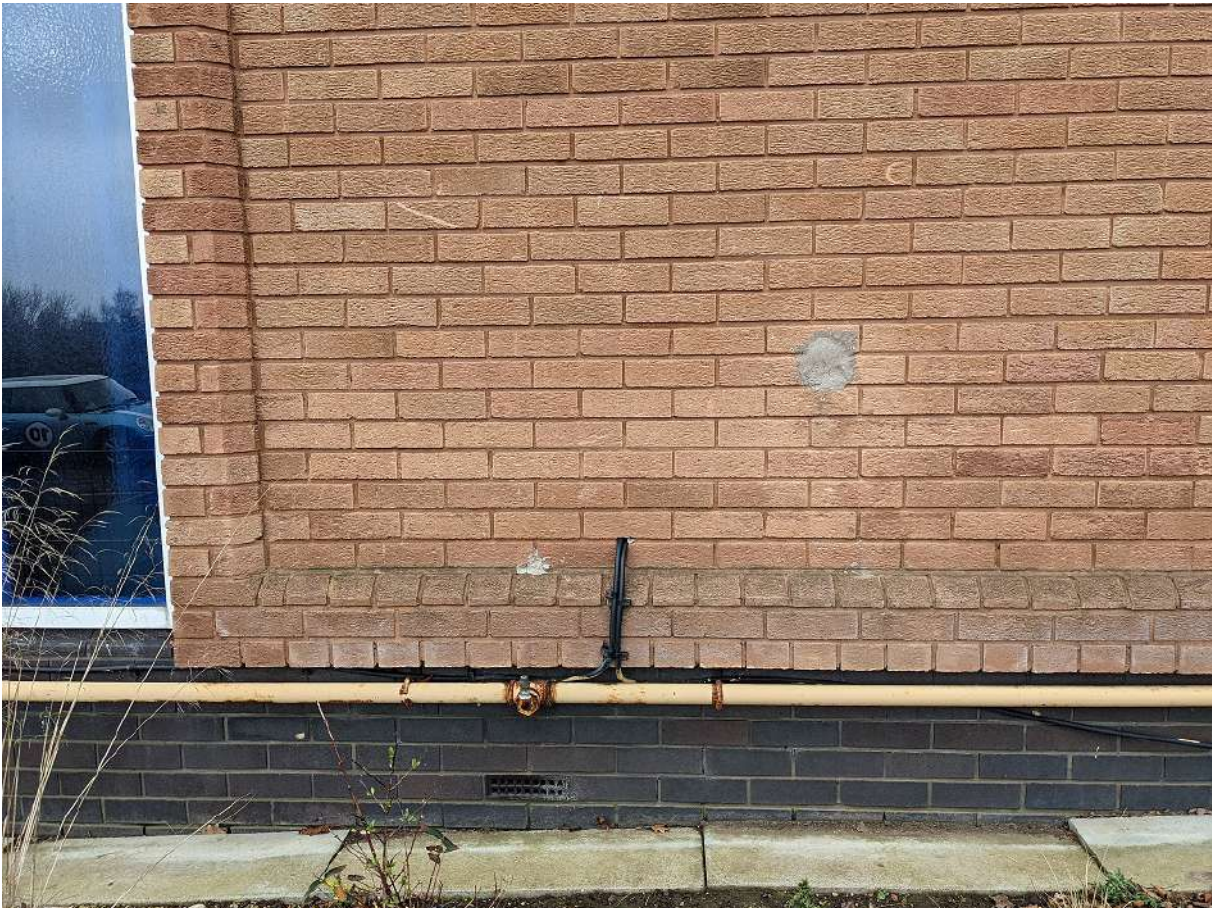
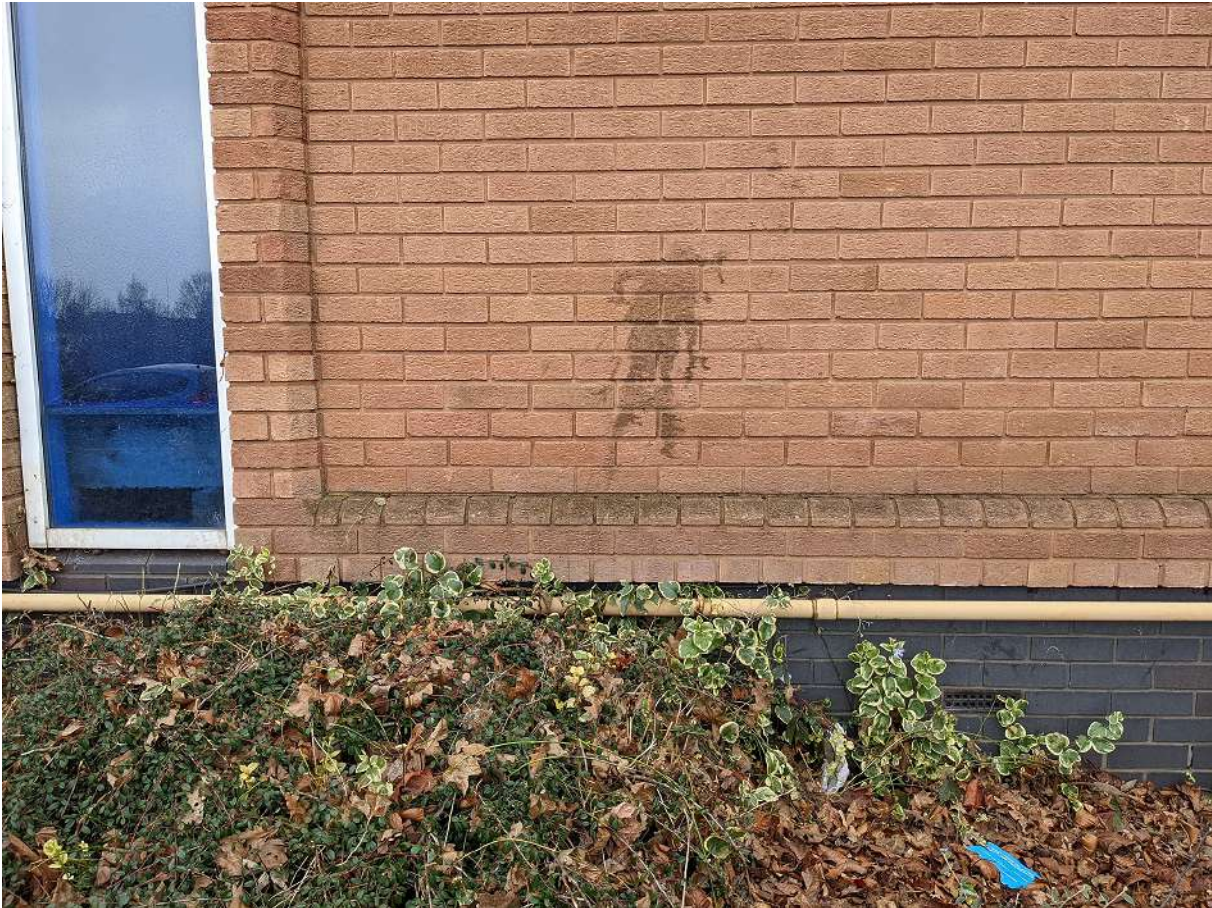
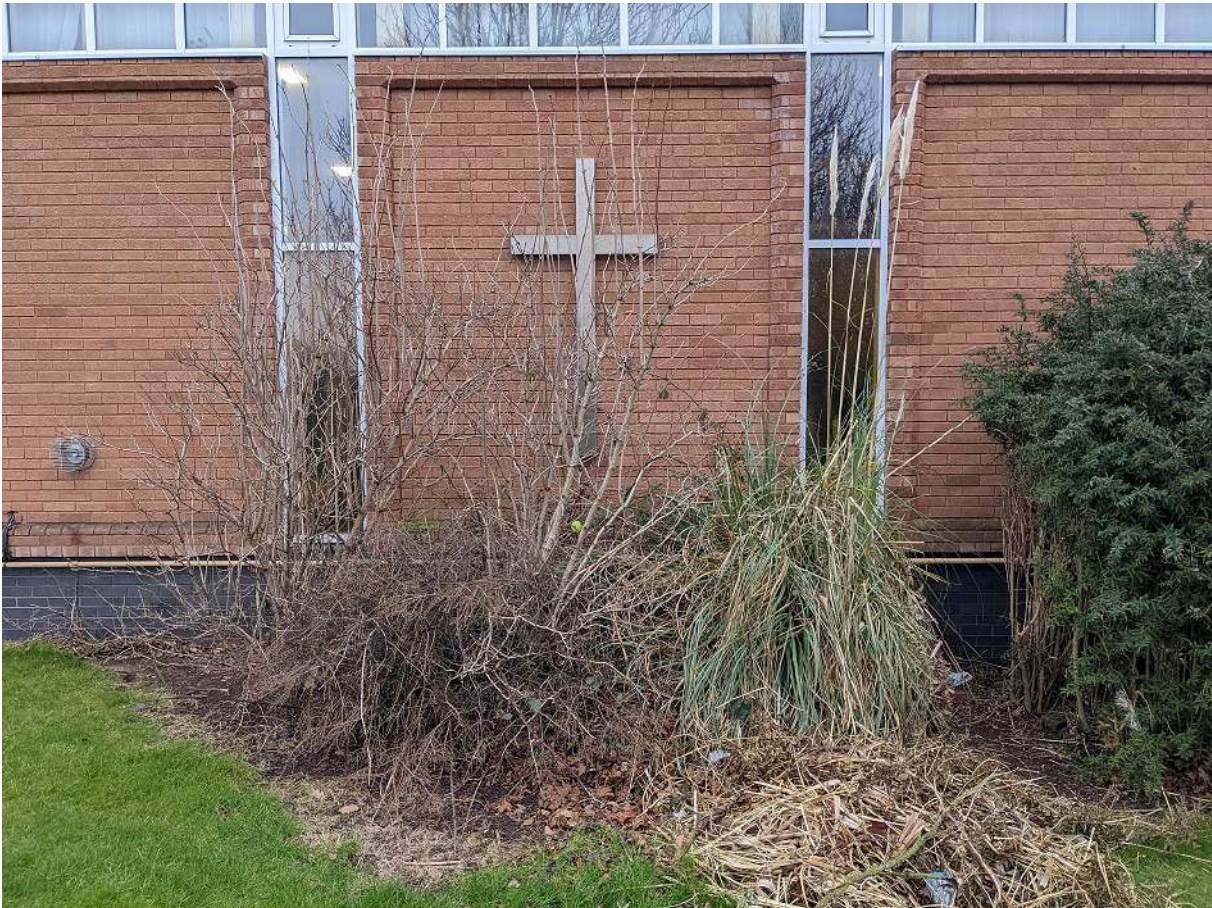
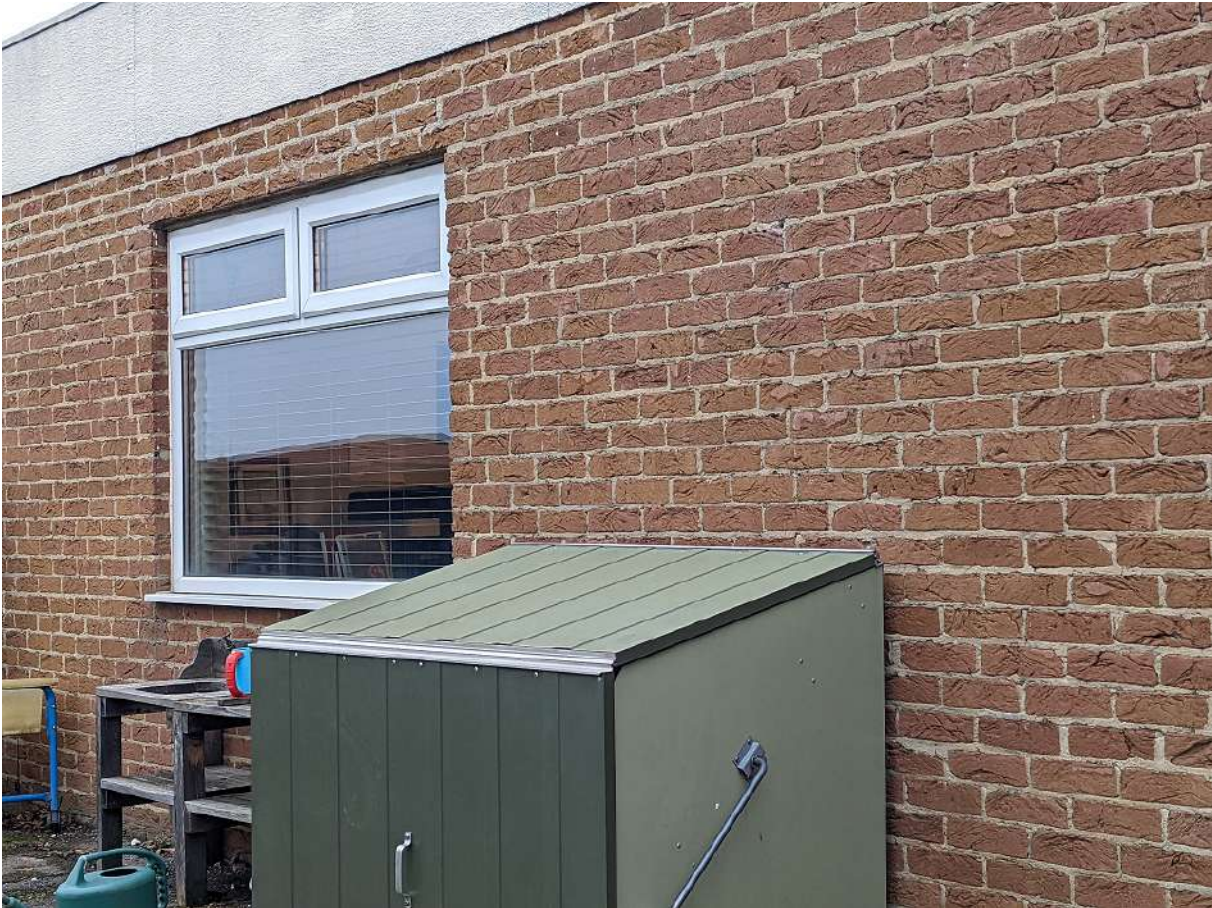
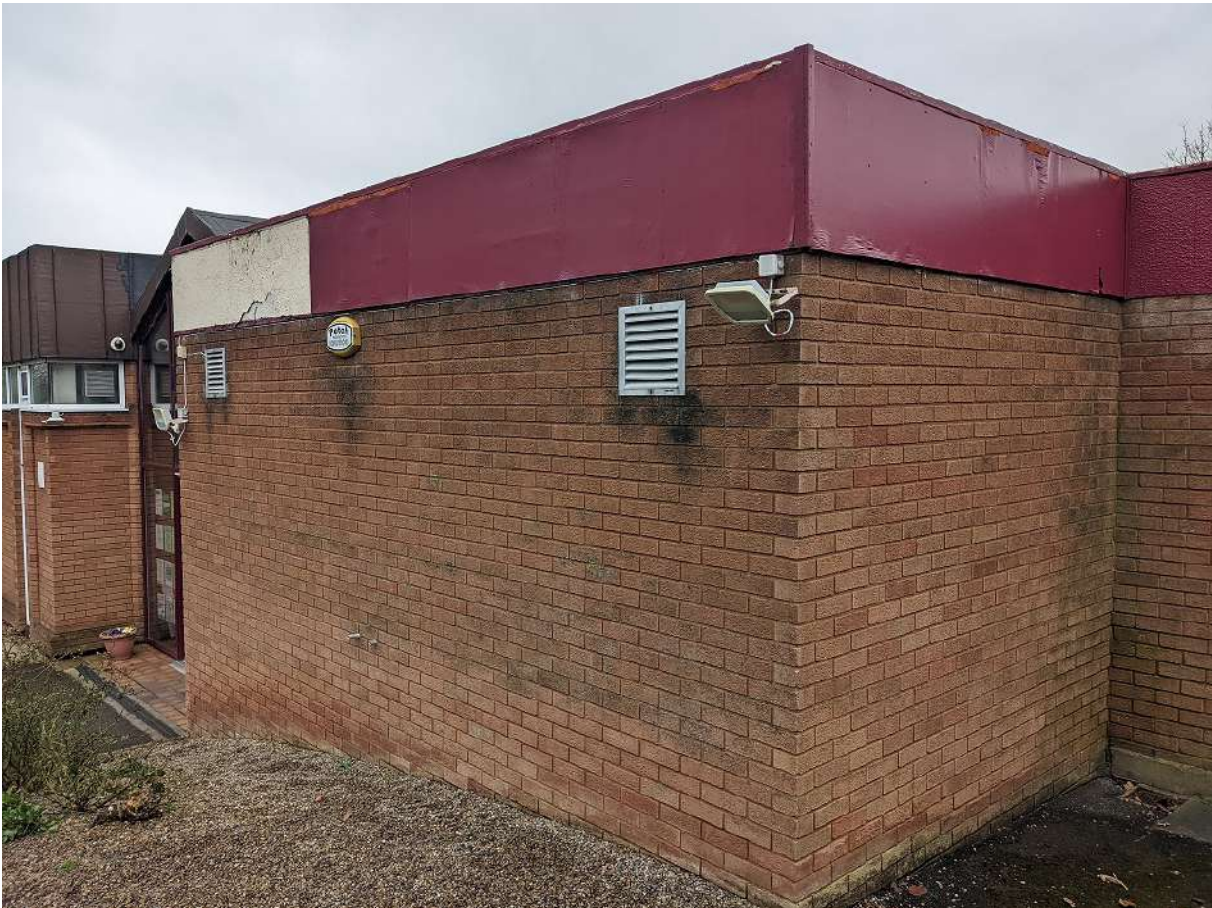
7.1.1 The brickwork and pointing are in a good, sound condition with no signs of cracking due to ground movement. The detailing to the brick panel edges is such that moss is able to develop on the horizontal bottom edge due to general water run-off from the elevation.

7.1.2 There are fixing holes to brickwork on the second panel from the north on the east elevation where previous signage has been removed. Also, across this elevation evidence of mortar repairs carried out to redundant service holes that have executed in a dark grey mortar that stand out against the light orange/brown brickwork.

7.1.3 There is staining to the brickwork on the third panel from the north on the east elevation as a result of impact from an object thrown at the church walling.

7.1.4 Illuminated signage has been installed at high level to brickwork of the east elevation (north end) reading 'THE PARISH CHURCH OF Holy Trinity WITH St. Mark'. This signage compliments a large cross fixed to the east elevation (south end) and south elevation of similar material albeit not illuminated. Occasional streaking across the polished surface of all objects is noted.

7.1.5 Much of the plants and shrubs along the east elevation have been stripped back allowing clear inspection of the building fabric. There are shrubs and plants across two thirds of the south elevation, which impedes on the fabric.

M As a routine item of maintenance, it is recommended that the moss and algae growth is carefully removed and cleaned using an anti-fungal solution.

R1 It is recommended to carry out minor brickwork repairs to the east elevation in a colour matching mortar by an experienced mason.

R1 It is advised to carry out a brickwork clean to remove the staining mark.

M It is recommended that the signage and cross are cleaned on an annual basis as a routine item of maintenance.

M It is recommended that as a routine item of maintenance regular care and upkeep of the soft landscaping along these elevations are carried out.
