QUINQUENNIAL INSPECTION REPORT

HOLY TRINITY with St. MARK

UPSALL GROVE, FAIRFIELD, STOCKTON-ON-TEES, TS19 7QU

JULY 2022

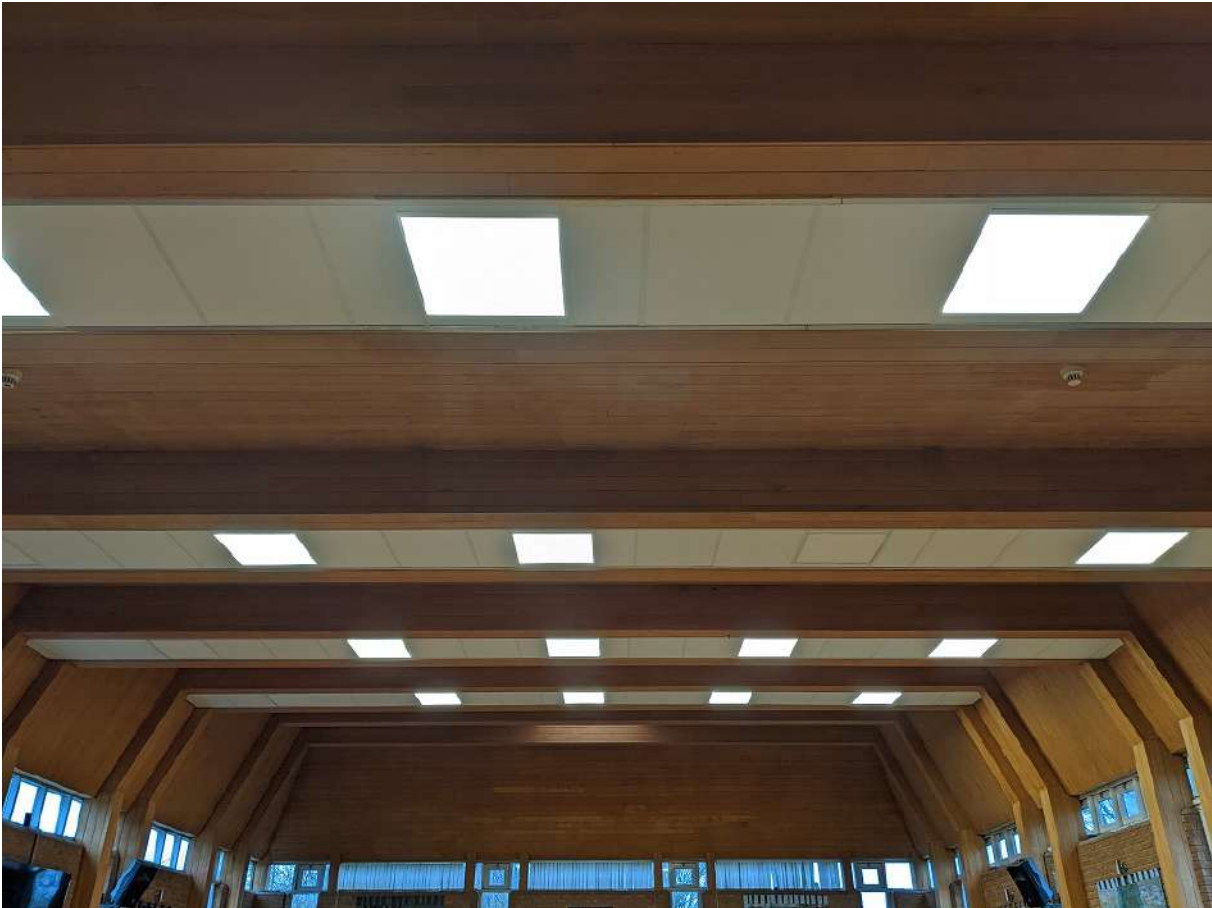
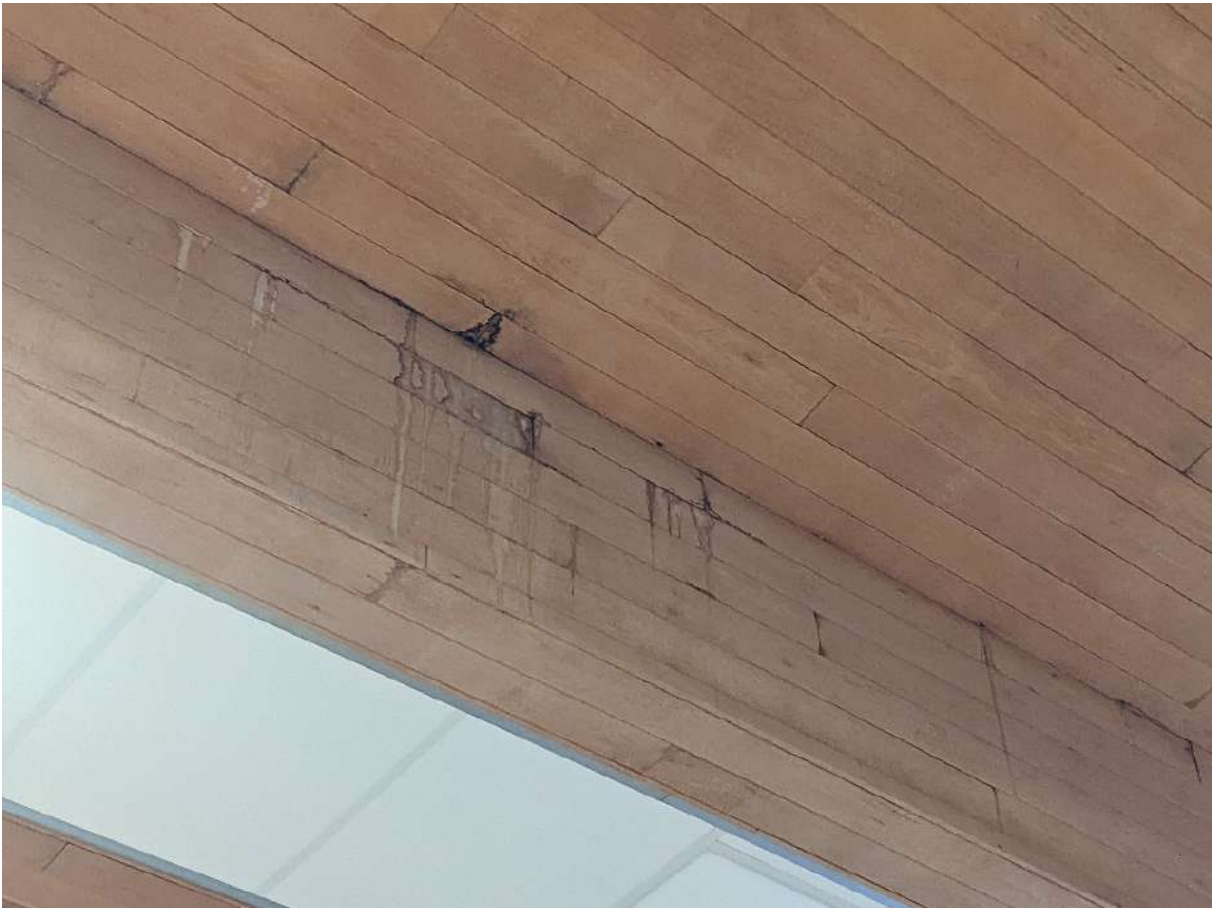
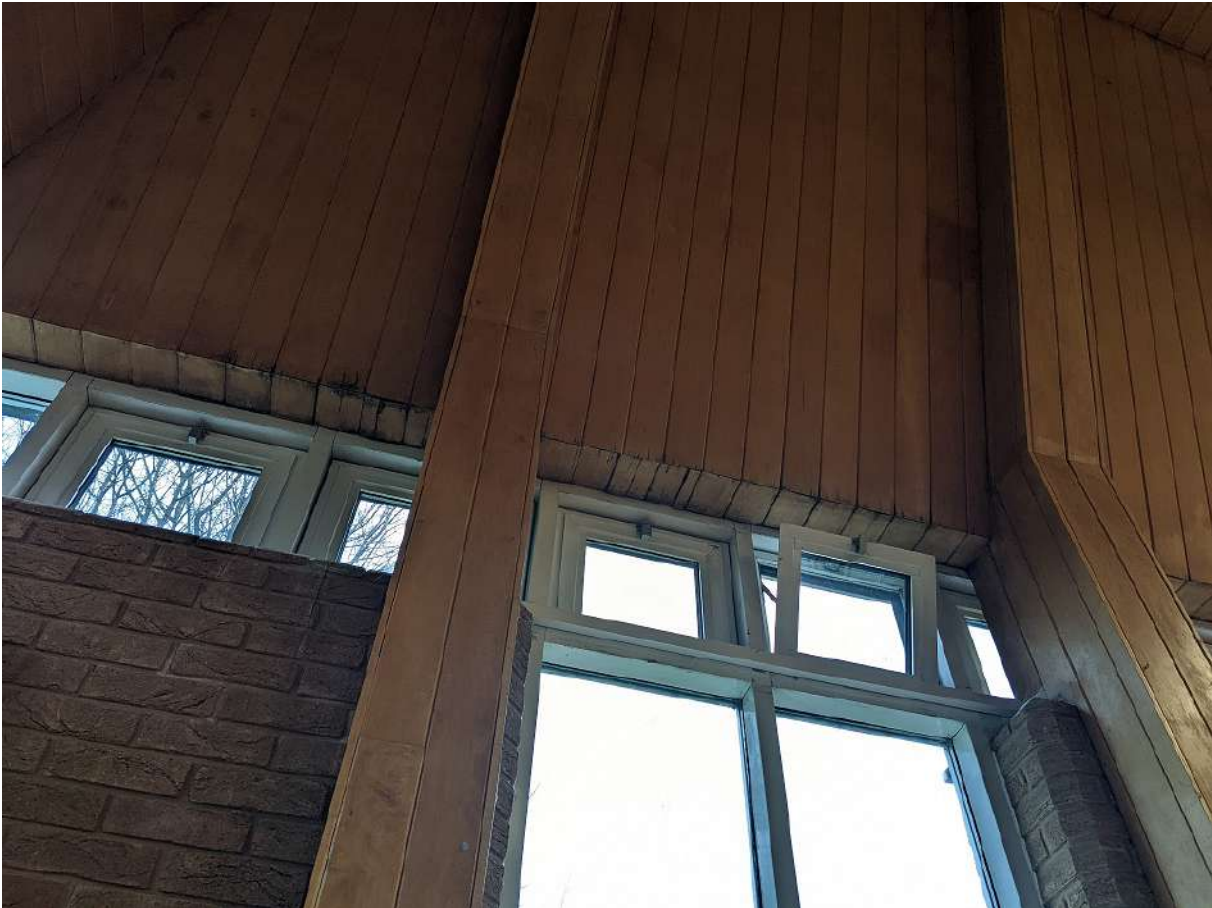
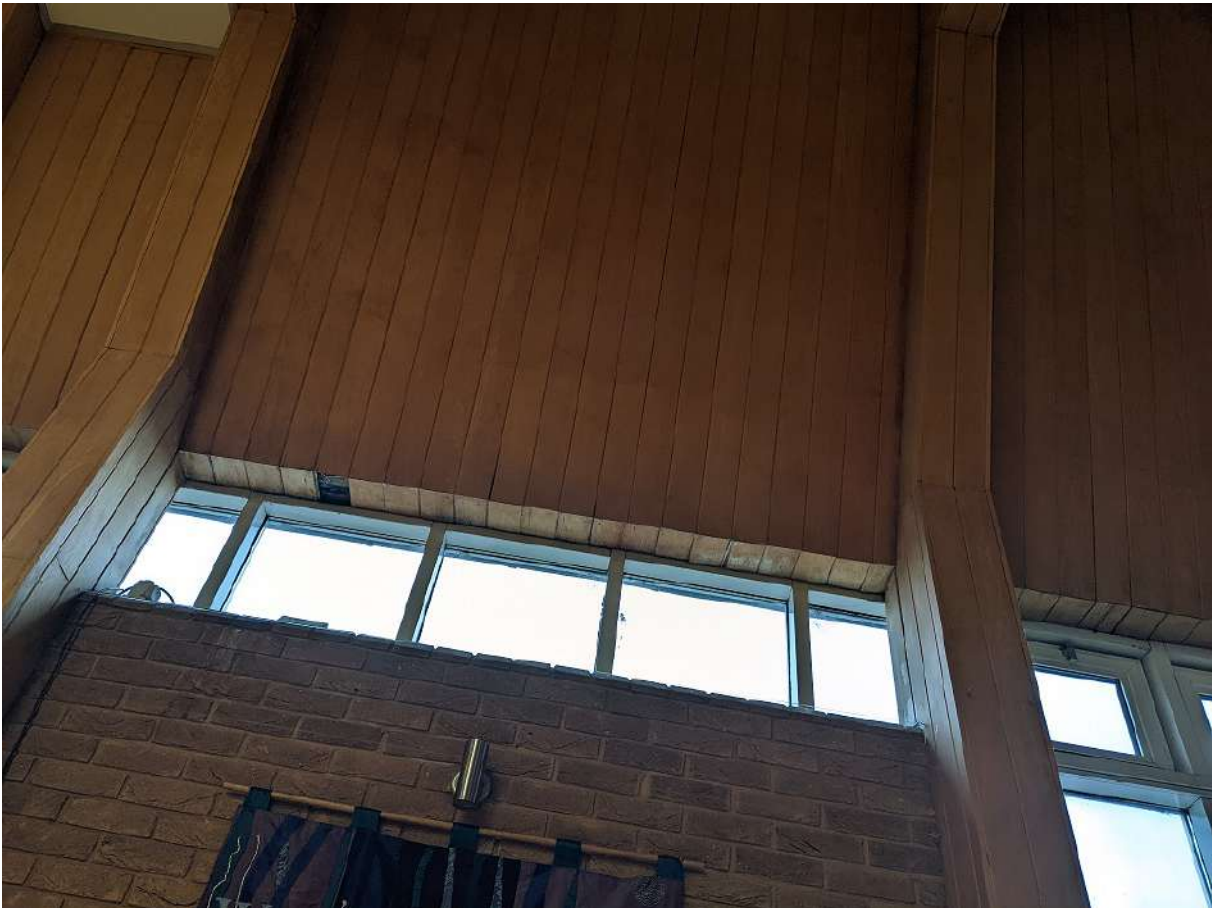
Unusually the entire surface finish of the second structural bay from the north is coated in a white bloom. The source and reason for this discolouration is presently not known, perhaps incorrect workmanship in the original application of varnish/staining of the timbers. Although this is aesthetically unpleasing there is no apparent defect to warrant any immediate action.

In addition, there are signs of water ingress understood to be historic surrounding the east side downstand within the same structural bay. This is seen as streaking to the timber which has stained black through time.

It is recommended that further detailed inspection is carried out of this section of the ceiling lining via the use of an aluminium tower scaffold.

Inspection to be carried out alongside specialist in wood finishing.

R2 13.1.2 Implement remedial repair work to the defective surface finish of the ceiling lining informed by investigation and detailed inspection.

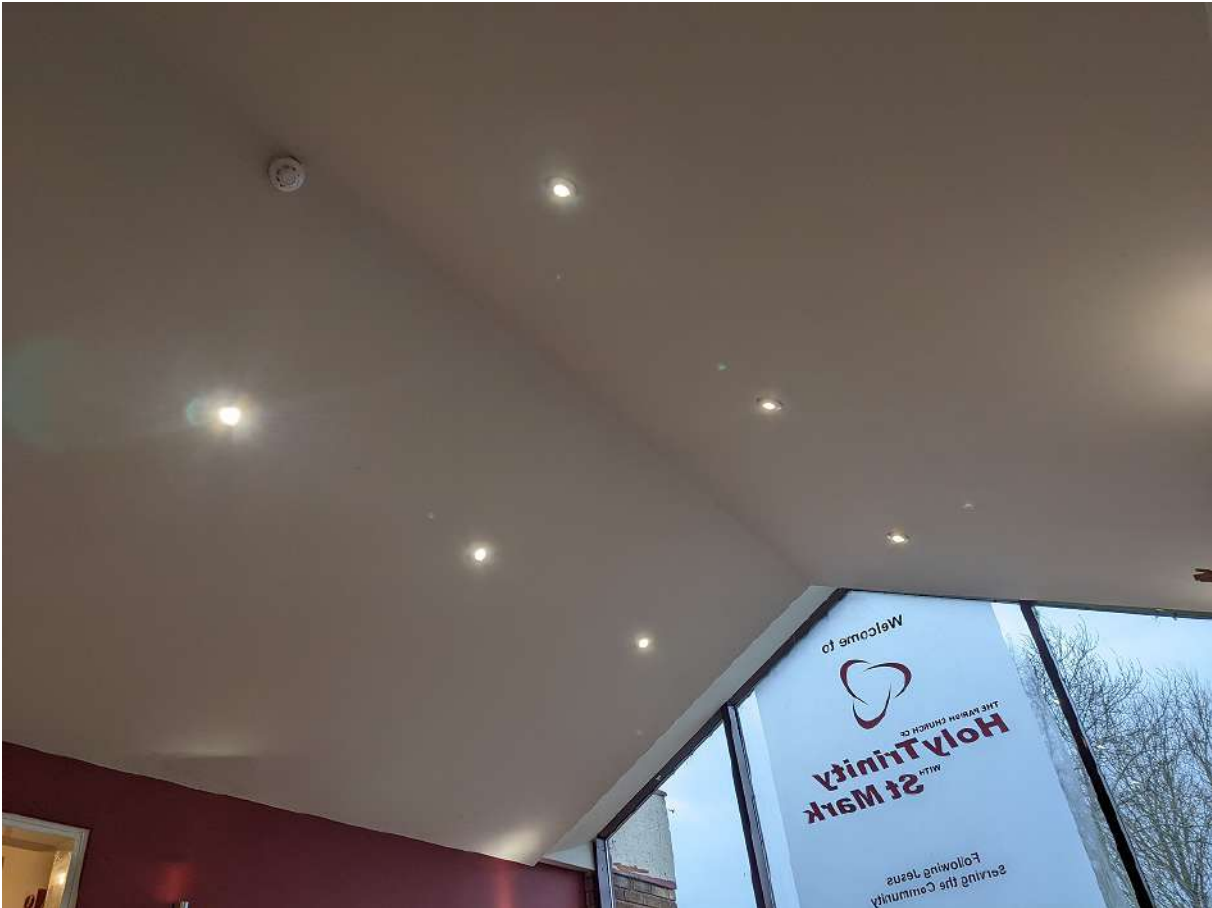
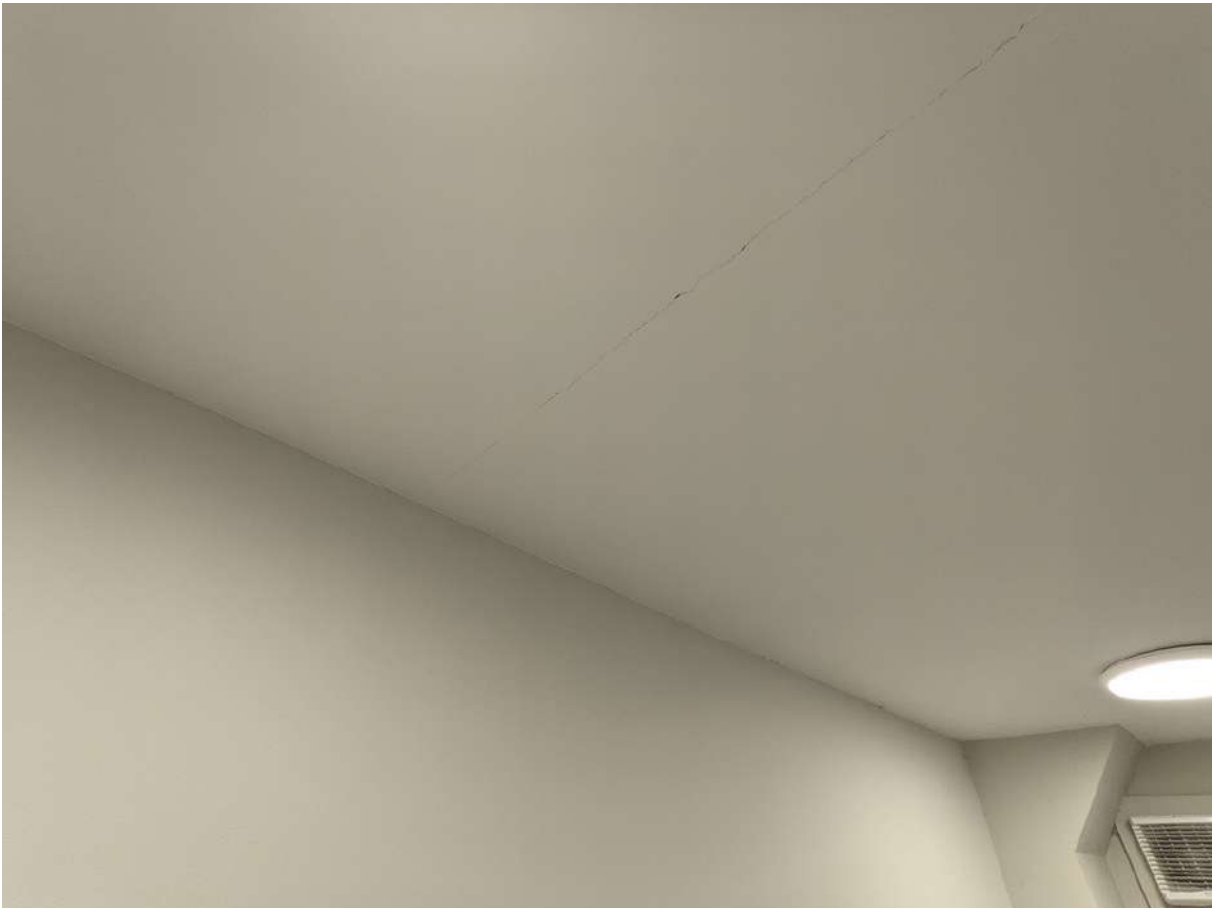
13.2.2 Ceiling finishes to the church office, link corridor and WC are all in a good condition. The exception being a hairline crack developing within the ceiling to the WC's. Suspected due to flexing within the timber roof structure has caused this cracking along the edge of a board.

R1 It is recommended to refix the plasterboard and fill the ceiling crack.

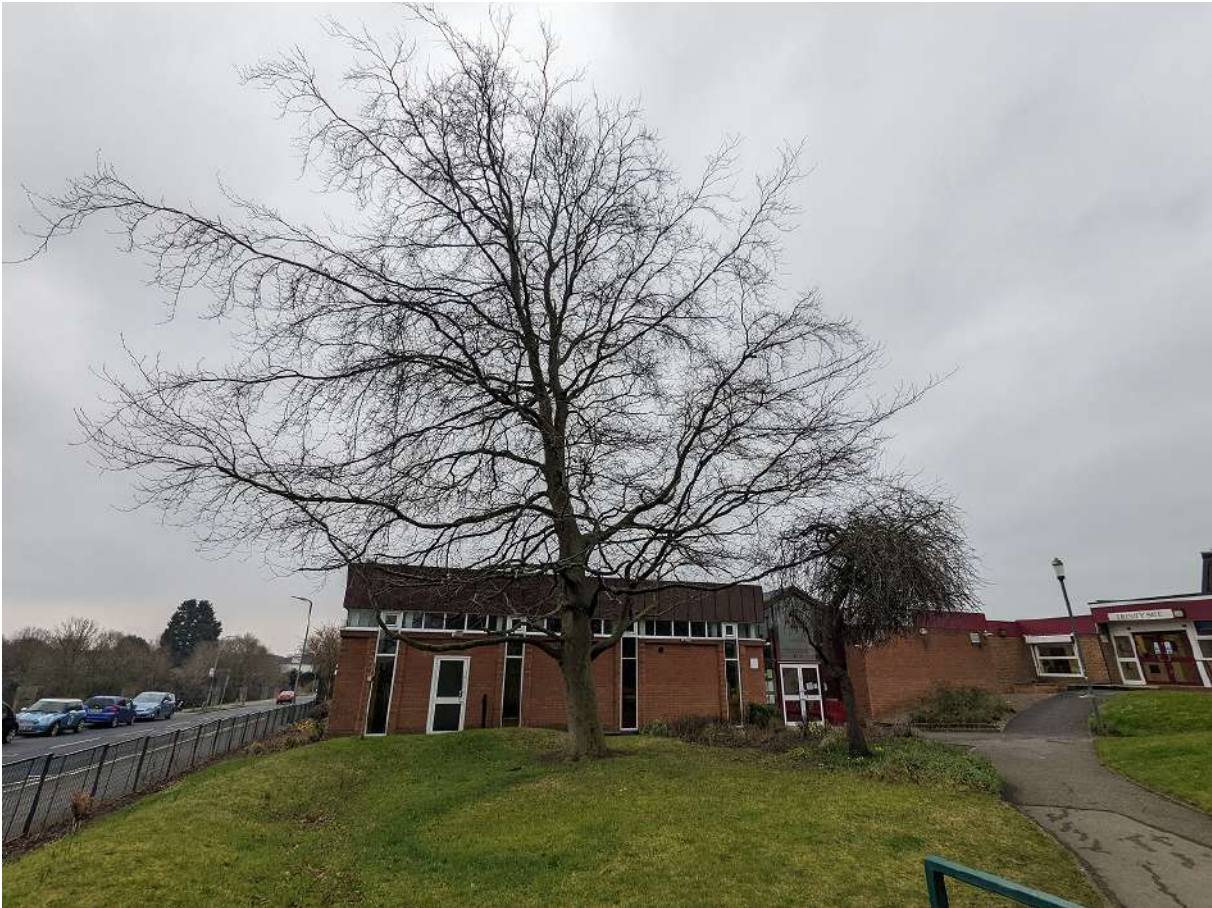
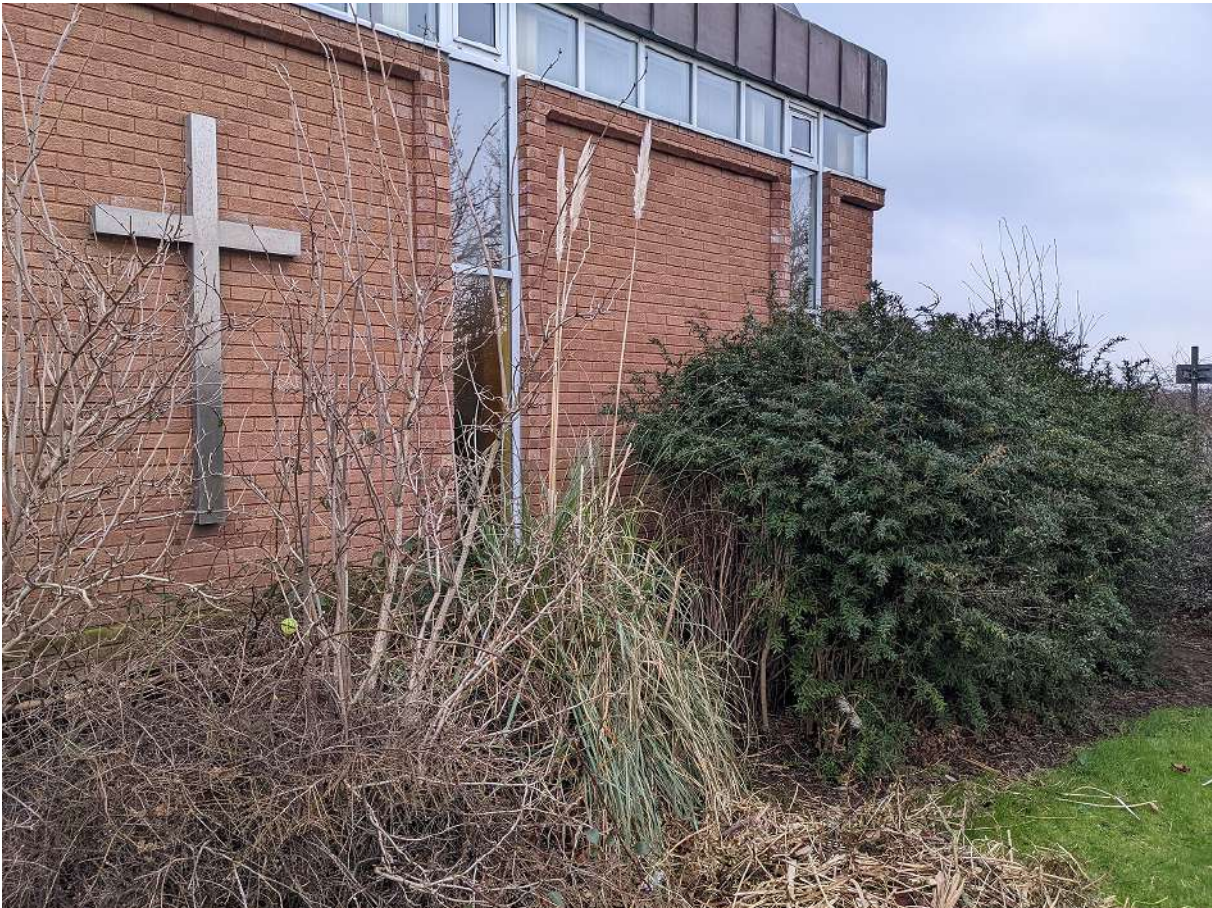
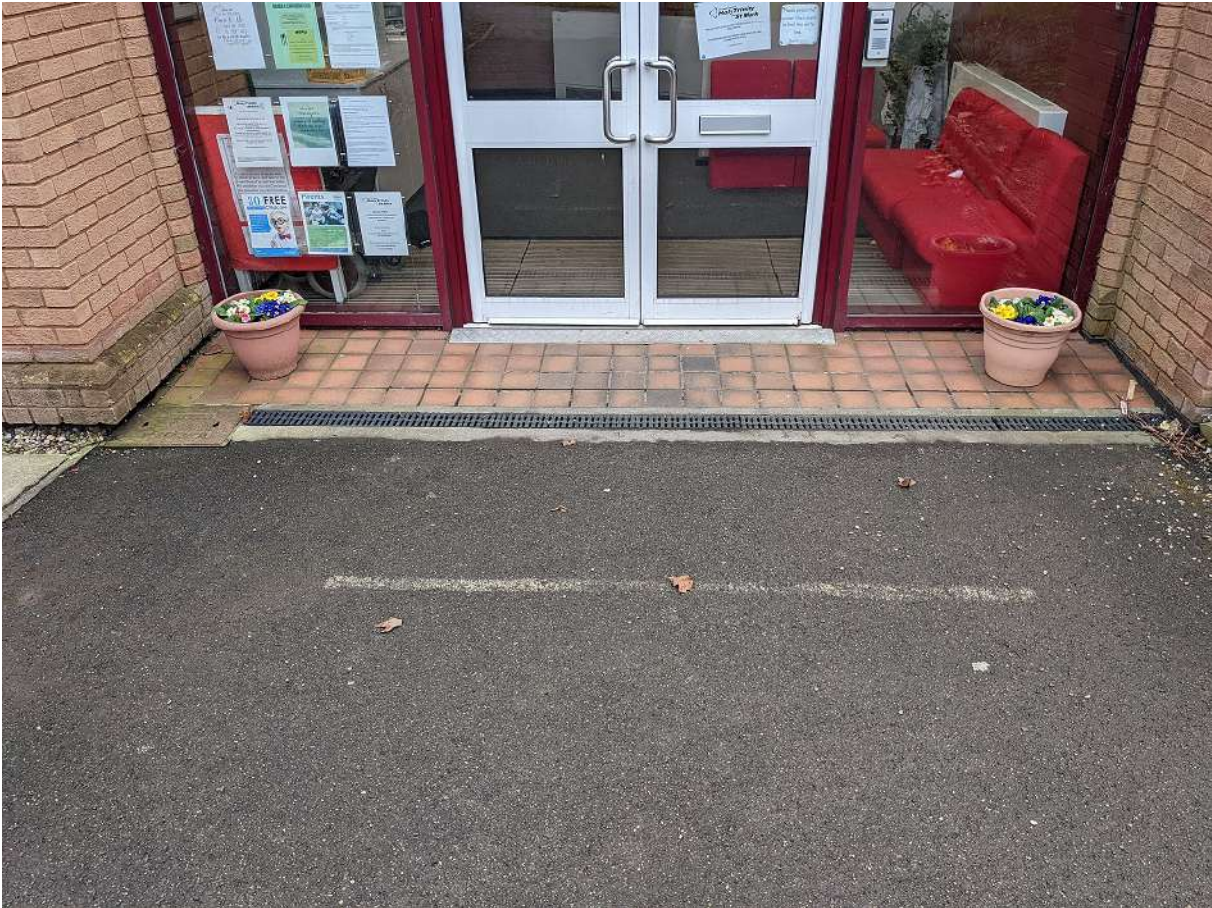
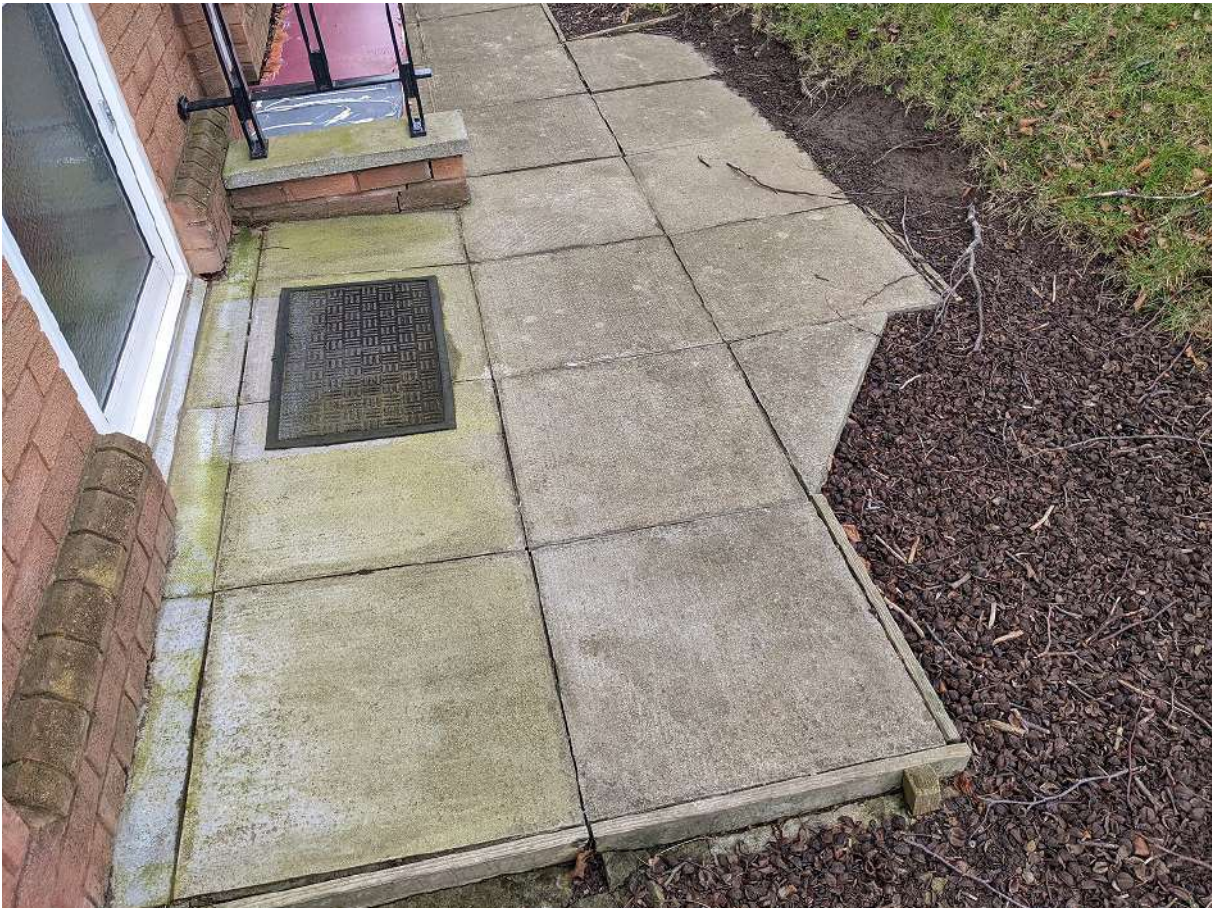
37.1.2 Plant and shrub growth to church building walls can be the source of water ingress and/or create signs of settlement/movement due to root growth which in turn can cause damage to the building fabric.

M It is recommended to carry out regular maintenance to plant/shrub areas.
