Parish Church of All Saints  
Stranton

Diocese of Durham  
Archdeaconry of Durham  
Deanery of Hartlepool

Quinquennial Inspection Report  
June 2022

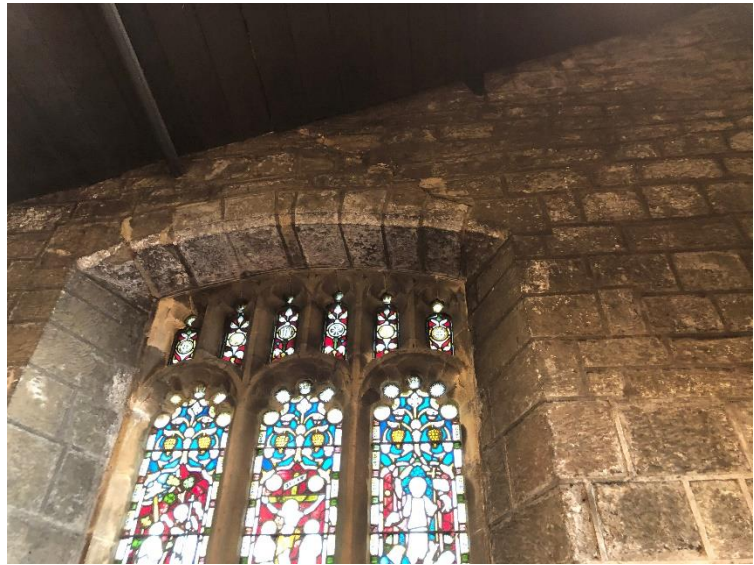
Fig 1. East gable above window  
cracking (Fulthorpe Chapel):  
no visible change

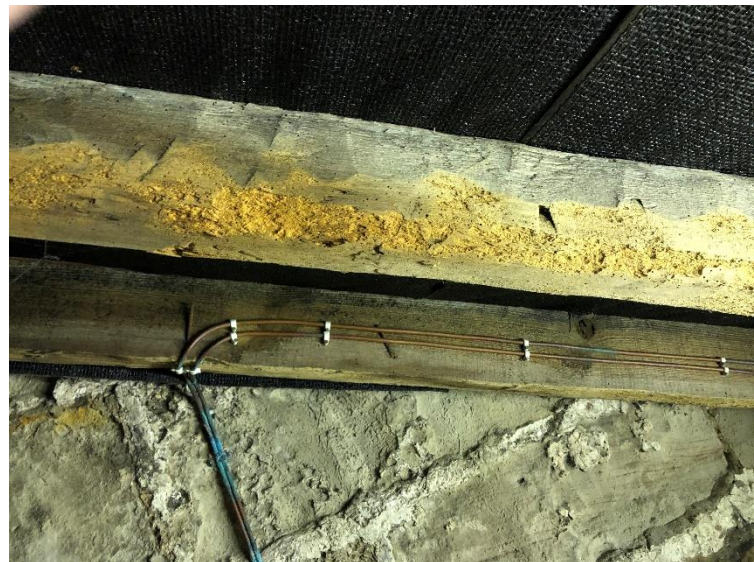
Fig 2. North aisle roof timber,  
previous window infestation:  
check treatment

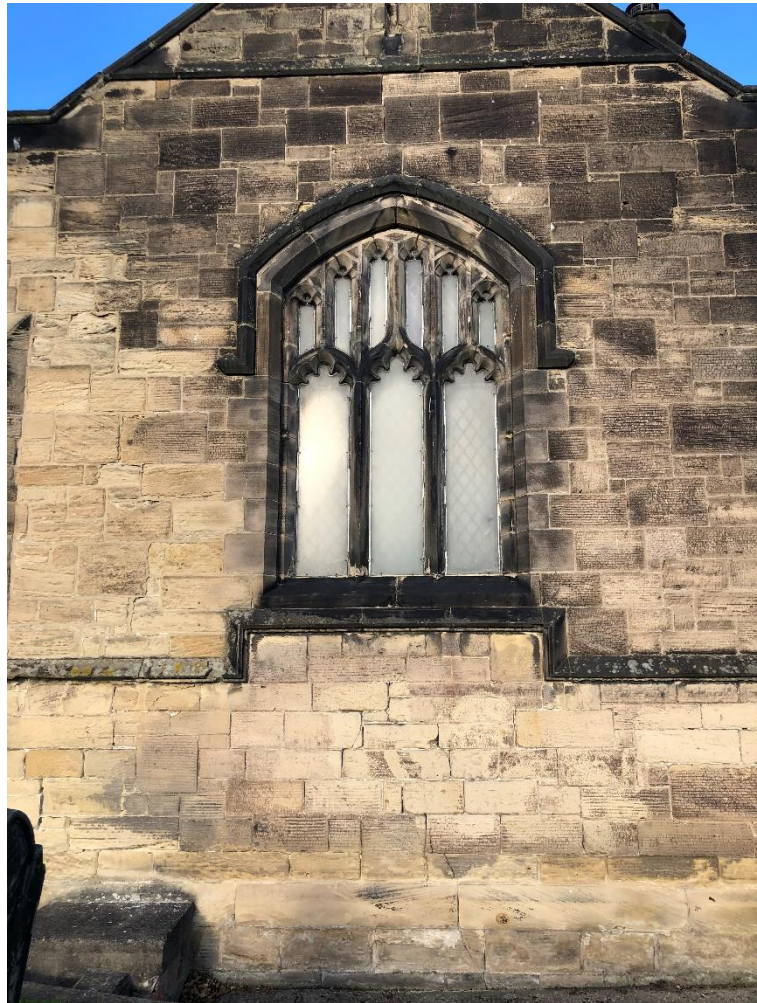
Fig 3. Vertical cracking below organ chamber south window: no visible change

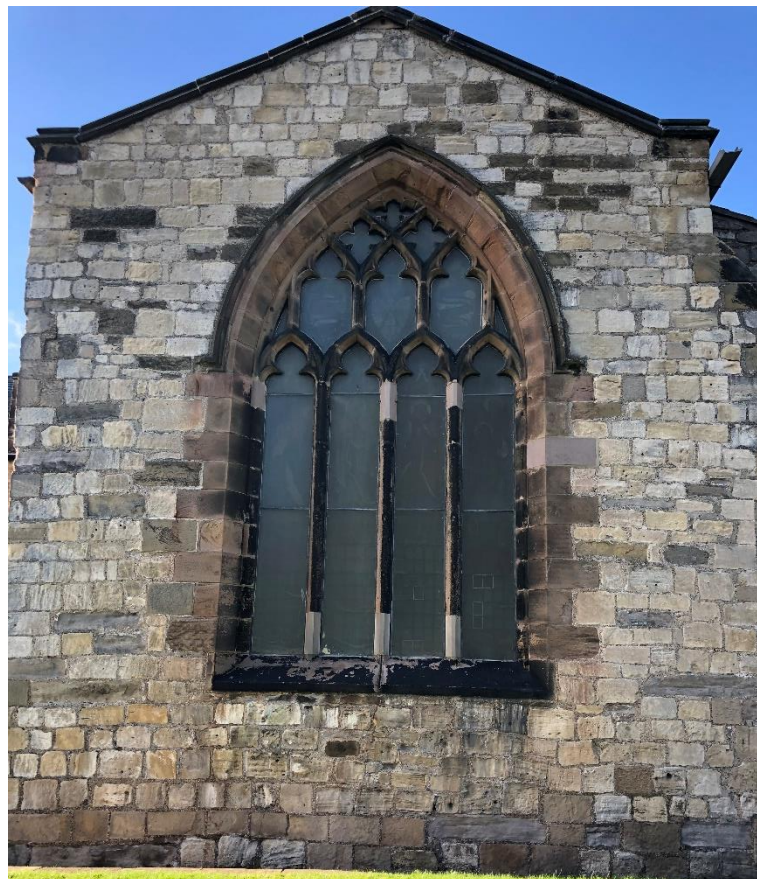
Fig 4. Vertical cracking below east chancel window: no visible change

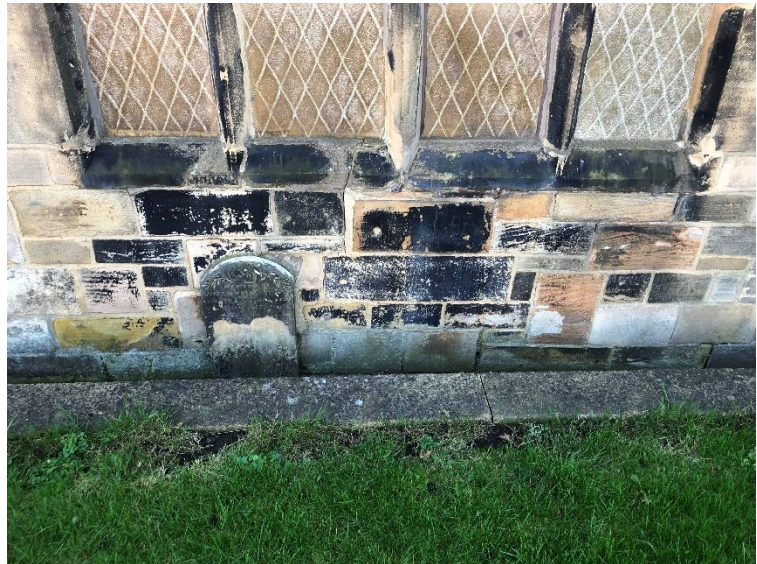
Fig 5. Window detail showing  
glazing and repointing to  
Choir Vestry

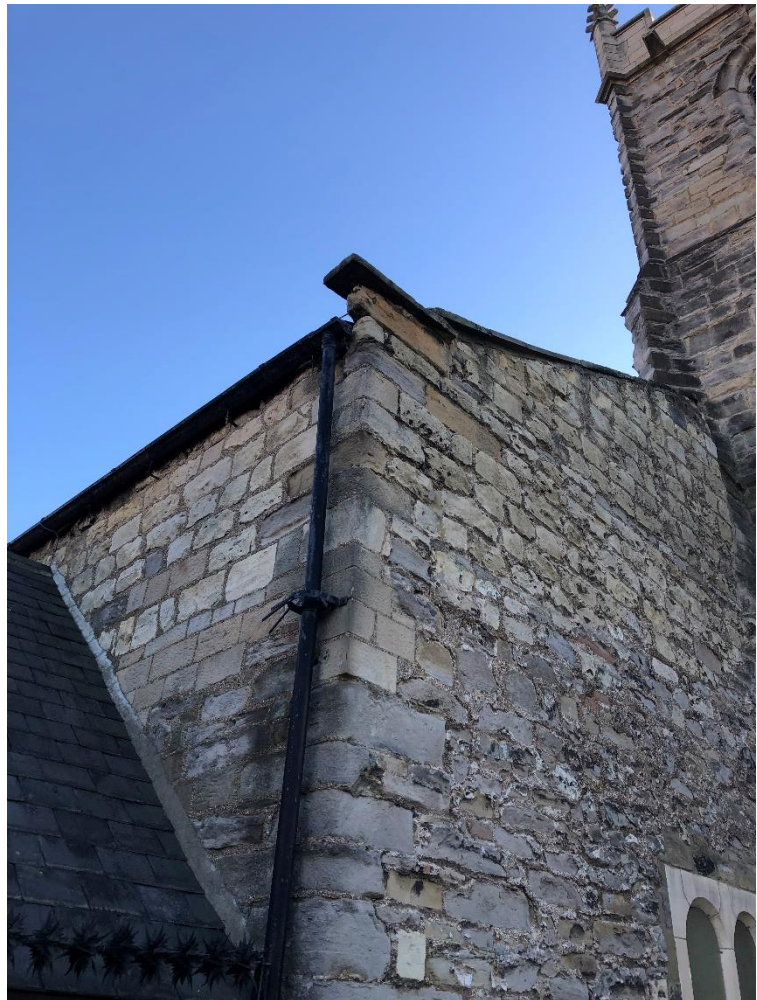
Fig 6. Eroded kneeler, north  
aisle, west gable;

Tower/north aisle junction, no  
further water ingress reported

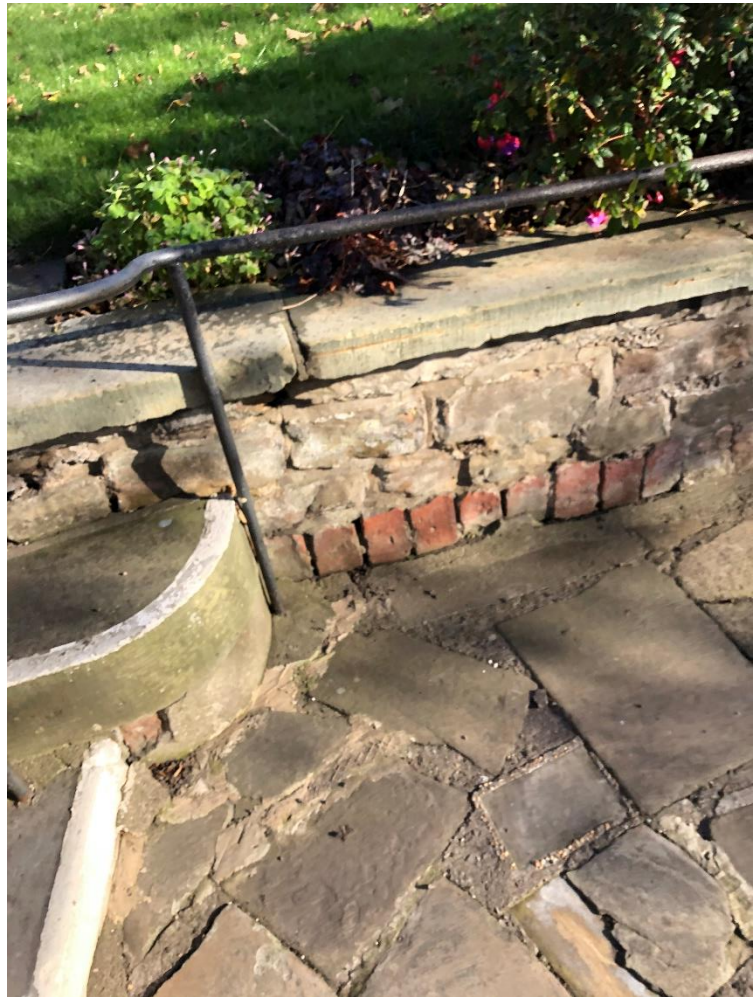
Fig 7. Open joints, entrance steps retaining wall

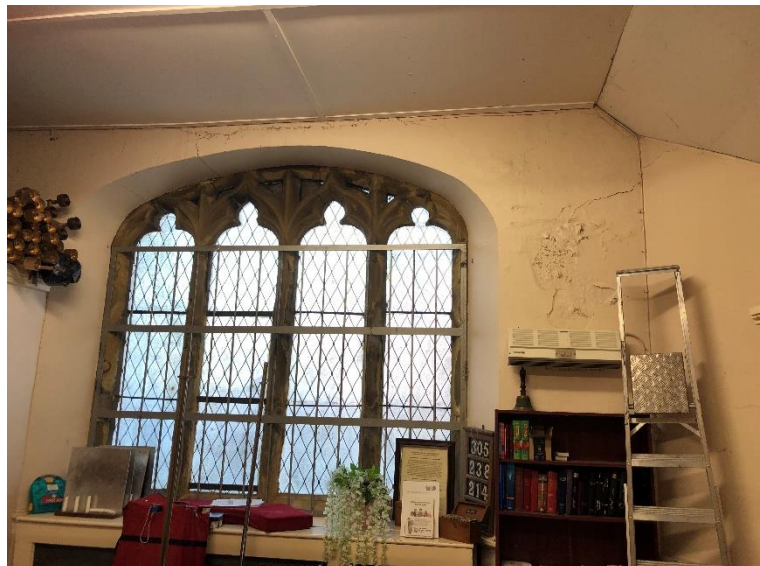
<b>12.0</b>	<b>Internal Walls</b>
12.1	Only in the Choir Vestry and Kitchen are the walls plastered.
12.2	Damp penetration has slightly damaged the decoration (and possibly the underlying plaster) on the north wall of the Choir Vestry at window springing level and just to its east, but this seems no worse than previously. The dampness may have been eliminated by the re-slating of the roof but if it persists, pointing of the open joints between the gable watertabling stones may be the answer.

Fig 8. Localised cracking and salts liberated to north wall, Choir Vestry

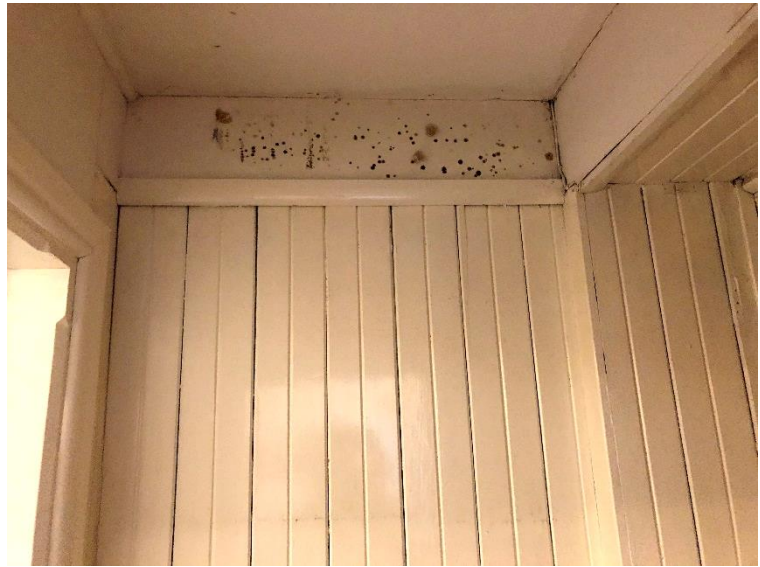
Fig 9. Mould (condensation?) in west lobby, Choir Vestry

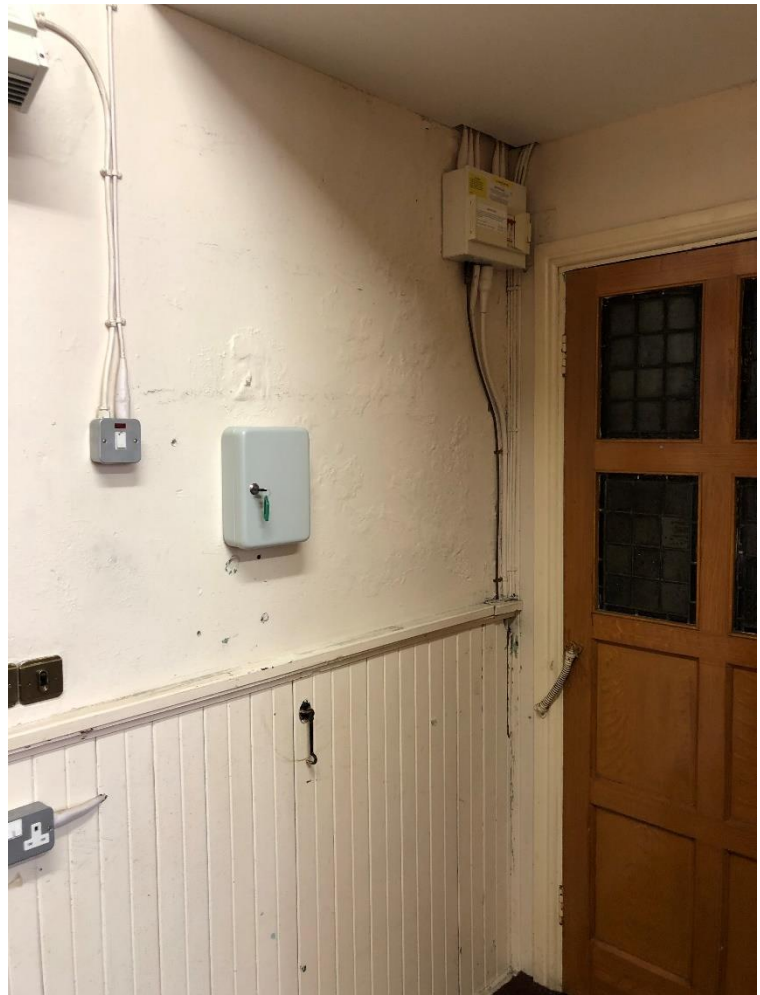
Fig 10. Paint breakdown, Choir Vestry

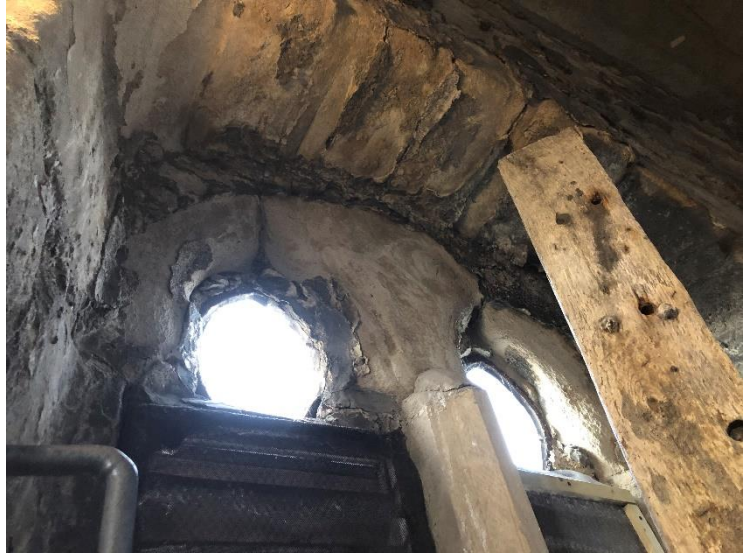
7.6	The heads of the Belfry openings have un-coloured obscure glass, mortared directly into the stone surrounds. The lack of any flexibility in this fixing method has resulted in cracking of the glass but no action is needed on this.  Wire mesh to louvres should be checked and gaps around timber frames filled. Significant erosion has occurred to the eastern Belfry opening. Consideration of options here will be separately detailed.

Fig 11. Western Belfry opening  
prior to mullion removal

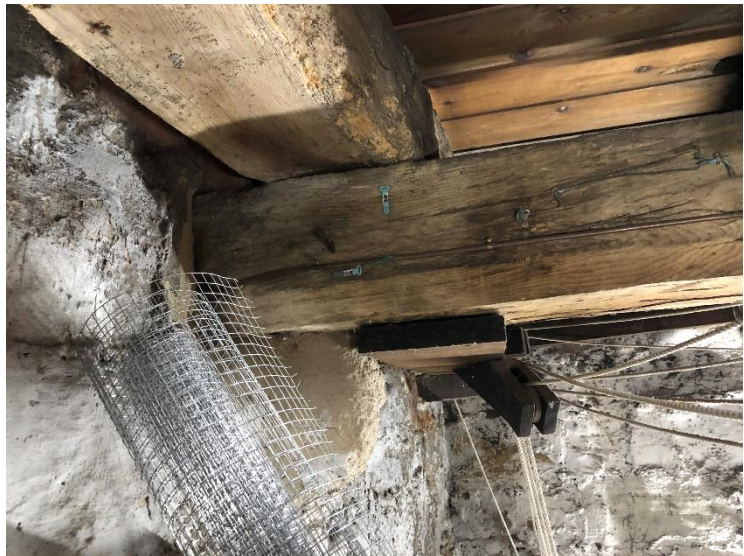
3.2	<p>Evidence of past woodworm activity in roof timbers, etc., was recorded in previous inspections and these also mention that treatment was carried out in 1957/8. Treatment was carried out in June 2018, no recurrence evident since.</p> <p>Previous inspection of the roof void to the north Aisle revealed levels of woodworm activity requiring immediate treatment and thorough, detailed inspection of all structural timbers in that vicinity. Treatment was carried out in June 2018, no recurrence evident since.</p> <p>There were also signs of historic infestation to the underside of the Fulthorpe Chapel ceiling.</p> <p>The wooden chest standing on the threshold of the Nave roof access hatch in the Ringing Chamber should be checked.</p>

Fig 12. Check woodworm  
treatment (Tower)

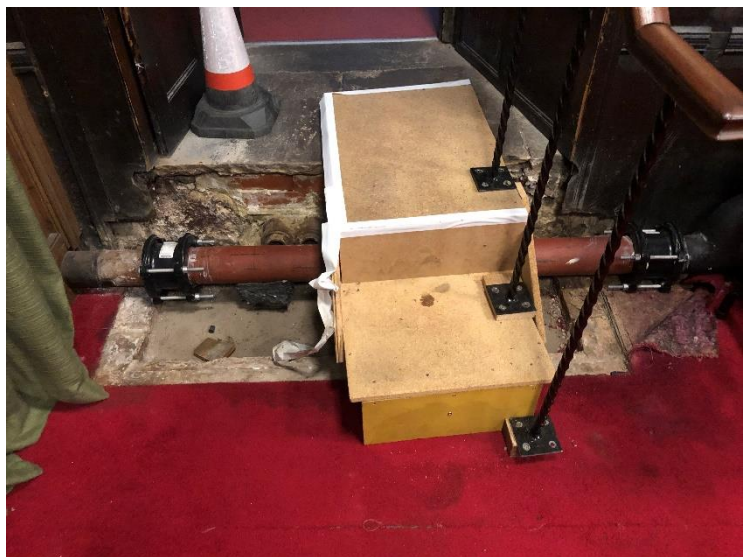
Fig 13. Replacement  
steps/handrail to kitchen  
(pipework repair)

<b>RECOMMENDATIONS</b>
<b>URGENT WORKS REQUIRING IMMEDIATE ATTENTION - Category 1</b>
Reinstate handrail/steps to kitchen with maintenance access to pipework (see Appendix B, Fig. 13)
<b>WORK RECOMMENDED TO BE CARRIED OUT DURING NEXT 12 MONTHS - Category 2</b>
Replacement of hinges/shoot bolts on Tower access hatch; check access ladder (see Appendix B, Fig. 14)
Secure access ladder to north aisle roof void (see Appendix B, Fig. 15)
Filling of gaps around glazing of Choir Vestry windows and identify sources of moisture ingress (flue?) (see Appendix B, Fig. 16-17)
Bringing down of any substantial loose lumps of plaster/masonry from western edge of Nave ceiling
Belfry openings (see Appendix B, Fig. 18): <ul style="list-style-type: none"> <li>• Replacement of bird guard mesh (consistent wiring to louvres and surrounding gaps, timber scribed to stonework)</li> <li>• Investigation into feasibility/costs of work to Belfry stonework openings (eroded stone jambs to east window and elsewhere)</li> </ul>

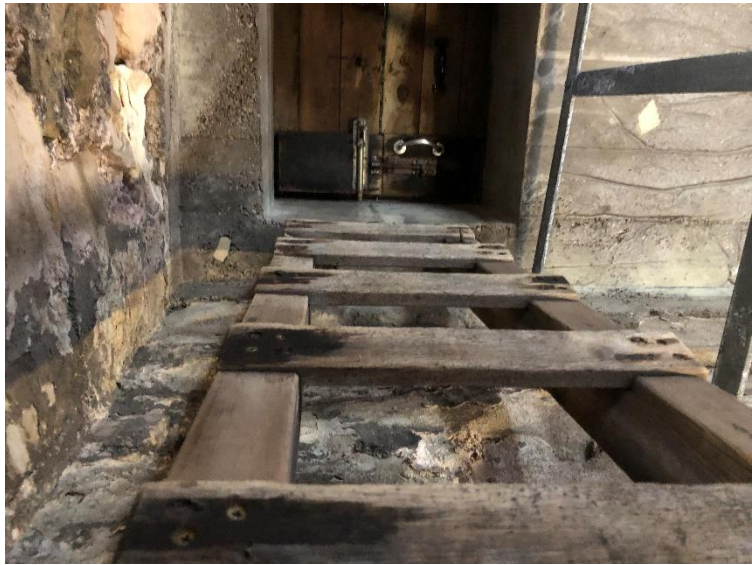
5.7	The condition and arrangement of the hinges/bolt on the Tower roof access hatch are such that it cannot be closed easily. Access to the Tower roof through the bell chamber is extremely tortuous and although there is a galvanized handrail adjacent to ladder to the roof trapdoor, specific hand and foot holds should be clearly available and adequately marked along an acceptable access route. This could form part of the Bell frame maintenance procedure. The Tower access hatch ladder should also be regularly checked for condition.

Fig 14. Tower access hatch/ladder

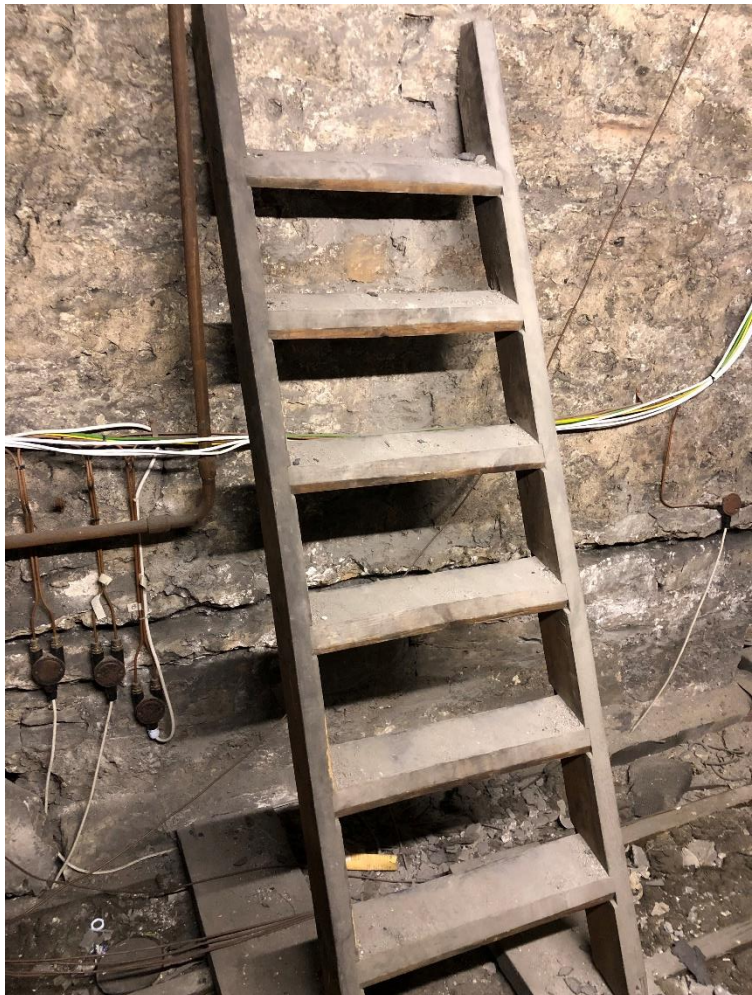
Fig 15. Access ladder, north aisle roof void

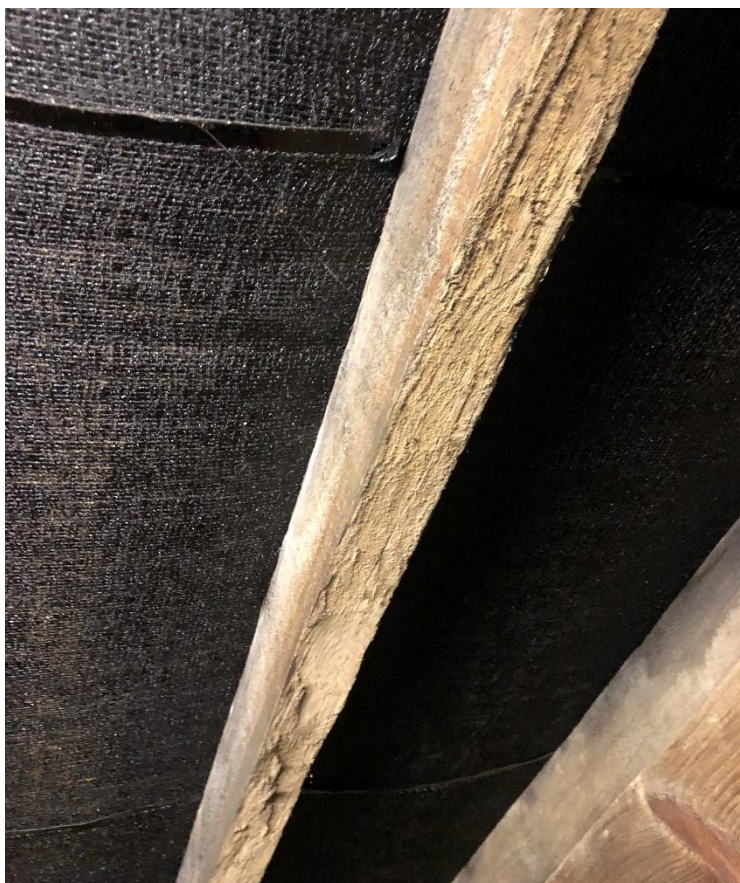
Fig 19. Loft space,  
exposed timber

Check woodworm treatment to loft spaces/exposed timber (see Appendix B, Fig 19)
Stop up roof eaves gap in north aisle loft space
Testing of lightning conductor installation
Continuing attention to churchyard trees (by Local Authority)
<b>WORK RECOMMENDED TO BE CARRIED OUT DURING NEXT 5 YEARS - Category 3</b>
New limewashing of upper walling in Ringing Chamber; creation of safe access arrangement to roof
Re-painting of handrails, railings, fencing, etc., in Churchyard
Keeping structural movement of Clergy Vestry (now Kitchen) wing under observation
Re-covering of Tower roof
Consideration of replacing 'Meshlite' glazing with something better
Minor re-pointing and consolidation of boundary walls and stone paving; keeping possible movement in south-west retaining wall under observation.
<b>WORK TO BE CONSIDERED BEYOND 5 YEARS - Category 4</b>
Further repair and re-pointing of masonry externally and in Belfry
