## QUINQUENNIAL INSPECTION REPORT

**St. NICHOLAS' CHURCH**  
RECTORY BANK, WEST BOLDON, NE36 0RF

FEBRUARY 2021

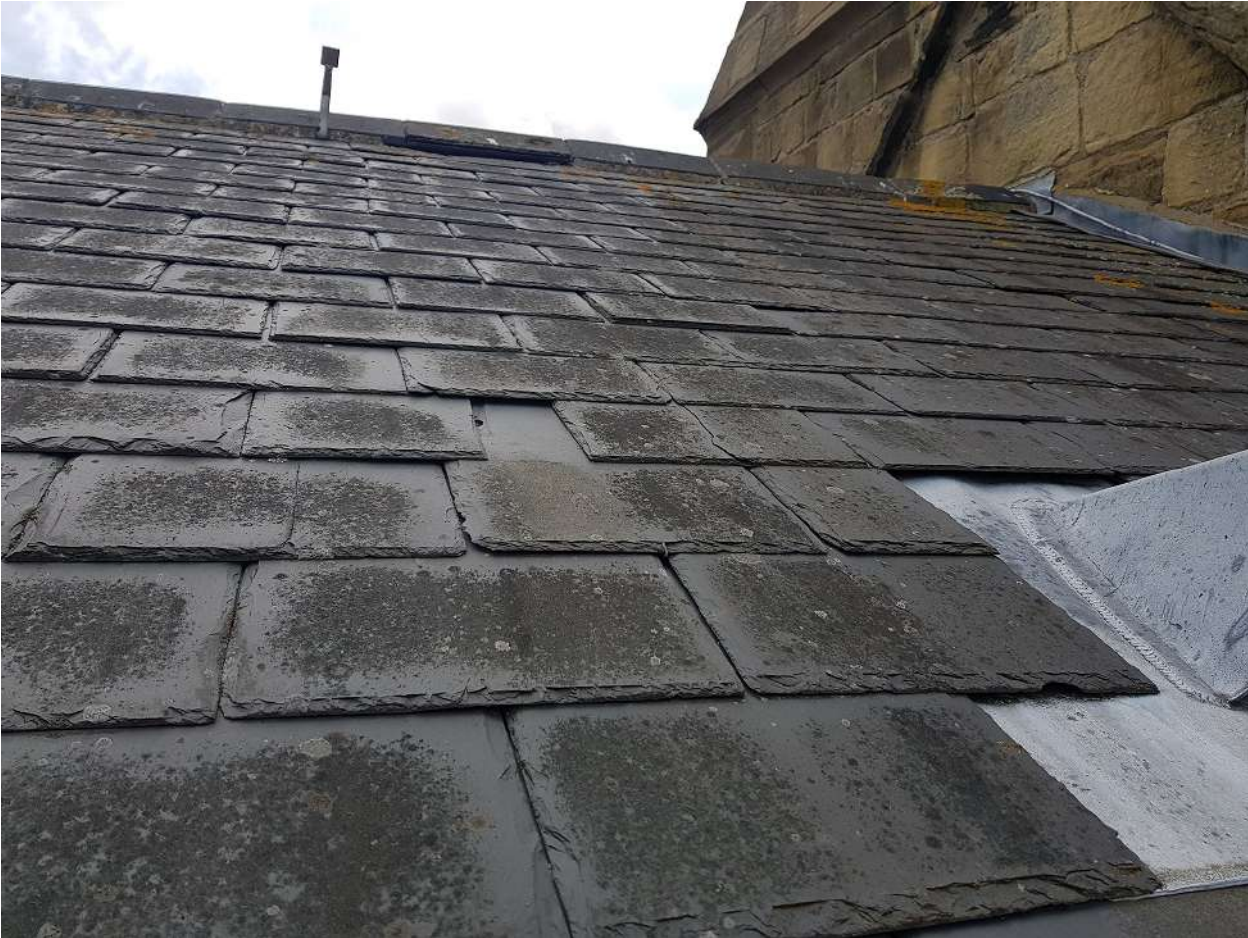
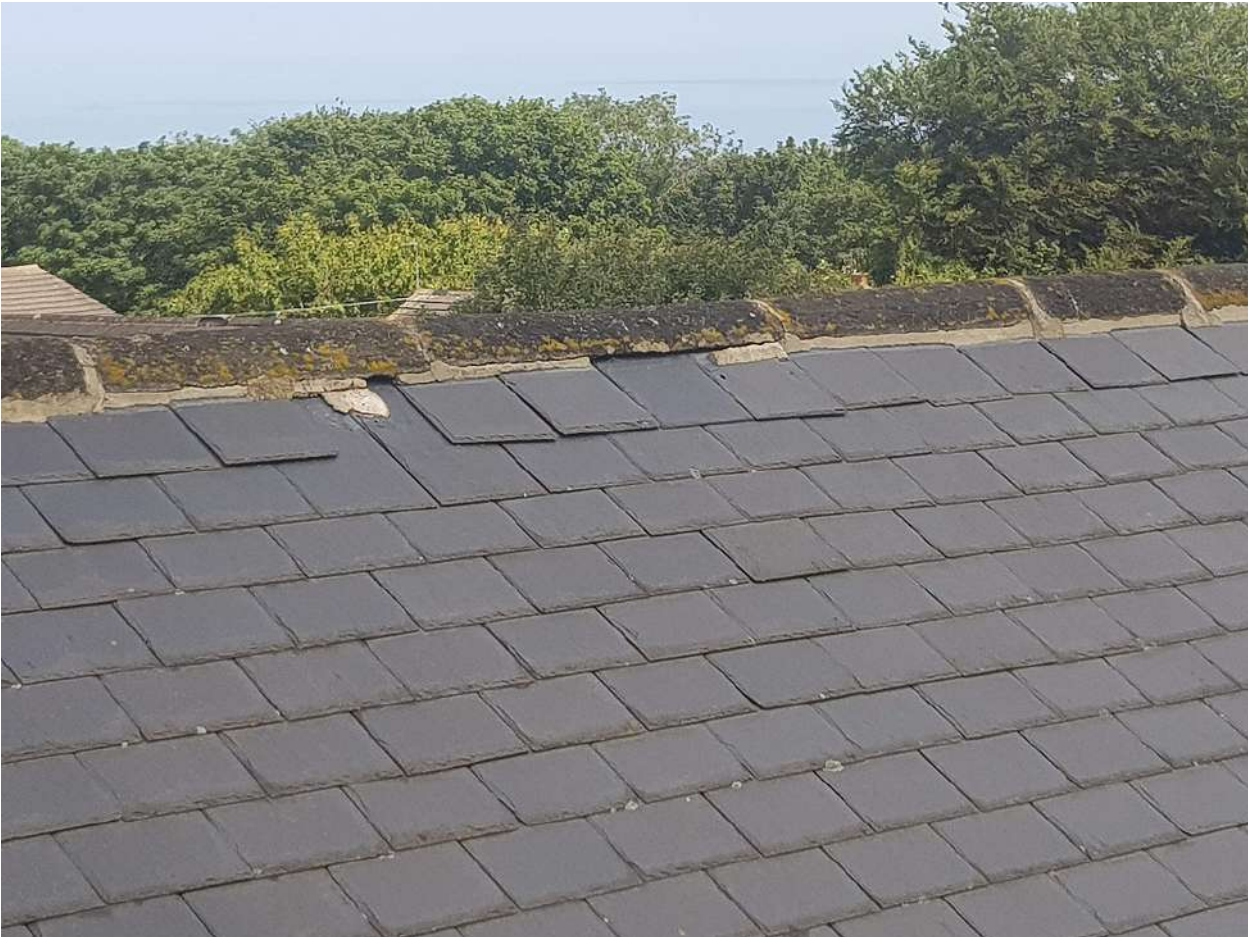
- 3.2.1 The condition of the chancel roof covering is found to be in a fair condition. Checking faculty records it is not clear when the roof was last recovered. Coursing of the slates appear to be generally consistent which suggests that the nail fixings for now are holding adequately. Abutment flashings all look in satisfactory condition. There are however isolated incidents of either slipped, cracked and/or missing slates which will need attending to, less however than that of the nave.

It is recommended as an urgent repair item that isolated slate repairs are carried out by a competent and experienced roofing contractor.

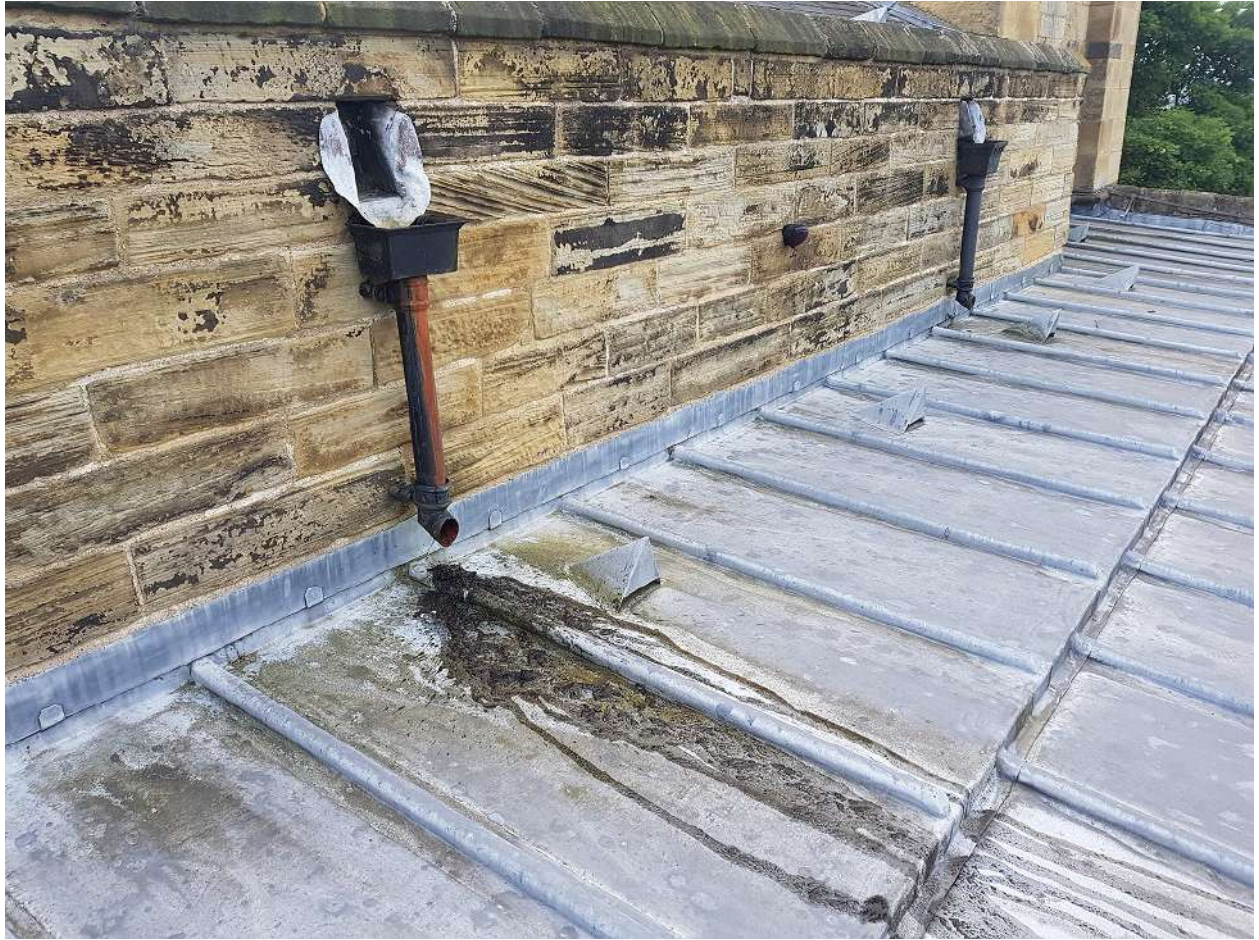
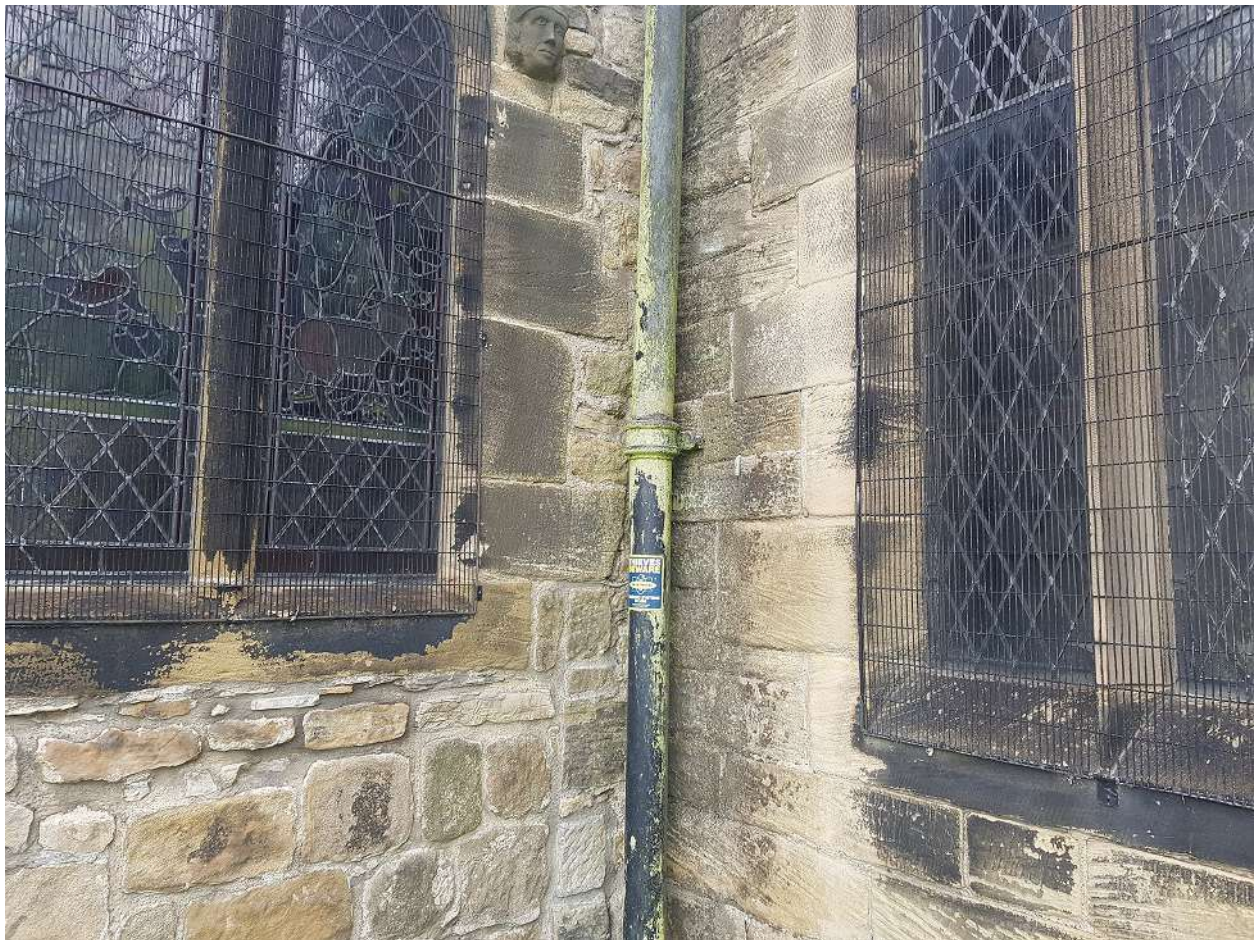
- 4.3.1 Downpipes generally found in a deteriorating condition, particularly to the north side. The lower section to the central downpipe is badly rusted which suggests a failure of the joint between the adjacent section of downpipe.

The west downpipes bottom two sections are badly rusted/deteriorating and have plant growth emanating from the joint of the second bottom pipe.

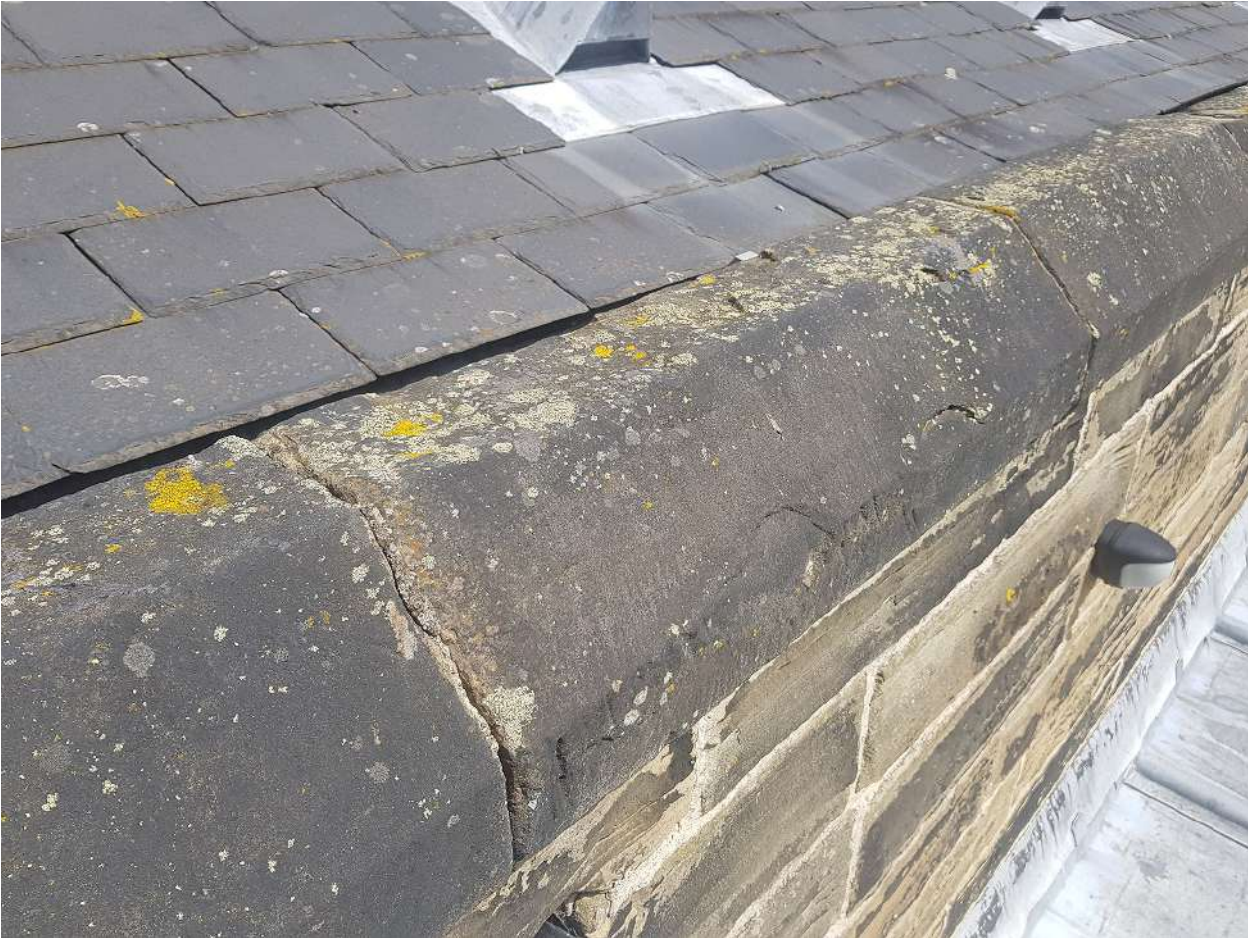
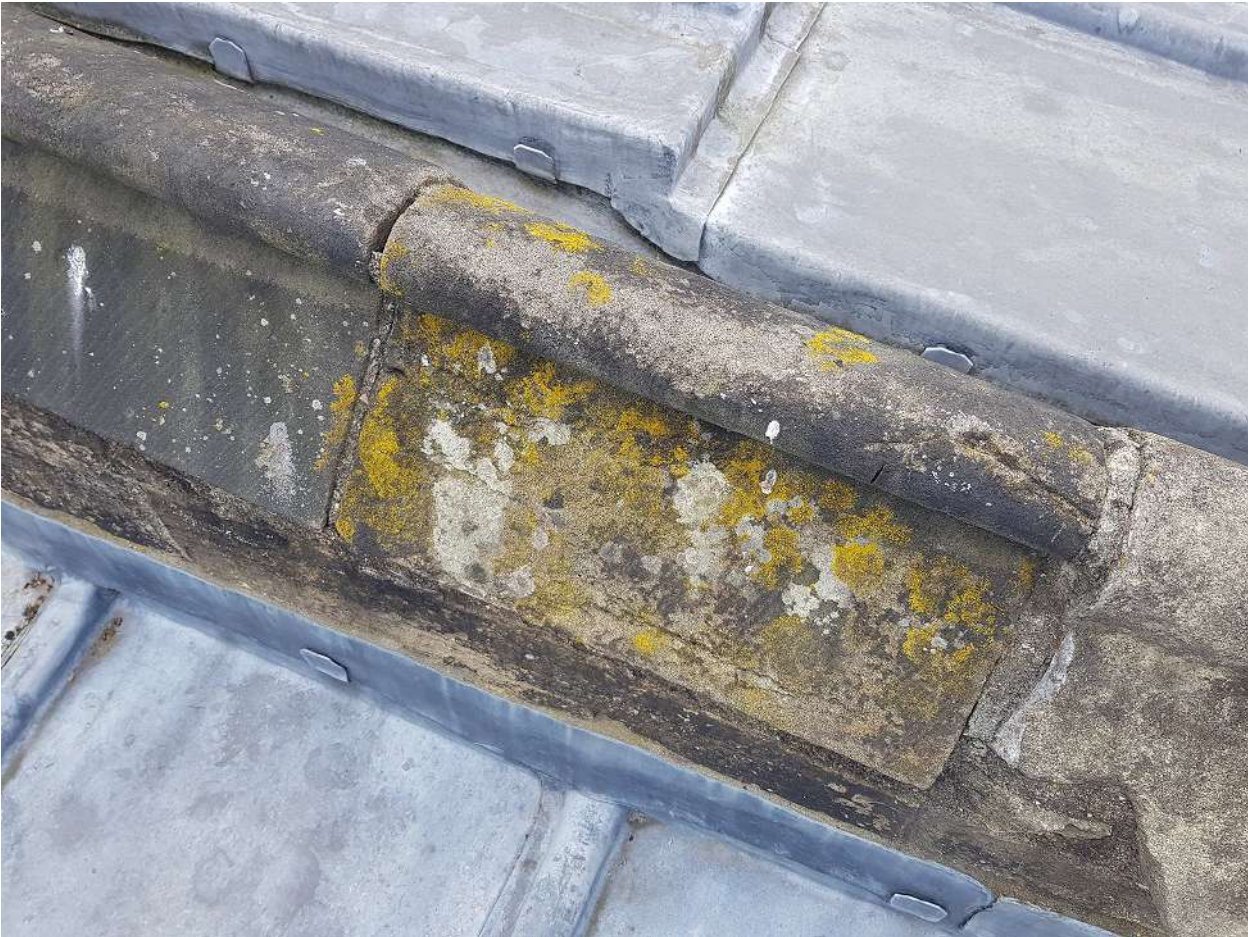
- 6.4.2 Stonework to the apex cross looks in a sound, satisfactory condition. Adequacy of the cross fixings were not able to be inspected/tested as part of this inspection.

It is recommended that inspection and testing of the apex cross fixing is carried out to assess its structural integrity.

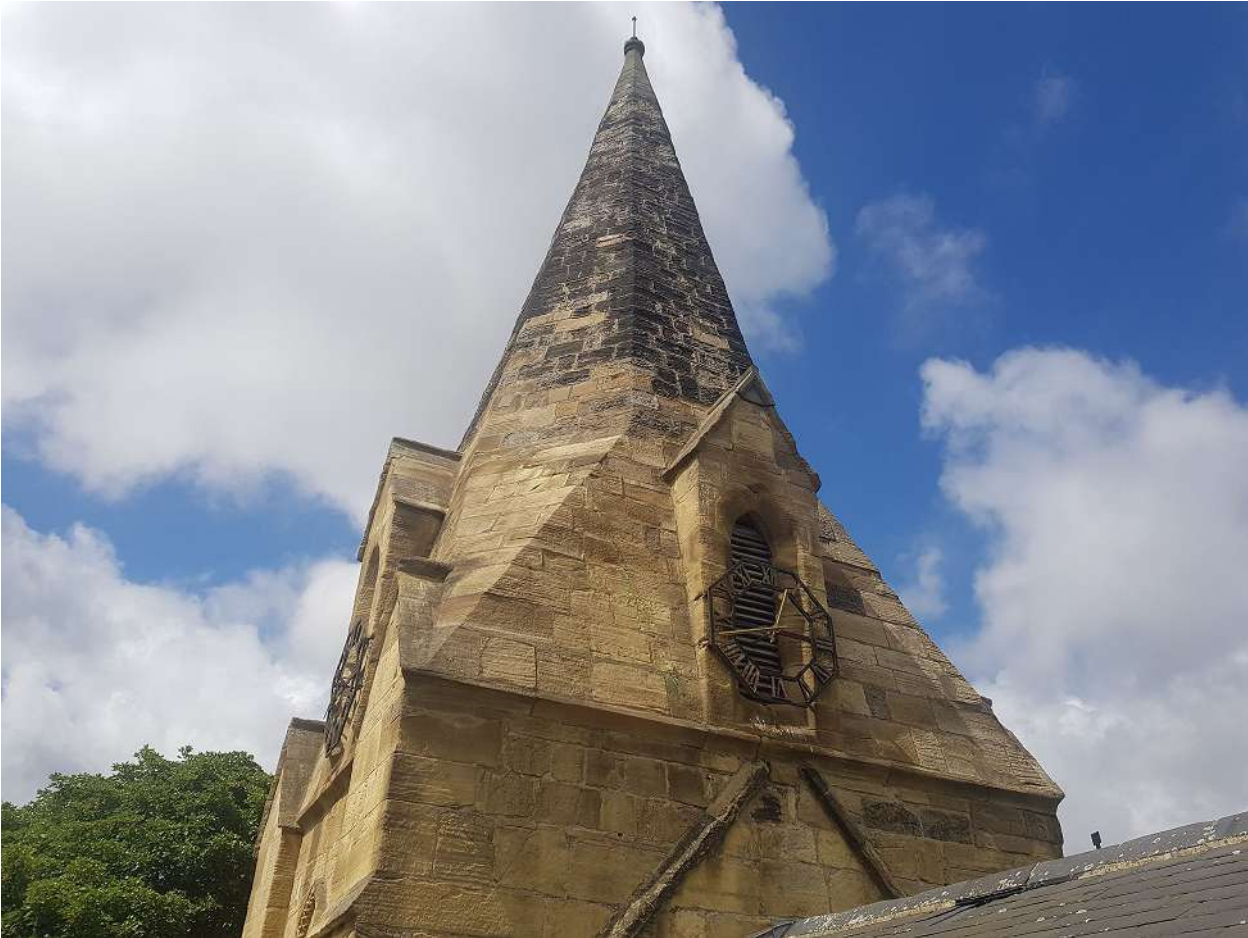
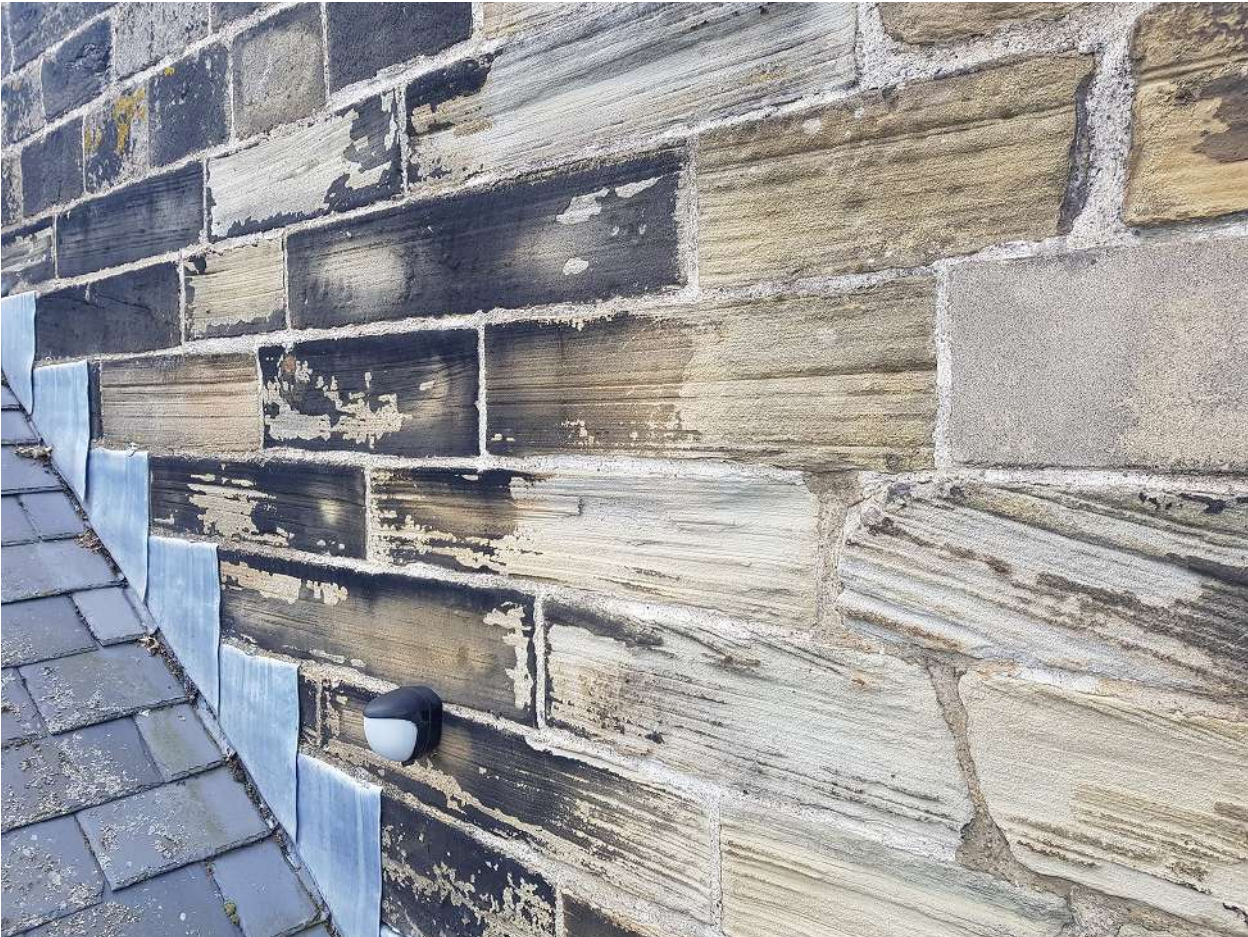
- 7.1.1 Stonework is generally in a sound, satisfactory condition. There are isolated incidents of defects ranging from split stones, soiling causing discoloration, erosion with loss of the stone face and deterioration due to weathering but none so much to an extent that will require intervention now. Erosion of the tower plinth is particularly pronounced.

The east facing belfry opening has a stone ridge with roll mould detailing. This appears to be lifted slightly and would benefit from further investigation.

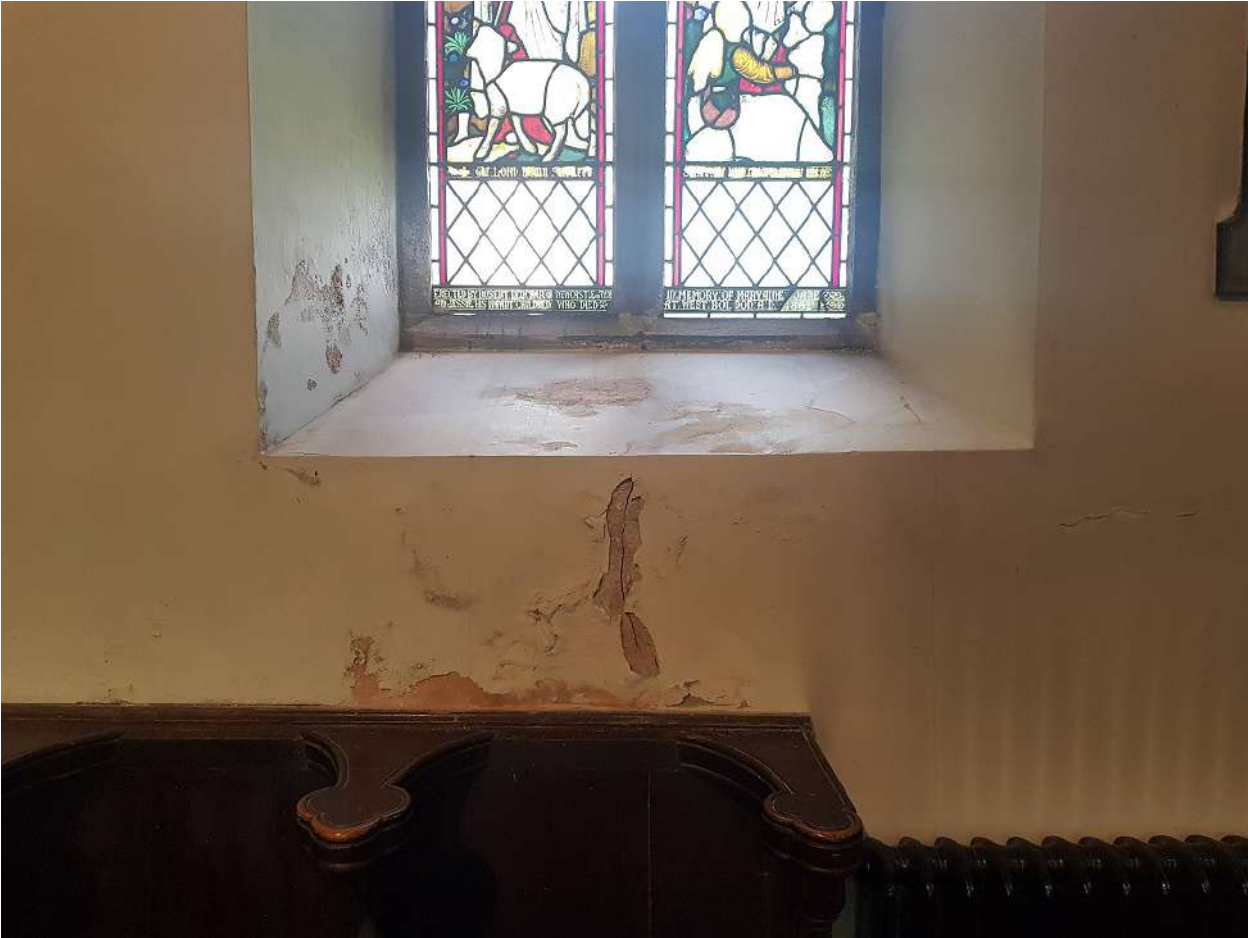
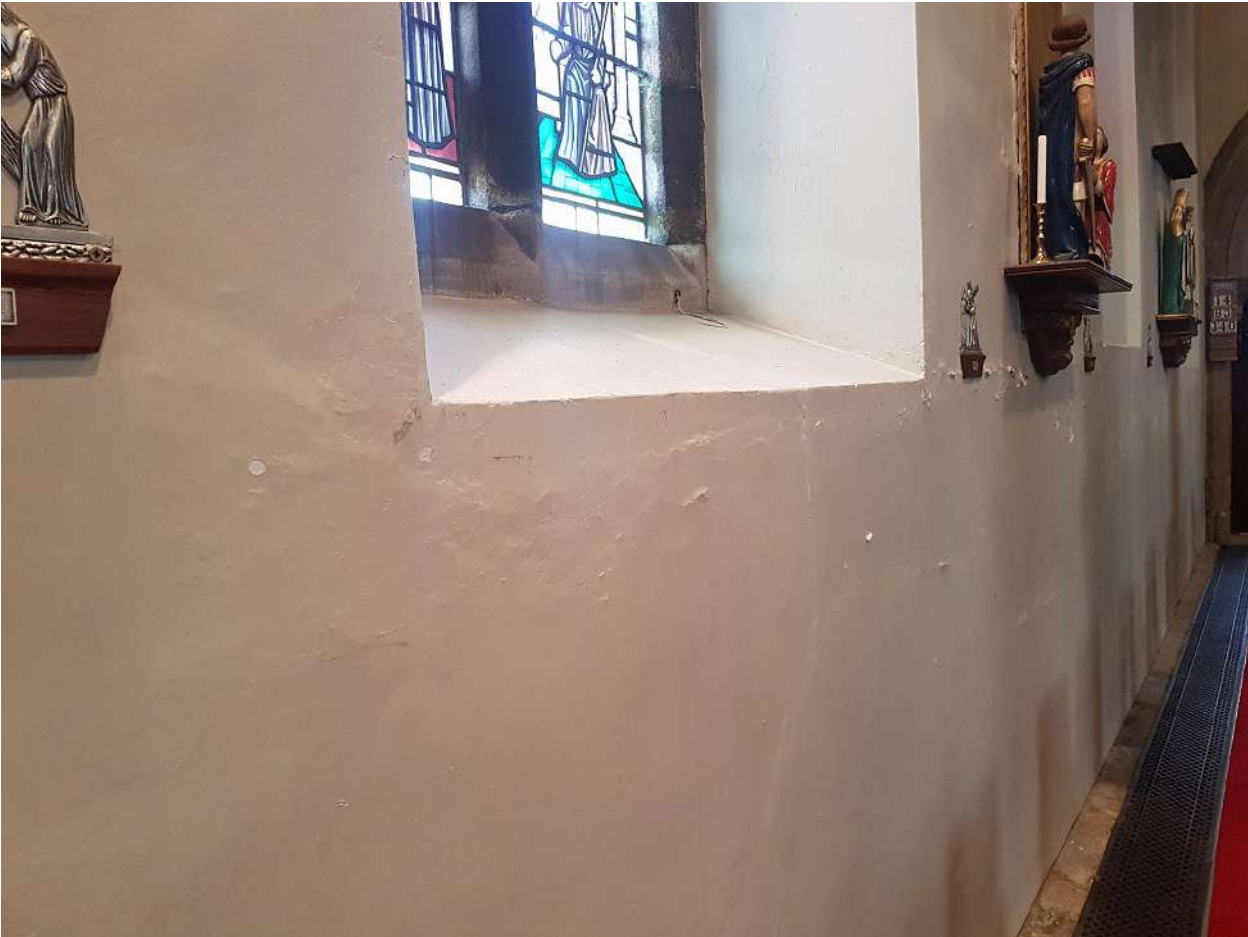
17.3.1 The decoration finish to the plastered walls is generally in a satisfactory condition. The exception to this is a breakdown of condition horizontally at approx. 1.5m above floor level along the north wall. Defects included bubbling, cracking of the paint finish the cause of which is not immediately known. Heating pipework running along this elevation may well be contributing to an adverse reaction locally to the building fabric. Further investigation is necessary to this plastered finish.

<b>R1</b>	Carry out investigation of breakdown in decoration finish to north wall which may require a degree of plasterwork removal.
-----------	----------------------------------------------------------------------------------------------------------------------------

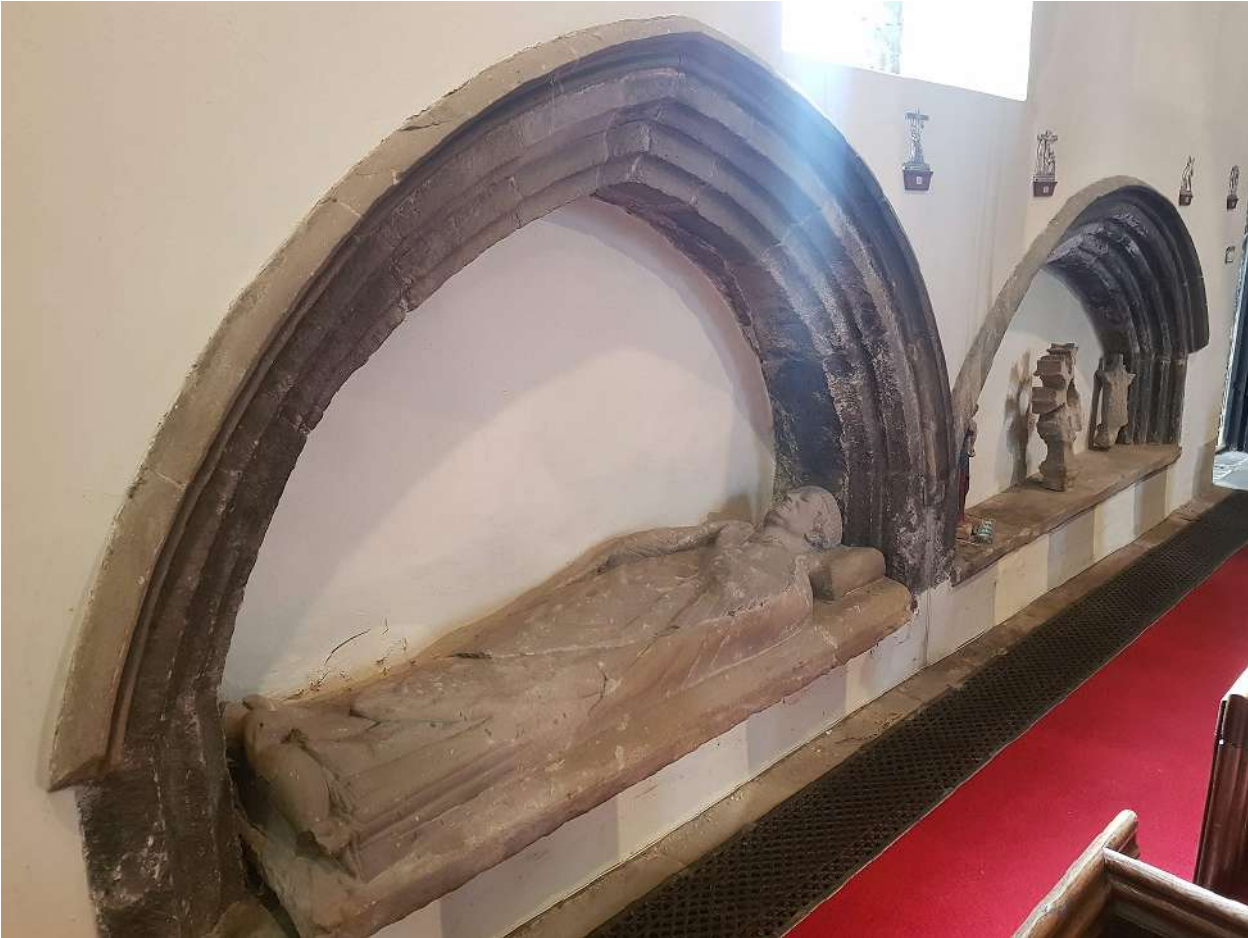
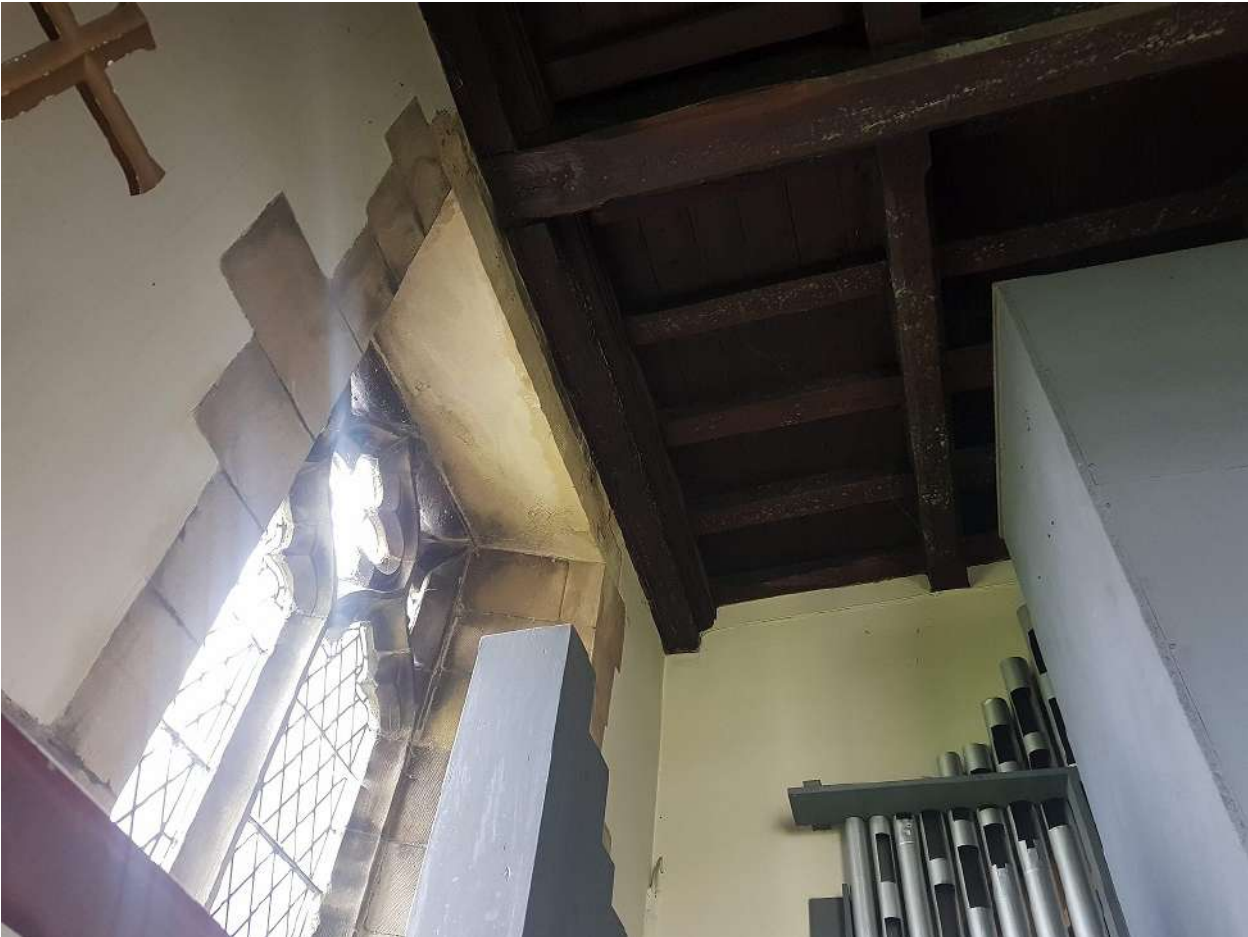
17.4.2 Exposed stonework to the piscina, tomb recess (E and W) and west end walling are generally in a sound, satisfactory condition. Albeit could benefit from a conservation clean.

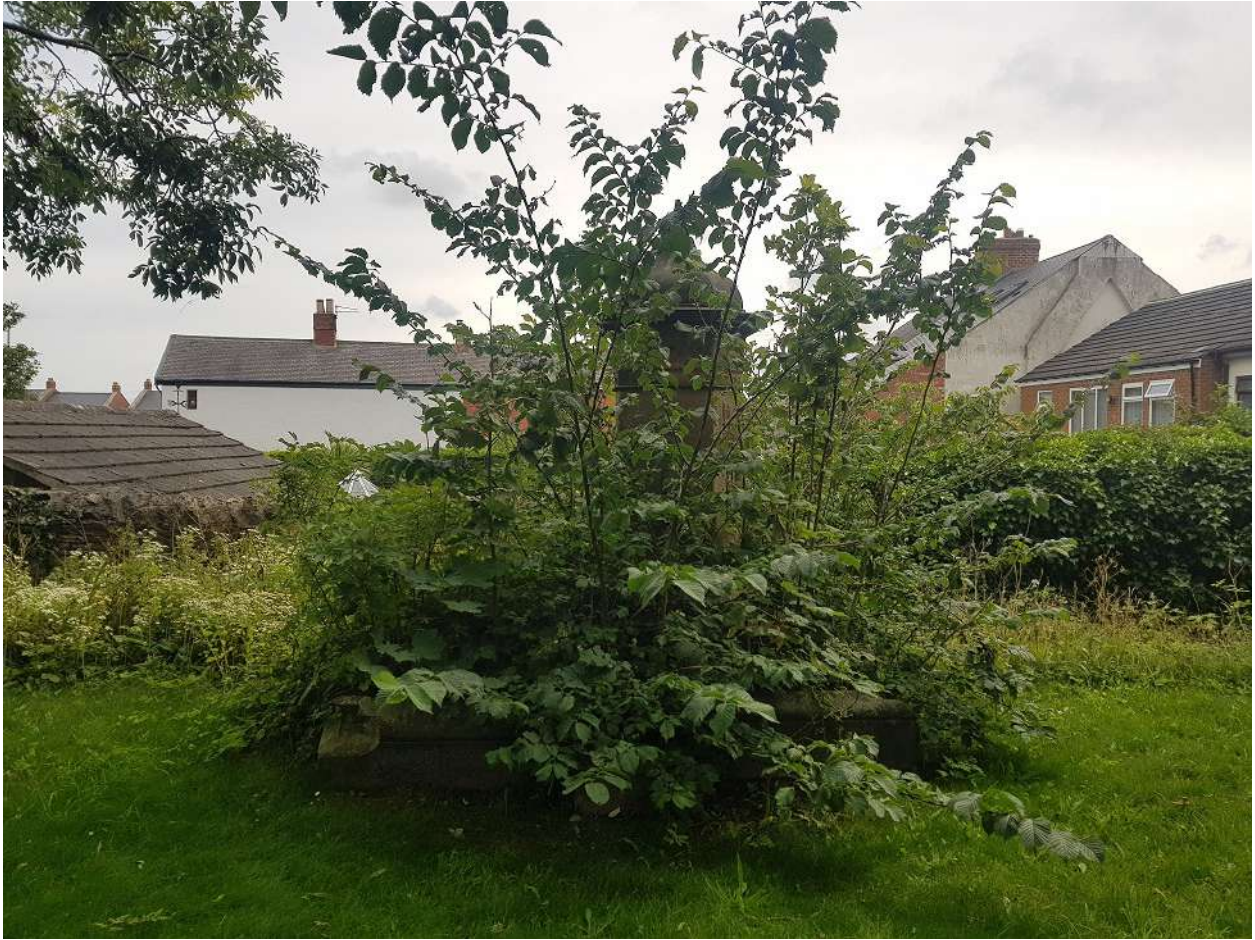
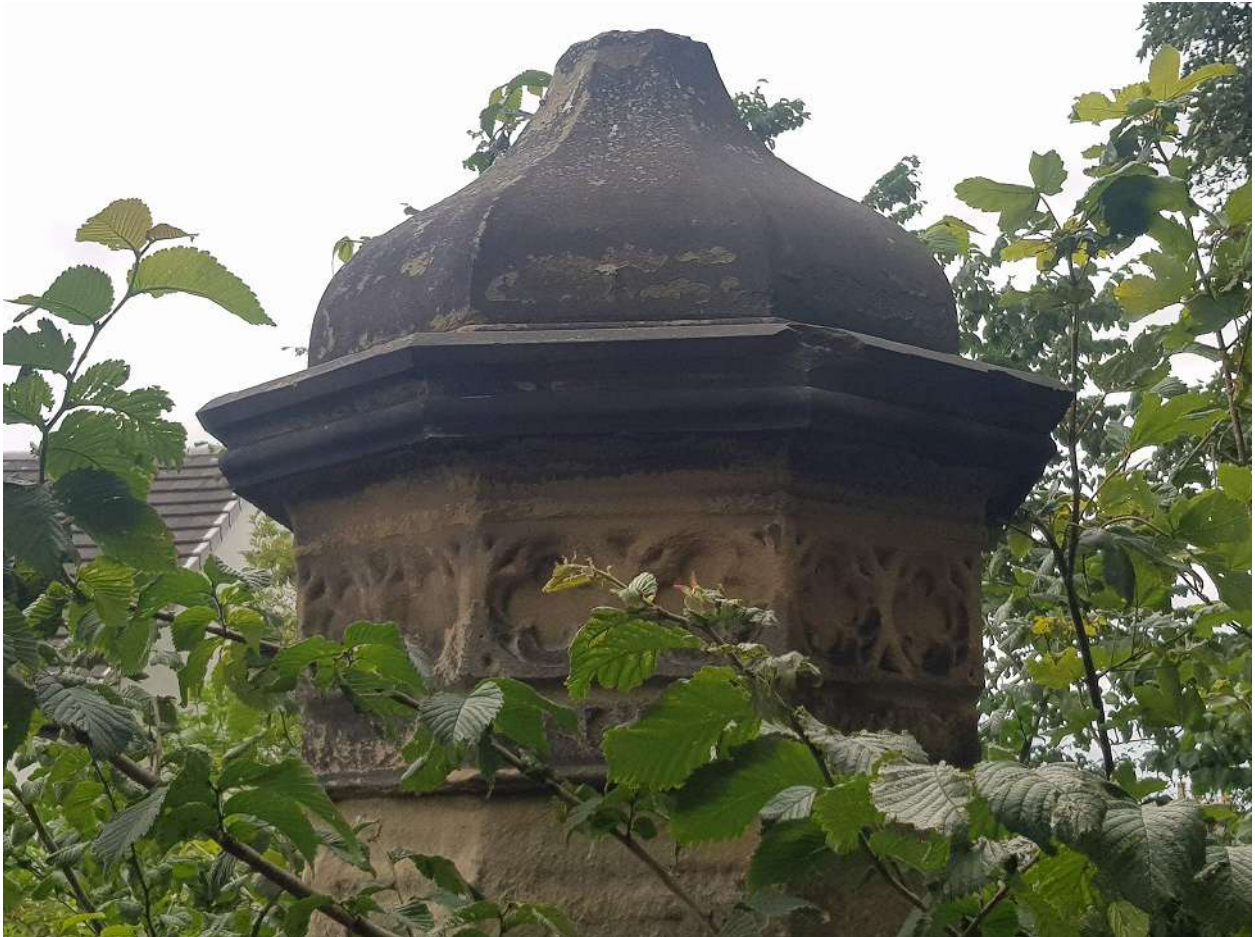
A condition assessment of the headstone/tomb condition within the churchyard is desirable to inform a phased approach to their future care, management and repair.

<b>R2</b>	Commission condition survey of existing headstones and box/table tombs within the churchyard.
-----------	-----------------------------------------------------------------------------------------------
