# Quinquennial Inspection Report

## St Mary the Virgin, Whickham

**Date of inspection:** 4 March 2021 (weather conditions: cold, overcast, occasional showers)

**Ref:** 21011/5

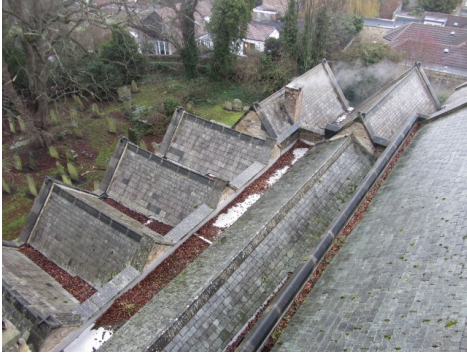
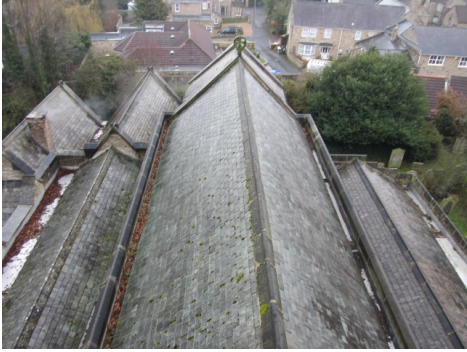
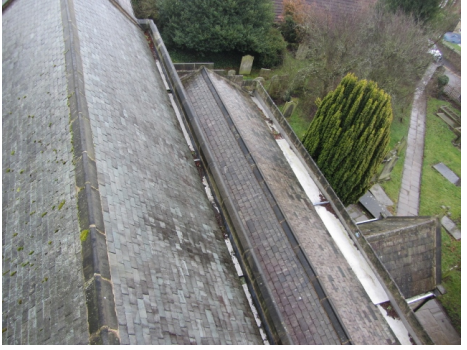
<p>View of roofs from Tower</p>	<p><u>Porch:</u>            Stone ridge – solidly bedded and pointed.            Stone slates set to diminishing courses.            Lead flashing to raking roof to wall junction.            Mortar fillets to gable upstand pulling away from wall.</p> <p><u>South Aisle:</u>            Ridge - solidly bedded and pointed.            Westmorland slates set to diminishing courses.            Stainless steel parapet gutters in stepped bays – some leaves near outlet.            Mortar fillets to stepped gable parapets.</p> <p><u>Nave:</u>            Ridge stones – some missing bedding.            Westmorland slates set to diminishing courses - some moss in joints on north slope.            Parapet gutter blocked with leaves on north side.            Lead flashing to Tower upstand walls junction.            Mortar backing to east gable upstand/ slate junction.</p> <p><u>Chancel:</u>            Ridge stones – some missing bedding.            Westmorland slates set to diminishing courses - some moss in joints on north slope.            Lead flashing to east gable in good condition.            Mortar backing to east gable upstand/ slate junction.</p> <p><u>Organ Chamber:</u>            Ridge and slating as before.            Parapet gutters blocked with leaves.</p> <p><u>Vestry:</u>            Ridge stones – solidly bedded and pointed.            Westmorland slates set to diminishing courses - some moss in joints on north slope.            Mortar backing to east gable upstand/ slate junction OK.            Leaves in parapet gutter with Organ Chamber.            Lead flashing to North Aisle upstand wall – needs checking for leaks (see 2.5 for wall plaster damage in passage).</p> <p><u>Outer Vestry:</u>            Flat roof – no access gained for inspection.</p>

<p><u>Outer North Aisle:</u> Four gabled roofs with valley gutters on north south axis. Ridge stones and Westmorland slates as before. Parapets are blocked with leaves. Roof to north gable junctions need checking for leaks (see 2.5 for wall plaster damage by parapet gutters)</p> <p><u>Inner North Aisle:</u> Duo pitched roof running east west. Ridge stones and Westmorland slates as before. Parapet and valley gutters full of leaves.</p>	
Repair needs	<p>Localised re-bedding of ridge stones. Clearing all parapet and valley gutters of leaves. Checking North Aisle flashings and gutters for leaks and making appropriate repairs. Replacing mortar fillets to rear of Porch gable wall.</p>	<p>B M  B B</p>
<b>1.2 Rainwater goods and disposal systems</b>	Generally: cast iron gutters, hoppers and downpipes discharging over open gullies taken to soakaways.	
<p>Condition</p>

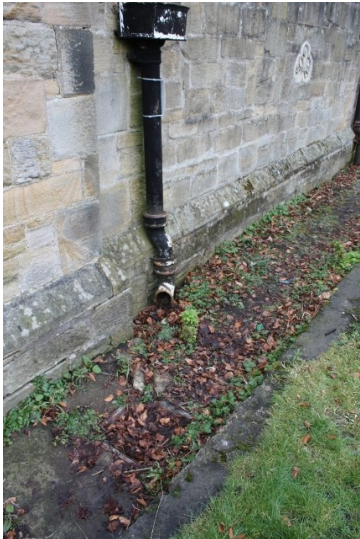
<p>Flaking decoration; gully and channel blocked</p>	<p><u>Porch:</u> Stainless steel eaves gutter/ capping – rather industrial and somewhat out of keeping on a 12<sup>th</sup> century grade 1 church!! Painting in a lead grey would reduce its impact.</p> <p><u>South Aisle:</u> West gable LH pipe upper section is cracked. Downpipes and hoppers have flaking paint to both gables.</p> <p><u>Chance!:</u> Gutters blocked with vegetation near outlets on north and south sides. Decoration poor.</p> <p><u>Outer North Aisle:</u> Gutter on west side is blocked with vegetation. Gargoyle heads to outlets in fair condition. Low level offset joints to downpipes need re-caulking. Decoration to downpipes poor. Gullies blocked by leaves.</p> <p><u>Organ Chamber/Vestry:</u> Flaking decoration to hopper.</p>

Repair needs	<p>Clearing all gutters, hoppers and gullies of leaves and other vegetation. Replacement of cracked downpipe to S Aisle west wall. Re-caulking of downpipe joints. Redecoration of gutters, hoppers and downpipes. Painting Porch stainless steel gutter cappings in lead grey paint to reduce impact.</p>	<p>M  B B B E</p>

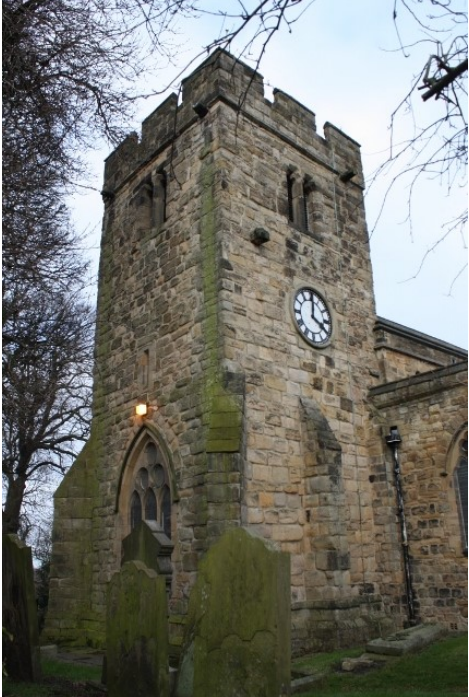
<p><u>Roof:</u> Leadwork and hatch in good condition. Parapet gutters need clearing out of leaves. Gutters discharge into stone spitters. GRP flagpole and base in good condition. See section 4.5 for comments on lightning conduction system. Stone roof over access staircase – stone and pointing in good condition.</p> <p><u>Walls:</u> Parapet solidly bedded and pointed. Stonework and pointing in good condition.</p> <p><u>Bell loft:</u> Somewhat difficult ladder and platform access to roof hatch. Steel bell frame, bells, headstock and ropes all appear in satisfactory condition. Lime wash finish to inner face of external walls – some yellow patches from damp.</p> <p><u>Bell ringing chamber:</u> Ply ceiling lining with painted beam; timber vertical boarded wall linings; carpeted floor – all in fair condition. Metal ladder – solid and decoration intact.</p> <p><u>Tower access staircase:</u> Some damp penetration leaving stains and blistering to inner face of external walls below windows - monitor.</p>	<p>M</p> <p>F</p>

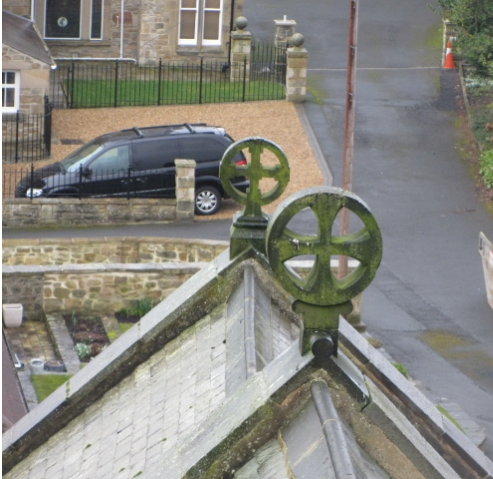
<p><u>Apex crosses:</u> Those to the Porch, Nave and Chancel gables are in good condition. See photo</p> <p><u>Chimney:</u> The chimney stack from the boiler has open joints in the brickwork which need repointing.</p> <p>The flue terminal and flashings lead need checking for leaks (see 2.5 for water staining to plaster in Vestry)</p> <p><u>Upstand walls:</u> The water tabling to the Nave east gable has an open joint near the apex cross which needs filling to prevent water ingress.</p> <p>Moss is growing out of the water tabling joints to the east gables of the Chancel, Organ Chamber and Vestry. These joints should be raked out and repointed to prevent water ingress.</p> <p>Open bed joint to stepped upstand coping to S Aisle west gable.</p>	<p>B</p> <p>B</p> <p>B</p> <p>B</p> <p>B</p>

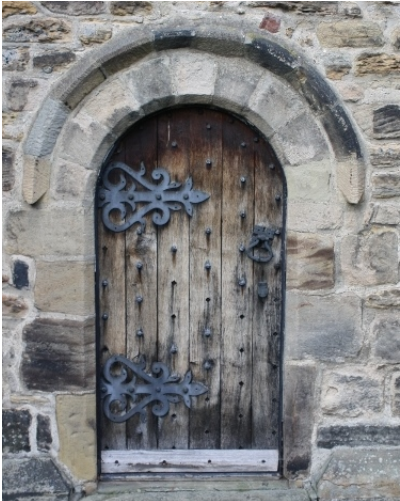
<p>Chancel priest's door</p>	<p>The external doors are generally in good condition. The timber is sound and ironmongery is appropriate for use and security. However defects were noted as follows:-</p> <p><u>Chancel priest's door</u> Oak boarded, studded, decorative hinges, arched head. In need of re-oiling.</p> <p><u>Porch door</u> Stain finish breaking down under UV light. It is recommended that the stain is removed and the door is oiled.</p> <p><u>Vestry door</u> Varnish breaking down. Removal of varnish and re-varnishing recommended.</p> <p><u>Tower door</u> Stain finish breaking down on weather mould. Removal of loose stain and re-staining recommended.</p>	C C C C

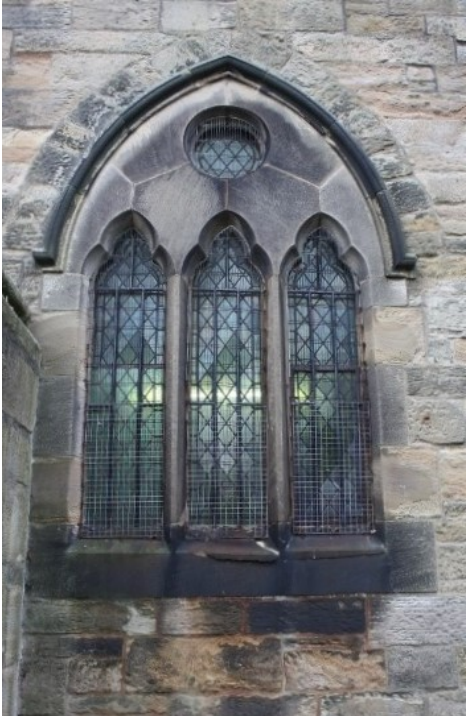
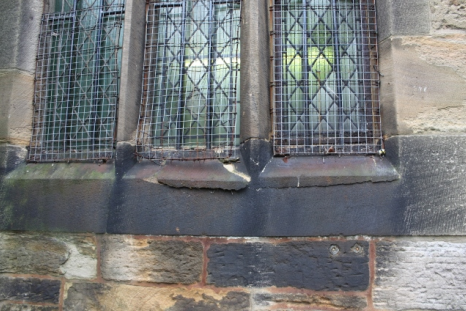
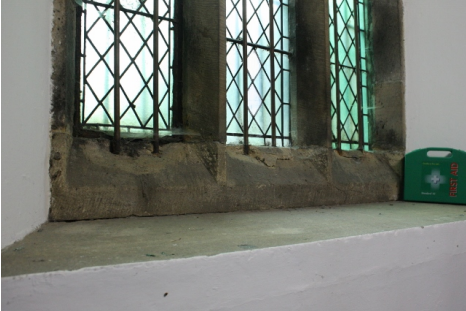
<p style="text-align: center;">Vestry window</p>	<p>Glazing, leading and ferramenta generally in fair condition Masonry generally in fair condition.</p> <p>However some defects were noted as follows:-</p> <p><b><u>Externally</u></b></p> <p><u>South Aisle</u></p> <ul style="list-style-type: none"> <li>• East window - mesh rusting to 3No circular upper lights</li> <li>• s vi - some surface decay to mullion</li> <li>• s viii – surface decay to upper stones</li> <li>• s ix – minor rusting to upper mesh</li> </ul> <p><u>Inner Aisle</u></p> <ul style="list-style-type: none"> <li>• n xi - decay to lower edge of hood mould - monitor</li> </ul> <p><u>North Aisle</u></p> <ul style="list-style-type: none"> <li>• n viii – rusting mesh grille – replace in polycarbonate</li> <li>• n x – mesh grille crudely fitted to exterior (not fitted within each light)</li> </ul> <p><u>Vestry</u></p> <ul style="list-style-type: none"> <li>• n v – inner mesh guard badly fitted and rusting Surface decay to underside of hood mould Cill badly spilt and with loose upper surfaces due to expansion of iron security bars</li> </ul> <p><u>Chancel</u></p> <ul style="list-style-type: none"> <li>• East window – open joint to cill of middle light</li> </ul> <p><b><u>Internally</u></b></p> <p><u>South Aisle</u></p> <ul style="list-style-type: none"> <li>• Some open joints in window masonry</li> </ul> <p><u>Nave</u></p> <ul style="list-style-type: none"> <li>• Some distortion of leading to south clerestory windows S ii, S iii, Siv - glass dirty and lots of cobwebs!!</li> <li>• Some surface decay to middle window masonry</li> </ul> <p><u>Chancel</u></p> <ul style="list-style-type: none"> <li>• Rose window – some staining from past leak</li> <li>• East gable lancets – some distortion in RH light</li> <li>• s ii – glass very dirty</li> </ul>

<p>Repair needs</p>	<p>Replacement of rusting window mesh in polycarbonate Repair/replacement of cill to Vestry east gable window Monitor surface decay to masonry where indicated Monitor distortions in leading for possible leakage Consider cleaning dirty glass</p>	<p>D C F F E</p>

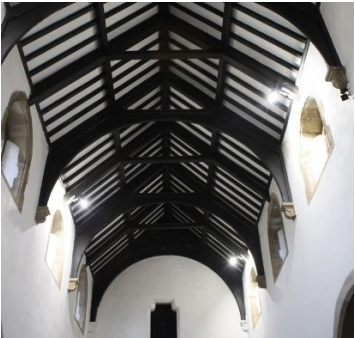
<p><u>Porch</u>: king post truss, purlins, rafters and boarded ceiling all in good condition.</p> <p><u>Nave and Aisles</u>: trusses, purlins, rafters, plastered ceilings generally in fair condition.</p> <p><u>Chancel</u>: trusses and plastered ceilings in fair condition.</p> <p><u>Vestry and passage</u>: trusses and boarded ceiling in good condition.</p> <p><u>Inner vestry and toilet</u>: plasterboard ceilings in fair condition but redecoration needed.</p>	D
<b>2.2 Presence of bats etc.</b>		
Comments	No bat droppings were noted during the inspection but the presence of bats should not be discounted. See section 6 for further information.	
<b>2.3 Partitions and doors</b>		
Condition

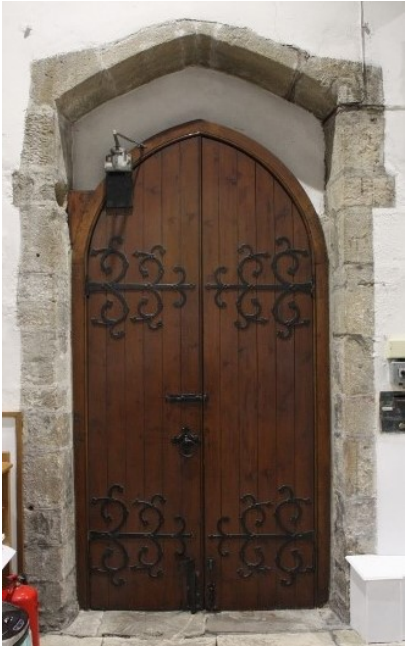
<p style="text-align: center;">Porch door</p>	<p><u>Partitions</u>: Timber stud partitions to Toilet and Rear Vestry. In satisfactory condition.</p> <p><u>Doors</u>: Porch – robust, arched headed, ledged braced and battened construction; decorative hinges, ring latch bolts. Good condition.</p> <p>Vestry – robust framed ledged braced and battened construction; 5 lever mortice deadlock; strap hinges. Good condition.</p> <p>North Aisle – robust framed ledged braced and battened construction; strap hinges, drop ring latch. Good condition but door binding on stone jamb.</p> <p>Inner North Aisle – robust framed ledged braced and battened construction; strap hinges, drop ring latch. Good condition.</p> <p>Toilet - painted hollow core flush door - satisfactory</p> <p>Inner Vestry - painted hollow core flush door - satisfactory</p>

Repair needs	North Aisle door – closing stile needs shaving to prevent binding on stone jamb.	B

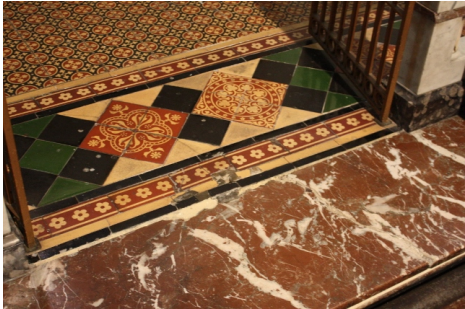
<p>Cracks in encaustic tiles and marble step</p>	
Repair needs	None required.	
<b>2.5 Internal wall finishes</b>		
Condition	<p>Plasterwork and lime wash generally in sound condition but defects noted below:-</p> <p><u>South Aisle</u>: some small damp patches at low level at rear of south wall (possibly drying out from recent works).</p> <p><u>Nave</u>: some blistering plaster and decoration below eaves on north side. See photo opposite.</p> <p><u>Outer North Aisle</u>: some blistering plaster at high level on north wall near valley gutters.</p> <p><u>Chancel</u>: some damage to plaster at HL on east gable from rain penetration</p> <p><u>Vestry passage</u>: some loose plaster at high level on west wall near external door due to rain penetration.</p> <p><u>Vestry</u>: some cracks and rust marks plasterwork at head of chimney flue.</p> <p><u>Inner Vestry</u>: painted stonework &amp; blockwork - some damp staining on east wall.</p> <p><u>Toilet</u>: some damp stains in places.</p>

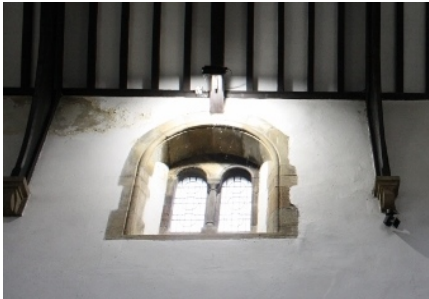
<p>Nave: water ingress at eaves level</p>

<p>Chancel: water ingress on E gable</p>	
Repair needs	<p>Investigation of causes of damp penetration (where noted) and appropriate actions taken.</p> <p>Removal of loose / blistering plaster</p> <p>The church would benefit from a fresh application of lime wash.</p>	<p>B</p> <p>B</p> <p>E</p>

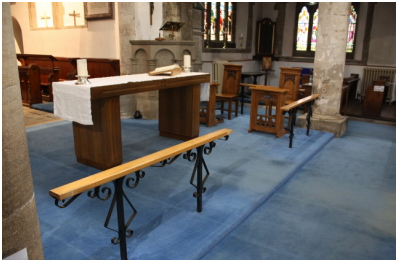
<p>Altar – simple oak framed Nave Altar – oak lipped and oak veneered structure Pulpit – stone sides and plinth – no handrail Brass eagle lectern Lady Chapel altar Priests prayer desks Communion rails (see photo) – a bit wobbly on north side.</p>	
Comments	<p>Consideration to fitting a handrail to the pulpit steps. Making north side communion rail more stable.</p>	E M

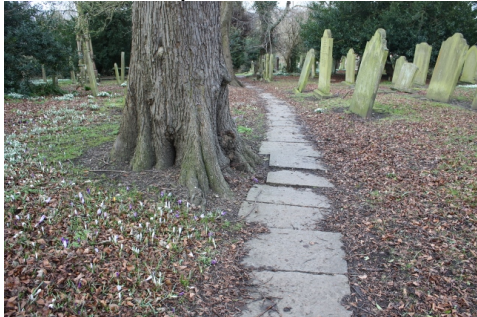
<p>Generally the riven York stone pavings are in good condition.</p> <p>The pavings near a tree some 15m north of the church are uneven due to tree roots posing a tripping hazard. Levelling these is needed. See photo opposite.</p> <p>The smooth pavings to the ramp adjacent to the North Aisle are slippery. Further consideration of options to control or remove the hazard is needed.</p>	  B  B
<b>3.2 Railings, gates and fences</b>		
Condition / repair needs	<p>Balustrade to dwarf wall: a section of handrail to the dwarf wall to the west of the North Aisle has been bent out of horizontal alignment. Straightening is recommended.</p> <p>The metal gates and railings on the south boundary are in fair condition structurally and decoratively.</p>	  M

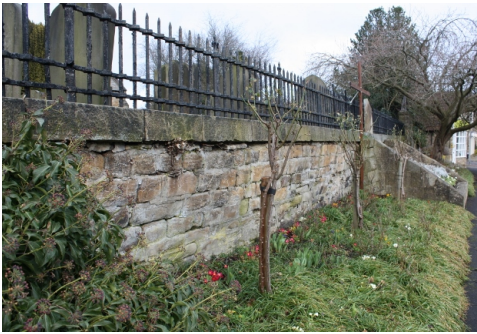
<p>The stone free standing boundary walls are in fair condition generally. However a section of the retaining wall on the south boundary is leaning outwards and there are open joints below the coping which need raking out and repointing. See photo opposite.</p> <p>The west boundary wall backing onto the gable of the terraced houses in Church Chare has open joints which need raking out and repointing to consolidate and prevent frost action.</p> <p>The PCC are advised to make Gateshead Council aware of these matters for further investigation / repairs.</p>	   B
<b>3.4 Churchyard</b>	<i>The churchyard is closed to burials and maintained by Gateshead Council.</i>	
Condition/ repair needs	<p>The churchyard contains many grave headstones, tombs and monuments. Some of the headstones are leaning and should be checked periodically for stability.</p> <p>A table top monument on the south side of the church has been laid flat for safety reasons.</p> <p>Grassed areas are cut during the growing season and the churchyard is generally well kept though leaves need removal by the boiler room steps and by the ramped access path on the north side of the church.</p>	    M    M
