DIOCESE OF DURHAM
CoE, Parish Church of St Stephen, Willington

Quinquennial Inspection No 12
25th October 2022

Kevin L Doonan RIBA AABC
Inspecting Architect

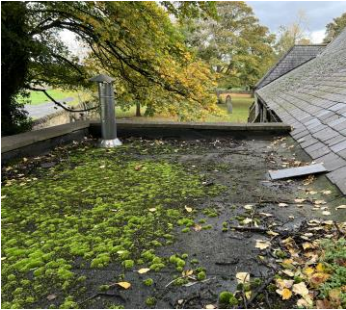
- 1.3 **Community Room** The Community room/boiler room roof is finished in built up felt. Vegetation growth has colonised part of the roof. In time, this can degrade the felt. This should be removed and the surface kept clear in the future. As noted previously, the felt could be nearing the end of its useful and should be monitored. D

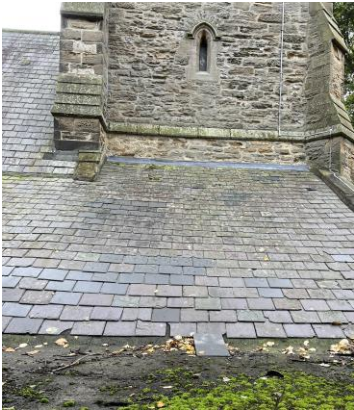
- 1.4 **North nave** At least 6 no slipped/broken slates overall, particularly at the change in pitch to aisle C
- 1.5 **North aisle** At least 12 no slipped/broken slates overall C

Item ref.		Budget cost £ excl VAT
1.4	Repairing slipped slates to north nave	250
1.5	Repairing slipped slates to north aisle	500
1.6	Repair mortar fillet to north chancel	150
1.8	New flashing to chimney stack	100
1.9	Repairing slipped slates to organ	100
1.9	Investigate and repair felted roof	250
1.10	Repair slipped slates to south chancel	100
1.10	Re-new mortar fillet to south chancel	100
1.11	Repair slipped slates to south nave	500

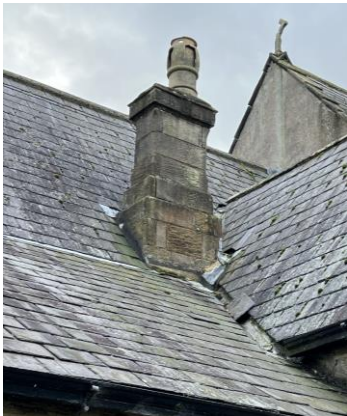
1.8	Chimney

<p>Masonry sound.</p> <p>No lead side or apron flashing but mortar fillet instead. There appears to be a hole in the flashing at the base of the chimney stack in the vestry roof. Investigate and a new flashing installed if necessary.</p>	C

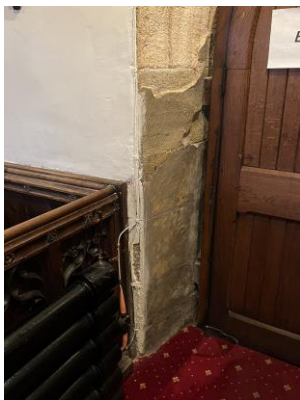
14.3 The surface of the stonework to the surround to the south porch door both within the nave and porch is losing its surface. This was noted in the previous inspection. Historically this has been partially repaired with a thin render smear, but this is coming away in part. Loose render surfaces should be removed and friable stone brushed back to allow the stone to dry out and breath. B

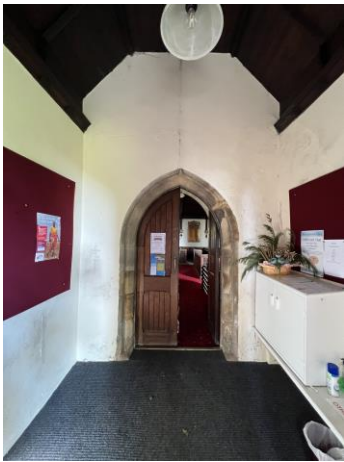
14.4

The north and west wall within the porch has loose friable plaster. The defective plaster should be hacked off and replastered with a lime plaster.

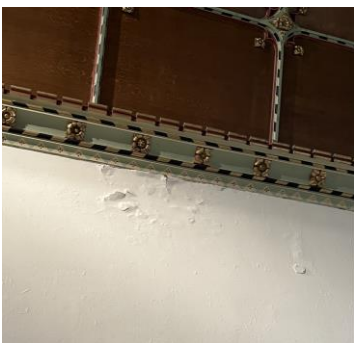
14.5

As noted in previous inspection there is evidence of blistering plaster/paintwork at high level north wall of Chancel. Check flashings/gutter joints, etc. externally at the change in roof pitch from Chancel to Vestry roofs.

Rub down loose surface when next decorated, and re-skim with plaster if necessary.

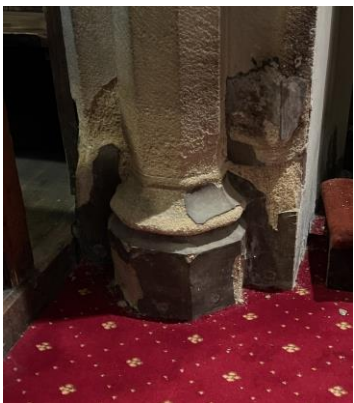
14.6

Deterioration evident to the stone column bases. Brush off the loose material and monitor.

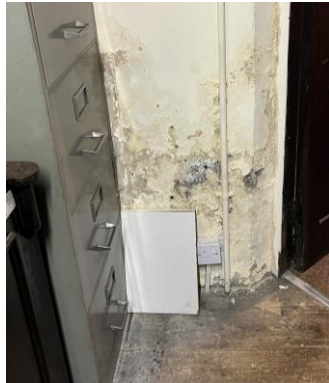
16.2

The chamber to the rear of the organ is also in a reasonable state of repair, apart from (as above) the north wall door opening. B
Investigate leaking rwp. Replaster effective plaster with lime plaster.
Brush back loose material from stonework.

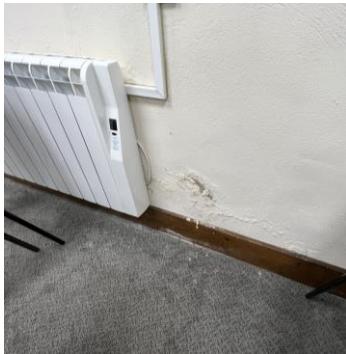
16.3

The vestry at the west end has been converted into a meeting room/kitchen. Staining to the west wall at high level was reported in the last quinquennial. That report recommended the roof be checked. Cracks in the masonry externally which were noted in the last QI and have been repointed. The staining internally should be monitored. M
As noted in previous inspection, low level areas of rising damp evident.
Door to church and external door sound.
Modern door to tower.

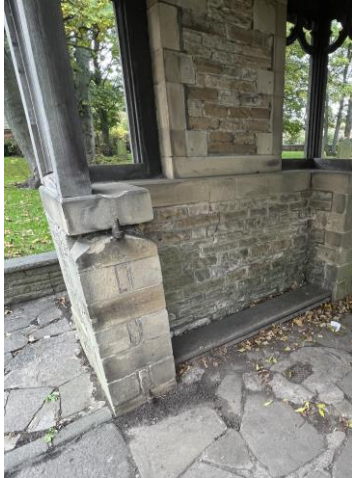
20.2

As referred to elsewhere in this report, the war memorial plates are stored within the church for safe-keeping from repeated vandal attack. Currently there seems to be no agreement on how the memorials should be displayed.

As noted in previous QI's, there is evidence of movement in the stonework with settlement cracks to the sides and front. The stonework jambs at the gate's upper hinge pins have sheared off on either side, either from distress or corrosion.

The seats are as described in the last quinquennial report, lying on the ground, because of repeated vandal attack.

There is evidence of some decay in the oak frame to the sole plate.

Parts of the gutters are missing, as is the rwp.

The conservation/restoration of the lych gate along with the display of the war memorials needs to be planned, agreed with the relevant bodies and implemented. Preferably the long term plan should be agreed within a year and the works implemented within this quinquennial.

- Repointing of the movement cracks in the stonework.
- Repair of the guttering and rwp with matching sections.
- Replace the decaying oak sole plates
- Agreement on the optimum way to display the memorial plates: either returned to the Lych gate or within the church?
- Reinstallation of the gates with associated stone repair?
