PARISH CHURCH OF ST AIDAN
ANNFIELD PLAIN

QUINQUENNIAL INSPECTION REPORT
SEPTEMBER 2014

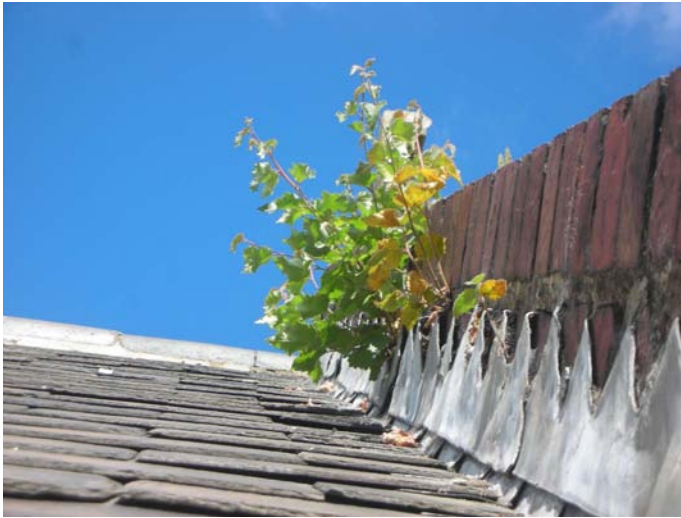
Open joints to flashings supporting vegetation

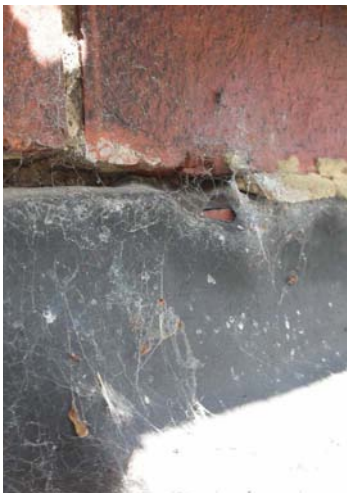
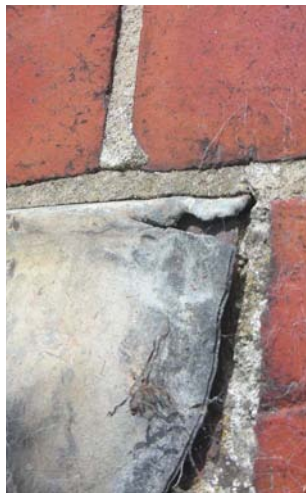
The apron flashing of the south aisle/chapel roof to the east wall of the nave is wearing thin and has several splits along its length. This lead would benefit from replacement.

Loose, ripped and split flashings

d) Replace lead apron flashings to aisle pitches against nave

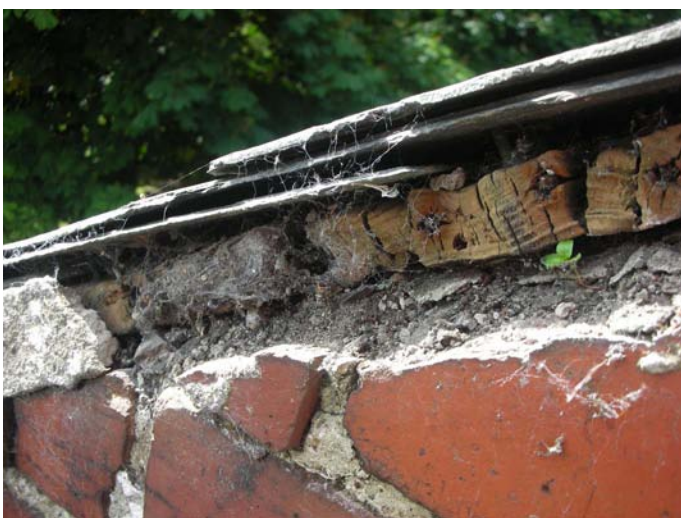
The pointing of the verge to the north elevation of this aisle has been carried out in a cement mortar which in several places has cracked and has fallen out exposing the ends of the timber battens which are seen to be rotten.

Cementitious mortar fillet to verge cracked, failed and detached

- a) Re-point verges to nave and aisles in lime mortar
- b) Re-point chancel gable from eaves height upwards, including both sides of parapet and copings. All re-pointing to be carried out in lime mortar. Consider adding lead or sheet membrane beneath coping bricks to protect wall head
- c) Replace broken/missing manhole covers
- d) Point up rear joint and cracks to south-east porch steps
- e) Inspection of roof void to chancel and timber beading at eaves level required to ensure there is no continued timber decay - tower scaffold access required
- f) Opening up for inspection of below floor voids, particularly in the meeting room and in front of the chancel arch as signs of timber decay evident
- g) Further inspection by timber consultant of bearings to rafters above priest's vestry

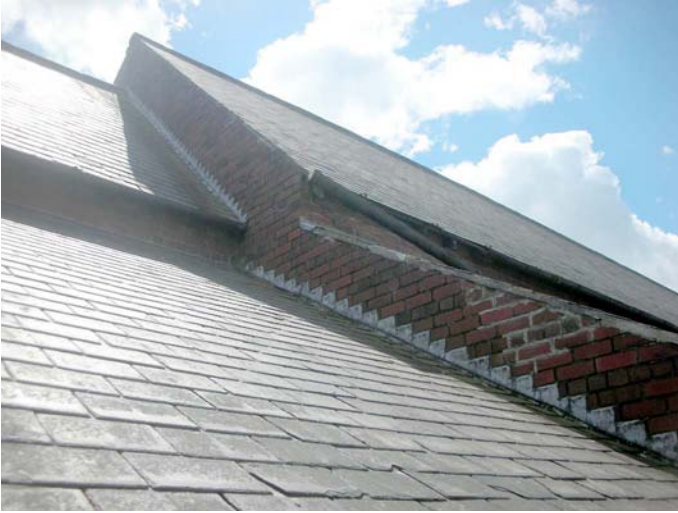
Slating in reasonable condition, re-pointing to nave and aisles and to verges in cementitious mortar

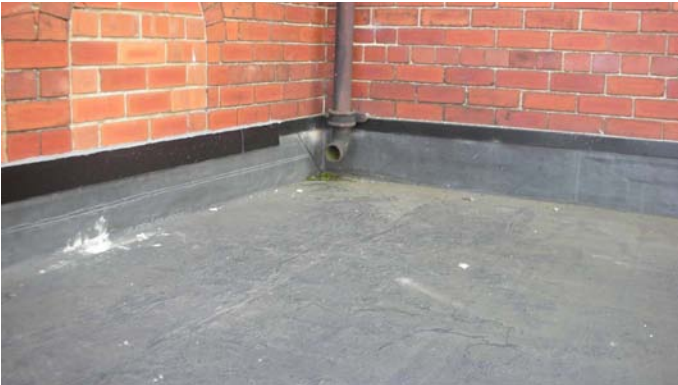
The flat roof to the kitchen is in good condition, having recently been re-laid in the last few years.

Kitchen re-roofed recently in single-ply membrane - good condition

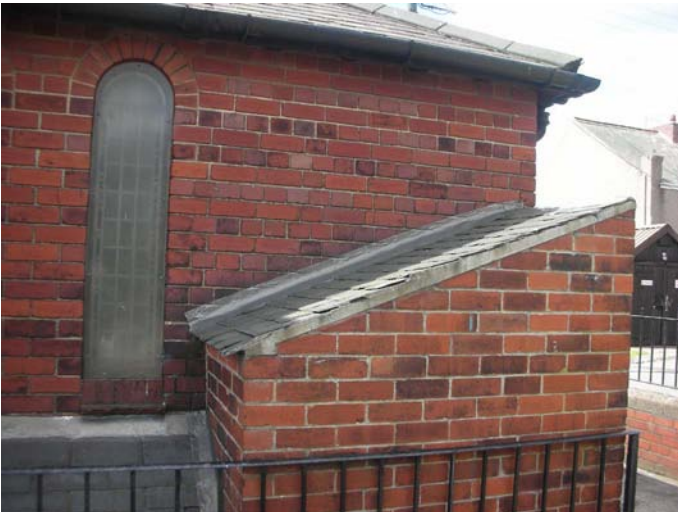
To the north elevation of the vestry the small low level pitched roofs of the boiler house steps and the boiler house itself are laid with natural slate, in reasonable condition with flash band instead of lead flashing. The flash band, although not an ideal material, is appropriate at this height but should be checked regularly for failure.

Flashband to steps and boiler house roof to be monitored

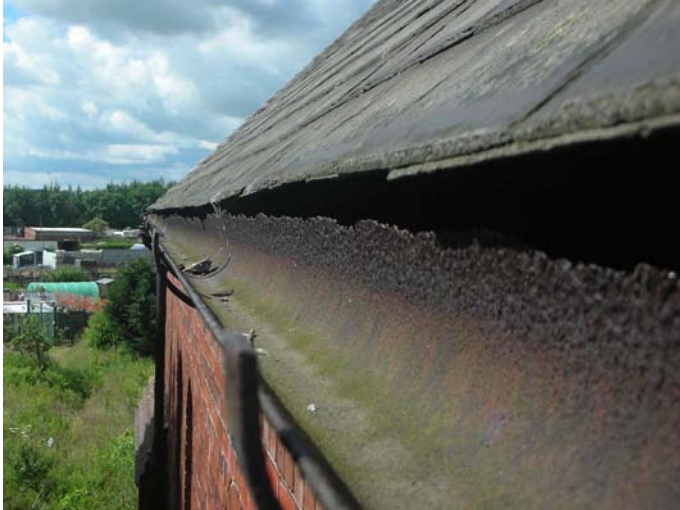
Cast iron gutters rusting

High level gutters of the chancel and of the nave are original cast iron and are severely deteriorating. There is heavy evidence of rusting at the joints and to the back of the gutters, the iron is extremely friable. Of the remaining cast iron downpipes, some have splits along their length.

On the west elevation of the nave a portion of guttering has recently collapsed due to rusting of the joint.

e) Re-seal and paint, or replace, all high level cast iron gutters and downpipes, check seal of all joints to all gutters and outlets

All high level cast iron gutters to nave and chancel should be either repaired and repainted for protection or they should be replaced.

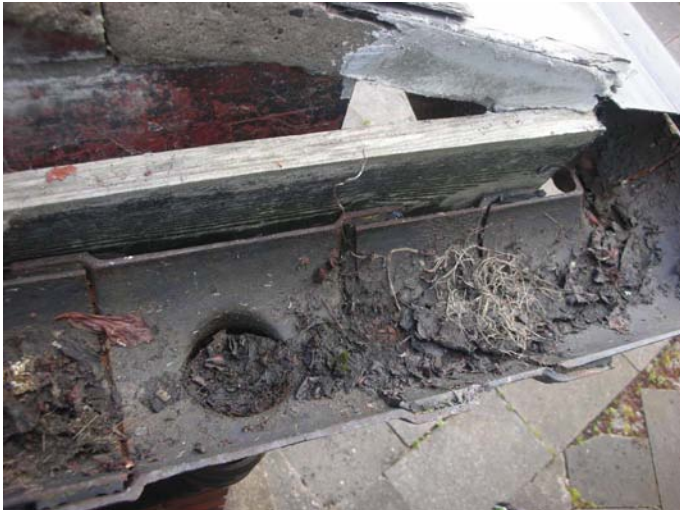
It is essential that all gutters and outlets are cleared out regularly. On the day of inspection the outlet from the north east porch roof was fully blocked and the gutter to the eastern chapel was blocked with debris and accumulated water. It also appears that this gutter is falling away from the outlet.

Blocked outlet

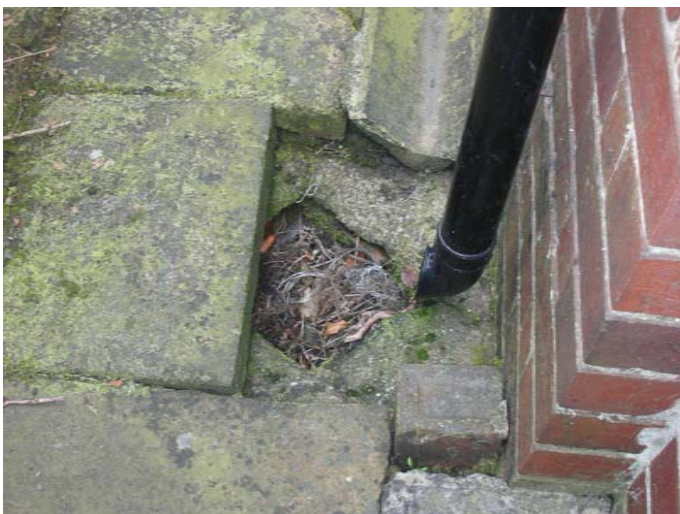
All downpipes appear to terminate in gullies which are connected to mains drain. Some grilles are missing.

Beneath the grills, many of the gullies are full of debris or are holding water, indicating that the drains below are blocked. It is believed that during storms the gullies to the east side of the Church overflow, indicating that the drainage routes are blocked below ground. It is essential that all gullies are clear and drainage runs are free flowing to prevent backing up of water soaking the base of the wall.

Blocked gully with no guard

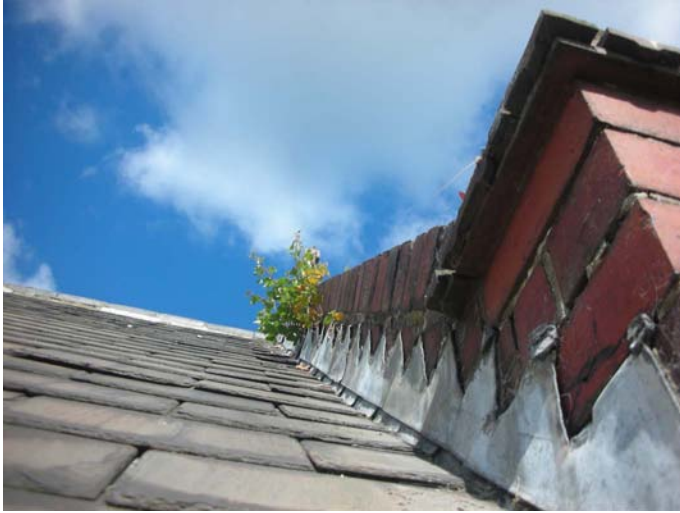
Upstand parapet of chancel gable has open joints, allowing water ingress. Cement smeared over flashings on west pitch (below) will be holding water

The main chancel gable parapet upstand is in relatively poor condition with open joints and vegetation growing on both the main north gable side and behind, above the flashings. It appears that in the past this parapet has been re-pointed in a cementitious mortar which is now causing issues with the brickwork and the mortar itself.

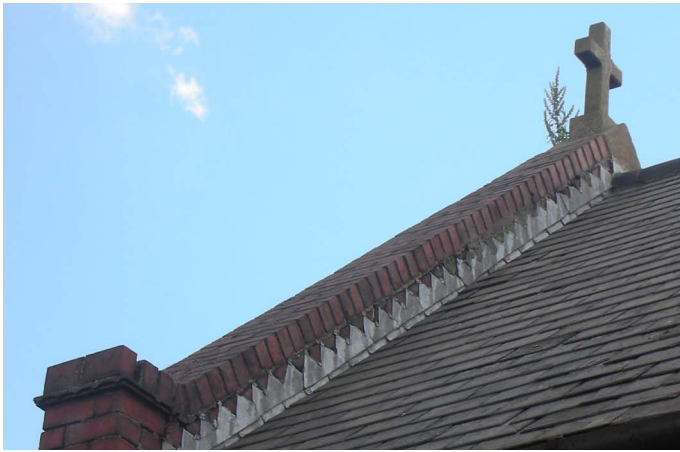
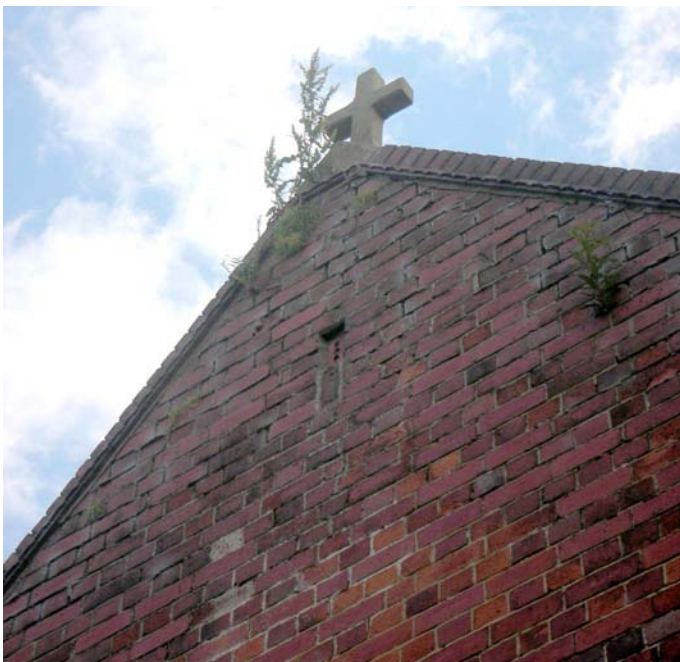
Deteriorated pointing and damaged brickwork to chancel gable

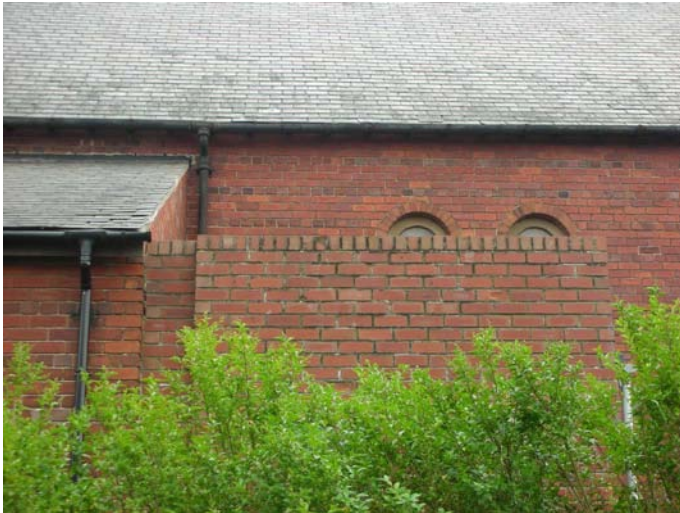
Kitchen extension - open joint to abutment with west aisle (meeting room), and signs of damp brickwork at high level

The modern brickwork to the kitchen extension appears to be pulling away from the south elevation of the meeting room, although this has been noted in previous quinquennials. The opening up of this joint should be pointed to ensure no water ingress is afforded, and future monitoring should be carried out to ensure the opening up is not increasing at an unusual rate.

The brickwork of the kitchen extension itself to its west elevation is not in exceptionally good condition and appears to have been getting wet. There is mossy growth in the joints and some of the brickwork has deteriorated. This can probably be attributed to the open joints to the brick-on-edge copings that top the parapet wall.

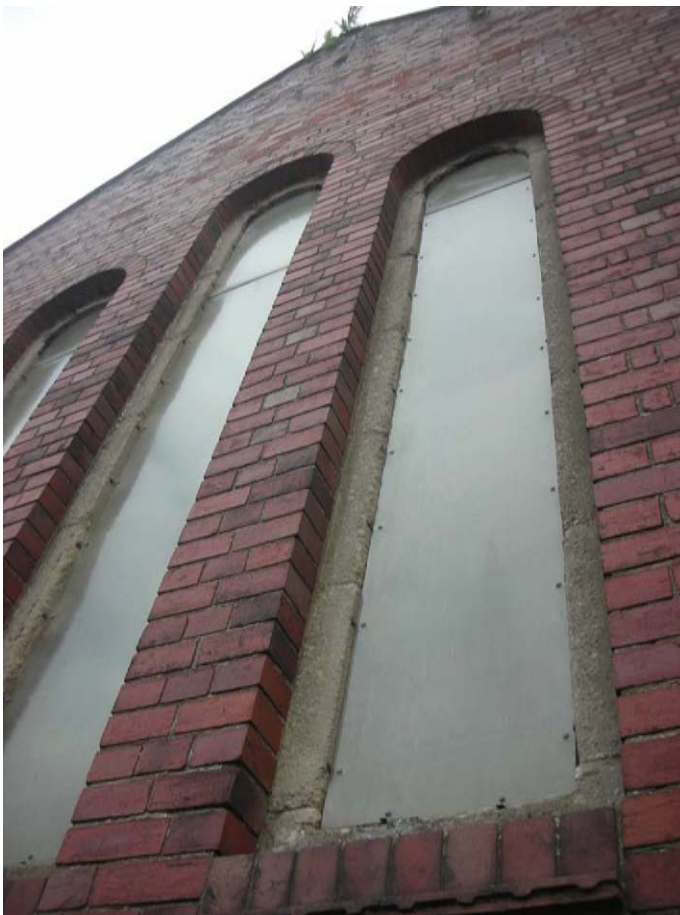
Replica reconstituted stone reveals deteriorating, ferrous fixings for polycarbonate sheets are rusting and polycarbonate is now cloudy and yellowing with age

The reconstituted stone reveals themselves are showing signs of deterioration and delamination due to water absorption. There is a build-up of sulphur crust to the heads of some windows which is causing advanced decay to the masonry around.

- a) Replace polycarbonate glazing with new, including removal of ferrous fixings and replacement with stainless steel
- b) Repair and stabilise artificial stone window surrounds
- c) Request advice on the need for a lightning conductor on the bellcote and install if recommended
- d) Re-tape all fibreboard ceiling panels throughout church and repaint
- e) Clean and nourish woodwork panelling throughout with beeswax
- f) Remove modern gypsum plaster from external wall of choir vestry and either leave bare brick, or plaster in lime
- g) Repaint toilets, and de-frass and paint iron security grilles

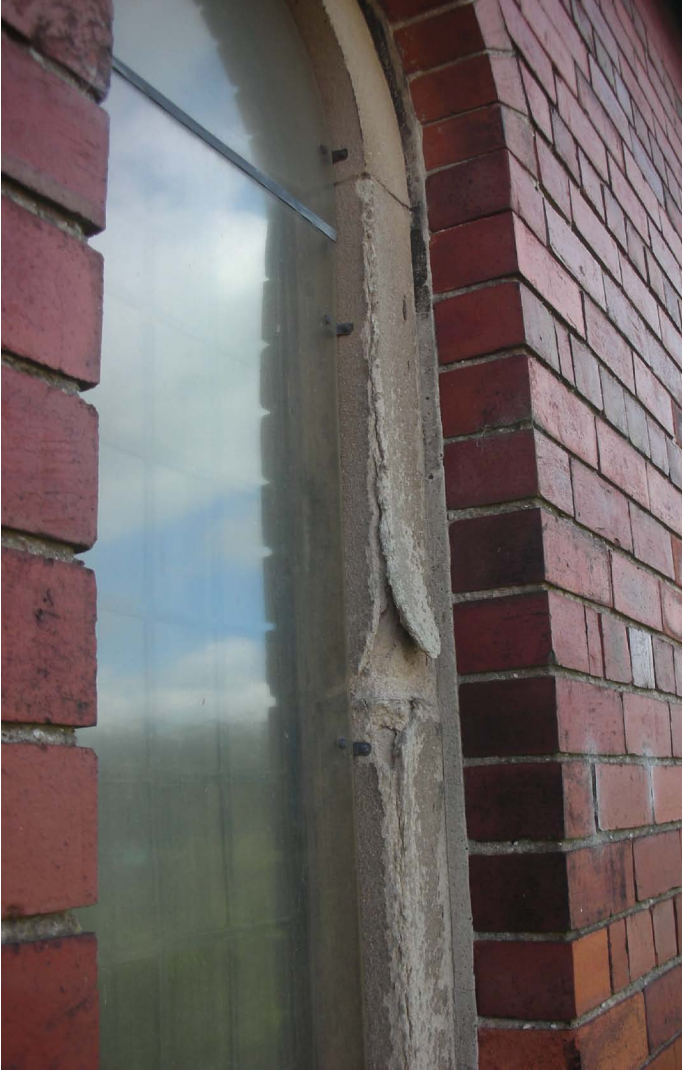
Spalling of reconstituted stone reveals

There is damage to the reconstituted stonework in almost all windows visible and as such all would benefit from some repair works and protection to continue their life.

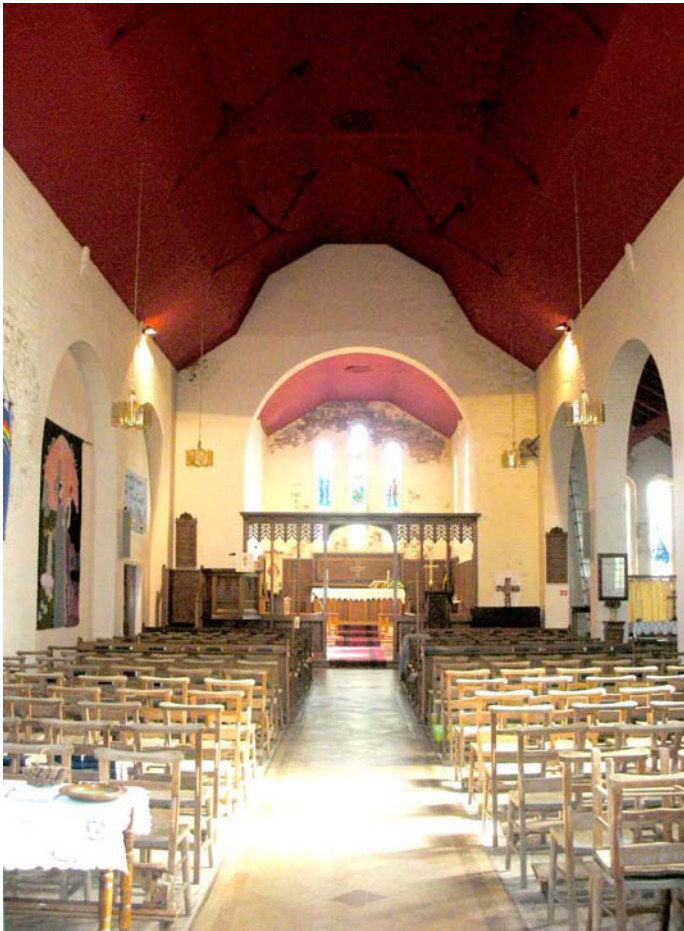
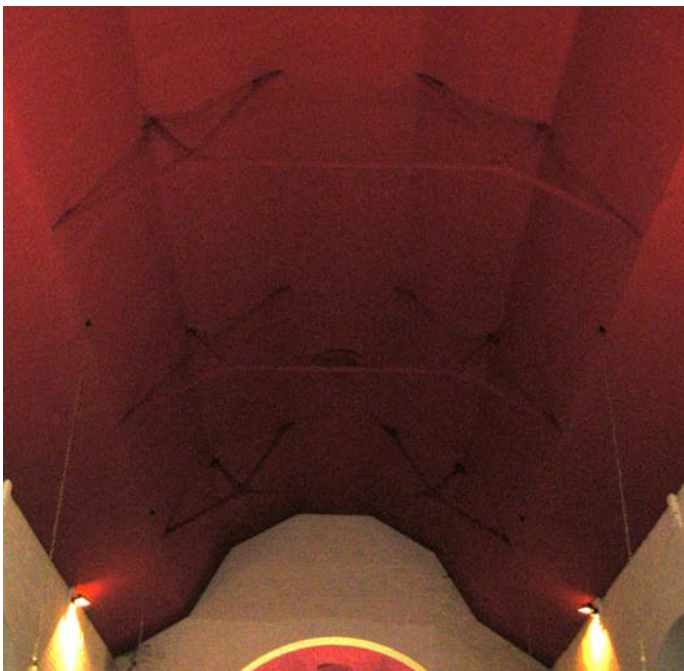
Facetted fibreboard ceiling with semi-exposed steel trusses

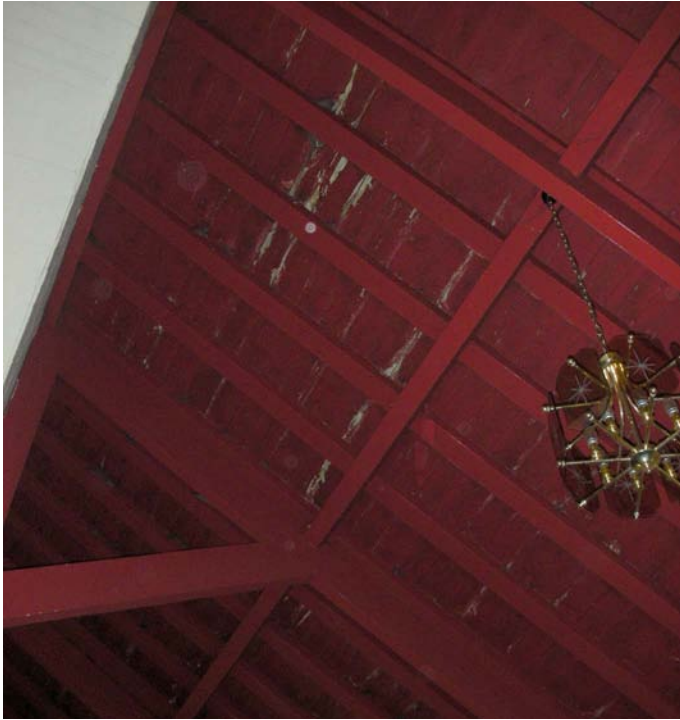
Exposed roof structure to aisles - evidence of water ingress

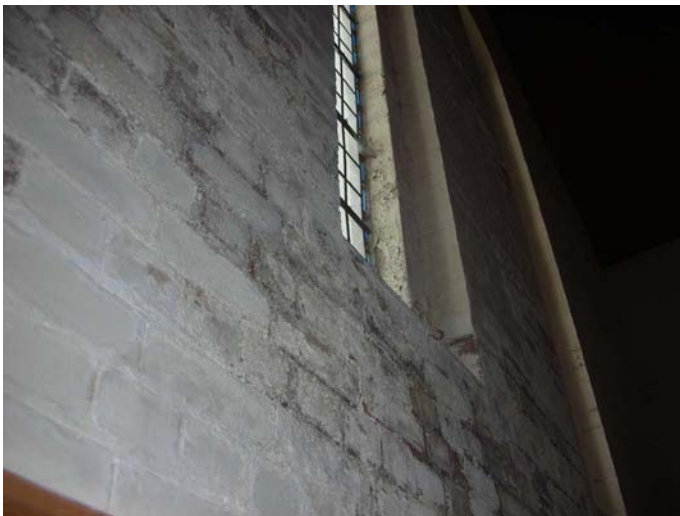
Friable paintwork and salt damage to brickwork, above and below.

As previously described, all internal finishes are paint. All internal exposed brickwork has been painted with an impermeable paint which has subsequently led to severe damage to the masonry itself through salt damage and deterioration.

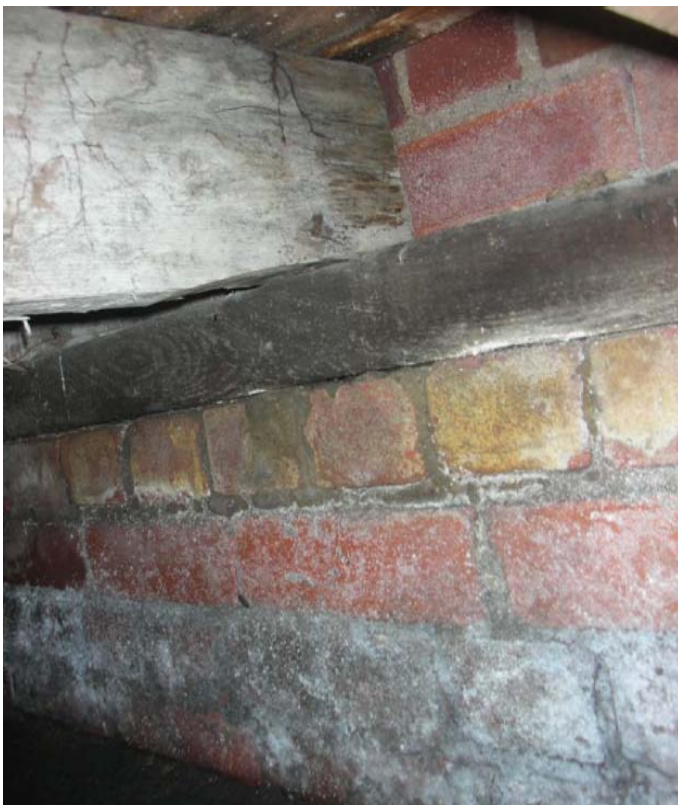
Possible signs of wet rot, damp timbers & wet ground

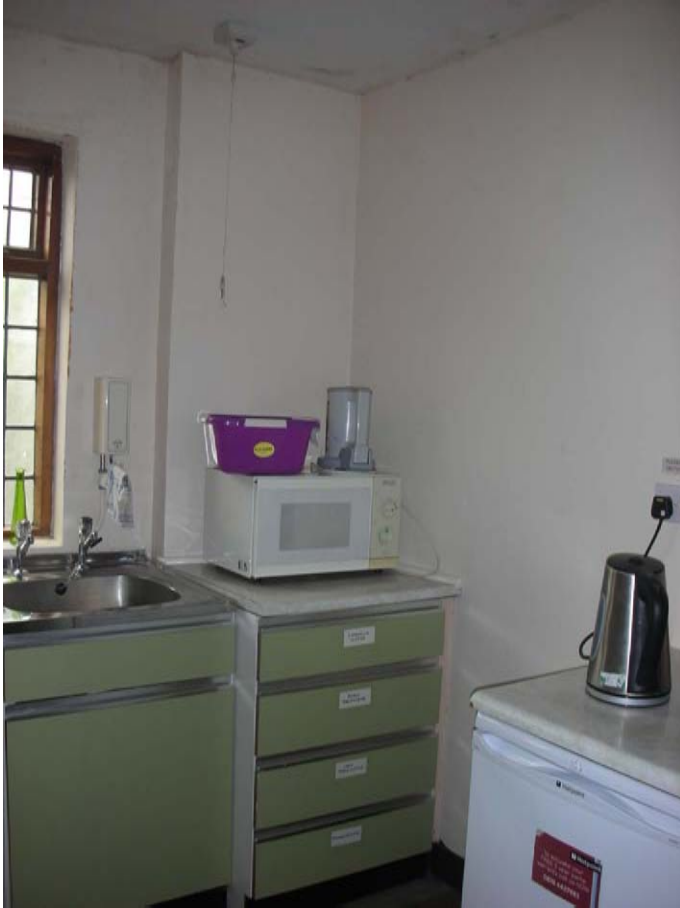
Signs of (historic?) water penetration over windows, and current evidence of black condensation mould above kettle

bowing indicating water ingress from above. It is understood that issues with the flat roof above have recently been resolved, so it is hoped that these signs of water ingress are now historic.

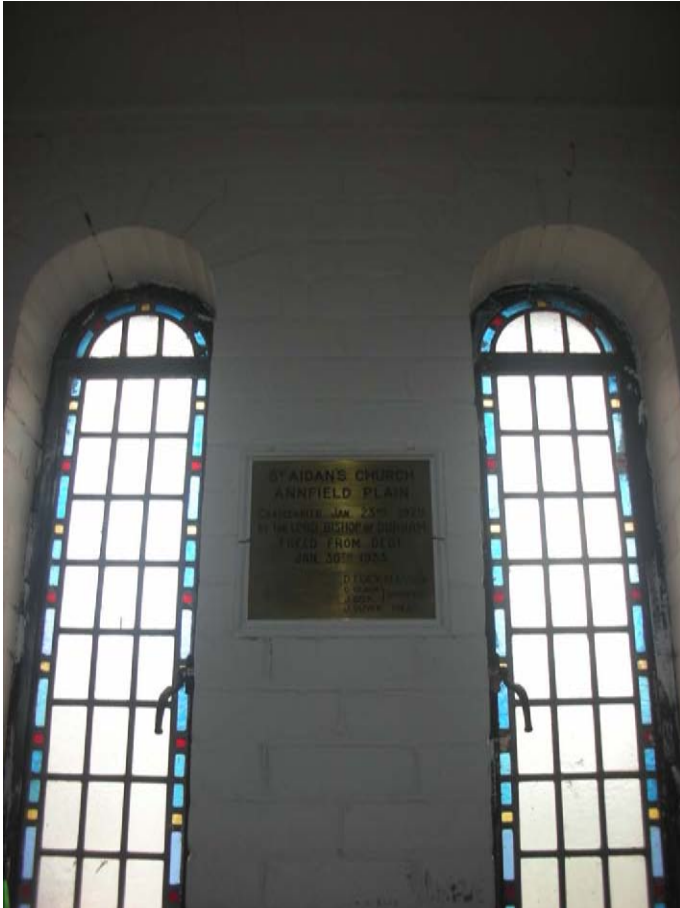
Leaded panels in cast iron casements within priest's vestry

c) Carefully remove, de-frass, paint and replace iron casement windows in priest's vestry

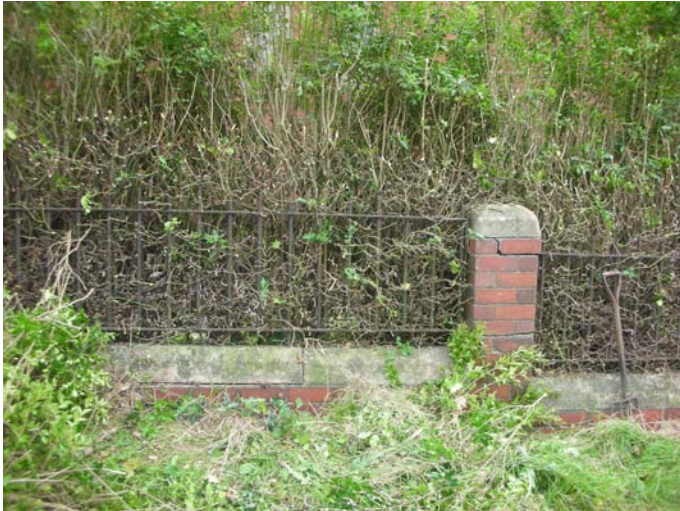
Boundary walls dislodged by vegetation

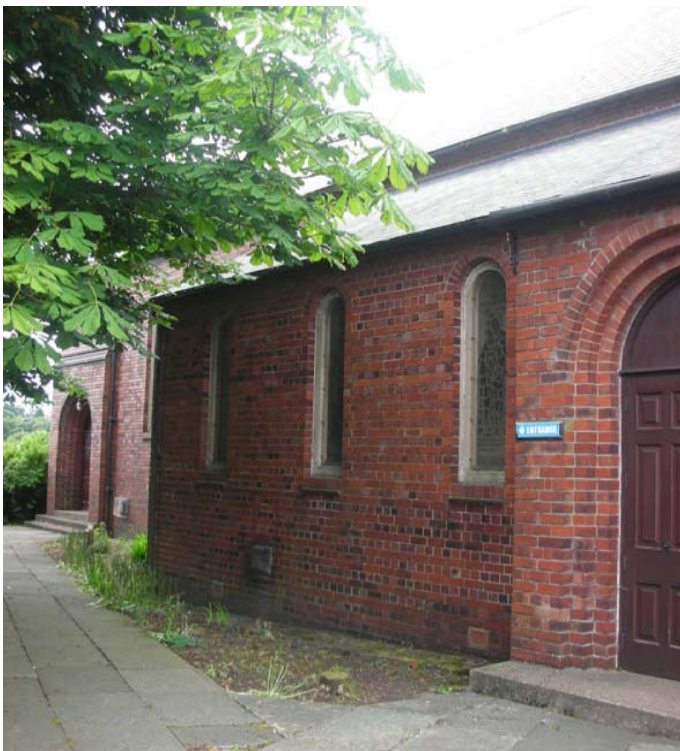
Pathways in reasonable condition, vegetation close to external wall

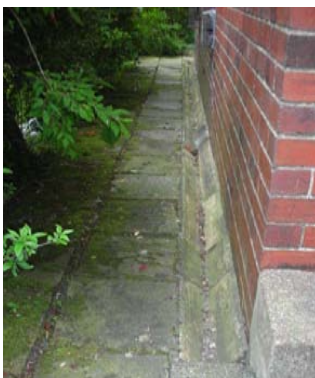
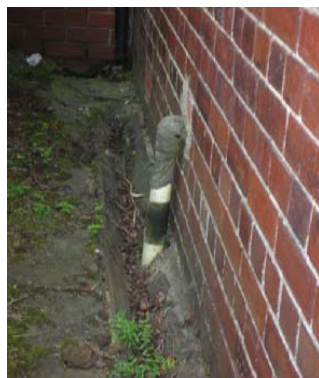
The flagging that is set right up against the external wall of the church, and the concrete trough drains set in some areas around the perimeter, also right up against the external walls, will be contributing to holding damp within the base of the walls. Although both the flags and drainage runs aim to discharge water and protect the base of the wall, it is likely that they are doing more harm than good, especially if the gullies are blocked or the underground drainage is not flowing freely. It should be a long term aim to remove these and replace with french drains, set away from the building line.

Flags and drainage channels against external wall will be holding water in the base of the wall

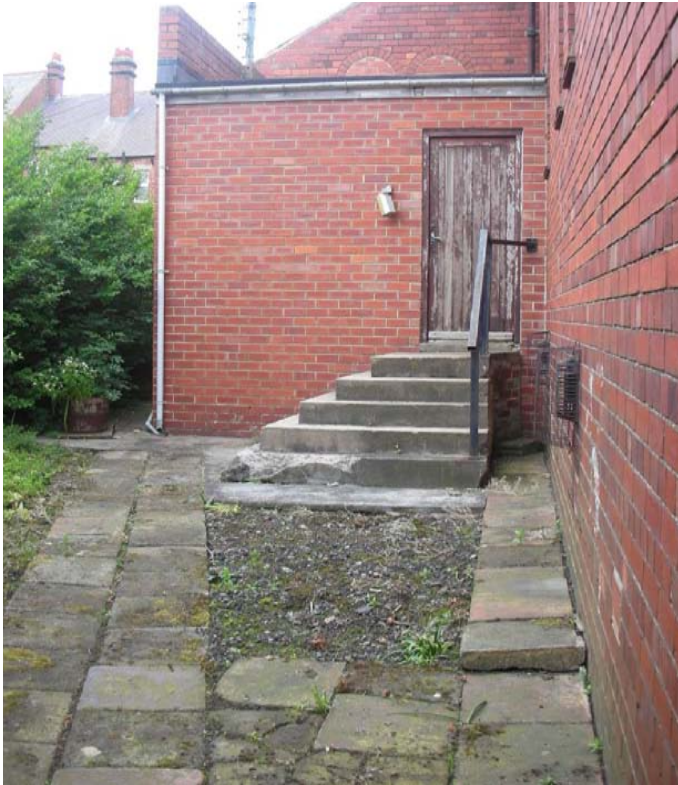
Pathways to west uneven but serviceable, kitchen steps in poor condition

The concrete steps to the kitchen are in very poor condition, and the concrete steps to the south-east porch are detaching from the wall and have substantial cracks through them. The kitchen steps require repairing as they could be considered a hazard. The gap at the rear of the south east porch steps should be pointed up, as should the cracks, to prevent water settling behind the steps and adding to the damp issues.

f) Repair external steps to the kitchen

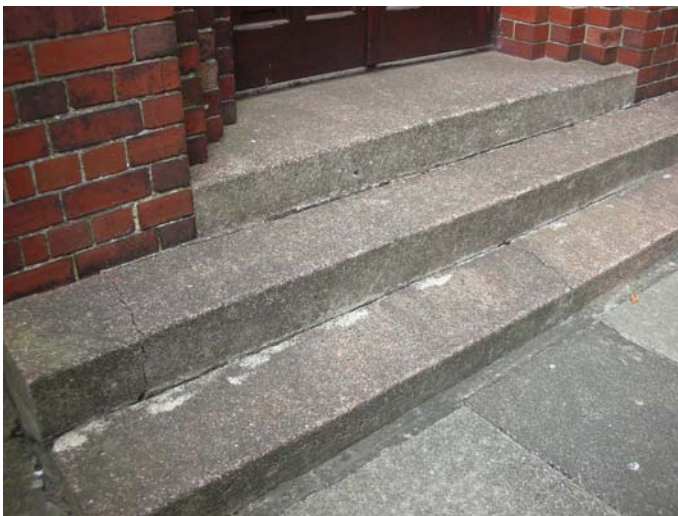
Substantial cracks in steps to south east porch
