**QUINQUENNIAL INSPECTION REPORT  
OF  
BELMONT, ST. MARY MAGDALENE**

**DIOCESE OF DURHAM  
ARCHDEACONRY OF DURHAM  
DEANERY OF DURHAM**

**QUINQUENNIAL INSPECTION AND REPORT**

**February 2020**

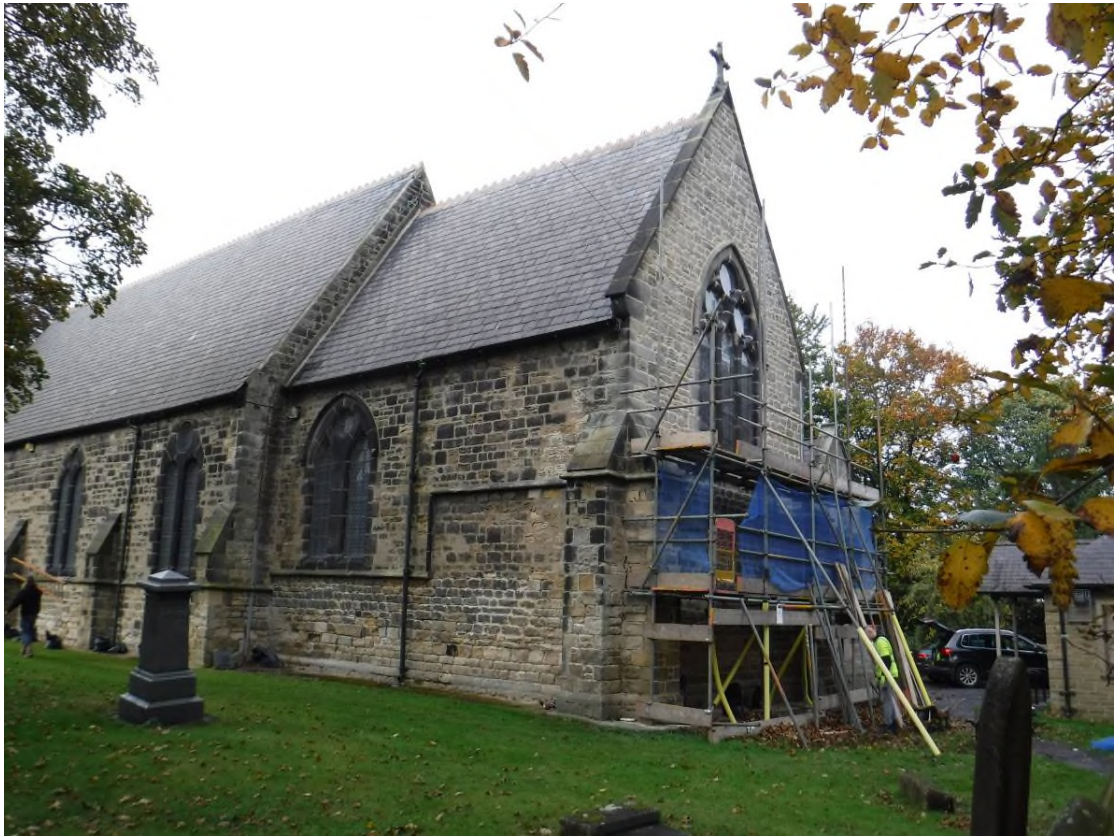
The building is located on a wooded and sloping site and is founded on clay. Previously reported movement to the east gable and west gable has been seen and recorded in 2007 and it was then that the east window tracery was repaired as part of the east window glass repair.

As part of the 2018 GPOW repair works the east gable was assessed by a structural engineer and their recommendations of a tie rod inserted at the arch springing points and some bed joint rods were carried out.

The whole east gable, like the west was repointed in lime and there are no obvious signs of cracking to it now.

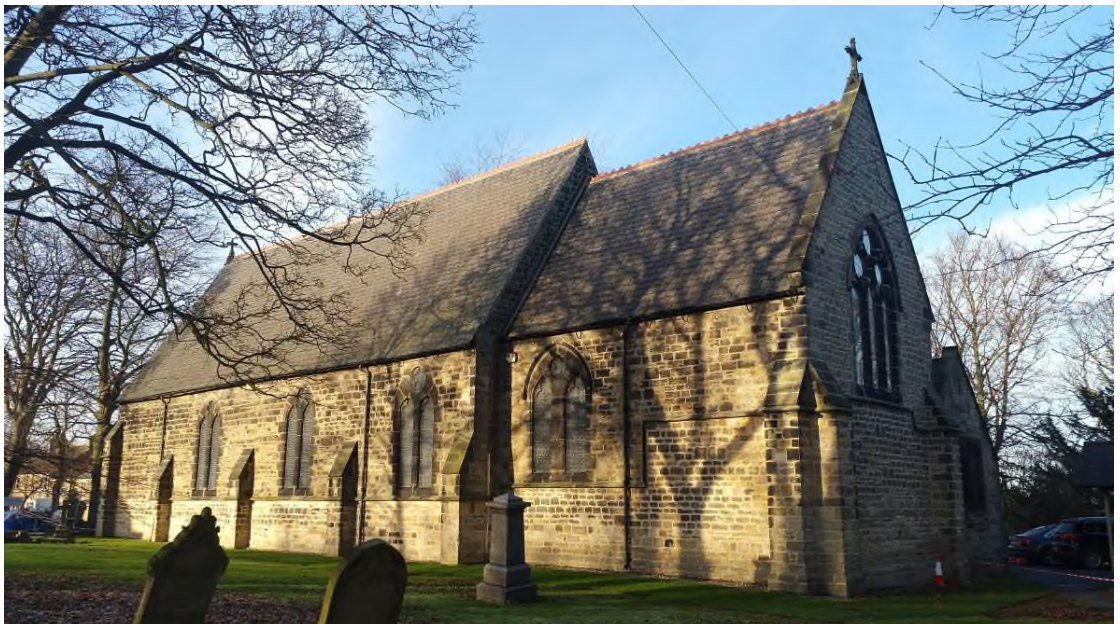
Ridged roofs with Welsh blue slates and stone water tables at the gables. It is likely that this is the original 1850's slating and is becoming time expired due to nail failure causing slipping slates. It has been patch repaired in the past and whilst it is not in need of immediate replacement it does continue to need continual repair. No leaks reported, there are some slipped slates that are

noticeable on the south nave and parts of the chancel at the south looked to have been silicined in. There is an area on the north side against the chancel where the roofs can't be seen easily and these need to be inspected from ladders.

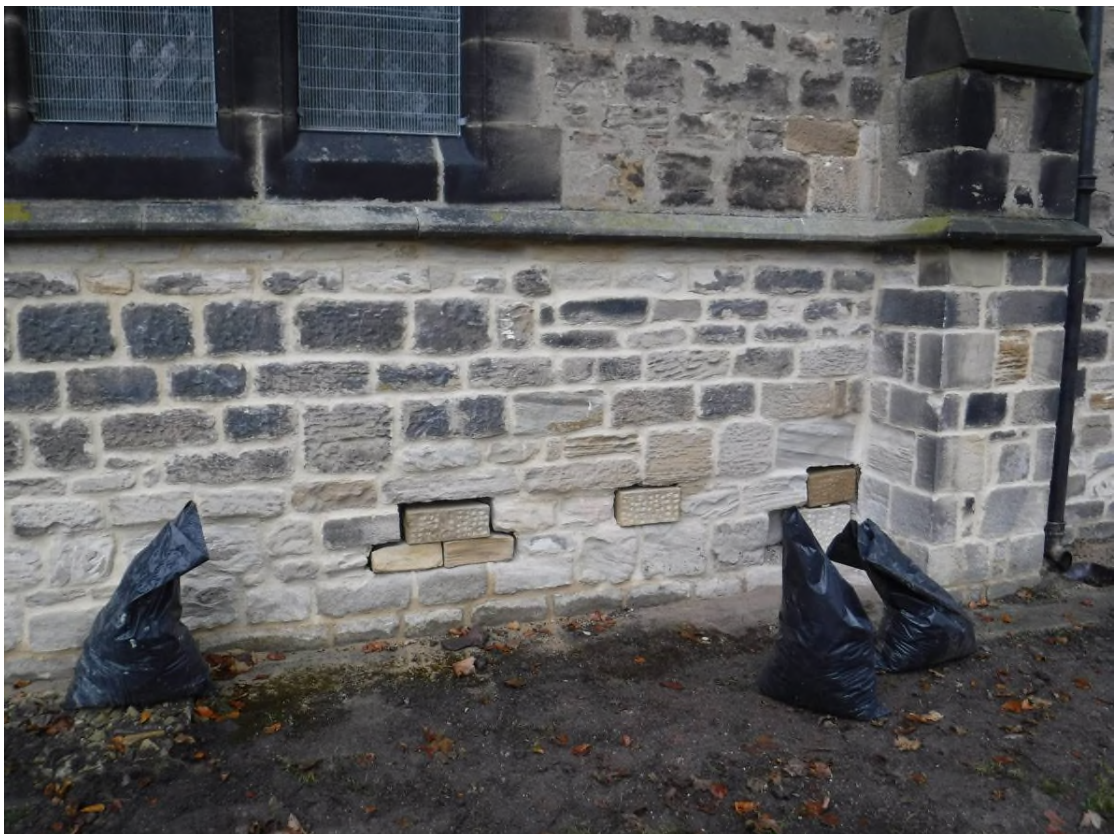
The significant erosion to the walls recognised at the last QI has now been attended to as part of the 2018 GPOW repair works, where multiple walling units were replaced and the whole of the bottom of the church walls were repointed. The remaining upper stonework is all cement

pointed and should funds allow, it would be worthwhile seeking to replace this with lime pointing in time. There are one or two stones that could be replaced if other works were being carried out.

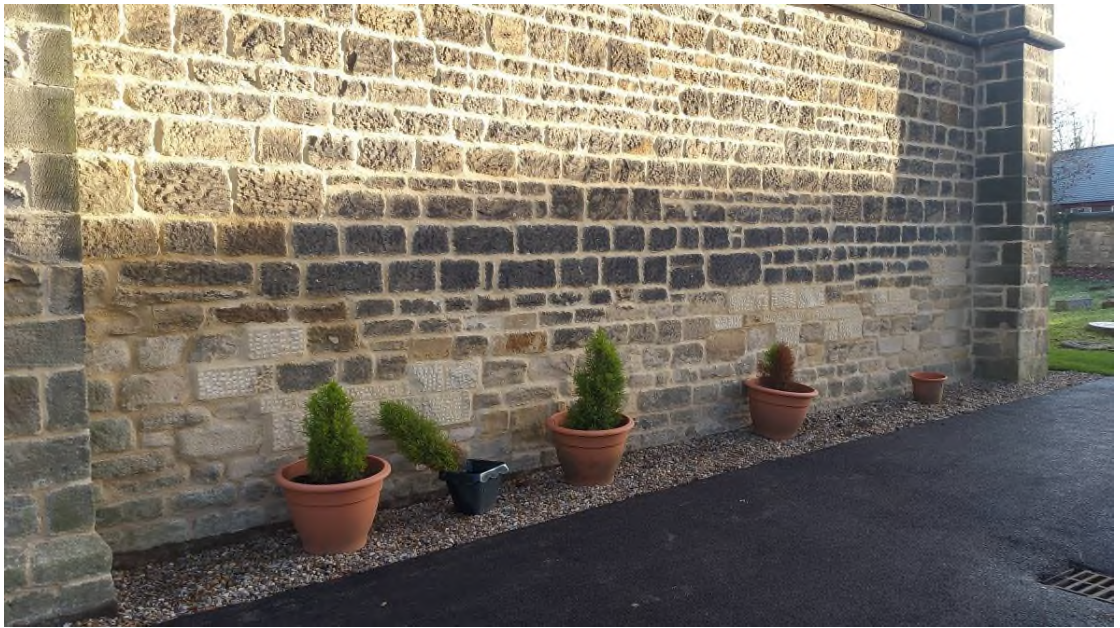
The concrete perimeter at the base of the walls was also removed and gravel margin installed to reduce the chance of ground water against the base of the walls and the work all looks in first class condition.

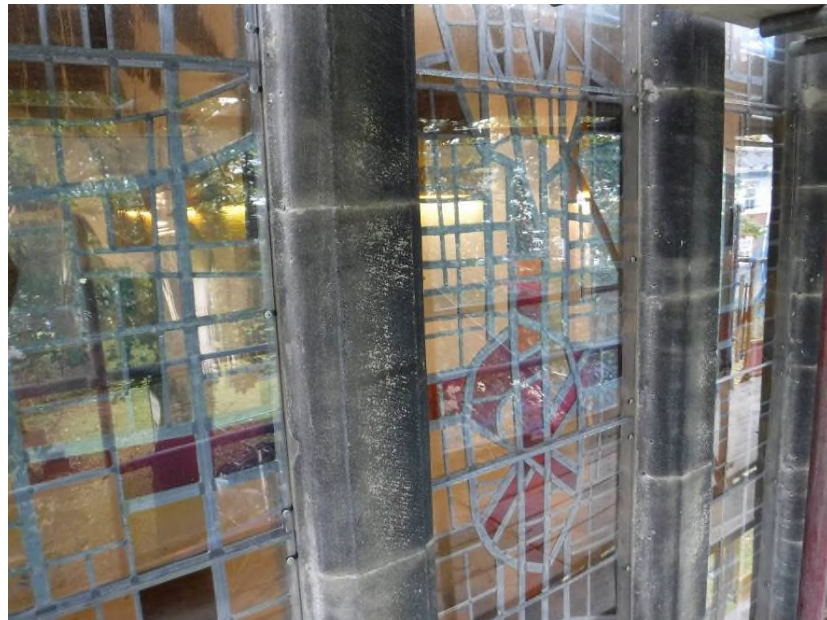
*West window*

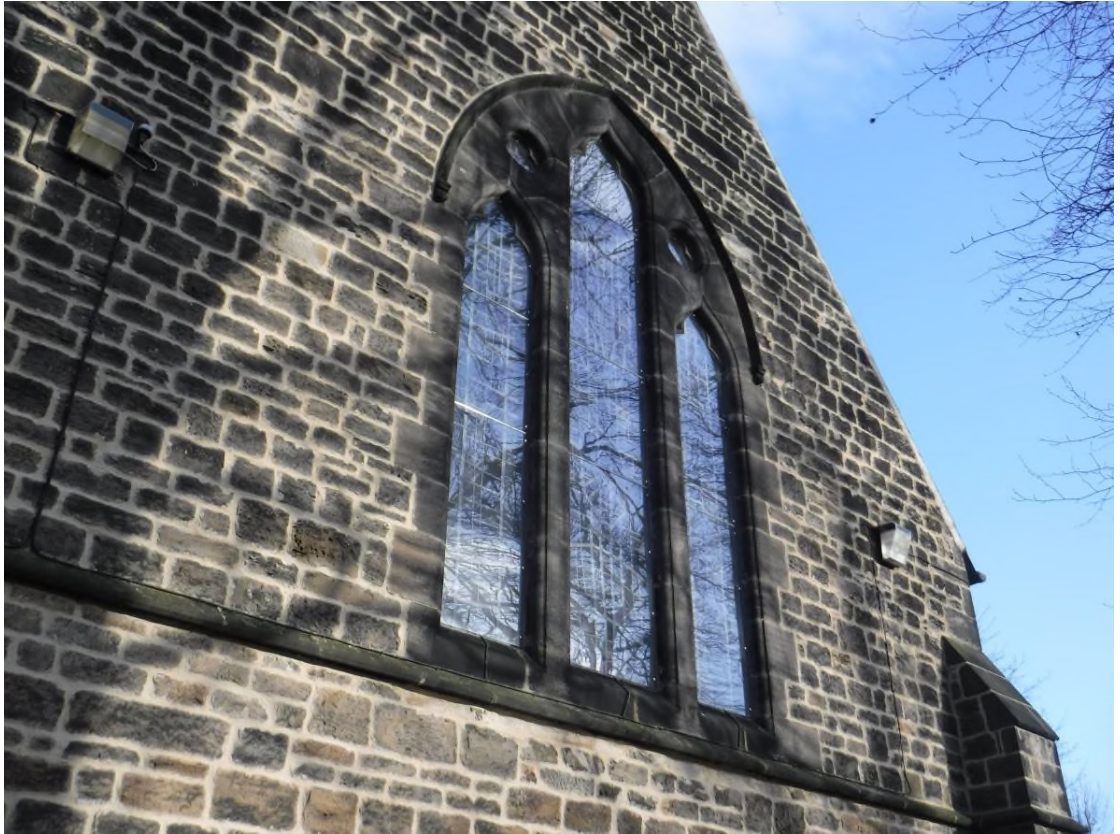
The east polycarbonate was replaced in 2007 and the west in 2018. Some of the galvanized mesh to the east vestry is now rusting.

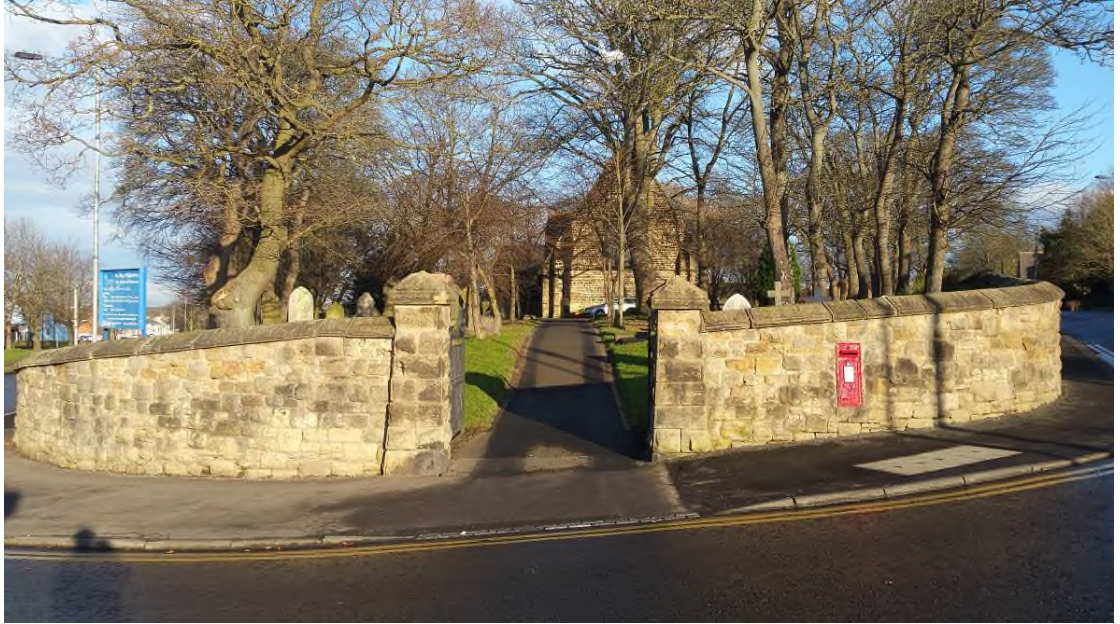
The graveyard is closed and the Local Authority have the obligation for maintenance to the boundary walls. They cut the grass and the PCC complete the work. The church walls retain the churchyard, which is higher, they are substantial stone walls with some erosion and some open joints but they are in reasonably good condition. They have not seen much in the way of cement repair work to them which is good and the Local Authority should be reminded that if they are doing any work it should be in lime pointing.

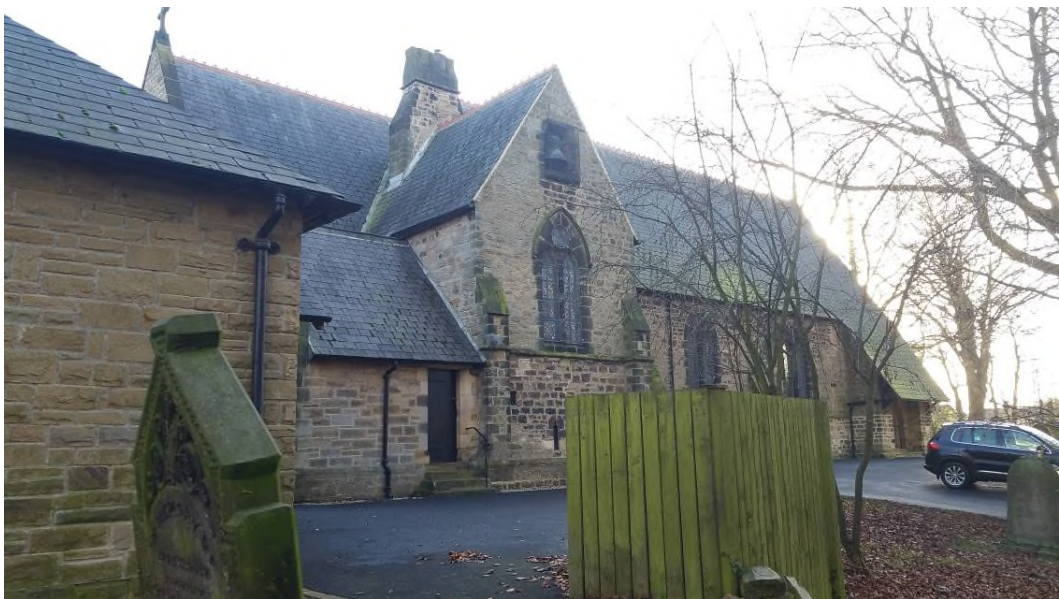
New tarmacking installed as part of the 2018 works. The double entrance gates are reset on new steel posts, have been redecorated recently and are in good condition though they are stuck in the tarmac and impossible to close. As are the path gates- which are all rusty.

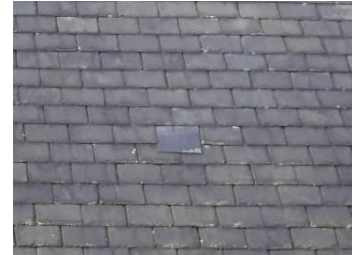
#### **B Chancel:**

- Ridge – Slightly fancier ridge cresting.
- West abutment – Pointed over in cement with lead soakers and flashing ok.
- East abutment – To gable water table in leadwork, one flashing looking to be coming out and the pointing to the underside of the water table is breaking up.
- General roofing – slating has some chips and a couple close to the nave looks as though they have been siliconed in in the past.

**Recommendation:** refix abutment flashing, check the siliconed slates

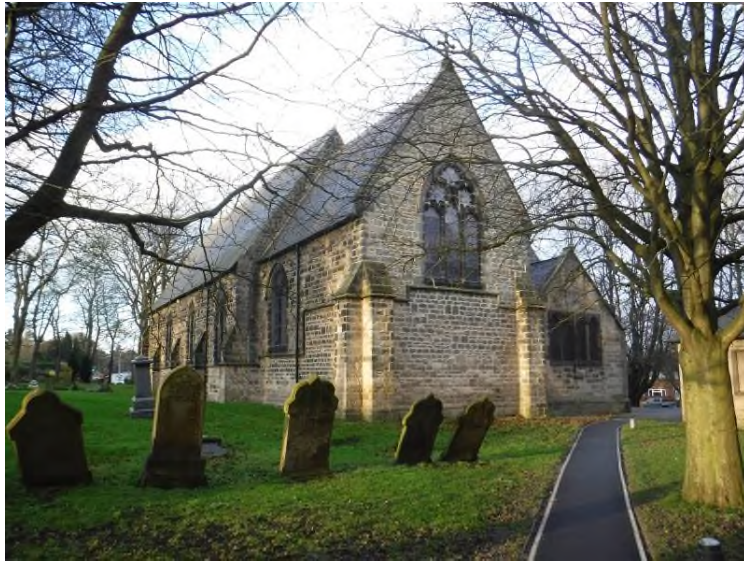
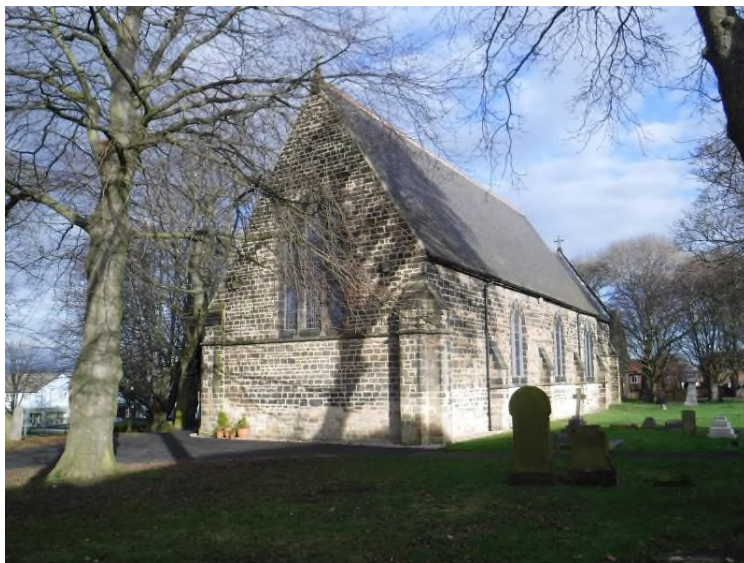
The defective stonework at the base of the walls was replaced in 2018 and repointed in NHL 3.5 St Astier lime.

The upper parts remain in cement and whilst there appears to be no significant problems with this, it would be wise, when funds allow to continue replacing cement pointing with lime.

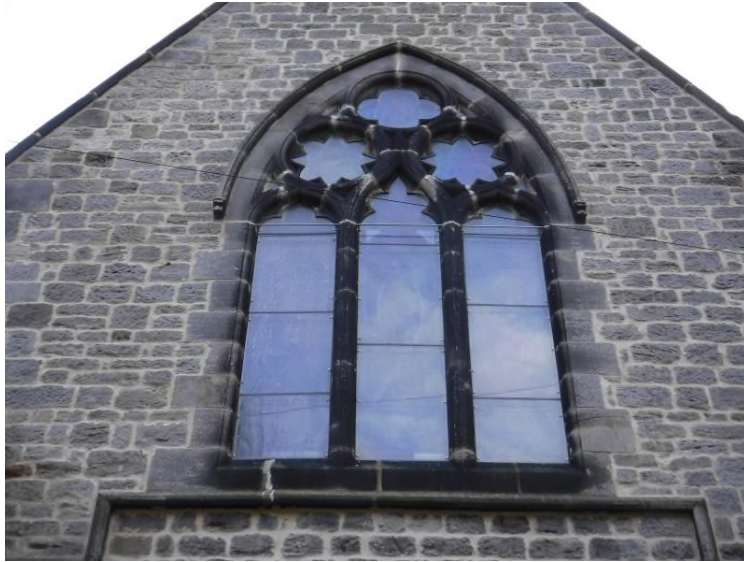
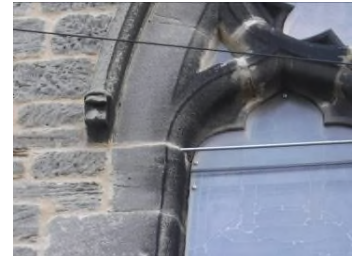
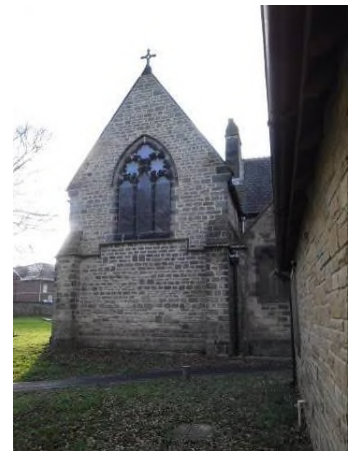
Chancel – No evidence of cracking at all now to the gable. The stainless steel rod inserted at the springing point of the arch looks good no movement at all there or cracking to the mortar and the polycarbonate covering looks good.

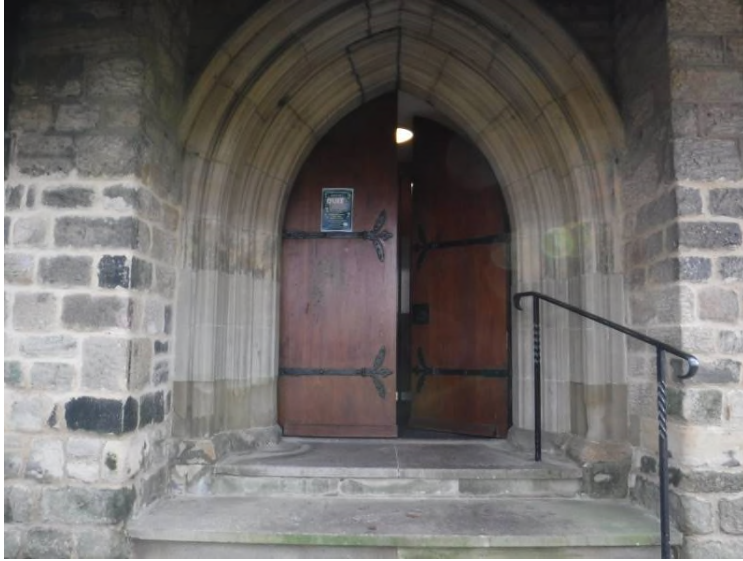
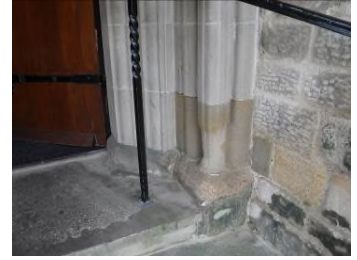
**Porch:**

The lower levels of this have been repointed, upper levels look ok. The arch moulding at low level has had some repairs in the past. There is more erosion but it will last another five years or so. Perhaps the ground works and repoint in lime at low level will slow down the erosion.

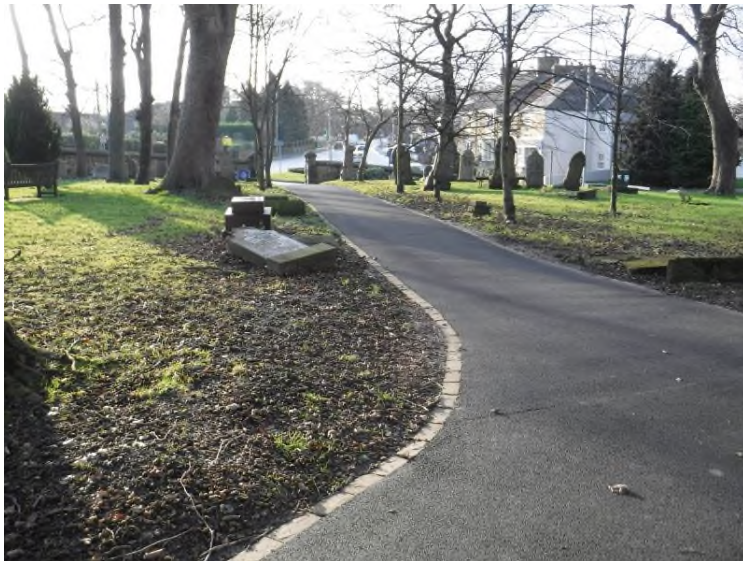
The churchyard is closed. A new tarmac drive and path to the south, it's all in good condition now. The graveyard is much tidier now than it has been for a long time, there are various memorials some which are laid down. Trees have been managed by the local authority.

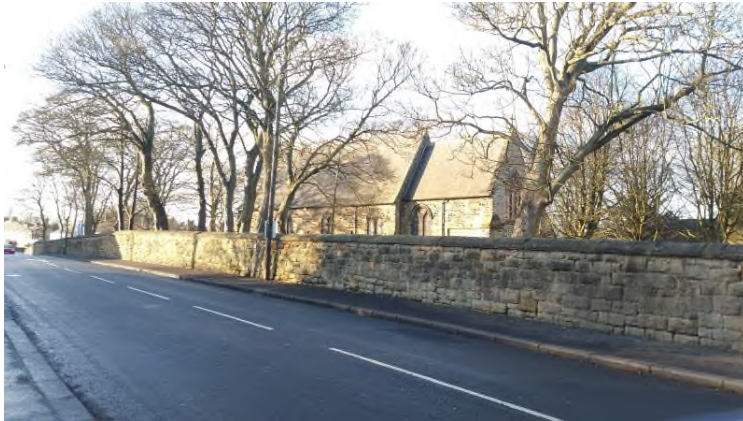
**Southside:**

Fine metal gate rusted into position now and has lost its bottom pin, not operating now it's lost its lock. The walling is generally sound and it's not been attacked by too much cement in the past, the local authority should be reminded that any repair works should be in lime.

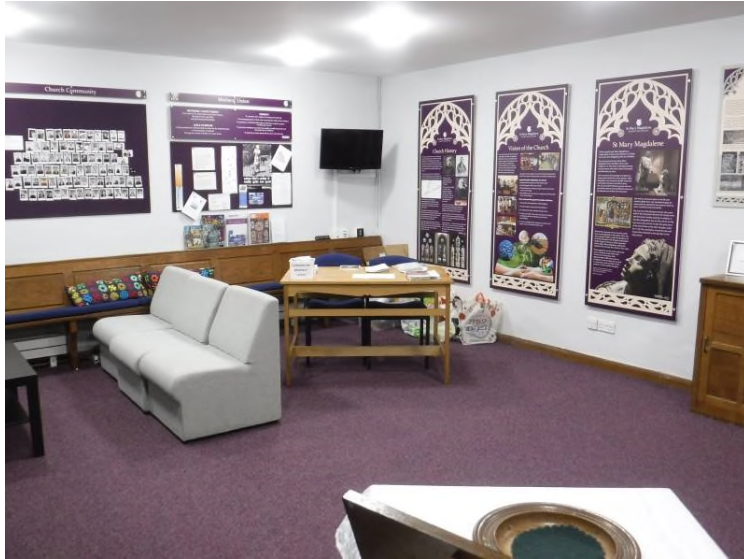
### C **Narthex:**

Recently refurbished as part of the GPOW works with new information boards. And redecorated with new carpet.

The doors to the nave are not closing well and need easing.

**Recommendation:** ease doors to nave

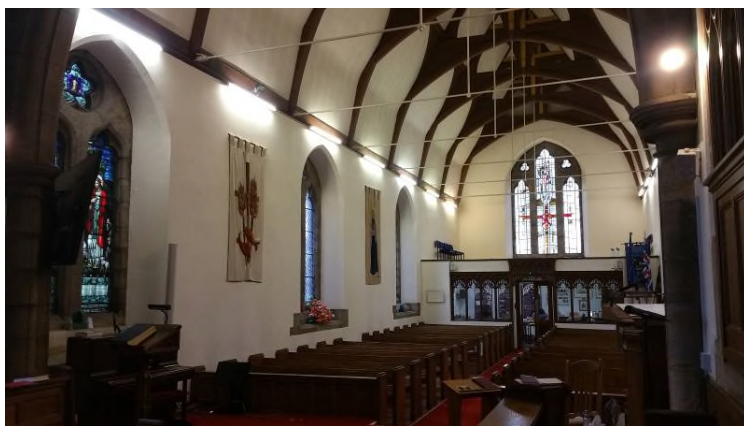
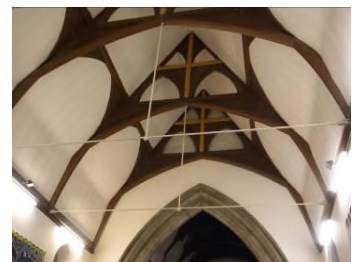
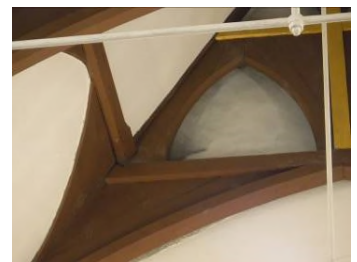
- **Nave:**

- **Ceiling** – Seven bay trussed ceiling with tie rods, the lower part of the ceiling showing ghosts of rafters indicating heat loss through ceiling. Slight hairline

cracking to some of the surface suggesting it might be plaster and lath. Decoration is looking a little tired now, there is some bloom on the painted timber work.

- **Walls** – Redecorated and looking in good condition. The lower parts of them behind the skirting heater units is a little rough and unfinished but rather difficult to attend to, is in the shadows and probably best left alone.
- **Floor** – Timber pew platforms level with the carpeted circulation, which is solid. There is a step up to the chancel arch in a suspended timber floor.
- **Windows** - Plate tracery windows, all clear glazed with diamond leaded patterns, apart from pictorial glass at the south eastern end, all in good condition.

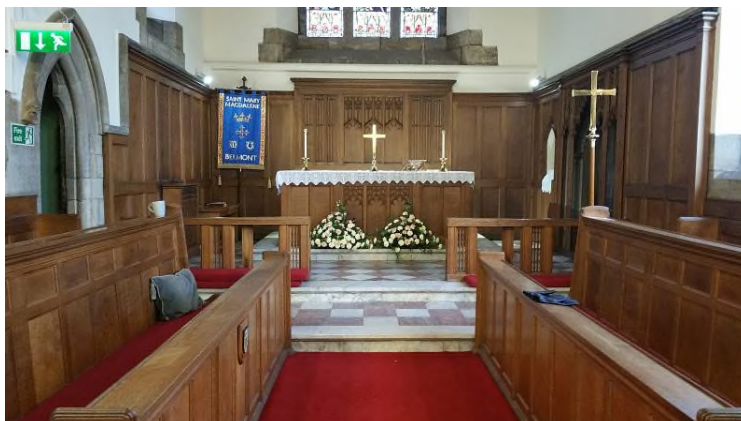
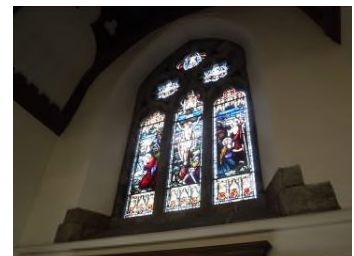
**Chancel:**

- **Ceiling** – Trussed roof a little like the nave but without the tie rods. This is also showing some ghosting on the decoration.
- **Walls** – redecorated.
- **Floor** – Is a combination of suspended timber and white and pink marble at the sanctuary, there is a couple of chips to the marble but generally ok.
- **Windows** – The east window condition is very good. The north and south windows are ok.
- **General** – Large organ recess, arch isn't visible behind the pipes but seemingly ok.
